BARE MITIGATION SITE ON AN UNNAMED TRIBUTARY TO PEAK CREEK, ASHE COUNTY

Year 5 Monitoring Report
Period Covered: June 16, 2005 – March 3, 2007

Prepared for the
North Carolina Ecosystem Enhancement Program

North Carolina Wildlife Resources Commission
Watershed Enhancement Group
Raleigh

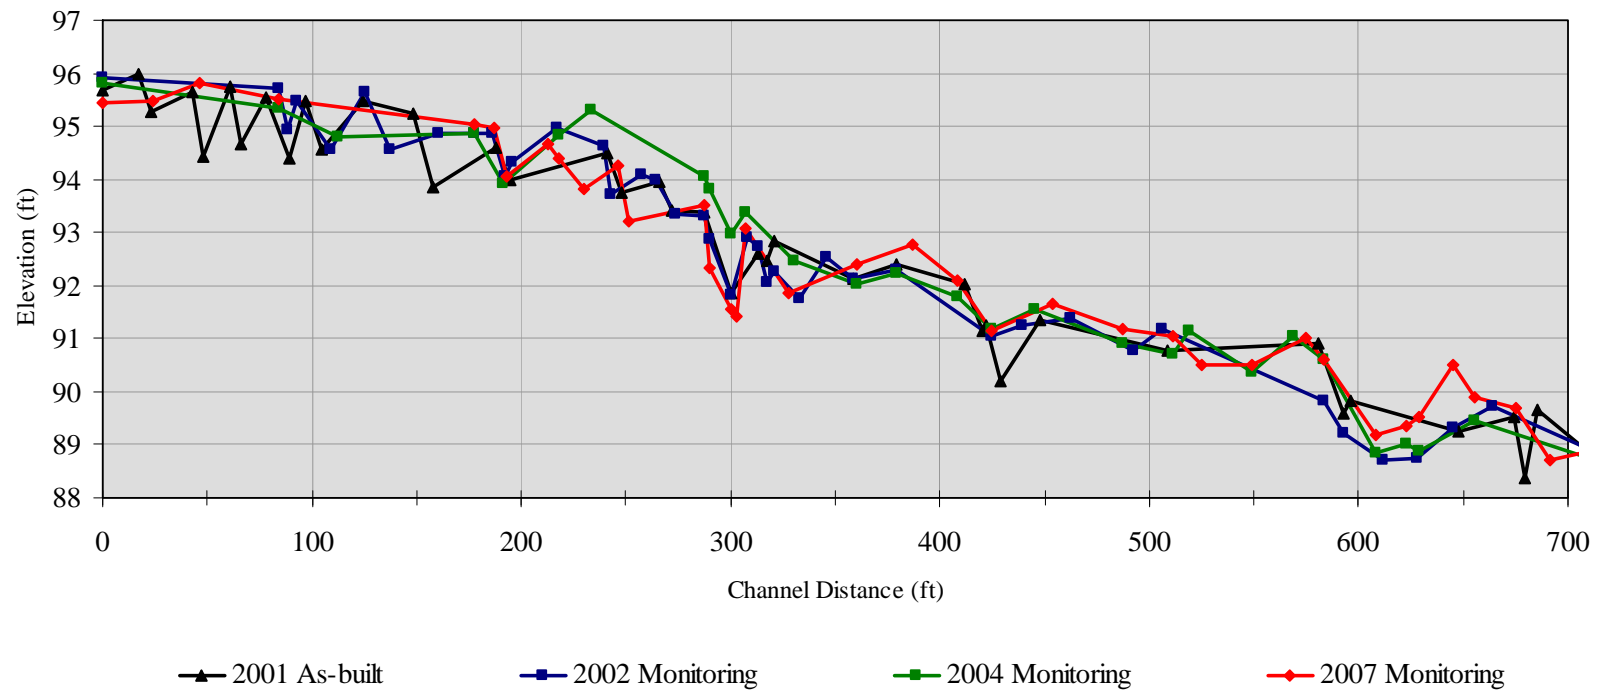
FIGURE 2.1.—Longitudinal profile from stations 0+00 to 7+00.

The 2007 longitudinal profile data revealed minor changes had occurred in the channel thalweg since the 2004 survey (Figure 2). From station 0+00 to 0+24 the thalweg has degraded

0.4 foot from all of the previous years' monitoring. From station 0+24 to 1+87 the channel continues to aggrade, filling in all of the pools created during construction. This is likely due to the erosion of soils from the riparian area upstream. That area has been disturbed by cattle grazing and mowing of the stream banks. It is interesting to note the formation of two pools from stations 2+13 to 2+46 and 2+46 to 2+87; and the pool between stations 2+87 and 3+07 is now deeper than it was at the time of the as-built survey. These changes could be attributed to the flood events associated with the series of hurricanes in September 2004; however, it is uncertain if this was the cause due to the lack of longitudinal profile survey data from 2005 and 2006. The thalweg has changed little from station 3+07 to 6+26 since the 2004 survey. From station 6+29 to 6+45 the channel has aggraded, shortening the pool, and creating a steeper riffle. The channel is similar to the previous years' surveys from station 6+45 to station 8+37. The pool at station 8+37 has deepened and lengthened and a riffle has formed at station 8+86. From station 8+86 to station 18+42 the channel elevations closely follow previous years. The 2004 survey documents the formation of a new pool at station 18+75; this year's survey reveals that the pool at that location has been filled in by channel bed material. This aggradation continues downstream to station 20+37. At that point, the channel reverses the trend and begins to degrade. At station 20+84 the channel deepens close to the 2001 as-built elevation, and at station 21+44 a new pool has formed, perhaps due to natural occurrences, or the rain events associated with the series of hurricanes in September 2004. These minor changes in the longitudinal profile appear to be natural occurrences and not because of instabilities caused by the stream enhancement activities. The 2007 survey ended at station 21+76 because the survey team believed that the end of the conservation easement fencing was the survey ending point.

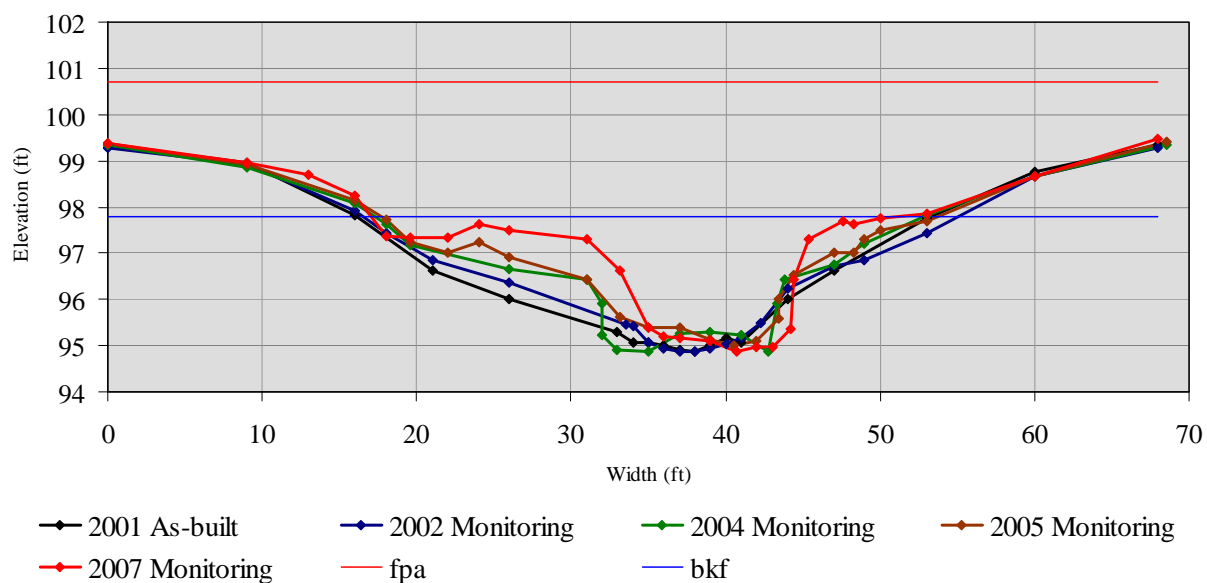
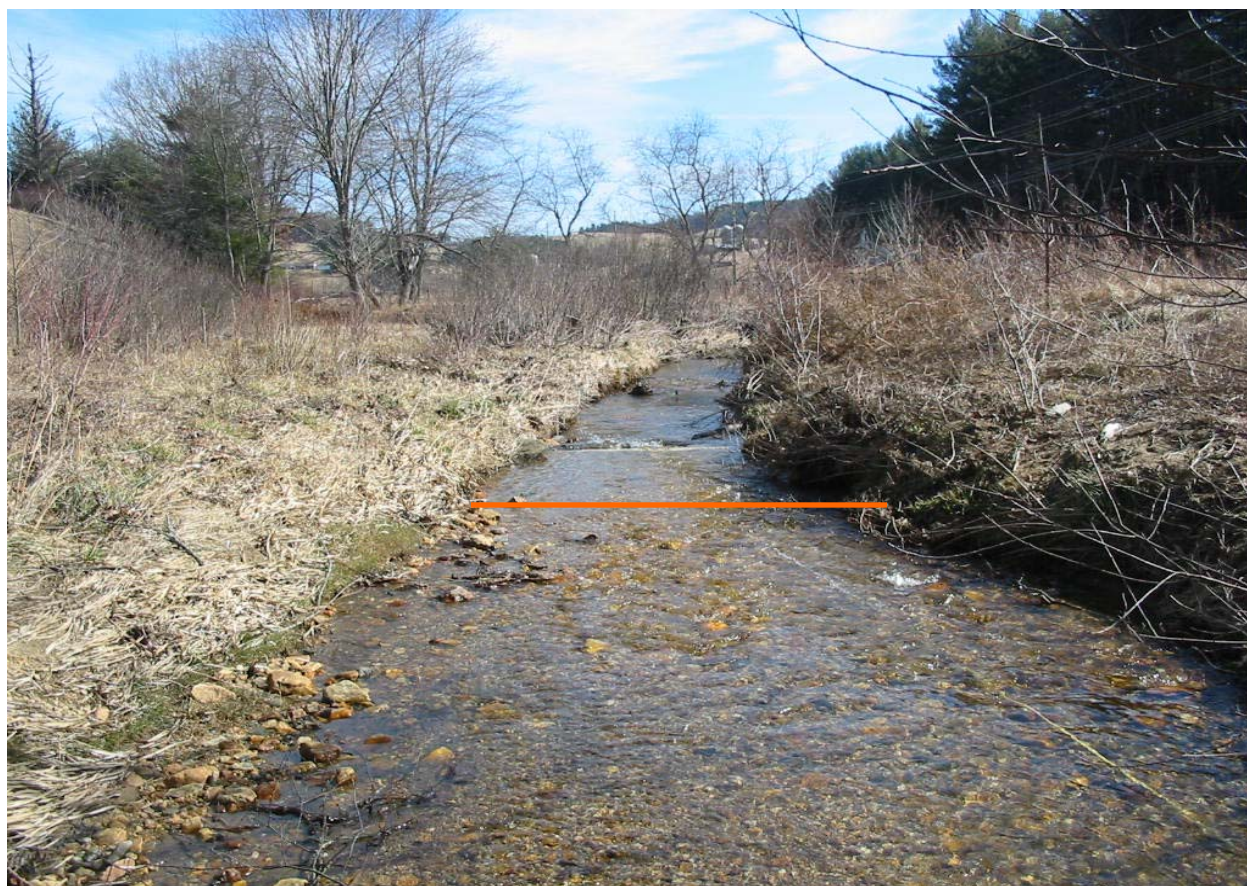
FIGURE 3.1.—Cross-section station 1+78, run.

CROSS-SECTION 1+78 – run (Figure 3.1): This cross-section transects a run that has evolved from a shallow pool. This change is attributable to the disturbance of the streambed where a livestock watering system supply line was repaired in 2004; and the three hurricanes of September 2004. The thalweg shifted from the center of the stream to the right bank. There appears to be some minor scour occurring on the right bank; however the bank was well vegetated, and did not show any significant signs of lateral movement. The streambanks continue to increase in height as a direct result of streambed materials being captured by the riparian vegetation during flood events.

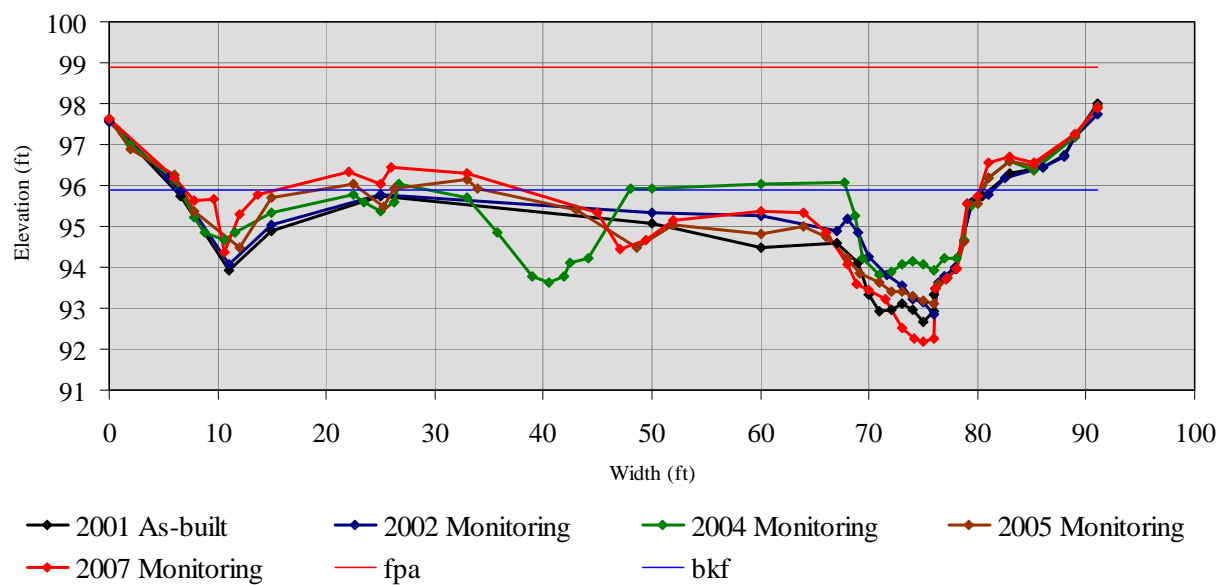
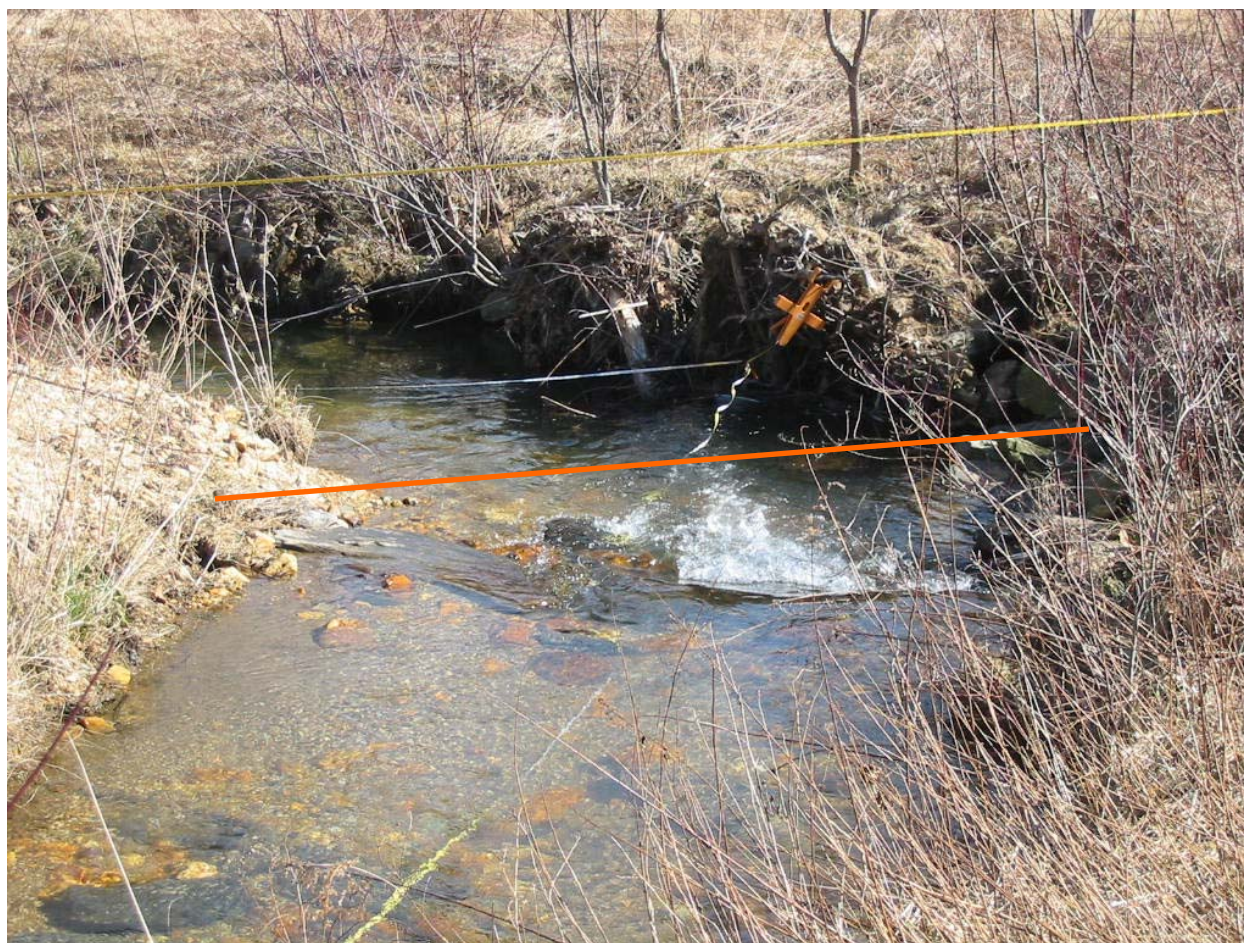
FIGURE 3.2.—Cross-section station 2+90, pool.

CROSS-SECTION 2+90 – pool (Figure 3.2): This cross-section transects a pool maintained by a rock vane and root wads. The pool has deepened below the 2001 as-built survey elevation, which could be credited to two storm events occurring between the 2005 and 2007 surveys producing flows $>4,000 \text{ ft}^3/\text{s}$ per second. The streambanks increased in height since the 2004 repairs (Mickey and Wasseen 2005a). This is attributable to streambed materials being captured

by riparian vegetation during flood events. The banks are stable and there has been no lateral shift in the stream channel.

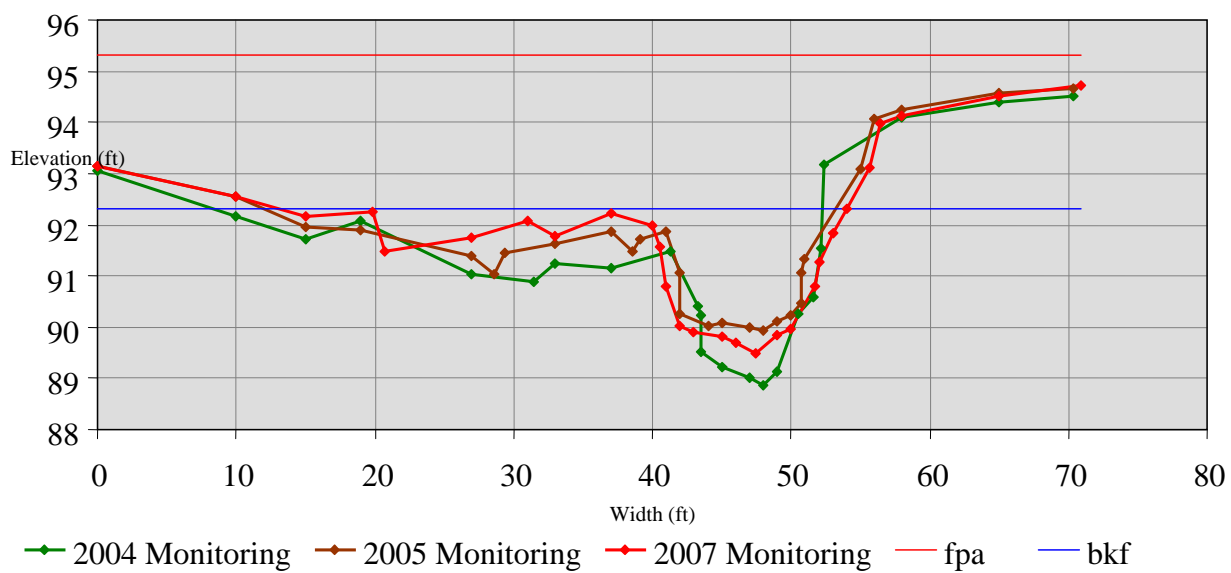
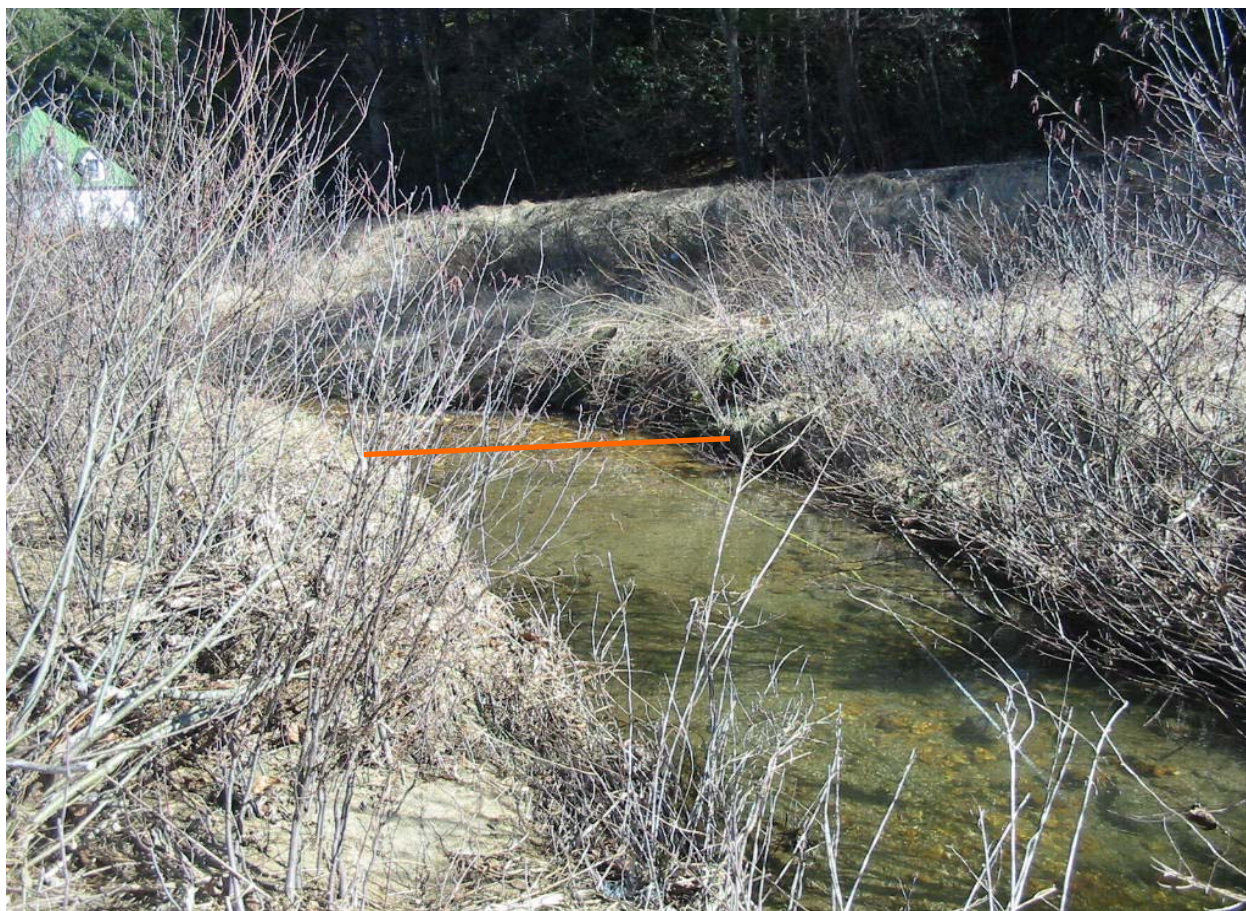
FIGURE 3.3.—Cross-section station 6+29, pool, new cross-section in 2004.

CROSS-SECTION 6+29 – pool (Figure 3.3): This cross-section transects a pool, and was added in 2004 to monitor repairs made to the vertical, eroding right bank. Both banks are exhibiting some erosion, but they are well vegetated and did not show any major signs of lateral movement. Pool depth has increased by 0.5 feet since the last survey.

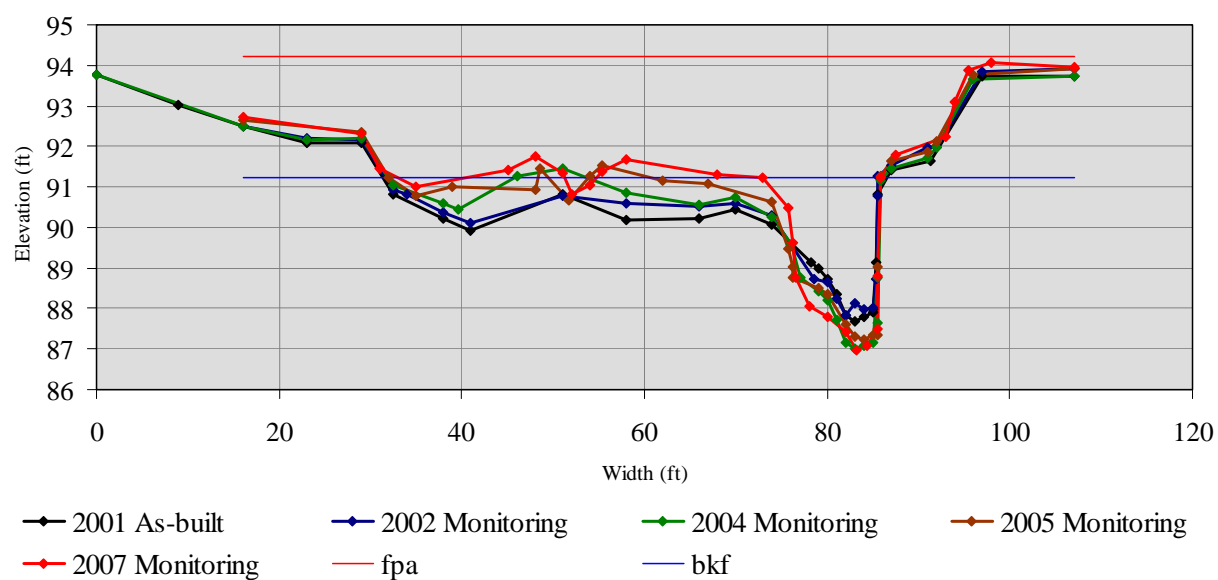
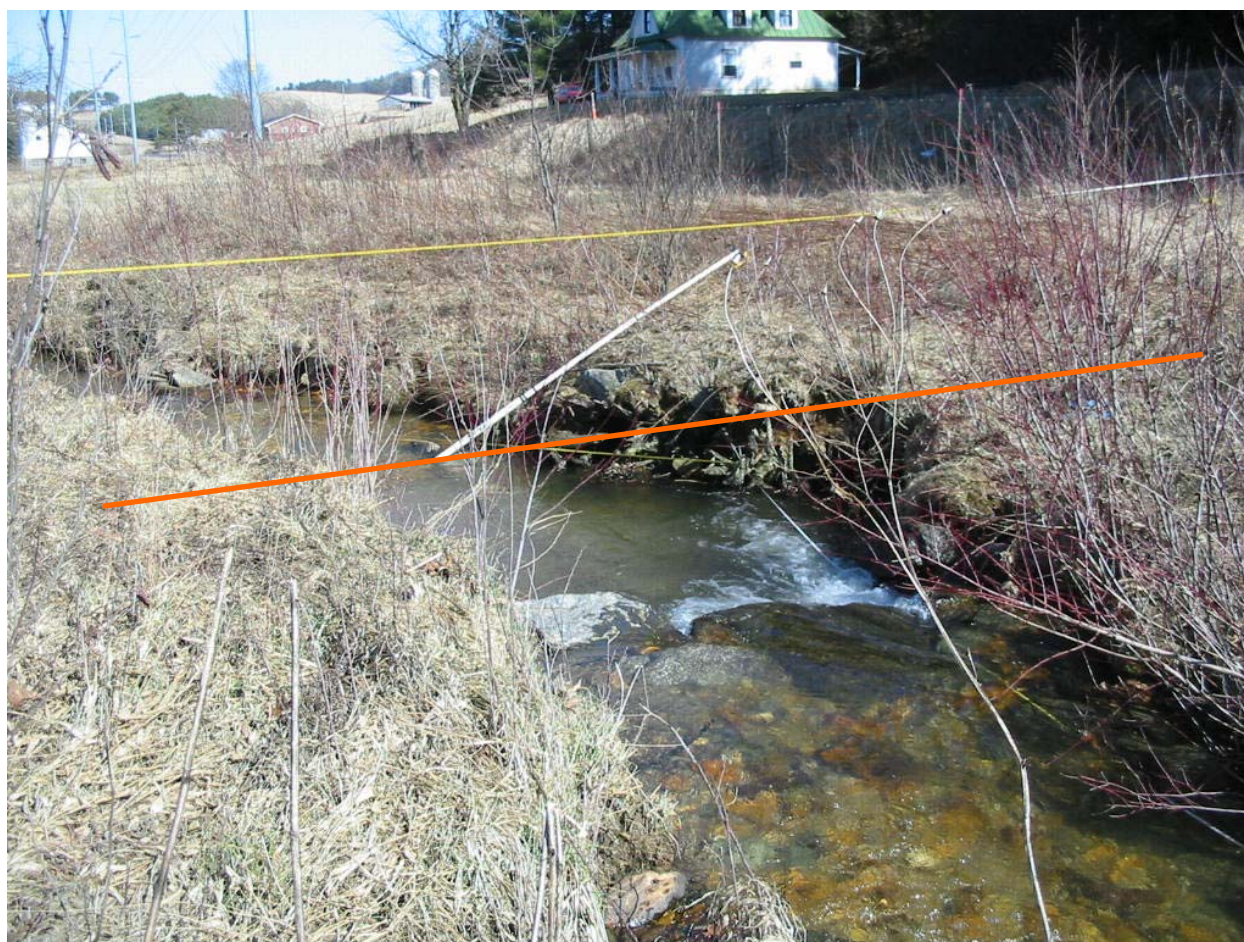
FIGURE 3.4.—Cross-section station 7+19, pool.

CROSS-SECTION 7+19 – pool (Figure 3.4): This cross-section transects a pool maintained by a cross-vane and root wads. The 2007 monitoring survey indicates no major changes from the 2005 survey. Point bar height has increased as streambed materials were captured by riparian vegetation during flood events. This cross-section has remained stable with no lateral movement observed along the stream banks.

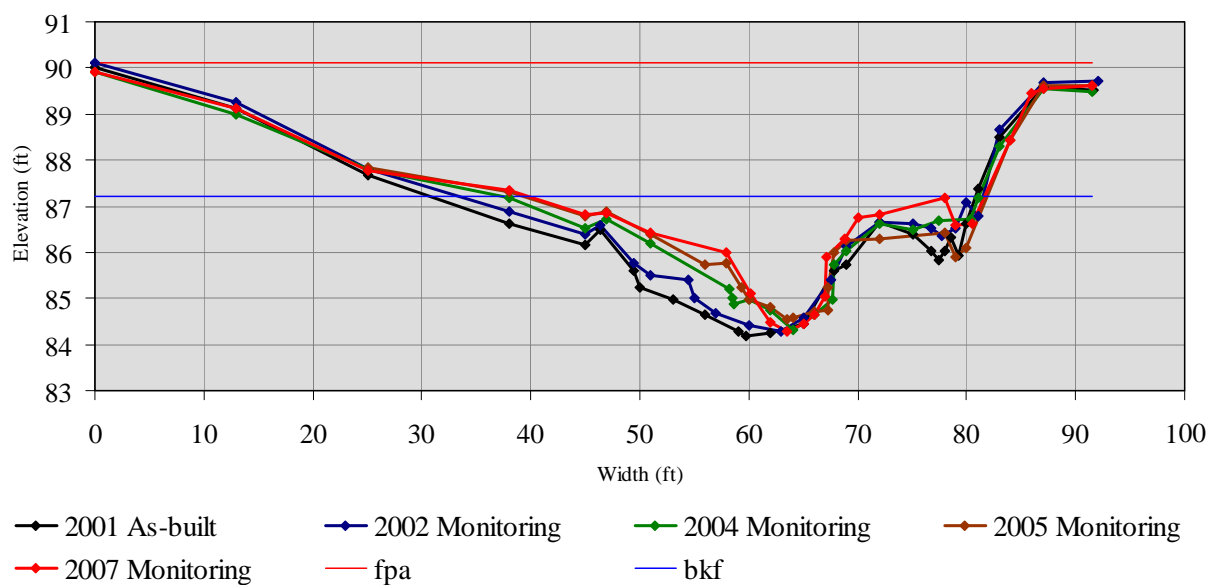
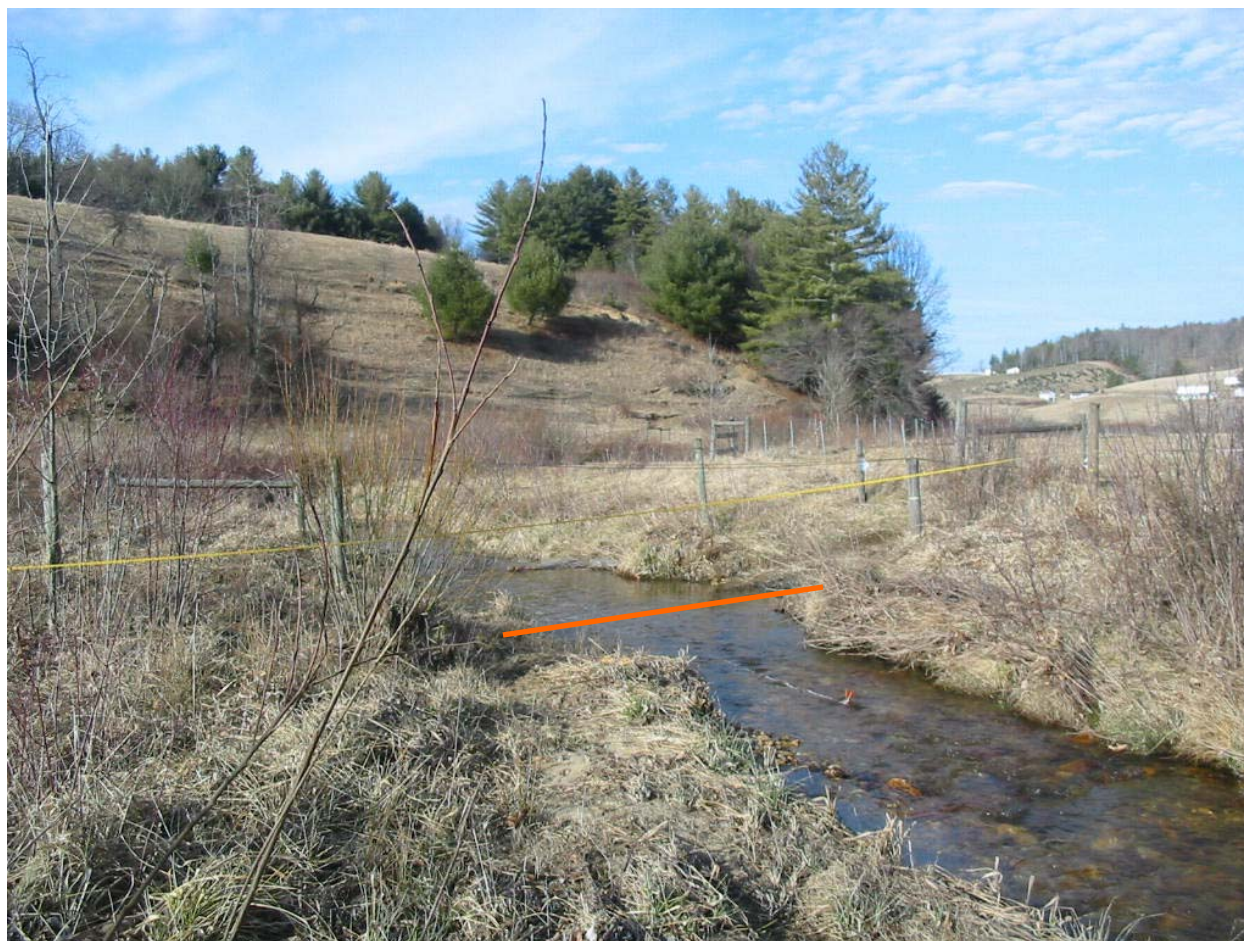
FIGURE 3.5.—Cross-section station 10+35, riffle

CROSS-SECTION 10+35 – riffle (Figure 3.5): This cross-section transects a stable riffle immediately upstream of the lower livestock crossing located at longitudinal profile station 10+64. No in-stream channel modifications were made at this site in order to monitor the natural recovery of the channel once livestock were excluded from the riparian zone. The wetted stream width as measured from water's edge to water's edge at base flow (elevation approximately 85.2 feet) narrowed from 18.3 feet in 2001, to 8.0 feet in 2005, and then to 7.0 feet in 2007. Vegetation along the left bank continues to trap streambed materials during bankfull and flood events, effectively narrowing the wetted perimeter of the channel. The right bank has remained stable.

An existing drainage ditch is present from location 0+78 to 0+80 on the cross-section. The landowner requested and was granted permission in 2005 to clean out the ditch to alleviate hydrologic trespass impacts to her pastures. The 2007 survey revealed the ditch is filling back in; however, the left bank of the ditch is increasing in height.

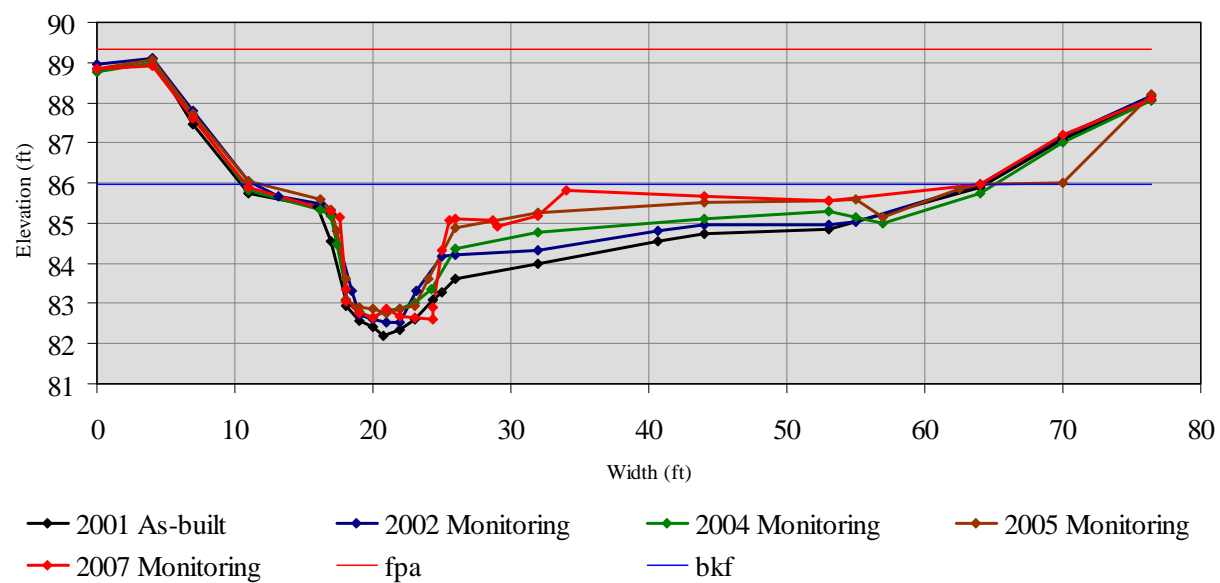
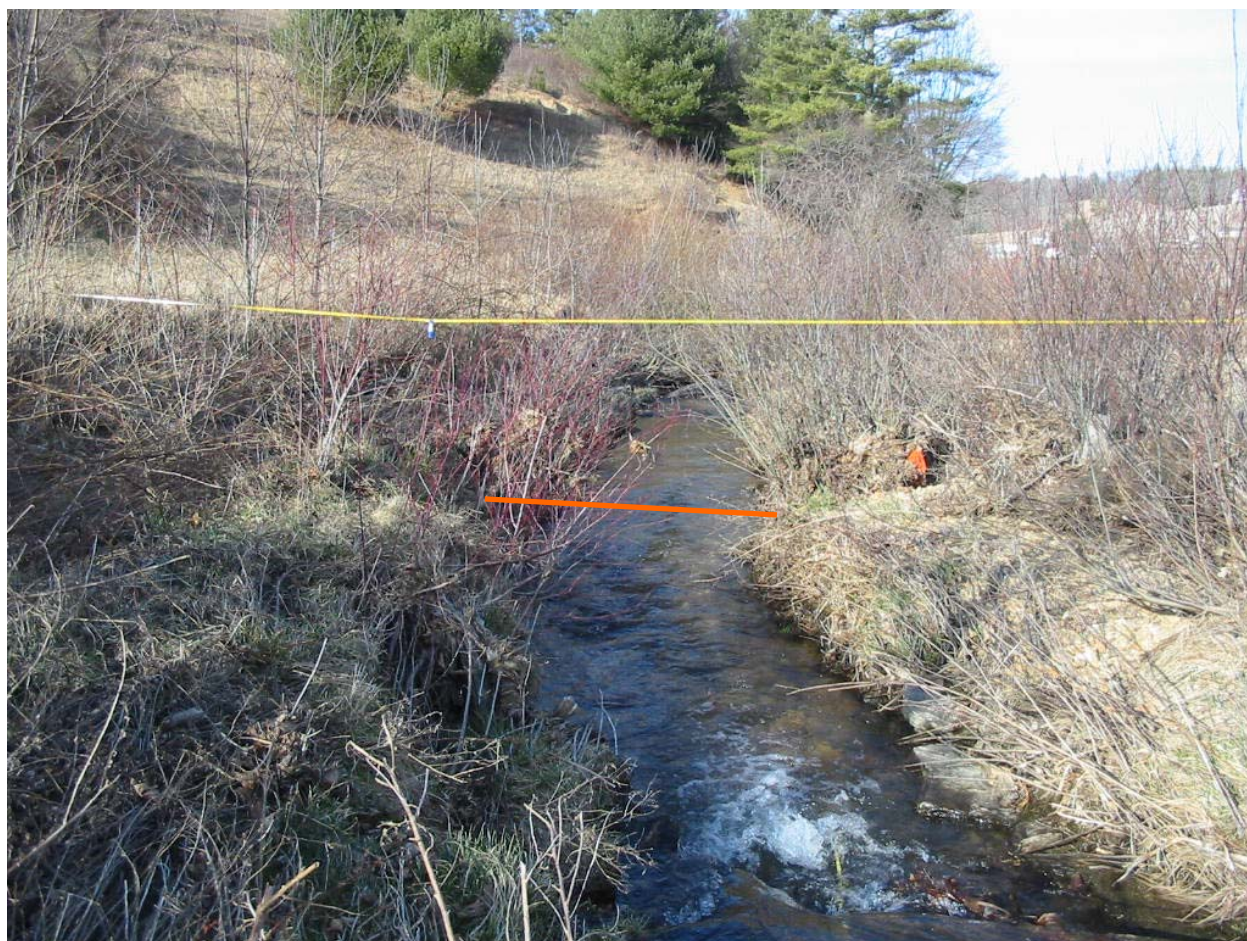
FIGURE 3.6.—Cross-section station 11+68, riffle.

CROSS-SECTION 11+68 – riffle (Figure 3.6): This cross-section transects a riffle that has a high left bank and a long, sloping point bar on the right bank. The left bank has remained stable. From 2001 to 2007 the point bar on the right bank has increased up to 1.5 feet in height from location 0+26 to 0+64 on this cross-section. This is a direct result of streambed materials being captured by riparian vegetation during flood events. While there has been some adjustment in the thalweg and right point bar, the stream banks are stable with no lateral movement. During the 2005 survey there appears to be an incorrect rod reading at location 0+70.

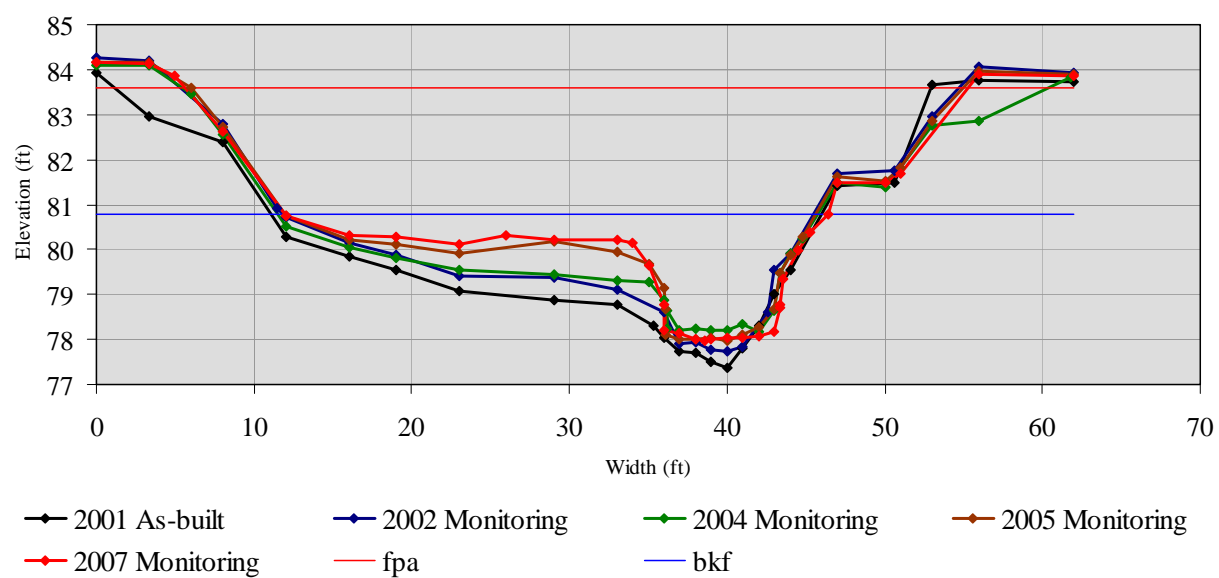
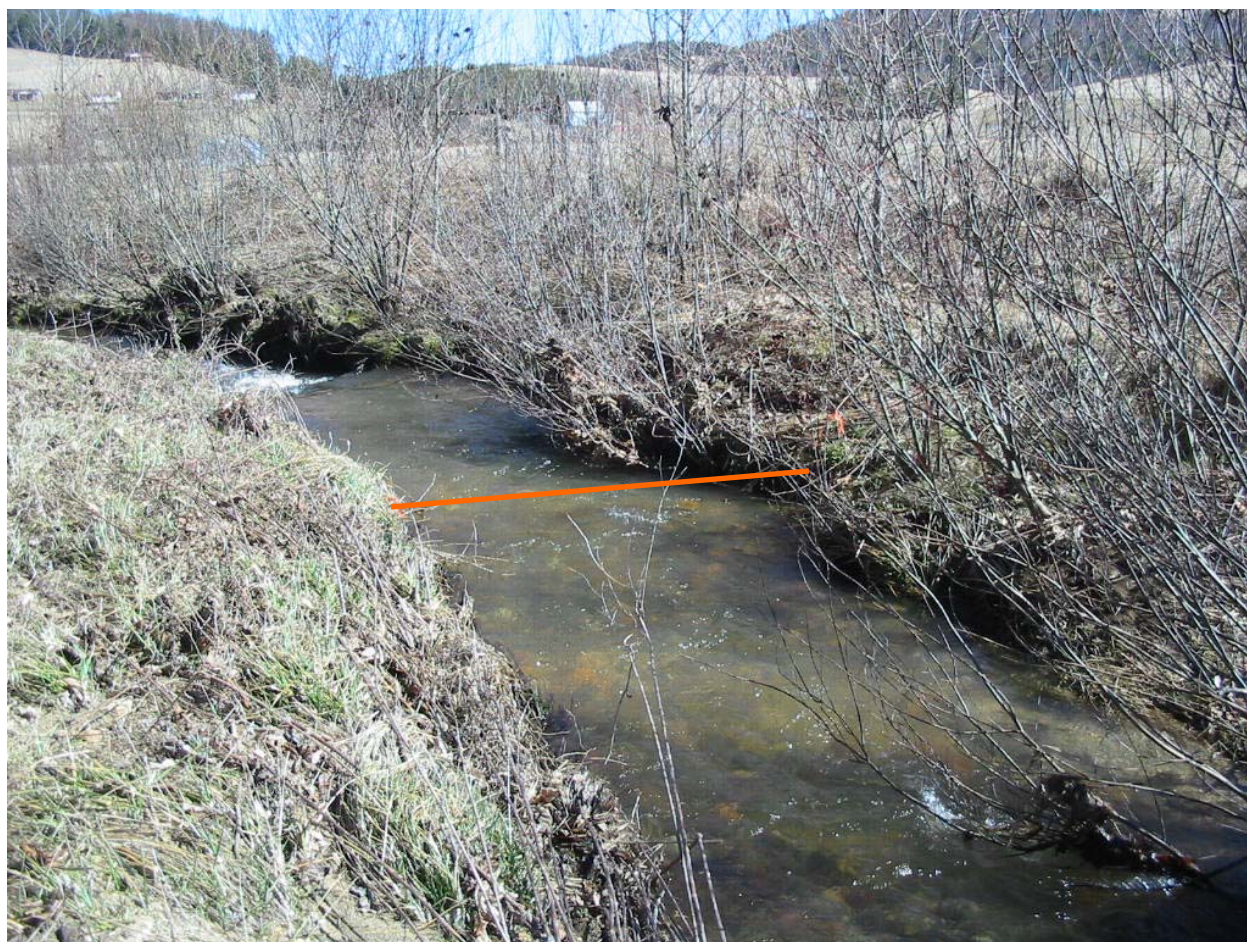
FIGURE 3.7.—Cross-section station 16+81, riffle.

CROSS-SECTION 16+81 – riffle (Figure 3.7): This cross-section transects a riffle that has a high right bank and long, sloping point bar on the left bank. The left point bar continues to increase in height as a direct result of streambed materials being captured by riparian vegetation during flood events. This cross-section has remained stable with no lateral movement along the stream banks. During the 2004 survey there appears to be an incorrect rod reading at location 0+56.

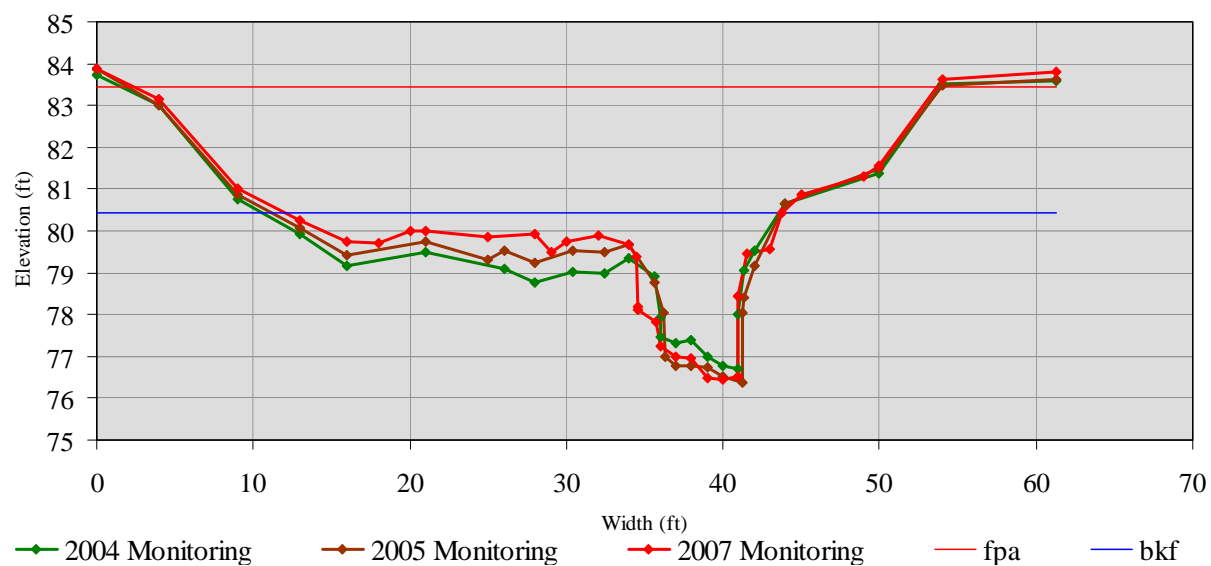
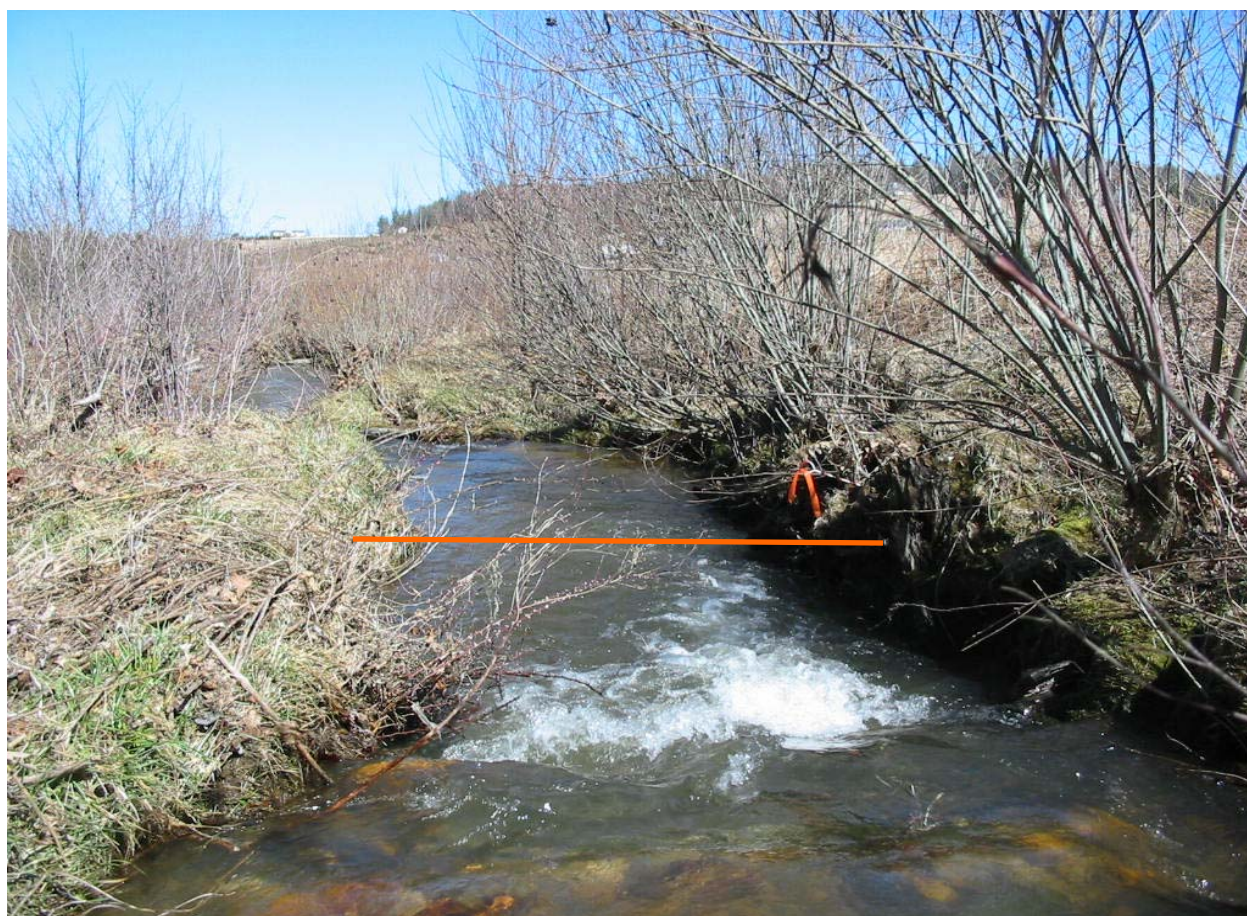
FIGURE 3.8.—Cross-section station 17+08, pool, new cross-section in 2004.

CROSS-SECTION 17+08 – pool (Figure 3.8): This cross-section transects a pool maintained by root wads. It was first surveyed in 2004 to monitor the pool formed by the root wads used to stabilize the bank. The 2007 monitoring survey indicates the left bank has exhibited some erosion from location 0+34 to 0+35 on the cross-section. There has been a slight deepening of the pool. The left point bar is increasing in height due to the deposition of streambed materials being captured by riparian vegetation during flood events.

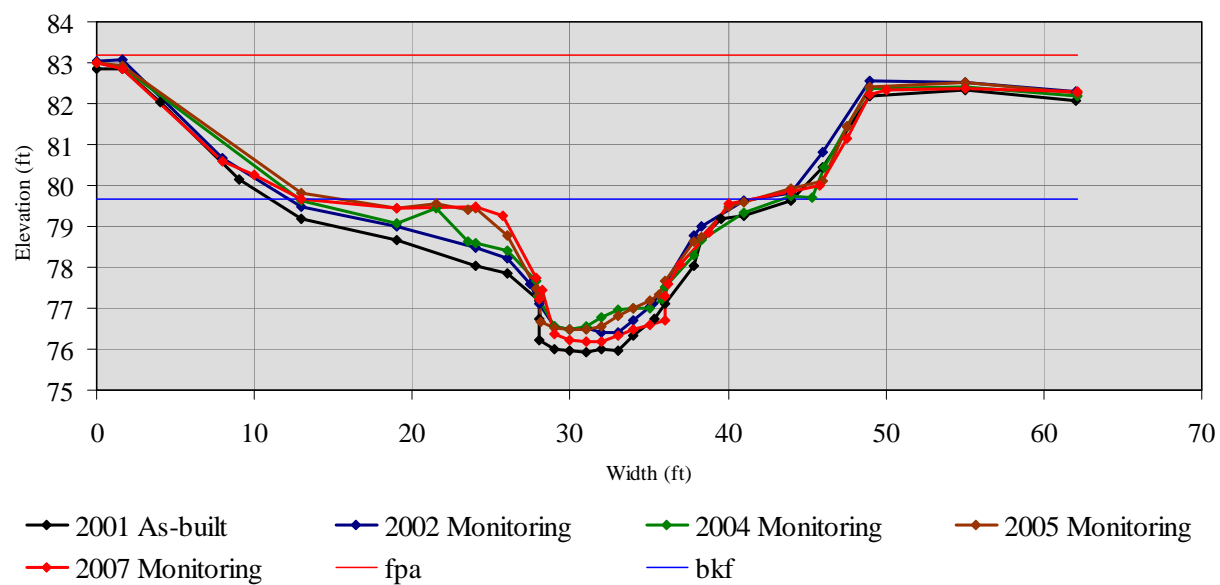
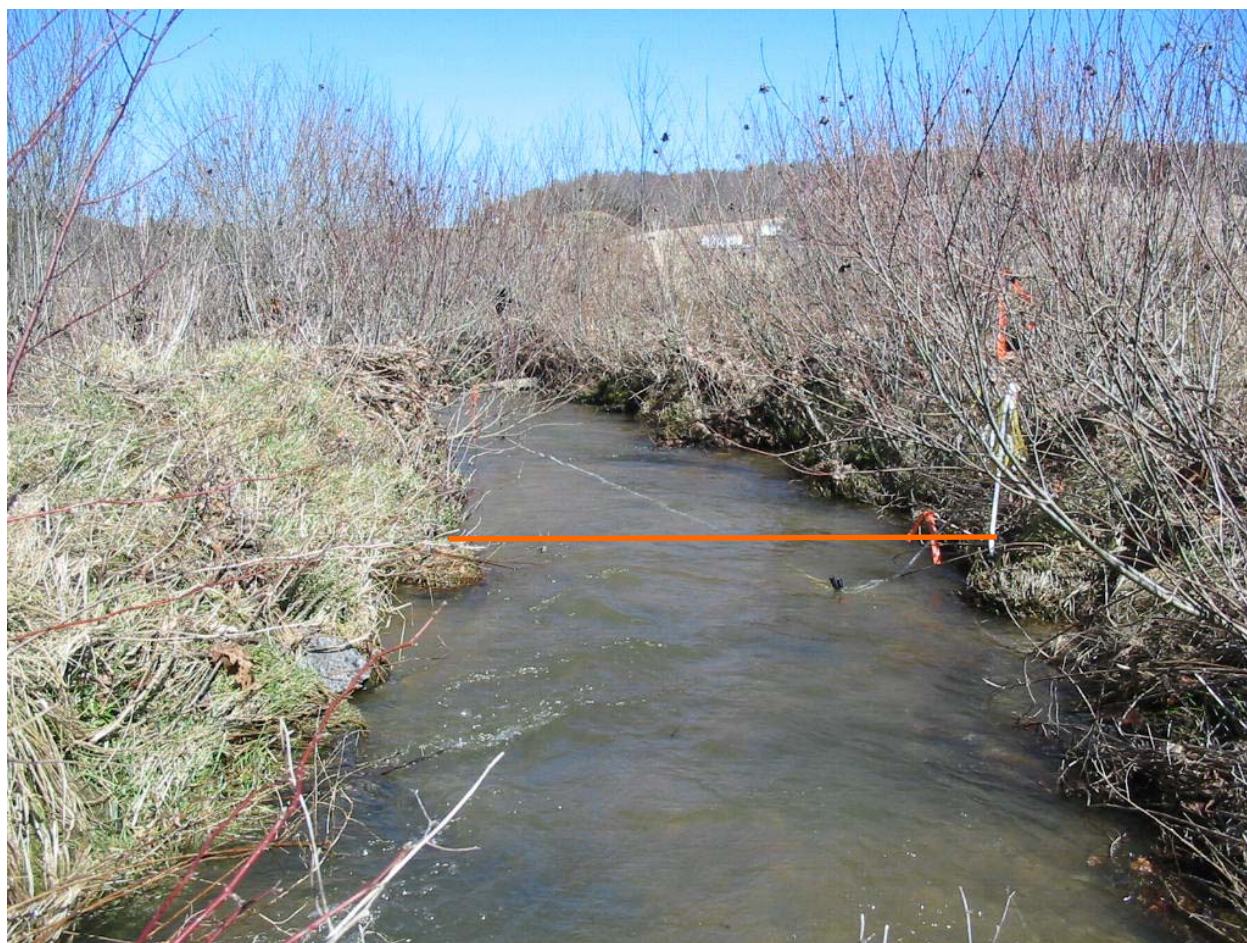
FIGURE 3.9.—Cross-section station 17+57, run.

CROSS-SECTION 17+57 – run (Figure 3.9): This cross-section transects a riffle/run complex below a rock weir. Both banks exhibited minor increases in height due to the deposition of streambed materials being captured by riparian vegetation during flood events. The thalweg at this site has remained stable since 2002. The banks are stable and there has been no lateral shift in the stream channel.

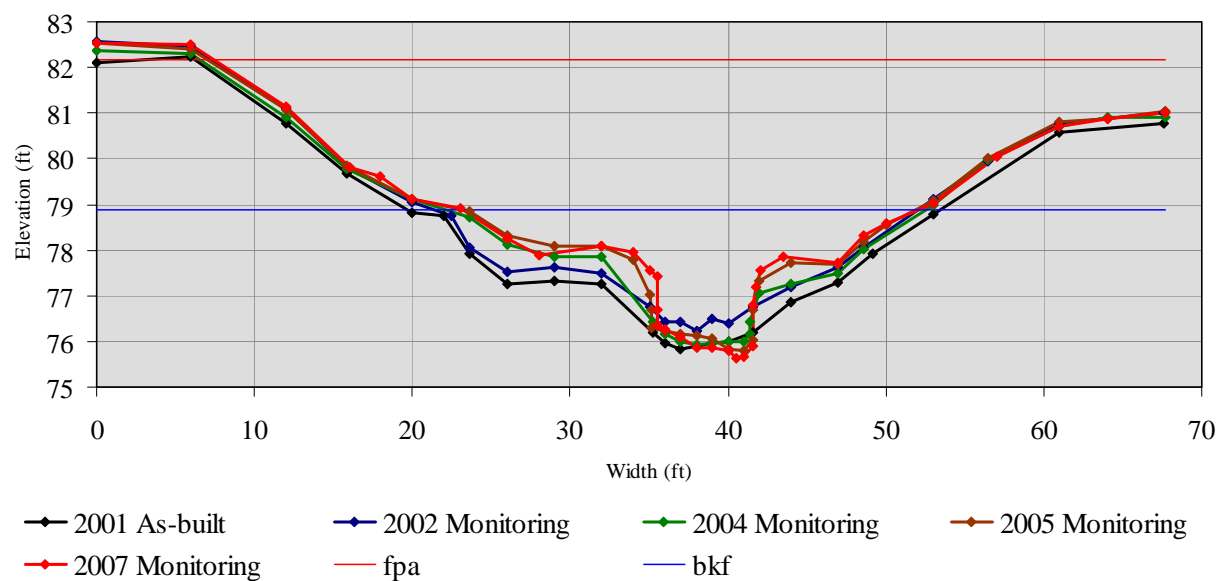
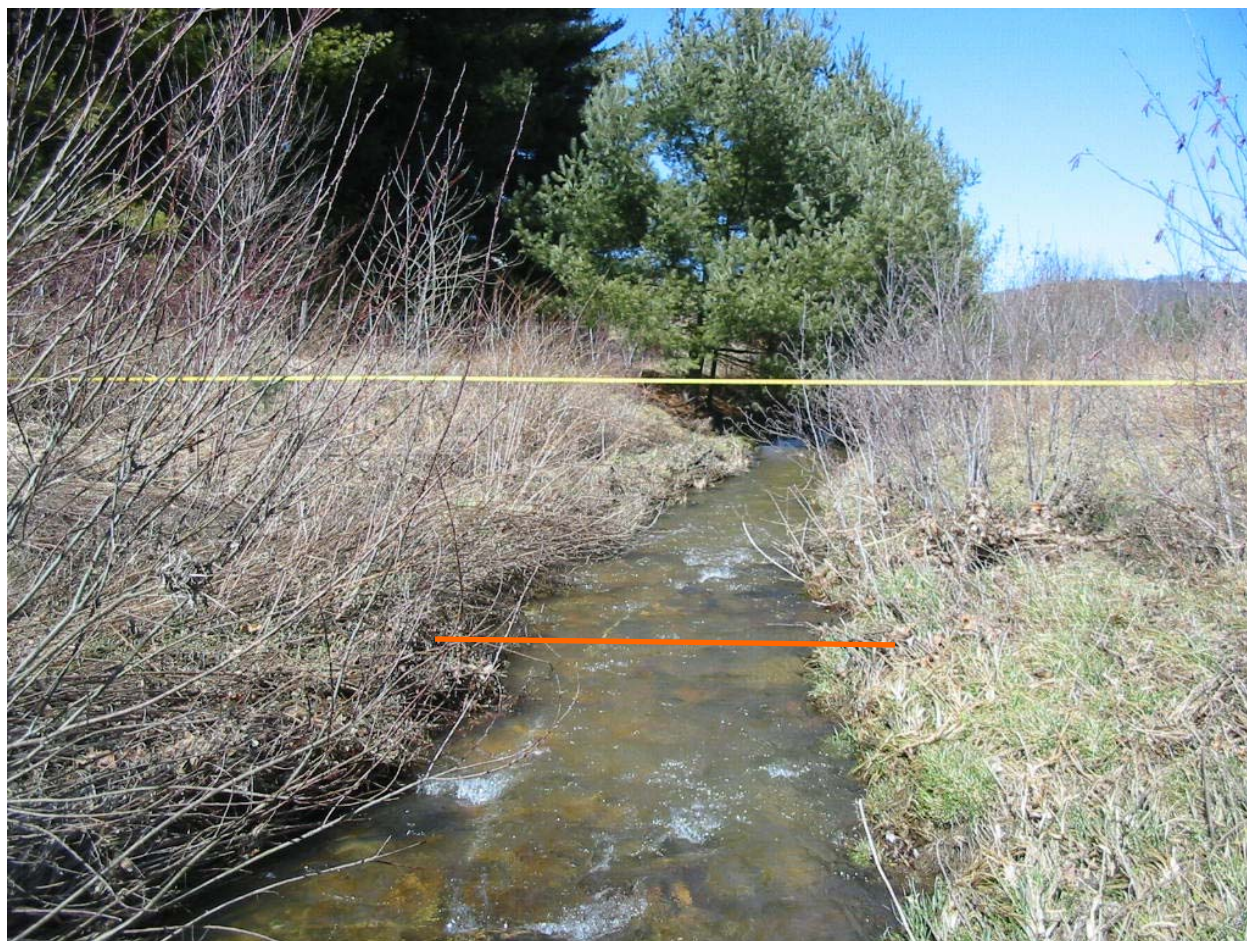
FIGURE 3.10.—Cross-section station 18+42, riffle.

CROSS-SECTION 18+42 – riffle (Figure 3.10): This cross-section transects a stable riffle. Enhancement activities in 2001 consisted of minor grading along the top of the right bank. The thalweg and stream bottom profile have remained stable. Both banks increased in height due to the deposition of streambed materials being captured by riparian vegetation during flood events.
