BARE MITIGATION SITE ON AN UNNAMED TRIBUTARY TO PEAK CREEK, ASHE COUNTY

Year 5 Monitoring Report
Period Covered: June 16, 2005 – March 3, 2007

Prepared for the
North Carolina Ecosystem Enhancement Program

North Carolina Wildlife Resources Commission
Watershed Enhancement Group
Raleigh

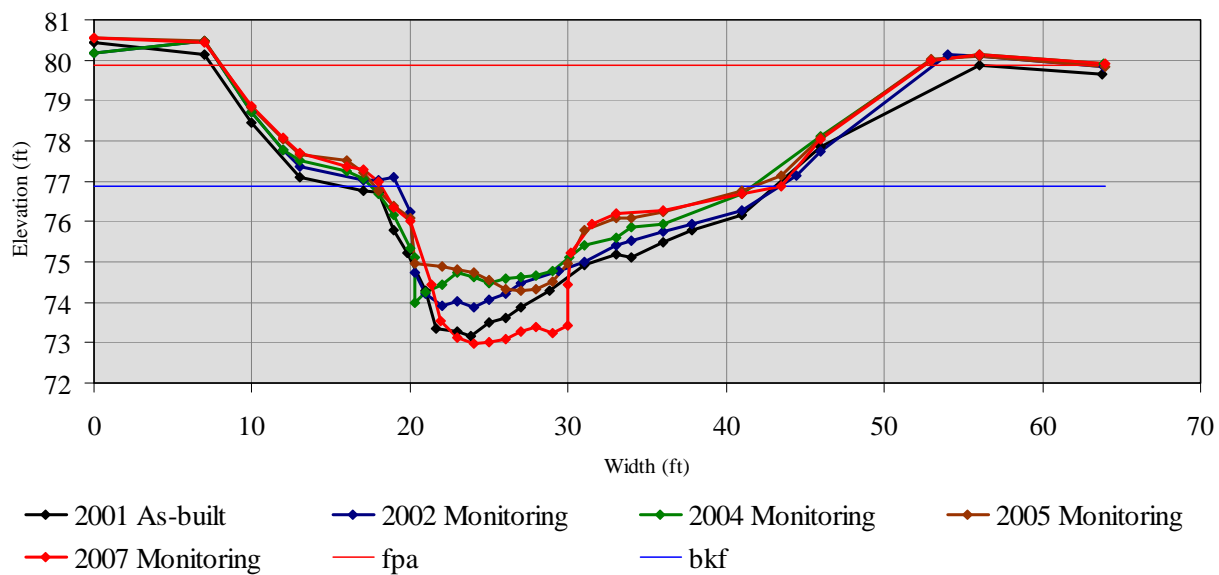
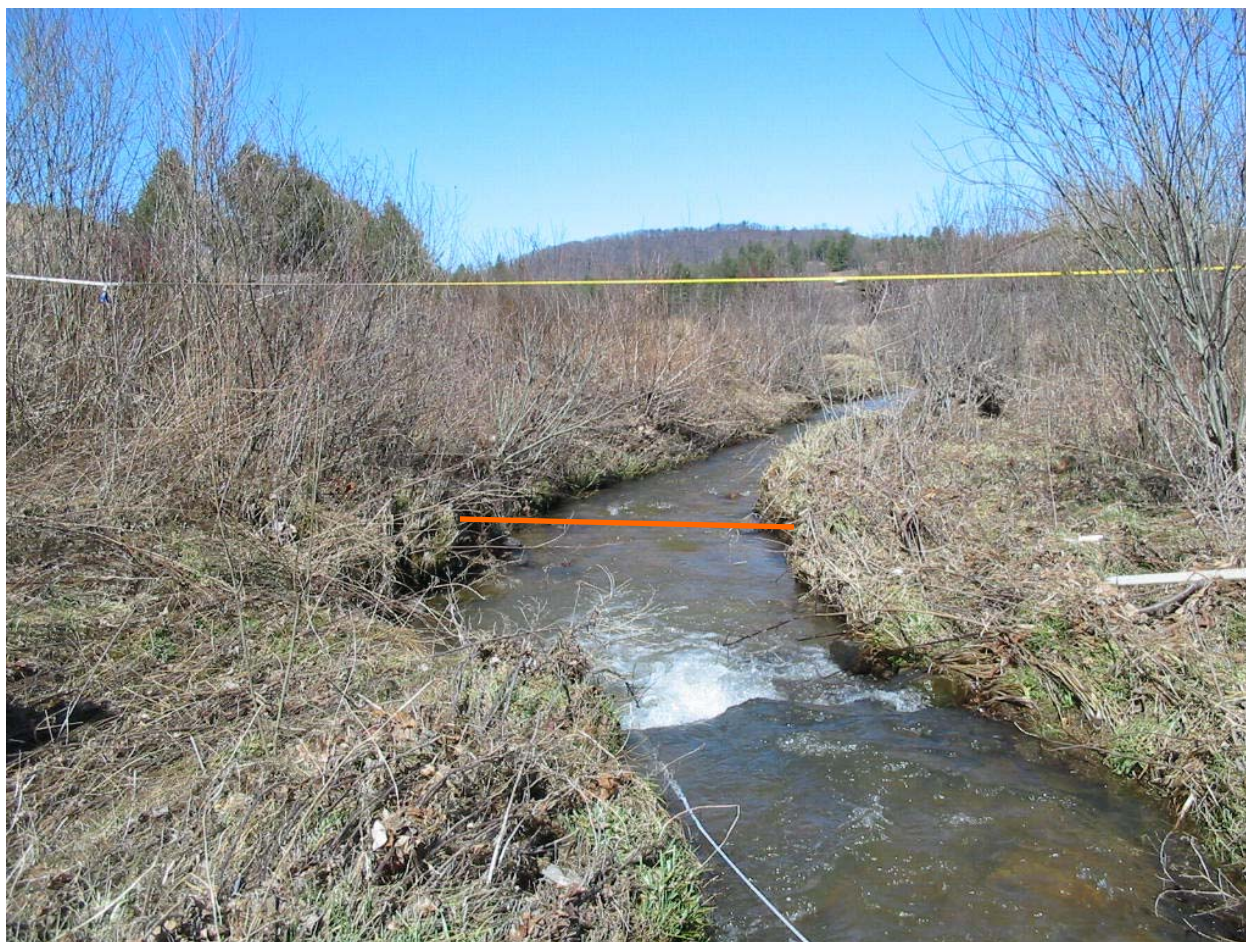
FIGURE 3.11.—Cross-section station 20+80, pool.

CROSS-SECTION 20+80 – pool (Figure 3.11): This cross-section transects a constructed pool stabilized with root wads. By 2005, this pool had aggraded 1.2 feet since its construction in 2001; however, in 2007 the pool had deepened 1.8 feet, which is slightly below the level found during the as-built survey. Both banks have increased in height due to the deposition of streambed materials being captured by riparian vegetation during flood events.

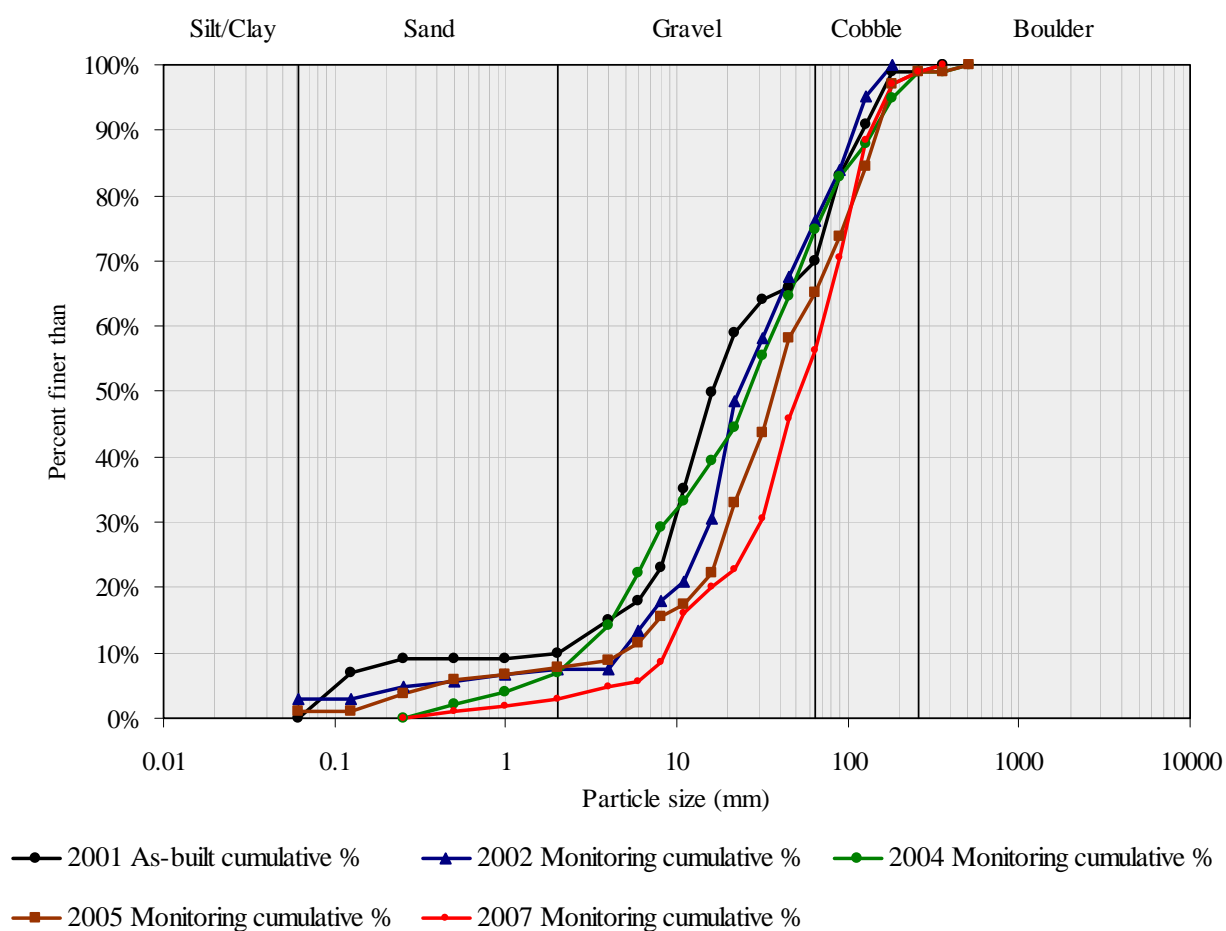
FIGURE 4.—Pebble count comparisons, Bare site, UT to Peak Creek, New River drainage, Ashe County, 2001-2007.

Pebble count data were collected from a riffle at cross-section 18+42 (Figure 4). Substrate analysis indicates an increasing trend in all particle sizes, from 2001 to 2007. Since 2001 the D_{50} has coarsened from medium (16 mm), to coarse (27 mm), to very coarse (52 mm) gravel. The increase in particle size, especially the D_{50} , is probably a result of the channel narrowing, which increases sediment transport competence. The D_{84} and D_{95} fluctuated very little from year to year; however, from 2001 to 2007 the particle sizes were generally increasing. The fluctuations in the D_{84} and D_{95} size class indexes are normal and can be attributed to flood events where sediment was transported from disturbed land higher in the watershed.

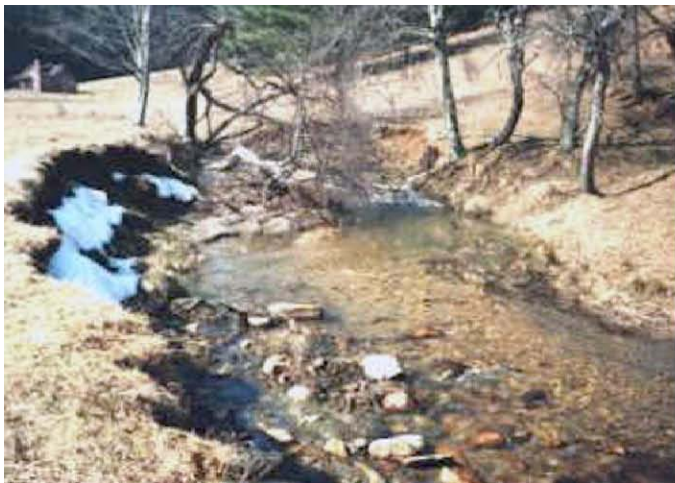
Eroding bank before construction, March 3, 2000.
