EEP Project Closeout Summary

Project Name/Number: Payne Dairy (Jumping Run Creek)
EEP ID 279
County: Alexander
Project Type: Stream Restoration, Enhancement
Wetland Preservation
Current Status: 5 Years of Monitoring complete

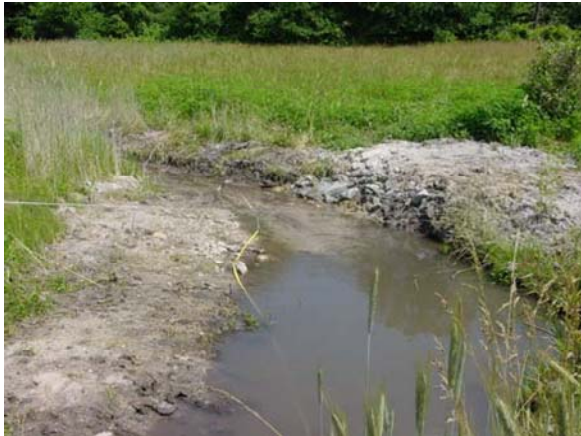
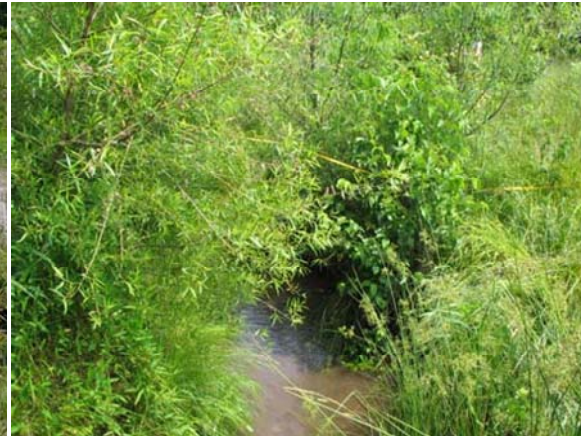
Photo point #3, view upstream at pool X-section.

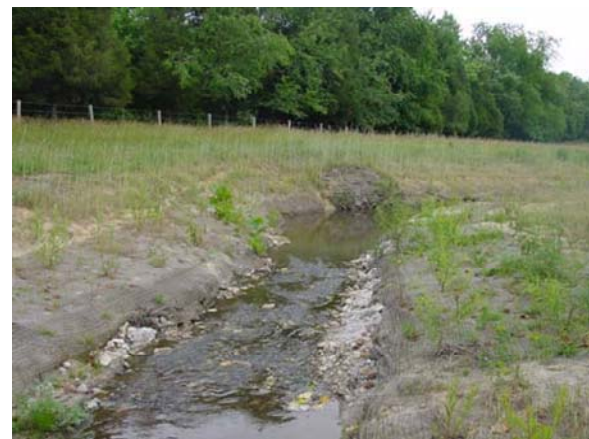
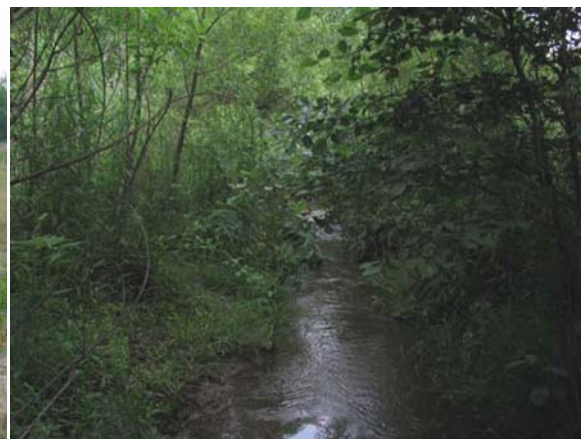
Photo point #40, view downstream near Henry Road.

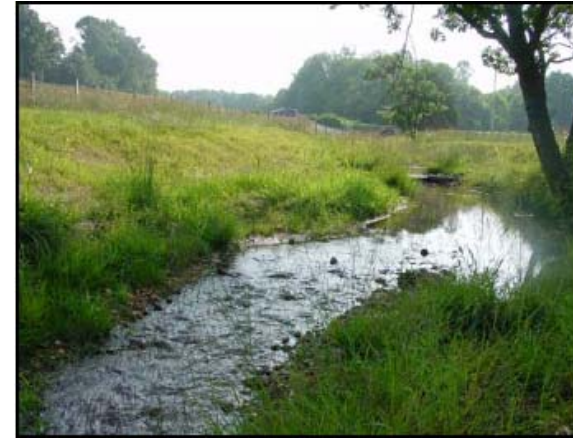
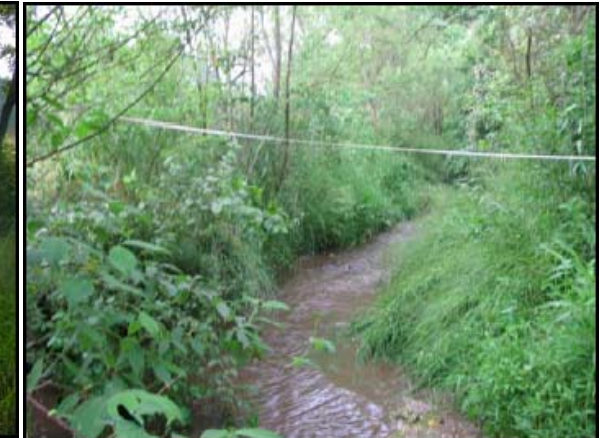
Photo point # 48, Upstream Pool View

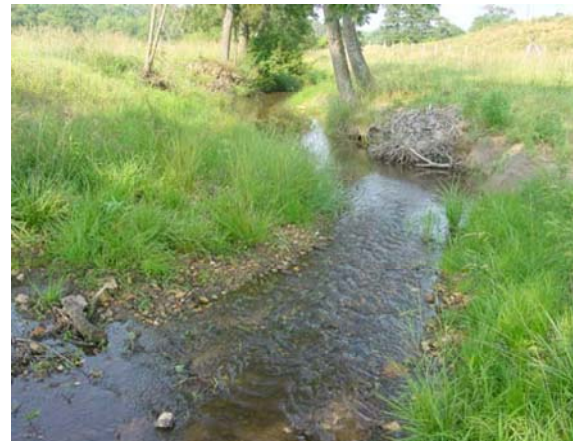
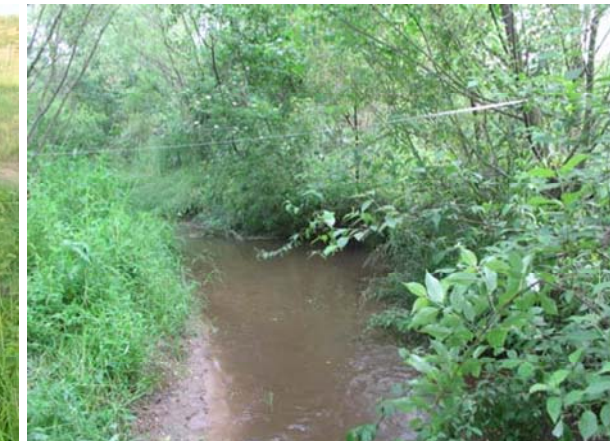
Photo point #49, view downstream at riffle X-section.

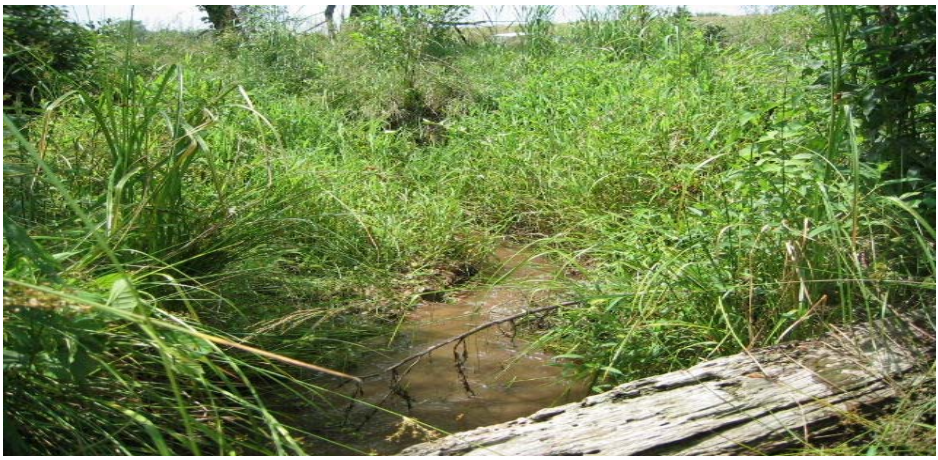
Figure 4. Area 1 Riffle cross-section typifying the development of an inner-berm feature

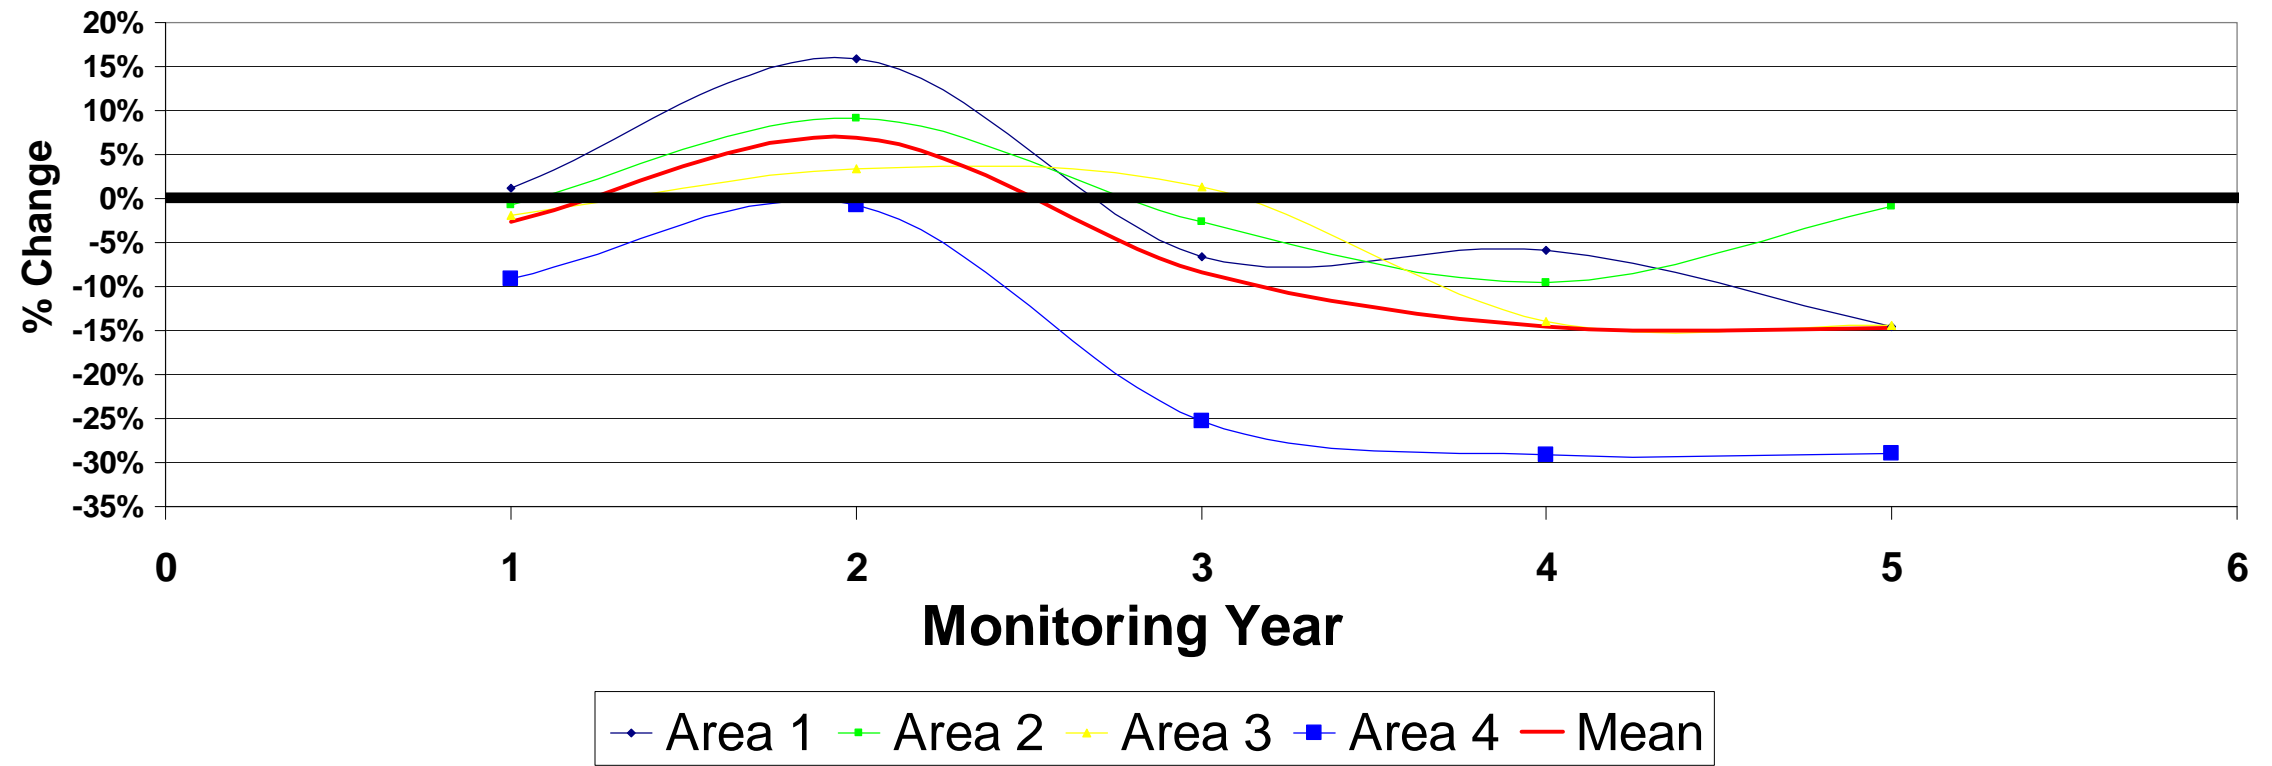
Figure 5. Percent change from As-built cross-sectional area

In order for the reach dimension to be considered stable, the change in the cross-sectional area should not be unidirectional and the amplitude in the variation should not increase over the 5-year monitoring period. A stream's cross-section may exhibit an initial adjustment before a stable variation pattern can be observed around some new point of equilibrium. This is often due to the fact that there is some level of uncertainty in any stream design, and the vegetation often takes 2-3 years to exert significant influence on the channel. The above plot includes the percent change relative to the as-built for each of the 4 project riffle cross-sections. The mean is also included. The project's cross-sectional area generally demonstrated a healthy pattern of variability. After an initial moderate increase in the cross-section between years 1 and 2, the cross-section generally decreased with the development of an inner berm depositional feature, effectively narrowing the channel. This condition was particularly evident in the cross-section from area 4. The onset of very dense vegetation was coincident with this decrease in area in Year 3. This adjustment was followed by a lower level of variation in years 4 and 5, indicating the cross-section has likely reached a stable equilibrium. The observed pattern indicates that the intended floodplain access was provided and maintained. Maintenance of a mean entrenchment ratio of approximately 5 over the 4 riffle cross-sections supports this observation.

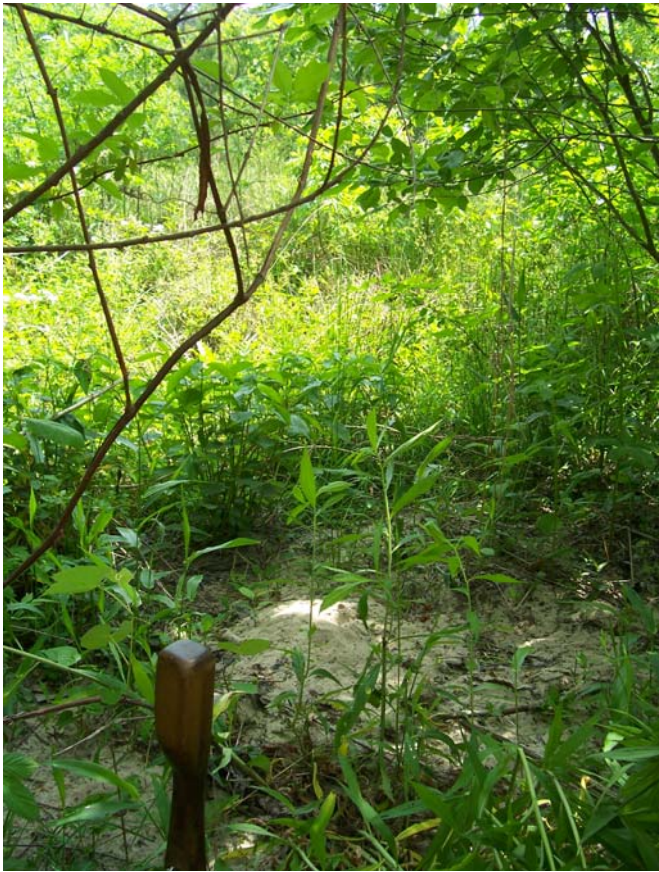
Figure 7. Fresh overbank deposition near top of project (2007).

There is evidence of recent deposition and wrack along the project reach (see Figure 7).
