EEP Project Closeout Summary

Project Name/Number: Reedy Branch
EEP ID: 301
County: Alamance
Project Type: Stream Restoration,
Current Status: 5 Years of Monitoring complete

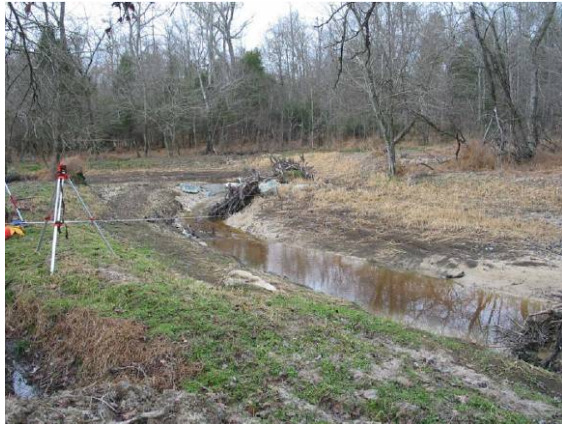
Cross Section #1. View upstream

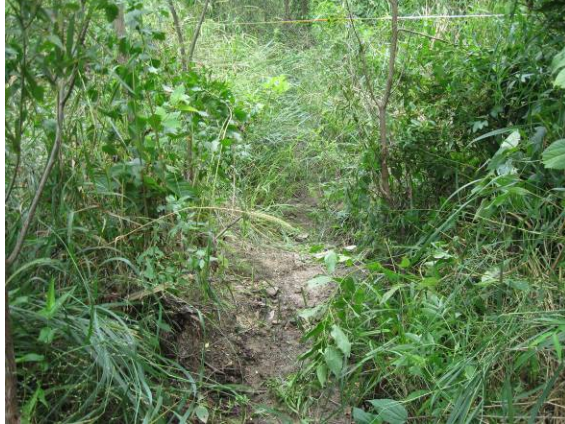
Cross Section #1. View upstream within channel.

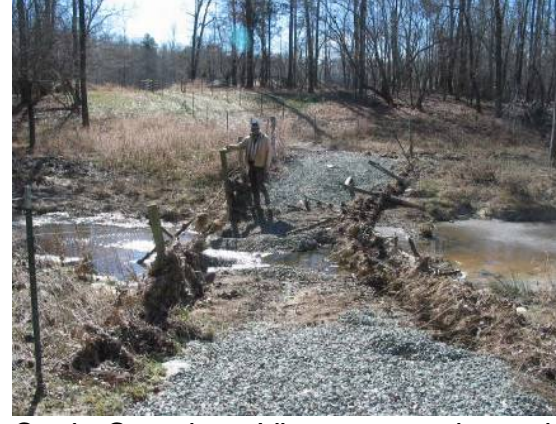
Cattle Crossing. View across channel from right bank.

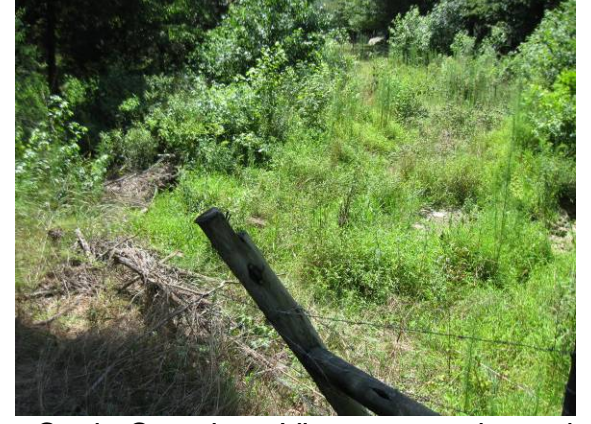
Cattle Crossing. View across channel from right bank.

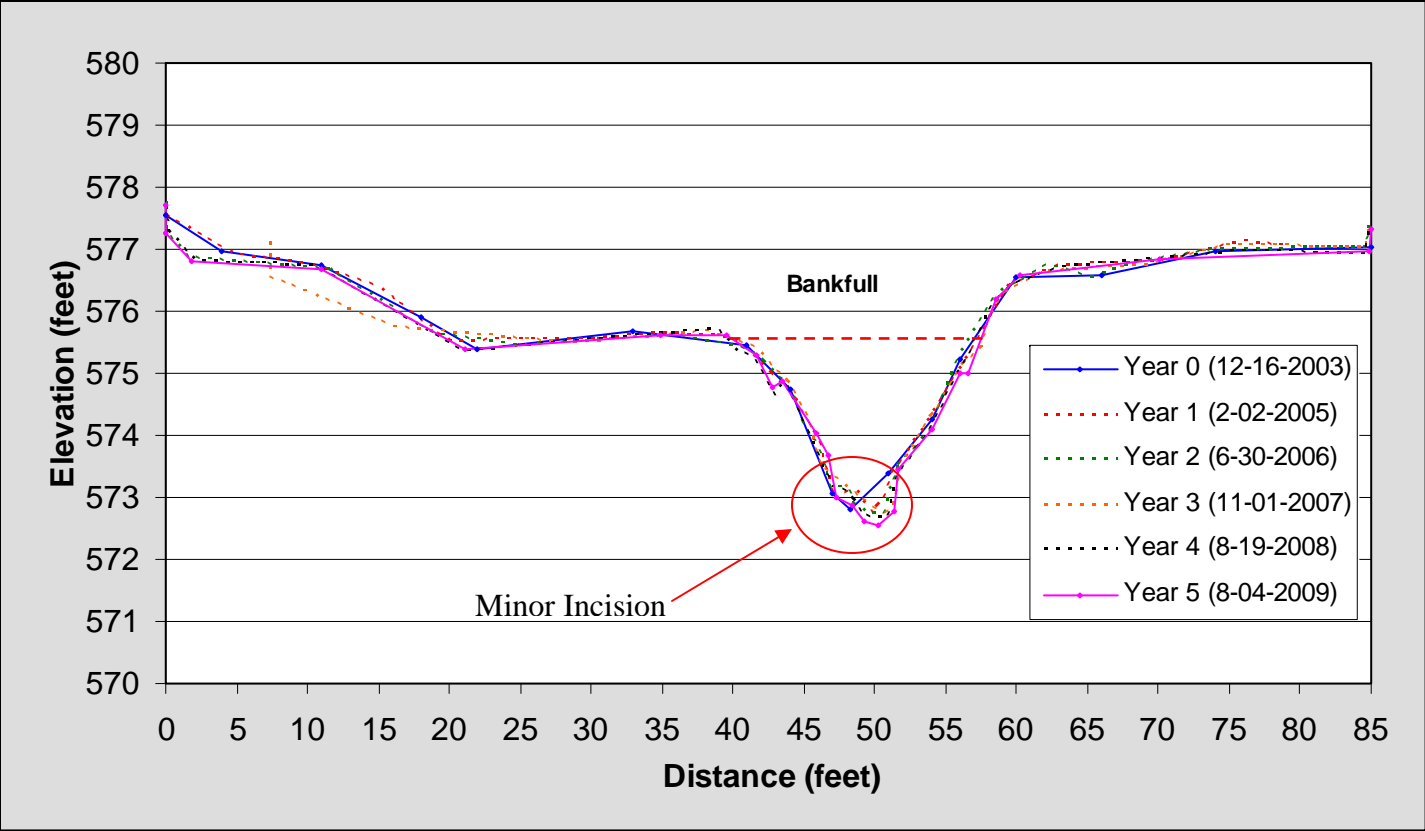
Figure 4. Riffle cross-section (XS-4) typifying minor incision observed at some riffles. Photo is view facing downstream of cross section 4 vicinity on August 4, 2009

Cross Section 4 – Riffle: Monitoring Year 5 - Silt (d50) to Medium Gravel (d84). Significant fining occurred in Monitoring Years 1 – 3, coarsening in Monitoring Year 5, and significant silt fining again in Monitoring Year 5. Had high percentage of silt in Monitoring Year 5.

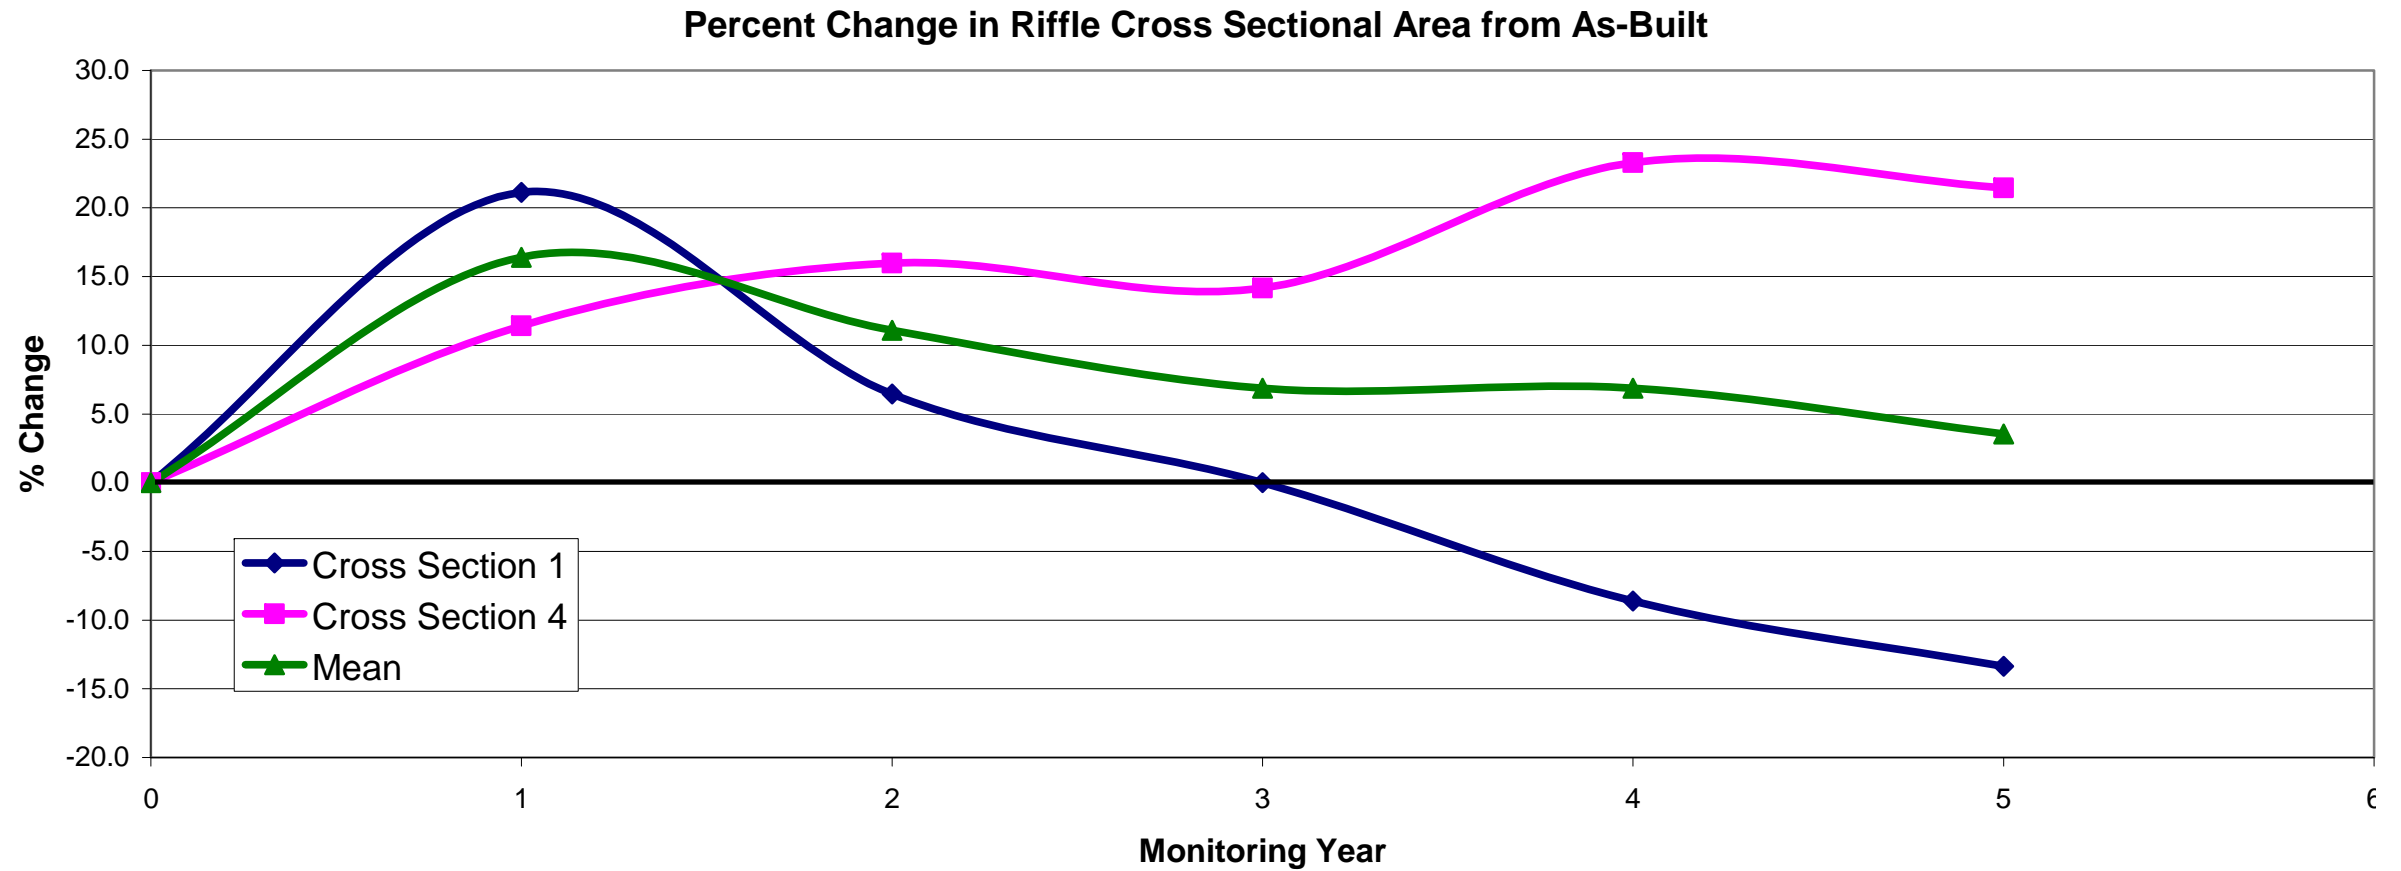
Figure 5. Percent change from As-built cross-sectional area

The production of this type of figure is but one method to assess channel stability. In order for the reach dimension to be considered stable, the change in the cross-sectional area should not be unidirectional, and the amplitude in the variation should not increase over the 5-year monitoring period. A stream's channel dimension may exhibit an initial adjustment before a stable variation pattern can be observed around some new point of equilibrium. This is often due to the fact that there is necessarily some level of uncertainty in any stream design, and the vegetation often takes 2-3 years to exert significant influence on the channel. The above plot includes the percent change relative to the as-built for each of the 4 project riffle cross-sections. The mean is also included. This projects' mean riffle cross-sectional area generally demonstrated a healthy pattern of variability. After an initial moderate increase in area during Monitoring Year 1, the area generally decreased toward As-Built conditions by Monitoring Year 3. This adjustment was followed by less variation in the final monitoring years, indicating the channel dimension likely reached a stable equilibrium. The observed pattern indicated that the intended floodplain access was provided and maintained. Maintenance of a mean entrenchment ratio of greater than 3.75 over the four riffle cross-sections supported this observation.

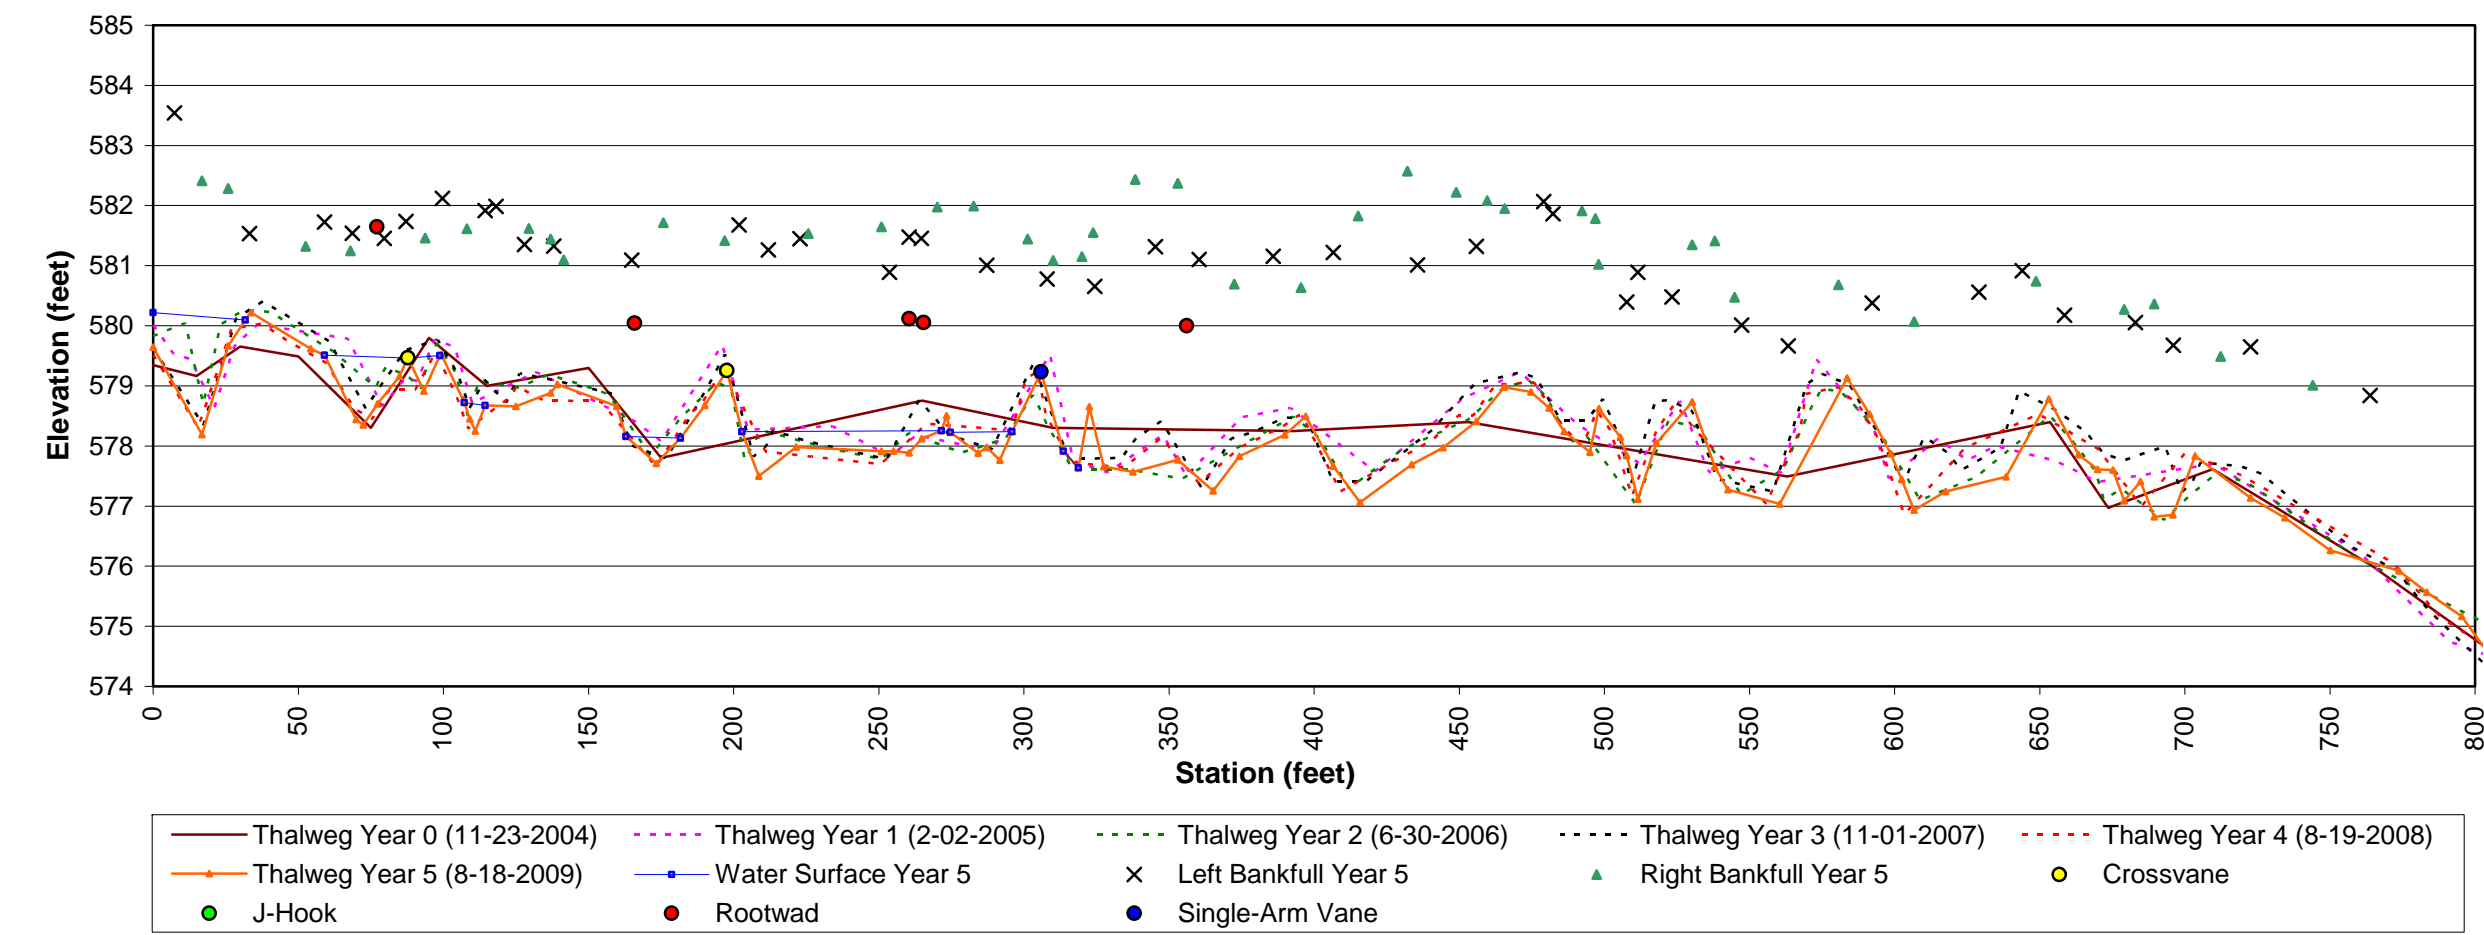
The reach demonstrated some vertical adjustment during Monitoring Years 1 – 3 in the form of aggradation in riffles, followed by stabilization of these areas in the final Monitoring Years. During Monitoring Year 2, 244 lf (8%) of the monitoring reach was noted to be affected by aggradation. During Monitoring Year 3, 293 lf (9%) of the monitoring reach had noted aggradation. However, riffle aggradation areas were probably normal post-construction channel adjustments in the form of the riffles narrowing to a stable dimension. That assessment was based on the trend observed during the final two Monitoring Years of aggradation clearing within the thalweg. By the final Monitoring Year, only one area (17 lf) of aggradation was found within a riffle, affecting 1% of the channel bed. No channel downcutting was documented during the five year monitoring period. The Monitoring Year 5 measured profile indicated that the project reach was vertically stable overall when compared to the project baseline. The figure below provides a sample of the surveyed profile. Bedform slope and spacing distributions naturally varied from year to year, but distinct riffle-pool bedform distributions were maintained, providing diversity in the bedform.

Figure 6. Longitudinal Profile Segment (Station 0+00 to 8+00). Note: The As-Built (MY-0) datum was of a different standard (coarser) than subsequent surveys.

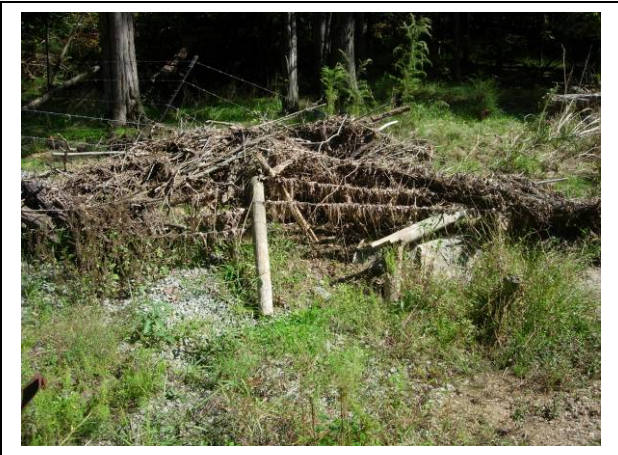
Figure 7. Debris caught in cattle fencing above bankfull elevation on October 13, 2008.

Livestock were excluded from the entire project, except where two cattle crossings were installed as part of the restoration. Both cattle crossings were noted to have severe fencing damage as a result of flooding in the past. Both crossings experienced damaged fencing, dislodged fence posts, and scour of the gravel path. Both of these crossings will be repaired in 2010. As noted in the Project Timeline table on page 1 of this report, warranty repair work was performed on the project in May of 2005 (Monitoring Year 1). There were three problems that were repaired. The first was a small area of run-on erosion down-slope from one of the construction access areas. The second area was a cross vane that was leaking. The last repair area was a section of cattle crossing fence that was pulled down during a storm flow event. The landowner repaired this fencing at his own expense, with help from the local County Extension Office.
