As-built report for the AH&W Mitigation Site Big and Little Warrior Creeks Wilkes County

As-built report for the AH&W
Mitigation Site, Big and Little Warrior
Creeks, Wilkes County

North Carolina Wildlife Resources Commission

February 24, 2003

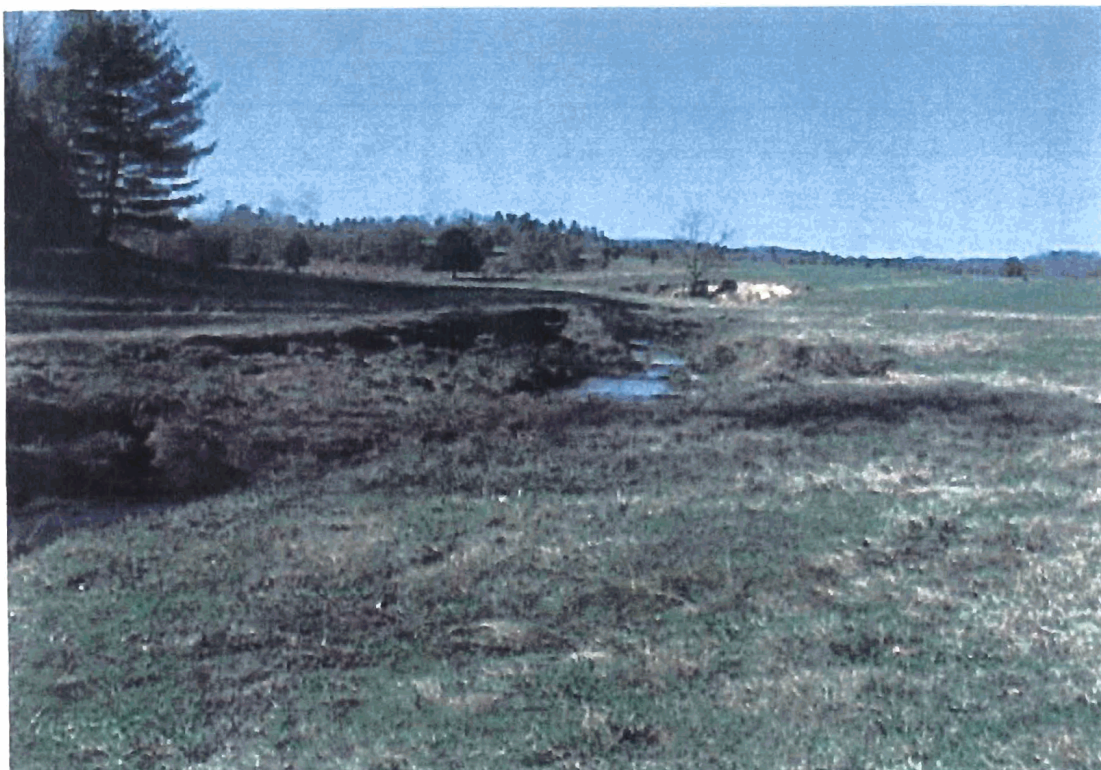
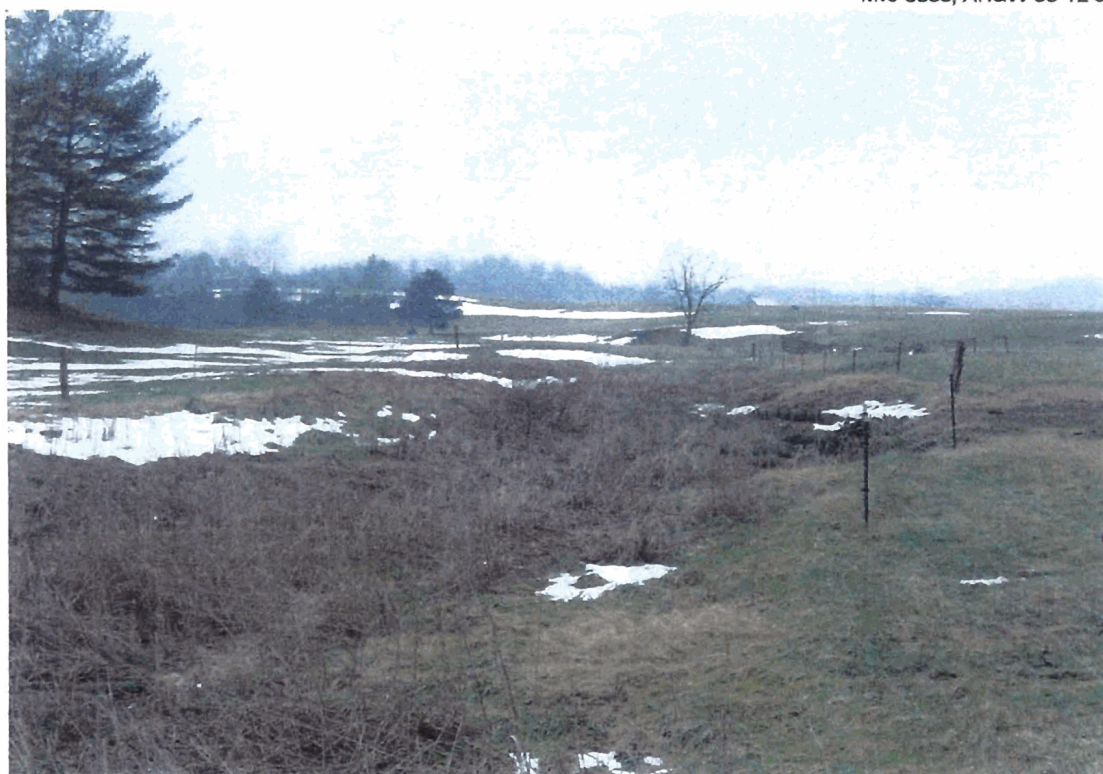
Mvc-003s, AH&W 98-12-9

Reach is above the last Left bank meander, in the lower pasture, on Big Warrior Creek. Photo is taken from inside the easement looking upstream. This is series number 3 from the BWC reference photos.

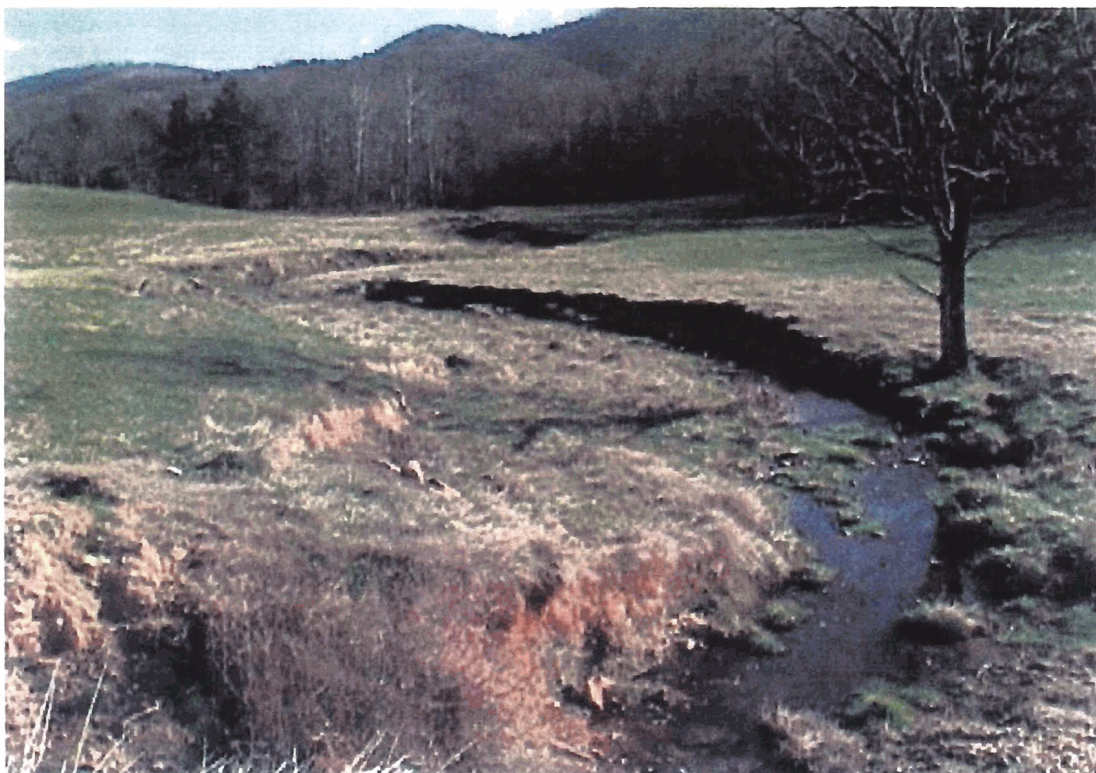
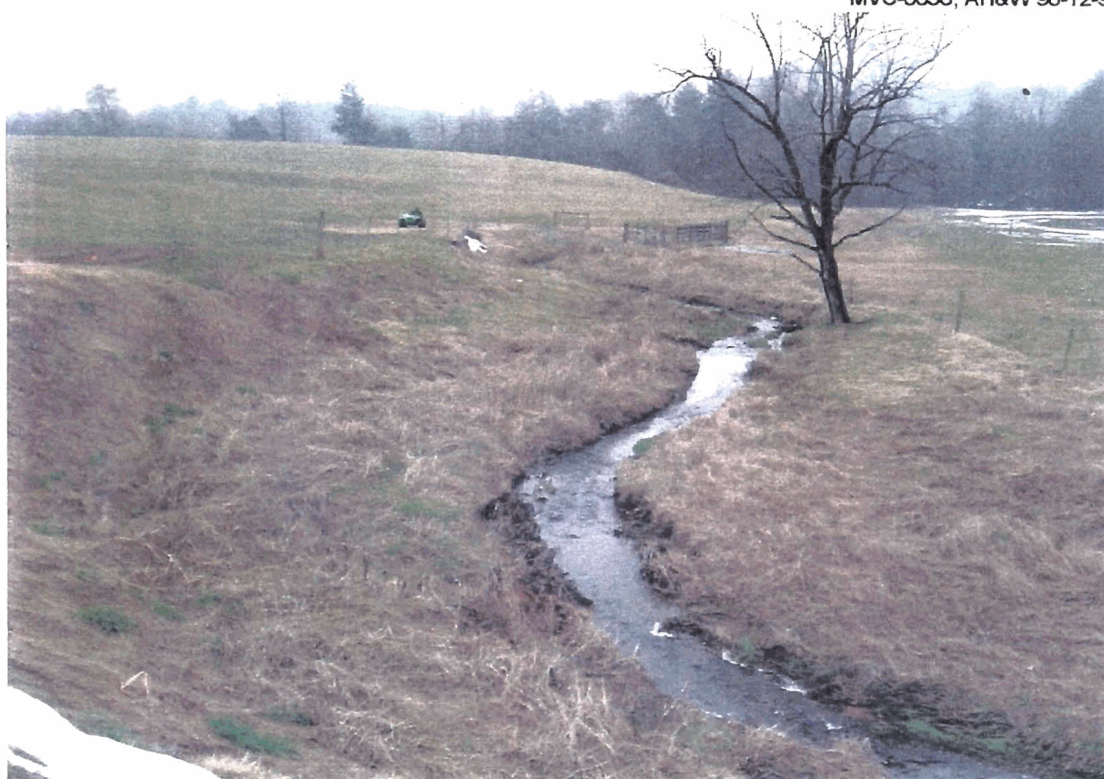
MVC-005S, AH&W 98-12-9

Reach below the high clay bank, in the lower pasture, on Big Warrior Creek. Photo is taken from the top of the bank looking downstream. This is series number 7 from the BWC reference photos.

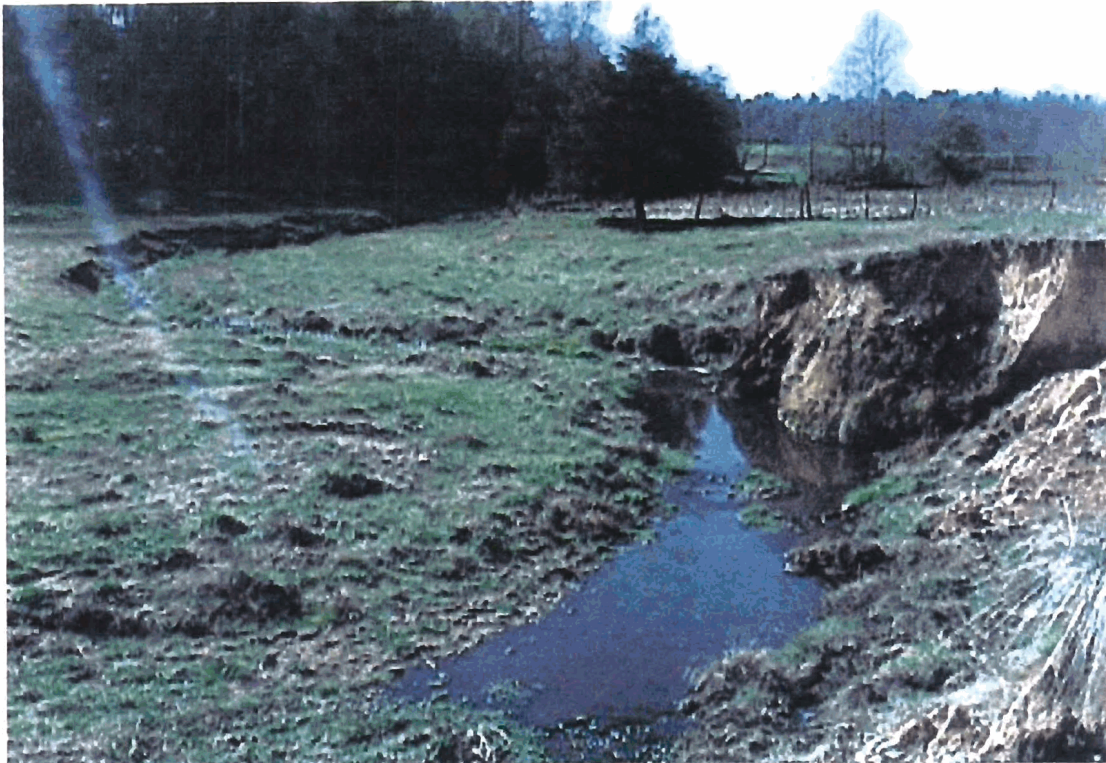
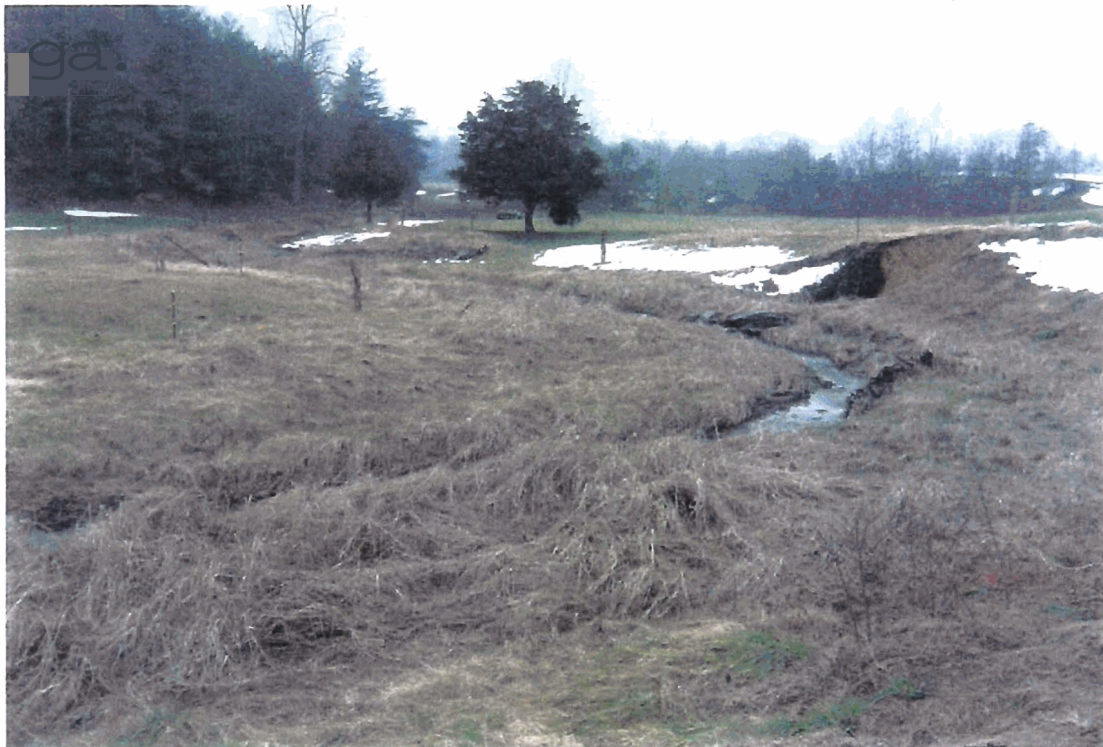
MVC-004S, AH&W 98-12-9

Reach showing the high clay bank and above, in the lower pasture, on Big Warrior Creek. Photo is taken from the top of the bank looking upstream. This is series 8 from the BWC reference photos.

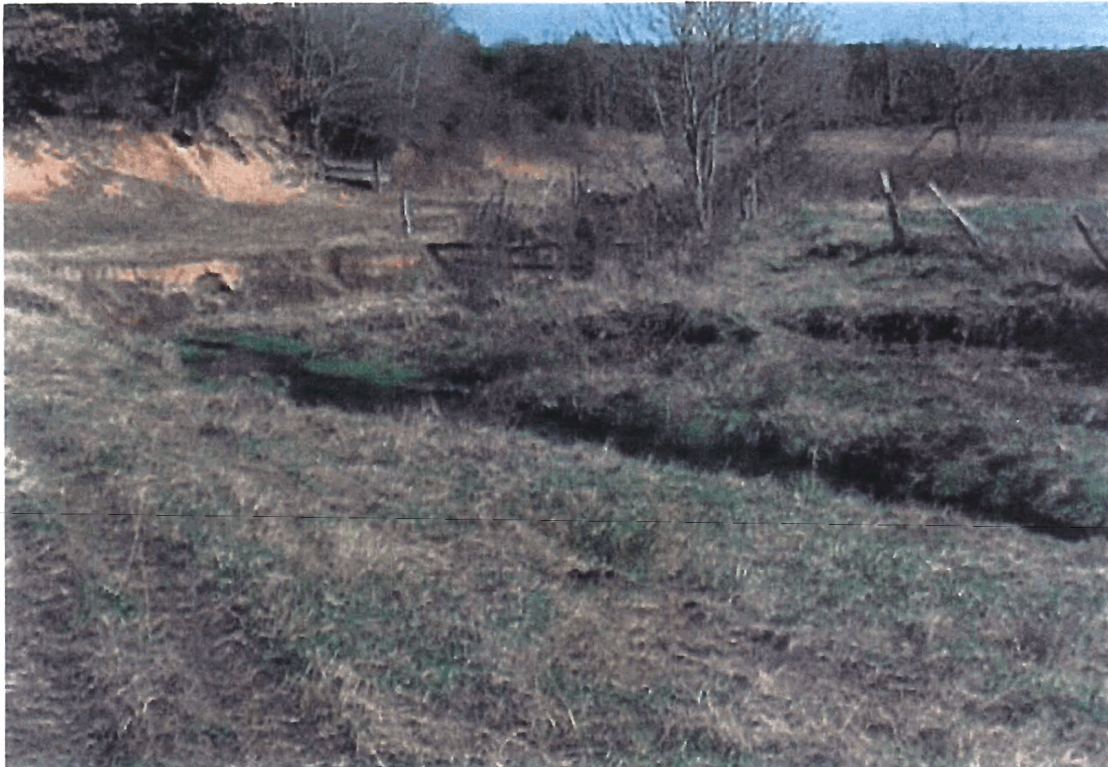
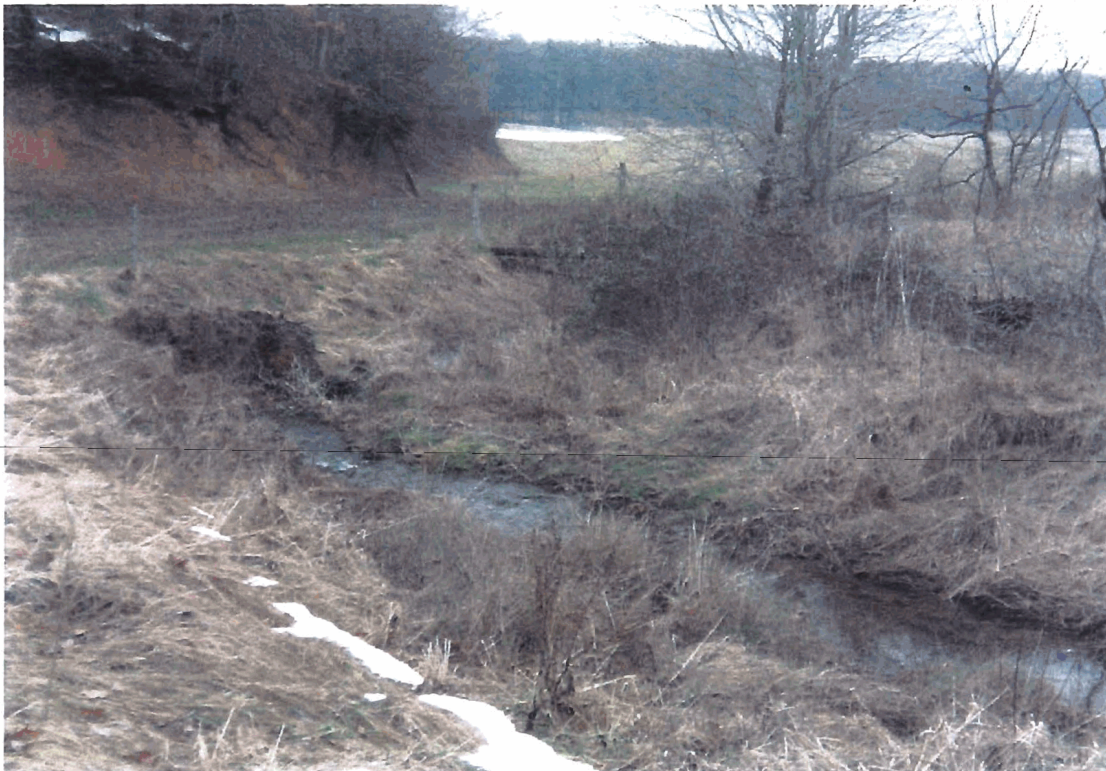
MVC-007S, AH&W 98-12-9

Bend at the end of the middle pasture, on Big Warrior Creek.
Photo is taken looking downstream from just above the bend. This
is series number 13 from the BWC reference photos.

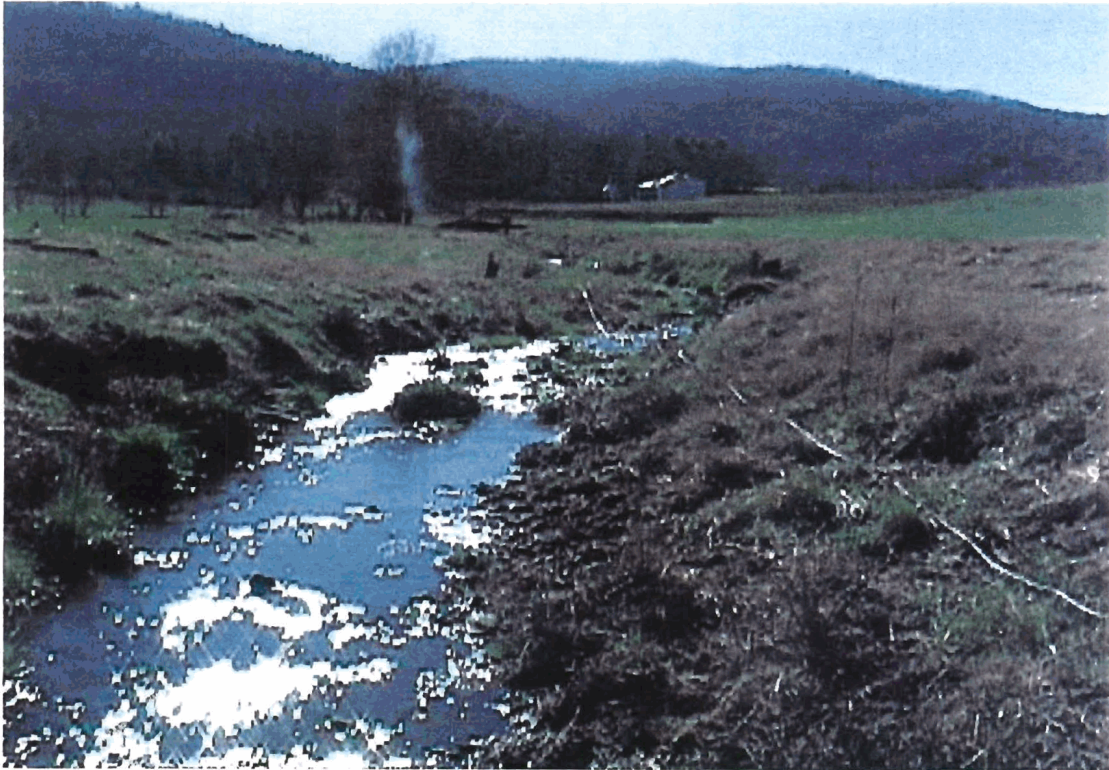
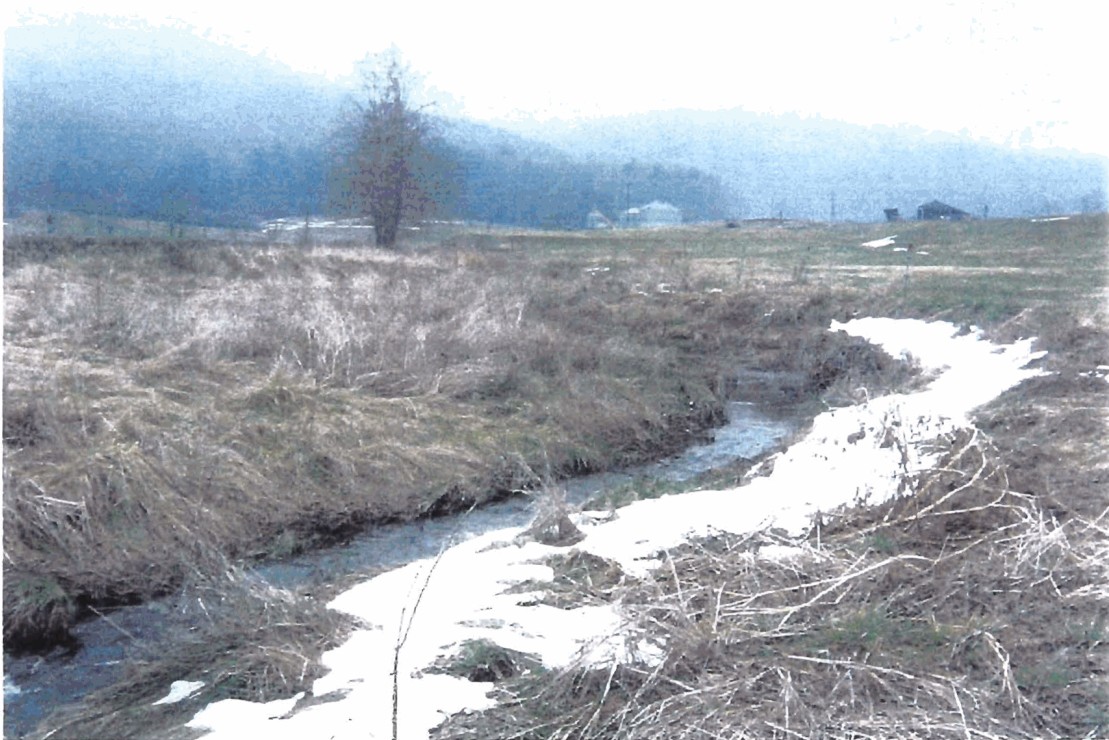
MVC-002S, AH&W 98-1E-9

Reach is in the middle of the middle pasture, on Big Warrior Creek. Photo is taken from a point bar looking upstream. This is series number 15 from the BWC reference photos.

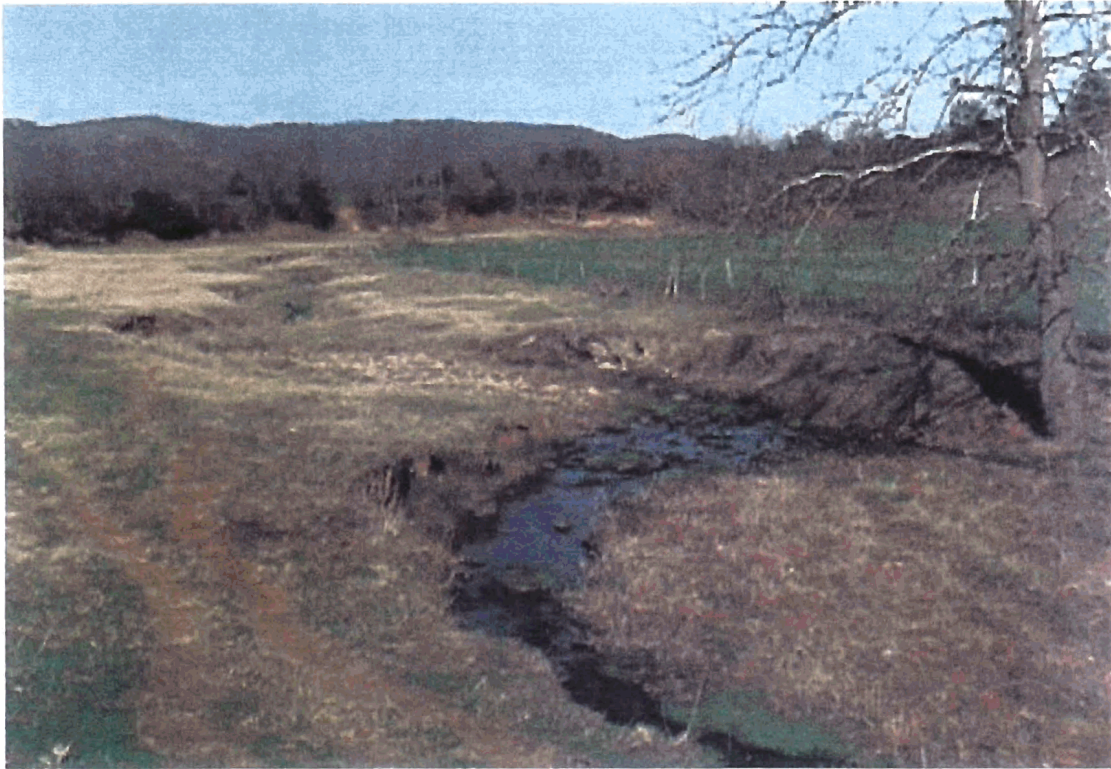
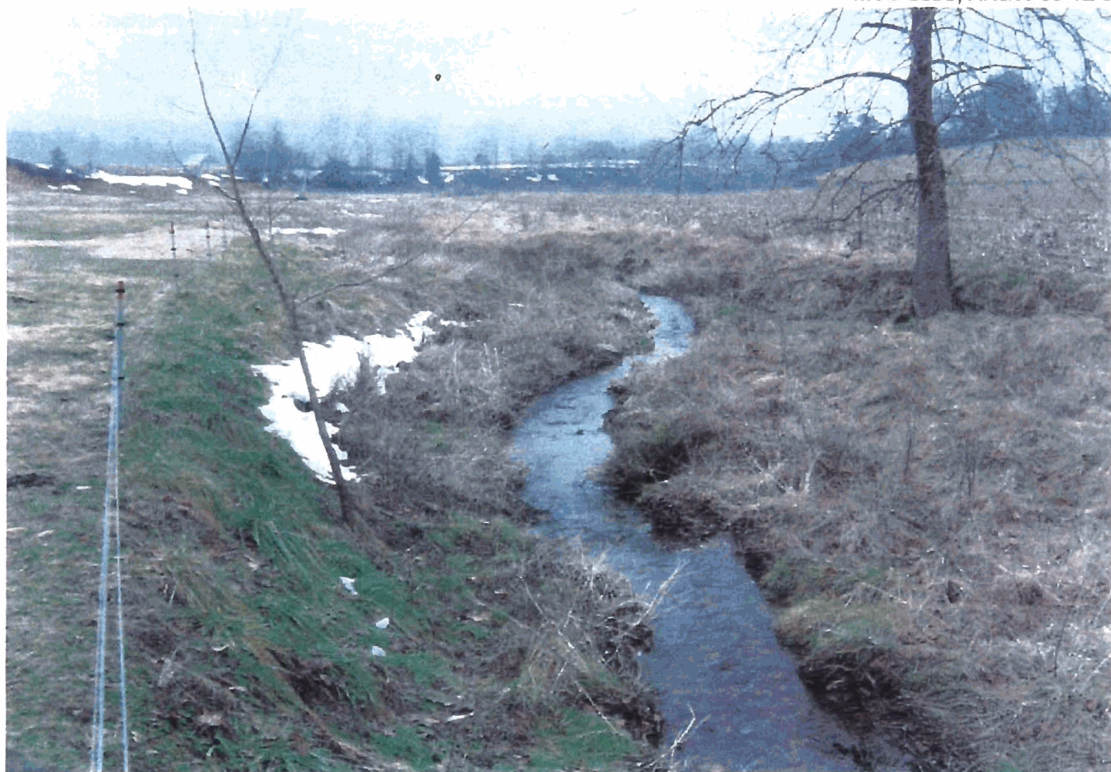
MVC-008S, AH&W 98-12-9

Reach below the Feed Barn, in the middle pasture, on Big Warrior Creek.
Photo is taken from the property line survey point looking downstream. This
is series number 17 from the BWC reference photos.

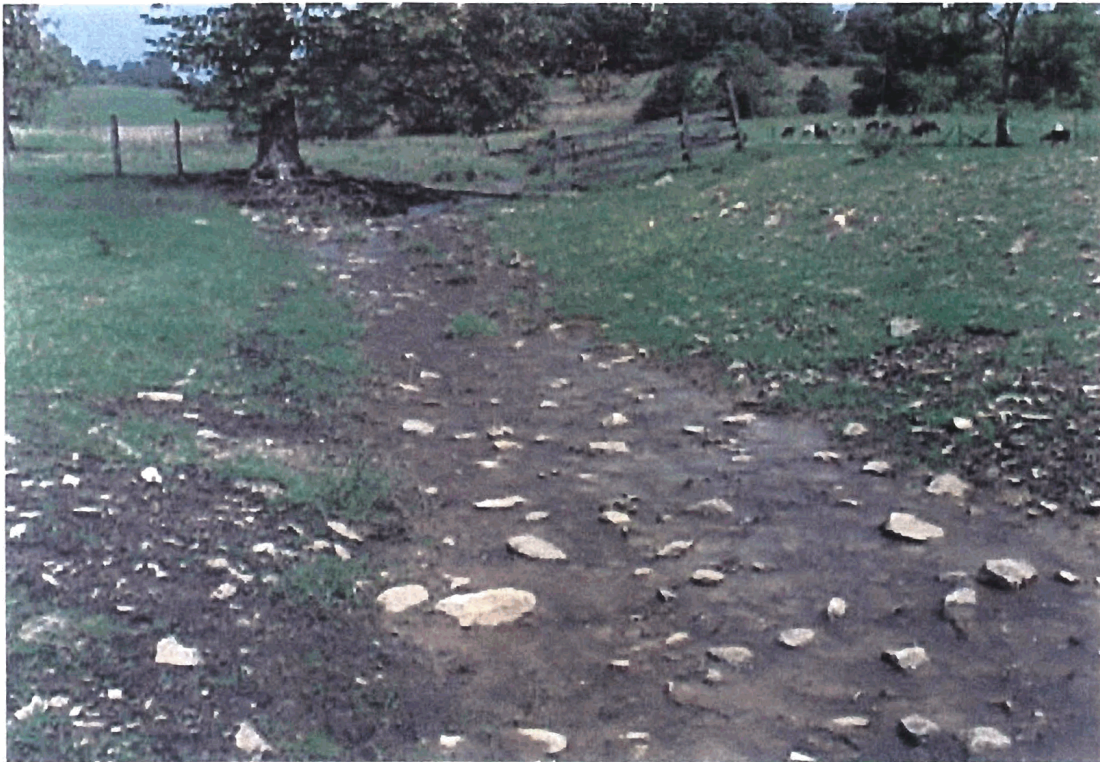
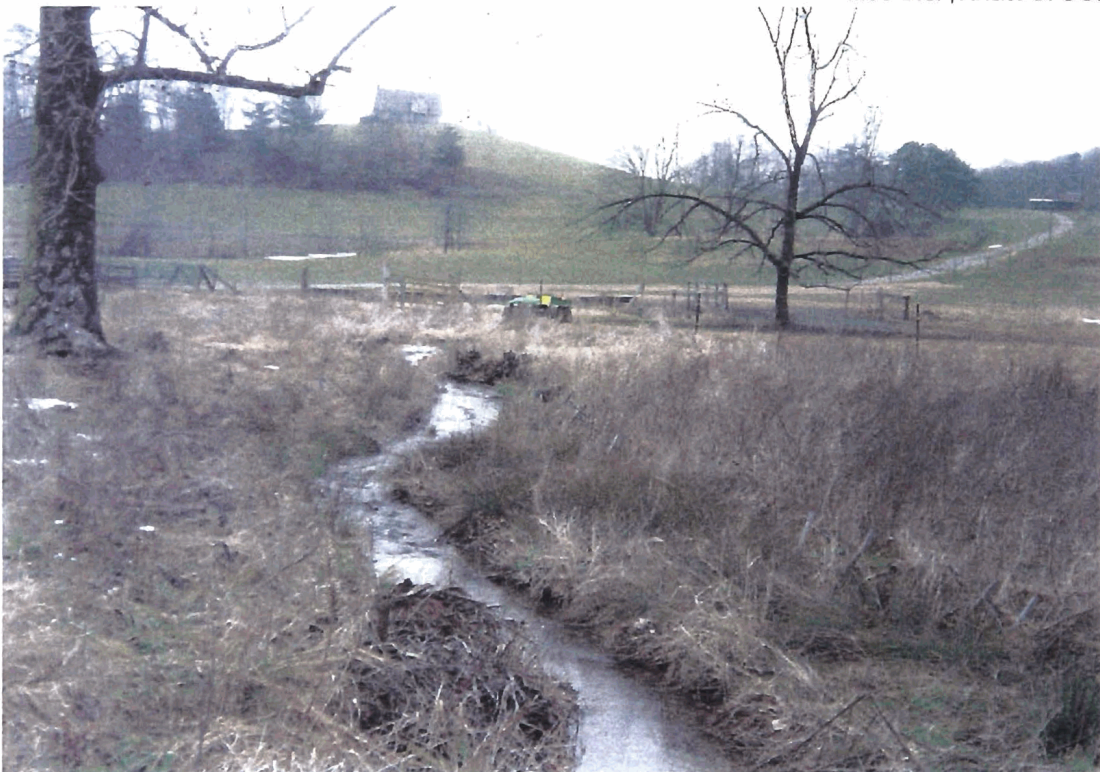
MVC-010F, AH&W 01-8-01

Reach above the bridge in feedlot, on Big Warrior Creek. Photo is taken from the left bank just above the first sycamore, looking downstream to bridge. This is series number 24 from the BWC reference photos.

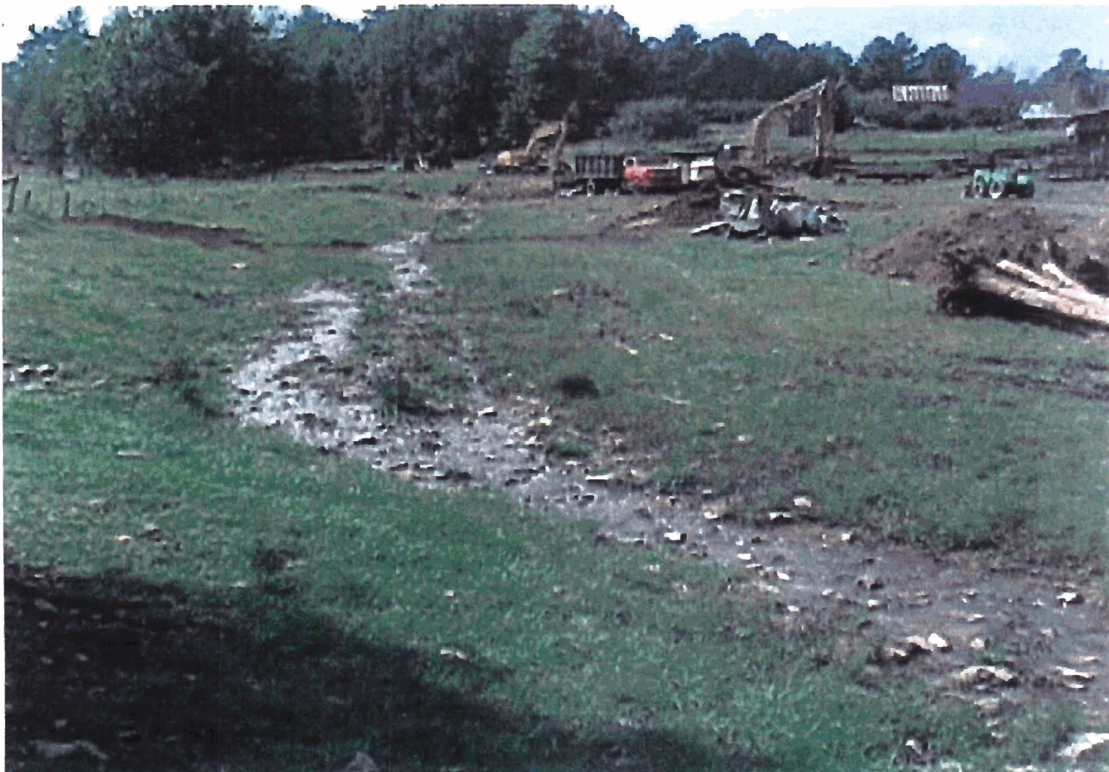
MVC-011F, AH&W 01-8-01

Reach is in the middle of the feedlot, on Big Warrior Creek. Photo is taken from the right bank, just below survey point 1A44, looking upstream. This is series number 27 from the BWC reference photos.

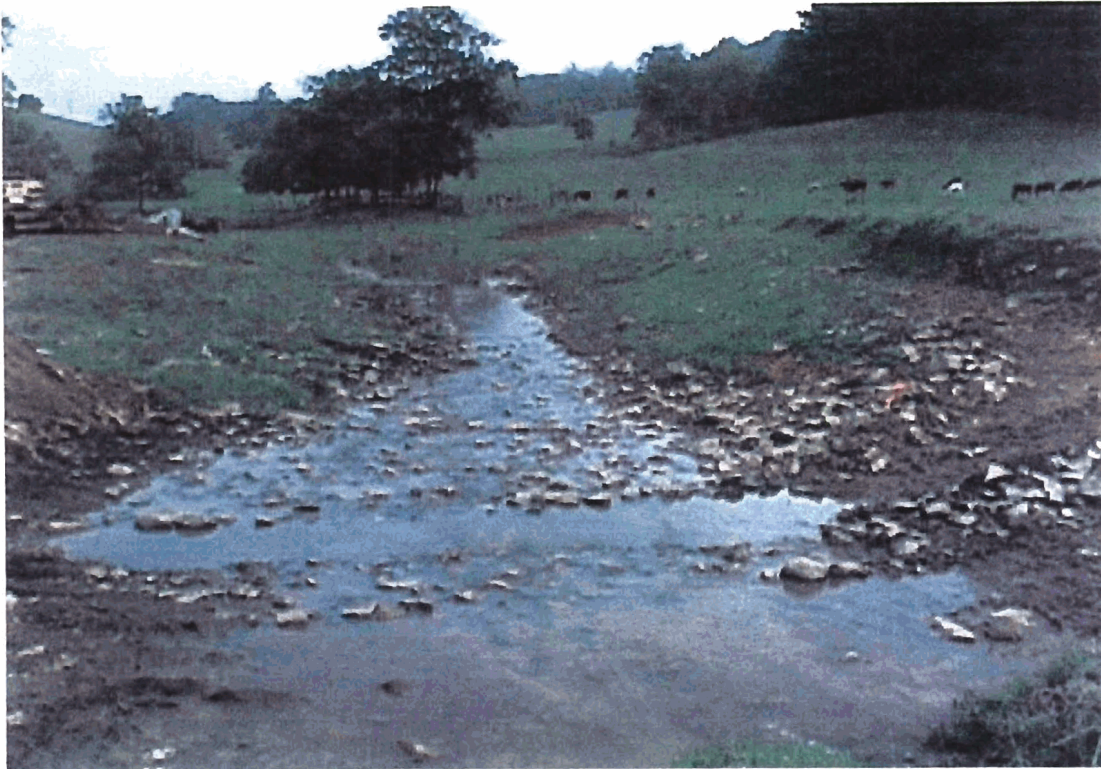
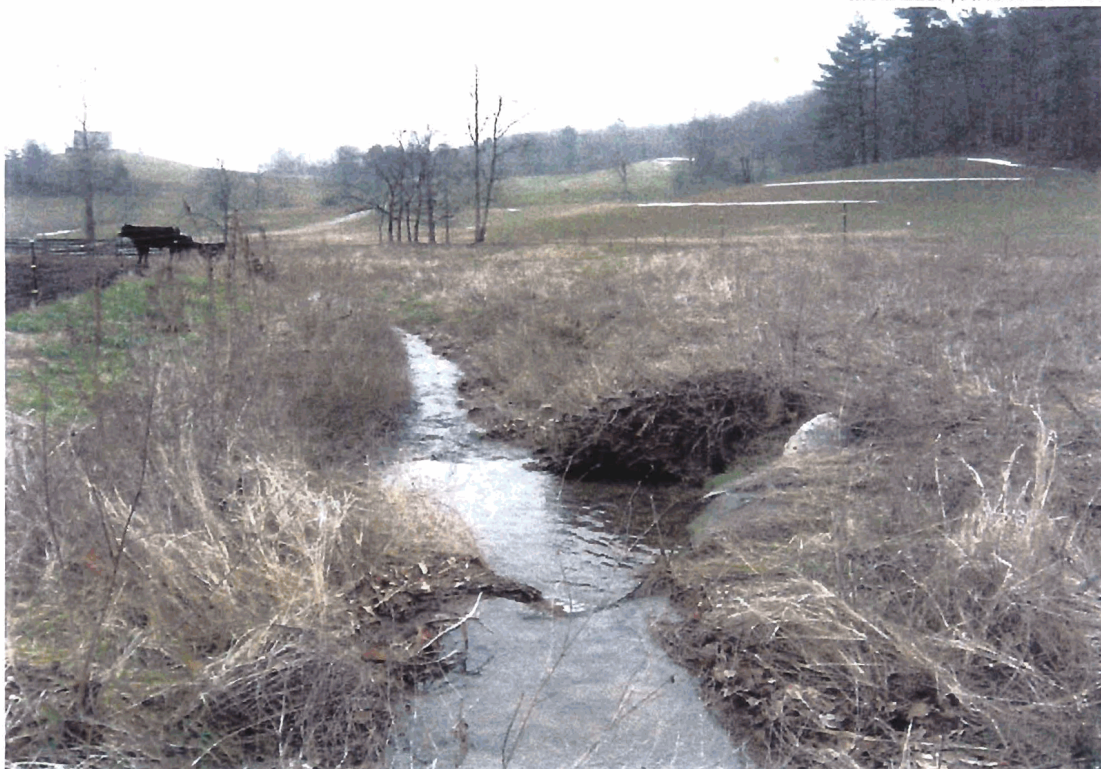
MVC-008F, AH&W 01-8-01

Reach is in the middle of the feedlot, on Big Warrior Creek. Photo is taken from the mid-channel, at the old cross-fence just below survey point 1A45 looking downstream. This is series number 28 from the BWC reference photos.

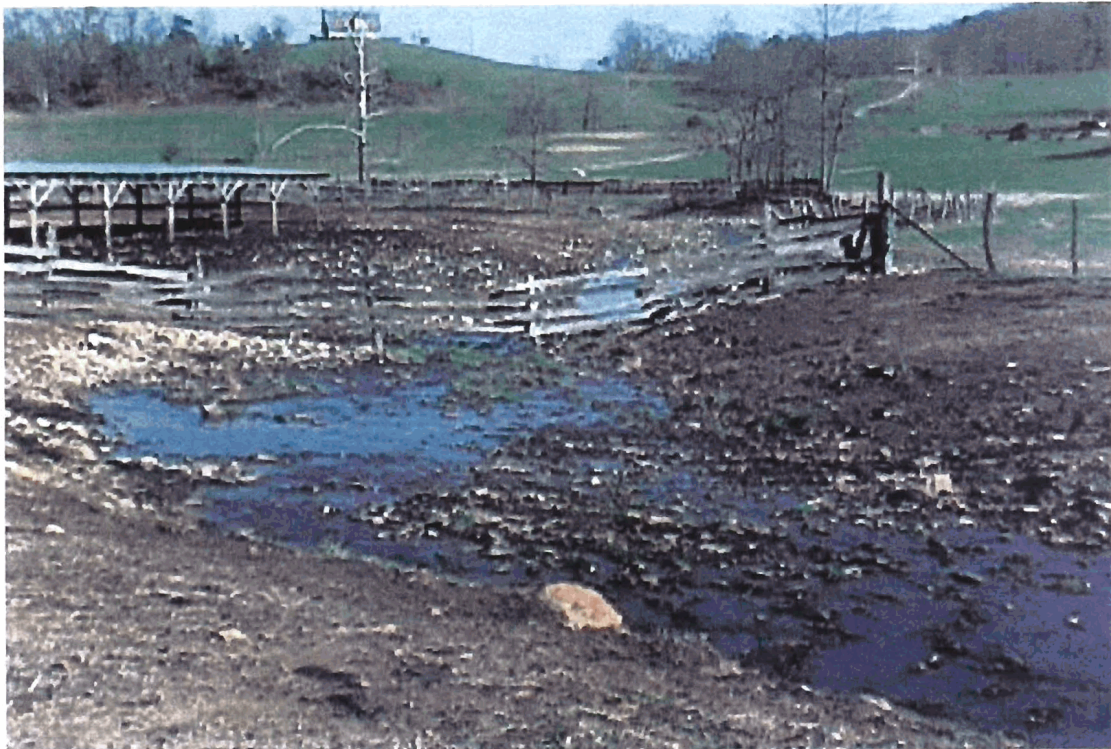
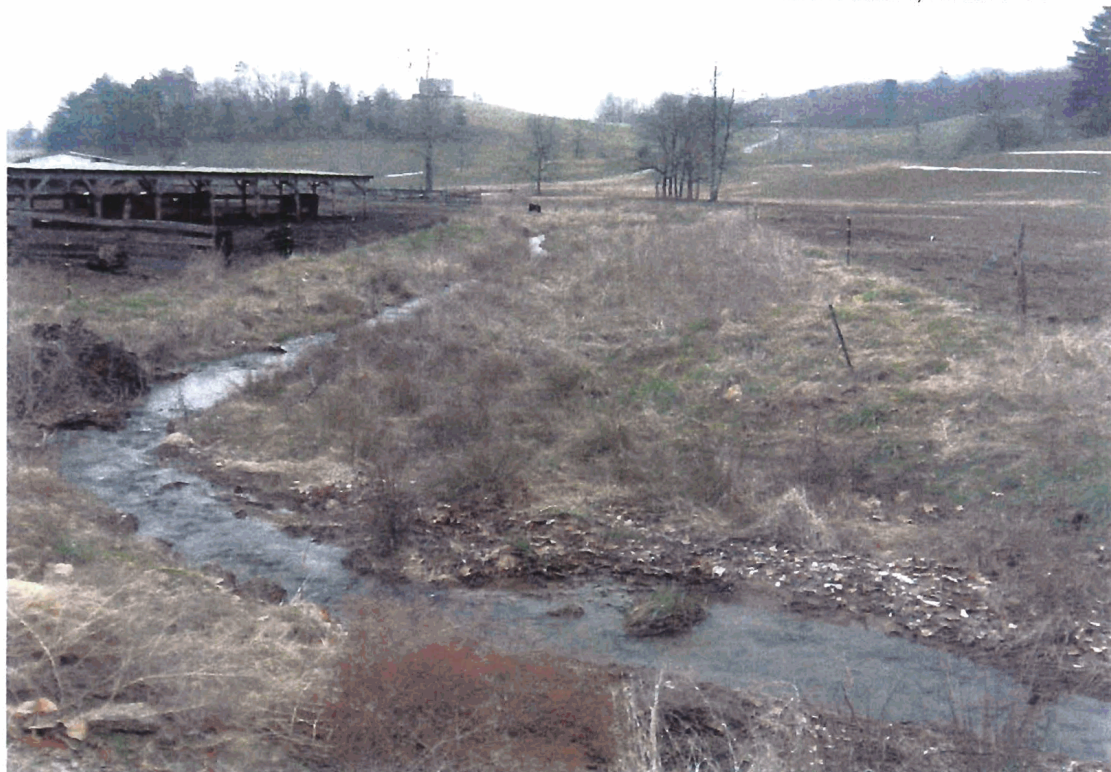
MVC-009S, AH&W 98-12-9

Reach is in the upper end of the feedlot, on Big Warrior Creek. Photo is from the left bank, just above the old cross-fence at survey point 1A45 looking downstream. This is series 30 from the BWC reference photos.

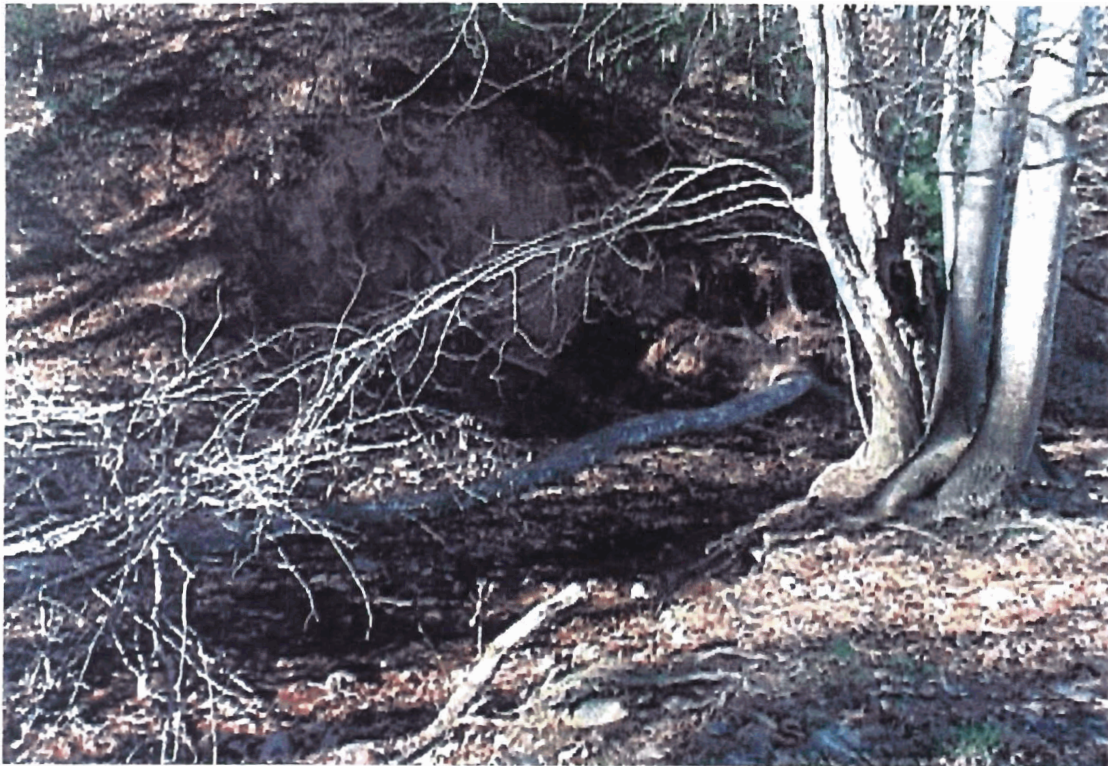
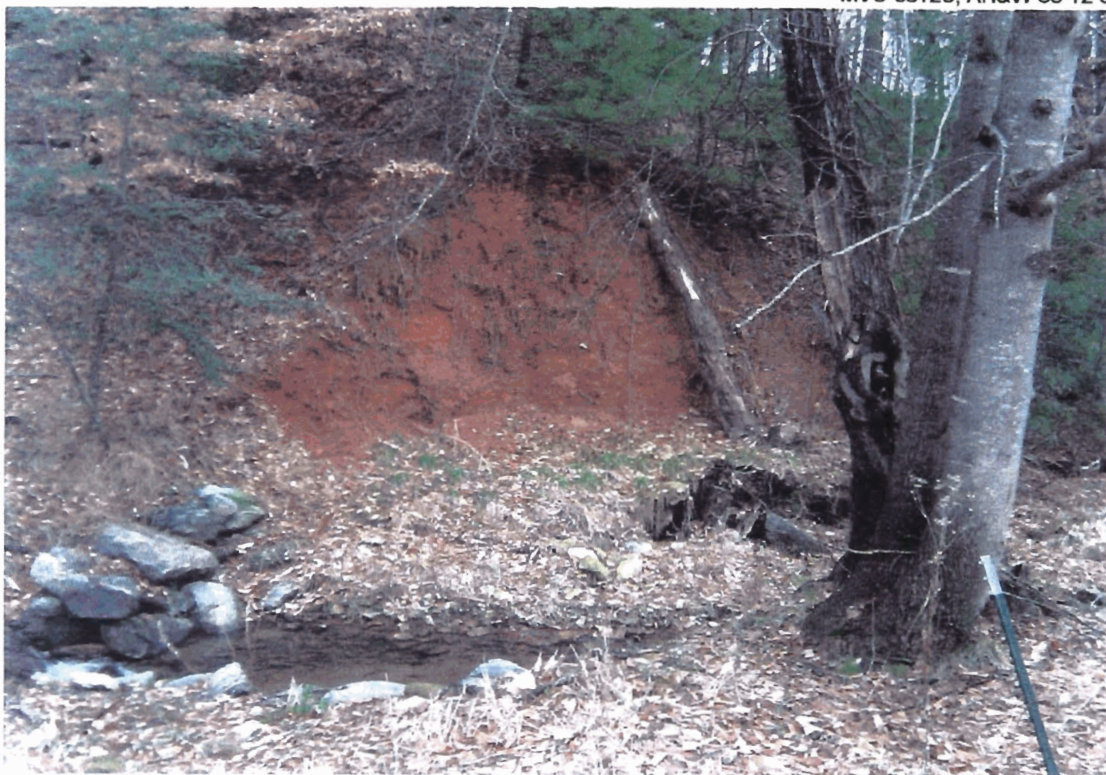
MVC-0012S, AH&W 98-12-9

Reach is in the middle of the upper pasture, on Big Warrior Creek. Photo is taken from the right bank just below s.p. 1A65 looking downstream to eroding clay bank area. This is series 52 from the BWC reference photos.

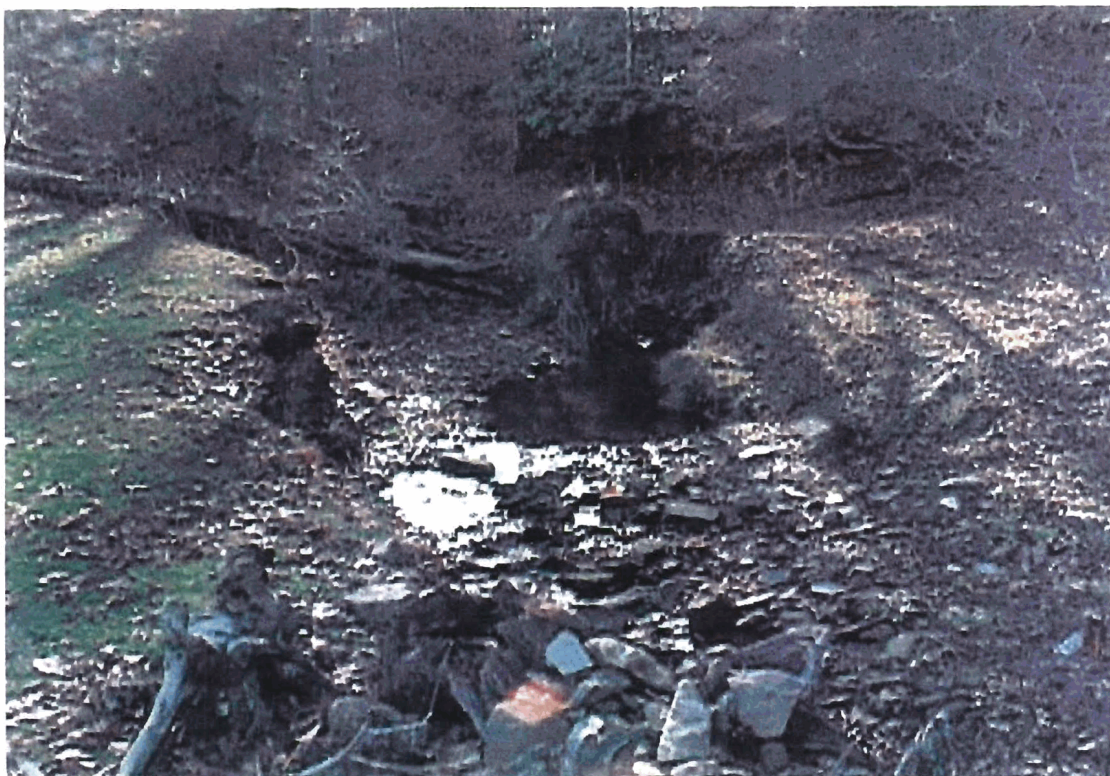
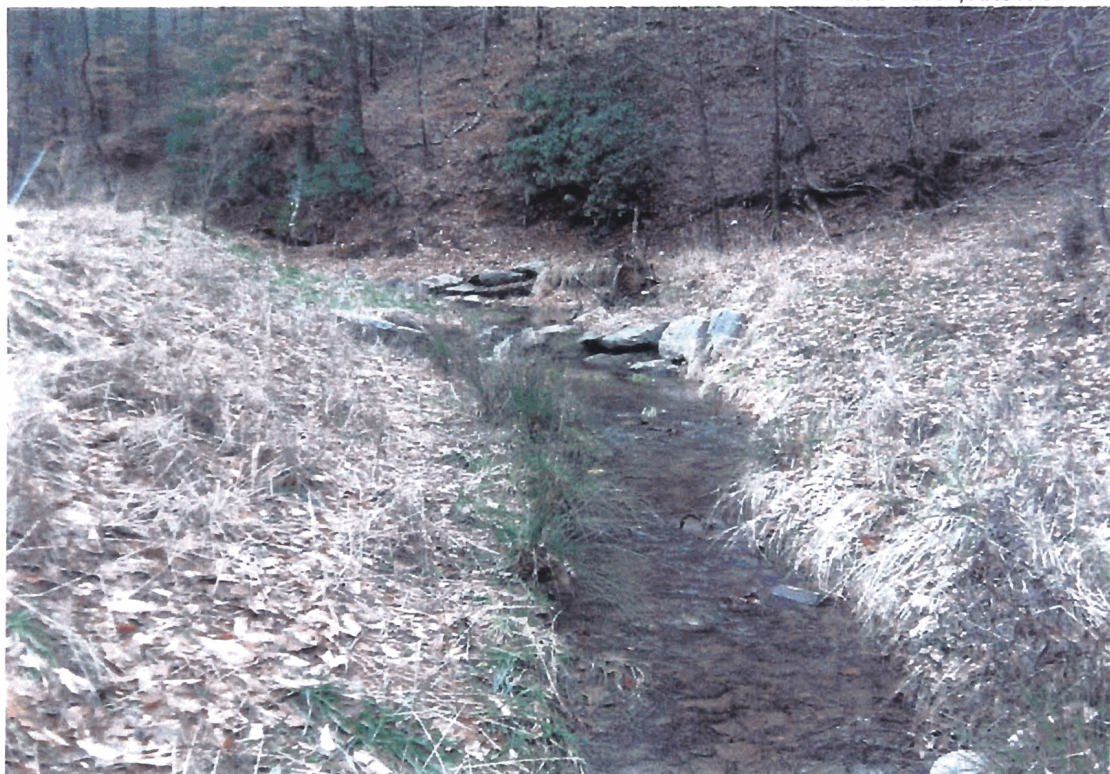
MVC-0013S, AH&W 98-12-9

Reach is in the middle of the upper pasture, on Big Warrior Creek. Photo is taken from the right bank just below survey point 1A63 looking upstream to site of old headcut area. This is series number 49 from the BWC reference photos.

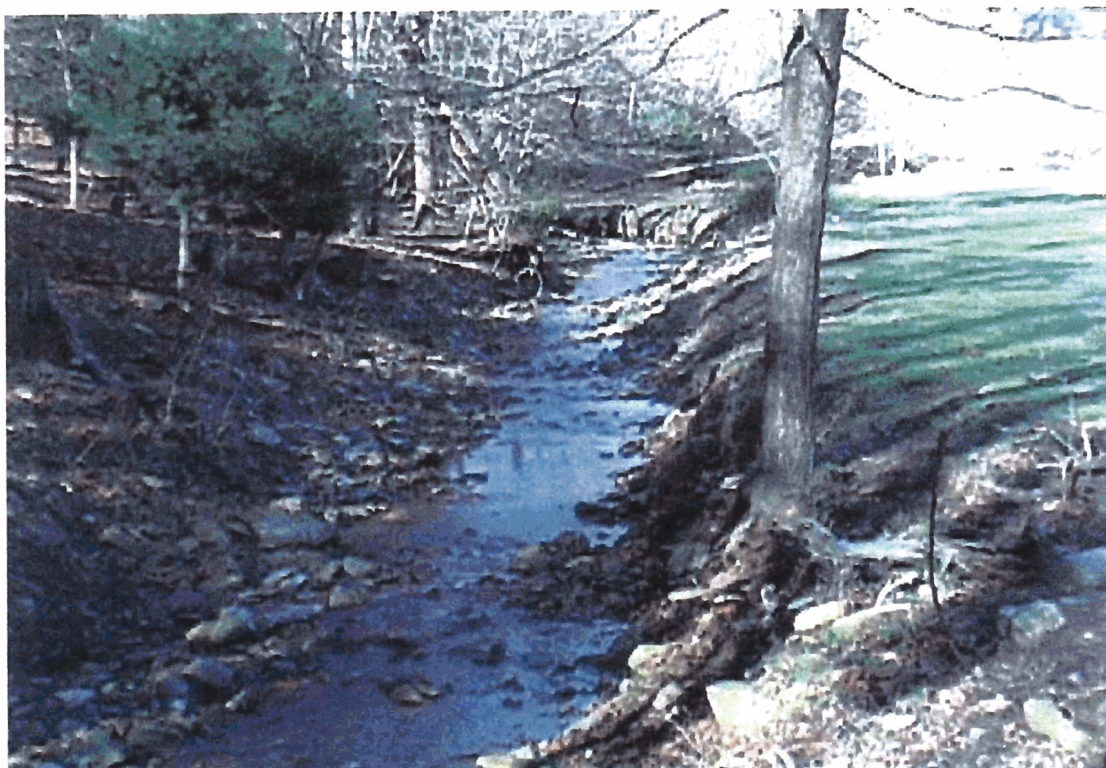
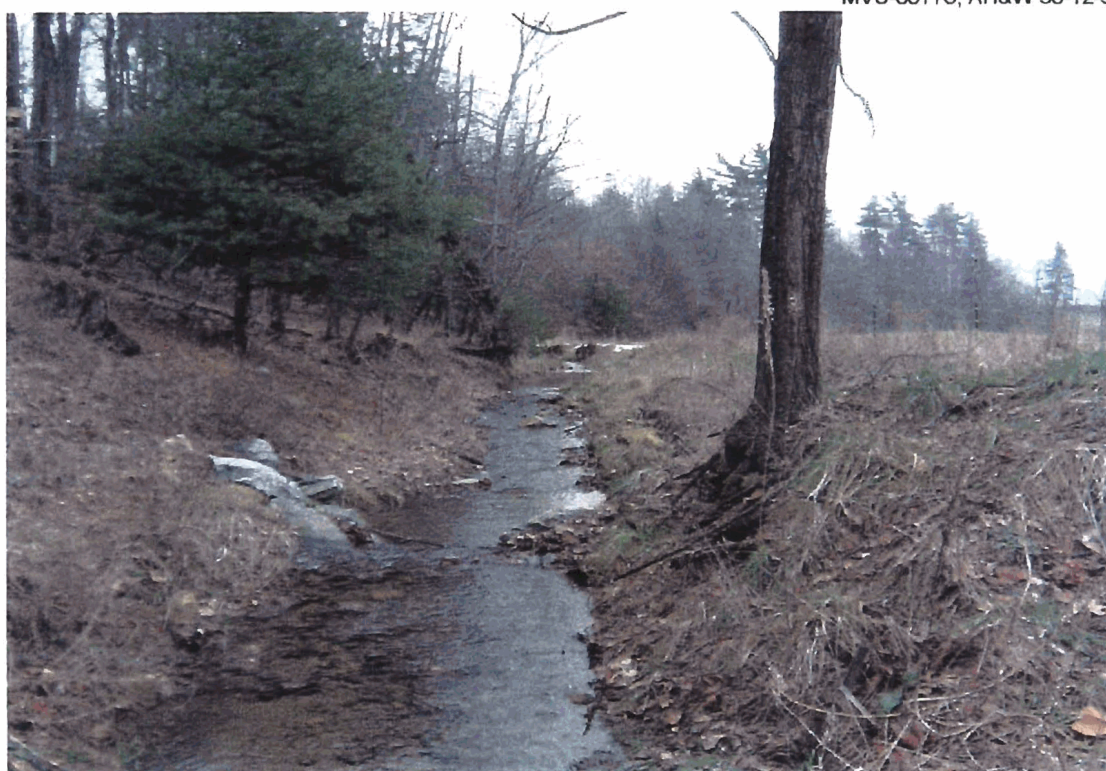
MVC-0011S, AH&W 98-12-9

Reach is at the upper end of the upper pasture, on Big Warrior Creek. Photo is taken from the left bank looking downstream to the single locust tree and cross-vane. This is series 58 from the BWC reference photos.
