As-built report for the AH&W Mitigation Site Big and Little Warrior Creeks Wilkes County

As-built report for the AH&W
Mitigation Site, Big and Little Warrior
Creeks, Wilkes County

North Carolina Wildlife Resources Commission

February 24, 2003

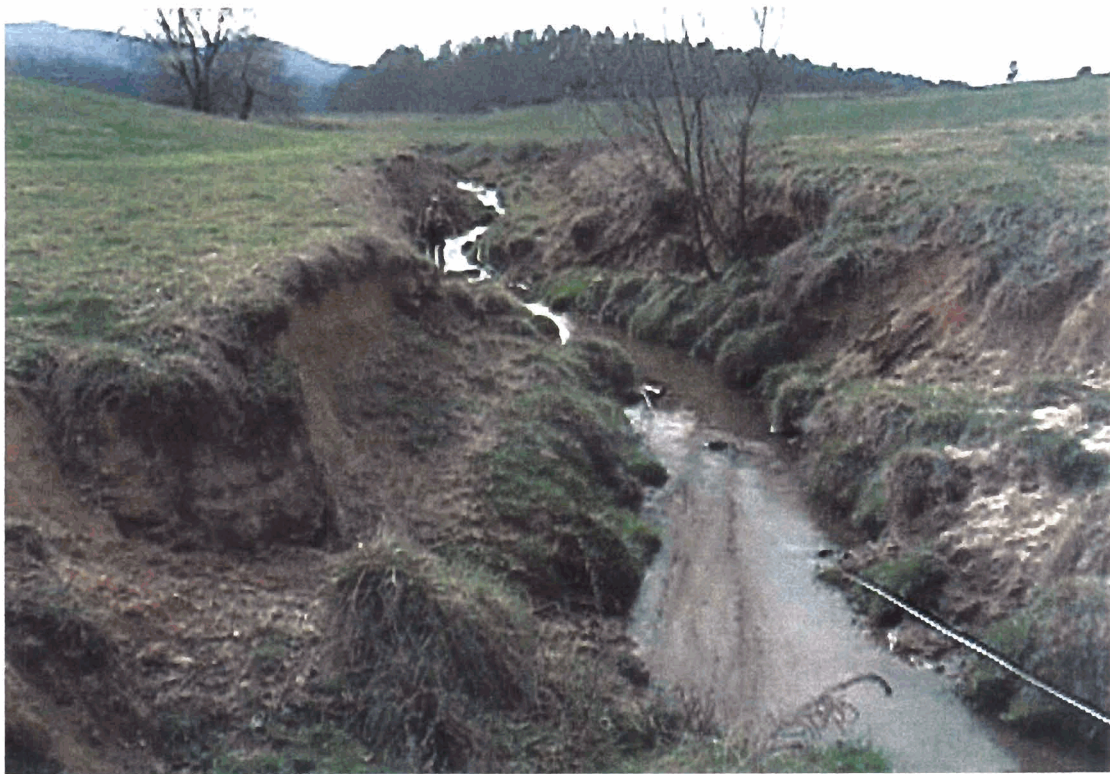
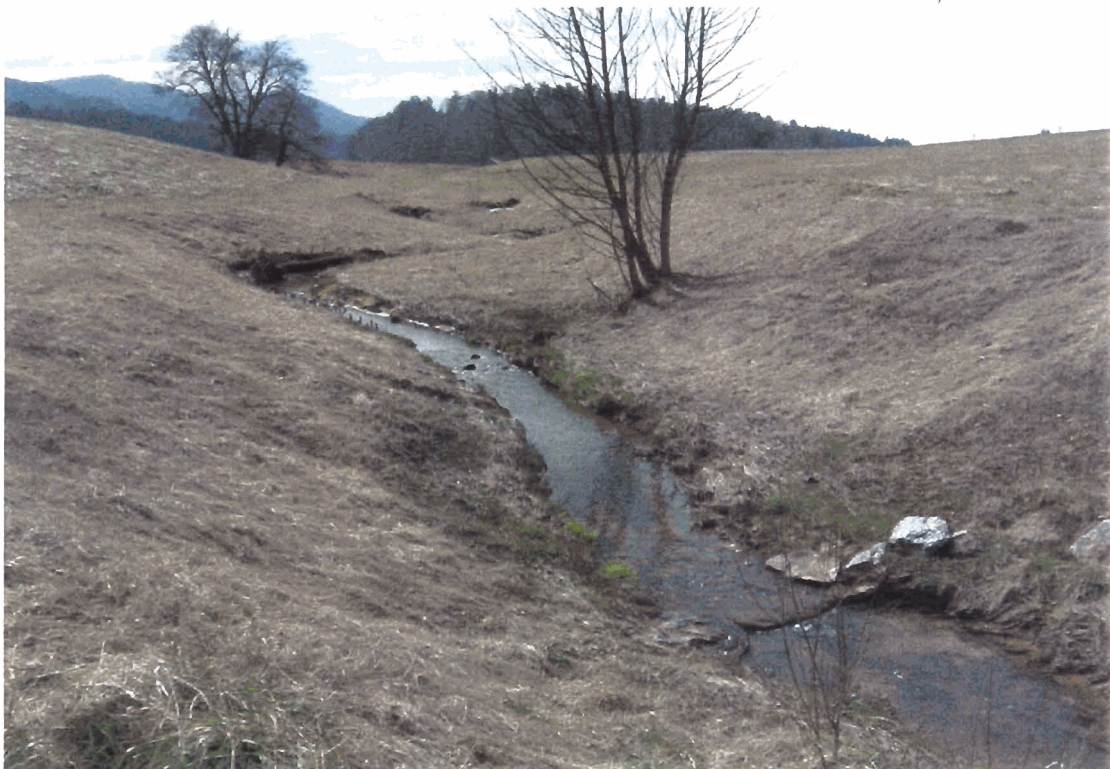
Lwbelow 18C, AH&W 98-12-11

Reach is the lower end of the lower pasture, on Little Warrior Creek. Photos are from the end of the project looking upstream to the lower large willow. This is series number 1 from the LWC reference photos.

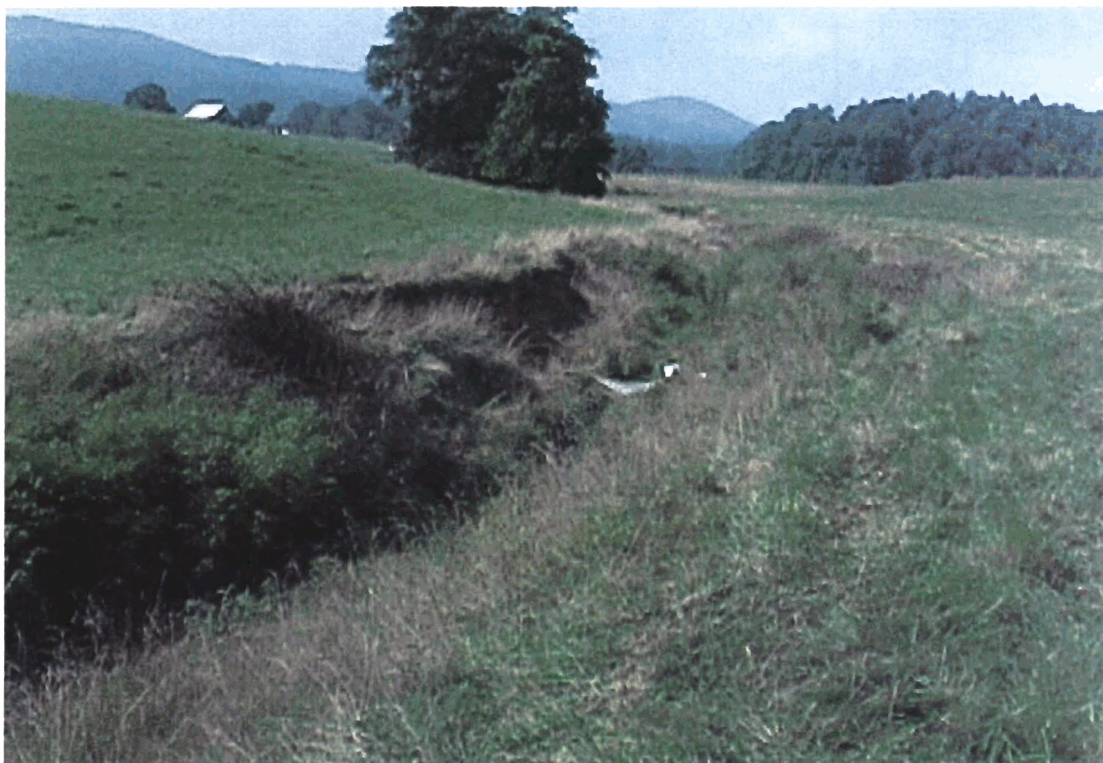
US of willow, 01-7-19 thermo & crossing

Reach is **the** lower end of the lower pasture, on Little Warrior Creek. Photos are taken from just upstream of survey point 2A38 looking upstream
This is series number 4 from the LWC reference photos.

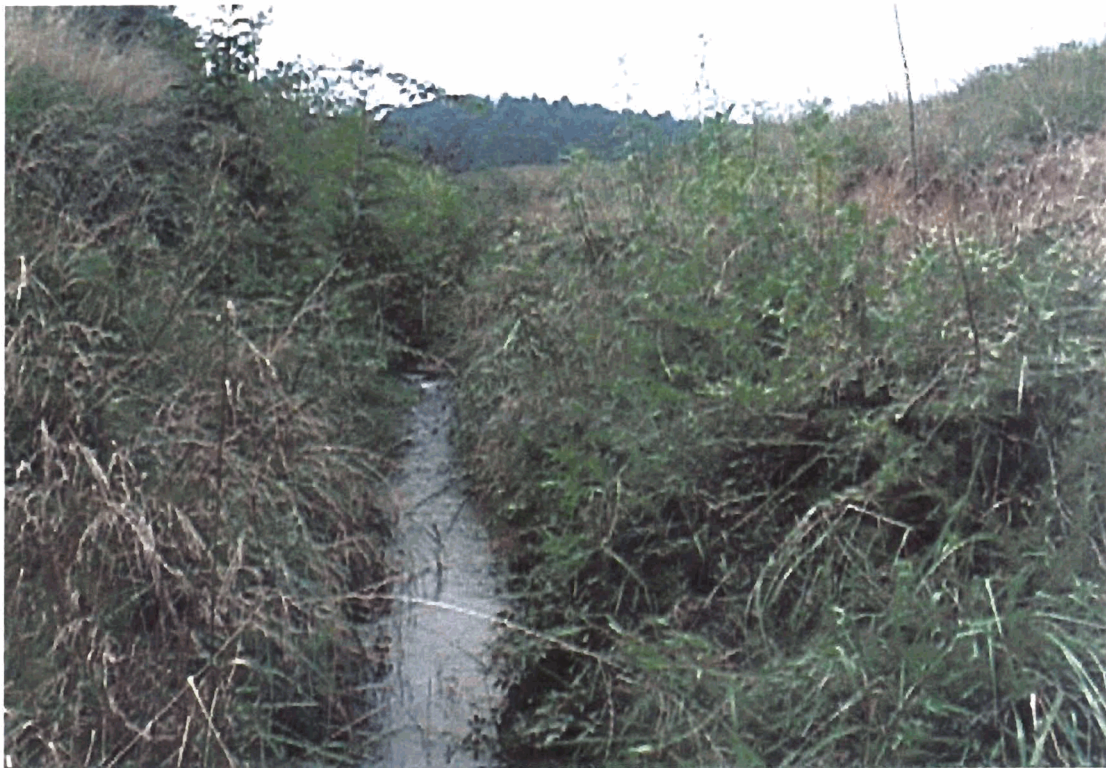
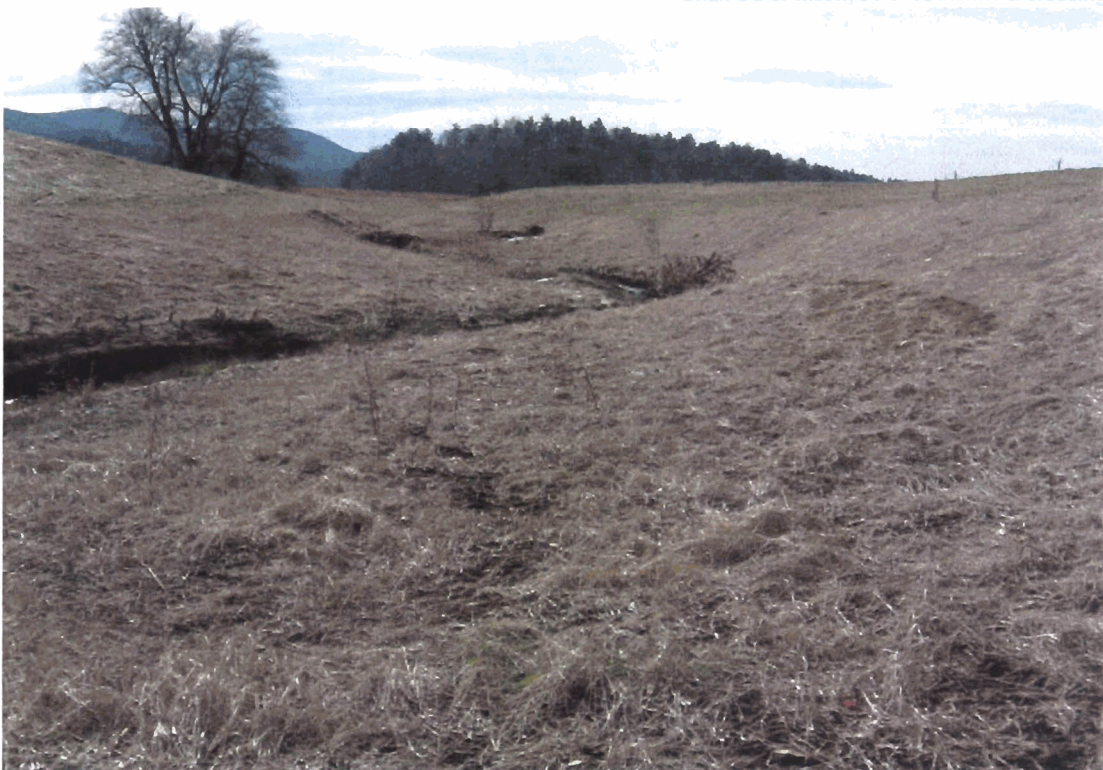
Chan US of willow, 01-7-19thermo & crossing

Reach is at the lower end of lower pasture below Hwy 18, on Big Warrior Creek. Photo is taken from just above the large willow looking upstream. This is series number 3 from the LWC reference photos.

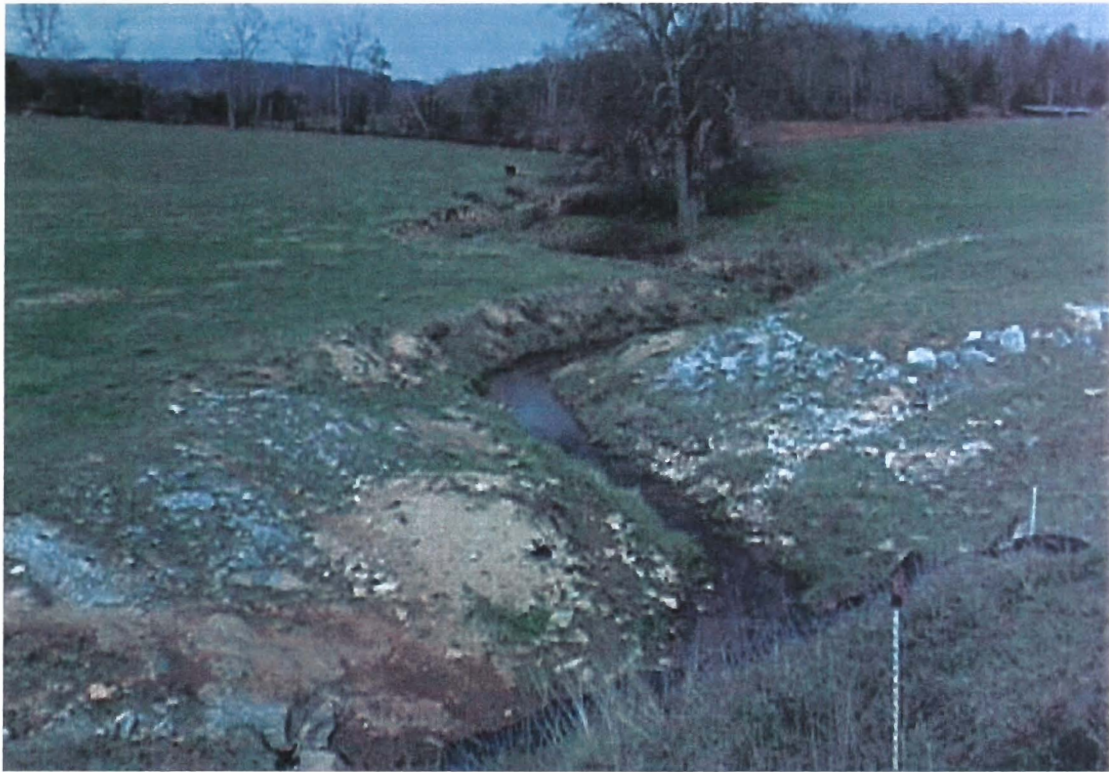
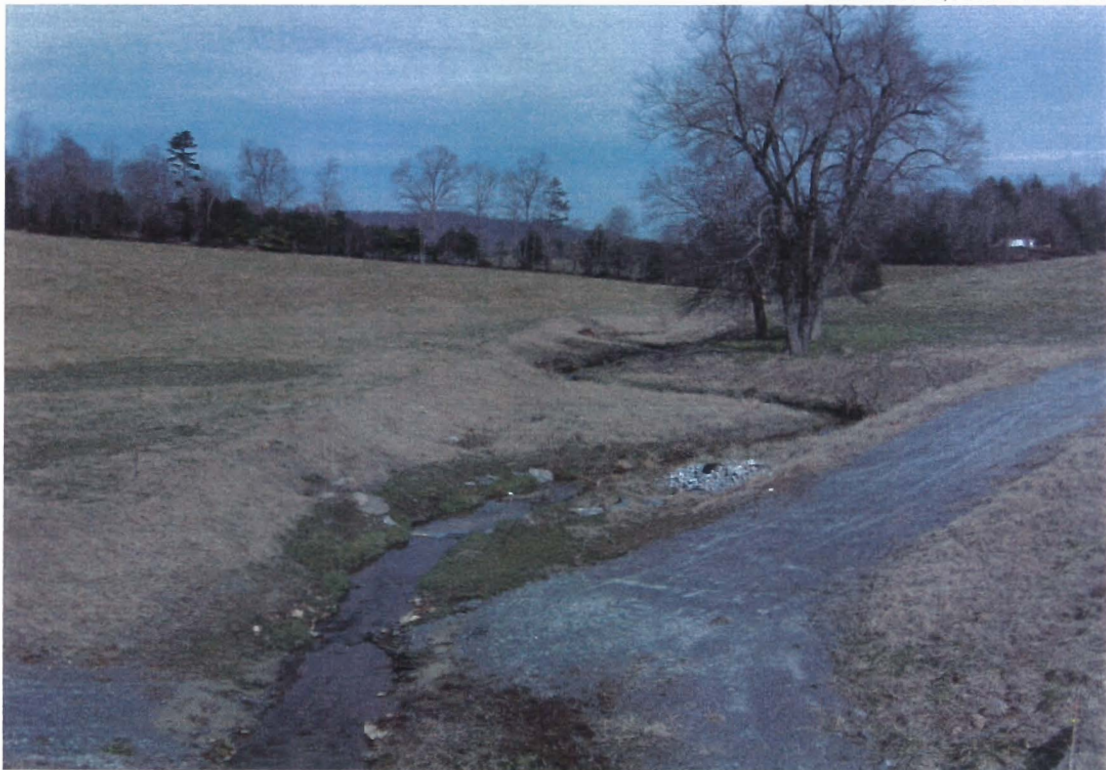
LWbelow18a, AH&W 98-12-11

Reach is the upper end of lower pasture below Hwy 18, on Big Warrior Creek. Photo is taken from on top of the culvert under Hwy. 18 looking downstream. This is series number 8 from the LWC reference photos.

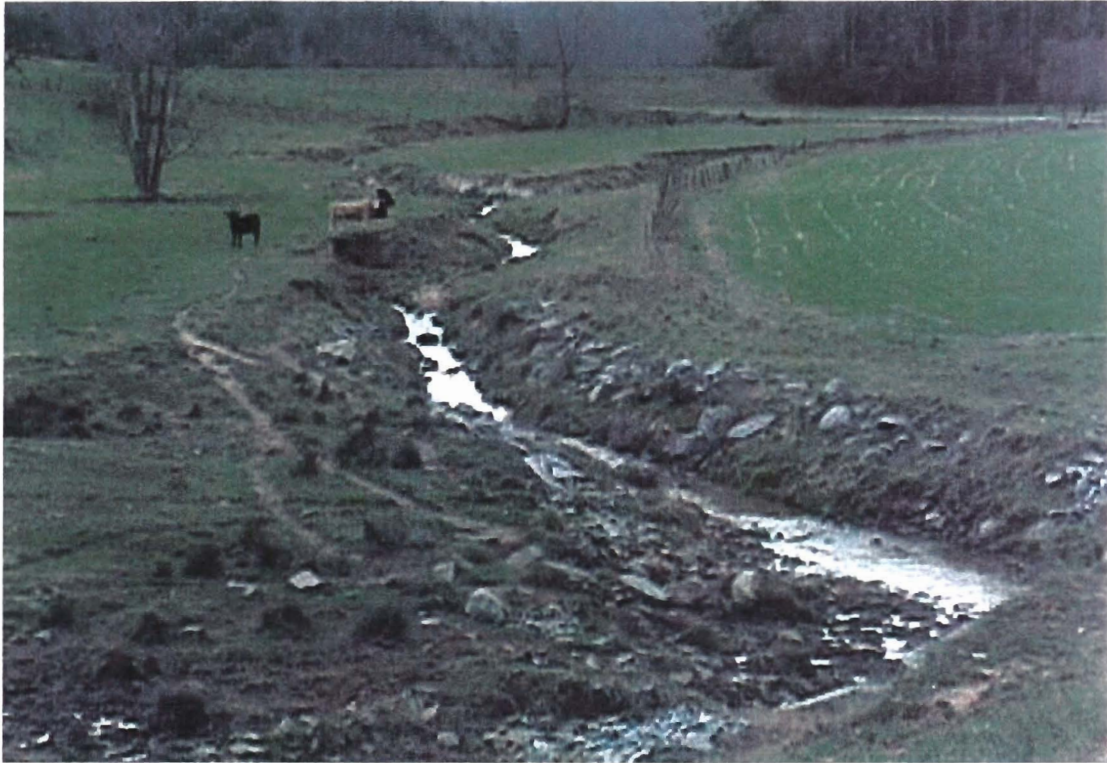
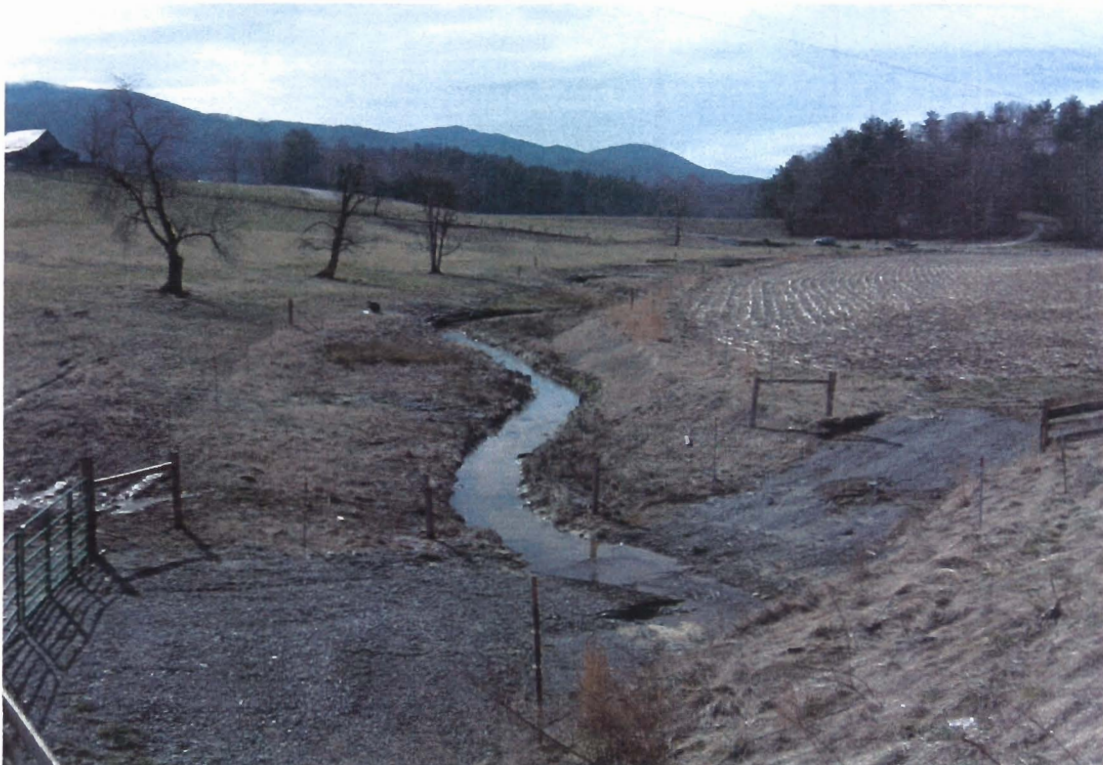
LWabove18a, AH&W 98-12-11

Reach is above the Hwy 18 culvert, on Big Warrior Creek. Photo is taken from slope below Hwy. 18, looking upstream towards Andrews Road. This is series number 10 from the LWC reference photos.

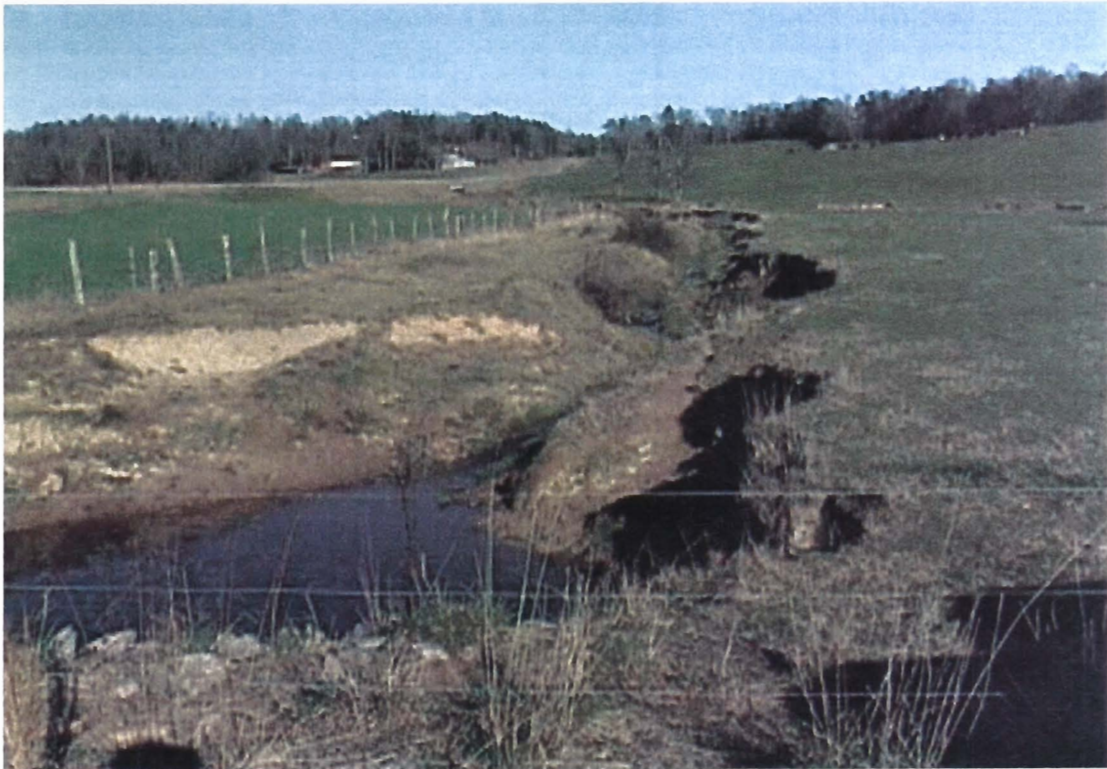
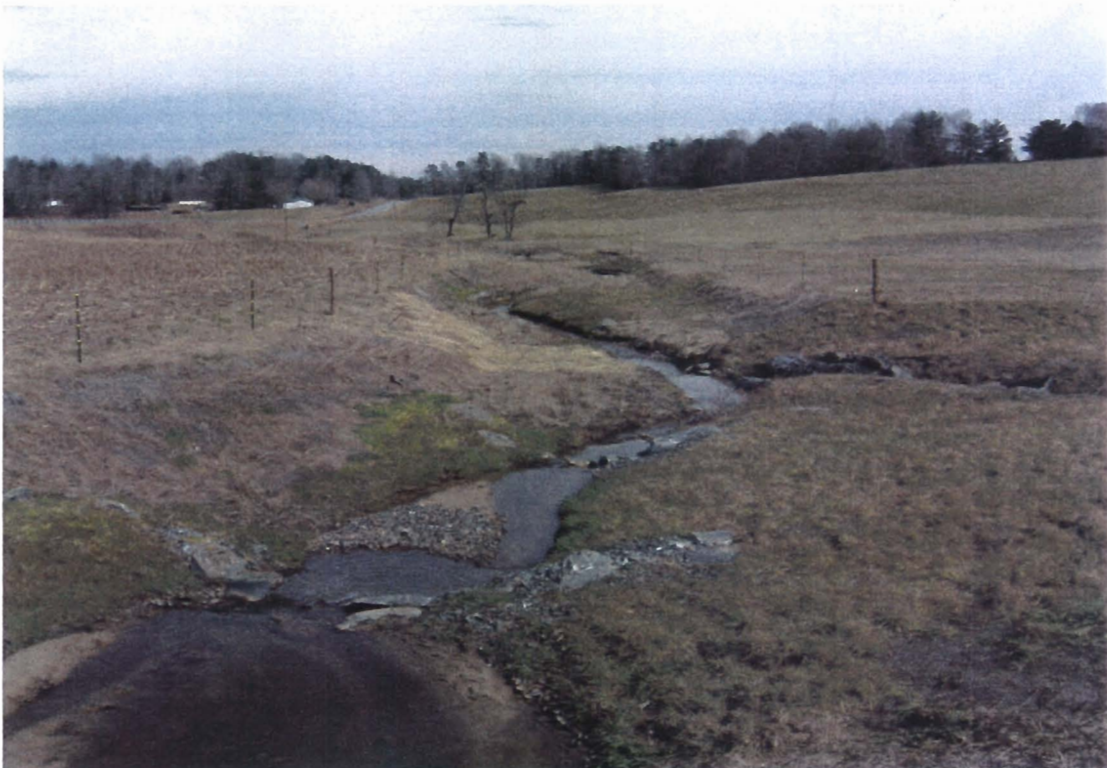
MVC-0016S, AH&W 98-12-9

Reach is below the culvert on Andrews Road, on Little Warrior Creek. Photo is taken from the right side of the culvert looking downstream towards Hwy. 18. This is series number 17 from the LWC reference photos.

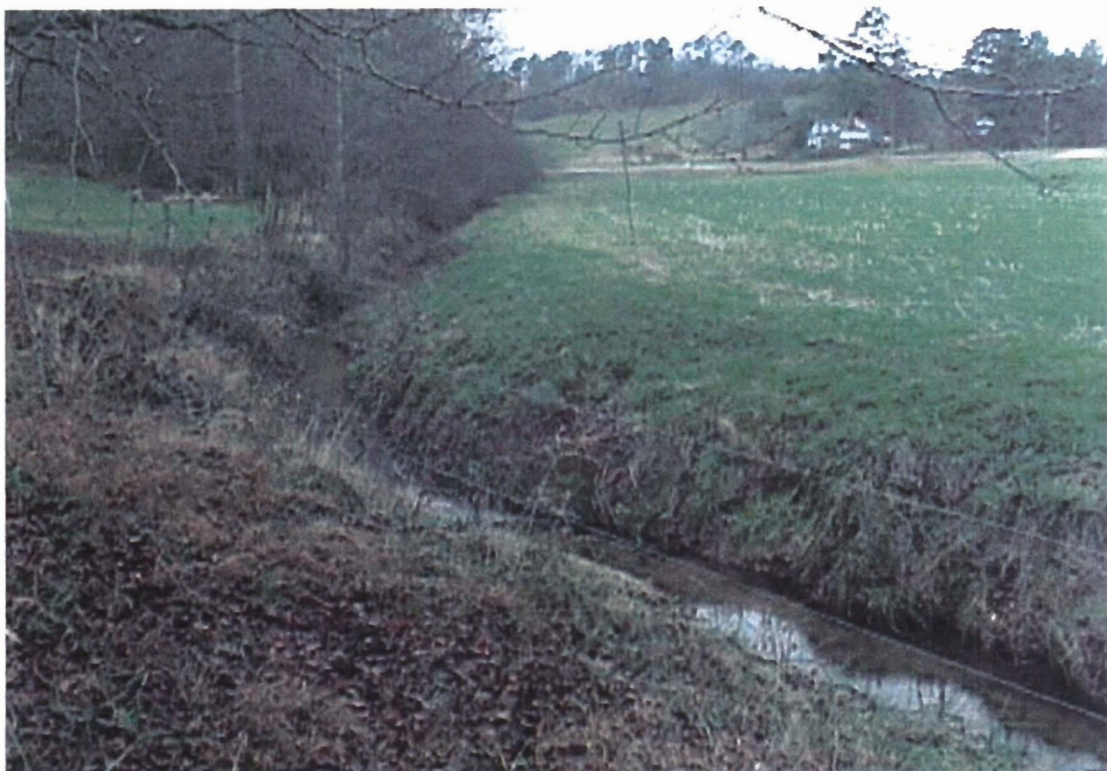
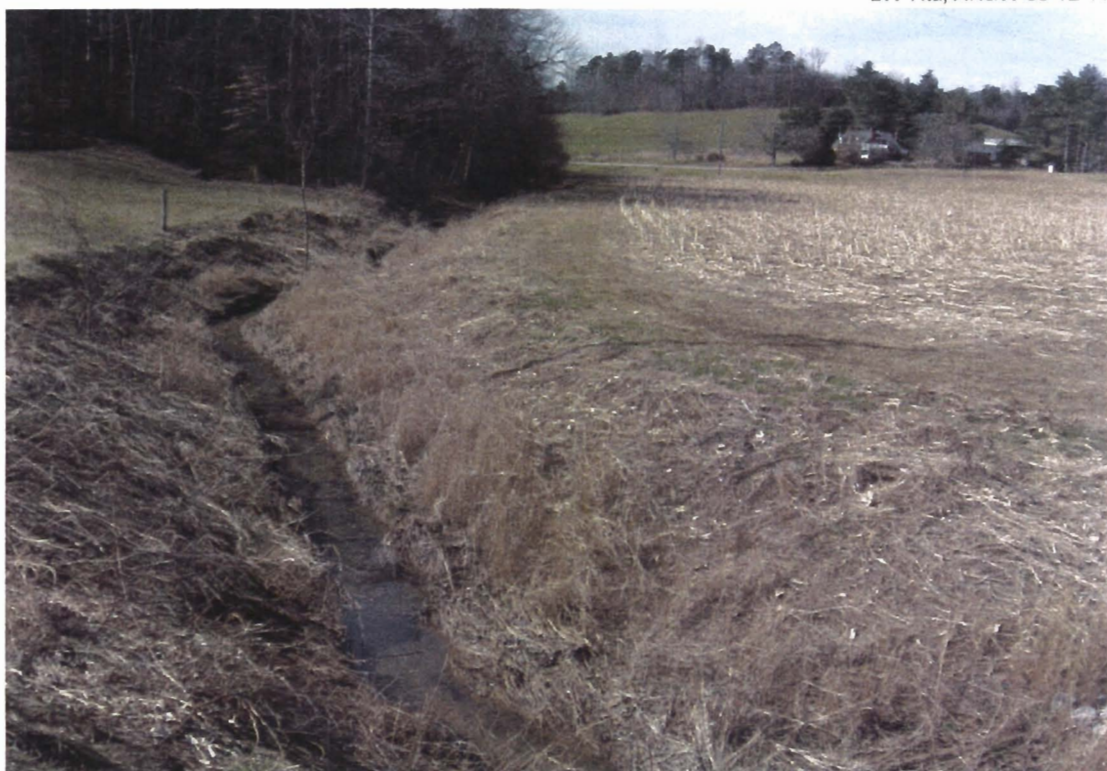
LW-Rta, AH&W 98-12-11

Reach is above the culvert on Andrews Road, on Little Warrior Creek. Photo is taken from the right side of the culvert looking upstream towards Hwy. 18. This is series number 22 from the LWC reference photos.

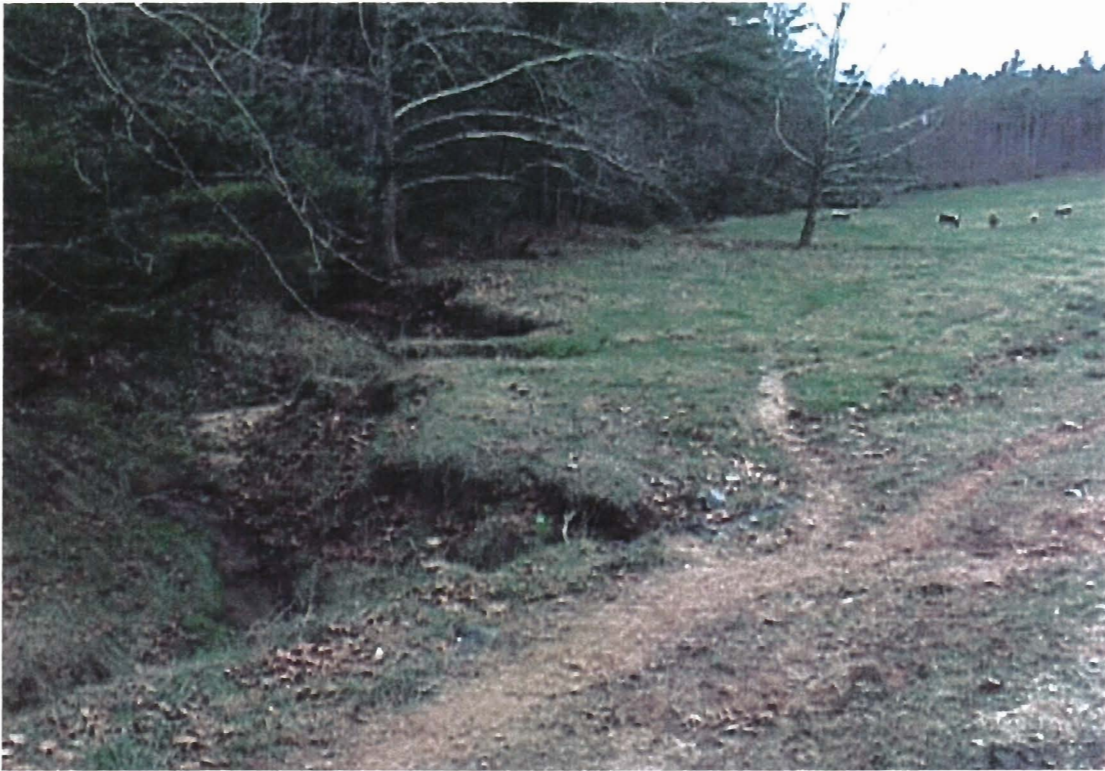
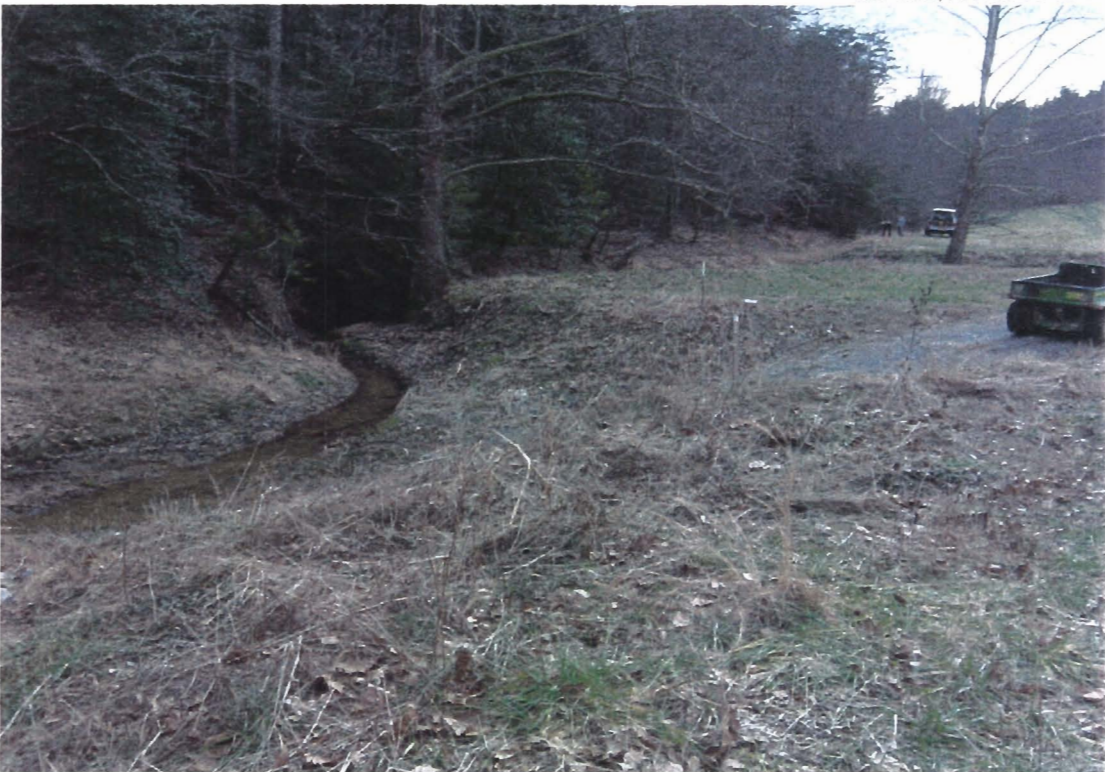
LW-RTB, AH&W 98-12-11

Reach is in the upper pasture south of Hwy 18 on Little Warrior Creek. Photo is taken from the left side of the channel looking upstream towards upper end of cattle crossing. This is series number 32 from the LWC reference photos.

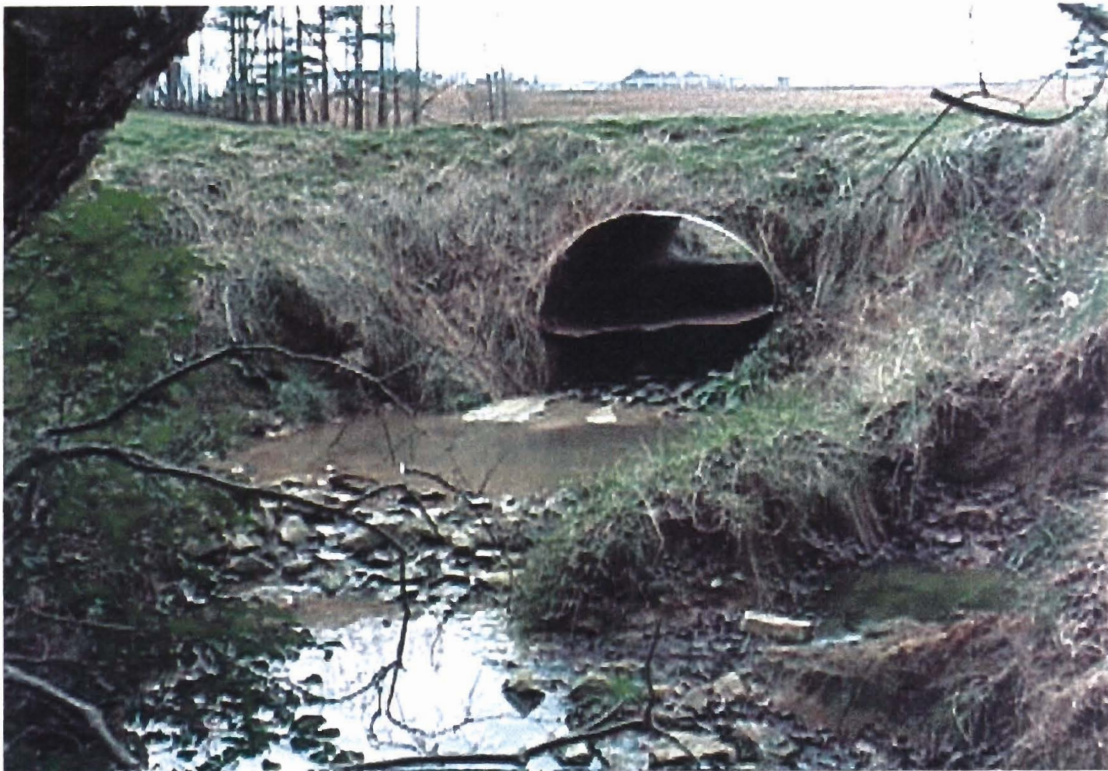
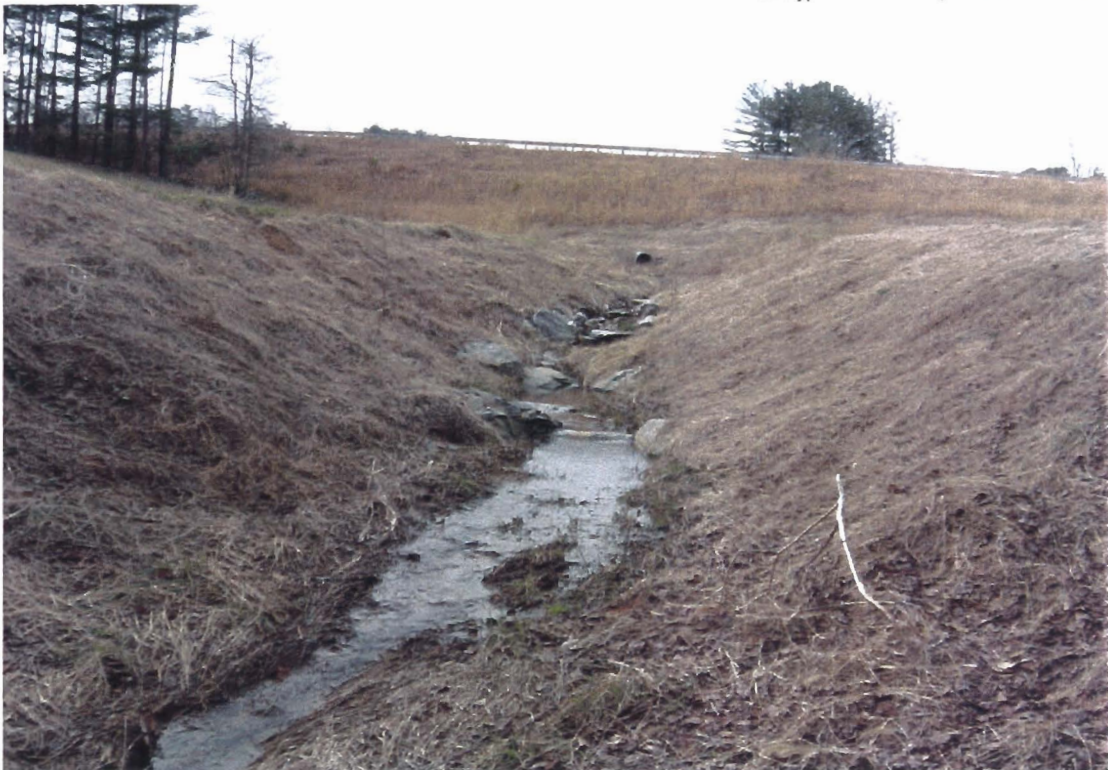
Lwbypassed culvert, AH&W 98-12-11

Reach is the upper tributary the crosses Hwy 18 on Little Warrior Creek. Photo is taken from the confluence looking upstream towards the highway. This is series number 38 from the LWC reference photos.
