N.C. Division of Coastal Management
Assessment of 27 Marsh Sills in North Carolina
Final Report

Prepared by: John Fear, Ph.D. and Bonnie Bendell

April 2011

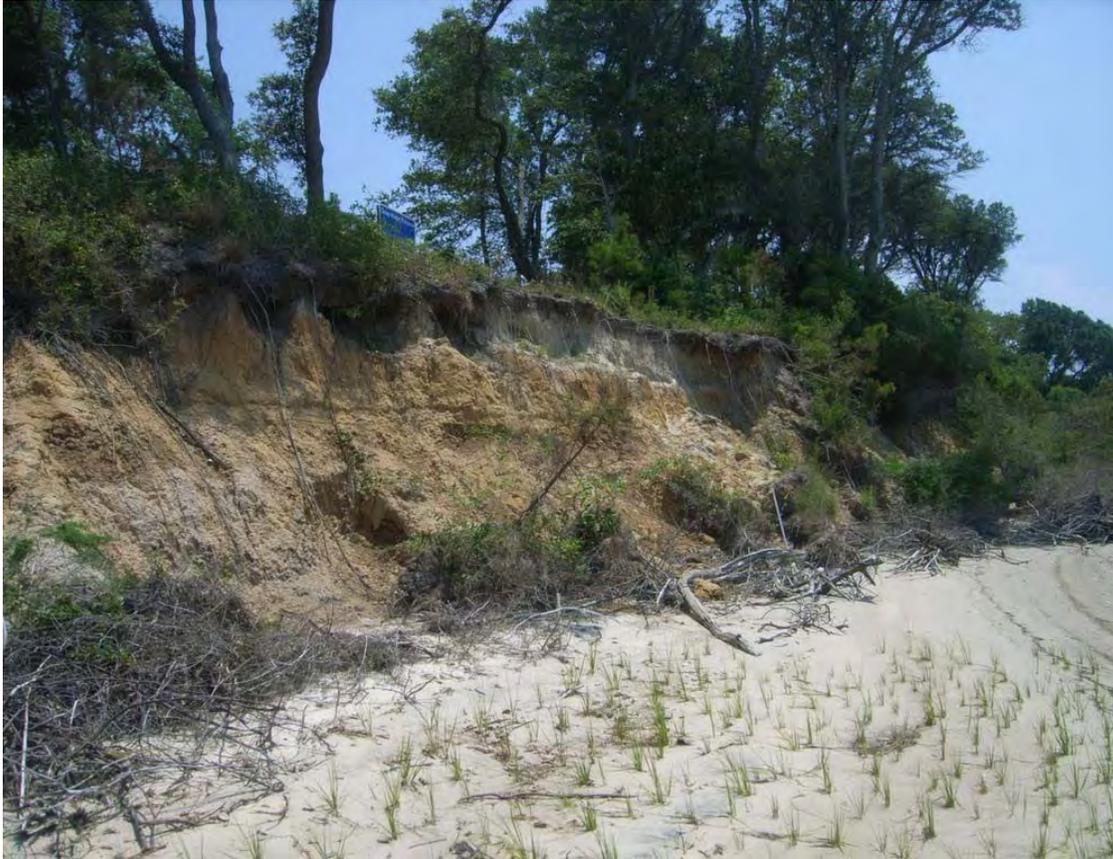
This finding is based on the responses of the field team to questions 9, 21, and 43 of the field datasheet (Table 3), the agency letter from DMF, and the responses of the property owners to property owner survey questions 4, 5, and 6 (Table 4). The field team noted 61 percent of the time that erosion was not occurring on the properties protected by marsh sills. Of the remaining responses, 13 percent of the time the field team was unsure and 25 percent of the time evidence of erosion was observable (Table 3, question 9). However, this does not imply that erosion was actively occurring at seven (25% of 27) of the visited marsh sills. One limitation of this study was that it did not account for the temporal difference between when the marsh sills were installed. Some of the visited marsh sills were more than ten years old, while others were recently constructed. The field team was only afforded a one-time snapshot view of the marsh sills. As such, it was not possible for the field team to assess when the observed erosion evidence actually occurred. There was only one site where the field team unanimously agreed that evidence of erosion existed, at project 47-09, the Jones Island marsh sill site in Onslow County. This marsh sill is newly constructed and sits in front of a pre-existing high bank bluff (Figure 3). It was the presence and condition of this bluff that the field team noted as evidence of erosion (Appendix 8.1, page 120, question 10).

Figure 3: Eroding high bank bluff with marsh plantings in front at Jones Island, Onslow County.

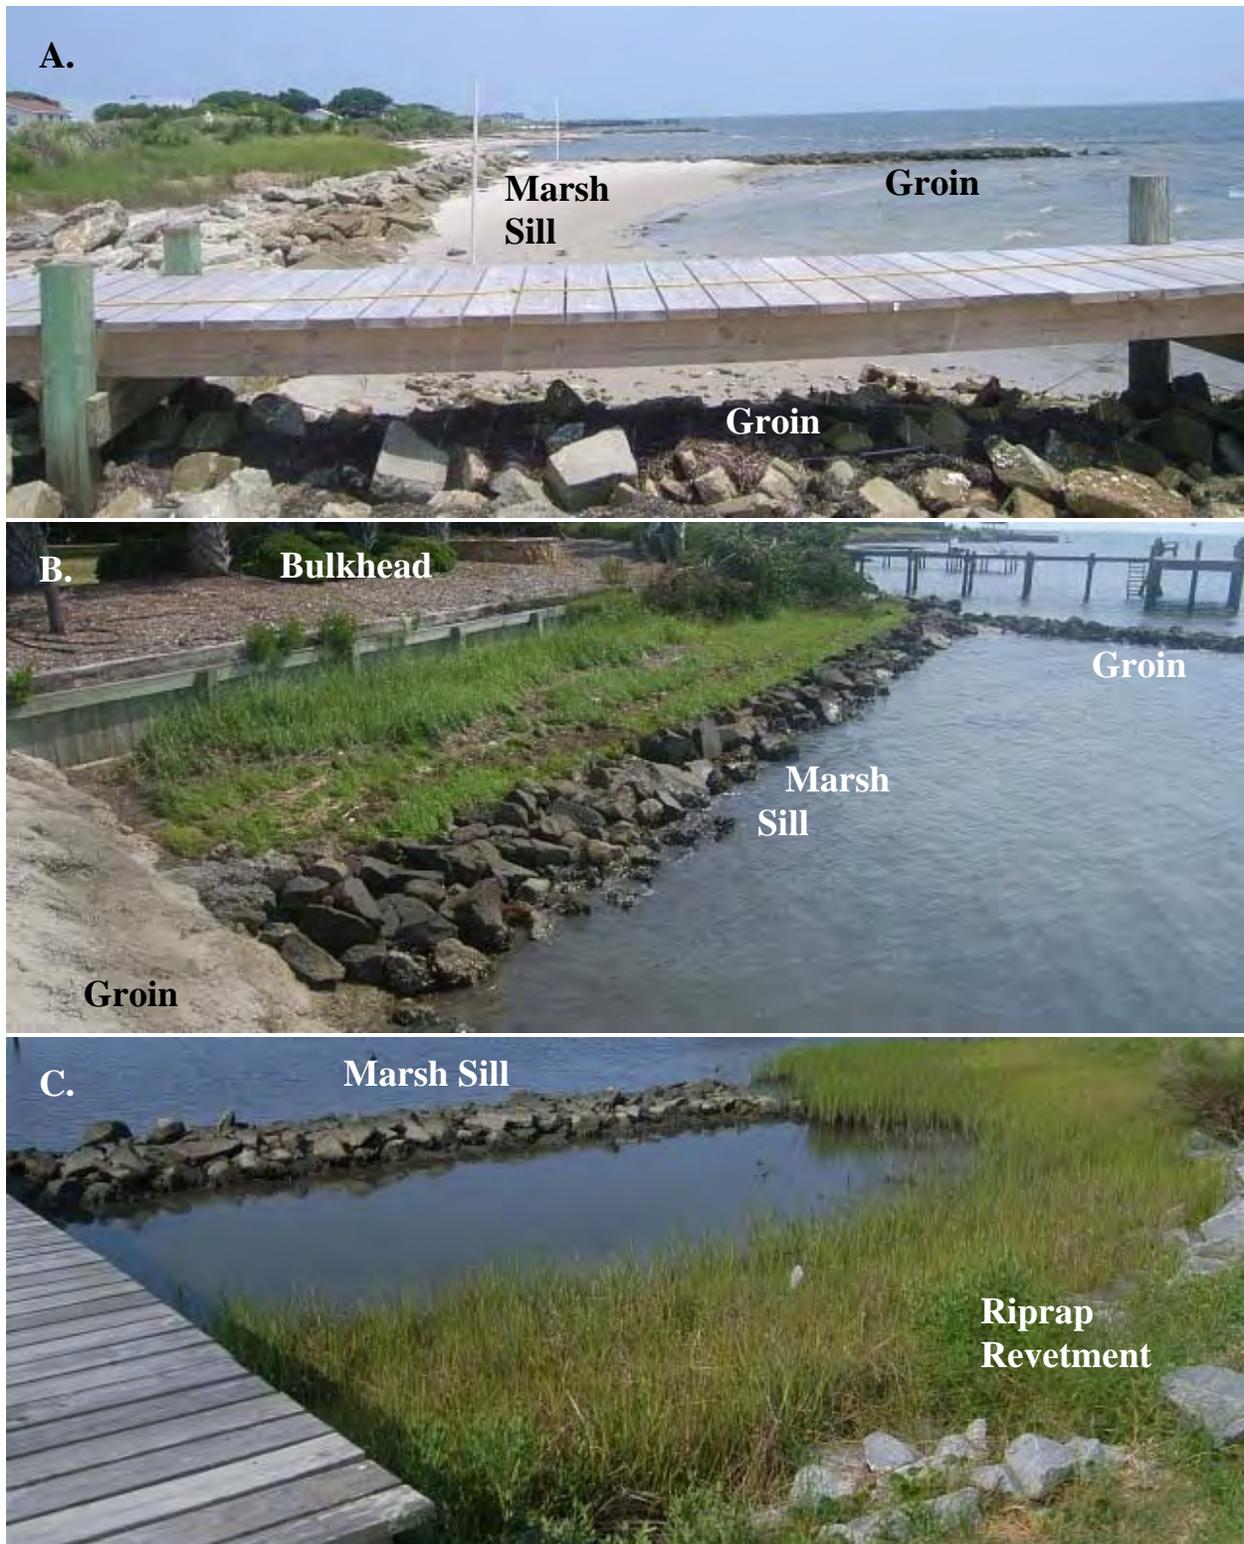
This finding is based on visual observation from the field visits. Of the 27 visited marsh sills, 12 of them (44 percent) were built in front of or attached to another type of shoreline stabilization. Most commonly observed were marsh sills built in front of bulkheads, or in combination with groins. Figure 4 shows examples of several marsh sills built in combination with other stabilization structures. The interaction of several shoreline stabilization structures operating synergistically is a much more complex situation compared to a marsh sill by itself. The design process and potentially the permitting for marsh sills must account for the potential interaction between two or more shoreline stabilization methods utilized at the same place and time.

Figure 4: Marsh sills built in combination with other stabilization structures. Panel A: marsh sill and groins; Panel B: marsh sill and groins in front of a bulkhead; Panel C: marsh sill built in front of a riprap revetment.

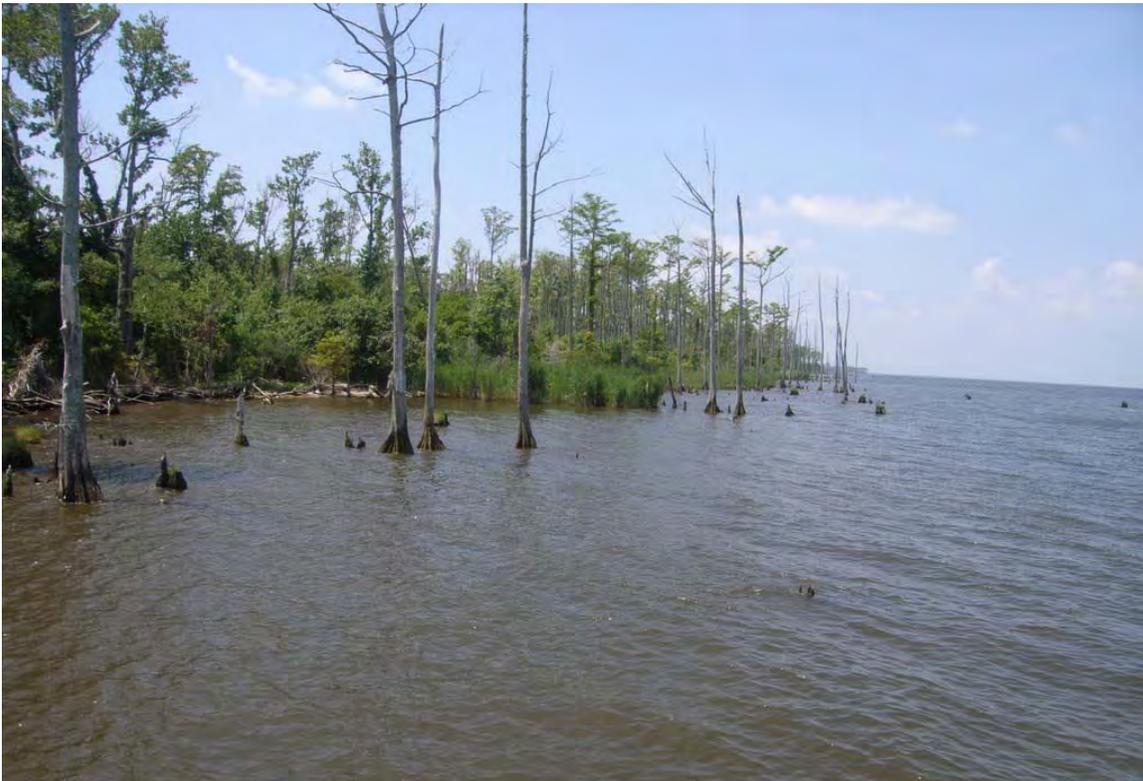
There were two site visits (permit 42-00-07 and permit 46565B) where all but one team member noted evidence of erosion on the adjacent property. In both cases, the field team member that did not agree with the others marked “unsure” on their questionnaire (Appendix 8.1 Page 137 and 93, Question 11). For the case of permit 42-00-07, the adjacent property contained a natural swamp forest with remnants of dead trees on the edge (Figure 5).

Figure 5: Adjacent property to marsh sill project 42-00-07.

It was the presence of these dead trees that most of the team members cited as the evidence of erosion (Appendix 8.1, page 137, question 12). This type of shoreline margin is a natural feature of the Albemarle Sound and was not caused due to the installation of the marsh sill.

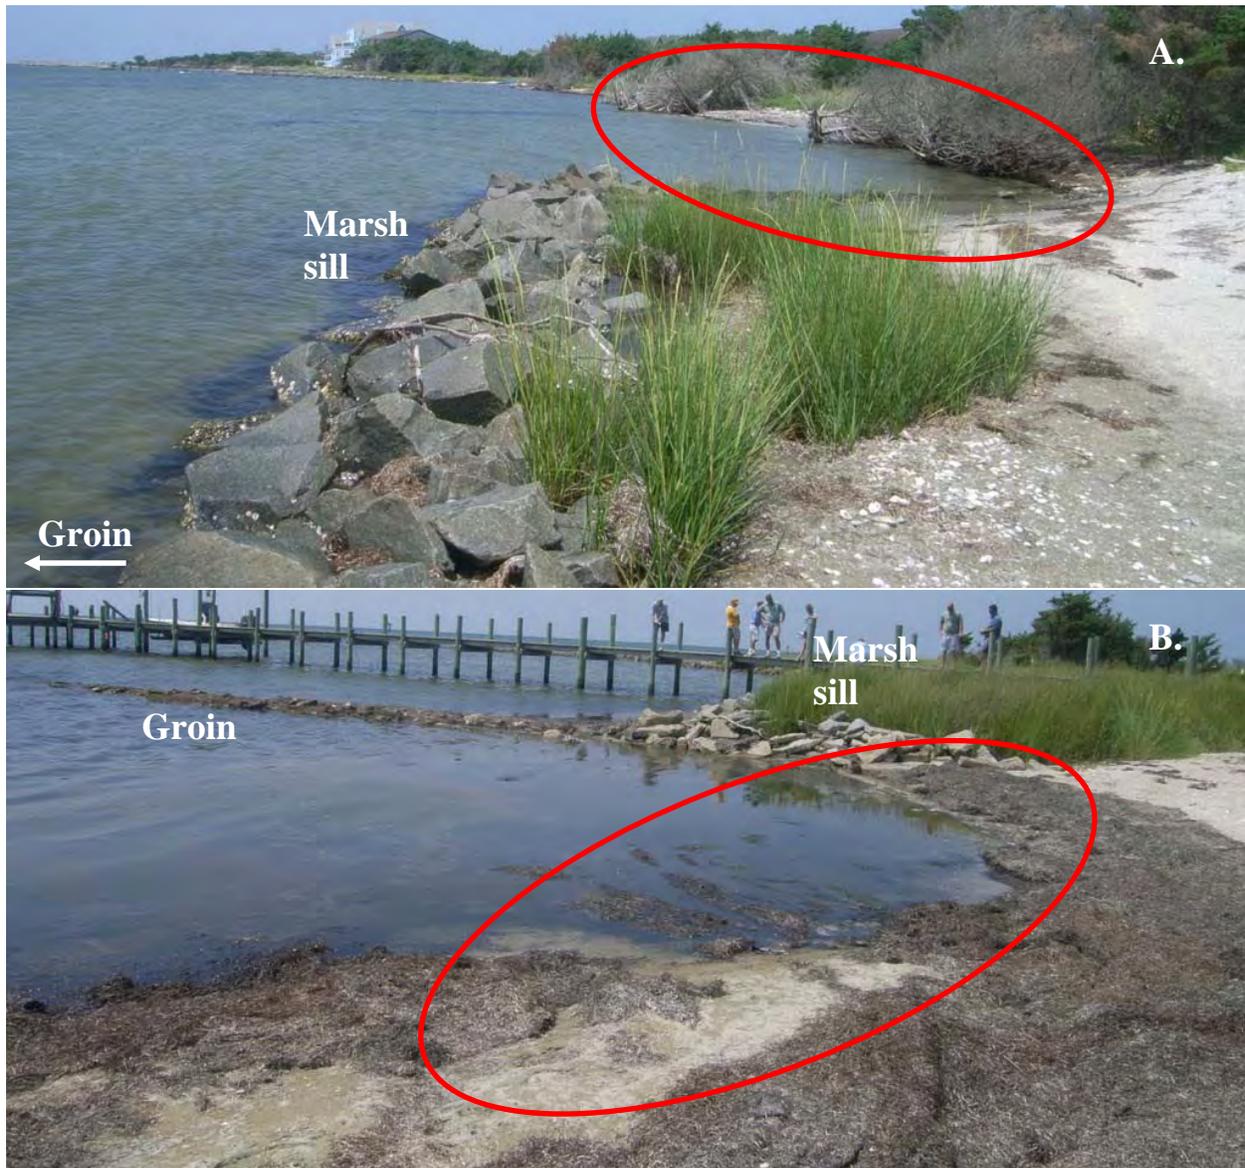
Several different areas of erosion on the adjacent properties were noted by the field team at site 46565B (Appendix 8.1, page 93, question 12). However, the field team was unsure if the erosion was being caused by the marsh sill or the two groins present at the site, as most of the erosion seemed to be occurring near where the marsh sill joined with the groins (Figure 6).

Figure 6: Erosion on adjacent properties of project 46565B. Panel A shows a picture of the adjacent property to the north taken from the junction of the marsh sill and one of the two groins. The groin extends off picture to the left as indicated by the arrow. Panel B is taken from the adjoining property to the south and shows where the other groin joins the marsh sill. The red circles on both panels show the areas of erosion.
