# Southeast Natural Gas Race Marcellus- to-Atlantic

# Mountain Valley Pipeline

The 330-mile Mountain Valley Pipeline project would connect Marcellus natural gas supply to demand markets in the Southeast region of the United States providing at least two billion cubic feet per day transmission capacity.

# Top Ten Most Common Erosion Control Problems

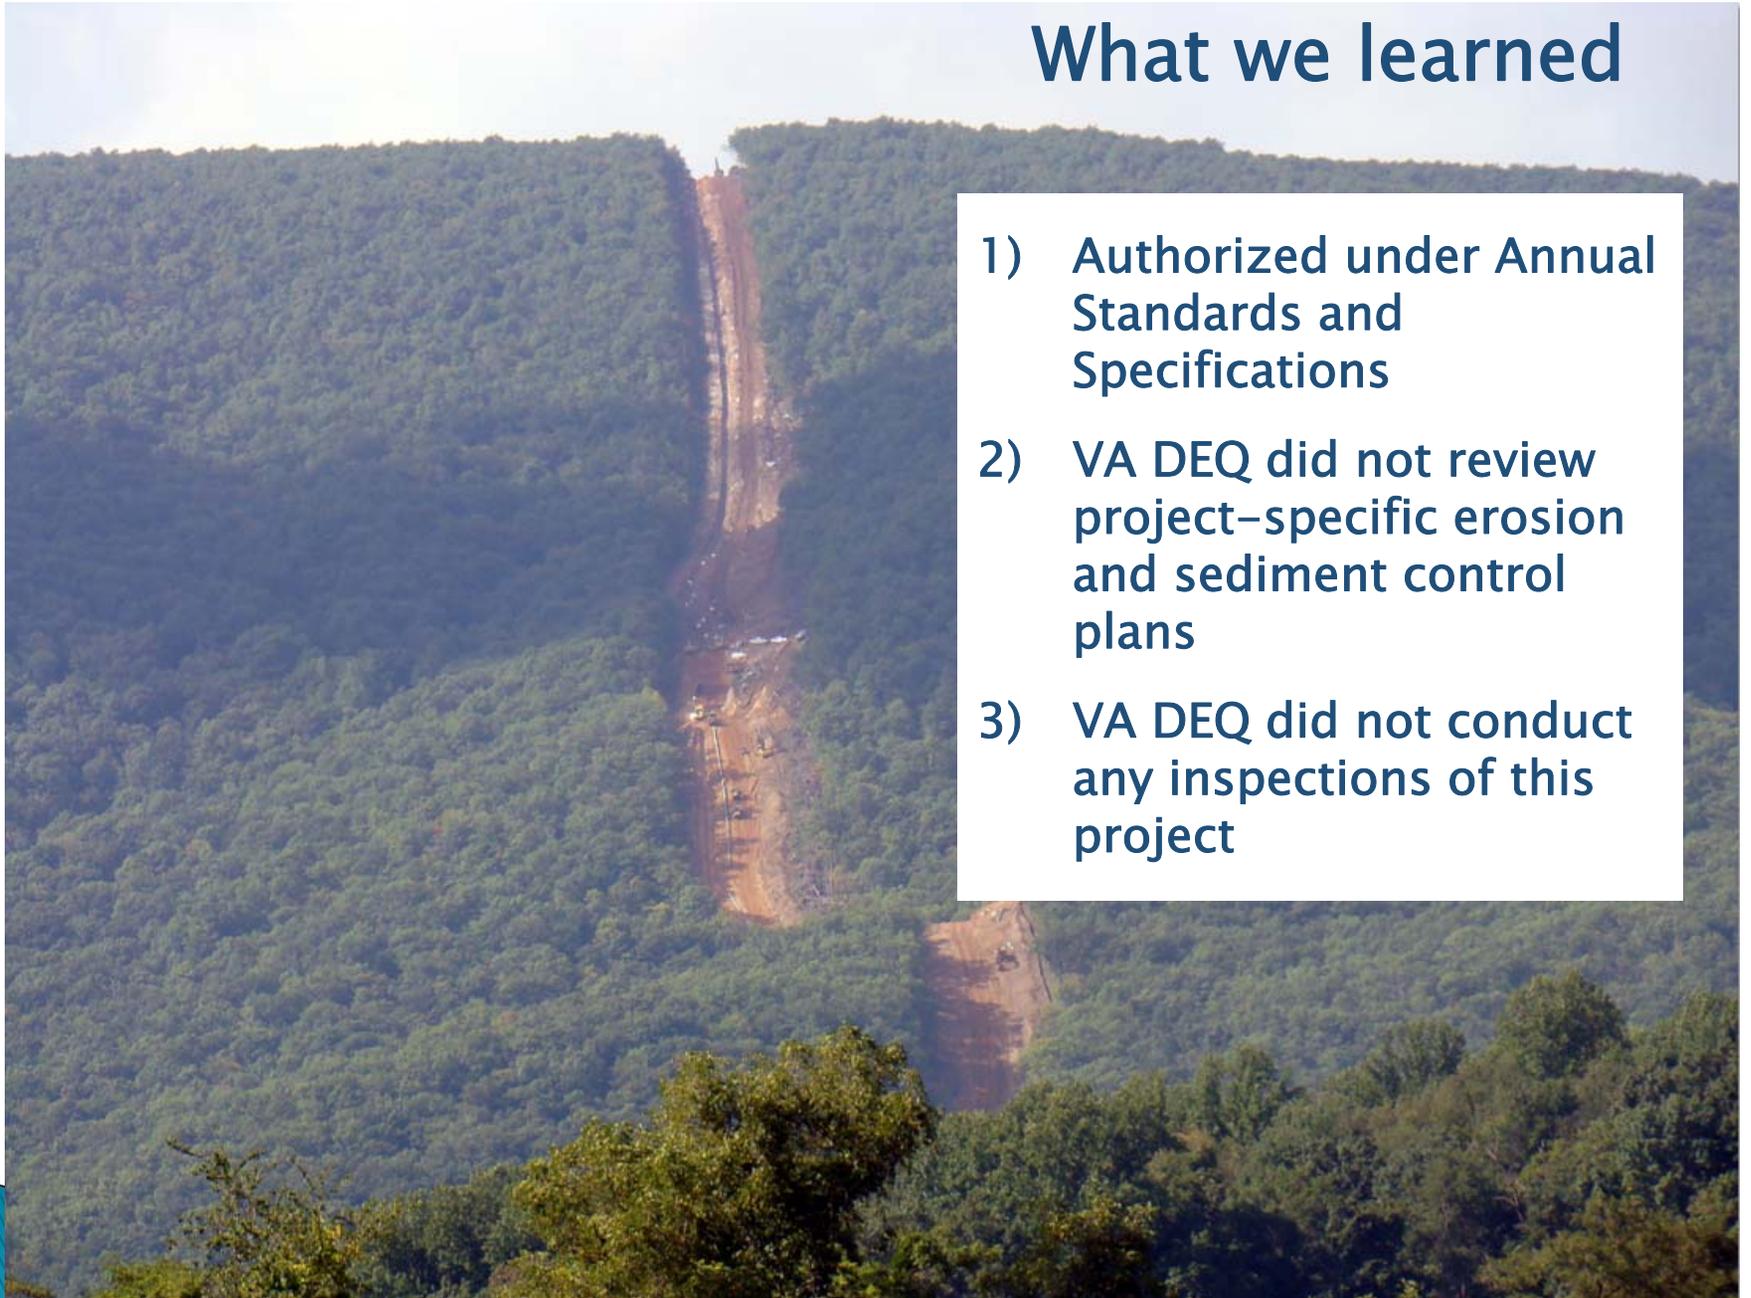
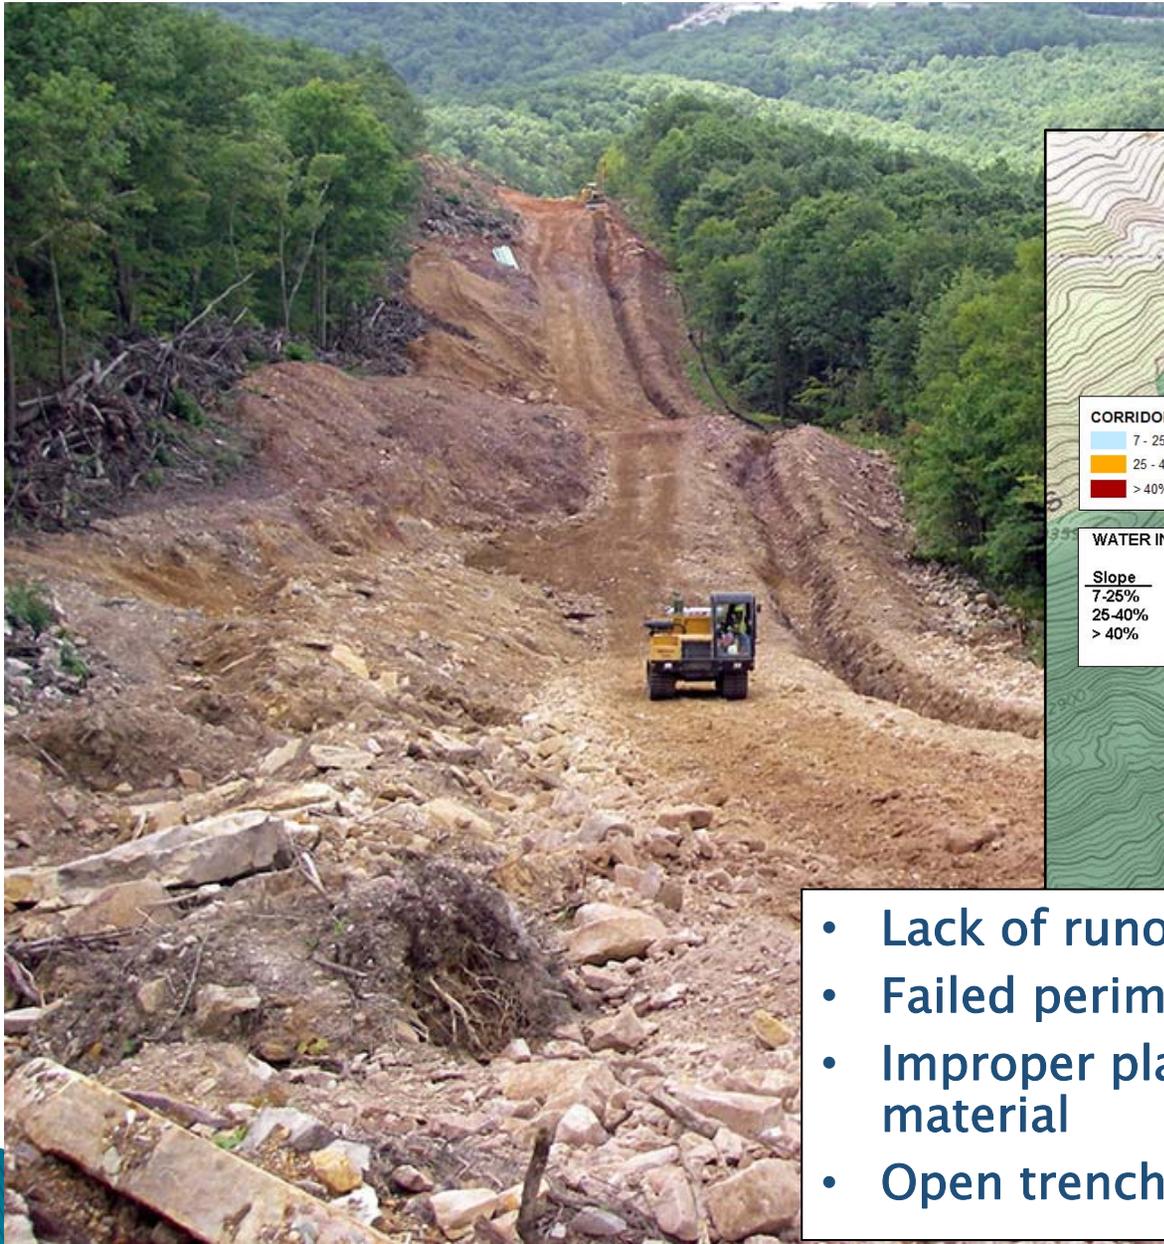
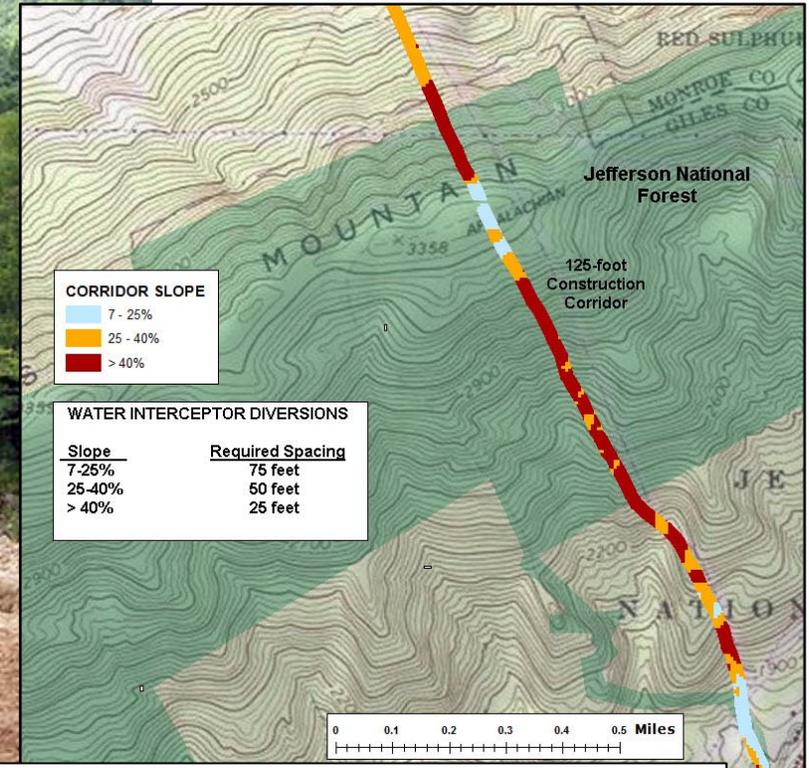
- Lack of runoff controls
- Failed perimeter silt fencing
- Improper placement of excavated material
- Open trench top-to-bottom

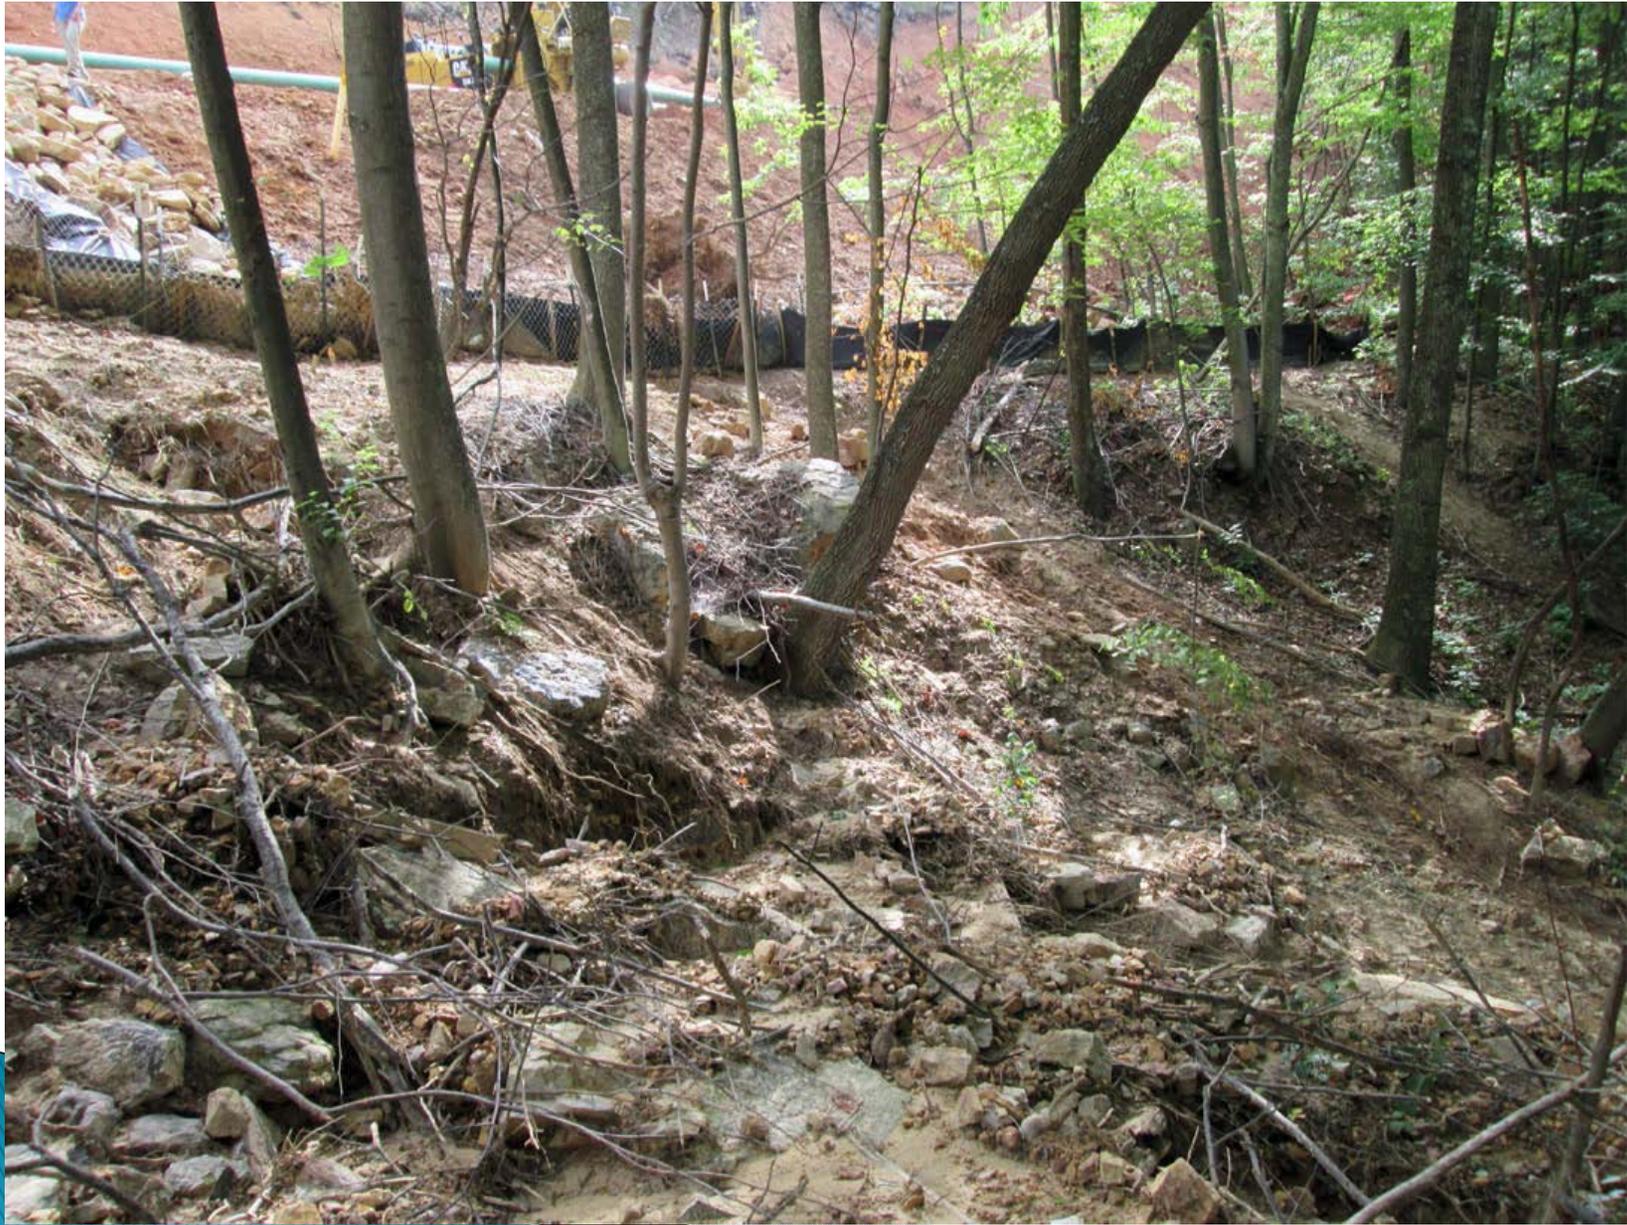
# Sediment flowing below silt fence

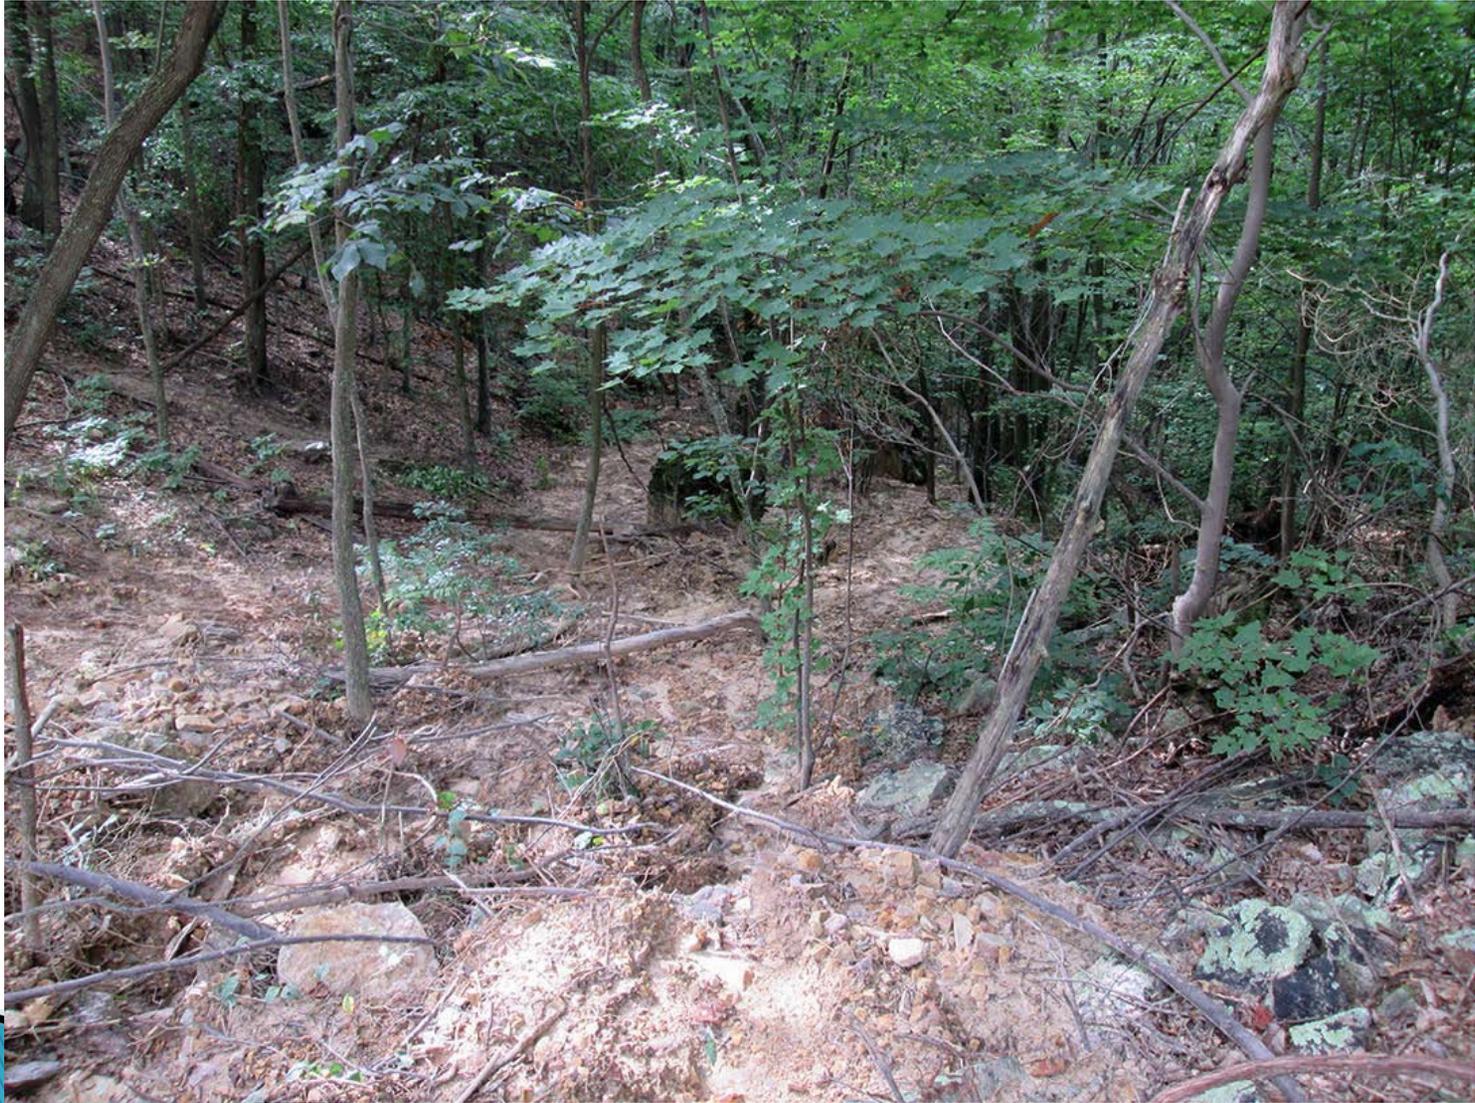
# Sediment flowing from corridor

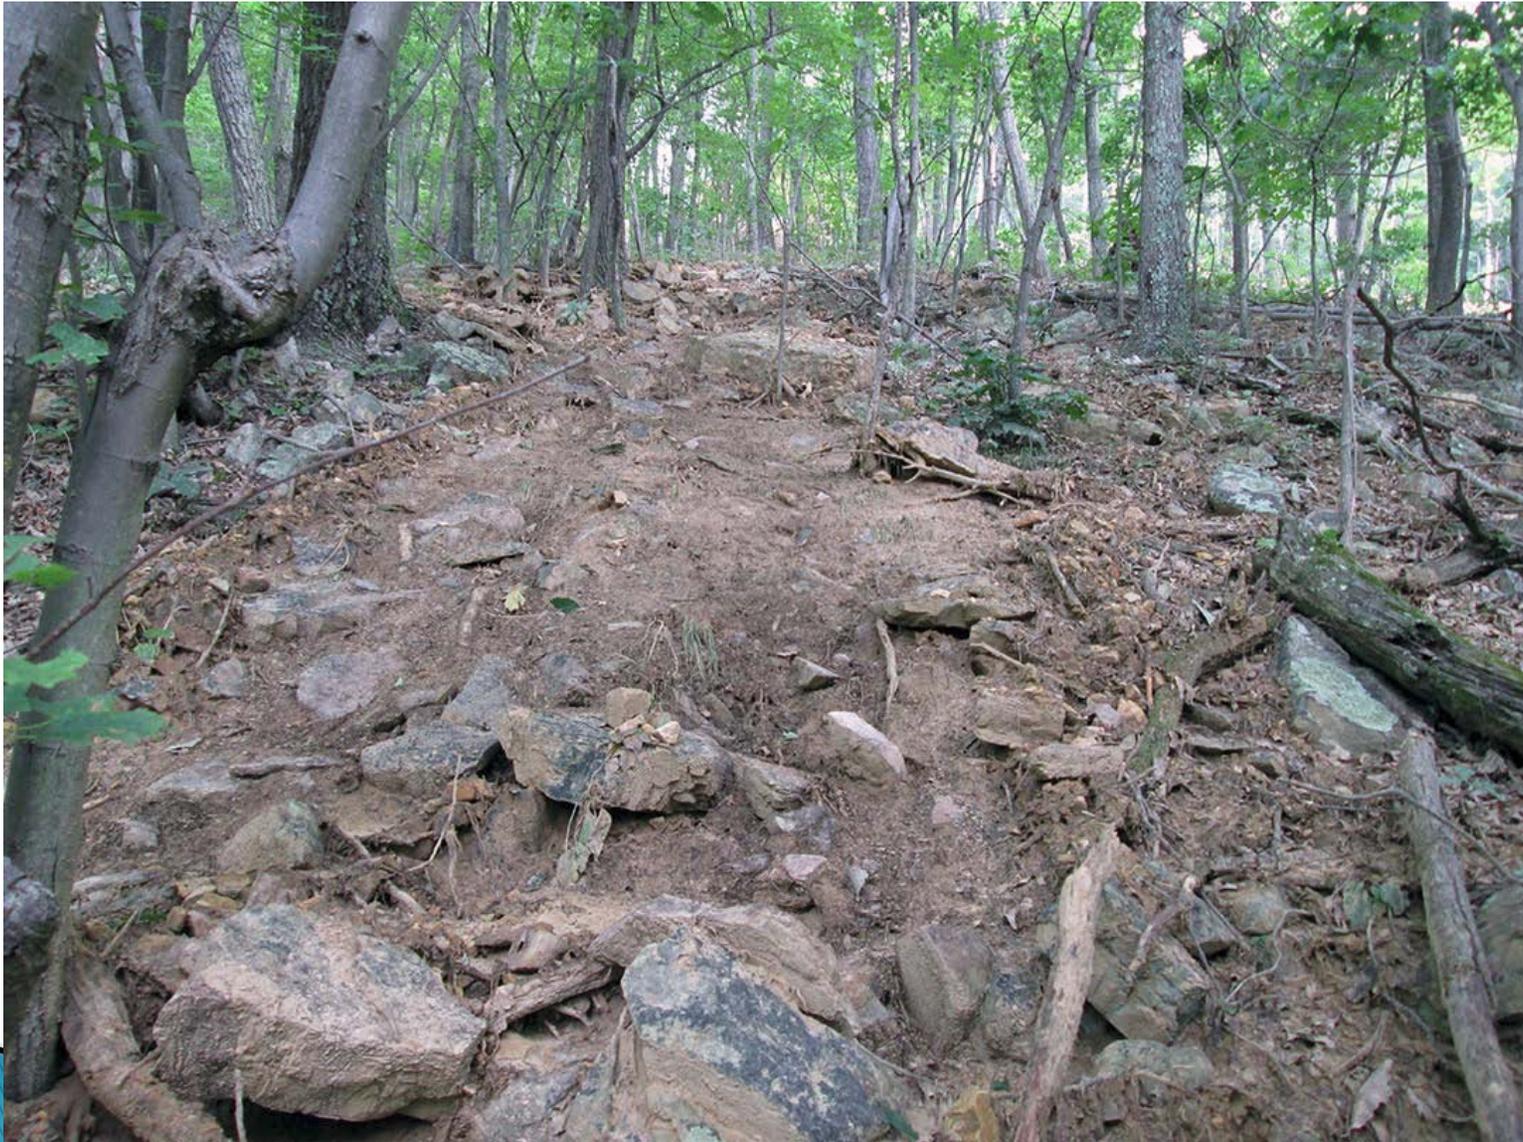
# Sediment flowing down hill side

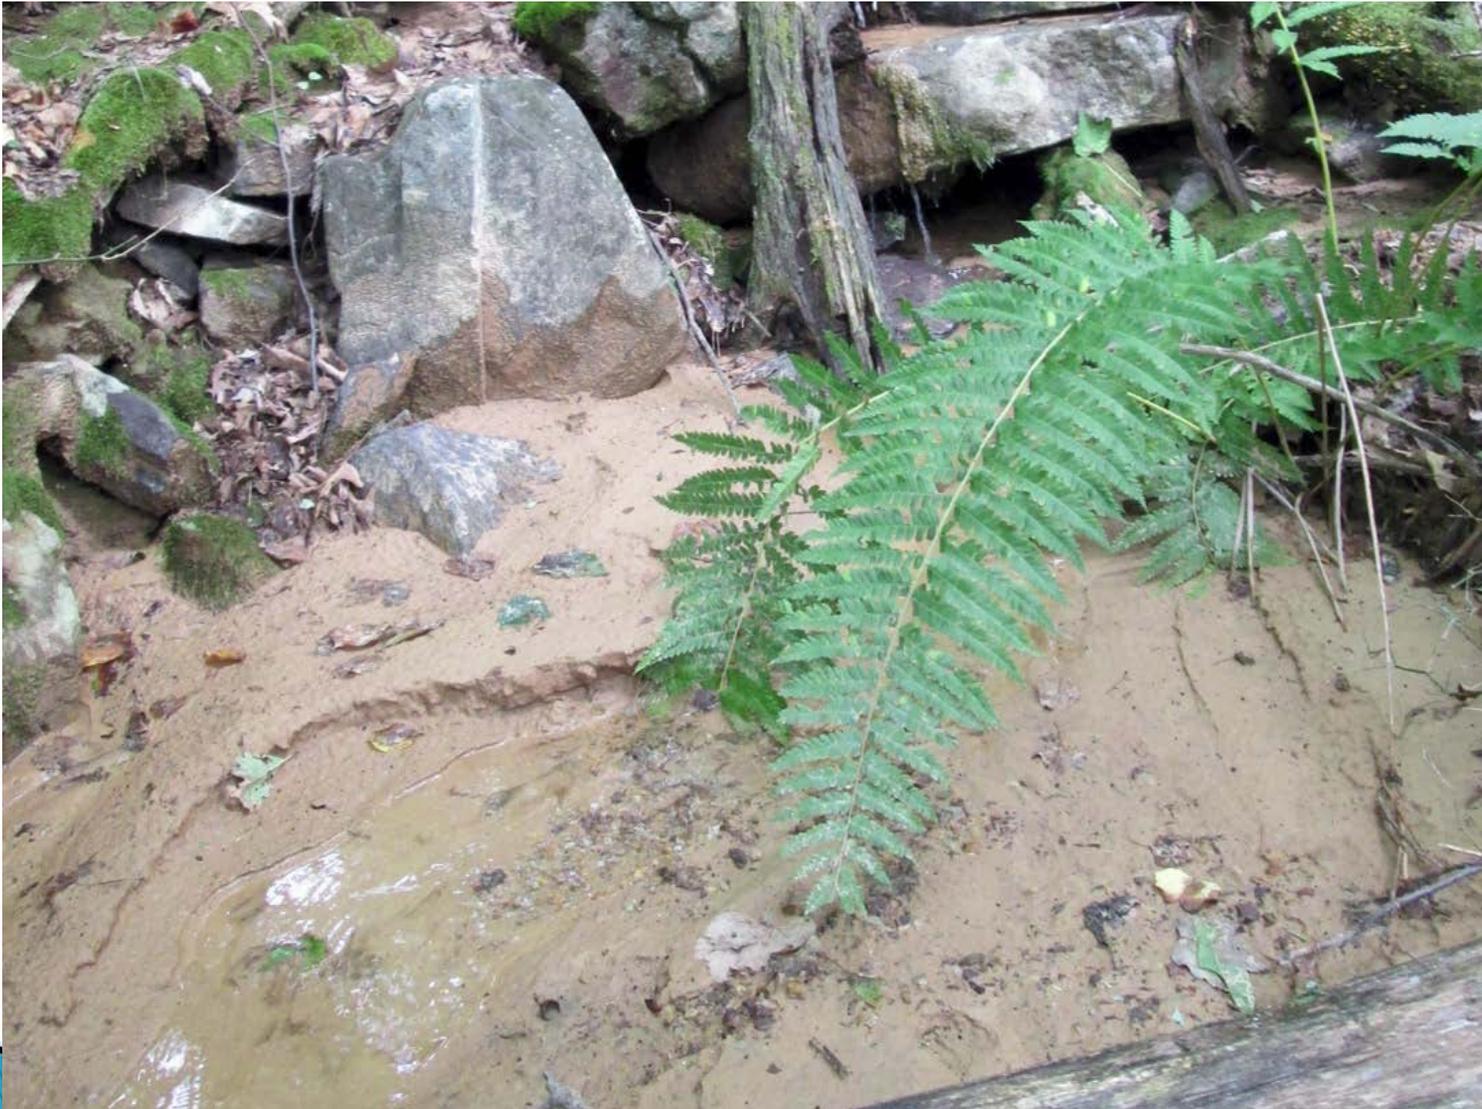
# Stream filled with mud

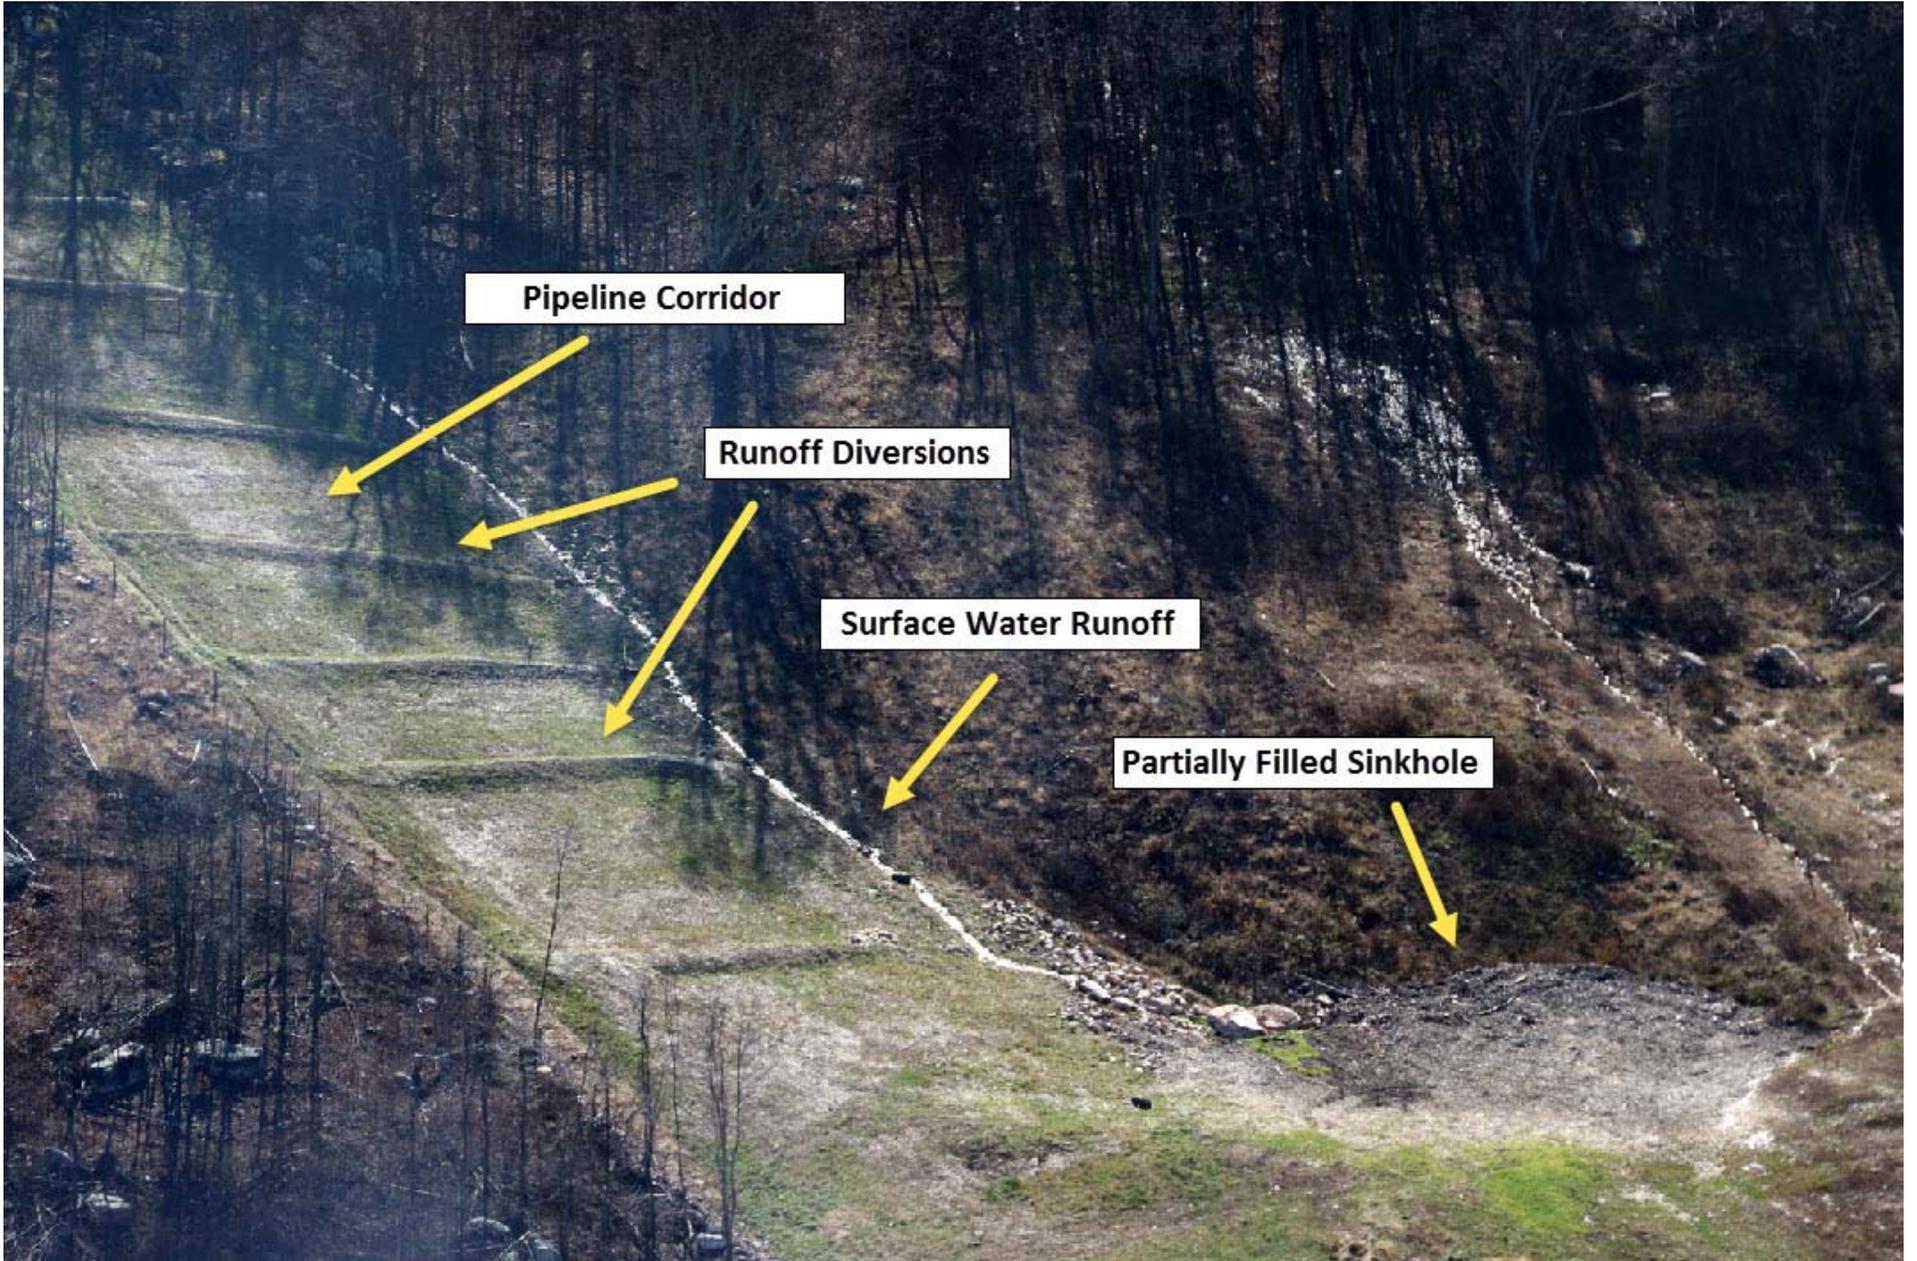
**Pipeline Corridor**

**Runoff Diversions**

**Surface Water Runoff**

**Partially Filled Sinkhole**

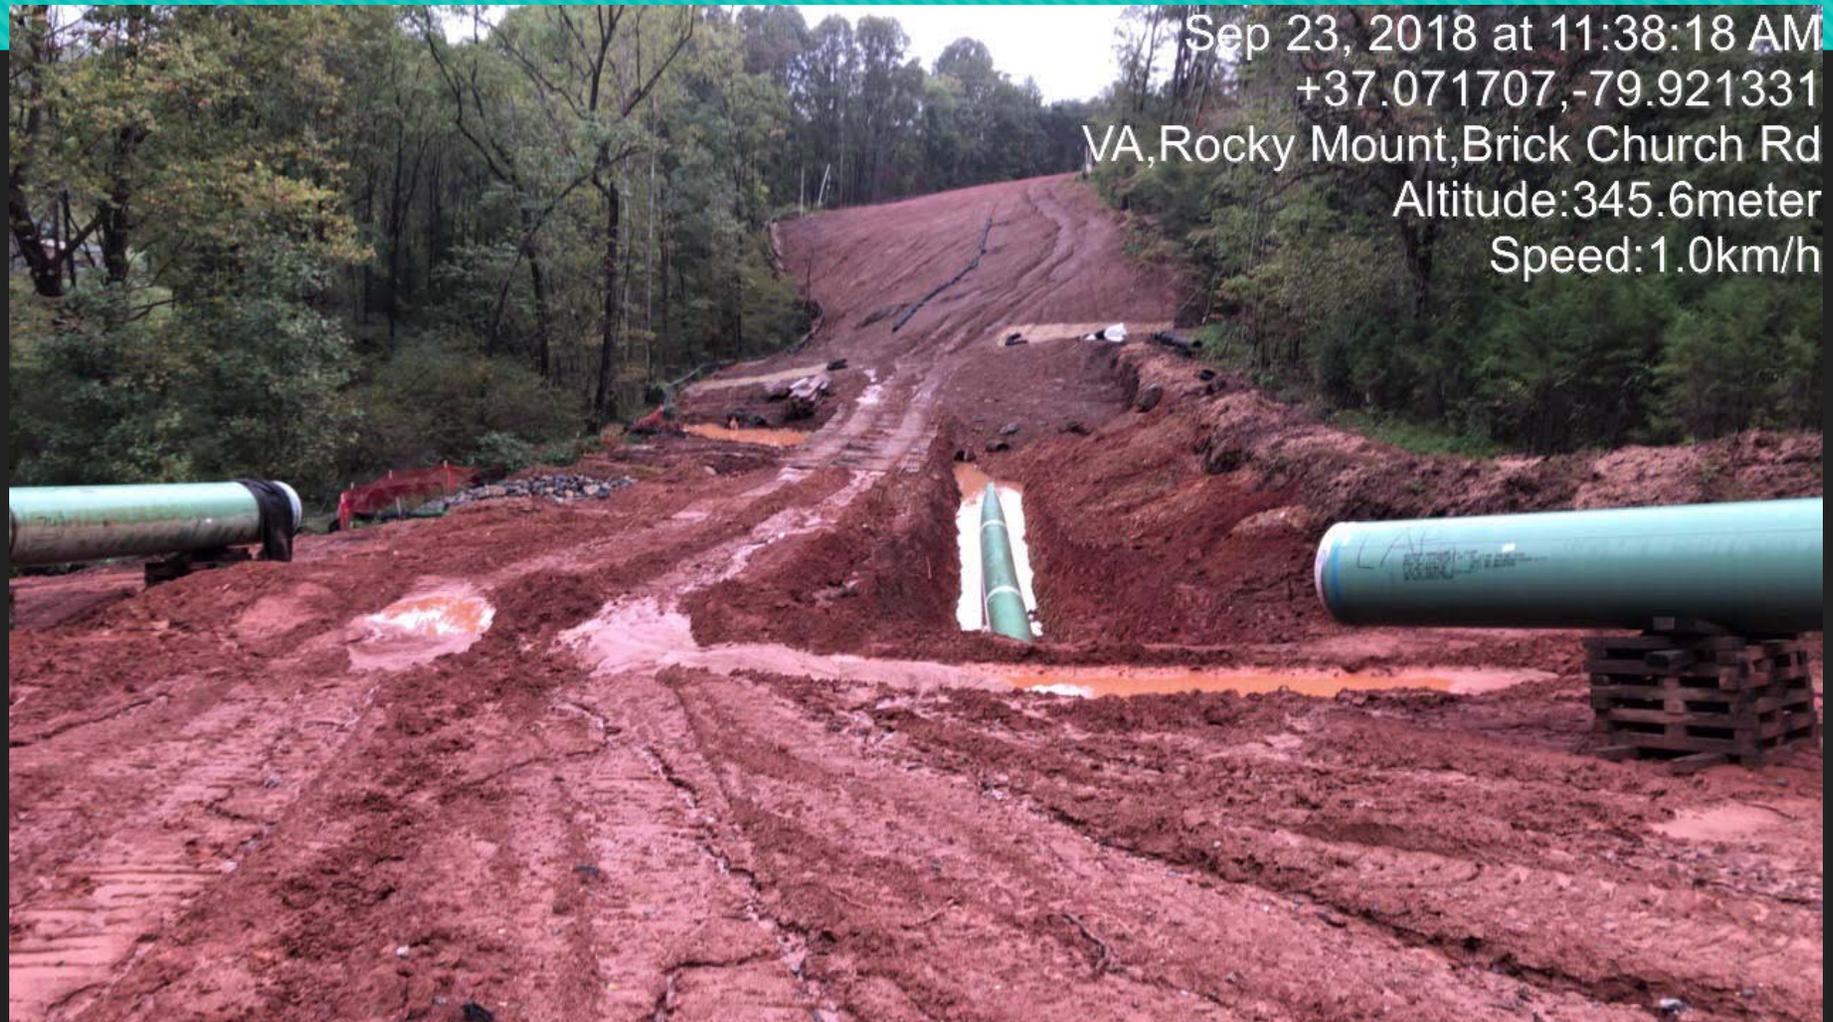
1) Failure to install, or delayed installation of, erosion and sediment control (ESC) measures as required by approved plans or by regulations.

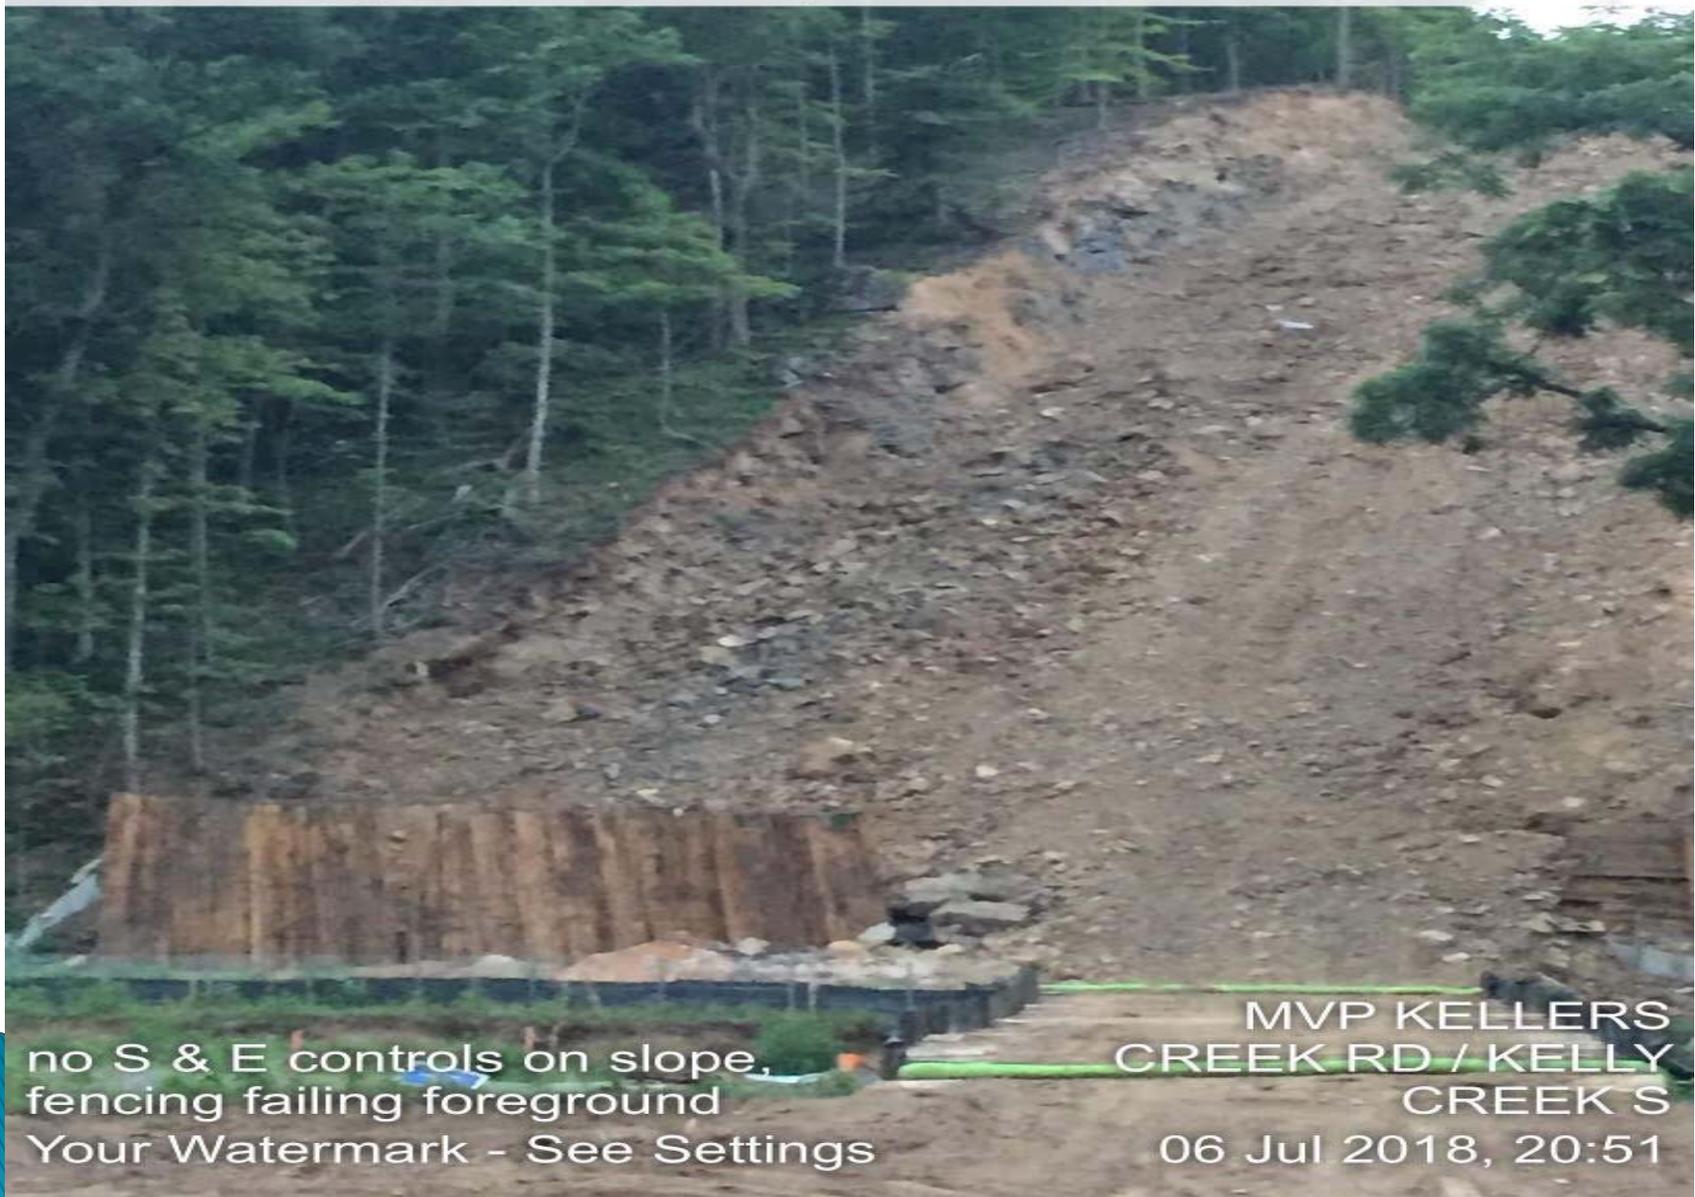
MVP KELLERS  
CREEK RD / KELLY  
CREEK S  
06 Jul 2018, 20:51

no S & E controls on slope,  
fencing failing foreground  
Your Watermark - See Settings

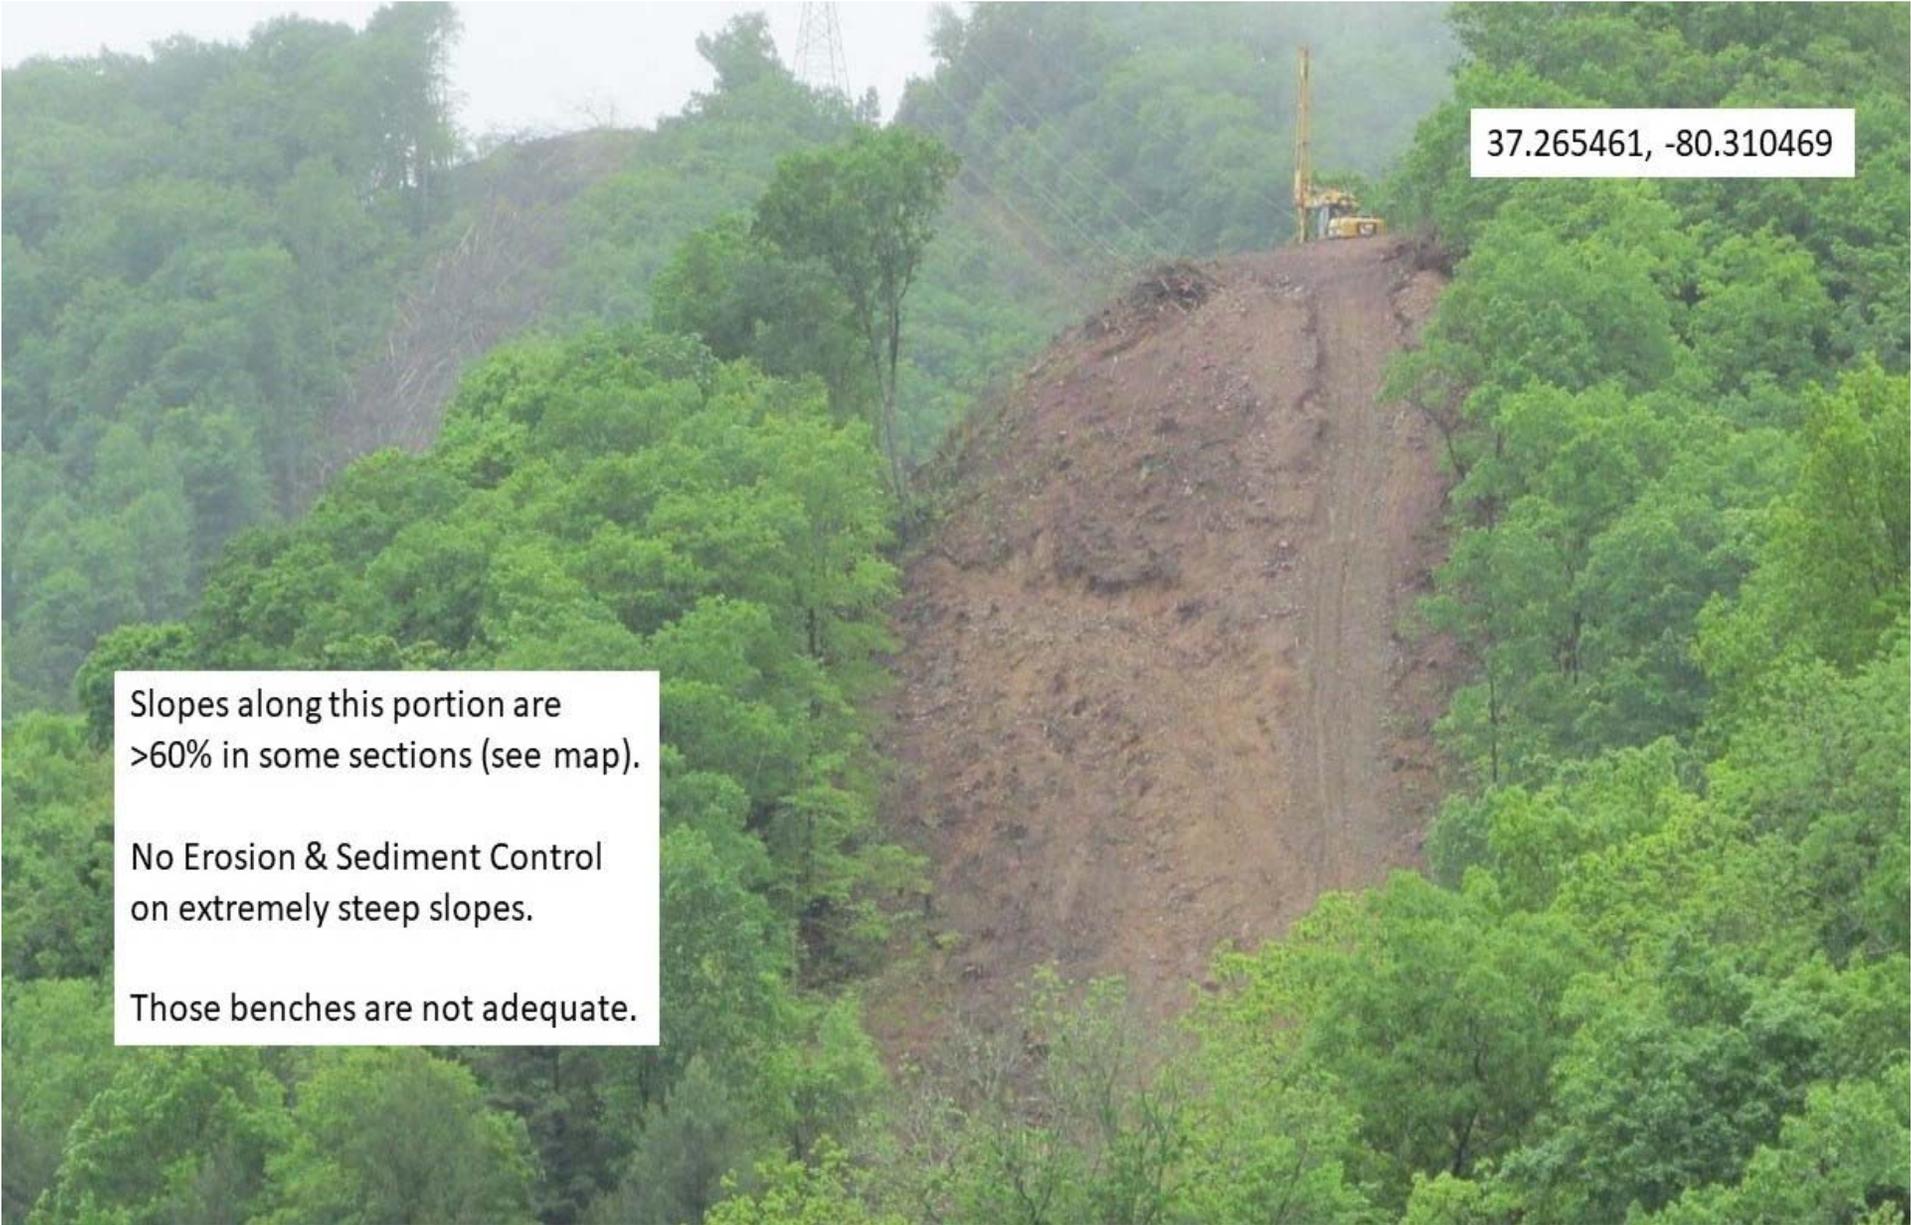
37.265461, -80.310469

Slopes along this portion are  
>60% in some sections (see map).

No Erosion & Sediment Control  
on extremely steep slopes.

Those benches are not adequate.
