# Southeast Natural Gas Race Marcellus- to-Atlantic

# Mountain Valley Pipeline

The 330-mile Mountain Valley Pipeline project would connect Marcellus natural gas supply to demand markets in the Southeast region of the United States providing at least two billion cubic feet per day transmission capacity.

# Top Ten Most Common Erosion Control Problems

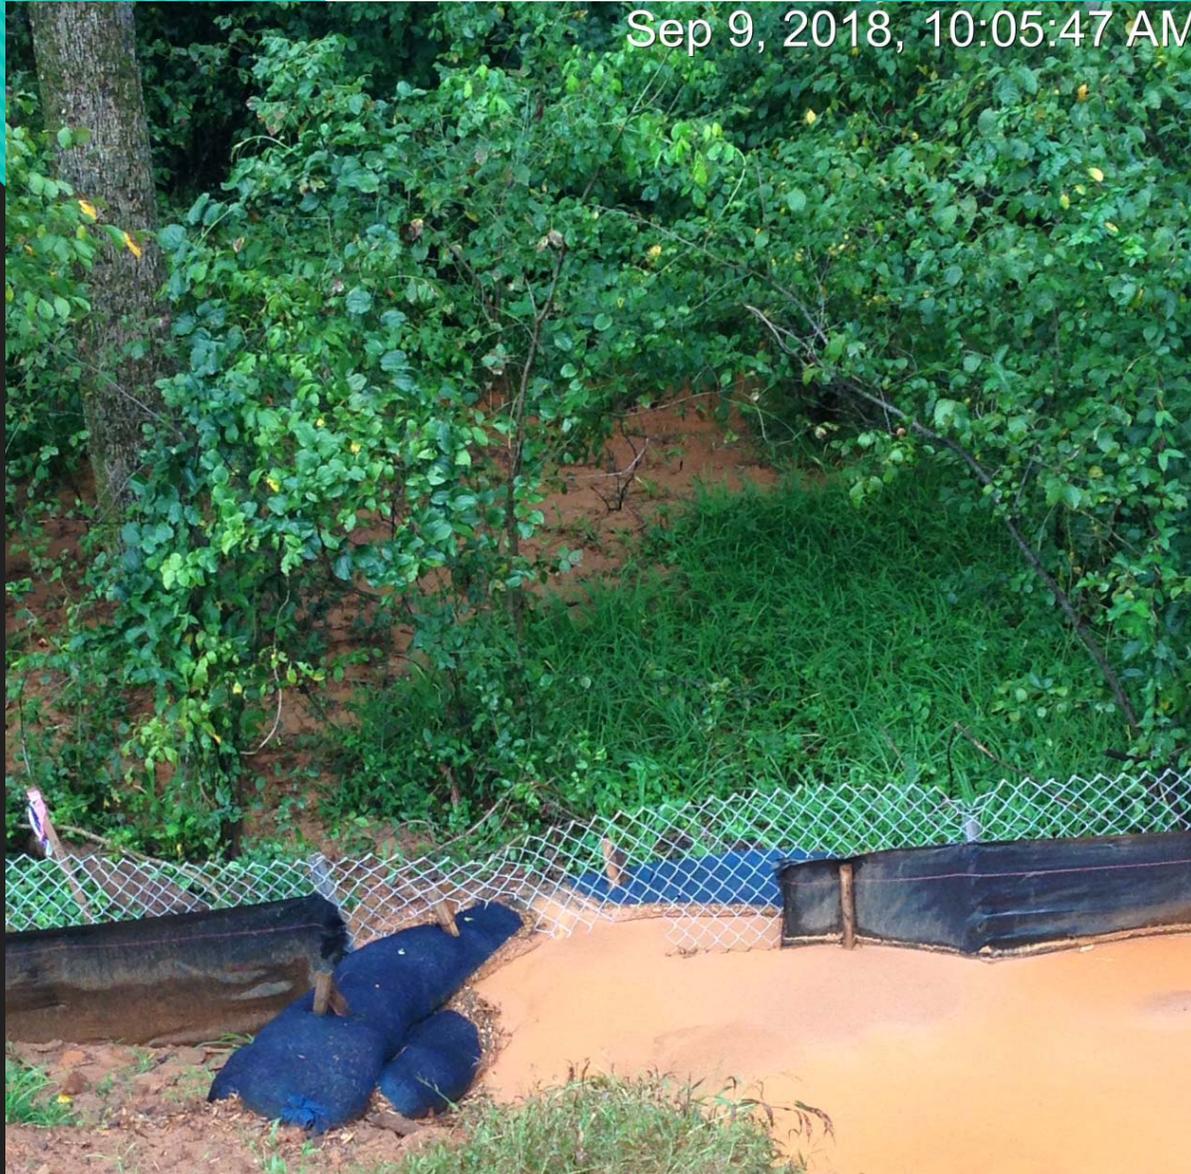
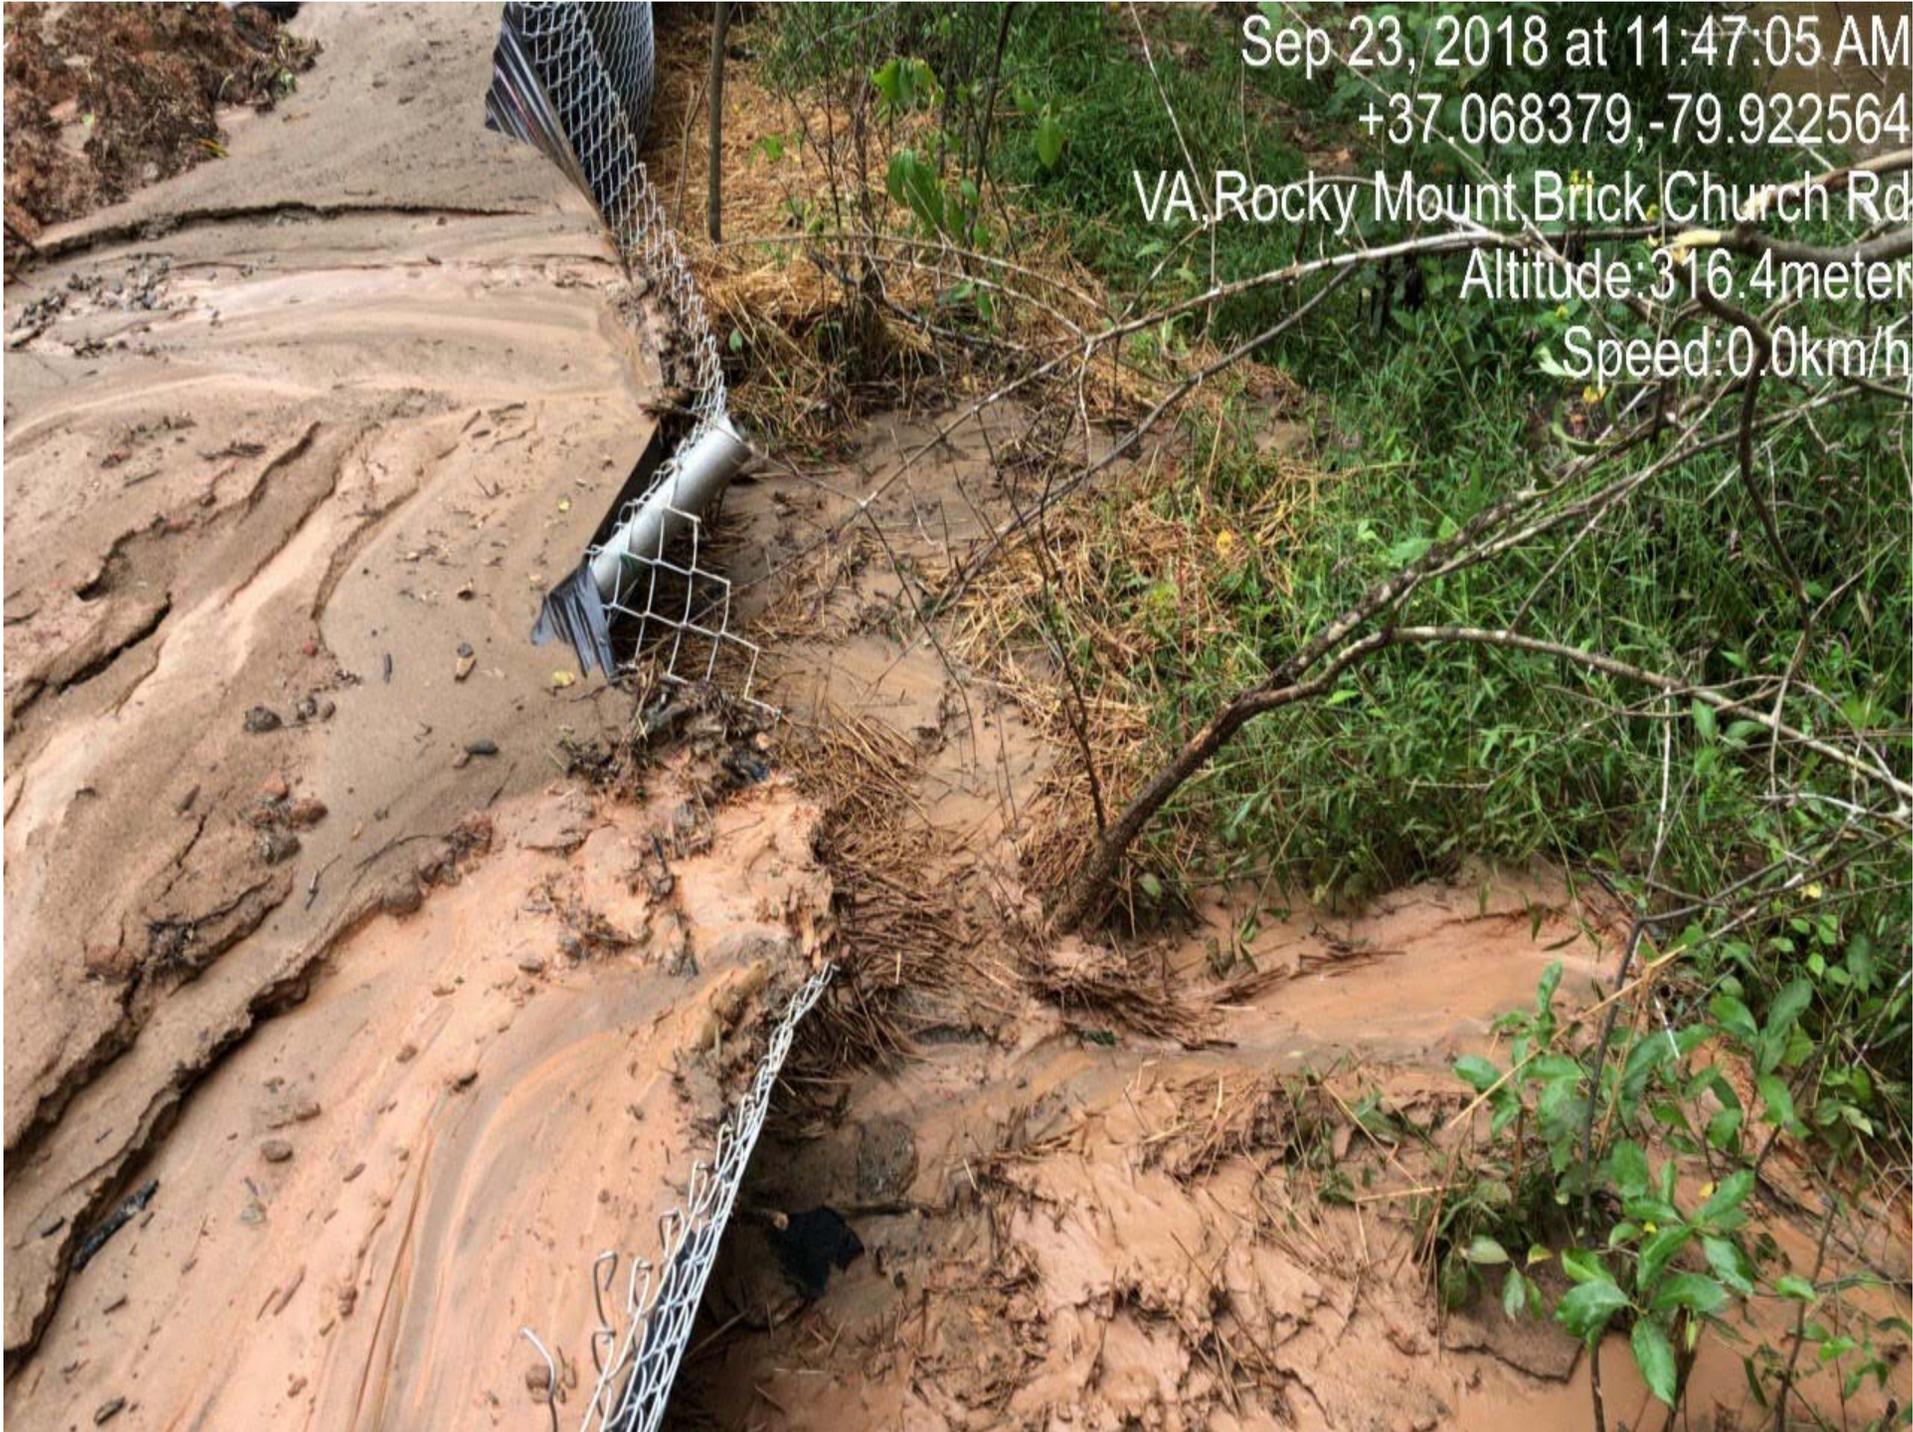
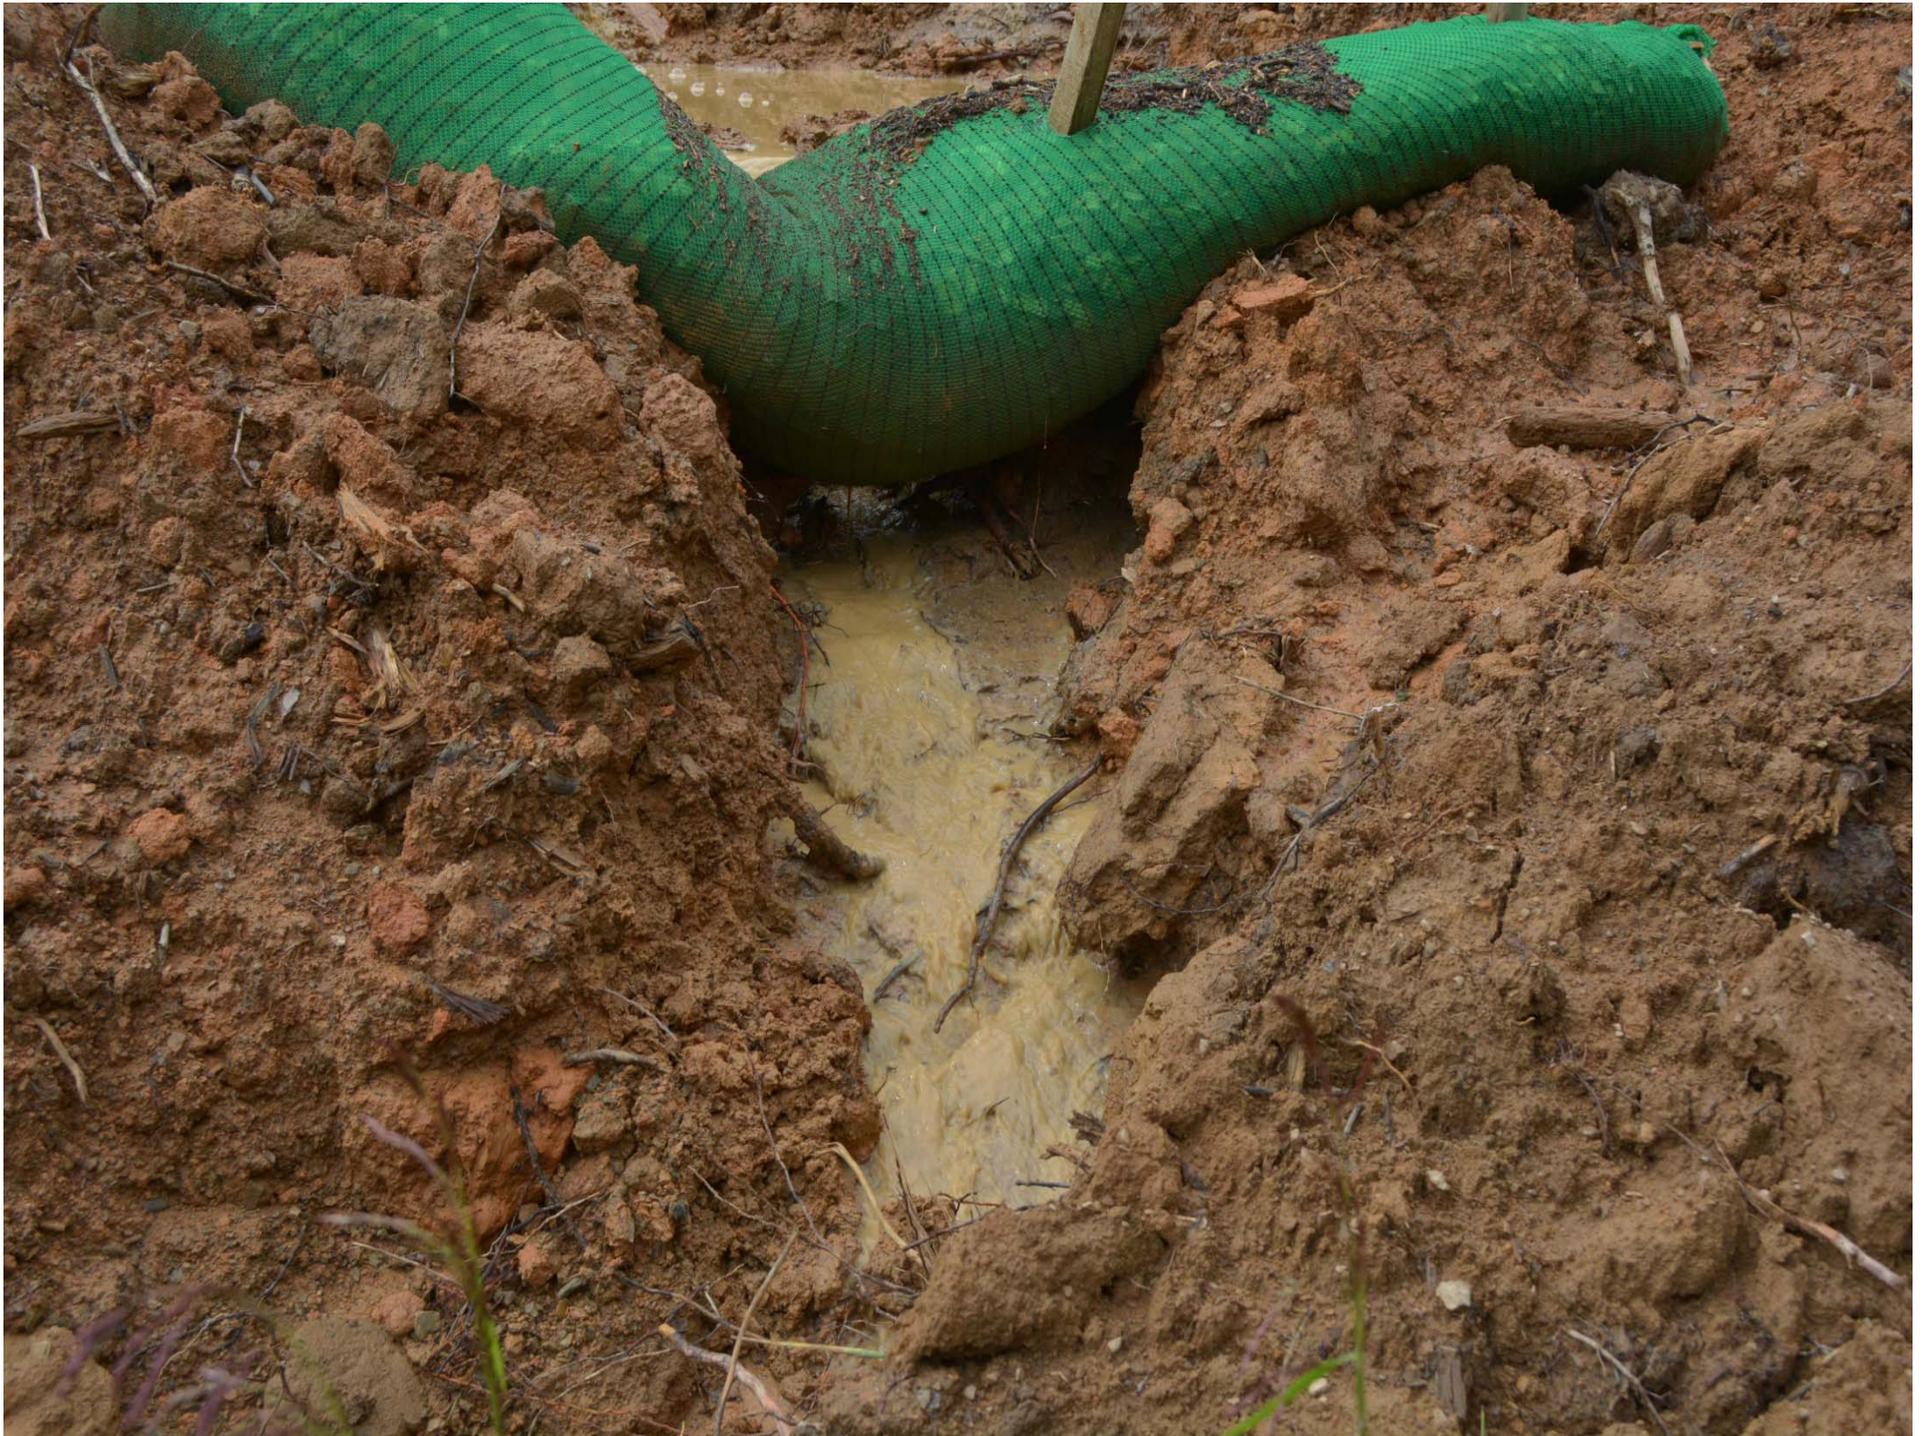
3) Failed, damaged, missing, or improperly installed silt fences, filter socks or other perimeter control devices.

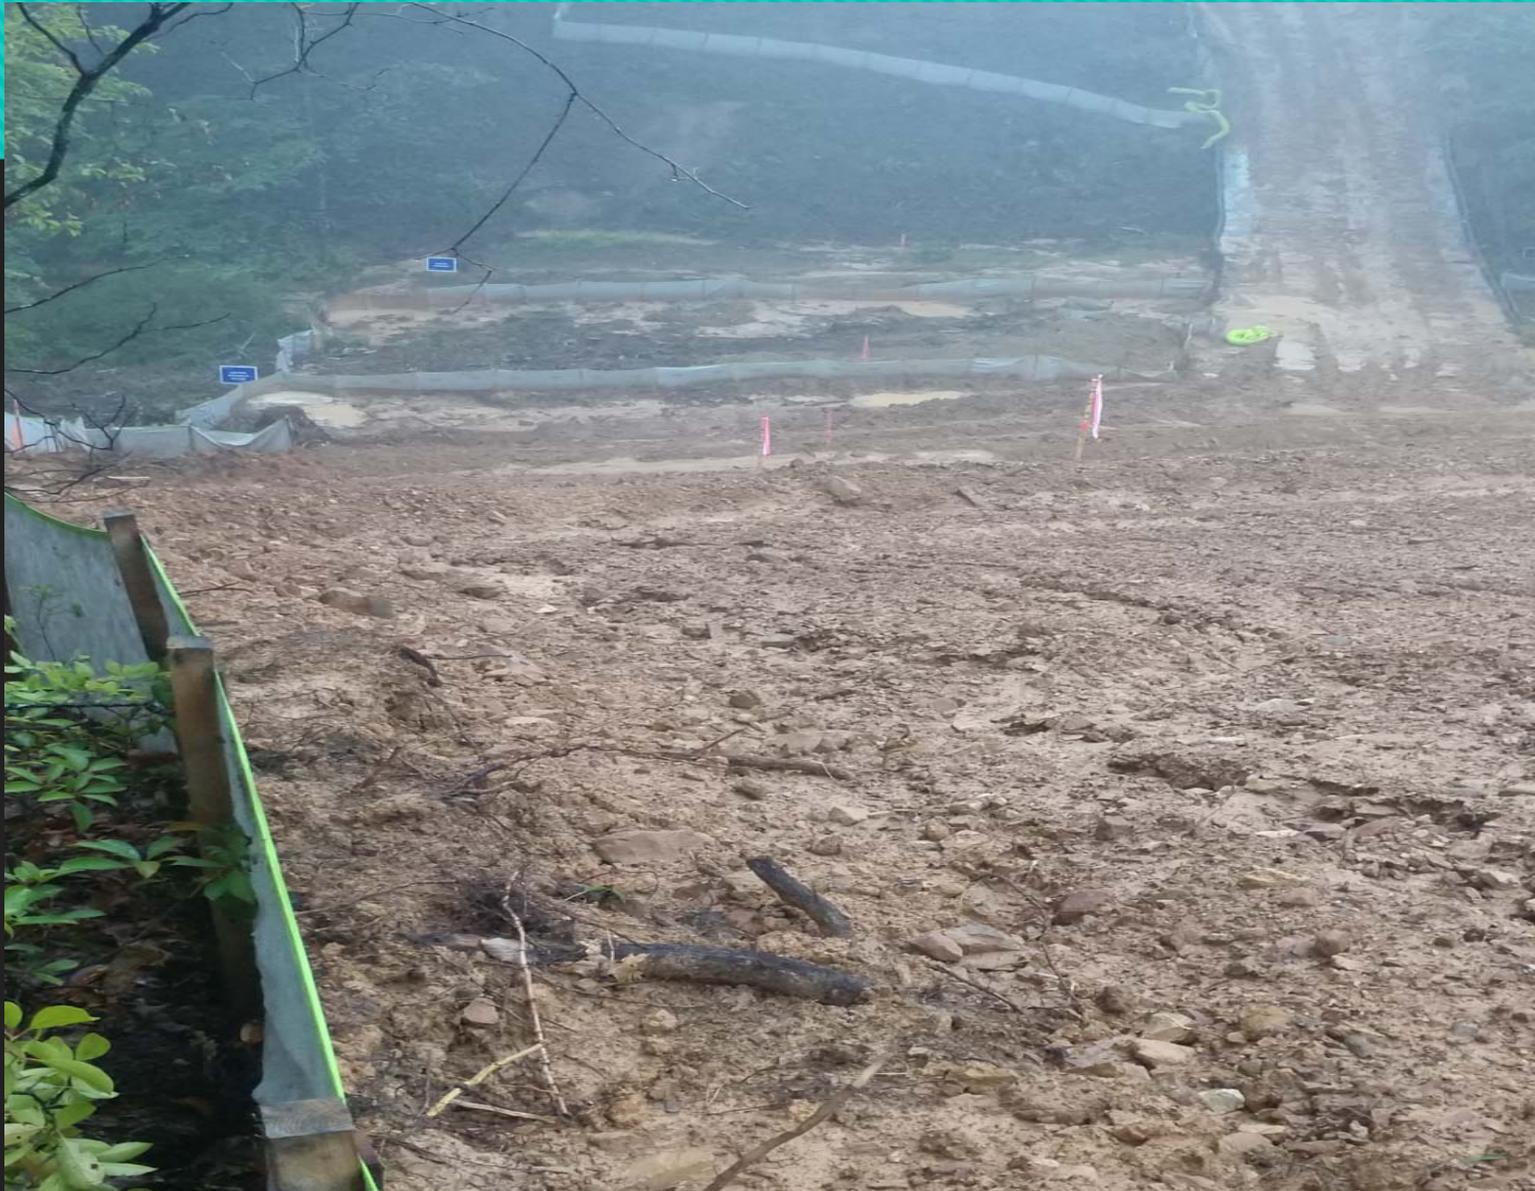
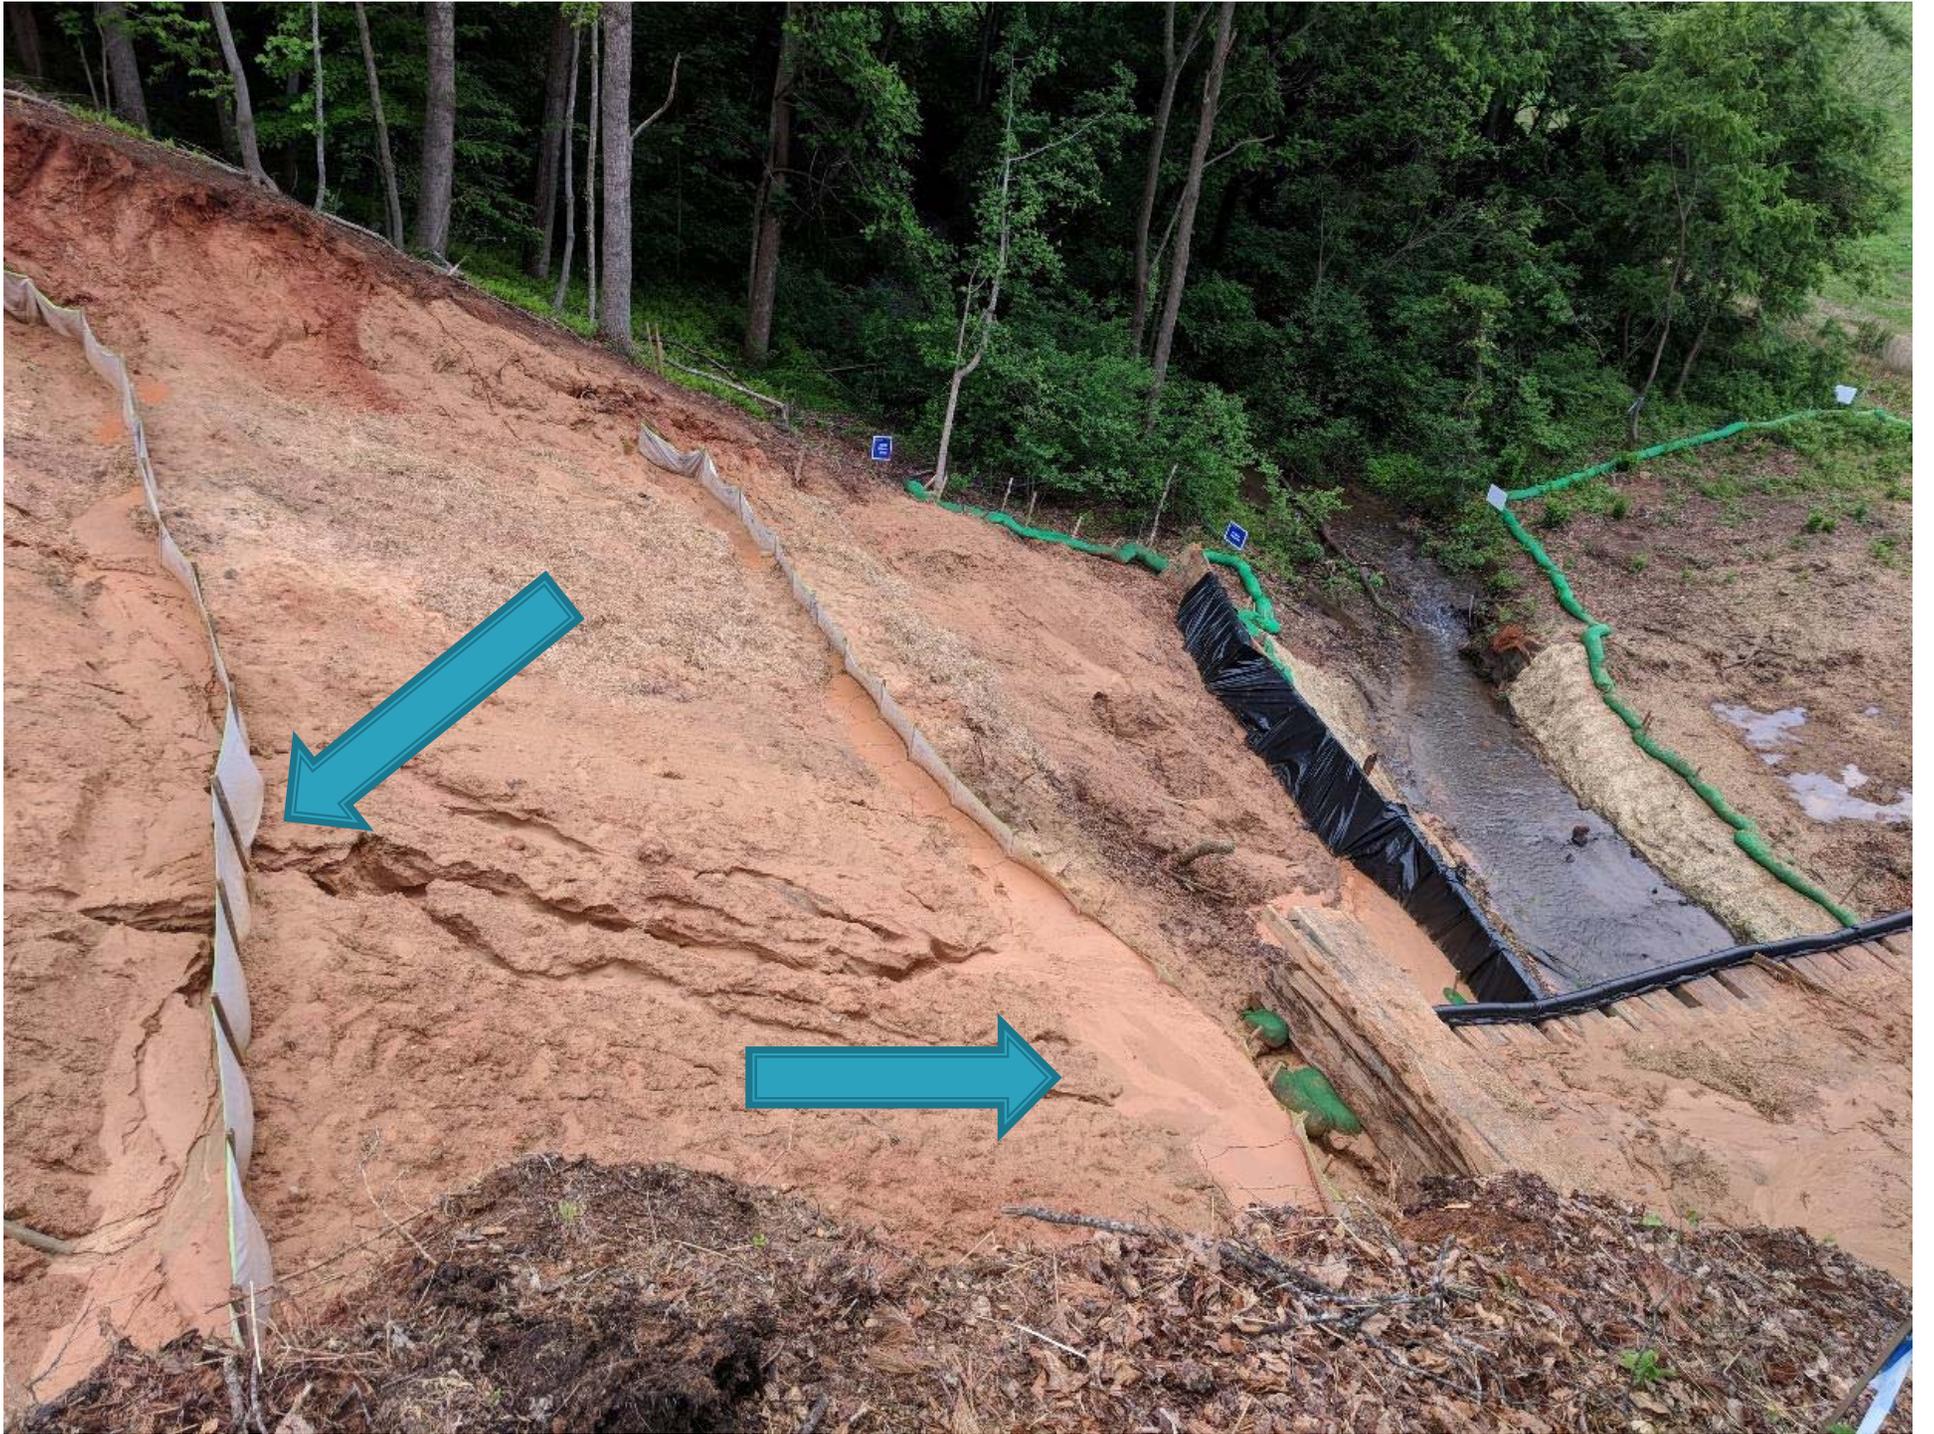
#### 4) Failed, damaged, improperly constructed or spaced right-of-way diversions

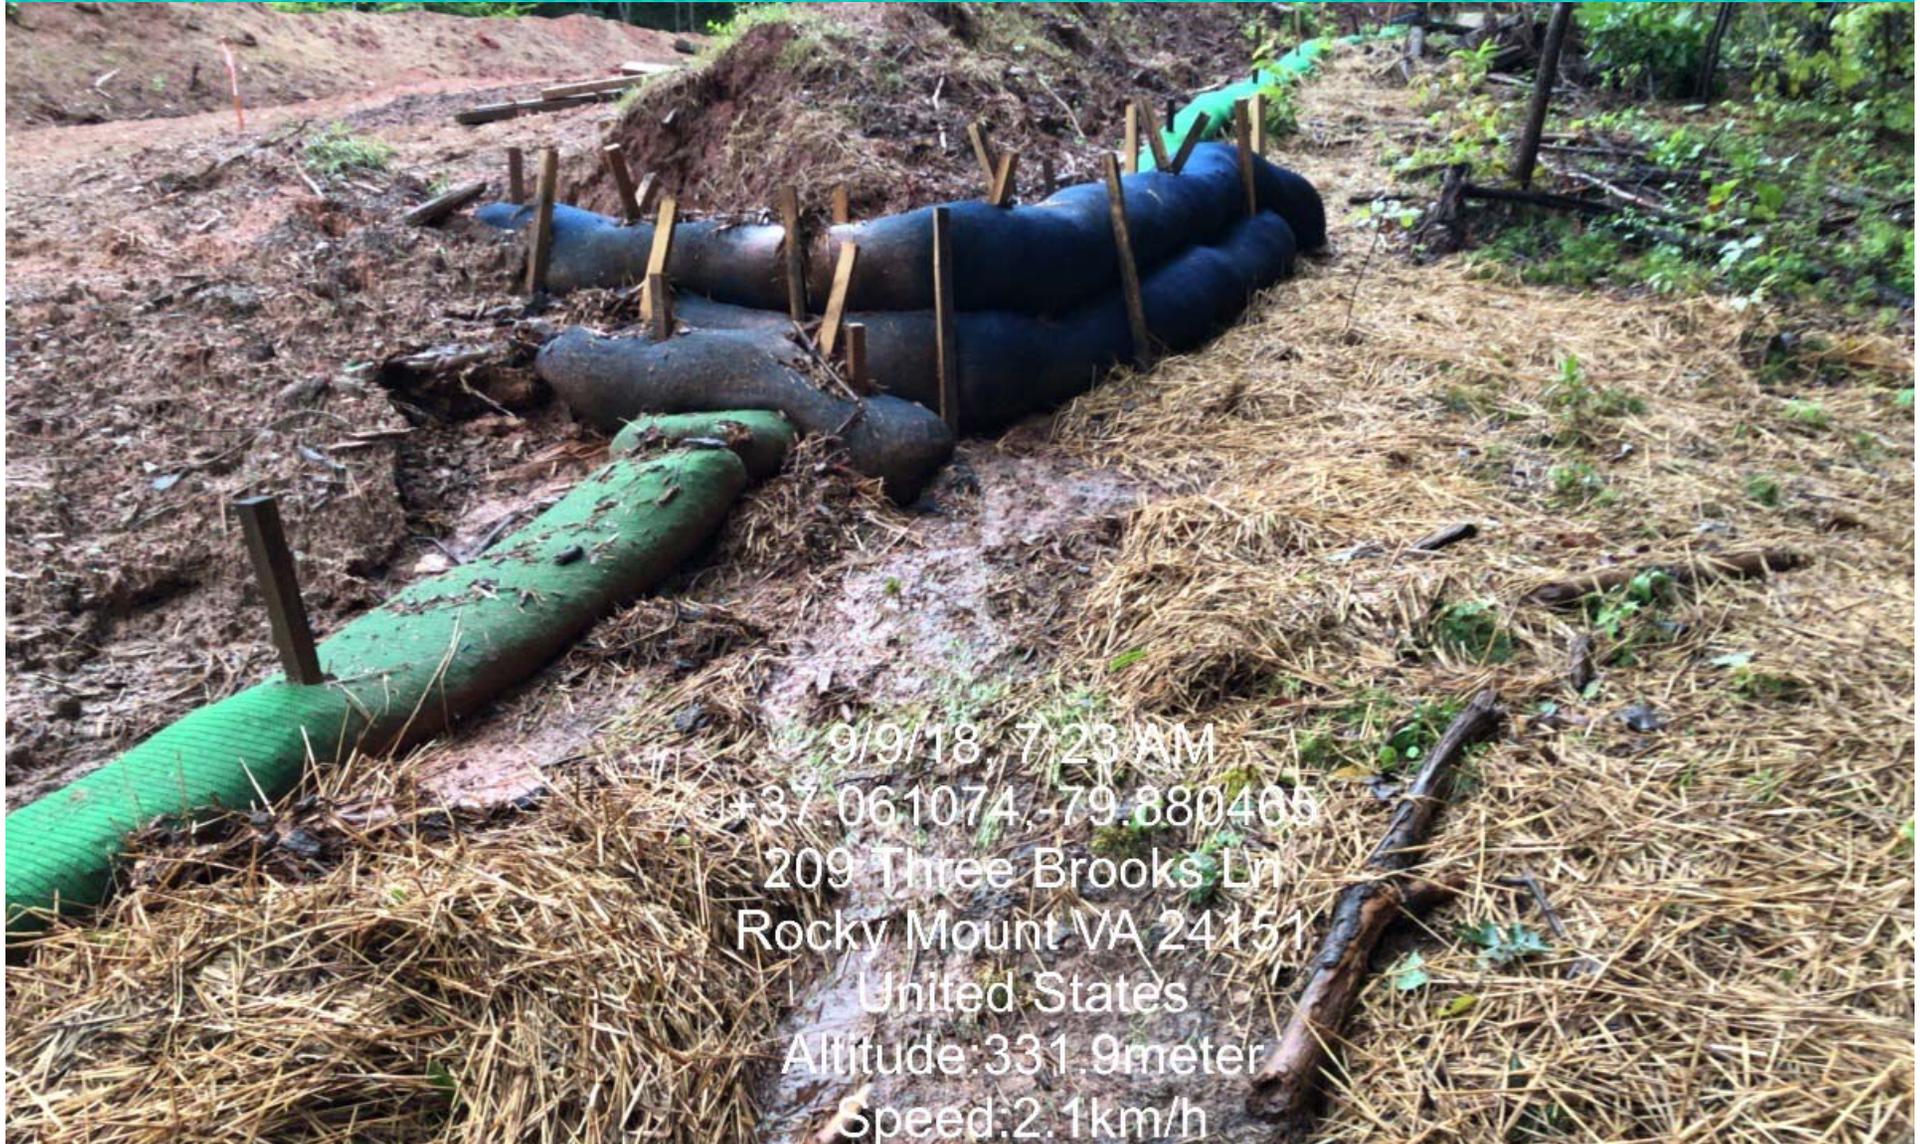
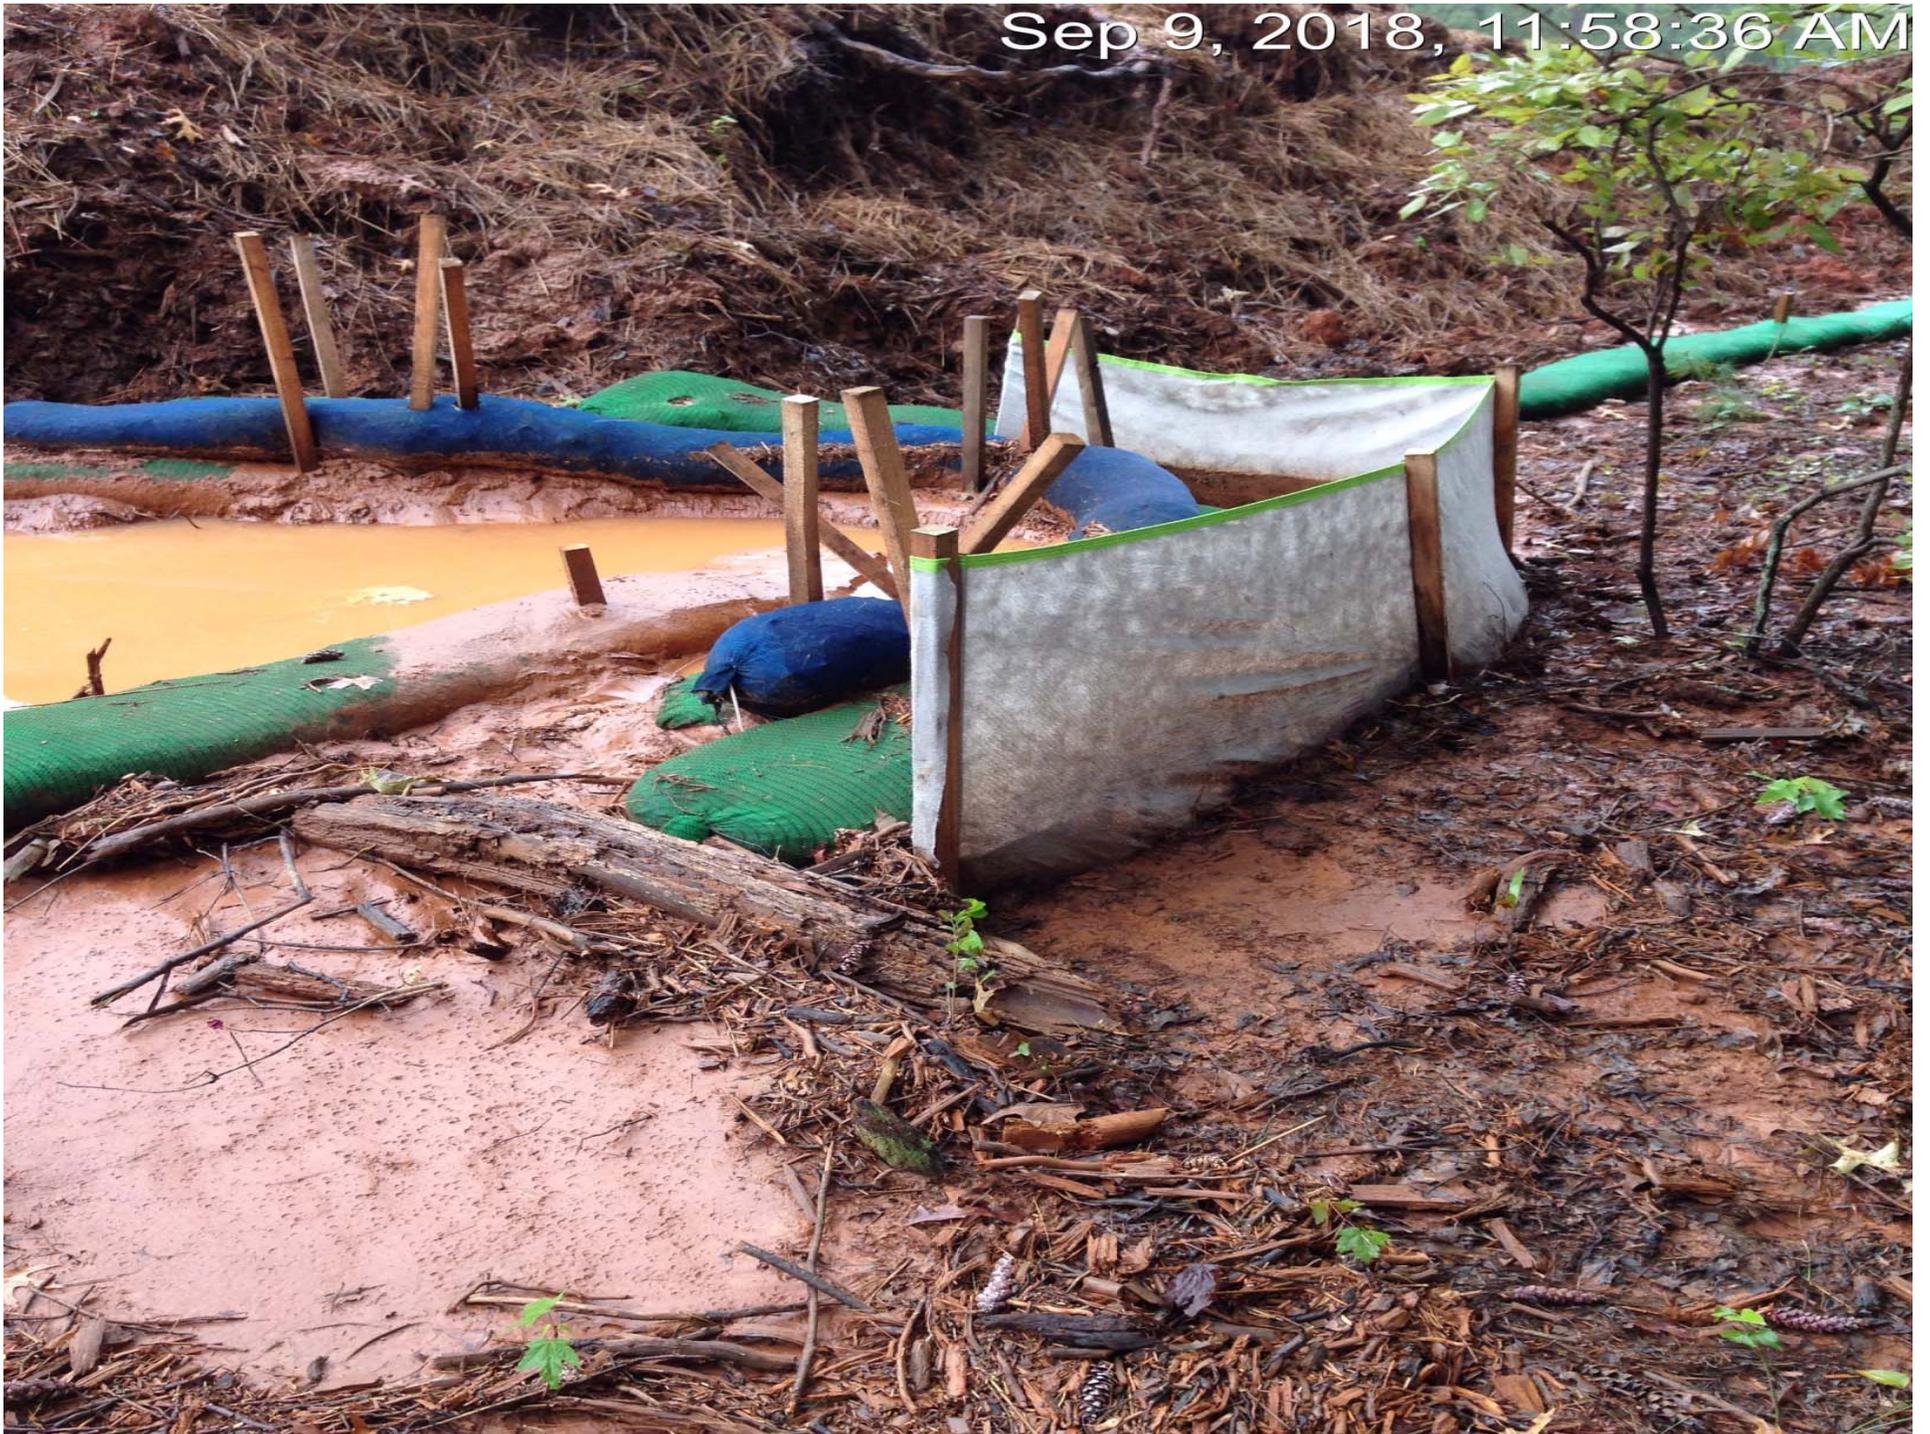
5) Failed or improperly constructed outlet structures at ends of right-of-way diversions.
