# Southeast Natural Gas Race Marcellus- to-Atlantic

# Mountain Valley Pipeline

The 330-mile Mountain Valley Pipeline project would connect Marcellus natural gas supply to demand markets in the Southeast region of the United States providing at least two billion cubic feet per day transmission capacity.

# Top Ten Most Common Erosion Control Problems

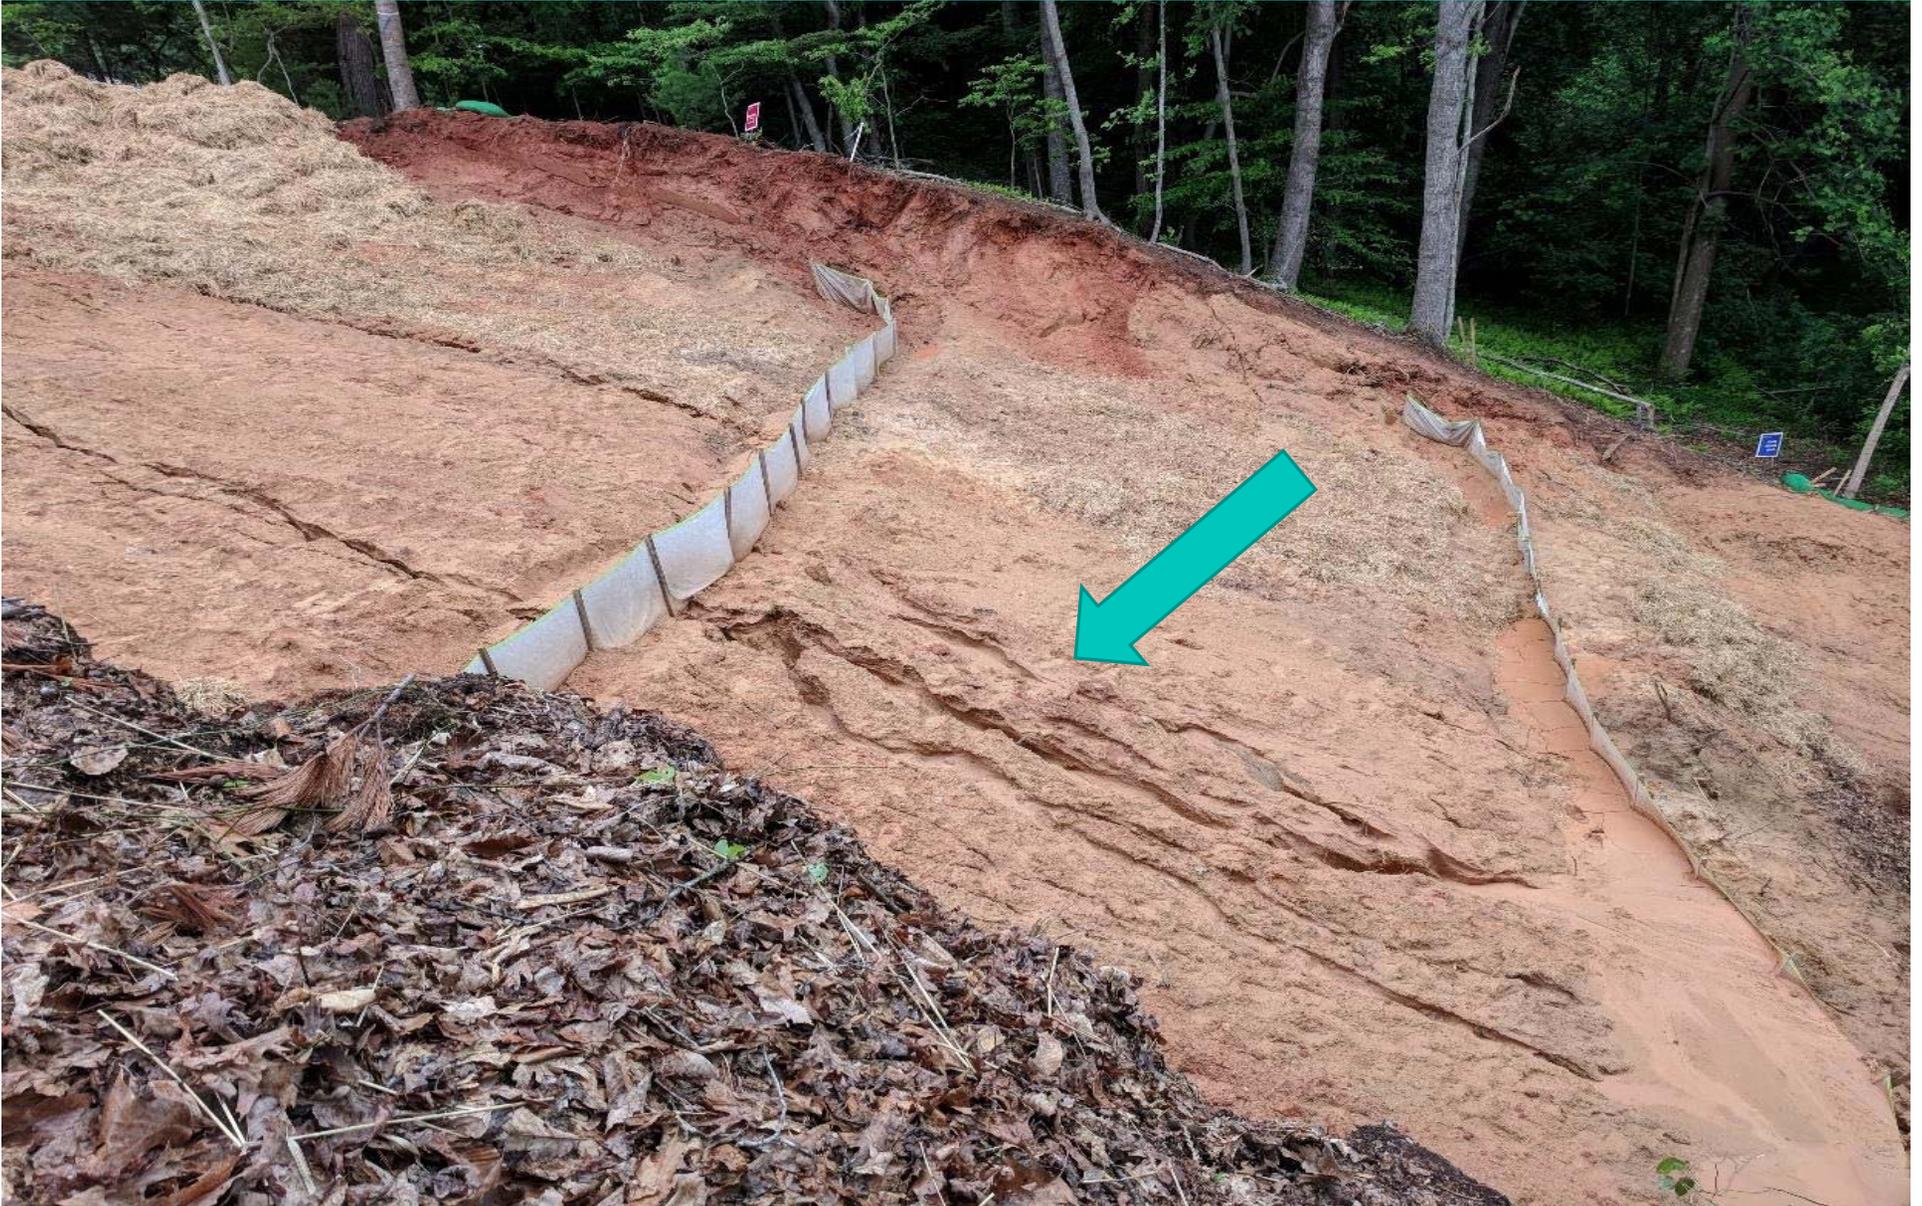
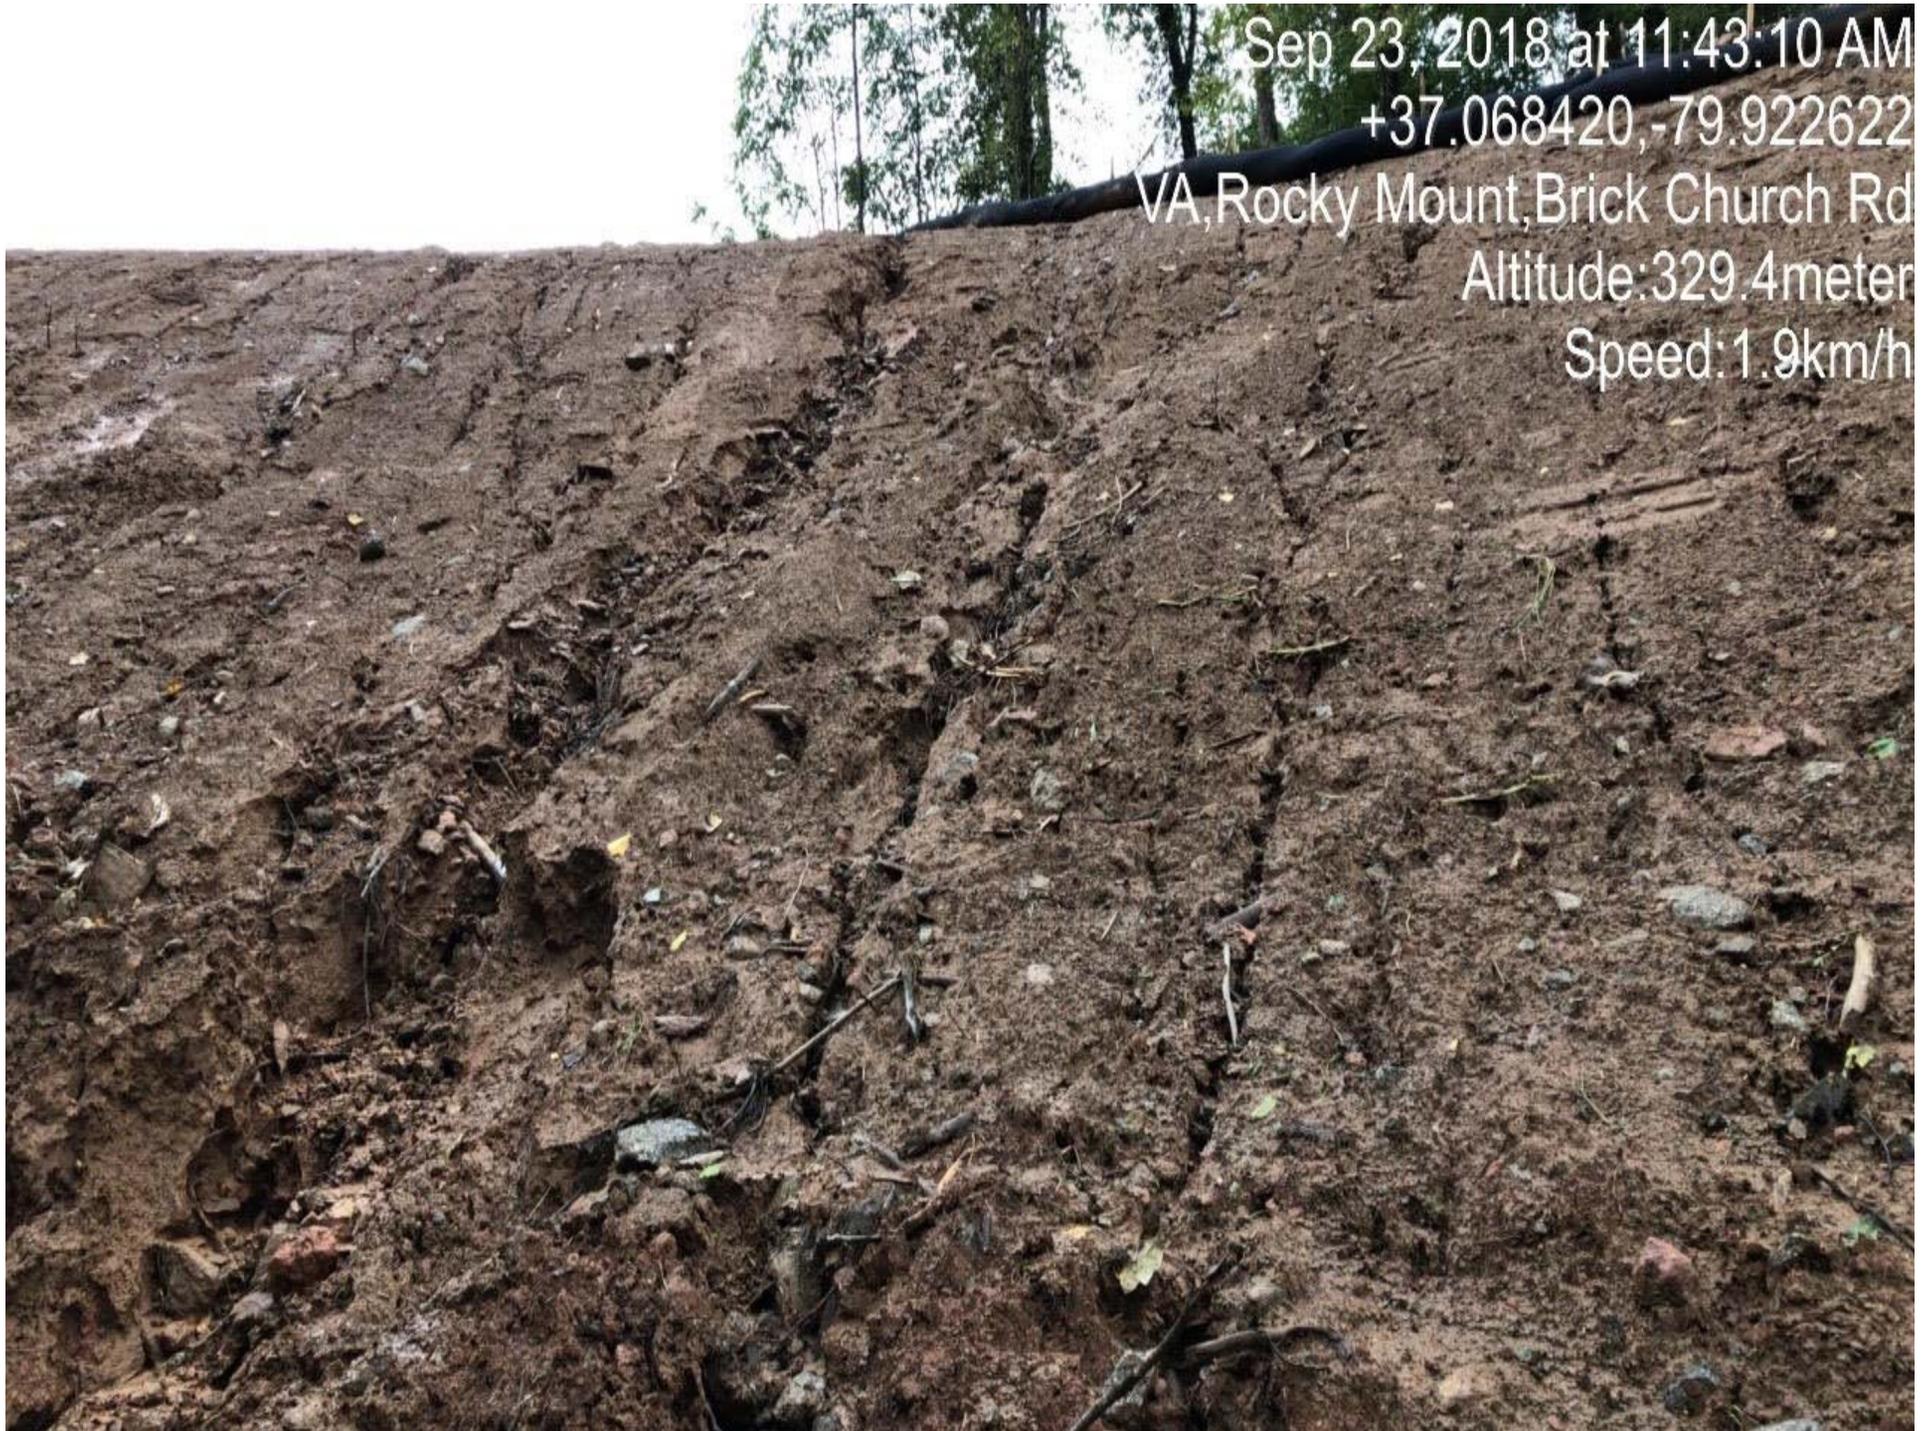
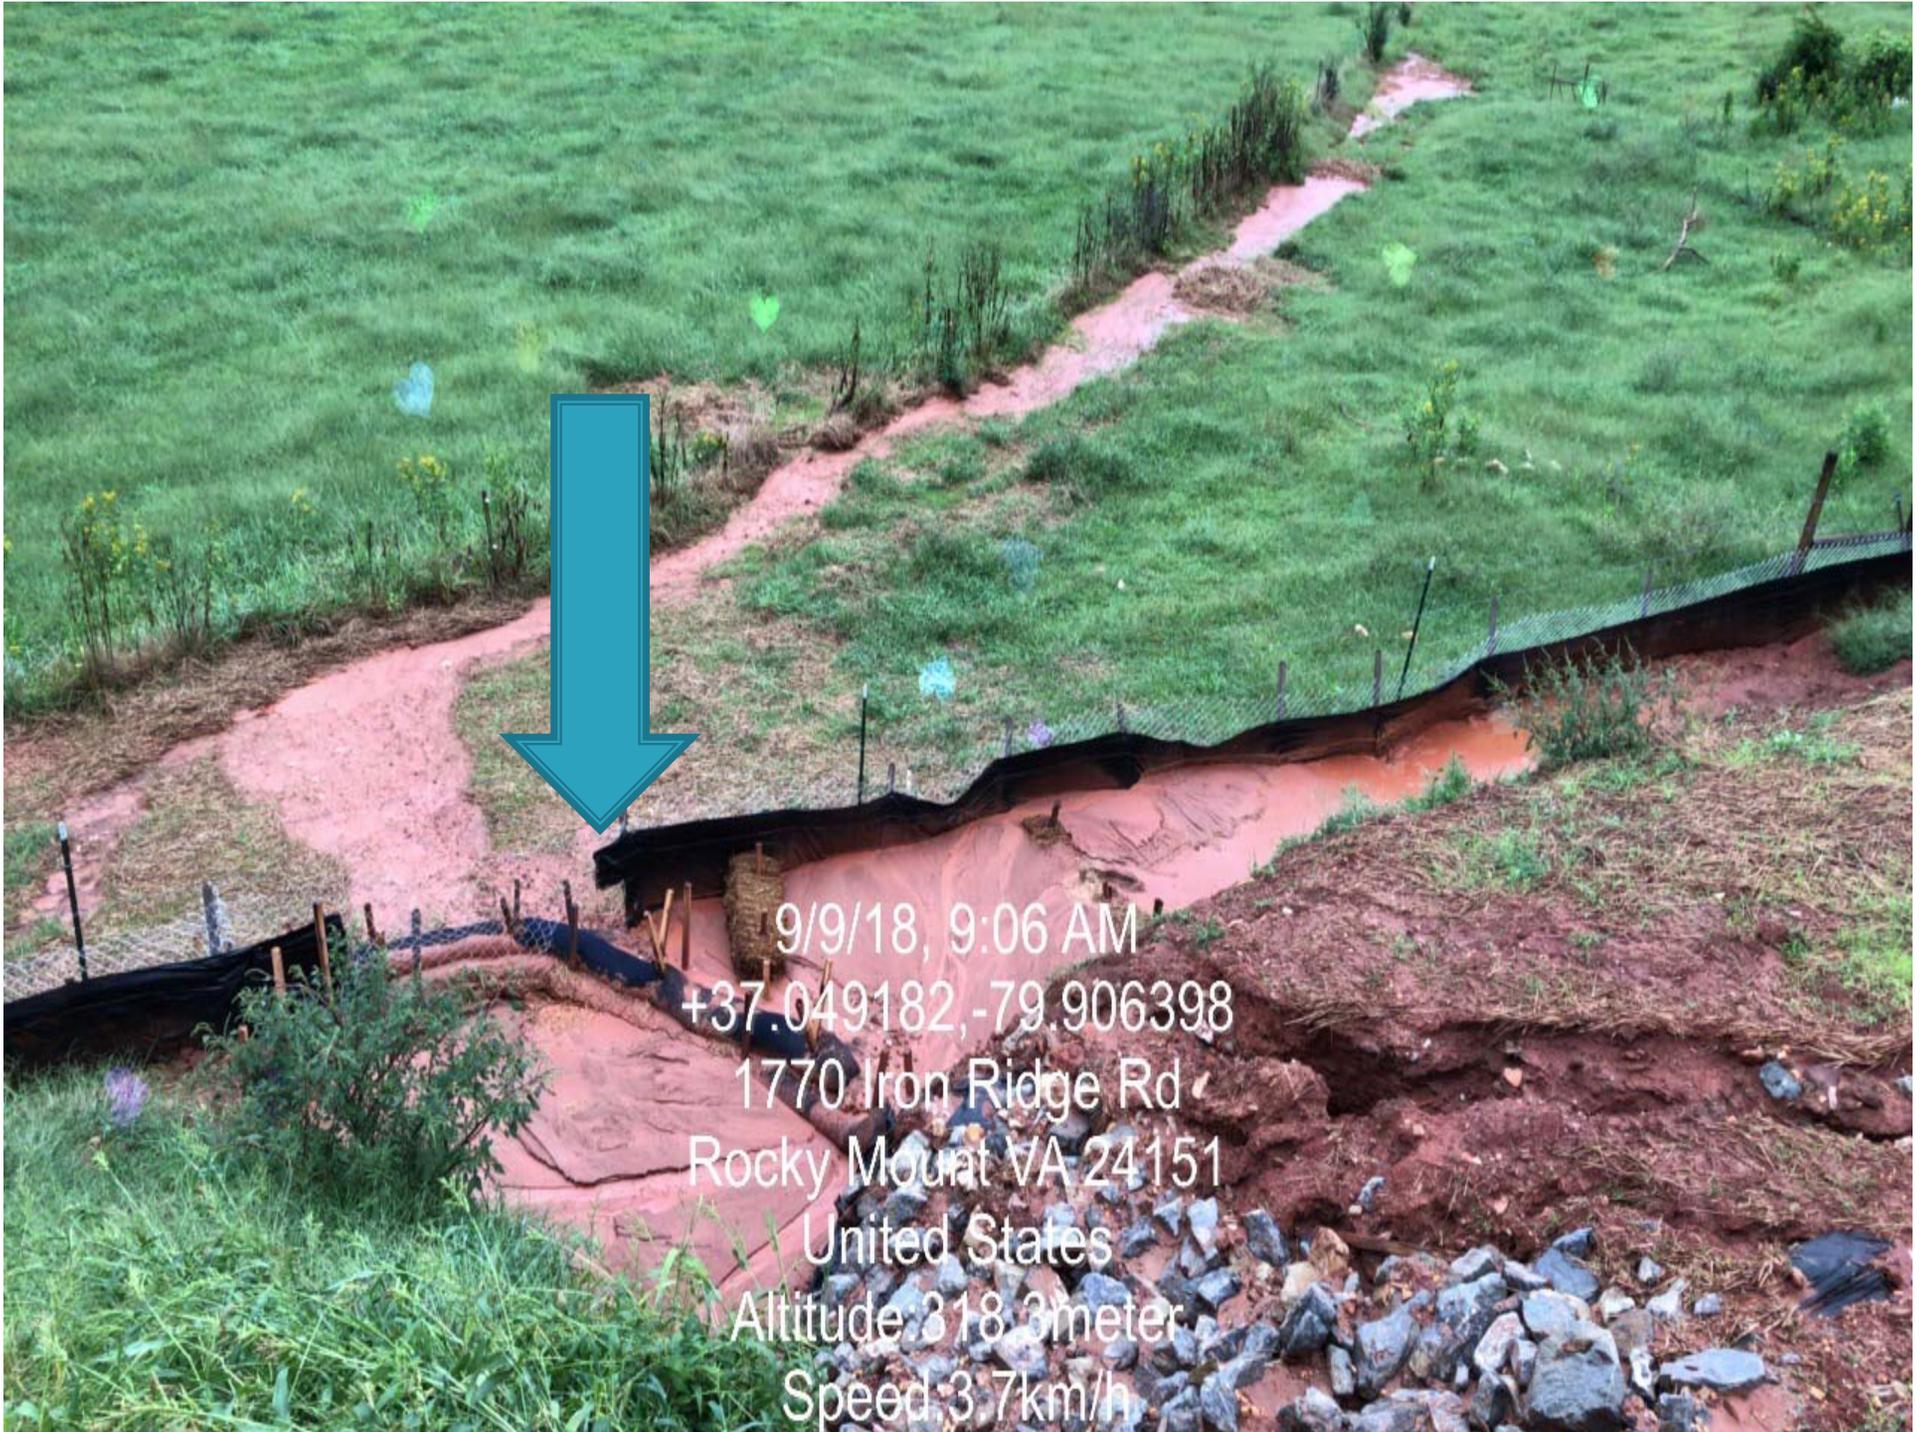
6) Formation of downslope gullies within or at the perimeter of the construction right-of-way.

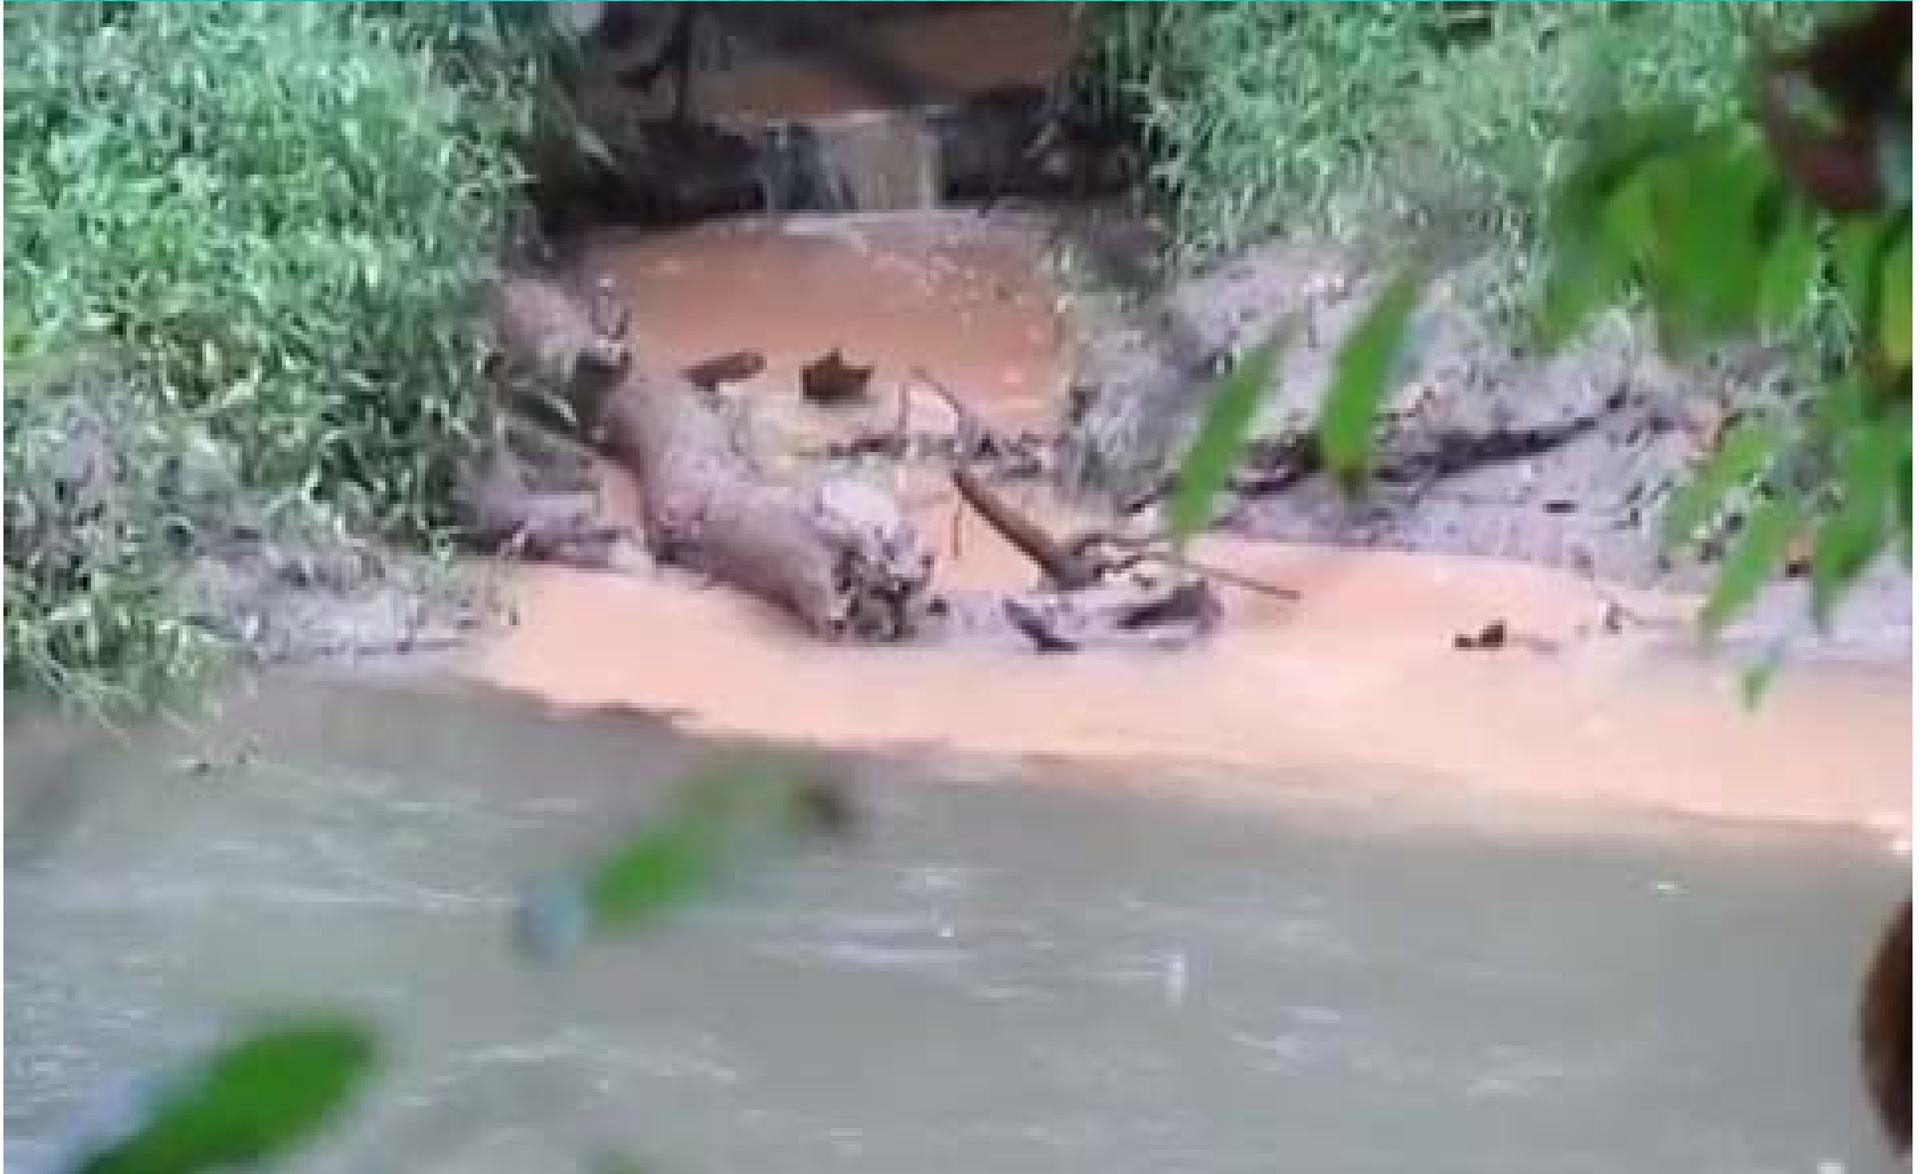
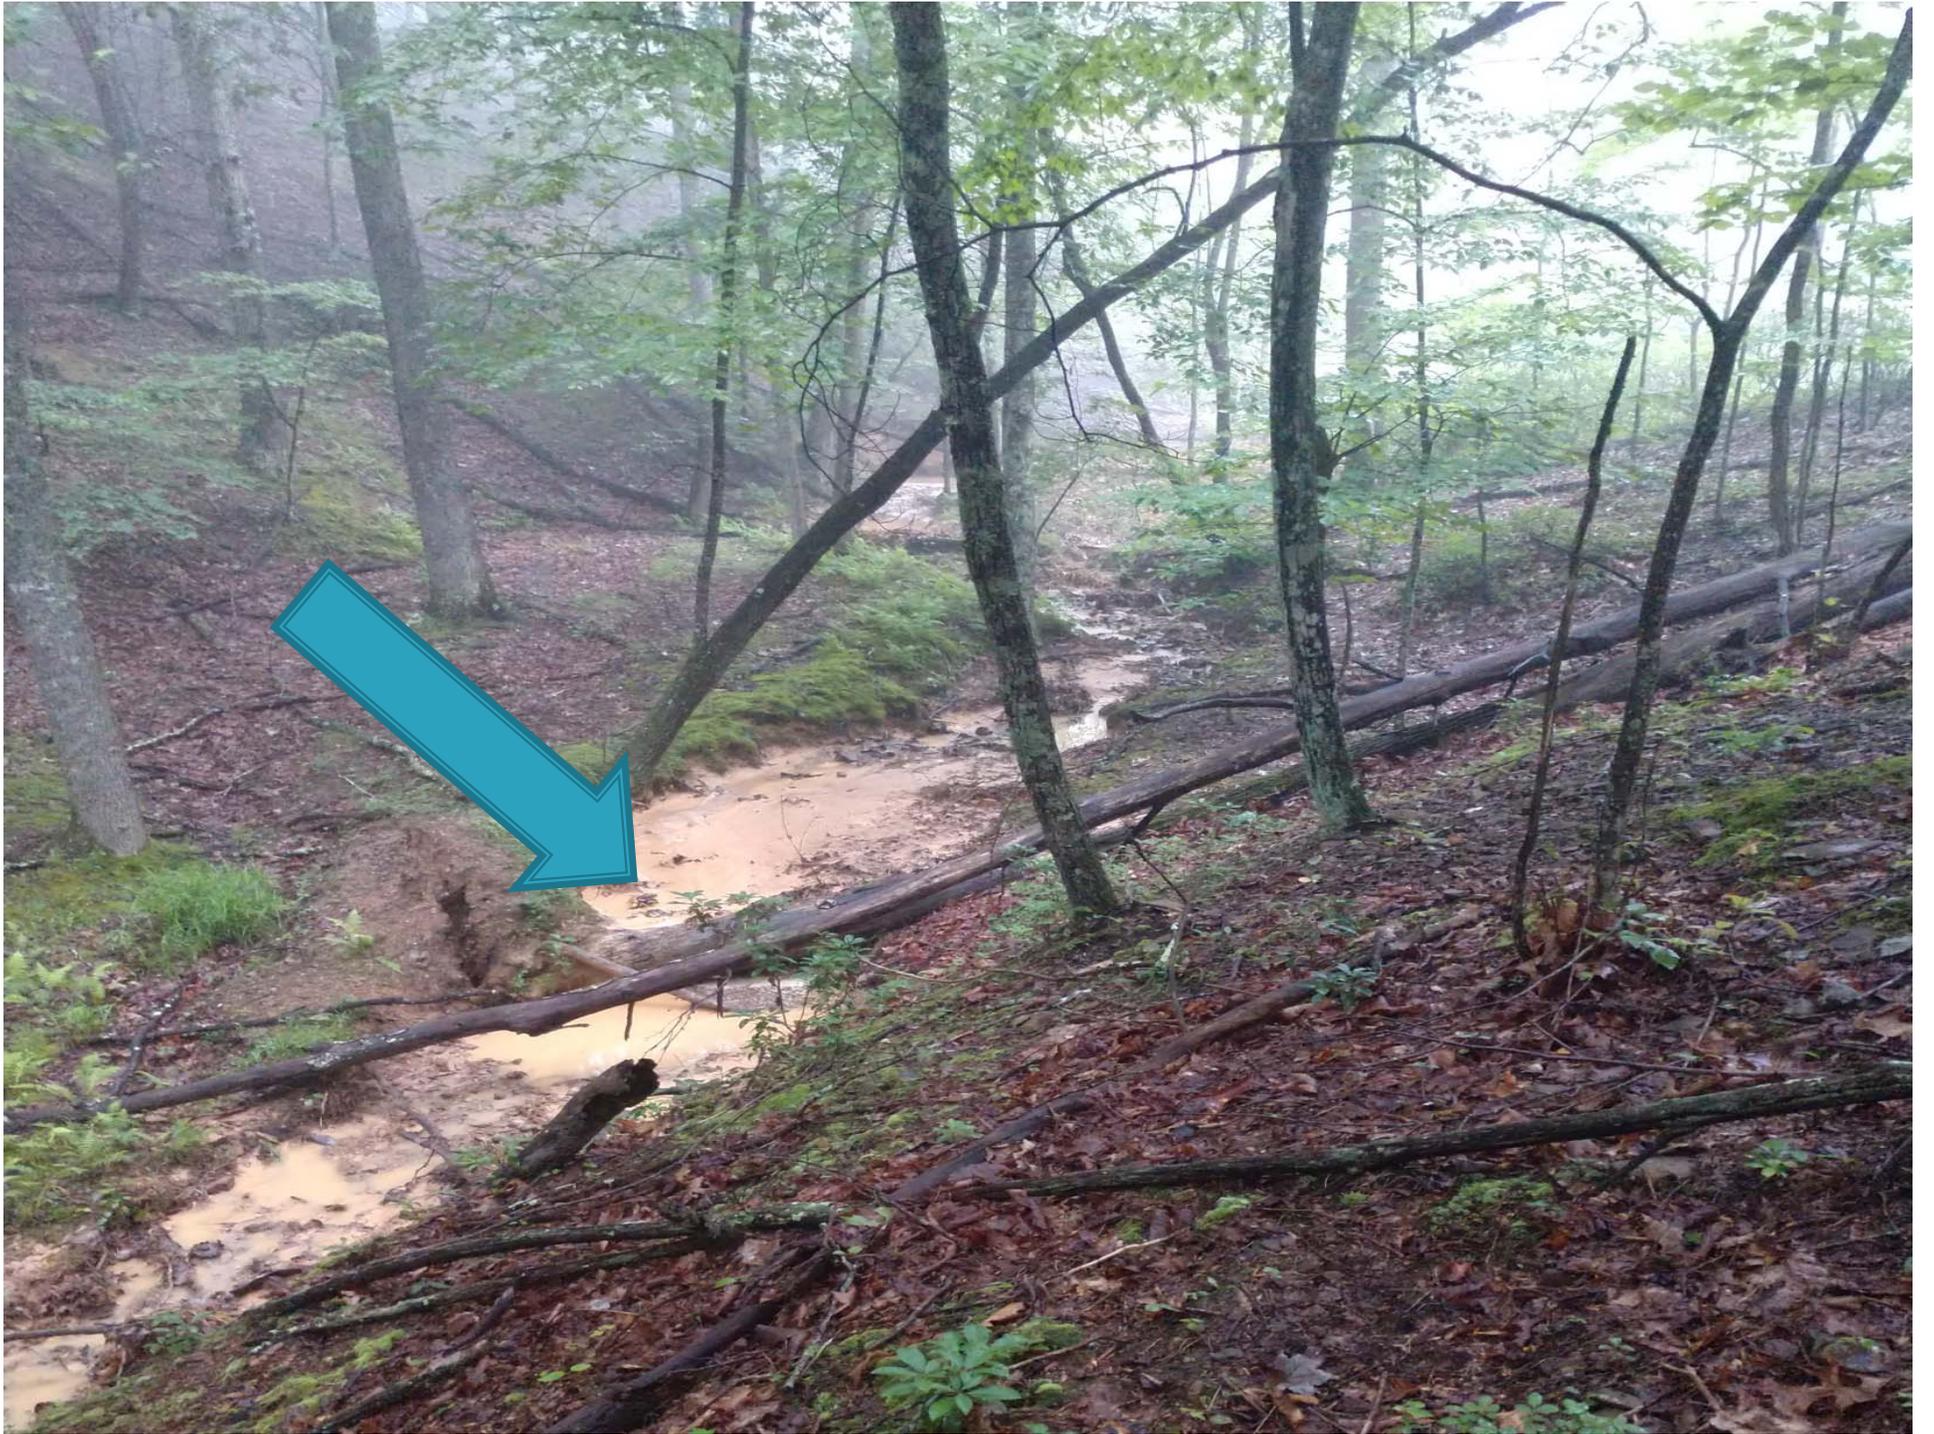
7) Sediment discharge into streams and wetlands during trenching operations from failed erosion control devices.

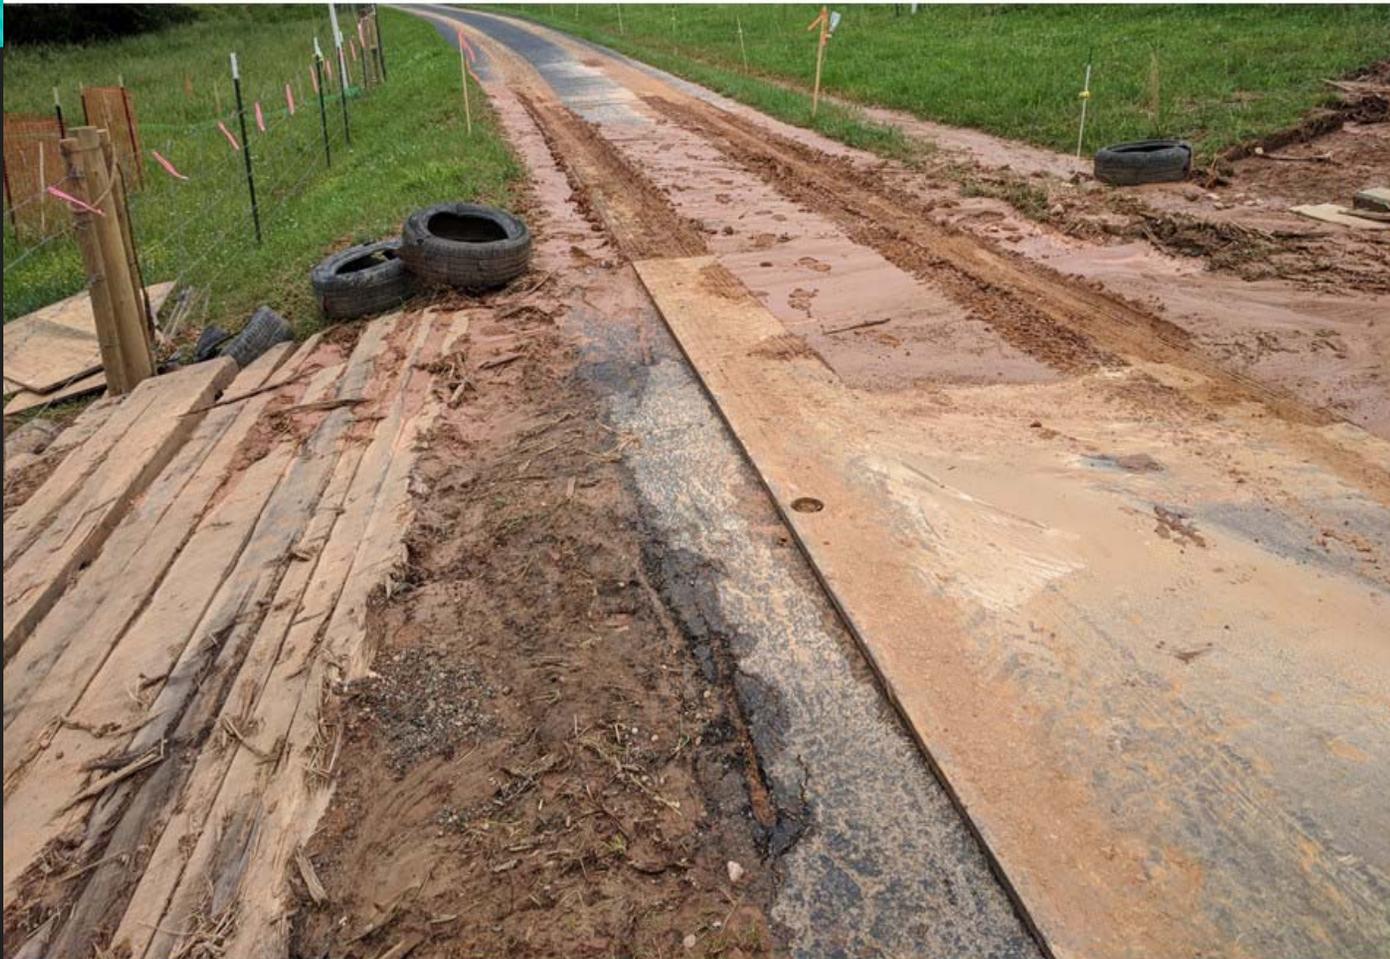
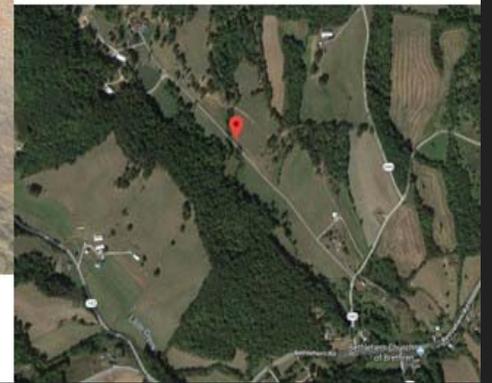
Franklin County  
Mountain Valley Pipeline  
Construction Site

## 8) Failure to construct and properly maintain construction entrances at public roads.

- Erosion gullies
- Bare soil - no mulch
- Failed BMPs
- Sediment discharge outside construction area

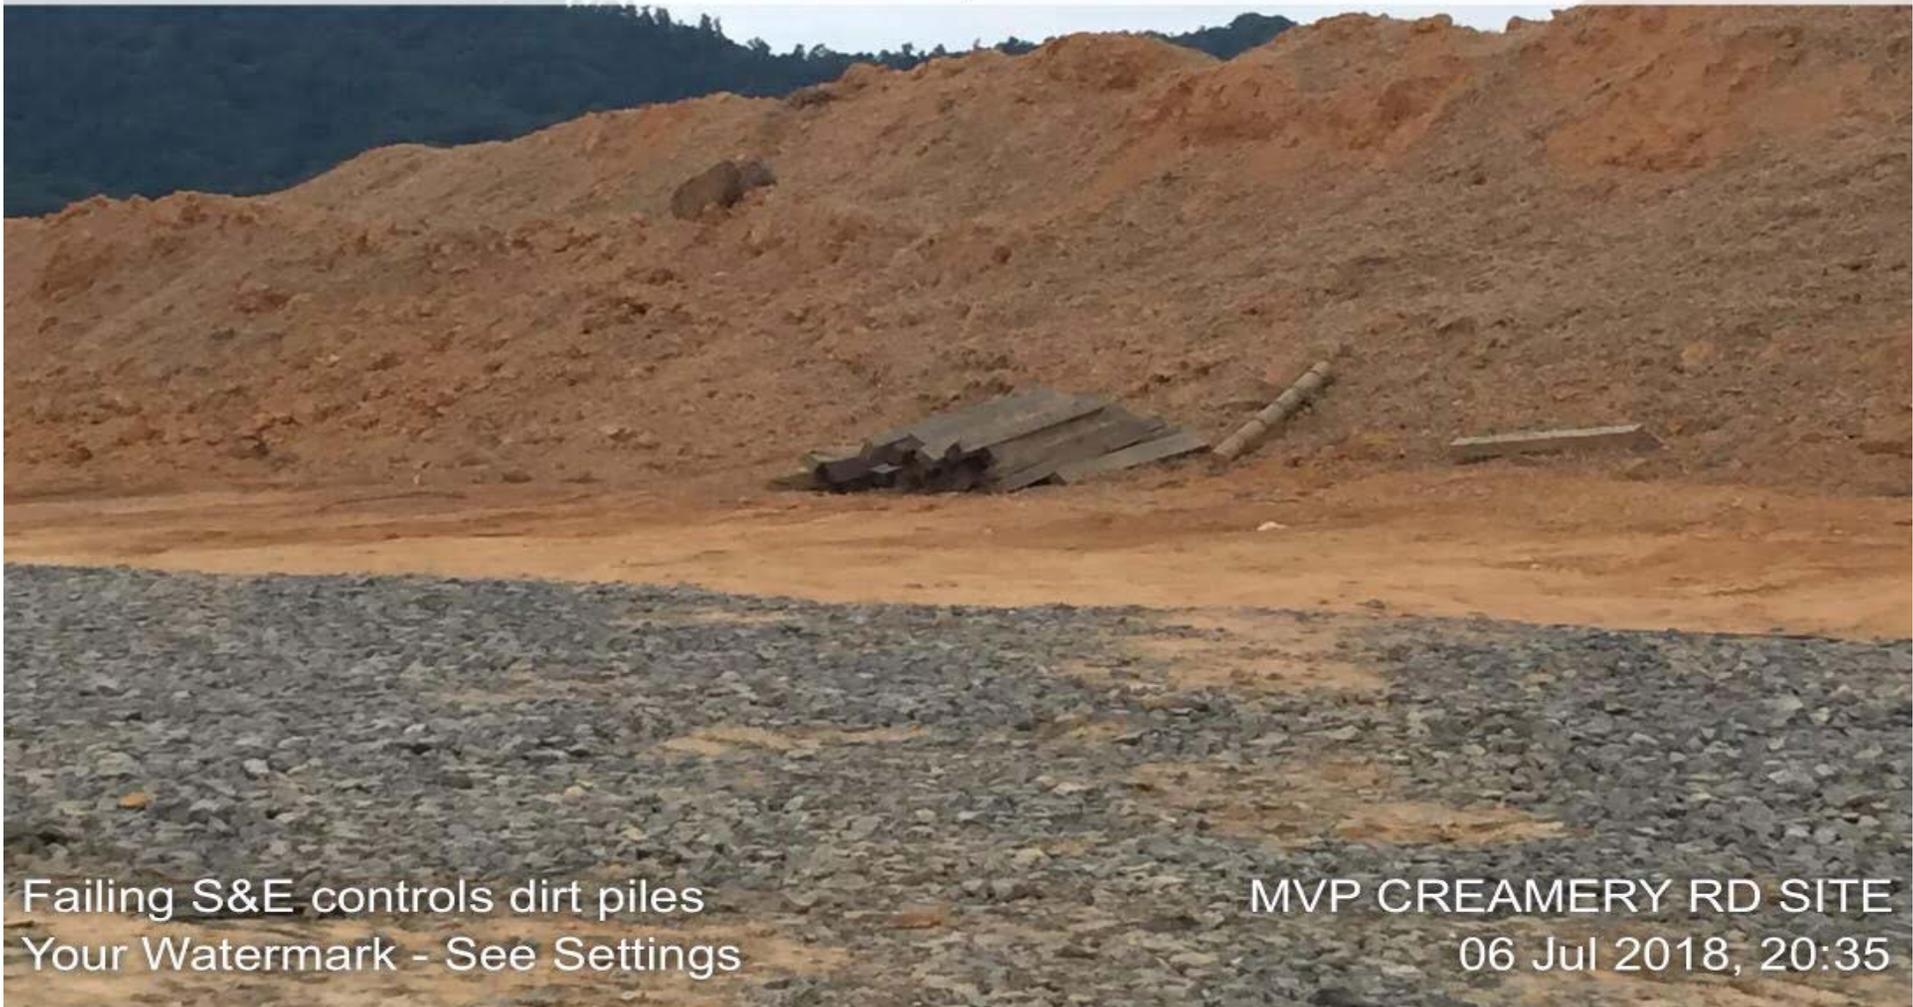
MVP CREAMERY RD SITE  
06 Jul 2018, 20:35

9) Failure to stabilize construction areas, bare ground, and stockpiles of spoil or topsoil, after active disturbance.

Failing S&E controls dirt piles  
Your Watermark - See Settings

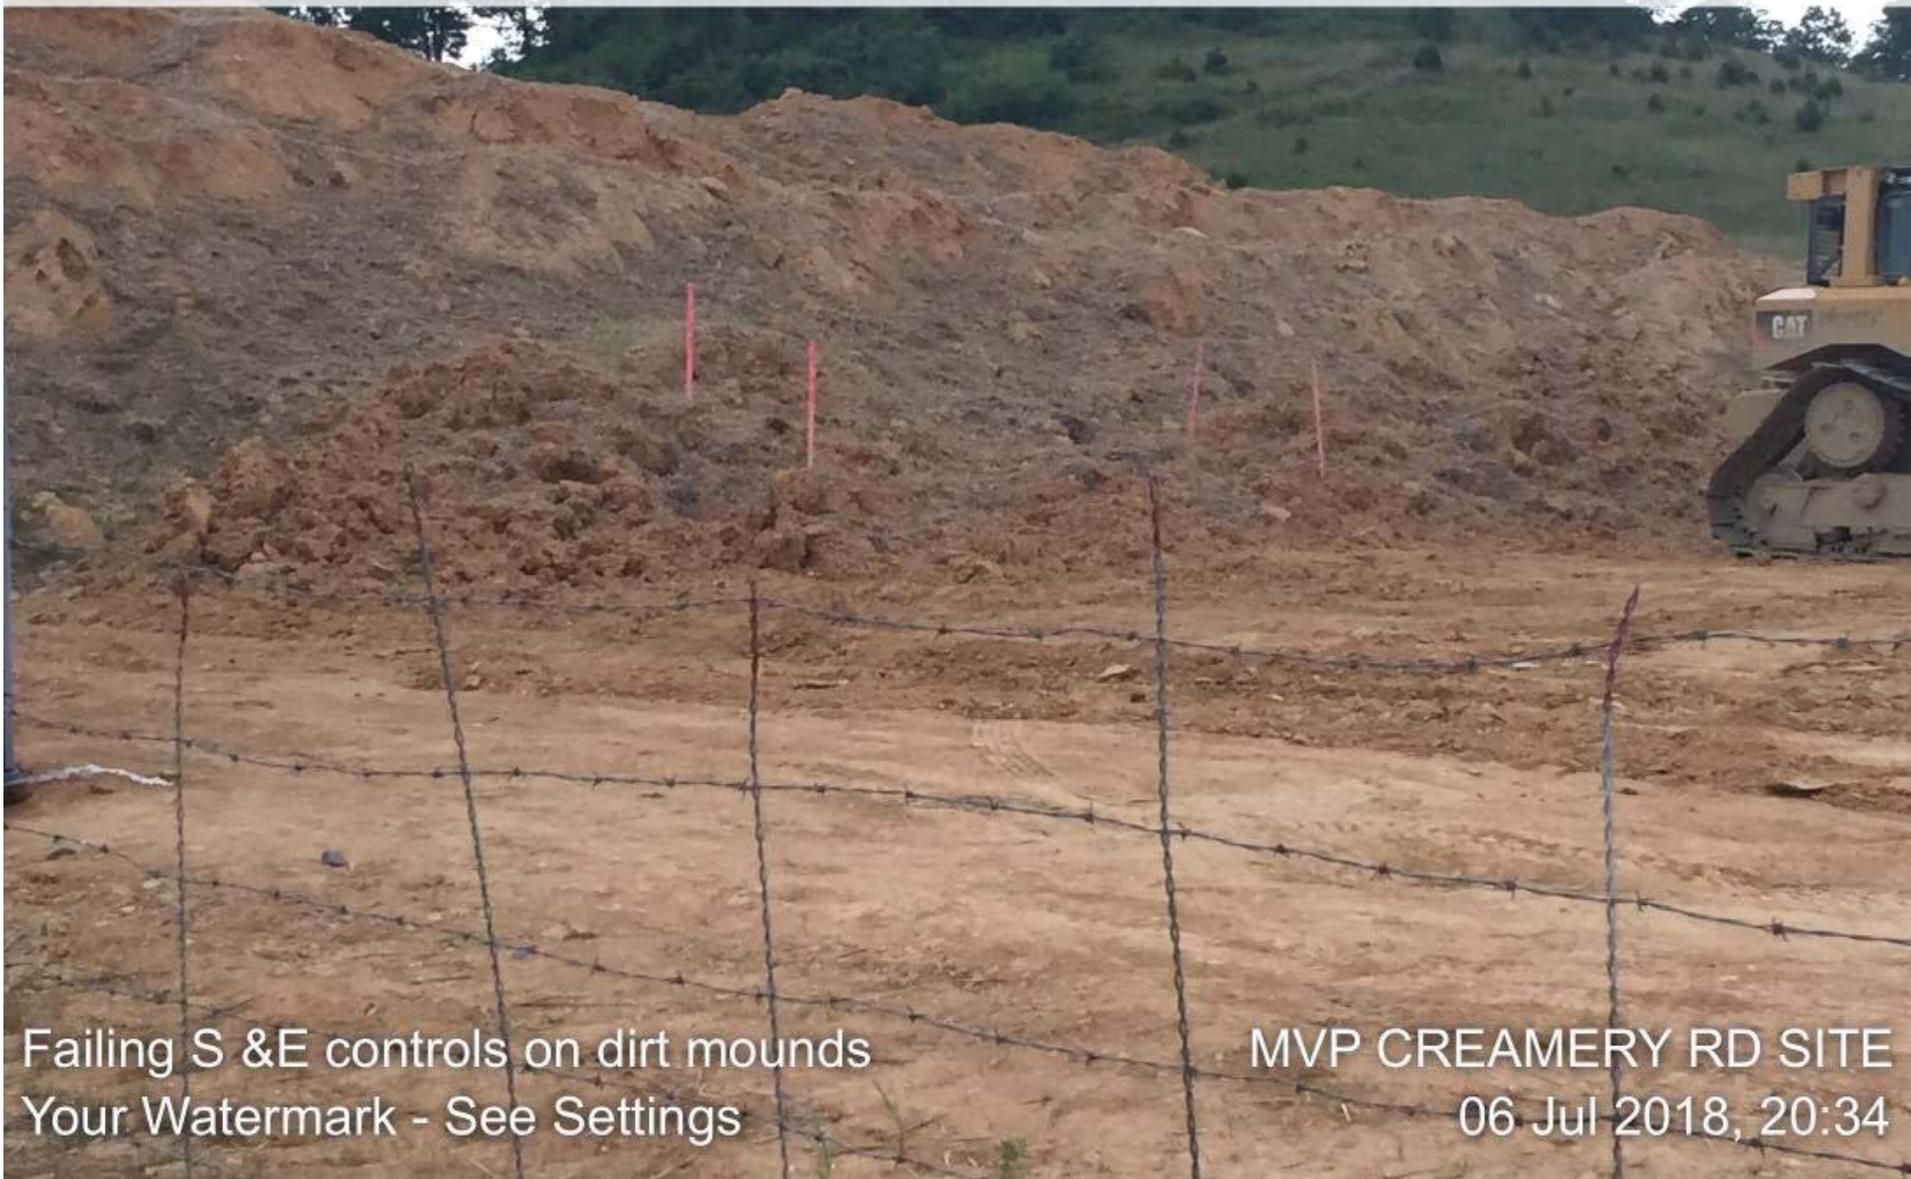
MVP CREAMERY RD SITE  
06 Jul 2018, 20:34

Failing S & E controls on dirt mounds  
Your Watermark - See Settings
