# BASIN FAILURE

## A Case Study on a Skimmer Basin Failure and Downstream Remediation

Jay Wilson, CPESC  
City of Charlotte

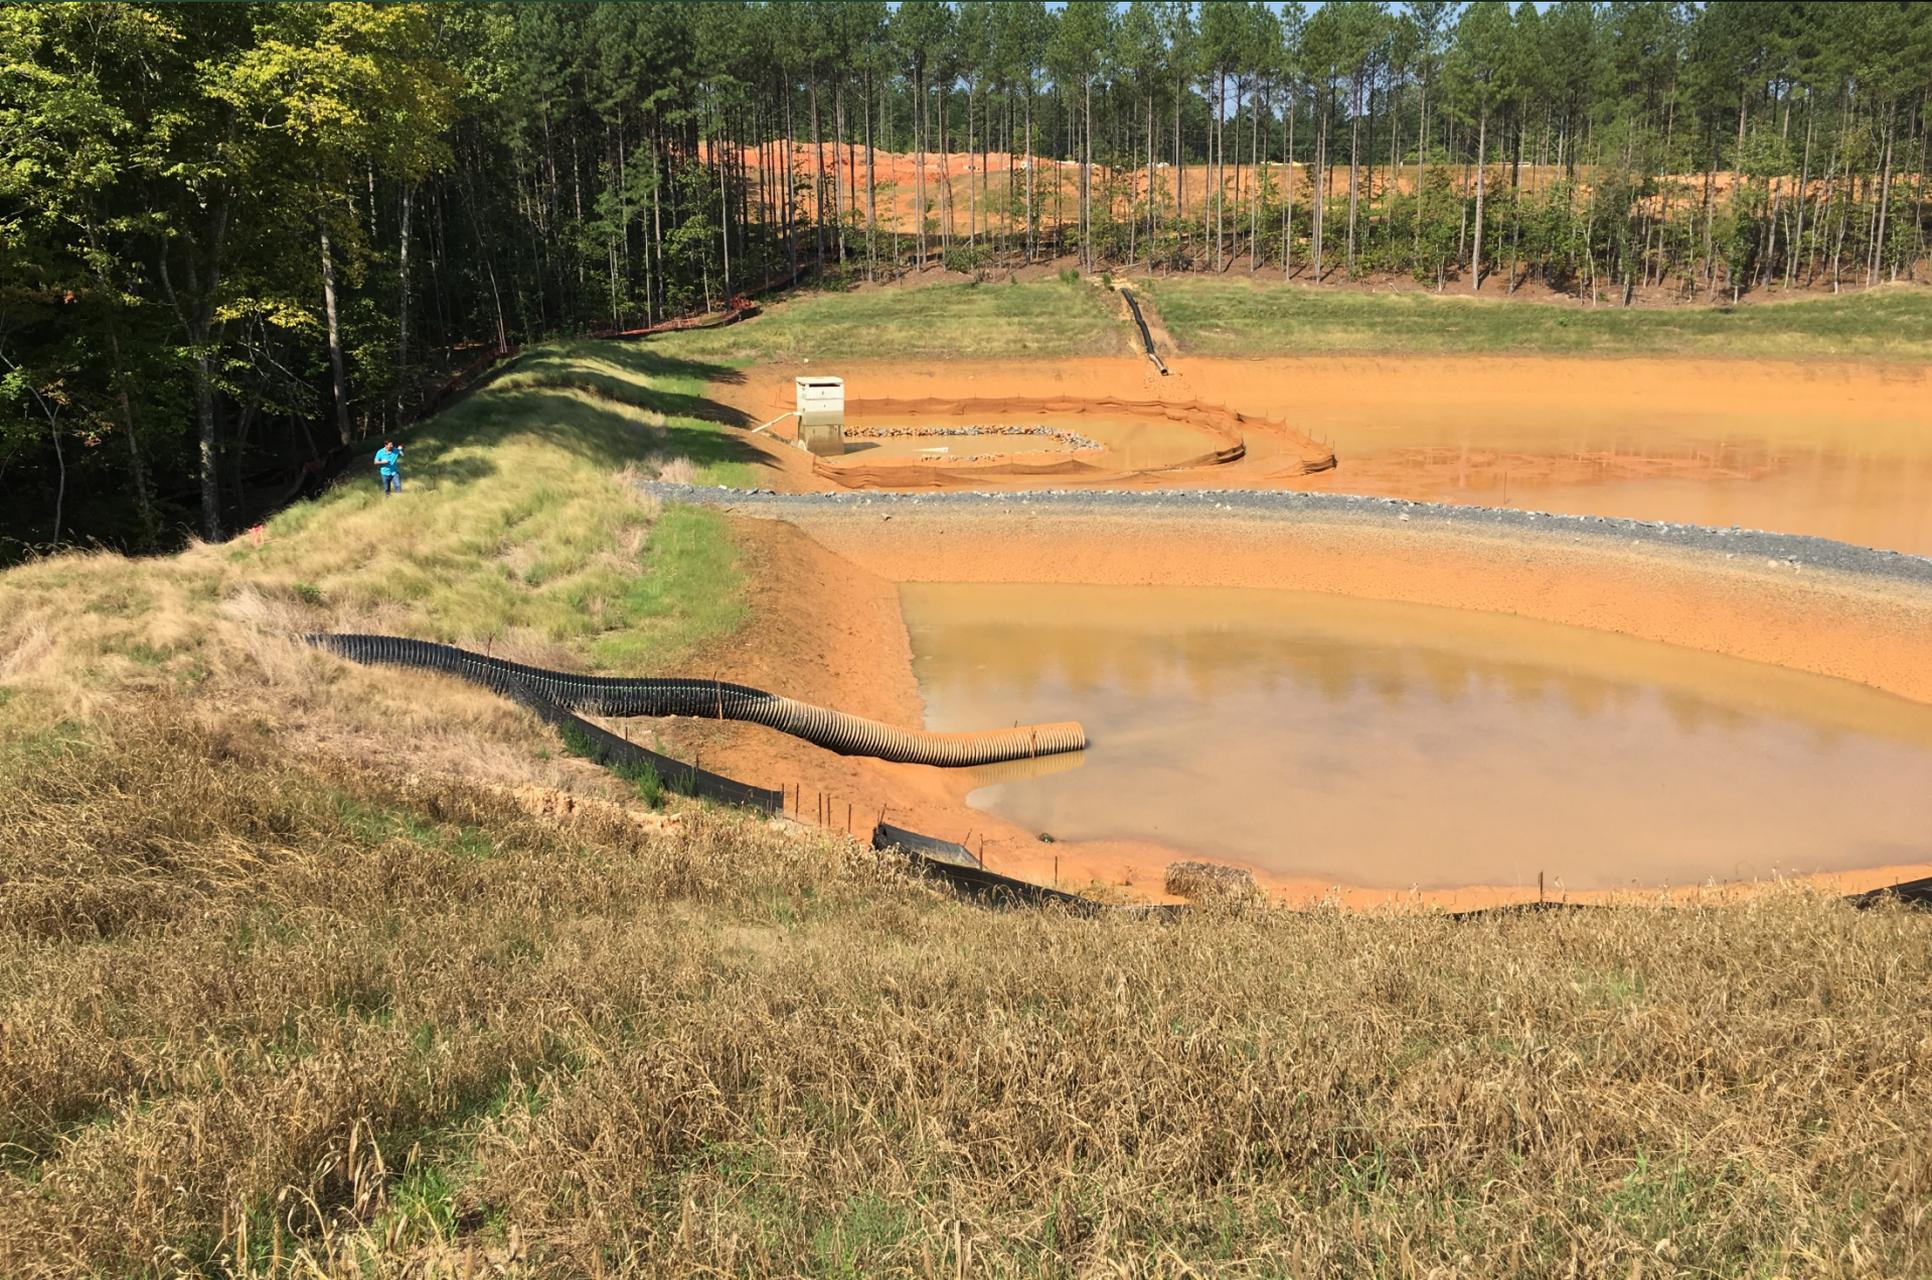
- Sunny day breach; had not rained in a week
- Trench-type failure over the barrel pipe

- Approximate 10' gap over barrel pipe at location of breach
- Pipe joints aligned but disrupted
- Grout seal between OCS riser and barrel pipe “rough”
- No visible external grout at pipe joints
- No anti-seep collar constructed
- Organic debris observed within embankment fill material
- Insufficient compaction
- Soil types not ideal (sandy Pacolet series)

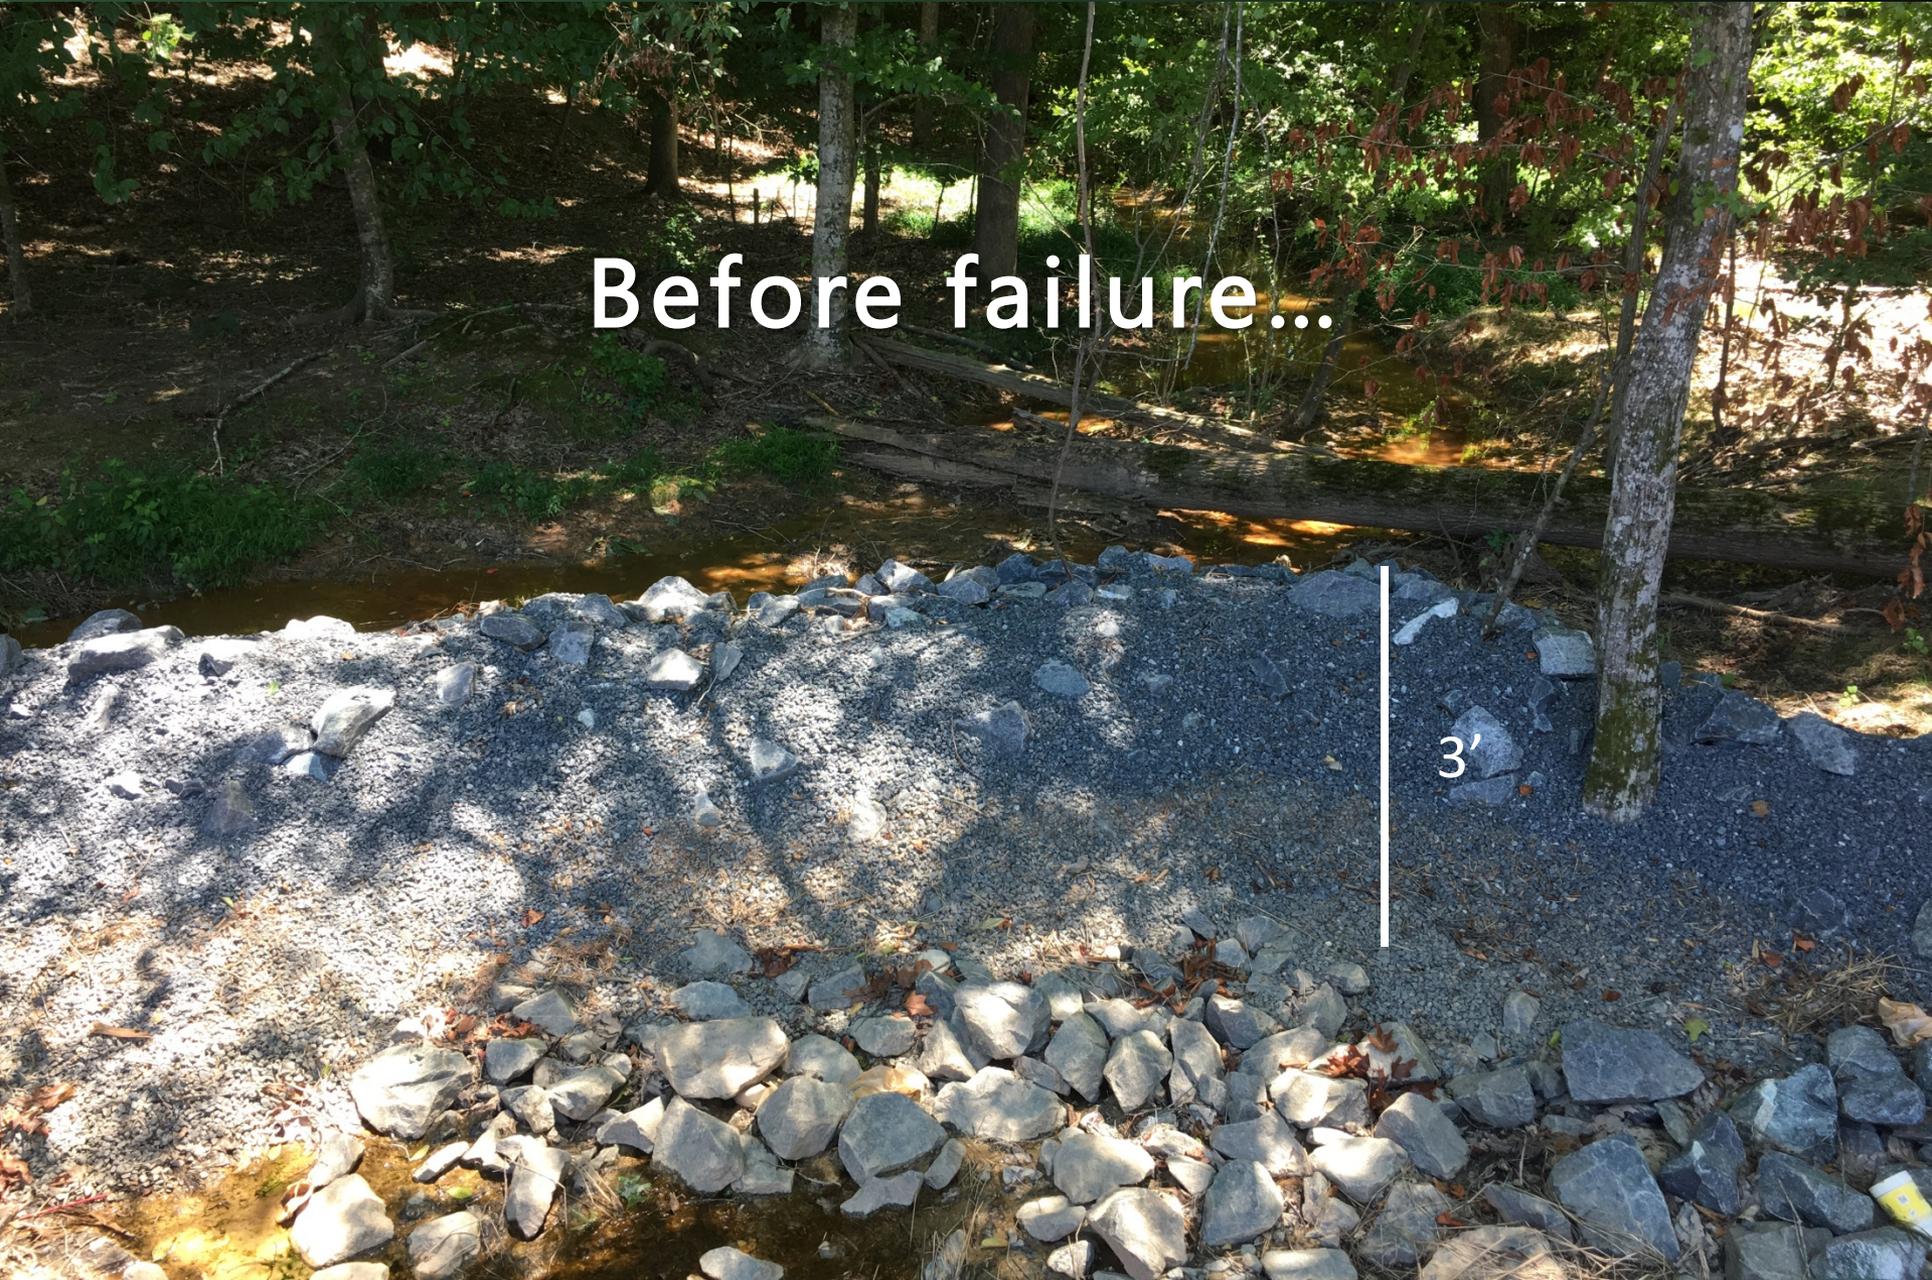
Before failure...

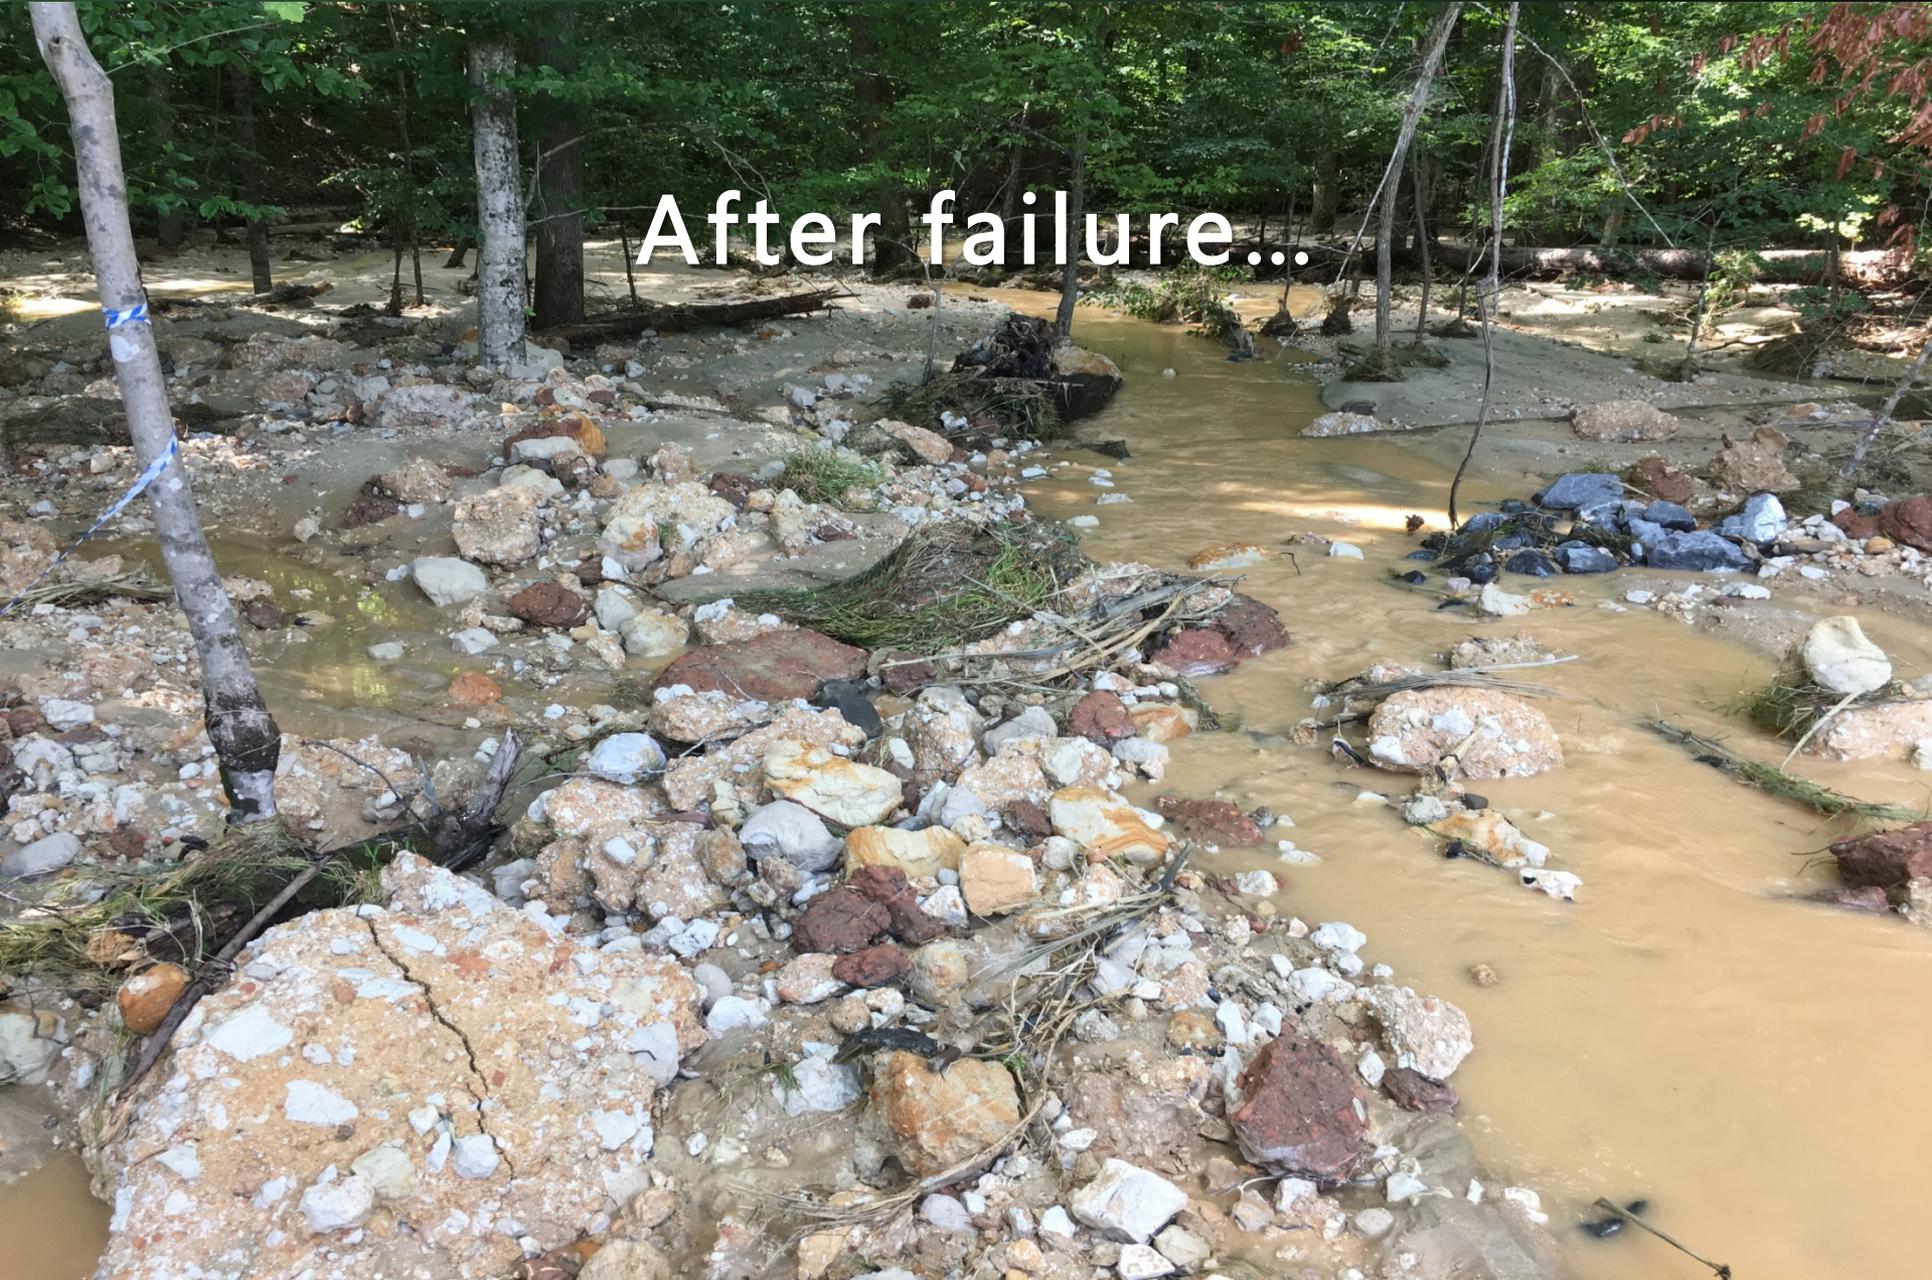
After failure...

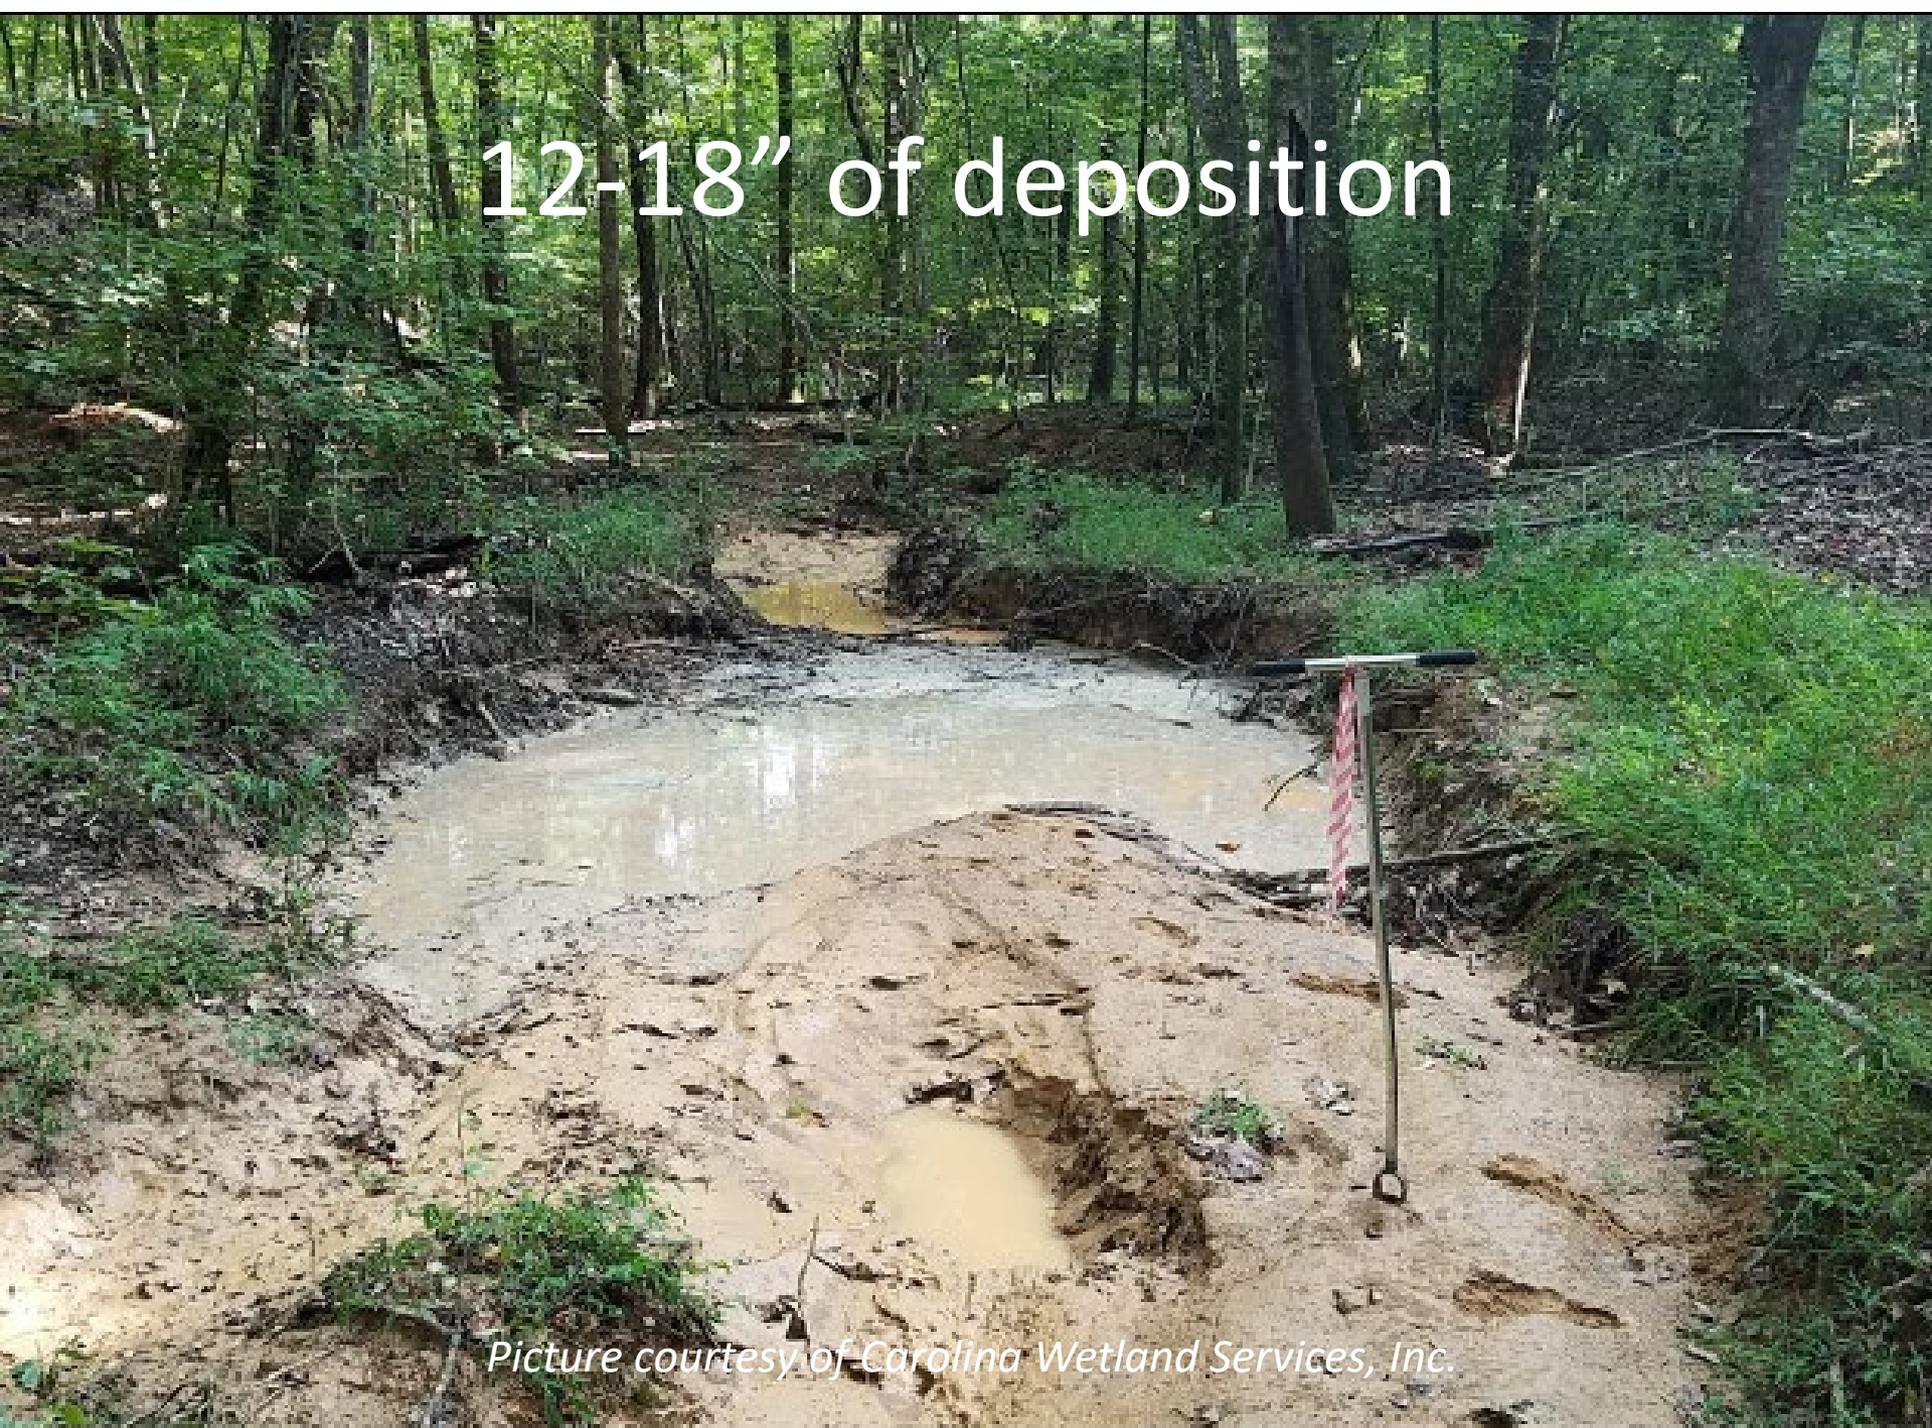
12-18" of deposition

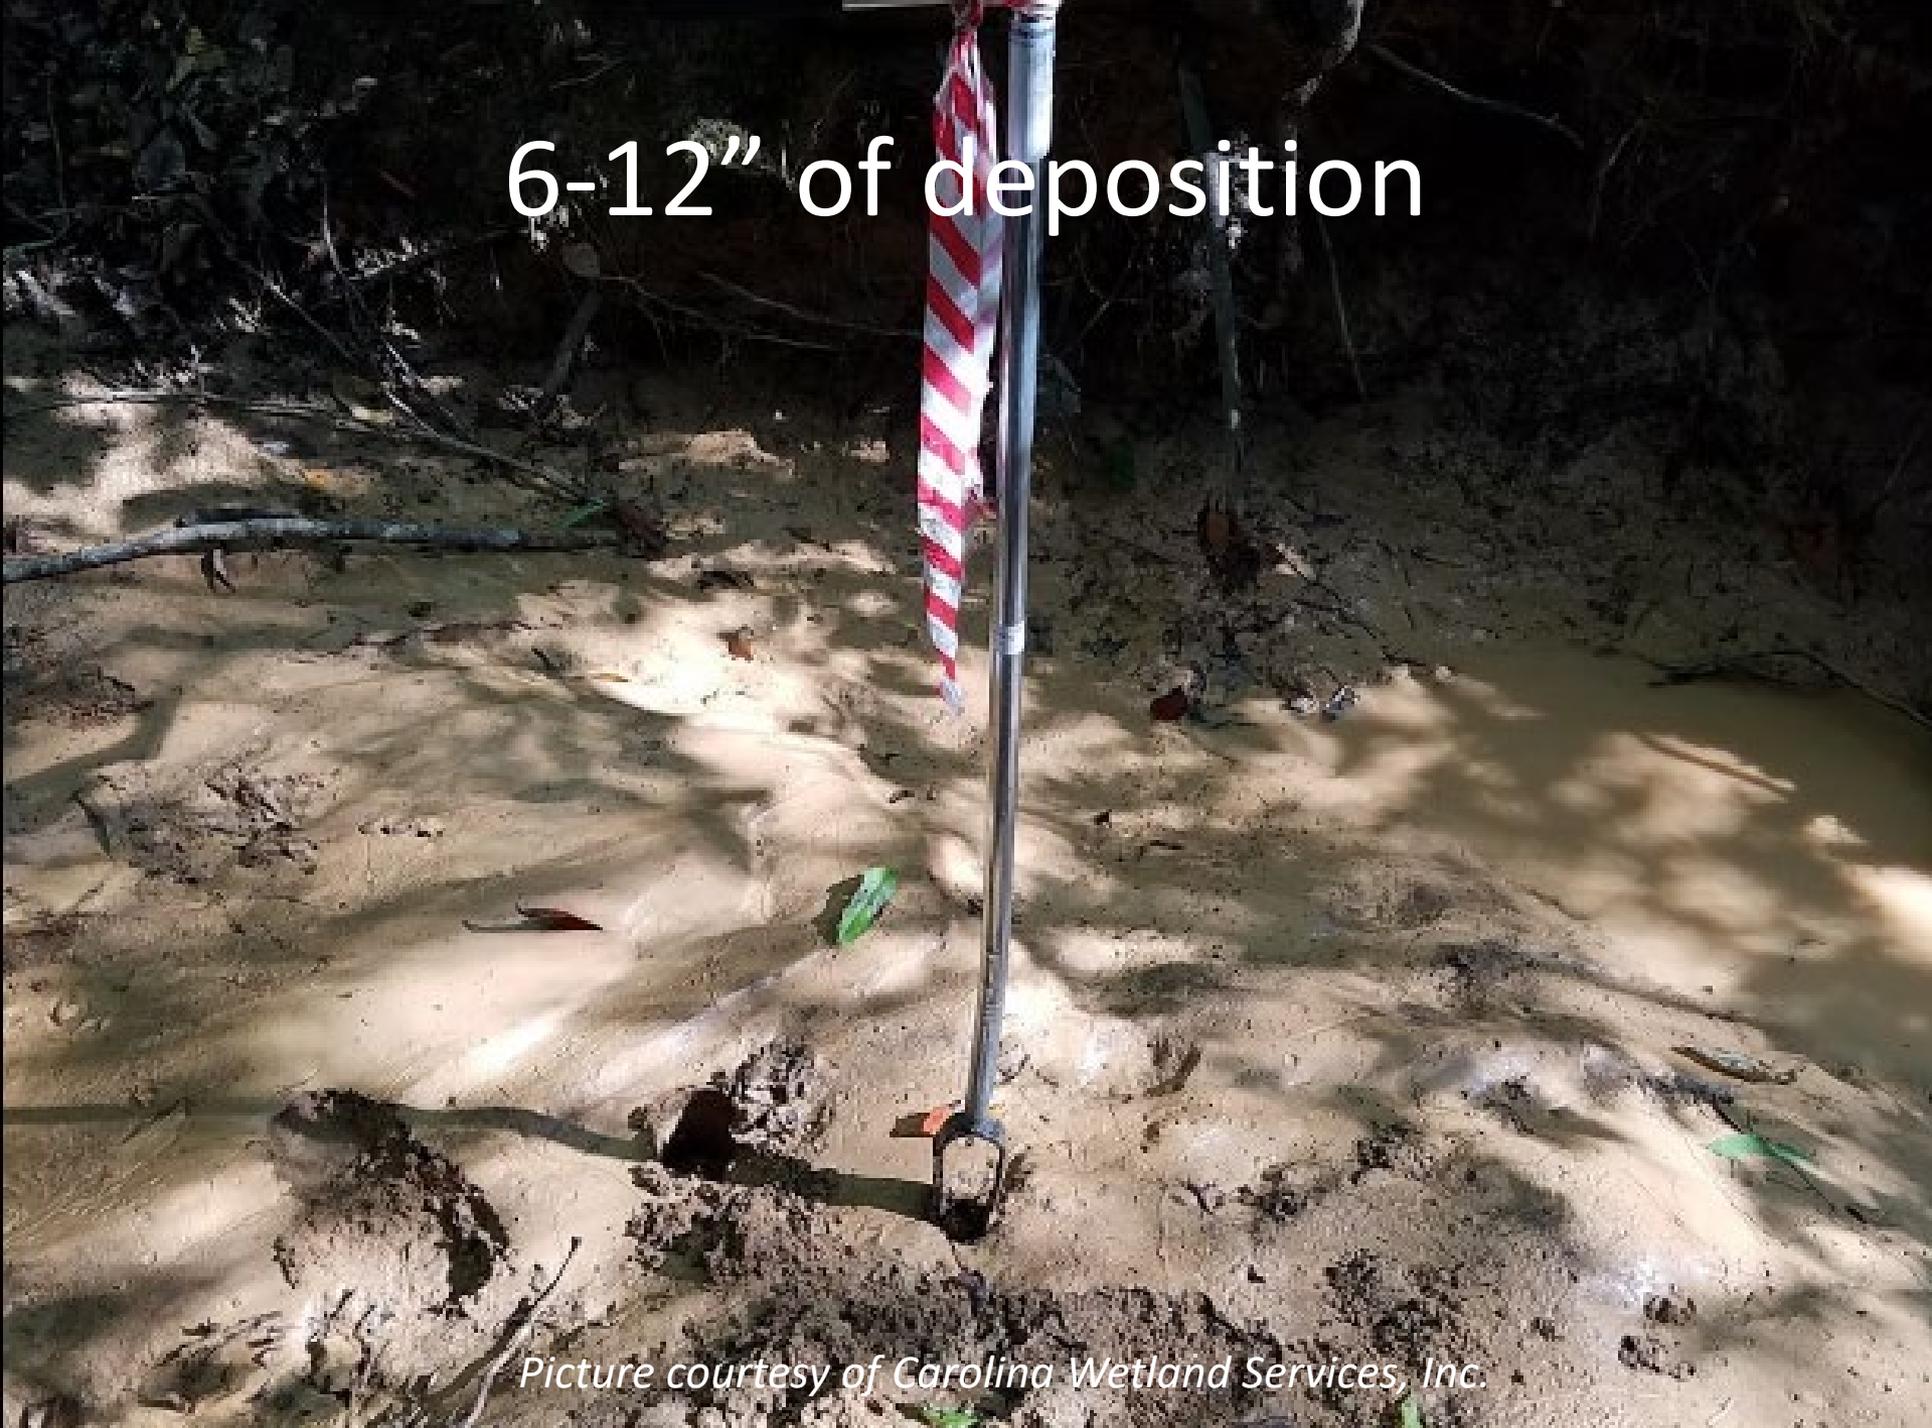
6-12" of deposition

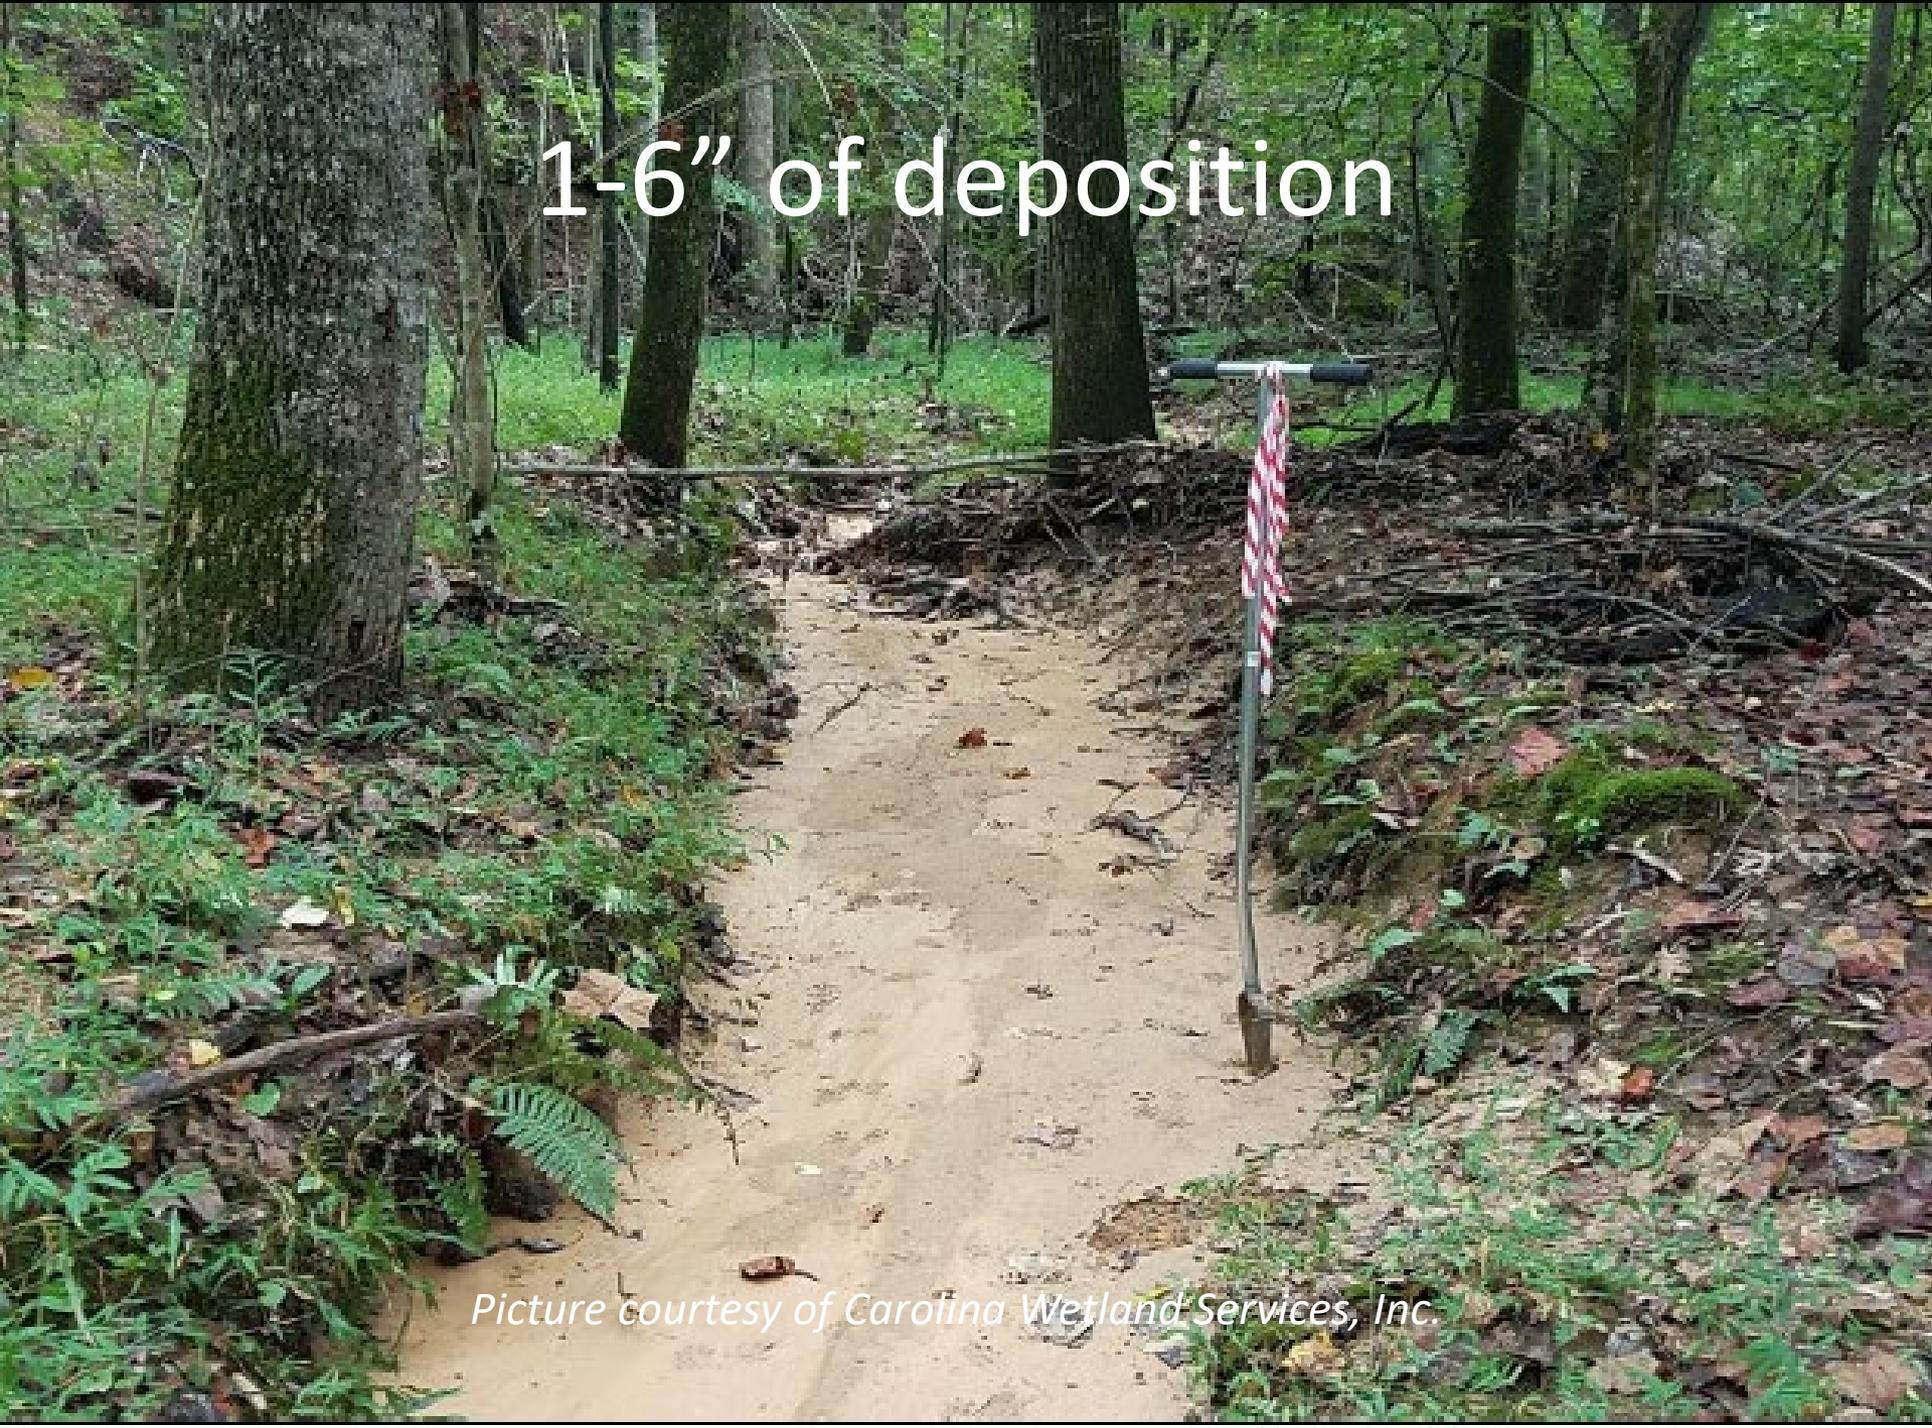
1-6" of deposition

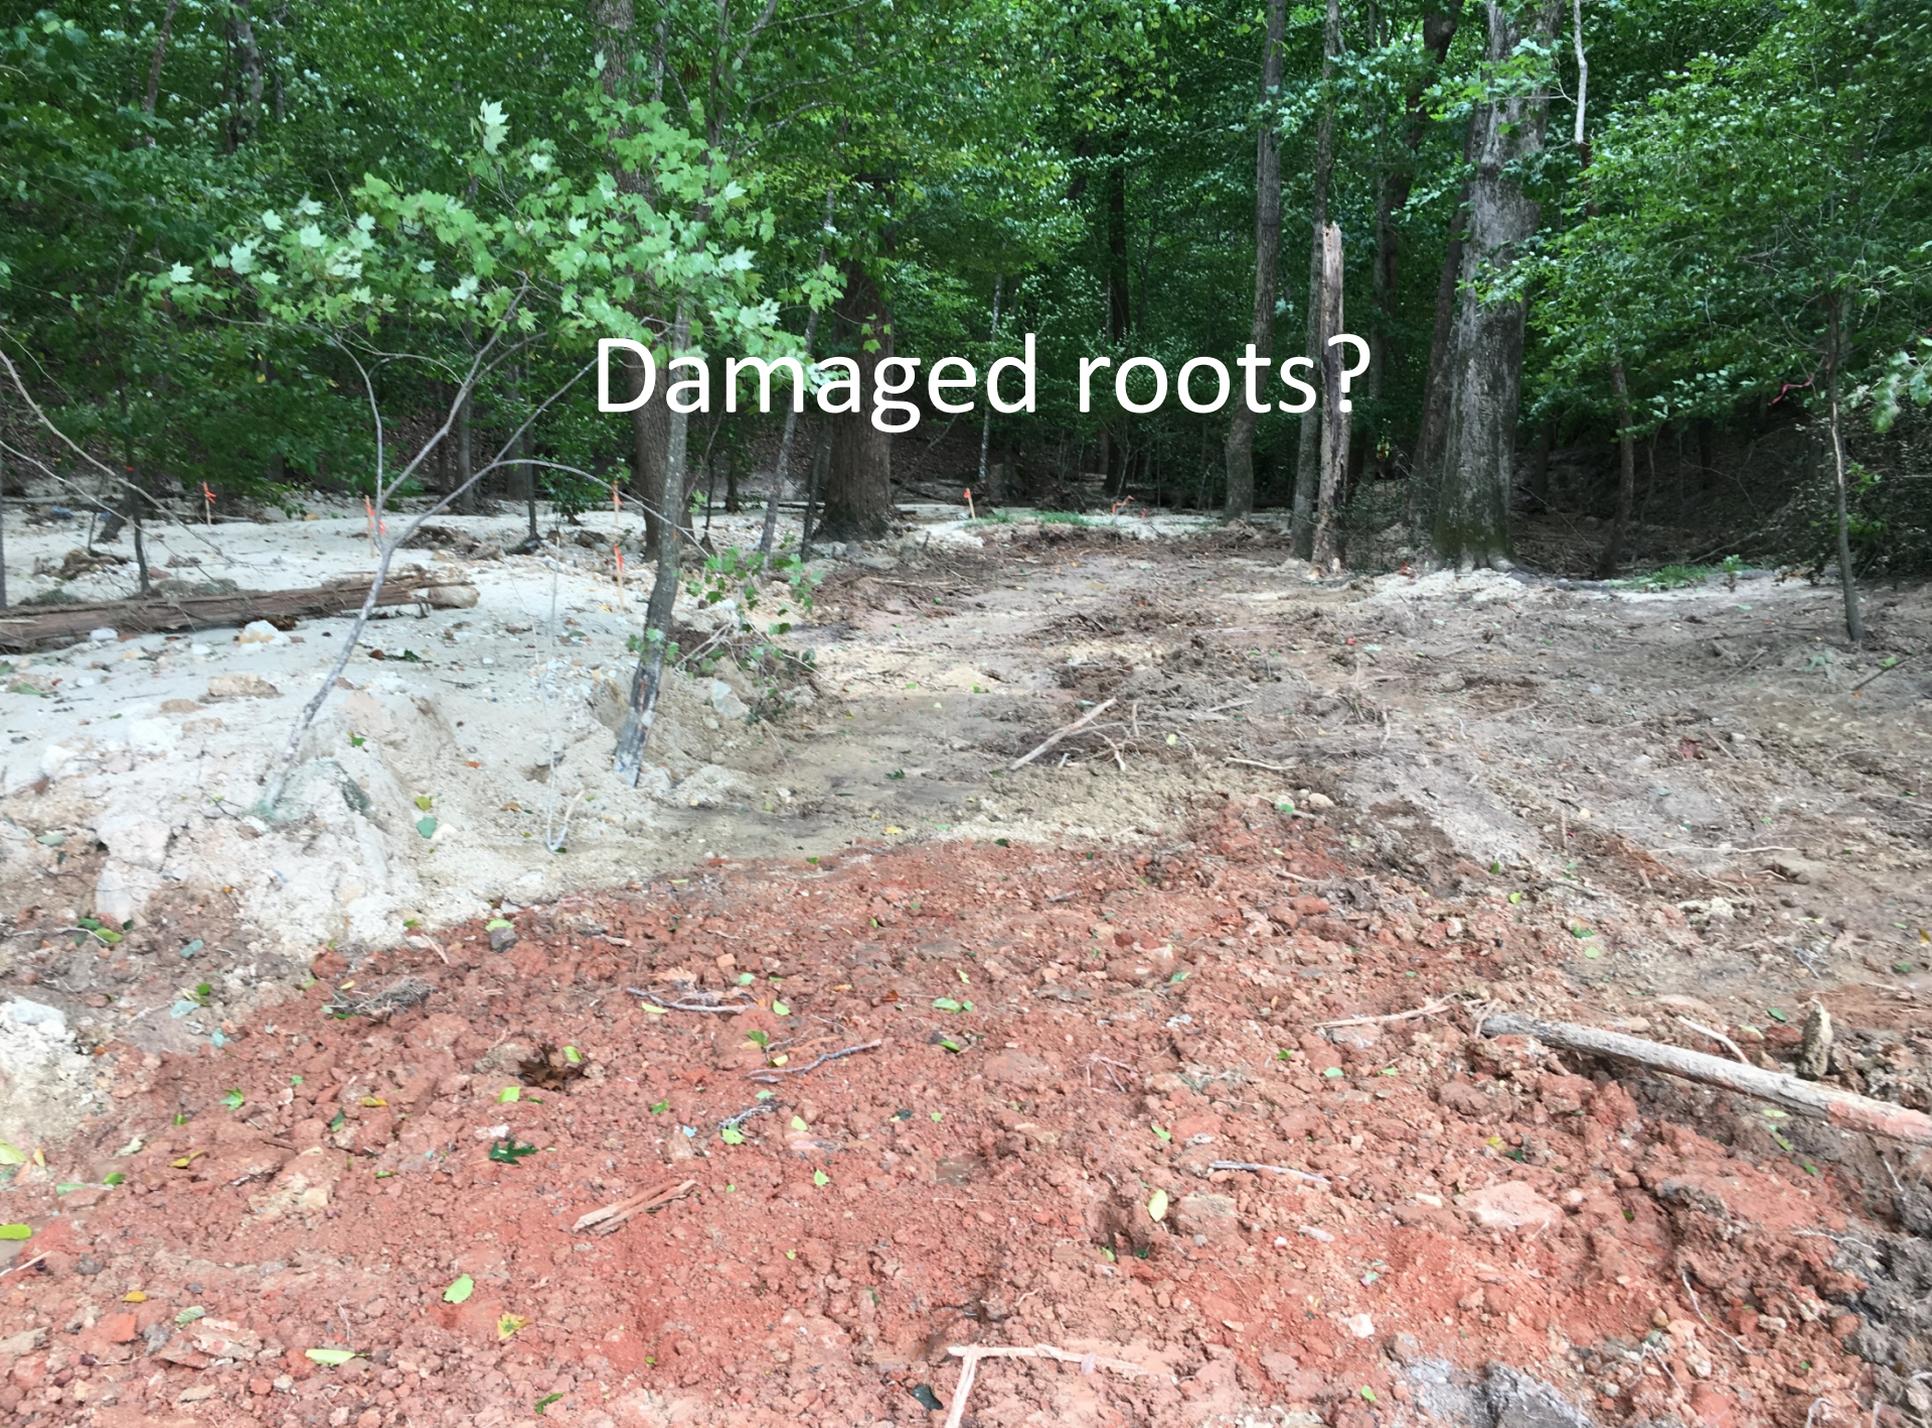
Damaged roots?
