**601 North II
Stream Restoration Site
NCEEP Project Number: 95025
Monitoring Contract Number: 003991
Monitoring Year 2
2014**

**601 North II
Stream Restoration Site
2014 Monitoring Report (MY 2)**

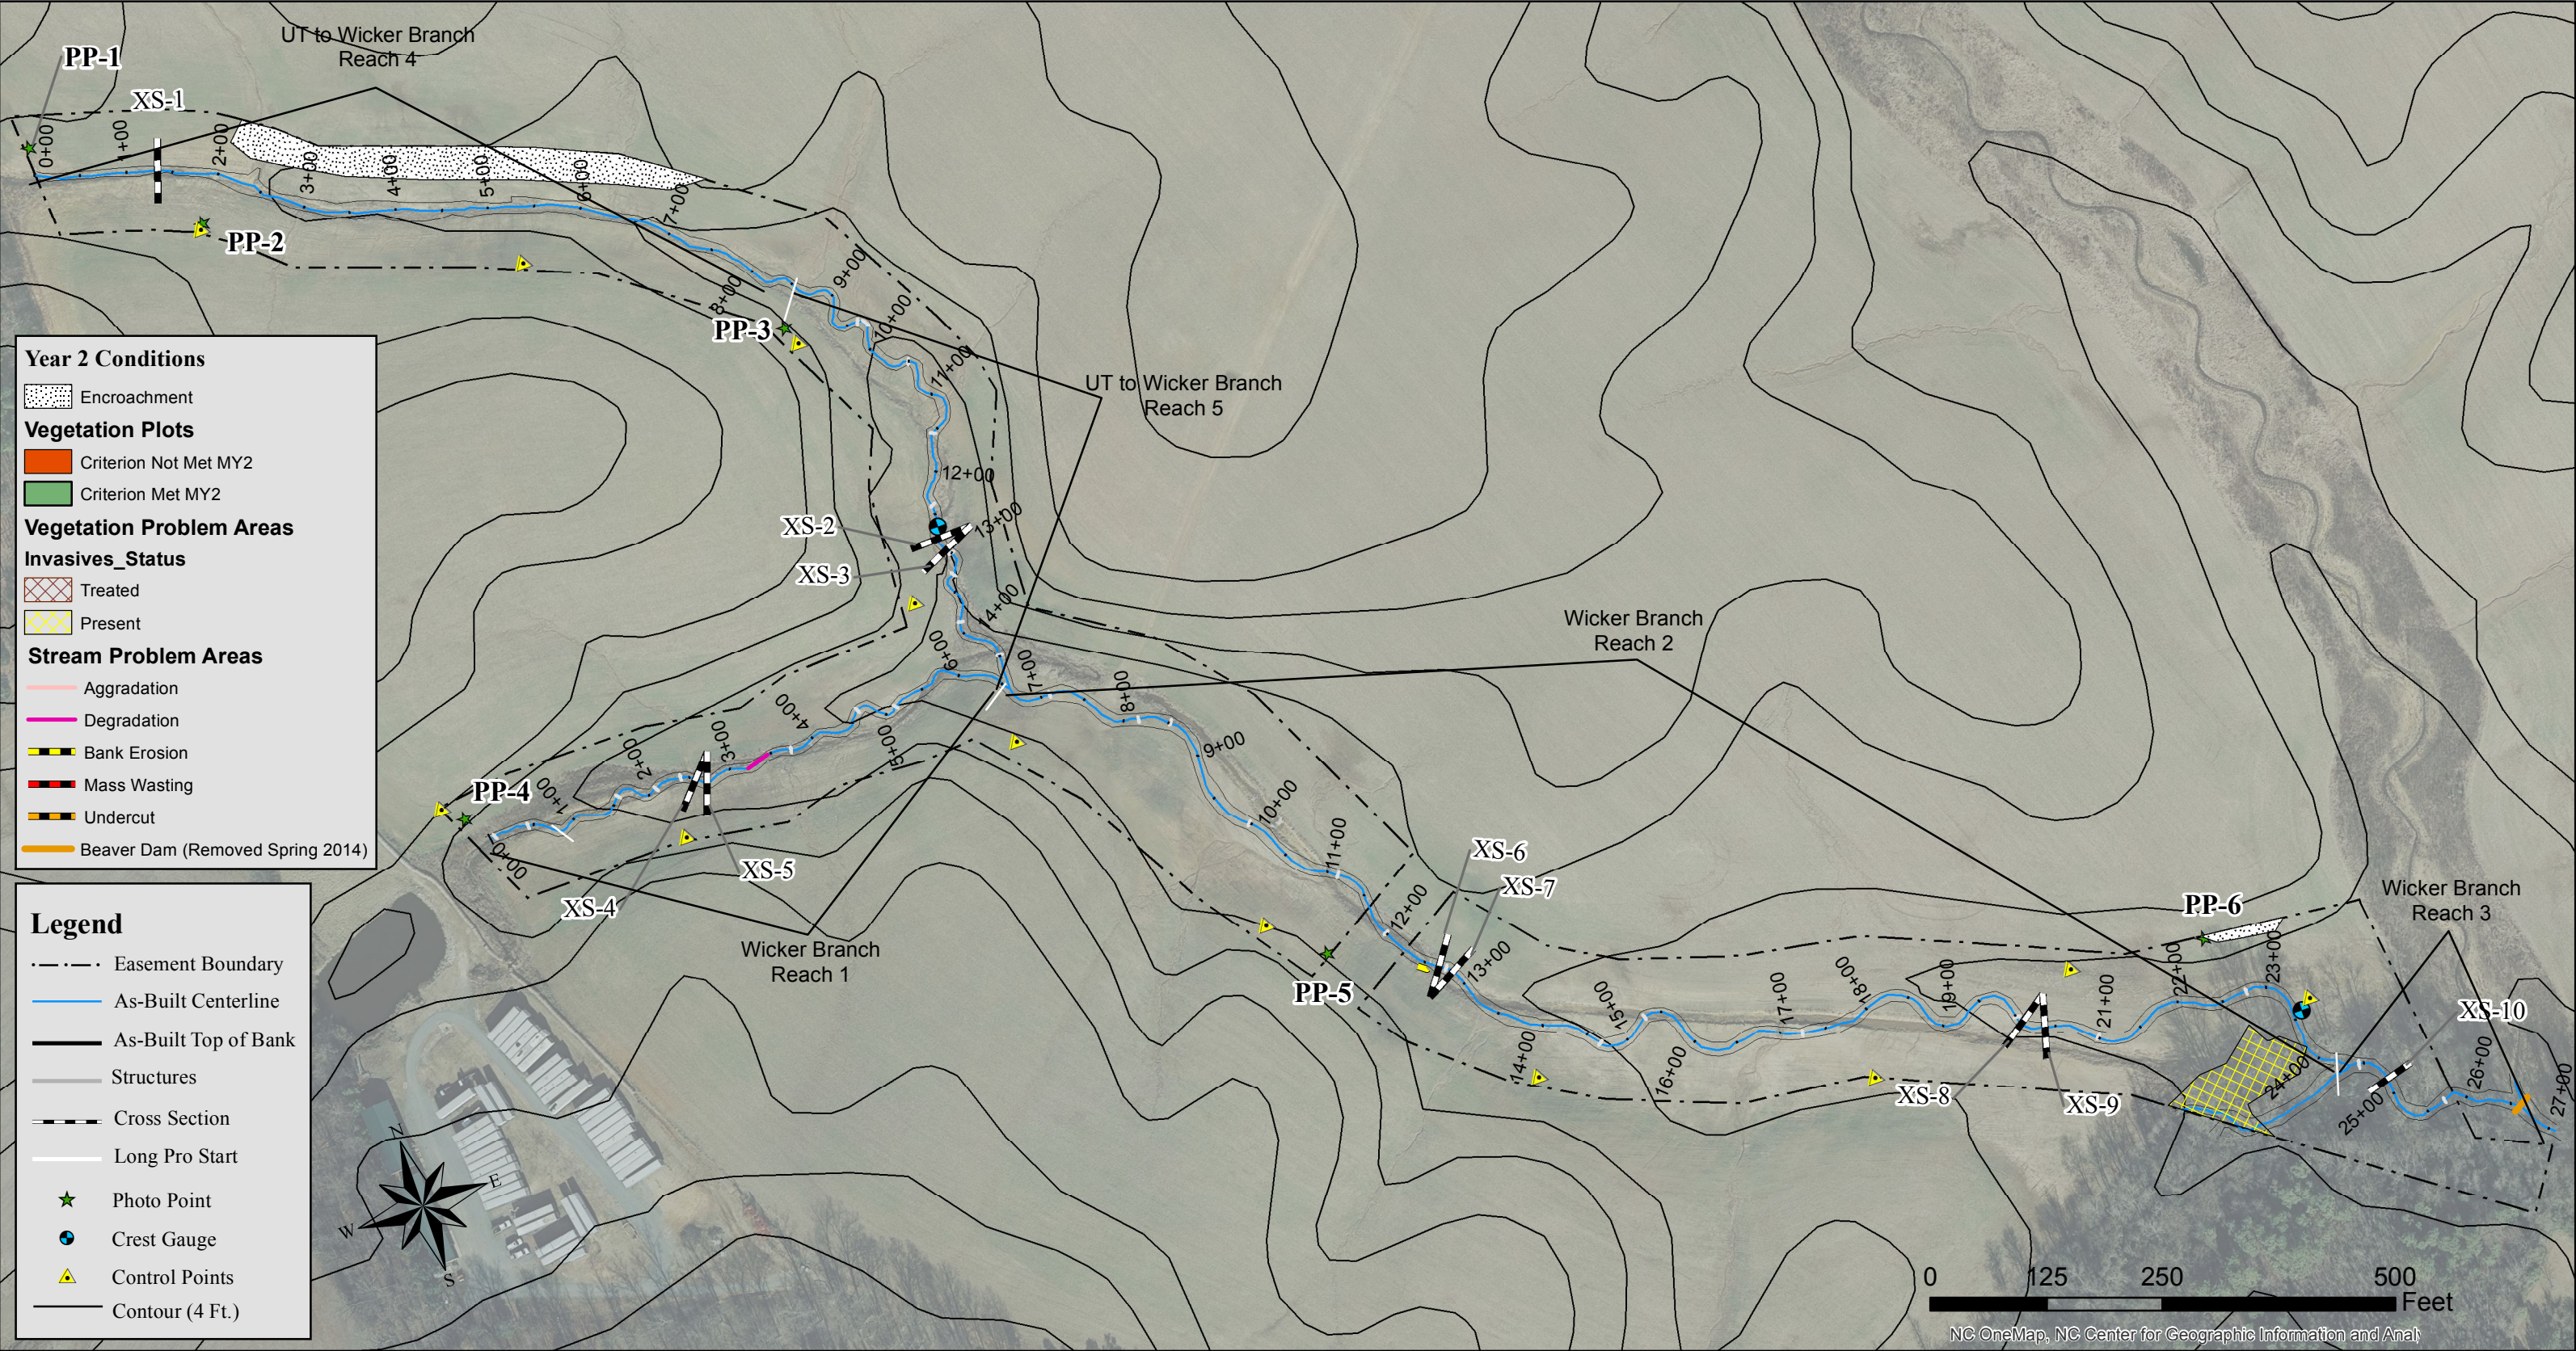
Figure 2. Integrated Current Condition Plan View

Beaver activity was documented on the mainstem, at the confluence of 601 North II and the companion site 601 North (Figure 2). This information was conveyed to EBX, who hired a private trapper to address the issue. The dam was removed during spring of this year (2014). The stream channel was not affected by the impoundment and herbaceous vegetation has since re-established in impounded areas. Additionally, two areas of encroachment were noted on the left descending bank of the easement along Reach 4 as well as Reach 2. Encroachment consisted of mowed areas where tractors from the neighboring property turned into the easement. EBX is coordinating with the adjacent landowner to avoid future encroachment and effected areas will be replanted in the spring (2015).

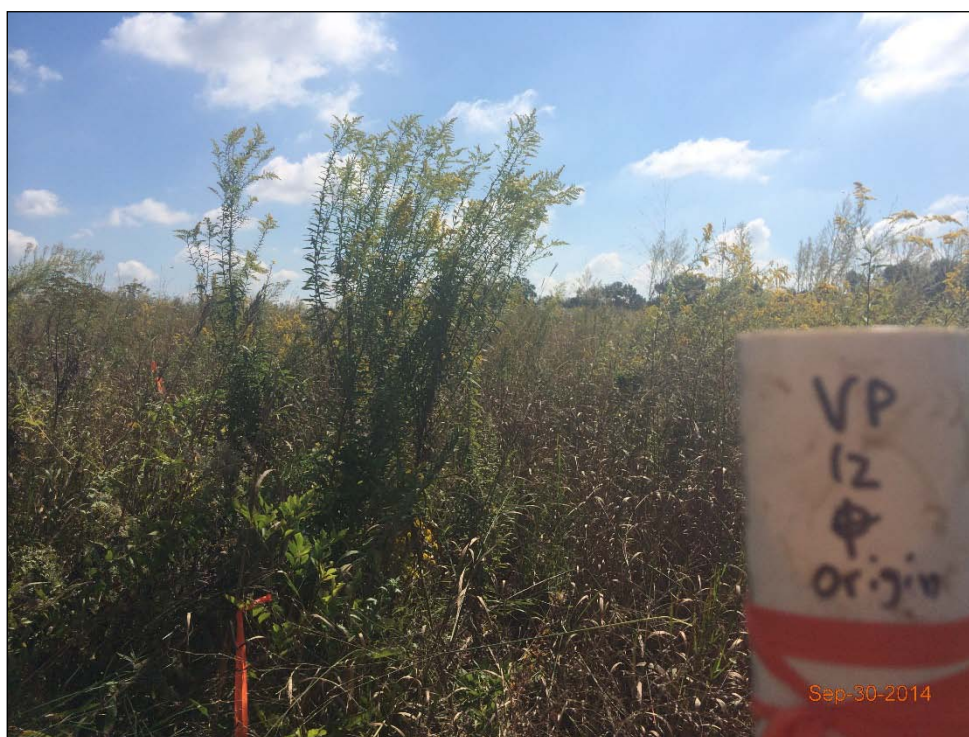
601 North II-Vegetation Monitoring Plot 12
September 30, 2014

Table 7. Vegetation Plot Criteria Attainment		
601 North II / Project No. 95025		
Vegetation Plot ID	Vegetation Survival Threshold Met?	Tract Mean
1	Yes	92%
2	Yes	
3	Yes	
4	Yes	
5	Yes	
6	Yes	
7	Yes	
8	Yes	
9	Yes	
10	Yes	
11	Yes	
12	No

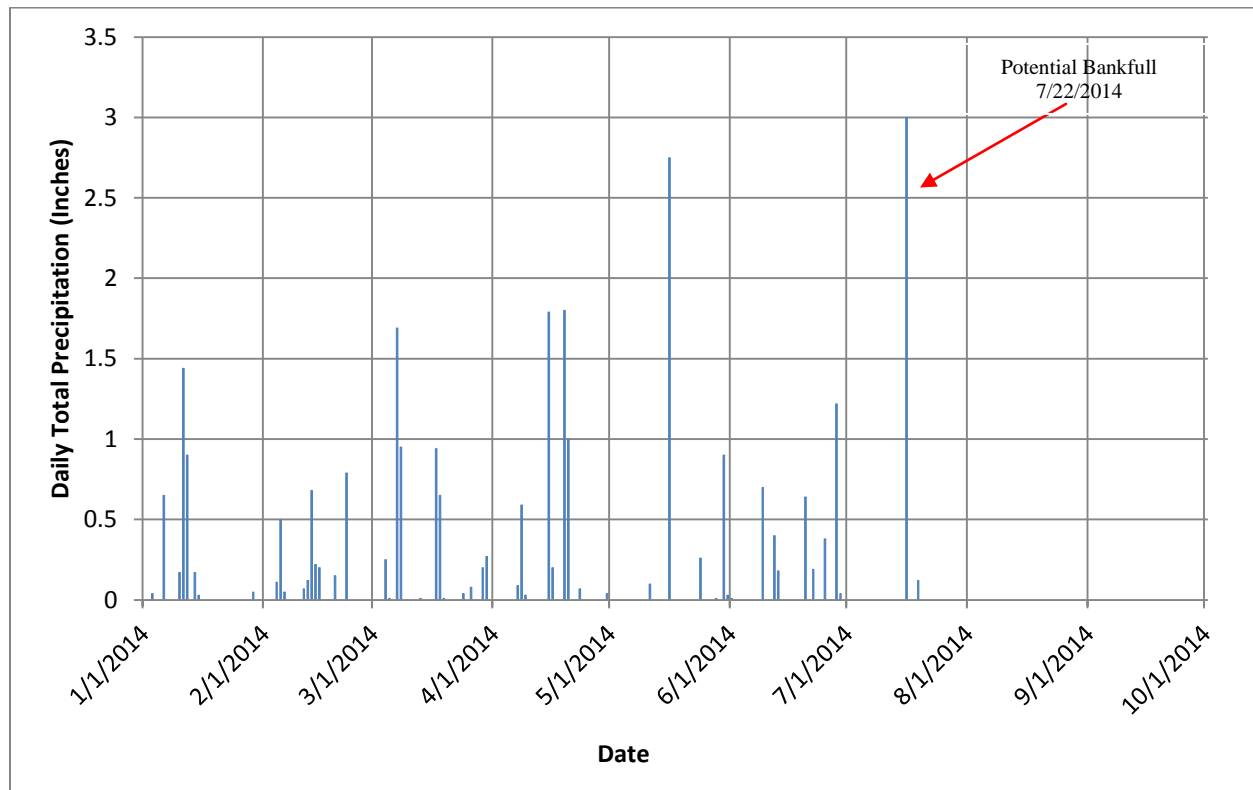
Figure 3. Daily Precipitation Totals for Monroe, North Carolina- NCCRONOS Station No. 315771

One bankfull event was documented during a September 2014 field visit (Table 12). The suspected date, based on precipitation data, is July 22, 2014 (Figure 3). This is the second bankfull event since construction was completed.
