Garner Branch (Chavis Park)  
Stream Restoration  
As-Built Report  
September 2002

As-Built Report  
**Garner Branch Stream Restoration Project**  
Chavis Park, Raleigh North Carolina

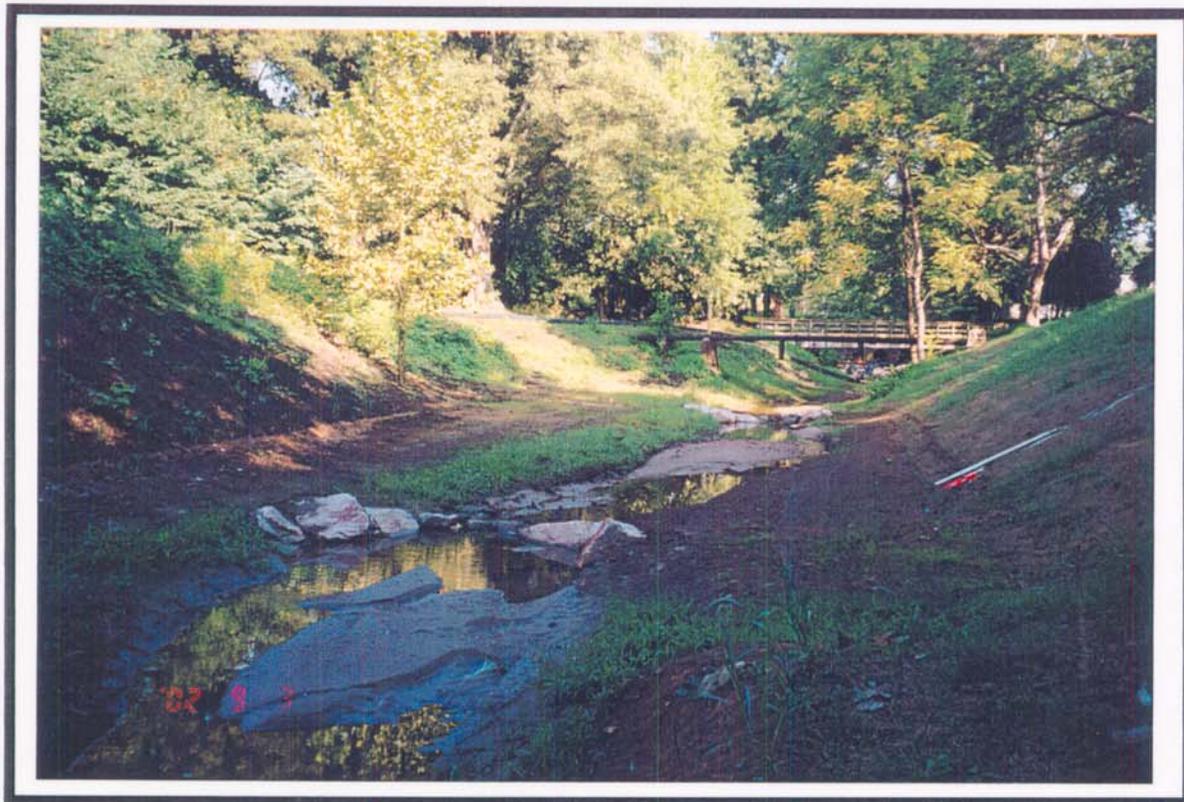
1. Cross Section #1: Third structure downstream of pipe crossing, 4<sup>th</sup> bolder downstream on the left arm as viewed looking upstream.
2. Cross Section #2: Structure just downstream of cross section, last bolder on right arm looking upstream.
3. Standing on top of the storm drainage concrete outlet pipe end, looking upstream at cross section #3.
4. Cross Section #4: At the rock structure that wraps around the island end, left cross vane, standing on left bolder on left arm of structure looking upstream at the main channel and the tributary.
5. Cross Section #5: Standing on the upstream left point of the "W" rock structure just downstream of the cross section looking upstream.

**Cross Section #1 As Viewed Looking Upstream**

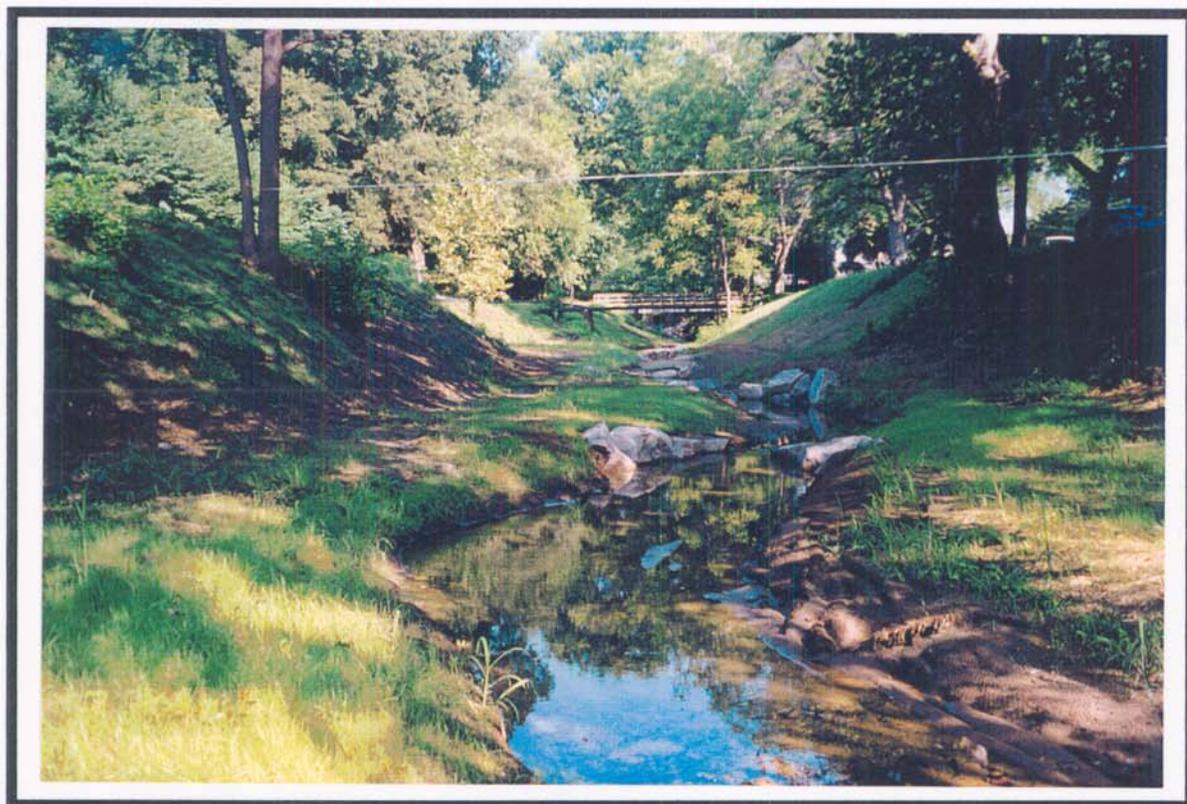
**Cross Section #2 As Viewed Looking Upstream**

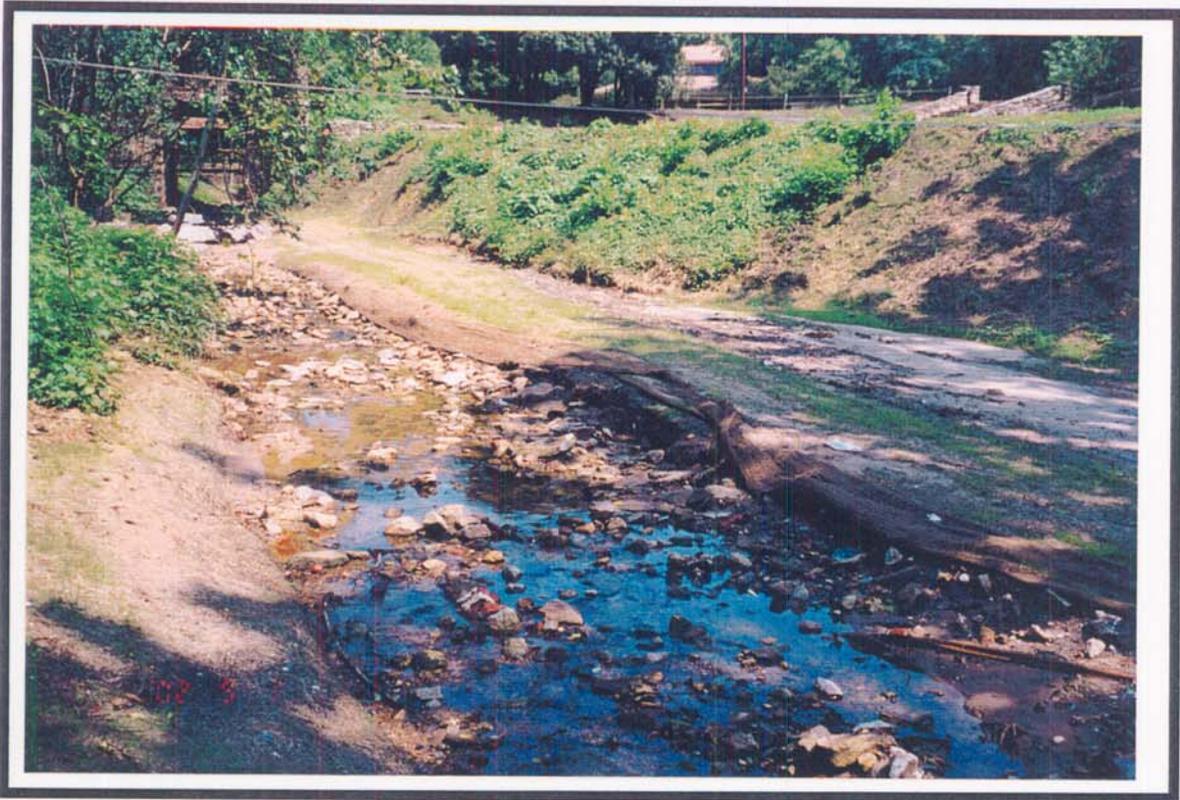
2. Cross Section 3 was located just downstream of the stone bridge approximately one half way into the project. The two tributaries just upstream of the stone bridge combine to provide approximately twice as much flow through this channel segment as the seen in sections 1 & 2 above. The construction work completed in this area involved lowering the existing floodplain elevation, bank toe stabilization with stone and joint plantings on the south bank, re-vegetation of the terrace banks, and the installation of a junction box and pipe to bring the stormwater discharge down into the stream. Cross Vane structures were also installed as shown on the as-built plan

**Cross Section #3 As Viewed Looking Upstream**

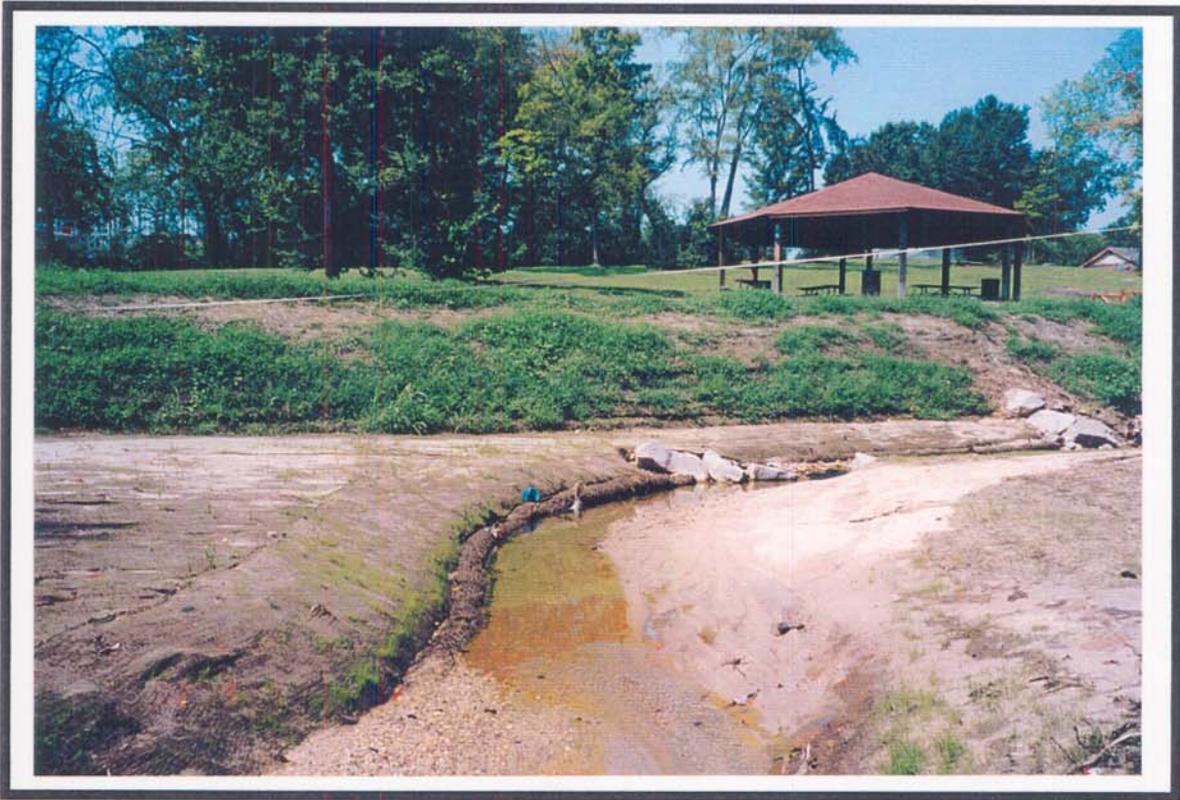
3. Cross Section 4 was placed to monitor the reconstructed floodplain between the main channel and the tributary entering from the south. The cross section begins on the left bank of the main channel crosses to the right bank and then turns to continue to the right bank of the tributary. This area was originally an island that had been cut around and had severely eroded and was contributing a significant amount of sediment over the years. The floodplain point was reconstructed to a slightly higher than bankfull elevation so that as floodwaters rise in the channel more flow is directed to the wider floodplain to the left of the channel. This was done to protect the point from erosion until vegetation is established. Structures were also an important part in the design of this area by directing flows to the reconstructed channel location. The placement of the cross vanes at the near the tip of the point and the continuation of the arms to connect around the point of the floodplain reinforces the point of convergence. In this area two sections of Vegetated Geogrids were constructed to stabilize the terrace banks.

**Cross Section #4 Main Channel As Viewed Looking Upstream**

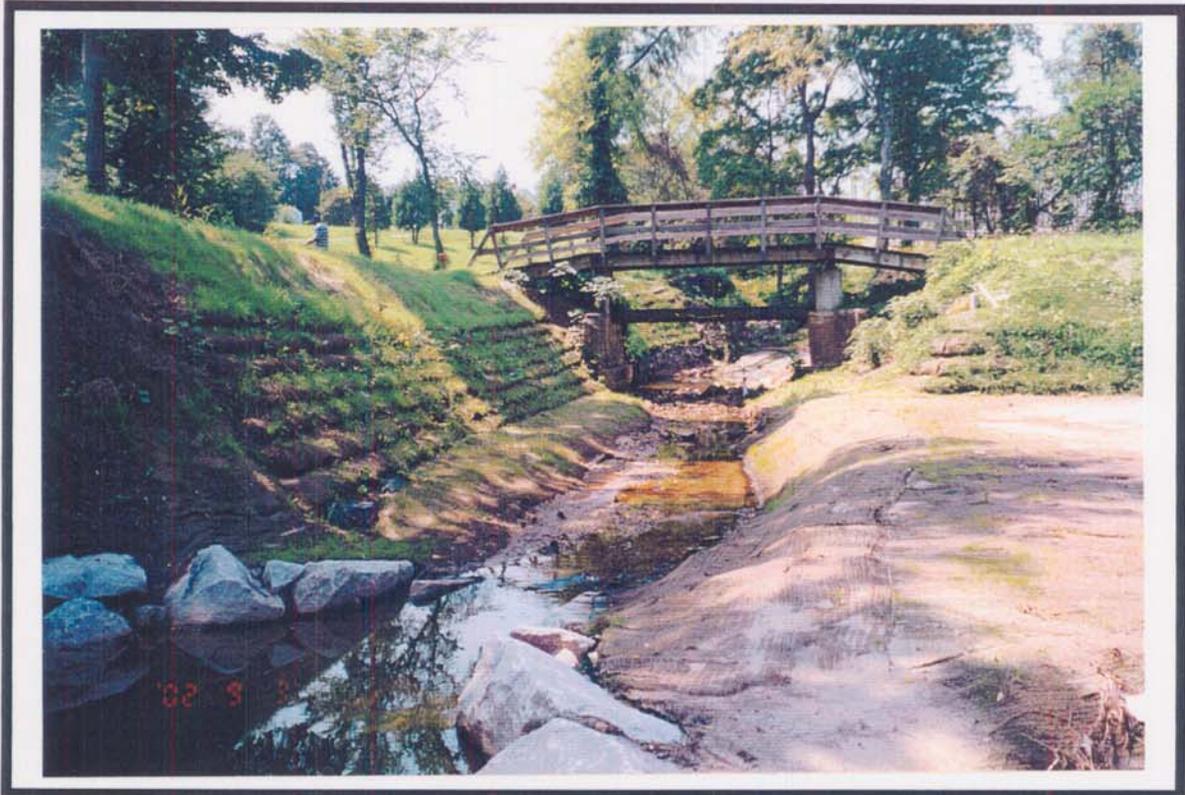
**Cross Section #4 Tributary As Viewed Looking Upstream**

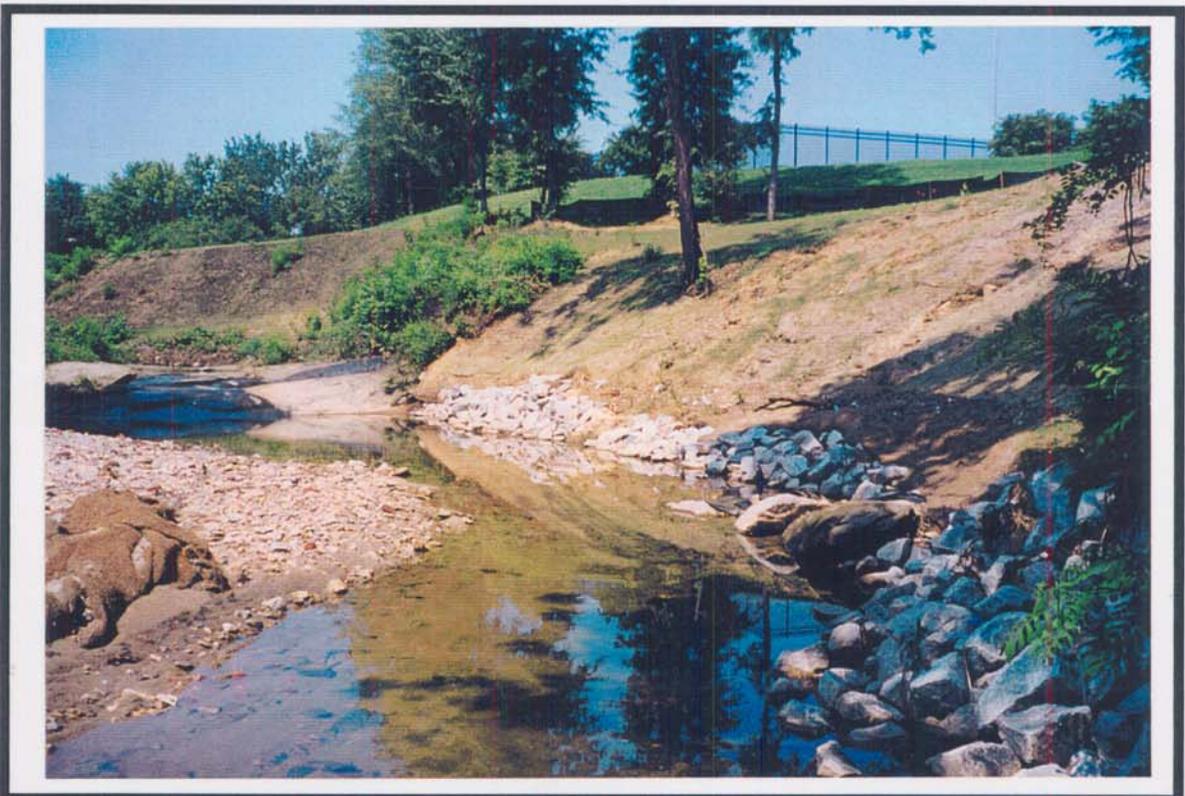
4. The last cross section is located just upstream of the culverts under MLK. This area was selected because it will experience the entire flow of the watershed. The flood plain was lowered to allow for the point bar in this area to develop. A large natural pool created by a bedrock nick point in the stream exists just upstream of the cross section. Just below the section a single rock vane, installed to protect the bank, and a “W” vane, installed to divide the flow into the twin culverts, were installed in the channel. Other work in this area involved the construction of storm drainage pipe and structures to bring an existing storm water pipe discharge point down into the pool location and not over the banks. The previously eroded bank near the newly constructed pipe was repaired and re-vegetated. A rock toe with joint plantings was also placed during construction to stabilize this bank.

**Cross Section #5 Main Channel As Viewed Looking Upstream**
