**601 NORTH II STREAM RESTORATION SITE
BASELINE MONITORING DOCUMENT AND AS-BUILT BASELINE REPORT (FINAL)
UNION COUNTY, NORTH CAROLINA**

NCEEP PROJECT No. 95925; CONTRACT No. 003991

Submittal date: **November 20, 2013**
Data collection period: **April - May 2013**

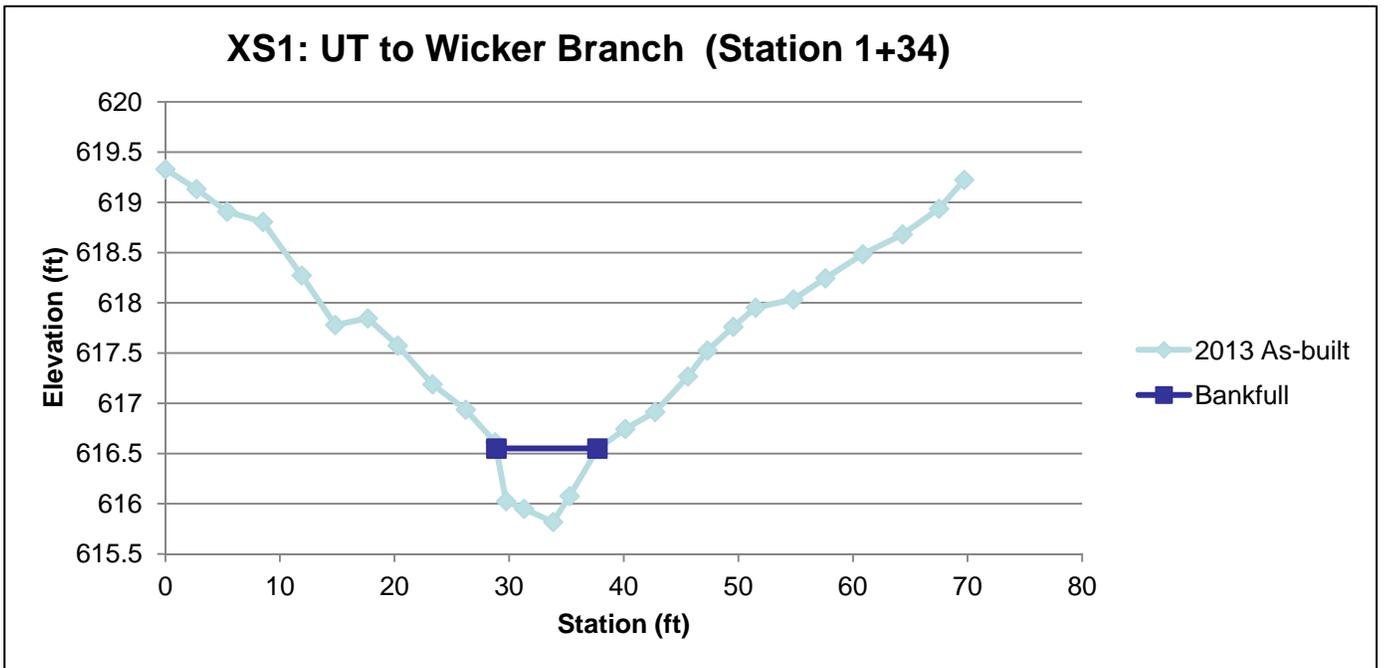
XS1 facing left bank (April 24, 2013)

XS	Stream Reach	Feature	Stream Type	BKF Width	Floodprone Width	BKF Mean Depth	BKF Max Depth	BKF Area	W/D Ratio	ER	BH Ratio
1	UT	Riffle	C	8.9	23.1	0.5	0.7	4.2	18.5	2.6	1.0

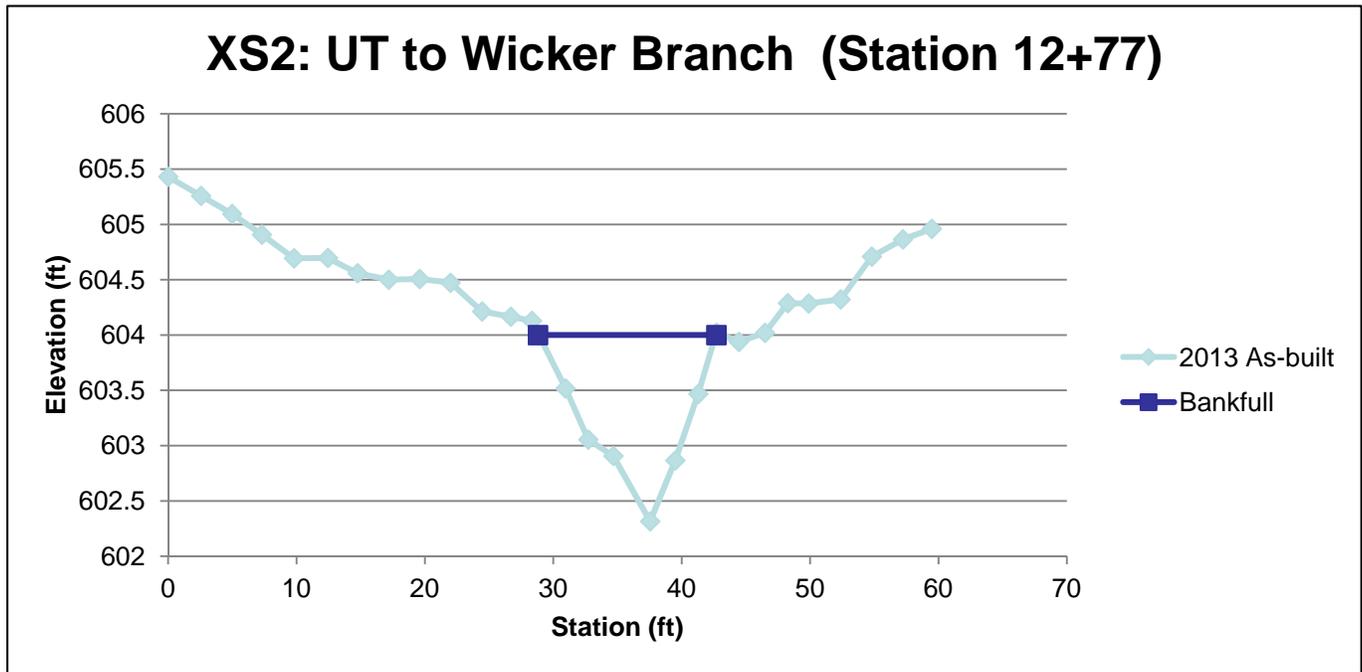
XS2 facing left bank (April 24, 2013)

XS	Stream Reach	Feature	Stream Type	BKF Width	Floodprone Width	BKF Mean Depth	BKF Max Depth	BKF Area	W/D Ratio	ER	BH Ratio
2	UT	Pool	C	17.6	64.1	0.7	1.7	12.8	24.5	3.6	1.0

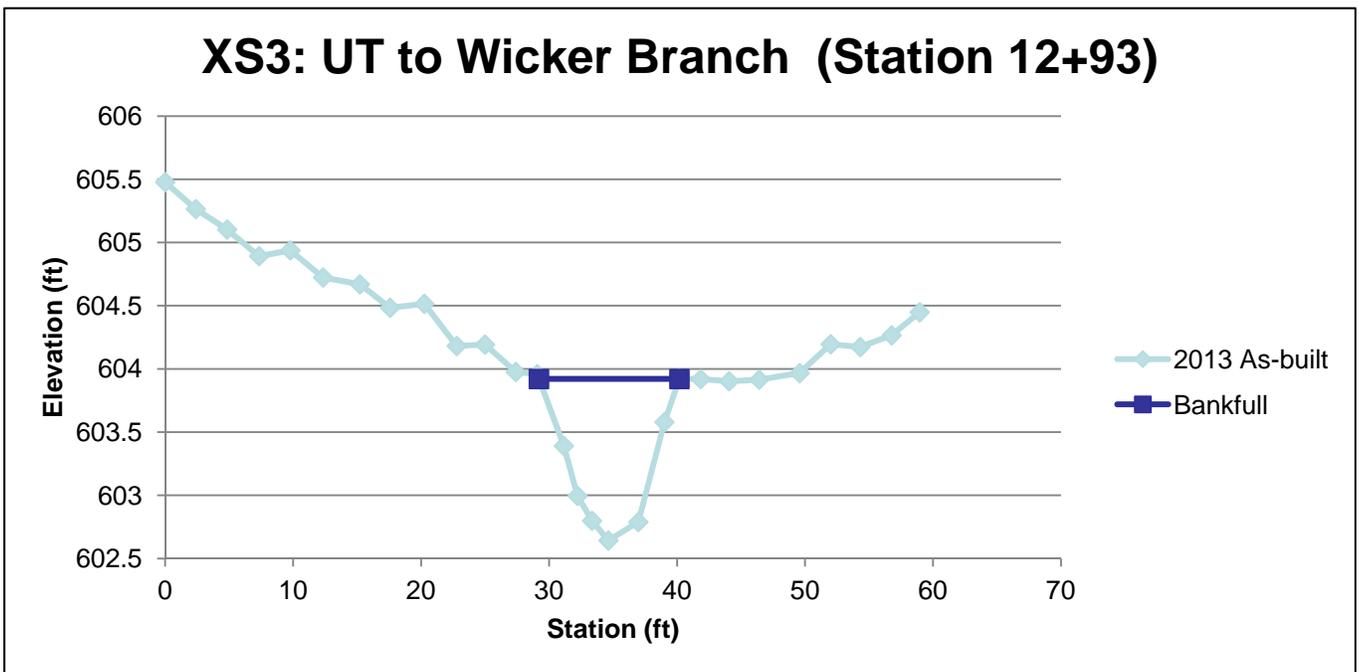
XS3 facing left bank (April 24, 2013)

XS	Stream Reach	Feature	Stream Type	BKF Width	Floodprone Width	BKF Mean Depth	BKF Max Depth	BKF Area	W/D Ratio	ER	BH Ratio
3	UT	Riffle	C4	11.0	65.5	0.8	1.3	8.5	14.1	6.0	1.0

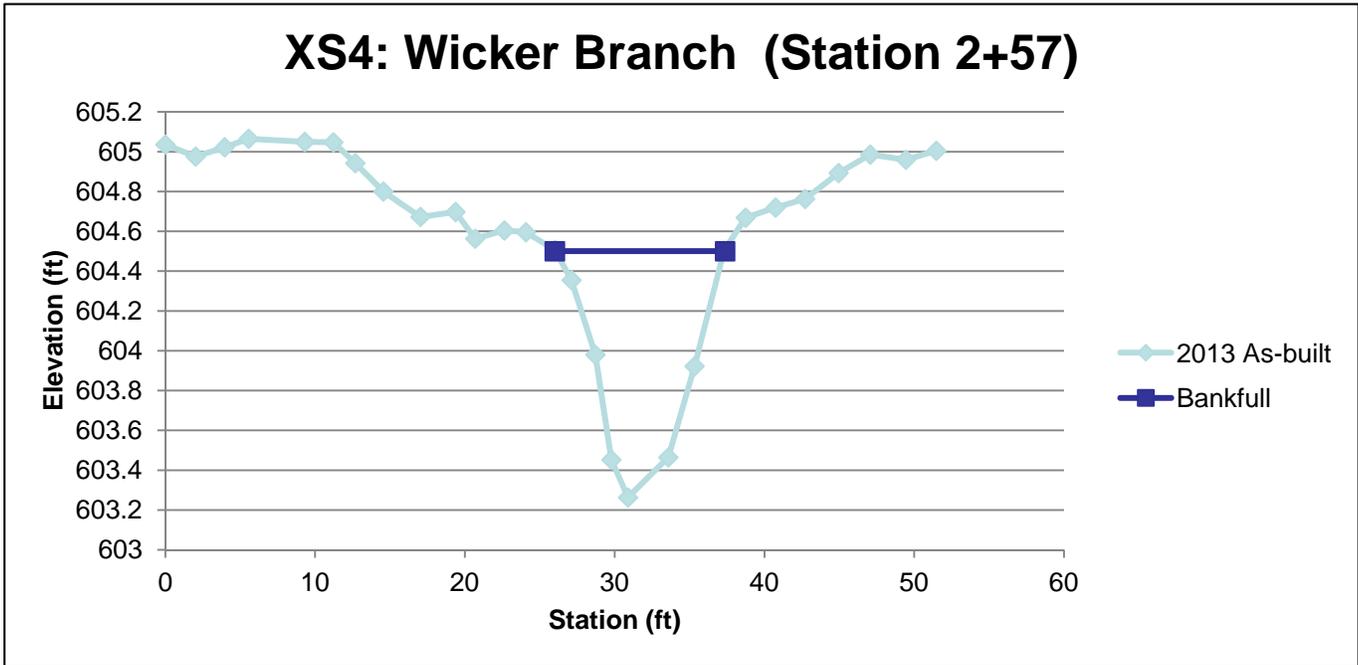
XS4 facing left bank (April 24, 2013)

XS	Stream Reach	Feature	Stream Type	BKF Width	Floodprone Width	BKF Mean Depth	BKF Max Depth	BKF Area	W/D Ratio	ER	BH Ratio
4	Wicker Reach1	Riffle	C4	11.4	59.7	0.7	1.3	7.9	16.6	5.2	1.0

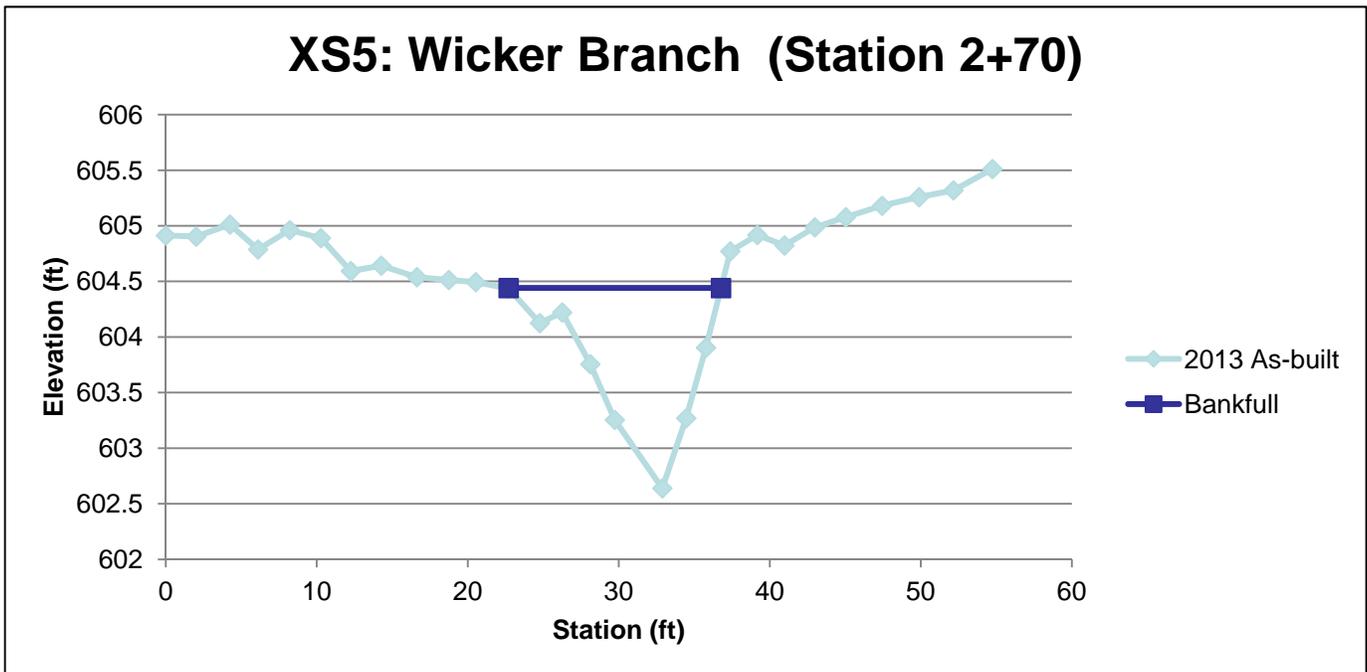
XS5 facing left bank (April 24, 2013)

XS	Stream Reach	Feature	Stream Type	BKF Width	Floodprone Width	BKF Mean Depth	BKF Max Depth	BKF Area	W/D Ratio	ER	BH Ratio
5	Wicker Reach1	Pool	C	14.2	65.6	0.8	1.8	11.5	17.6	4.6	1.0

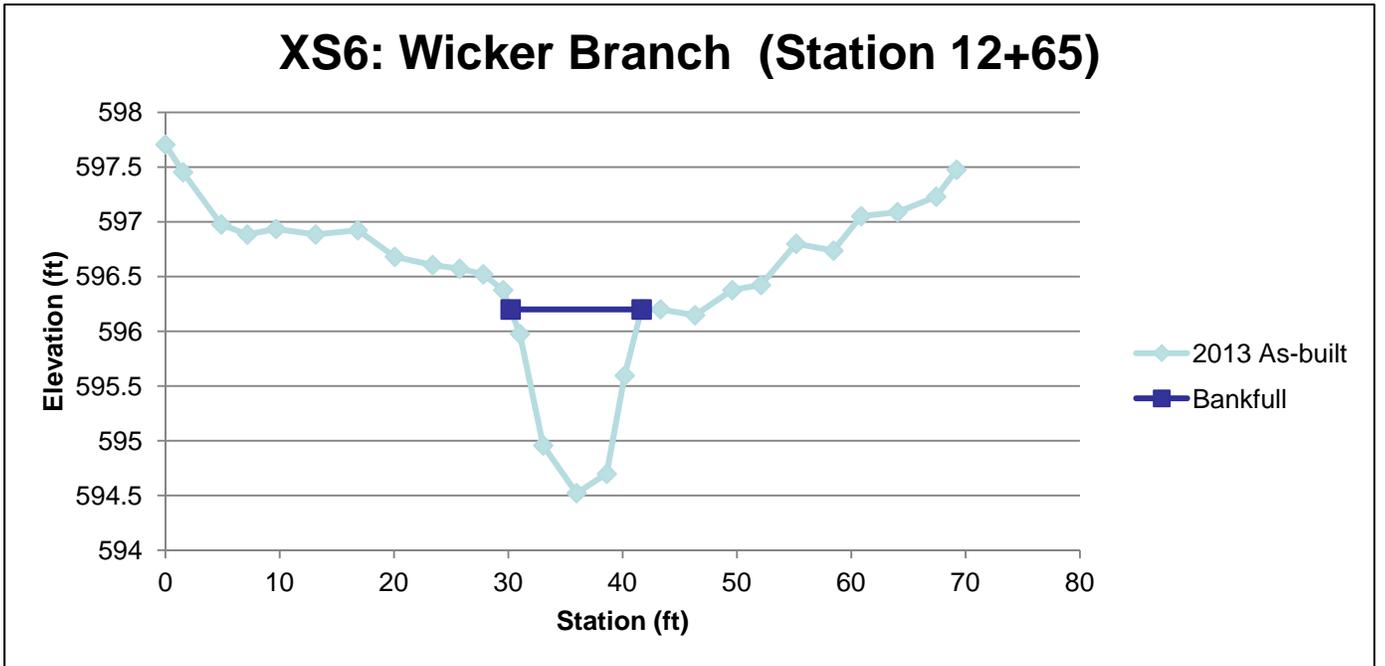
XS6 facing left bank (April 24, 2013)

XS	Stream Reach	Feature	Stream Type	BKF Width	Floodprone Width	BKF Mean Depth	BKF Max Depth	BKF Area	W/D Ratio	ER	BH Ratio
6	Wicker Reach2	Riffle	E4	11.5	69.2	1.1	1.7	12.1	10.8	6.0	1.0

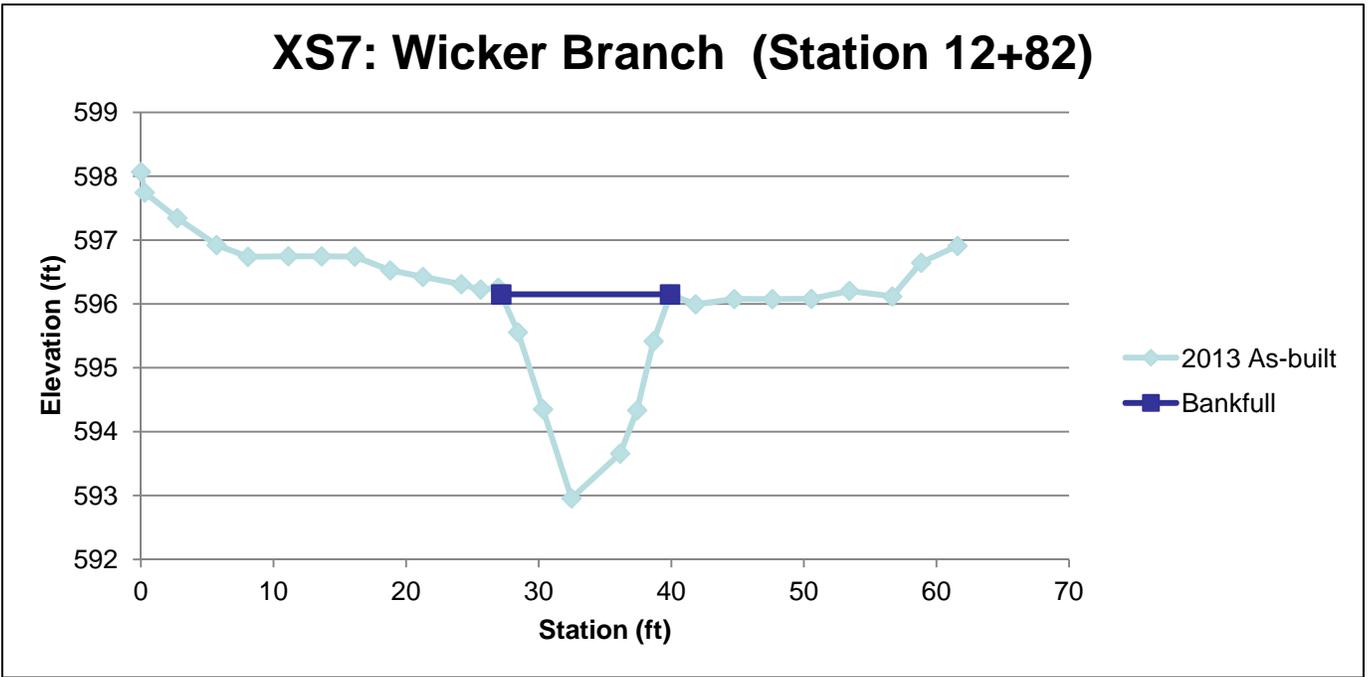
XS7 facing left bank (April 24, 2013)

XS	Stream Reach	Feature	Stream Type	BKF Width	Floodprone Width	BKF Mean Depth	BKF Max Depth	BKF Area	W/D Ratio	ER	BH Ratio
7	Wicker Reach2	Pool	E	12.8	69.5	1.8	3.2	23.2	7.0	5.4	1.0

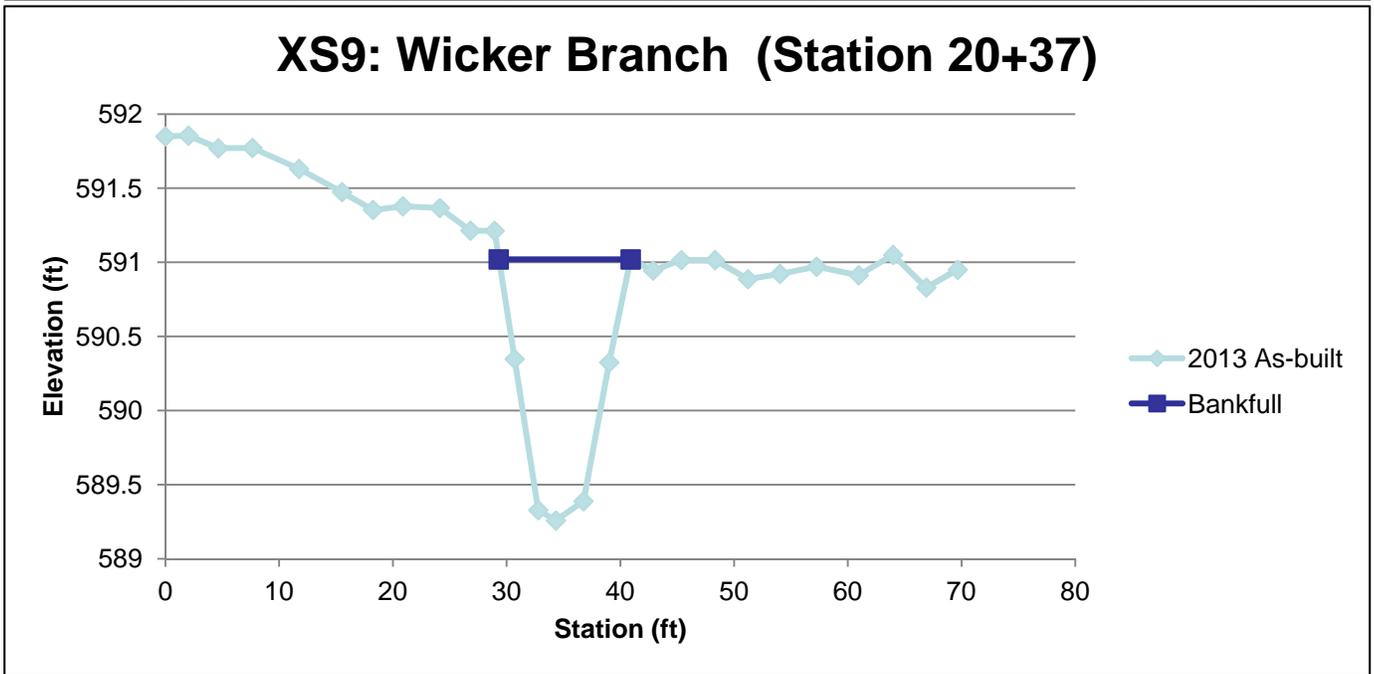
XS9 facing left bank (April 24, 2013)

XS	Stream Reach	Feature	Stream Type	BKF Width	Floodprone Width	BKF Mean Depth	BKF Max Depth	BKF Area	W/D Ratio	ER	BH Ratio
9	Wicker Reach2	Riffle	E4	11.6	69.7	1.1	1.8	13.0	10.4	6.0	1.0
