601 North II Stream Restoration Site

Annual Monitoring Report
NCDMS Project Number: 95025
Monitoring Contract Number: 003991
Monitoring Year 5 2017

**601 North II
Stream Restoration Site
2017 Monitoring Report (MY5)**

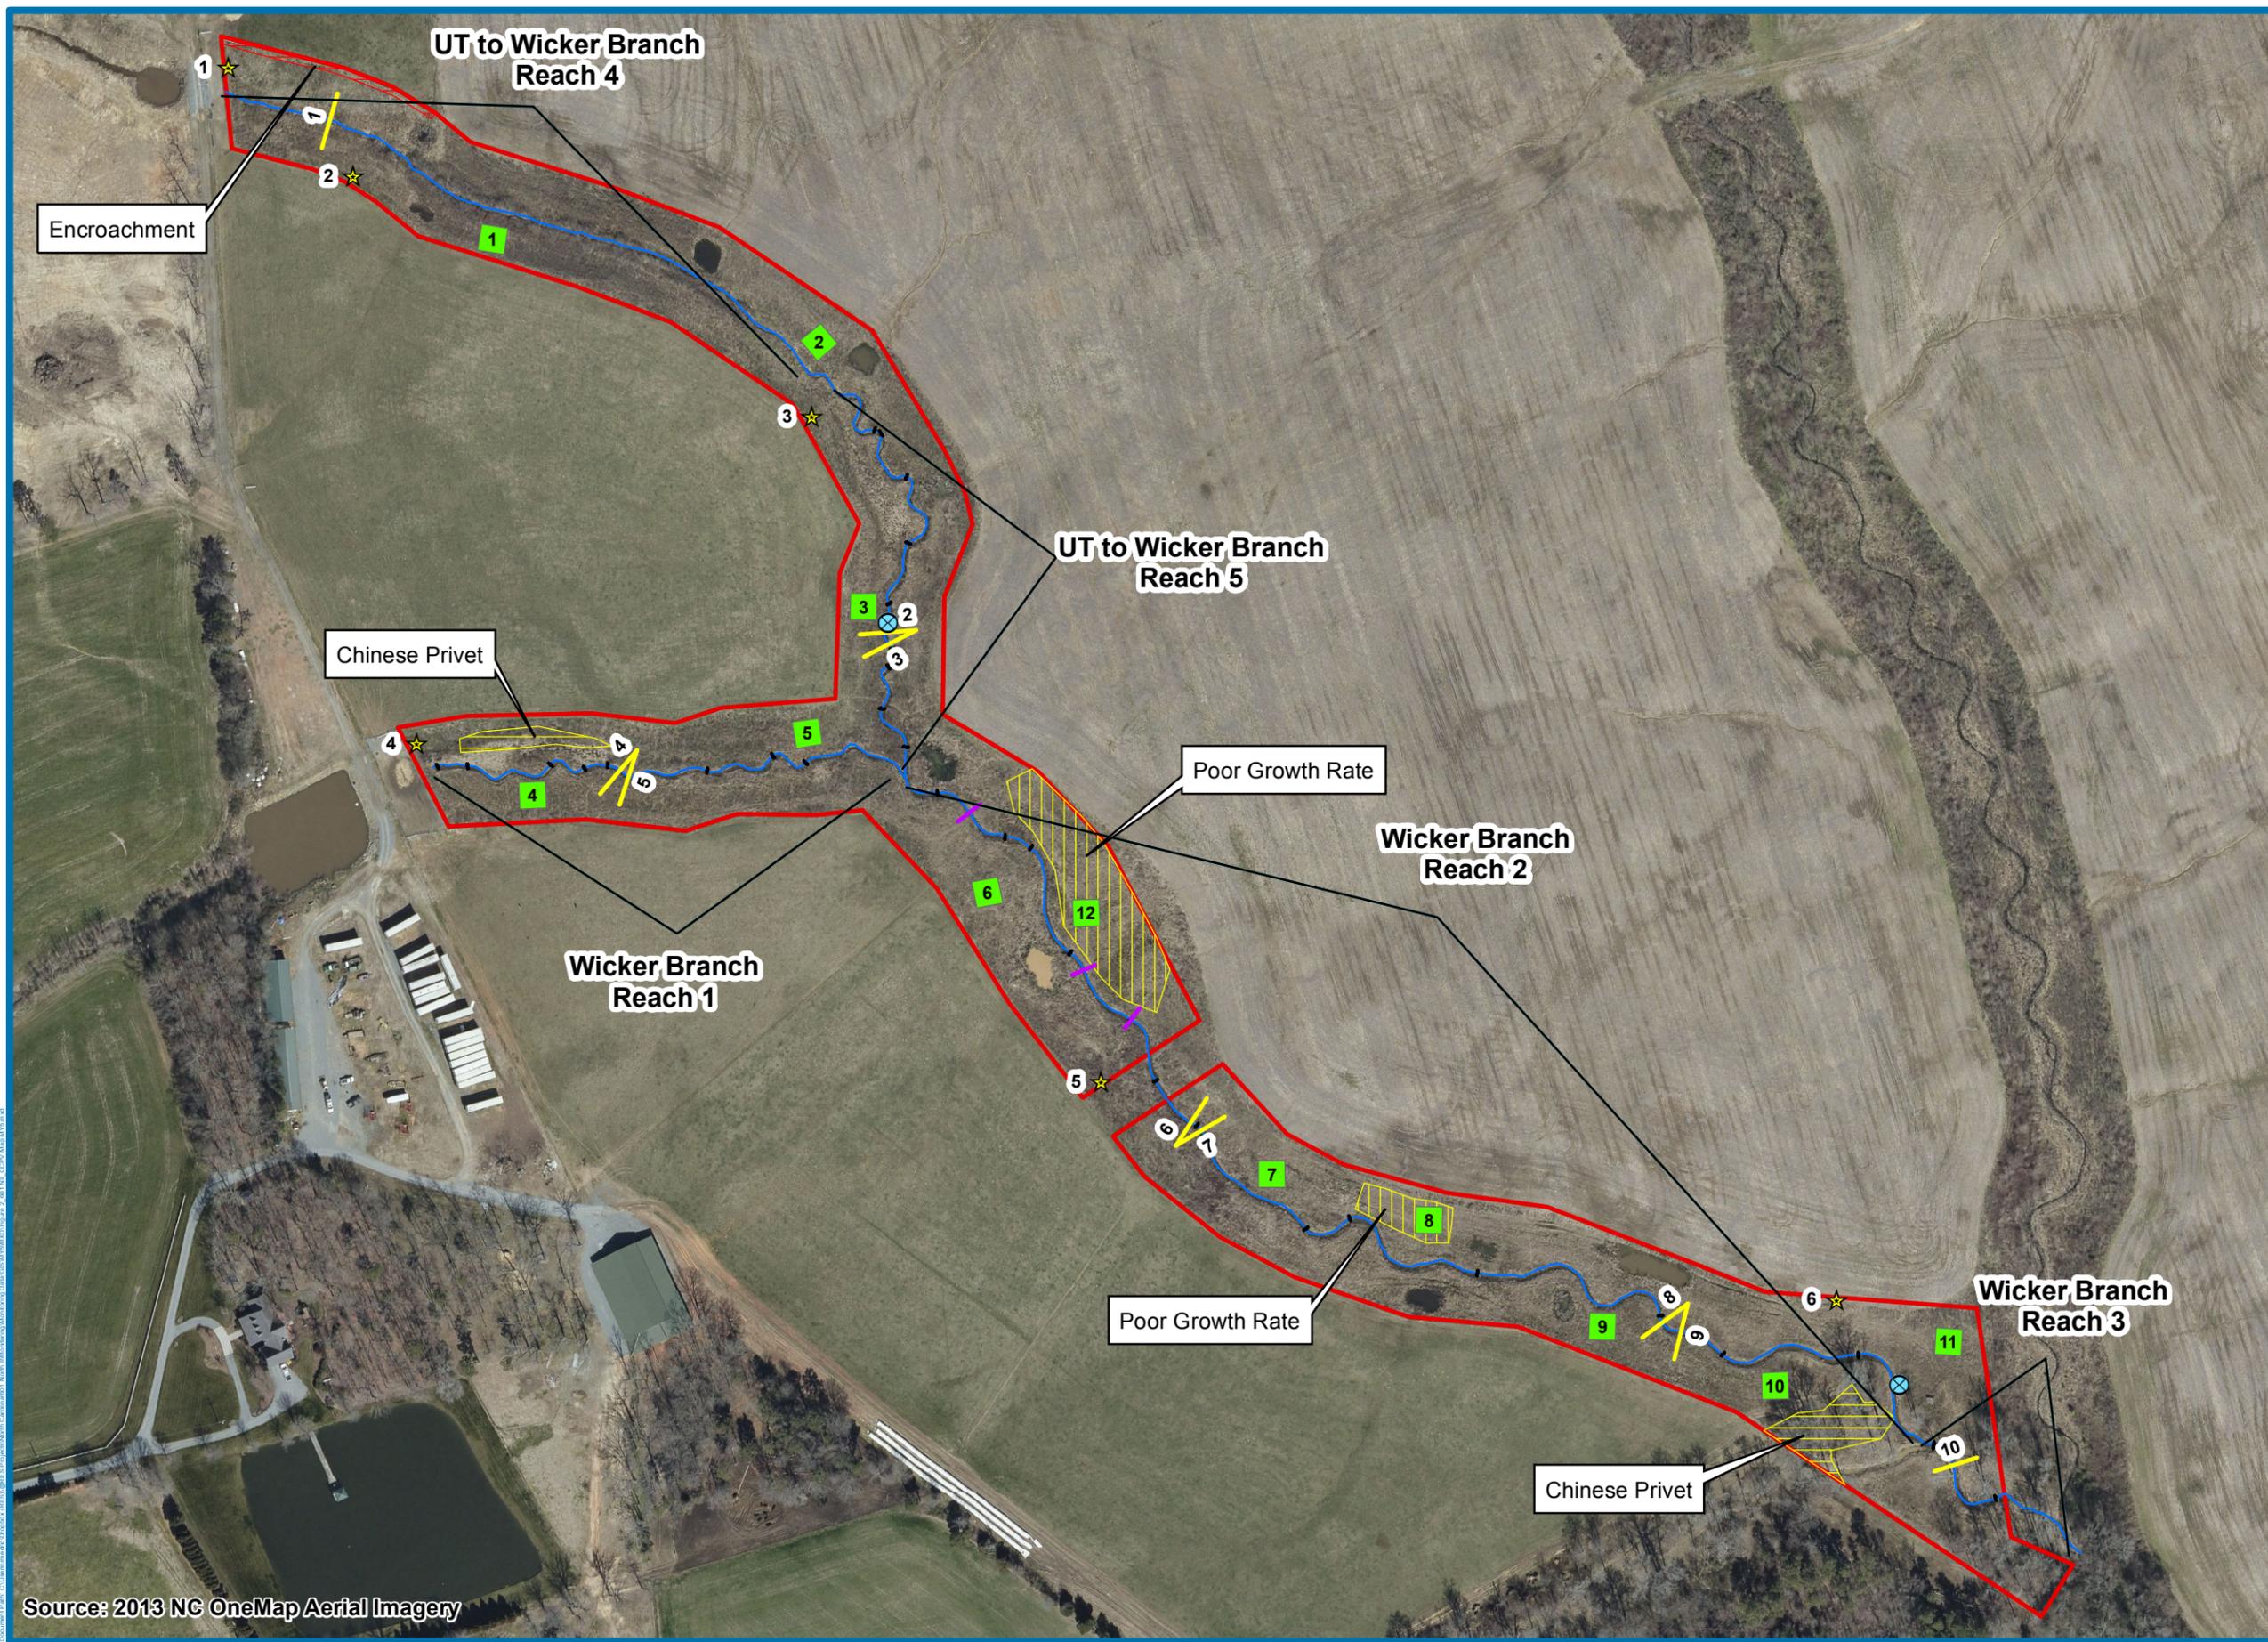
Figure 2. Integrated Current Conditions Plan View

Visual assessment of the easement indicates that herbaceous vegetation has become well established throughout the project. Limited areas of poor growth rates were noted during MY5 (**Figure 2**). These areas were greatly reduced in comparison to MY4. During MY5, a previously identified easement encroachment was observed on Reach 4, between station 0+00 and 1+50 on the LDB. This area consists

of clearing a path along the fence line using mowing and the application of herbicides. RES plans to lock the gate that is being used to access the easement. Then RES will install a new gate outside of the easement to allow the farmer access to the other field without having to cut through the easement. Invasive exotic vegetation (Chinese privet) was noted in two locations totaling 0.26 acres, or 2% of the easement area (**Figure 2 and Table 6**). Previously noted areas of invasive exotic vegetation that was comprised of Japanese honeysuckle was not included in MY5 as the vine was not hindering the growth of any of the planted stems. The Chinese privet will be treated during the upcoming growing season.

RES plans to lock the gate that is being used to access the easement. Then RES will install a new gate outside the of easement to allow the farmer access to the other field without having to cut through the easement.

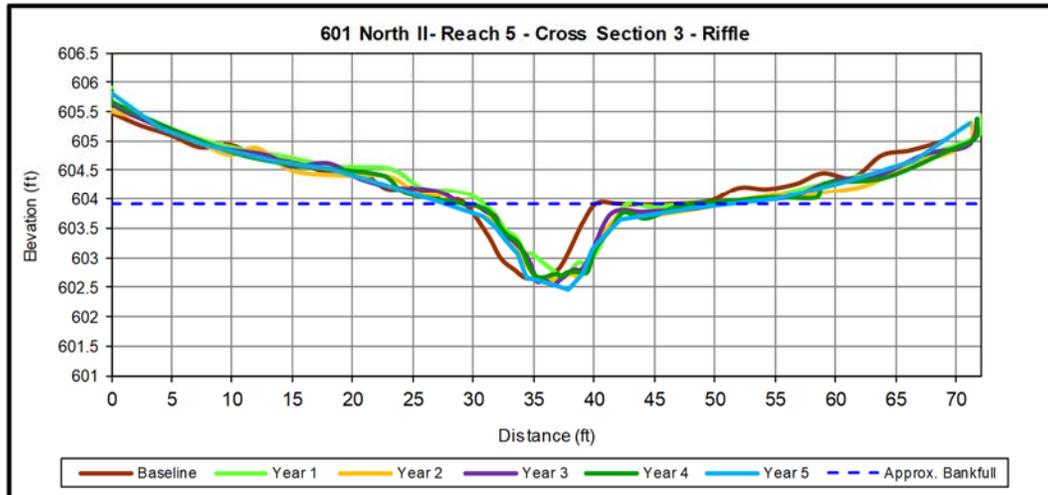
Cross Section 3

BHR for MY5 riffle cross sections has been calculated using the bankfull elevation from baseline. This method was used because the dimension of the channels has not changed enough to alter the bankfull elevation. BHR from previous years was not calculated therefore it is not included. This has been added to the report and as a footnote to Table 11a.

| Cross Section 3 (Riffle) | | | | | | |
|--|---|---|---|---|---|---|
| Bankfull Bank Height Ratio | 1.0 | 1.0 | 1.0 | 1.0 | 1.0 | 0.8 |

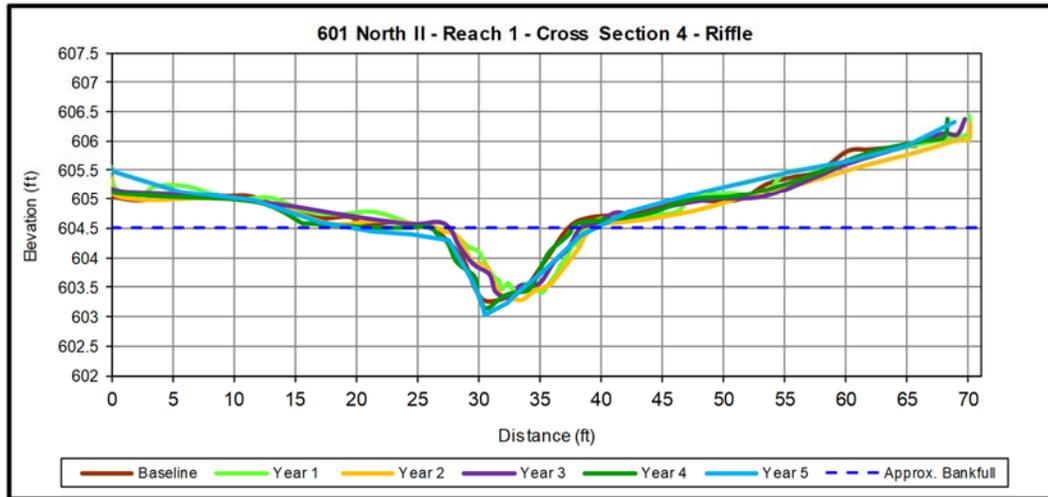
Cross Section 4

| Cross Section 4 (Riffle) | | | | | | |
|--|---|---|---|---|---|---|
| Bankfull Bank Height Ratio | 1.0 | 1.0 | 1.0 | 1.0 | 1.0 | 0.9 |

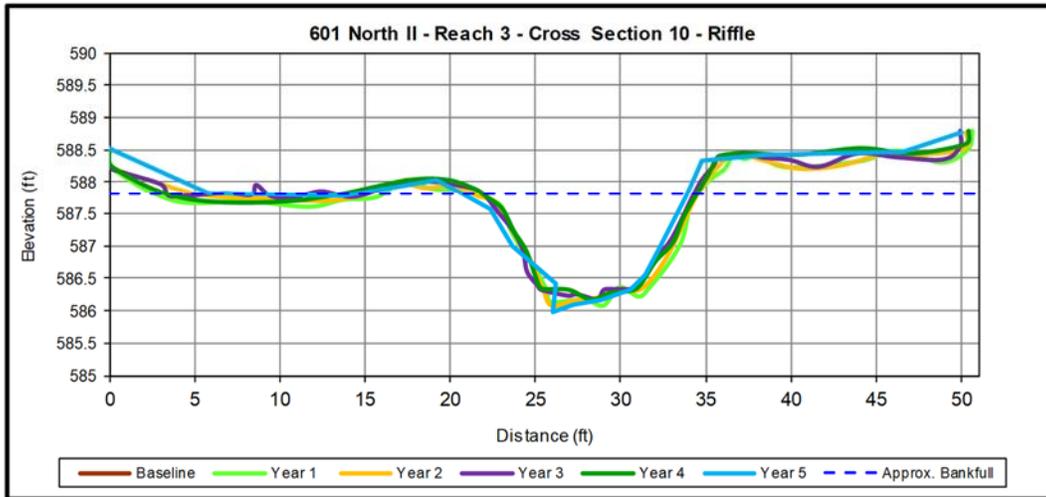
Cross Section 10

| Cross Section 10 (Riffle) | | | | | | |
|--|---|---|---|---|---|---|
| Bankfull Bank Height Ratio | - | 1.0 | 1.0 | 1.0 | 1.0 | 1.1 |

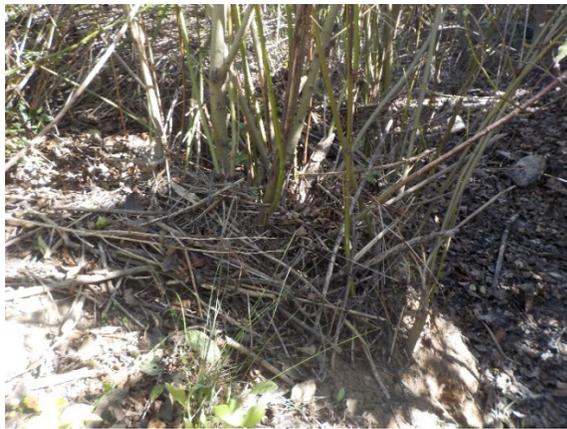
Bankfull events were documented on Reach 2 and Reach 5 in the form of wrack lines (**Table 13**). Both reaches have recorded multiple bankfull events throughout the monitoring period.

Photo 1: Wrack line on Reach 2
(10/18/2017)

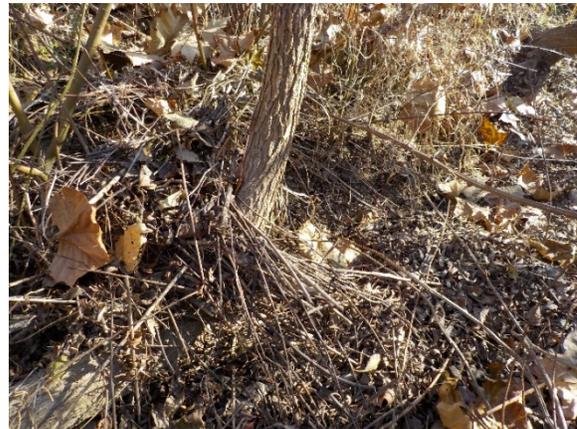
Photo 2: Wrack line on Reach 5
(11/28/2017)
