# ***YEAR 2 MONITORING REPORT***

## **ADKIN BRANCH STREAM RESTORATION PROJECT PHASE 1 – WASHINGTON AVE. TO LINCOLN ST.**

Lenoir County, North Carolina  
EEP IMS No. 7

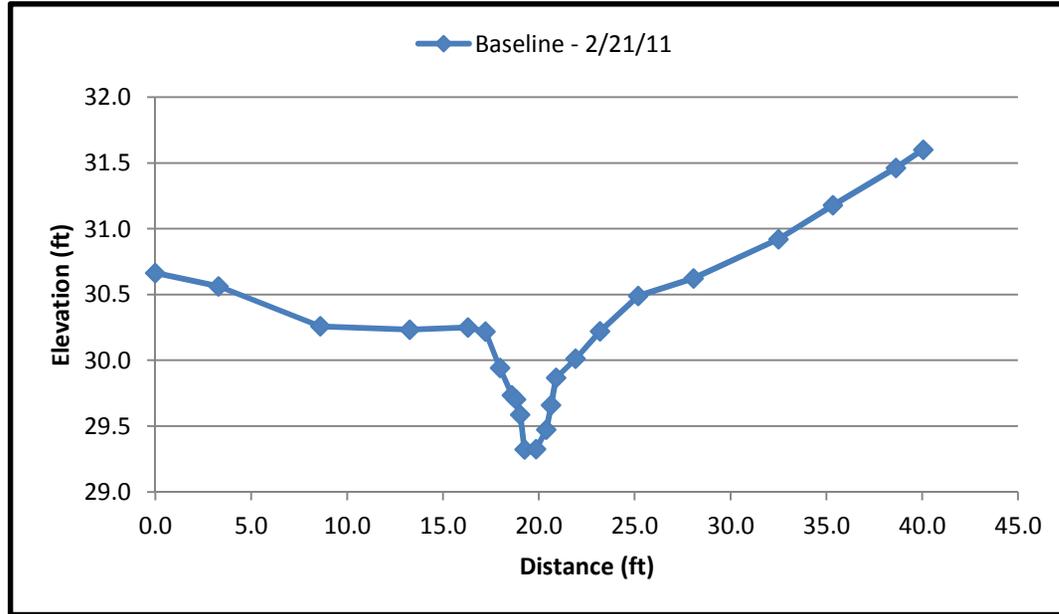
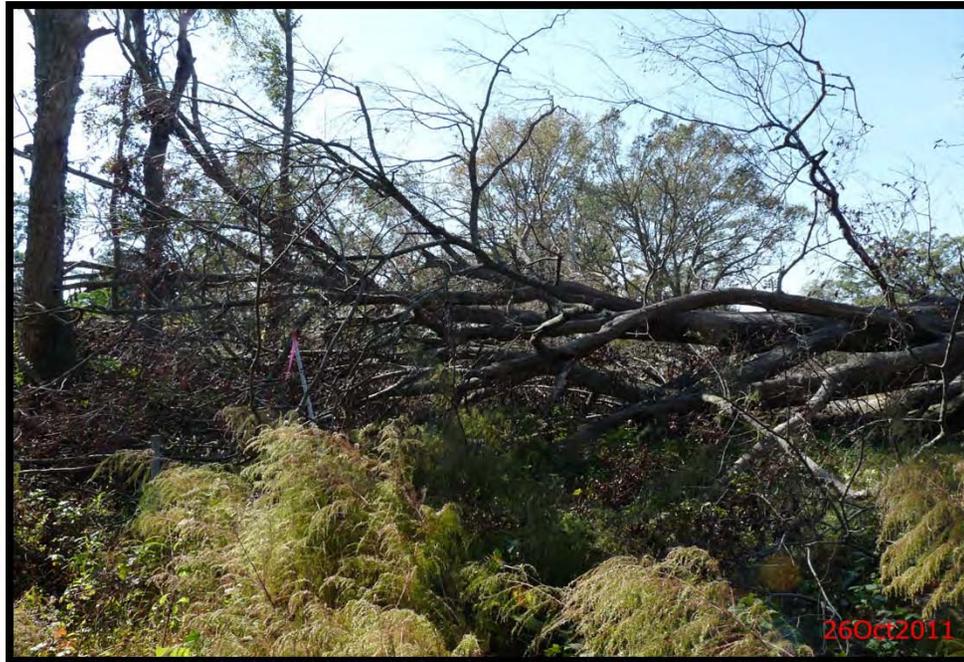
No Data - Fallen Tree over Channel

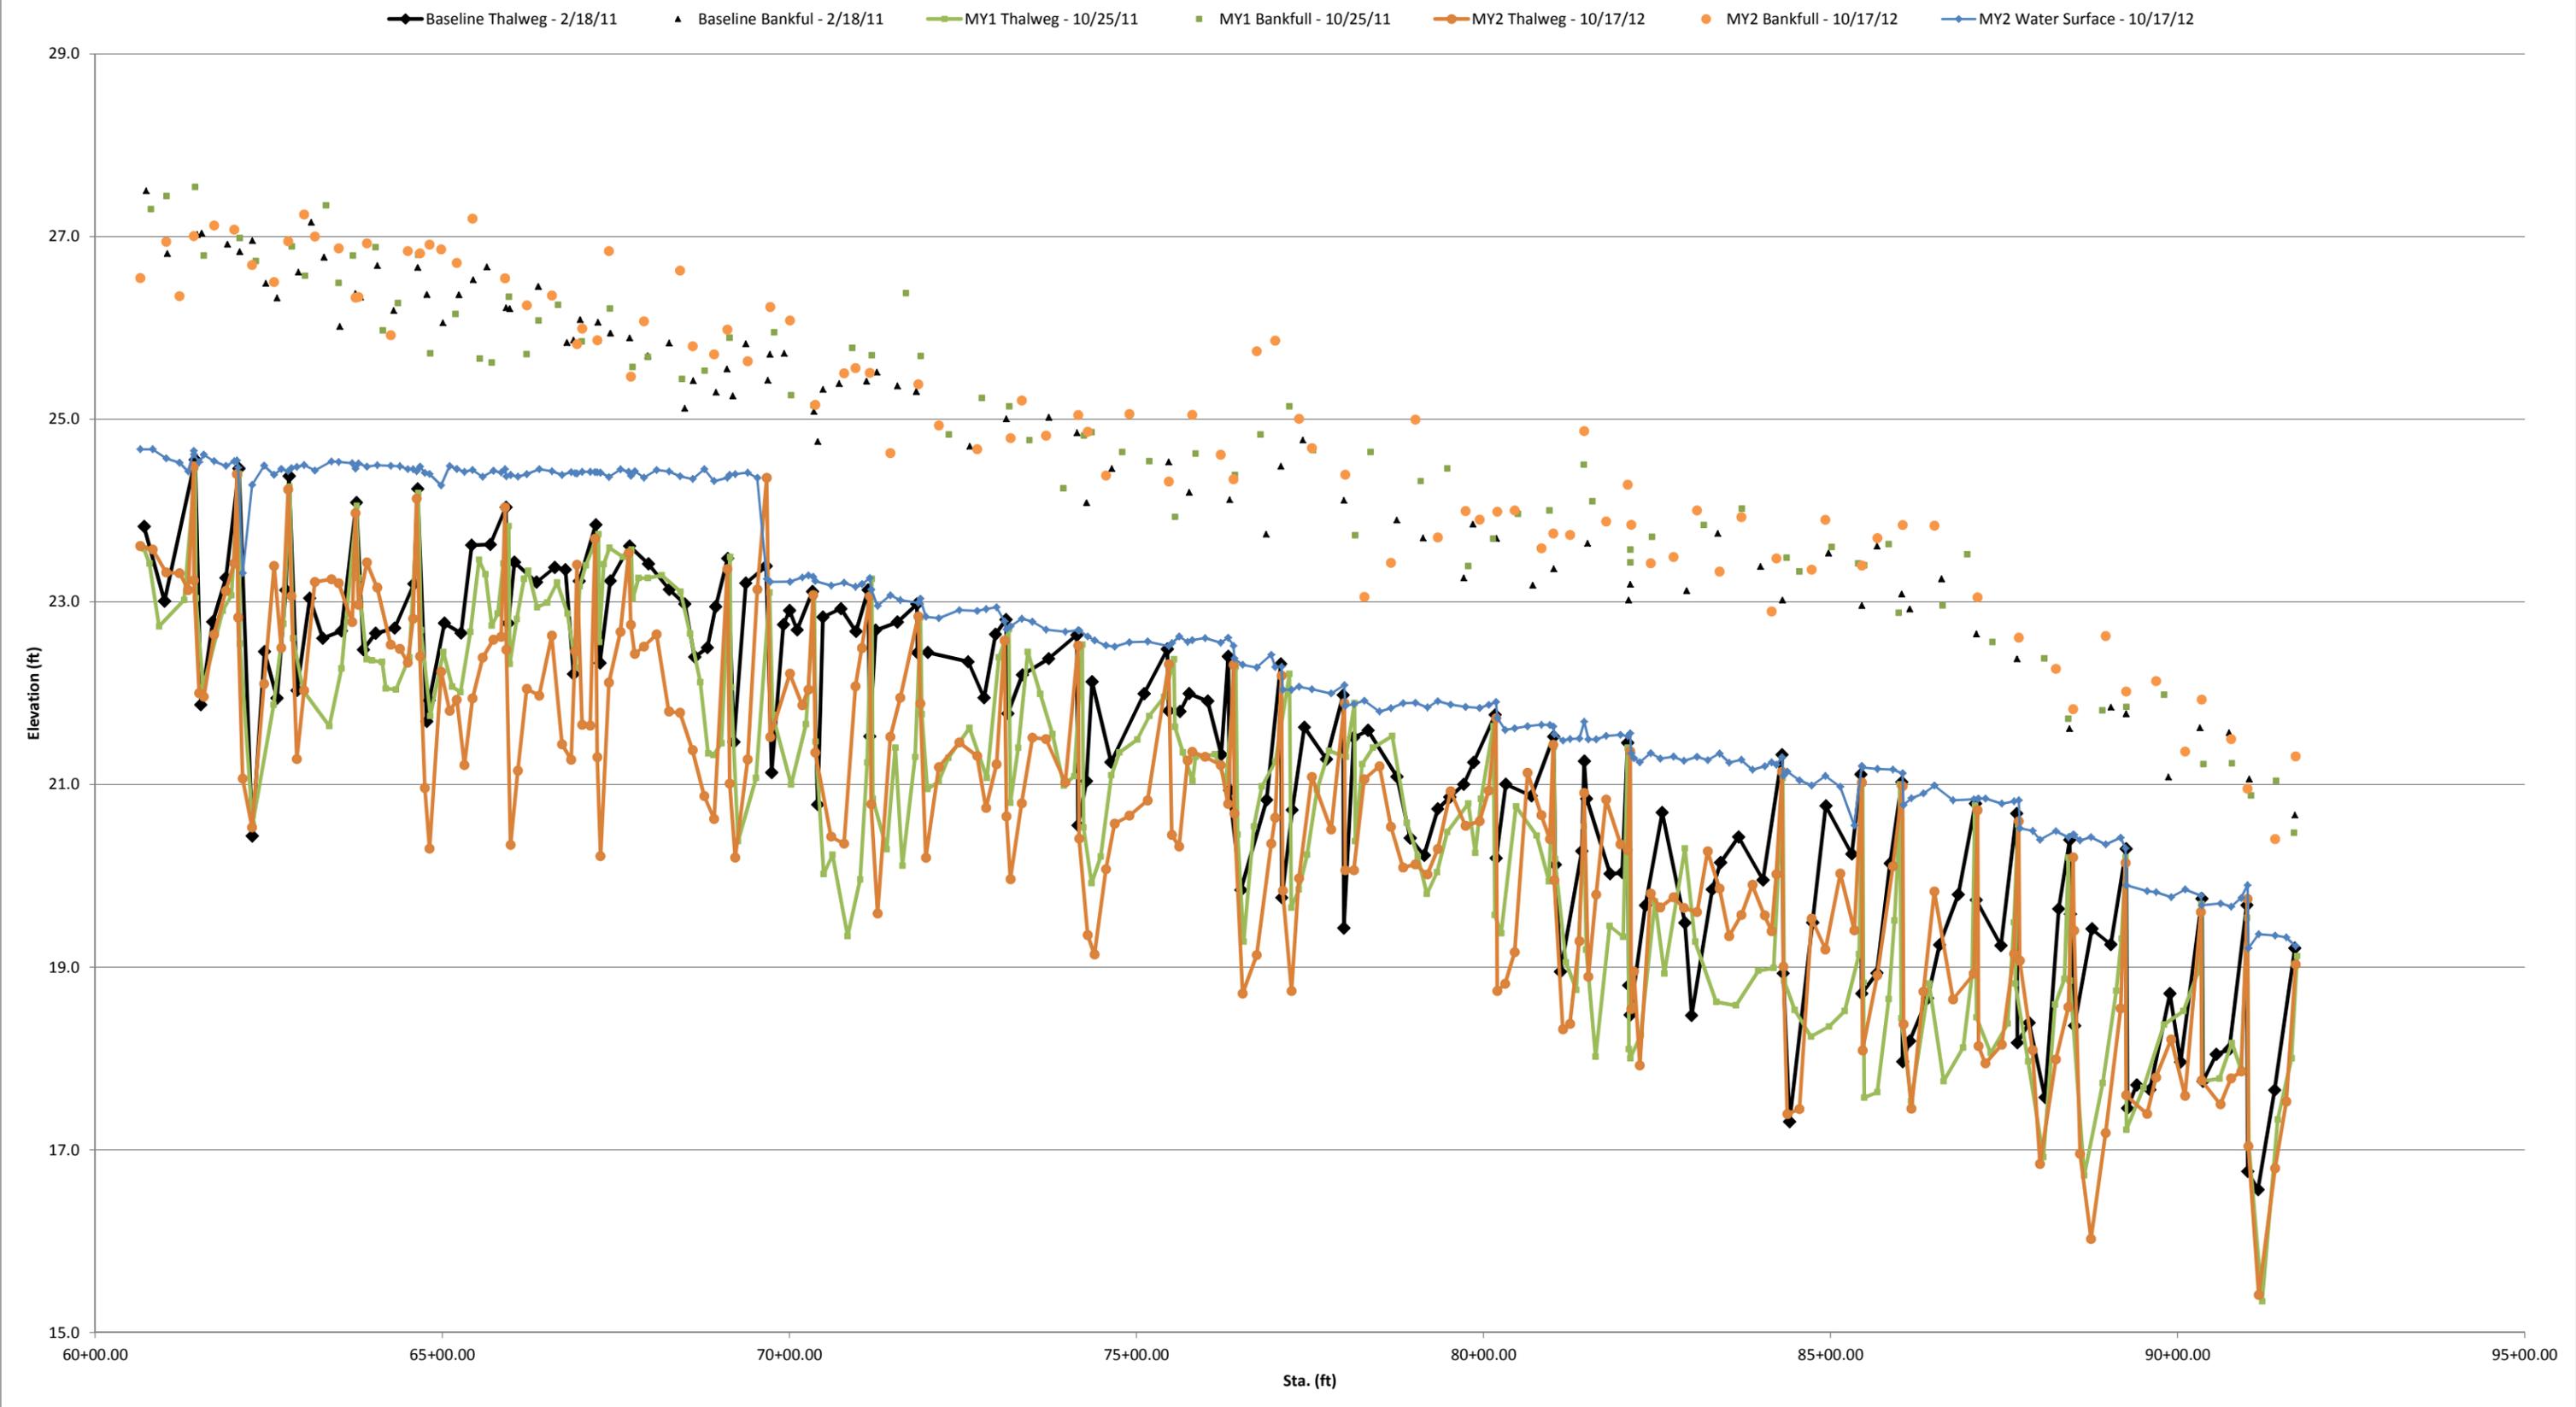
Figure 5.2 Reach 2 (Gordon St. to Lincoln St.) - Longitudinal Profile

Reach 2 contains the majority of problem areas on the Site. Four riffle segments were noted as unstable in Reach 2 as a result of the scour from large storm events, most notably, events associated with Hurricane Irene. Approximately 45 percent of the stream banks in Reach 2 are unstable due to a lack of vegetation. Fifteen bank segments (504 ft) were noted as moderately eroded and 13 bank segments (916 ft) have experienced mass wasting (Figures 3.21-3.25). Two log cross vanes have been compromised in Reach 2 as a result of stream bank erosion around the

vane arms (Figures 3.29 and 3.30). Six log structures are experiencing erosion on greater than 15 percent of the stream banks within their extent of influence. Table 5.2 provides a summary of the unstable sections within Reach 2. A Repair Plan has been developed to correct these problem areas, which includes the use of soil lifts, bank grading, and erosion control matting. The repair plan is expected to be implemented in the Spring of 2013. A beaver dam was observed at Station 69+60 and appears to have formed on top of rip rap that was placed in the channel by local residents. Rip rap was also observed in the channel near station 81+25. The beaver dam and rip rap will be removed when Hurricane Irene repairs are conducted. Problem areas are depicted on the CCPV and photos are presented in Appendix B.

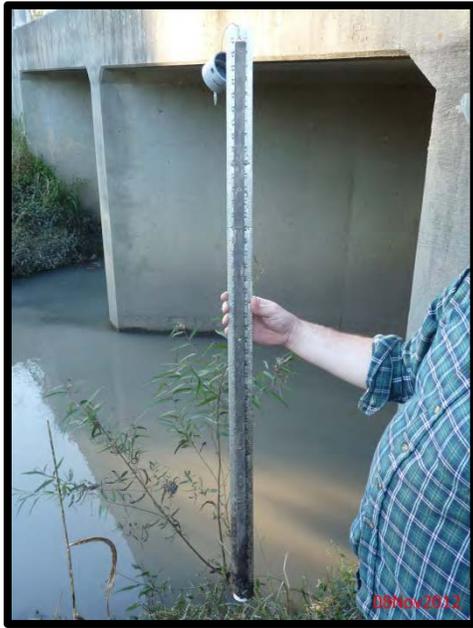
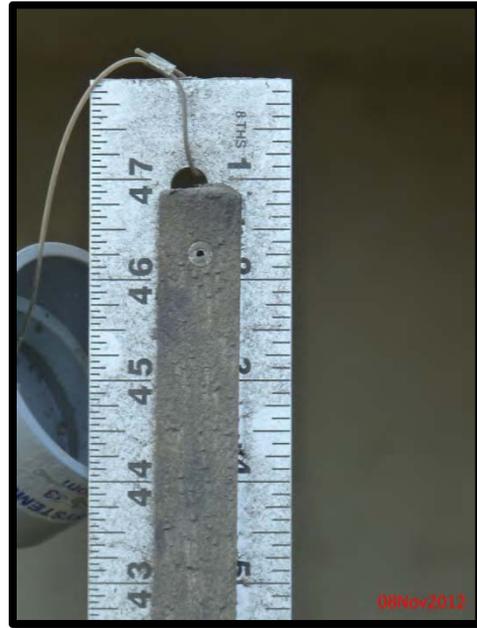
**Figures 6.1 & 6.2 Crest Gauge Photos**

Crest gauges installed on-site were inspected in October and November 2011. Crest Gauge 2 near station 75+25 was damaged during Hurricane Irene, but was reinstalled on November 8, 2012. The remaining crest gauges revealed that a bankfull event occurred at least once during 2012 (Table 13). Additional overbank evidence includes debris lines, and vegetation bent in the downstream direction. Evidence of bankfull events can be found in Appendix E.
