YEAR 3 MONITORING REPORT

ADKIN BRANCH STREAM RESTORATION PROJECT PHASE 1 – WASHINGTON AVE. TO LINCOLN ST.

Lenoir County, North Carolina
EEP IMS No. 7

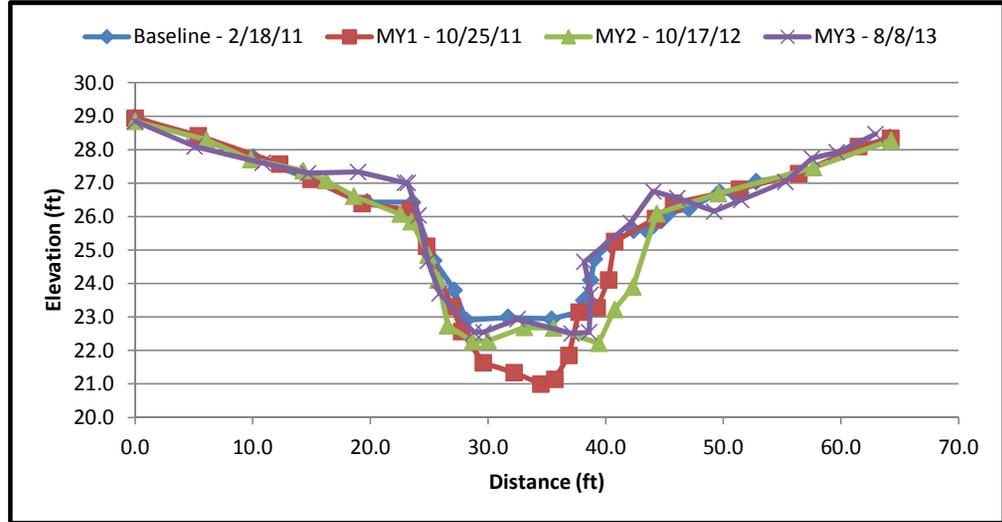
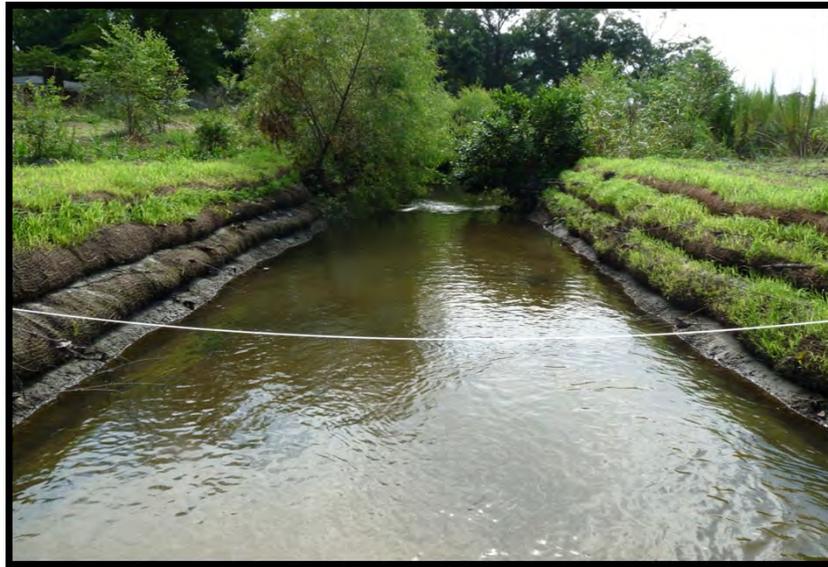
Baseline		MY1		MY2		MY3	
	Sta.	Elev.	Sta.	Elev.	Sta.	Elev.	Sta.	Elev.
XS-7 Riffle, Sta. 70+00	0.00	28.97	0.00	28.94	0.00	28.84	0.00	28.84
	10.03	27.78	5.37	28.42	6.08	28.29	5.07	28.09

throughout the upcoming monitoring periods to determine whether the condition necessitates repair in the future. Cross section 7 displays changes in geometry due to the installation of soil lifts as part of the Hurricane Irene repair plan. The repaired banks shown now for Year 3 have been restored to the geometry recorded in the baseline report.

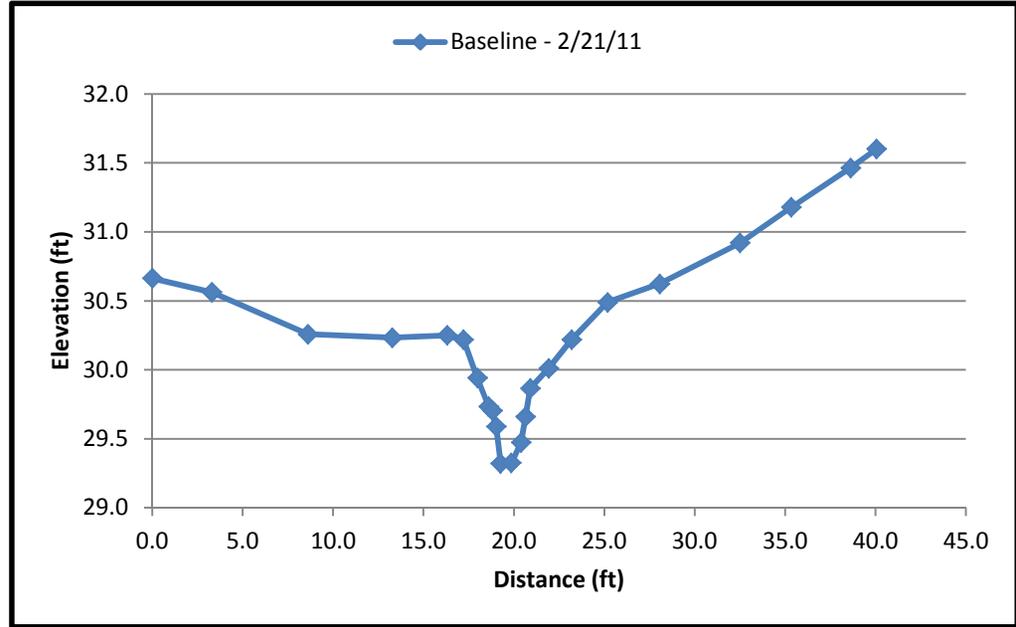
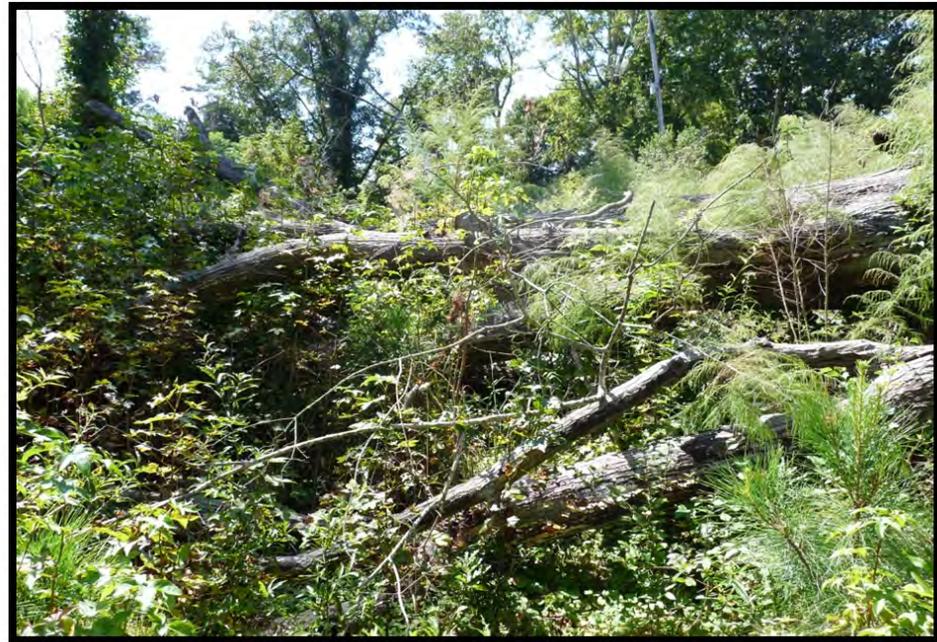
No Data - Fallen Tree over Channel

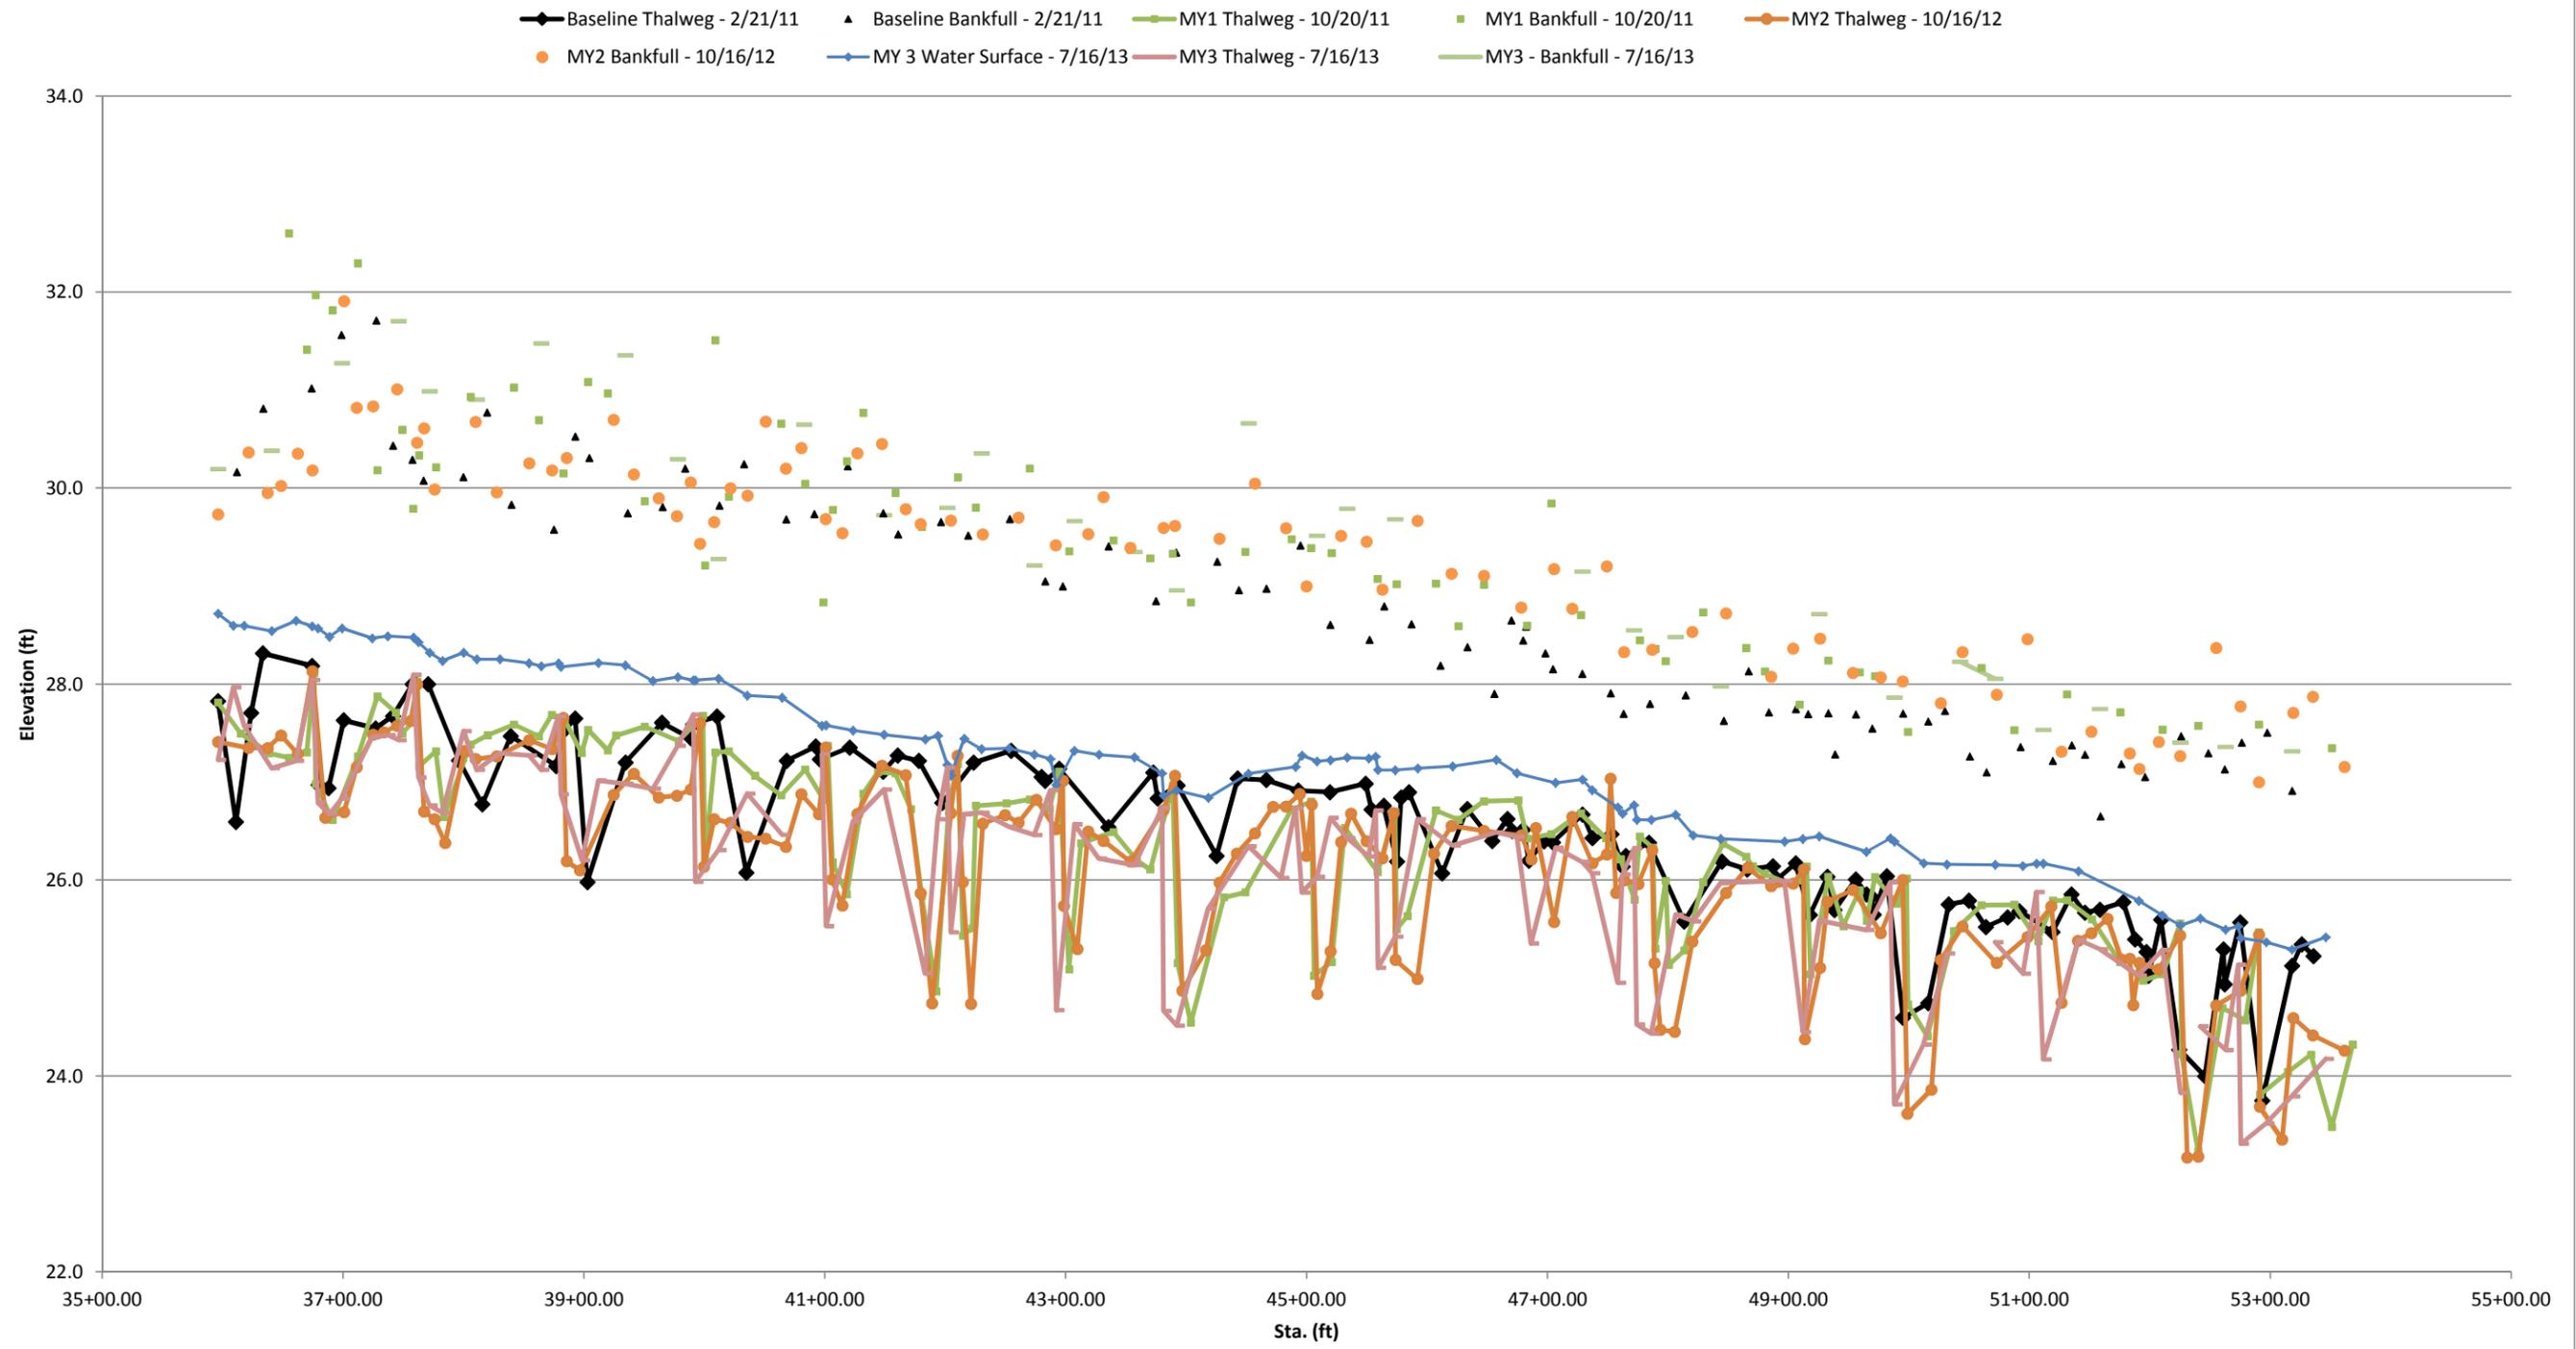
Figure 5.1 Reach 1 (Washington Ave. to Gordon St.) - Longitudinal Profile

Reach 1: Significant stream bed scour was observed from station 41+00 to 46+00. This scour likely occurred during the storm events associated with Hurricane Irene in late August, 2011. Several of the existing pools deepened and/or lengthened as a result of the storm events, but the log structures maintained grade control and the overall stability of the channel was not compromised. Only minor shifting of pools and riffles was observed throughout the remainder of the profile, which is expected in a sand bed system. The majority of stream banks and structures throughout the project were stable and functioning as intended. There was no evidence of trends

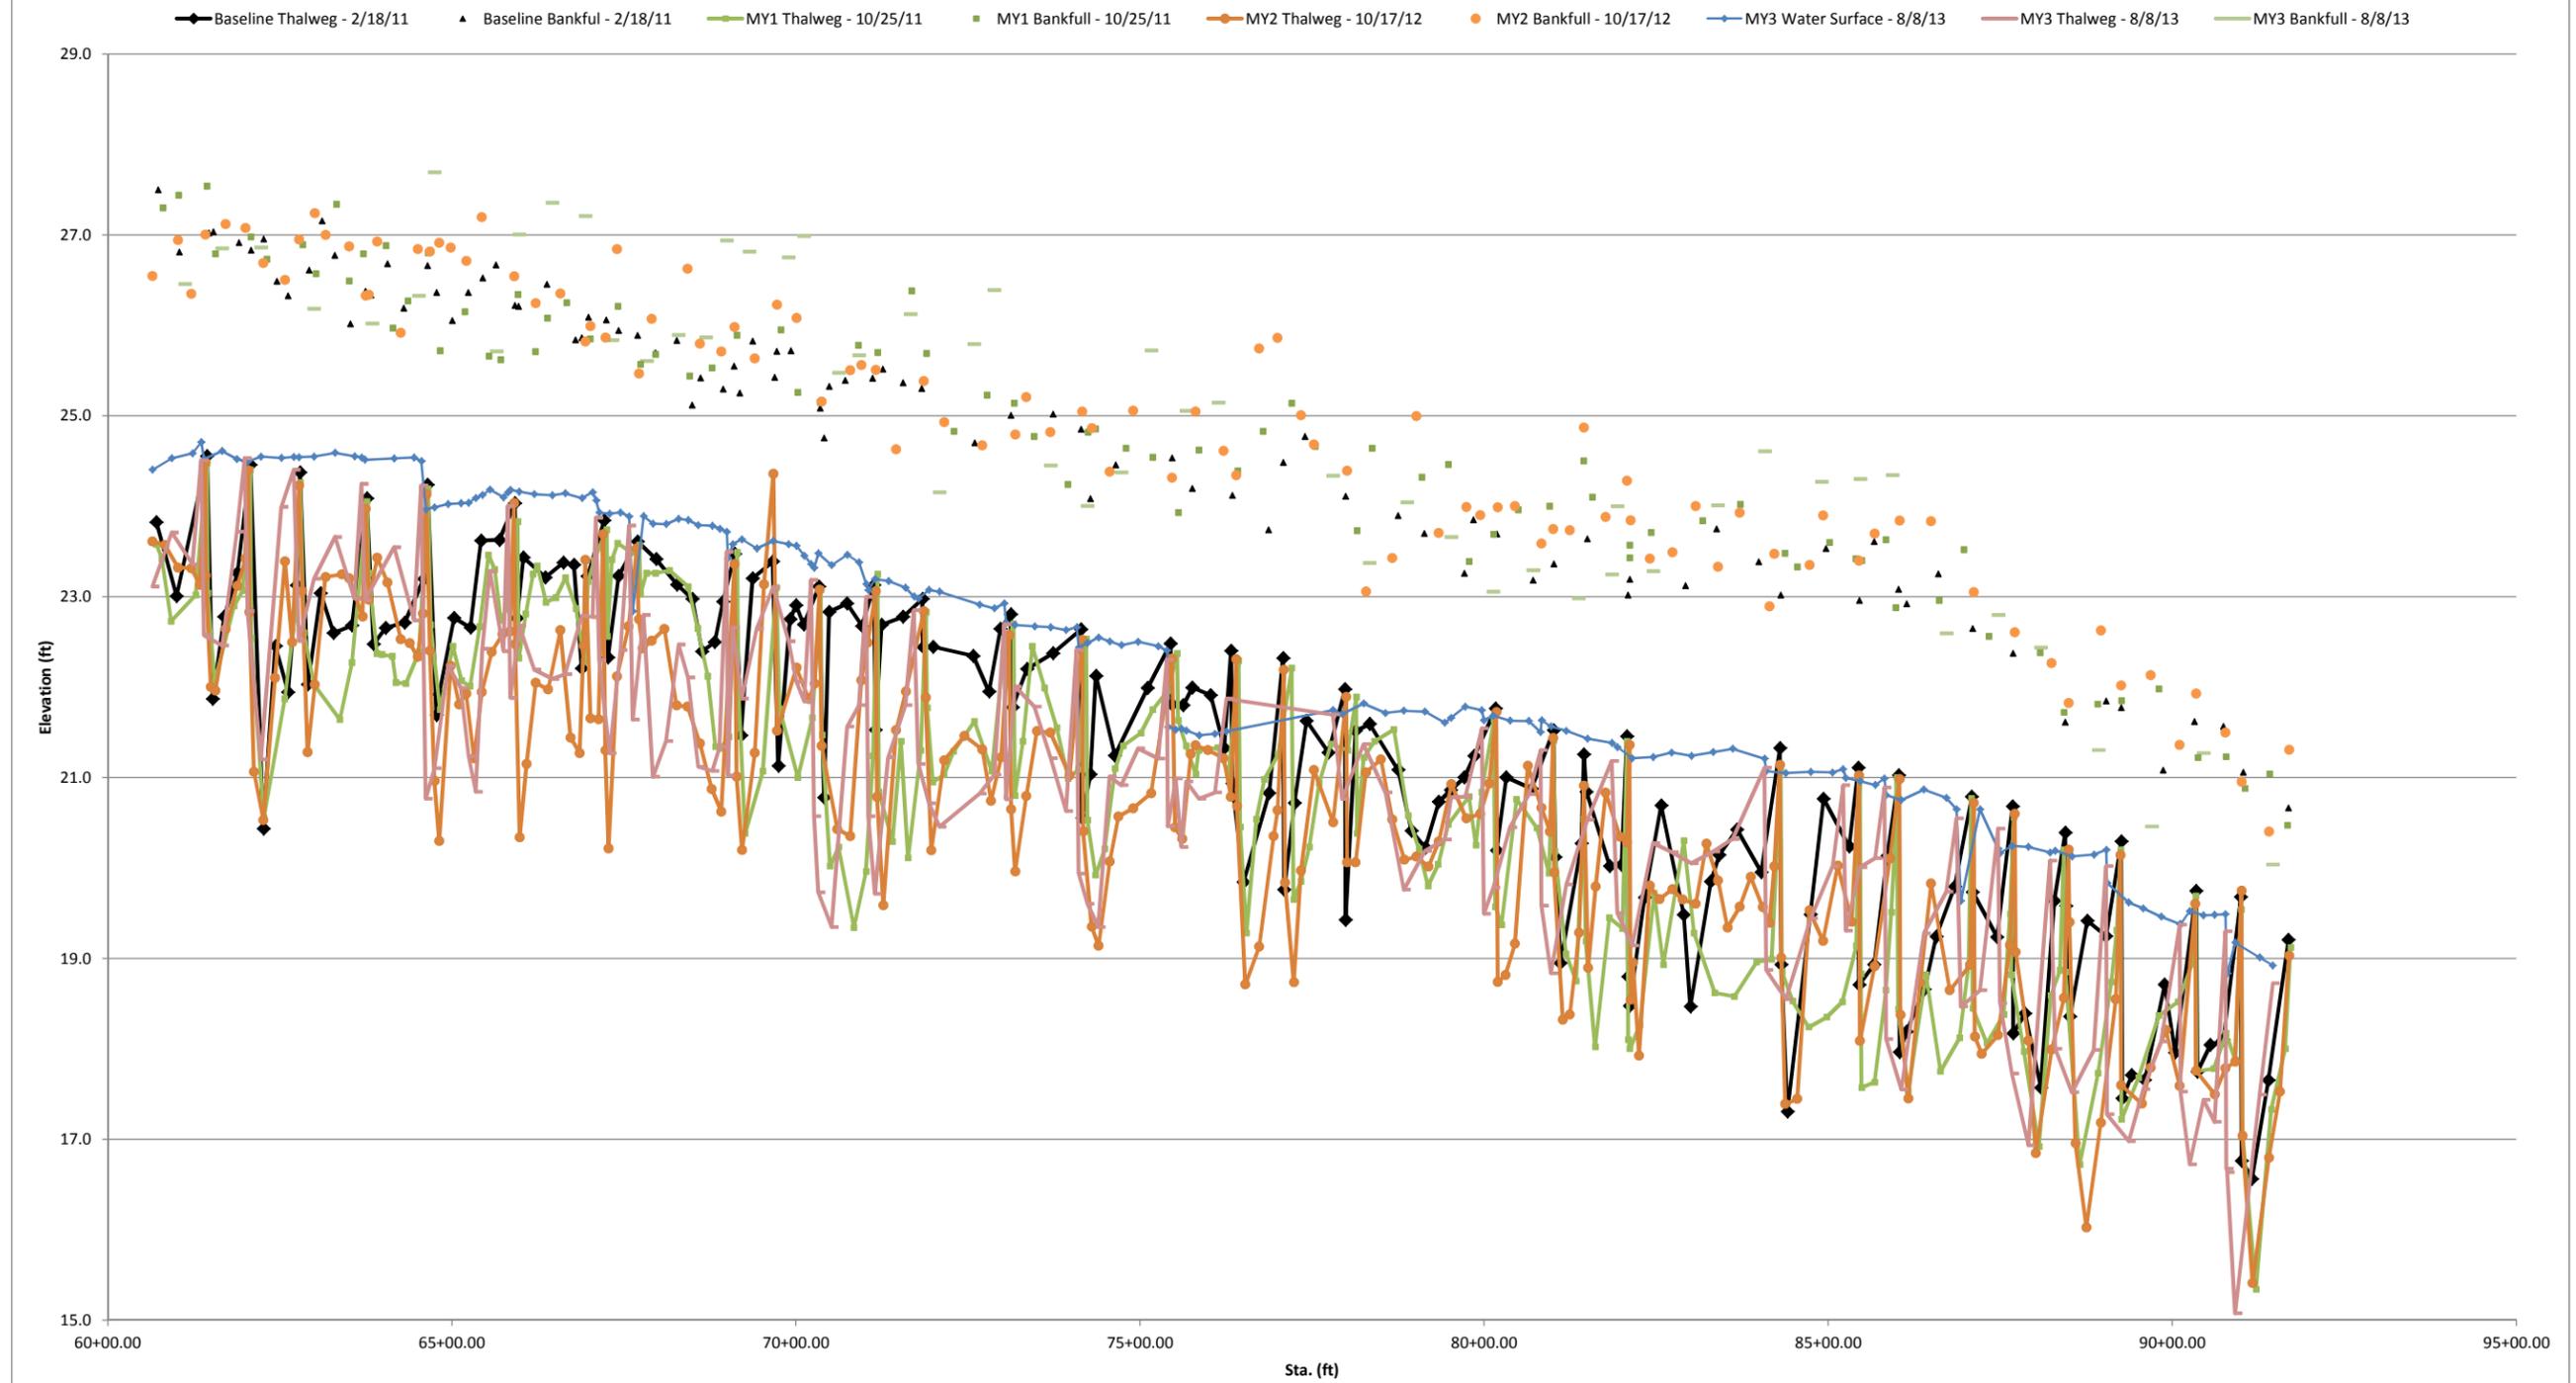
Figure 5.2 Reach 2 (Gordon St. to Lincoln St.) - Longitudinal Profile

Reach 2: The profile along Reach 2 provides evidence of the fluctuating nature of a sand bed system. Some pools became deeper and longer while others filled in and shortened. In general, the unstable sections of Reach 2 that were documented in the Year 2 Monitoring Report have been repaired as part of construction activities completed in September of 2013. The majority of the plans consisted of installed soil lifts along eroded banks, which are now shown in the CCPV. Fluctuation in channel bed features is expected to continue throughout the monitoring period, but the overall stream reach should stabilize once woody vegetation establishes along the stream banks.

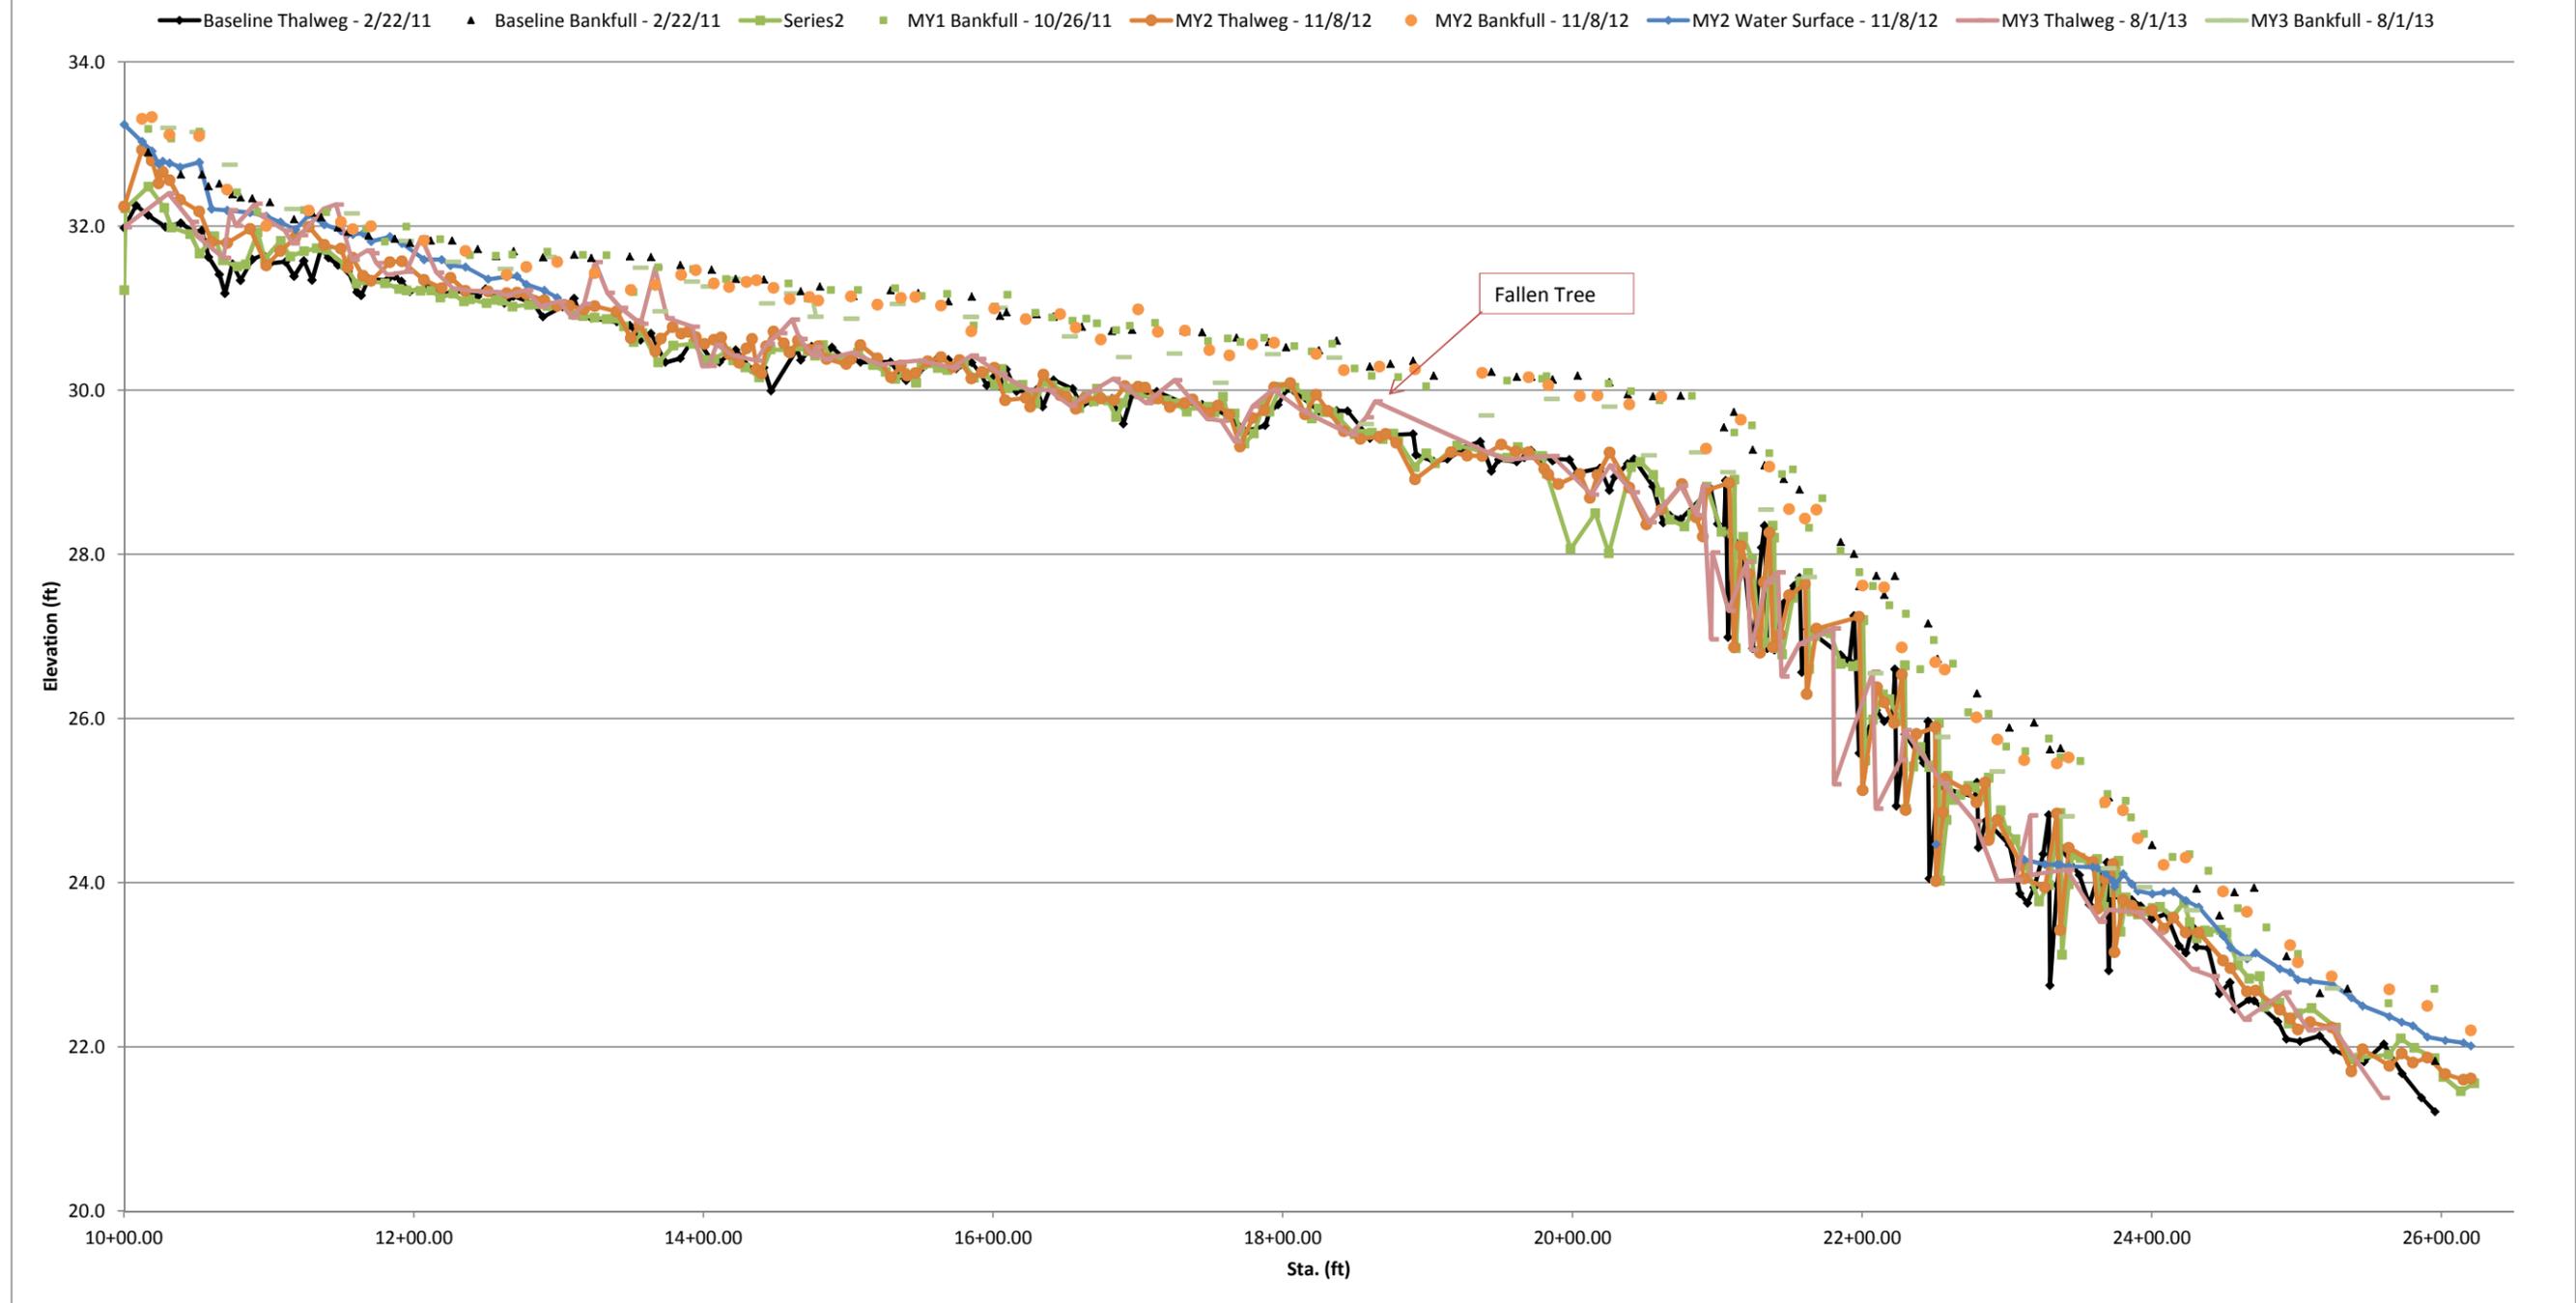
Figure 5.3 Reach 3 (UT to Adkin Branch) - Longitudinal Profile

Reach 3: Reach 3 experienced aggradation between Stations 10+00 and 12+35 due to dense herbaceous vegetation forming in the channel and trapping sediment. However, the stream remains stable and flood waters are accessing the adjacent stormwater wetlands as intended. Only minor shifting of pools and riffles was observed throughout the remainder of the profile, which is expected in a sand bed system. The majority of stream banks and structures throughout the project were stable and functioning as intended. There was no evidence of trends toward significant change in channel pattern. Cross sectional data indicated that the channel width to depth ratio was lowering as the channel matures.
