# **Beaver Creek Stream Restoration Monitoring Report**

**DMS Project # 028**

**Monitoring Year: 2016**

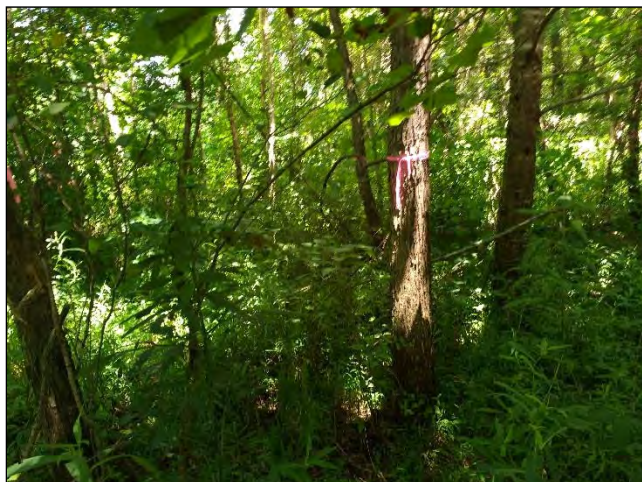
Plot 4 Photo. MY05 – 7/1/2016

| <b>Table 7. Vegetation Plot Criteria Attainment</b> | |
|---|---|
| 4 | No |

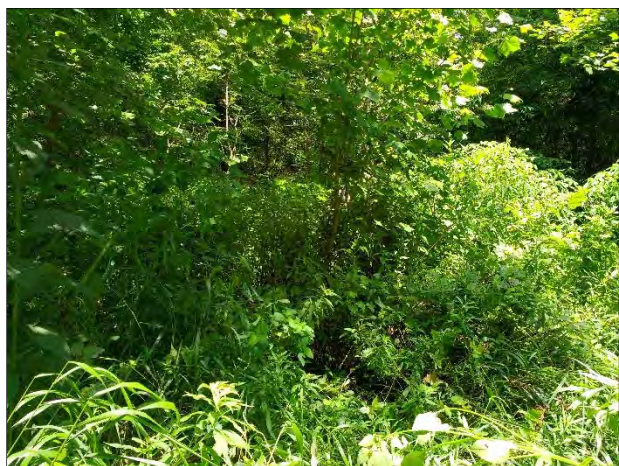
Plot 15 Photo. MY05 – 7/1/2016

| <b>Table 7. Vegetation Plot Criteria Attainment</b> | |
|---|---|
| 15 | No |

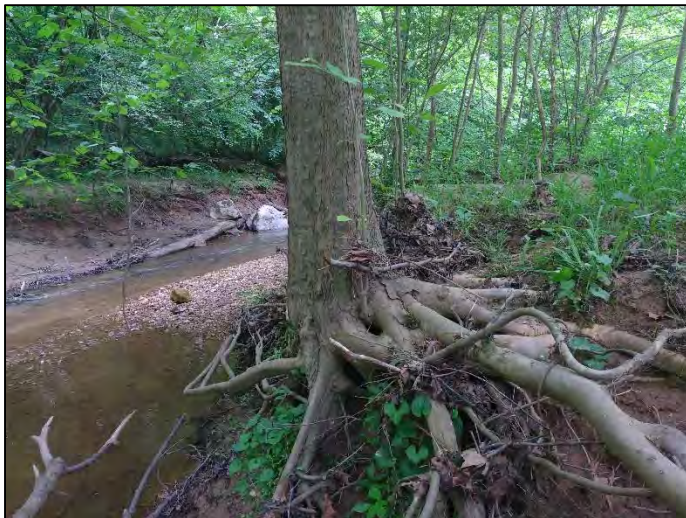
Photo 1. Wrack lines at bankfull

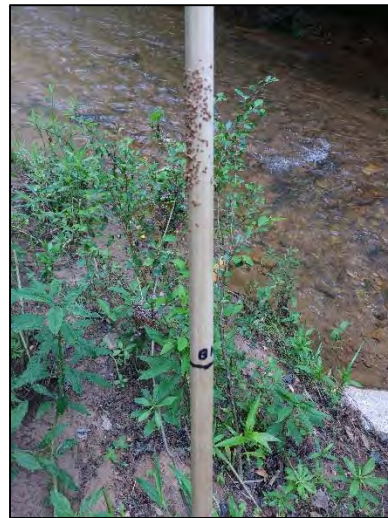
Photo 2. Crest gauge showing a bankfull event
