**Paschal Golf Course (Richland Creek)  
Stream Restoration Site  
Final Baseline Monitoring Report Addendum  
Project # 276  
SCO# 02-05911-02A  
Wake County, North Carolina**

**Submitted: May 2016**

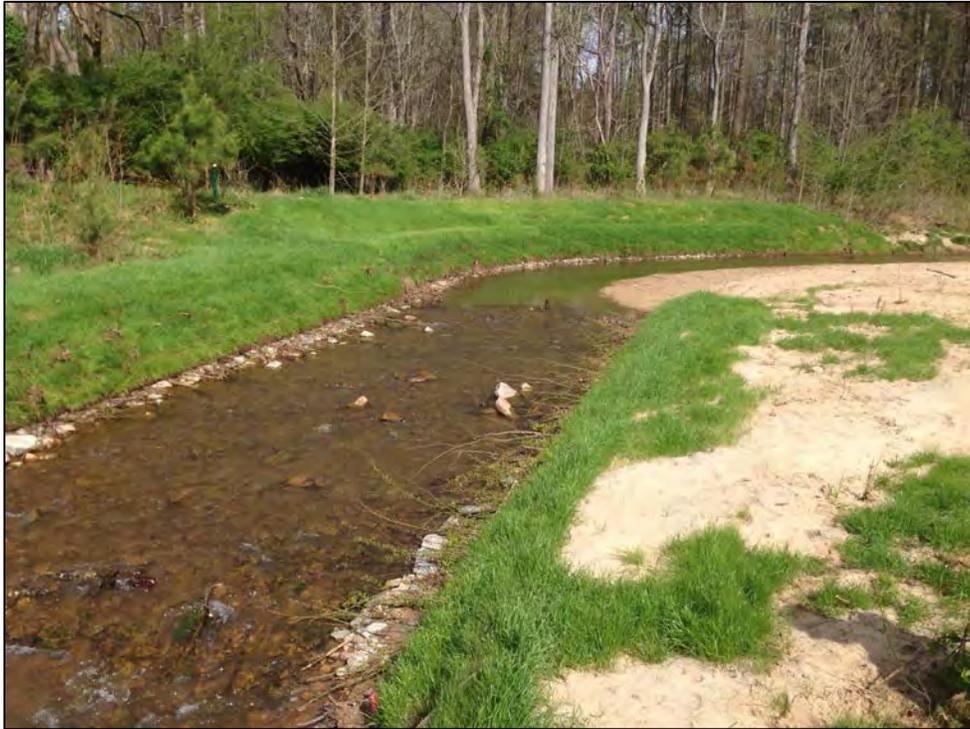
Area 1 consisted of an actively eroding outer bank. The bank had eroded through the bench and was eroding the terrace. Additionally, a mid-channel bar had formed in this location, which split the flow and caused additional erosion along the right bank of the downstream riffle. This was fixed by building vegetated soil lifts on a stone foundation along the outer bank, grading the inner bank back, and developing a new pool. The bank was built out towards the channel, but not as far as the original bank. This structure was tied to a downstream constructed riffle with adjacent soil lifts.

3/31/2016 – Repair Area 1. Looking upstream at the vegetated soil lifts on the outer bank in the background and the constructed riffle with vegetated soil lifts in the foreground.

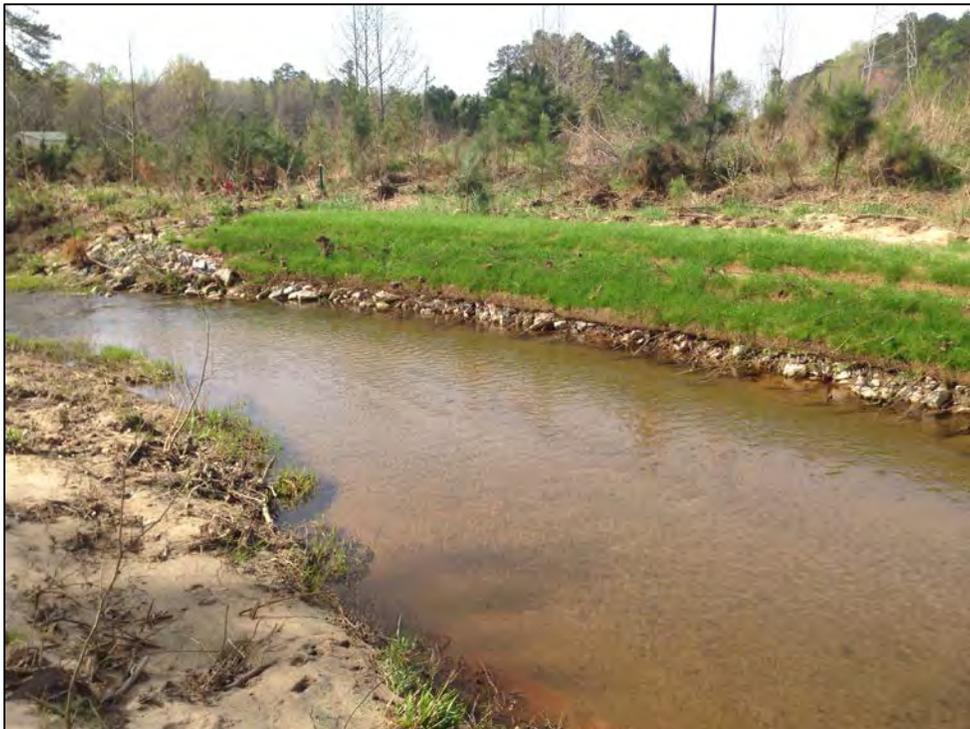
Area 2 also focused on an eroding outer bank. Unlike Repair Area 1, the erosion had not cut back to the terrace and there were no problems with deposition in this area. A vegetated soil lift with a stone foundation was installed in this location.

3/31/2016 – Repair Area 2. Looking downstream at the vegetated soil lifts on the outer bank.

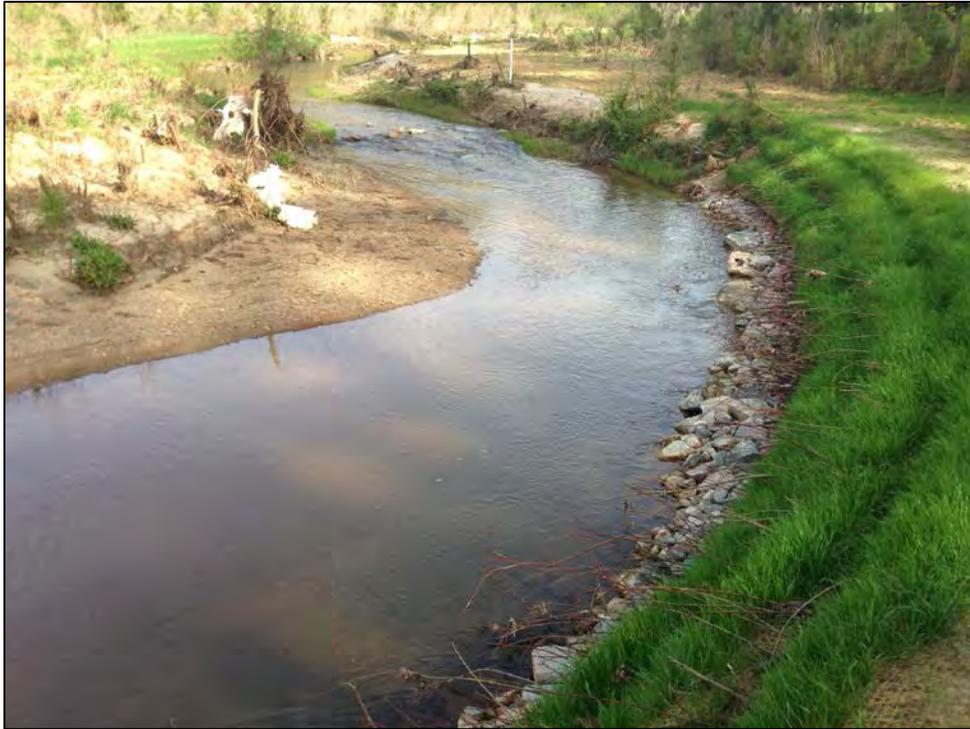
Area 3 consisted of an eroding outer bank, similar to Repair Area 2. The erosion stopped at a boulder single vane structure. Similar to the other repairs a vegetated soil lift with a stone foundation was installed in this location. The stones in the vane structure were removed up to where the vane tied into the bank, which was incorporated into the foundation for the lifts.

3/31/2016 – Repair Area 3. Looking upstream at the vegetated soil lifts on the outer bank.

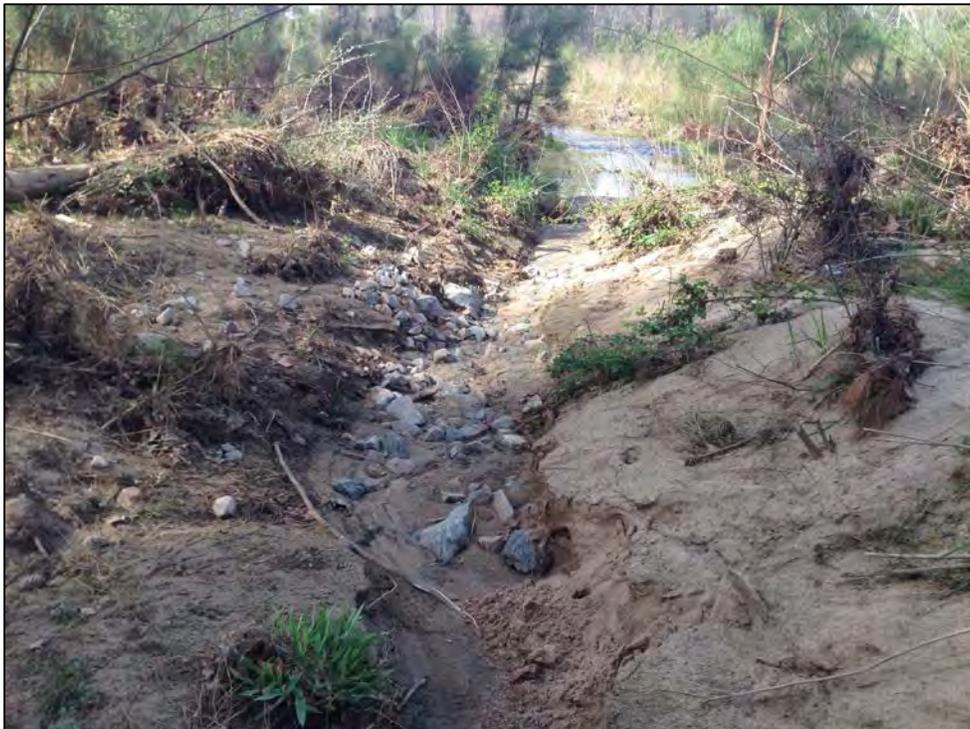
Additionally, Repair Area 3 has a side drain that comes from a small stormwater culvert just downstream of the bank to be repaired. This drain, which alternates between filling with sand and then washing back out, was stabilized with riprap at the confluence with the channel.

3/31/2016 – Repair Area 3. Looking downstream at the stone stabilization installed along the drainage ditch. Fine materials from upstream have washed into the riprap.

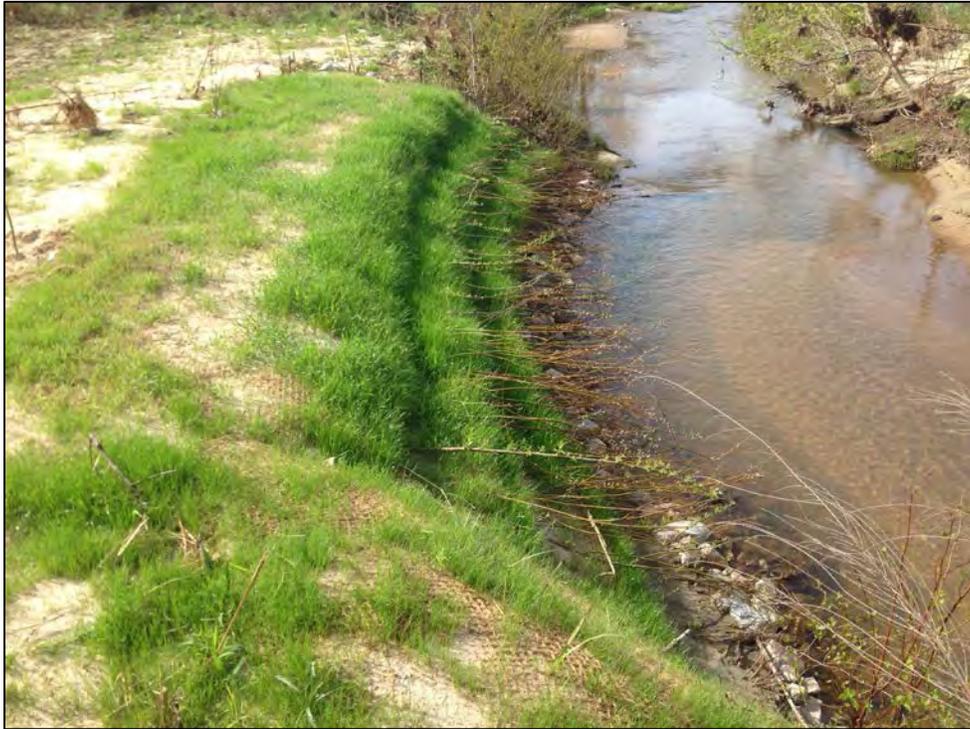
The most minor repair area was Repair Area 4, which consisted of an actively eroding outer bank. Similar to Repair Area 3, there is a boulder structure at the downstream end of the erosion that halted any further erosion. This structure has a better angle and was left in place. A vegetated soil lift with a stone foundation was installed in this location.

3/31/2016 – Repair Area 4. Looking downstream at the vegetated soil lifts on the outer bank.

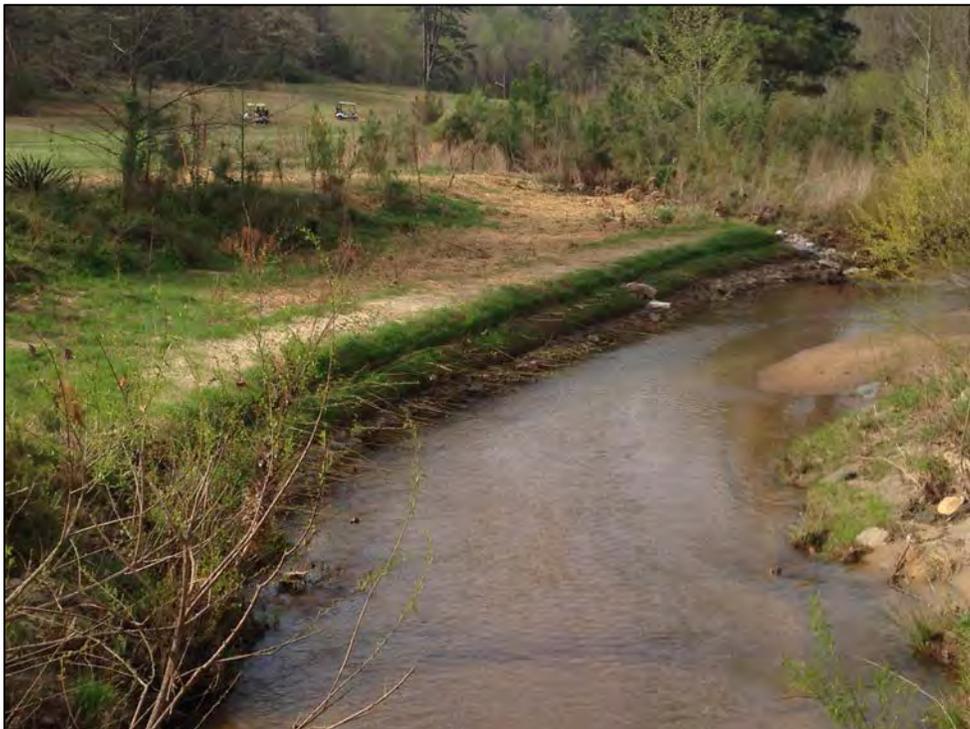
Area 5 consisted of an actively eroding outer bank downstream of the golf cart bridge. A 4" PVC drain pipe had been exposed and was hanging from this bank. A non-functioning single boulder vane was also located in the middle of this bank. A vegetated soil lift with a stone foundation was installed in this location. The PVC pipe is connected to an active drain line and was incorporated into the soil lifts. The vane arm was removed and the boulders were reused in the foundation.

3/31/2016 – Repair Area 5. Looking downstream at the vegetated soil lifts on the outer bank. Note the white PVC pipe that drains the golf course to the stream.

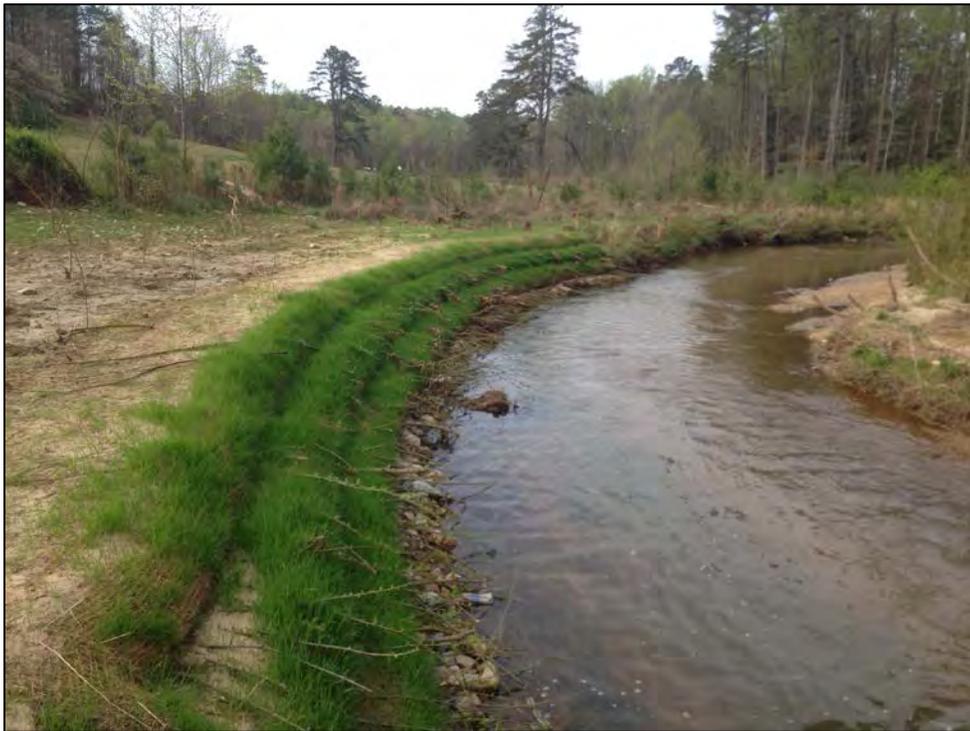
Area 6 was in the same state as Repair Area 3, with an eroding outer bank and non-functioning boulder vane. The repair approach was the same.

3/31/2016 – Repair Area 6. Looking downstream at the vegetated soil lifts on the outer bank.
