**YEAR 5 of 5 Monitoring Report  
Tributaries of Wicker Branch Stream Restoration  
Union County, North Carolina  
DMS Project Number: 95022  
Contract No: 003982  
USACE Action Id No: SAW 2013-01680**

**YEAR 5 of 5 Monitoring Report**  
**Tributaries of Wicker Branch Stream Restoration**  
**Union County, North Carolina**  
**DMS Project Number: 95022**  
**Contract No: 003982**  
**USACE Action Id No: SAW 2013-01680**

**RE: Year 5 (2019) Monitoring Report the Tributaries of Wicker Branch Project (DMS Project # 95022)**

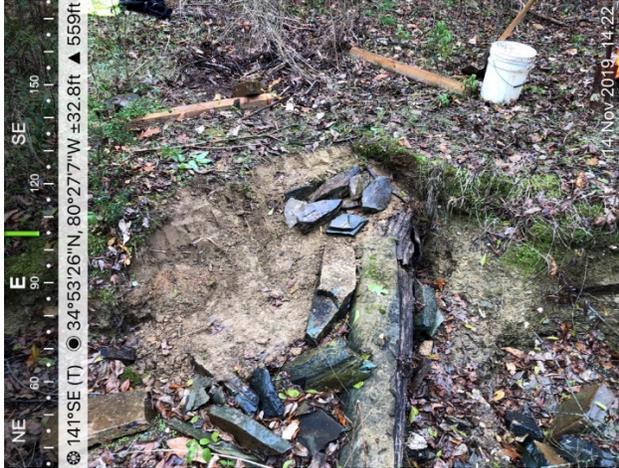
The restored stream channels appear to be stable with no areas of bank erosion observed. During construction in 2014 a headcut at the bottom of Tributary 1B was stabilized with a log sill and stone. Floodplain flows during bankfull events started to erode the bank around the left bank side of the sill in 2018. This was repaired in 2019 by filling the eroding area with soil and rock and placing a log sill in the floodplain to direct flow away from the end of the instream sill (see photograph at the end of **Appendix B**).

Repair of log sill erosion on lower portion of  
Tributary 1B

AECOM will be repairing the erosion that has occurred at the log sill toward the lower end of Tributary 1B. Geotextile matting will be placed in the scour area and the hole backfilled with soil and rock. A log sill will be installed in the floodplain immediately upstream of the scour hole to redirect flows during flood events to help alleviate stress on the area.

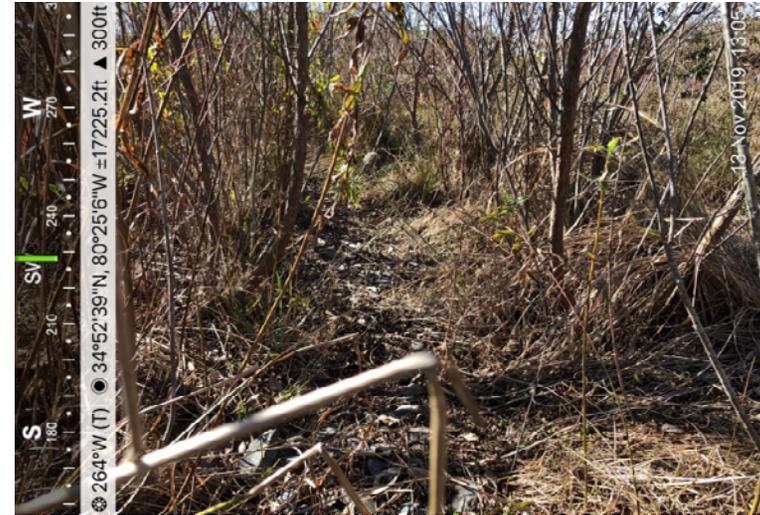
Photo: Cross-section 1 looking upstream

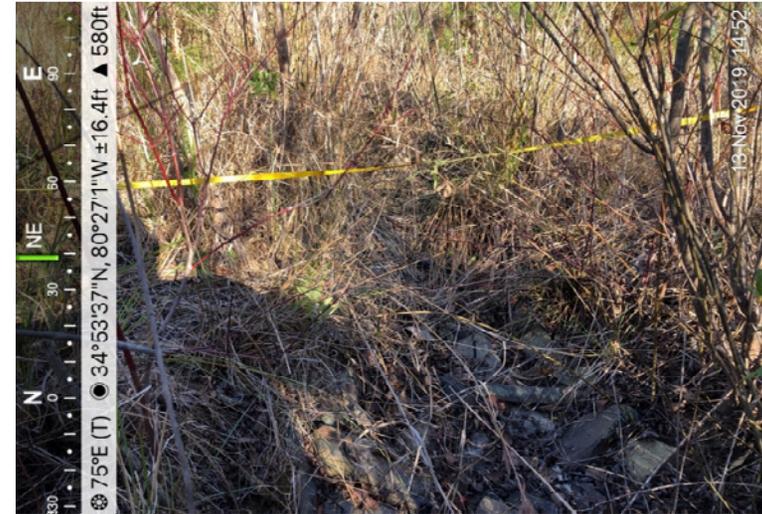
Photo: Cross-section 3 looking upstream

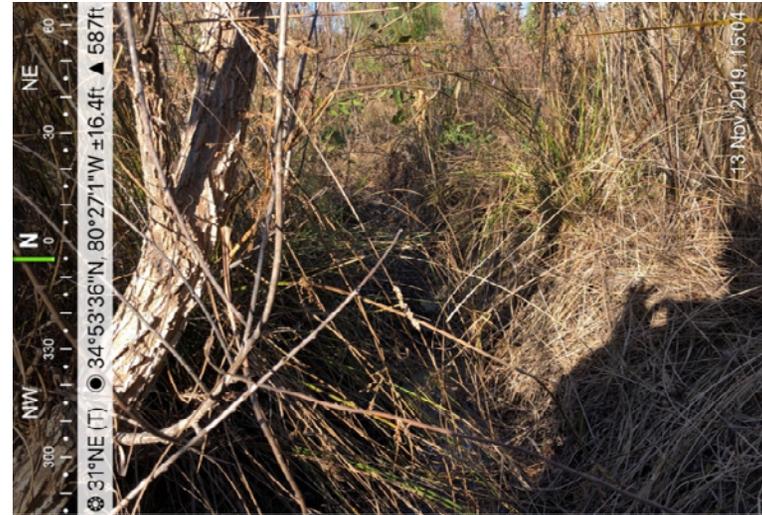
Photo: Cross-section 4 looking upstream

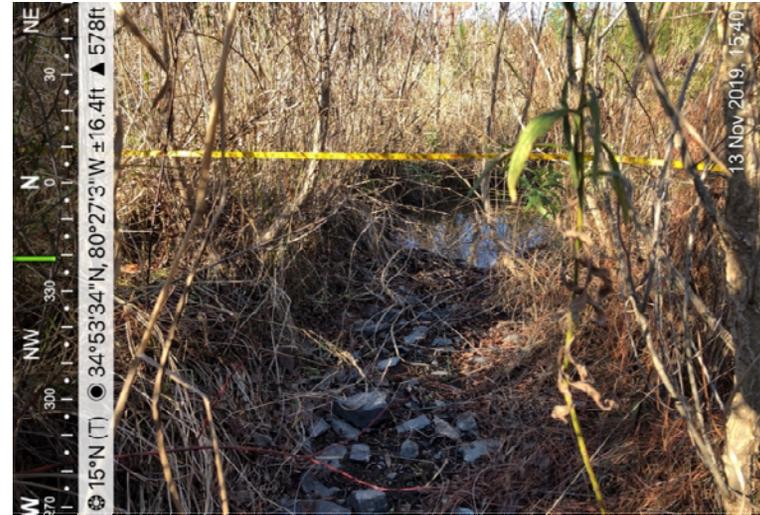
Photo: Cross-section 6 looking upstream

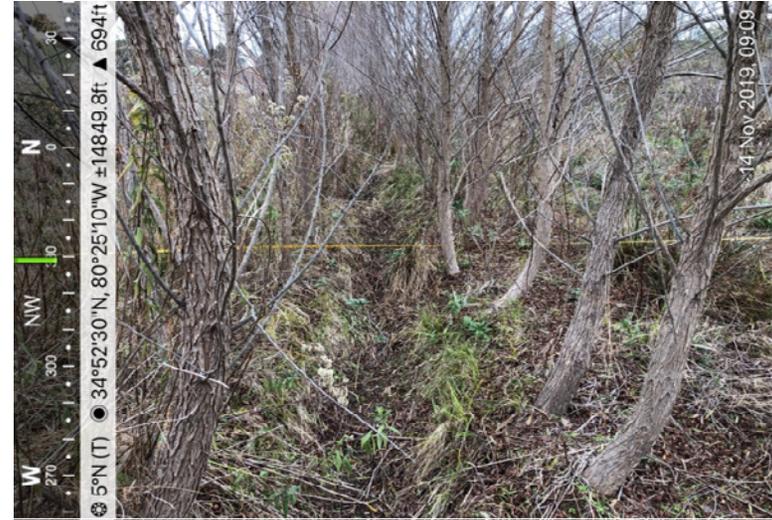
Photo: Cross-section 8 looking downstream

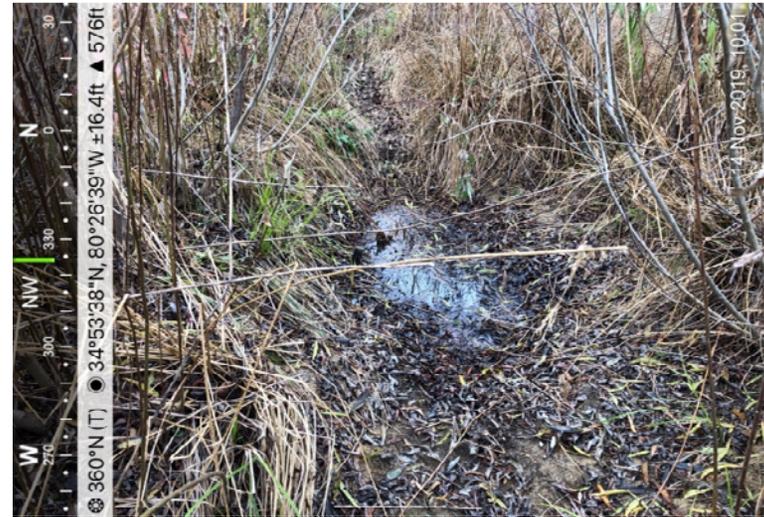
Photo: Cross-section 10 looking upstream

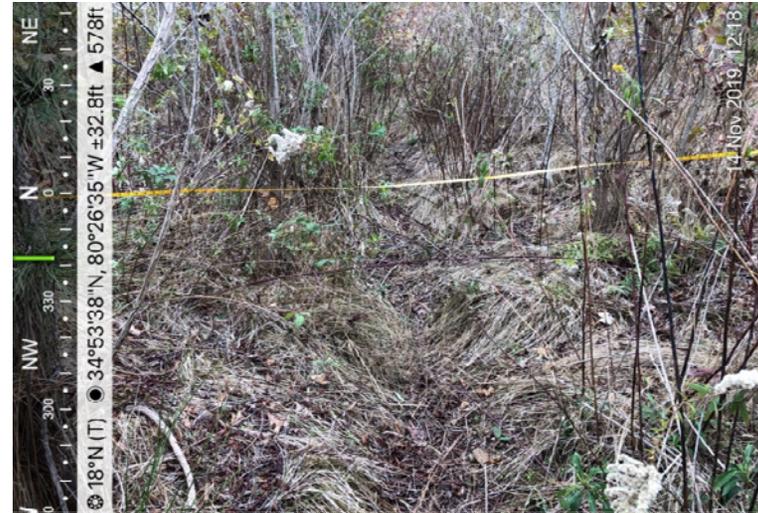
Photo: Cross-section 12 looking upstream

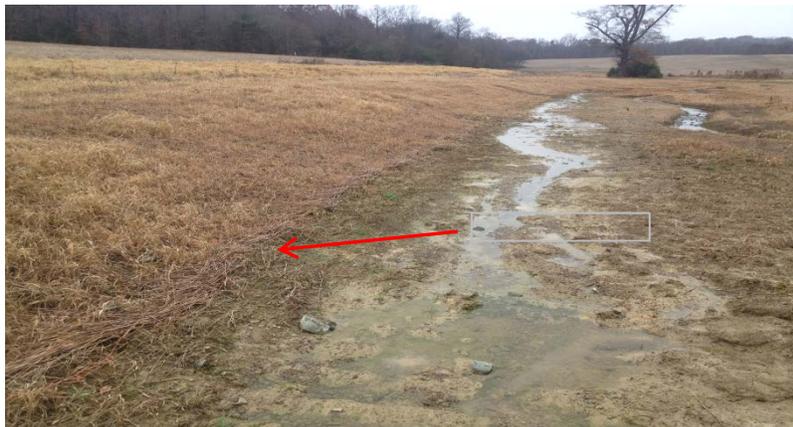
Photo of wrack lines from 11/23/2014 bankfull event

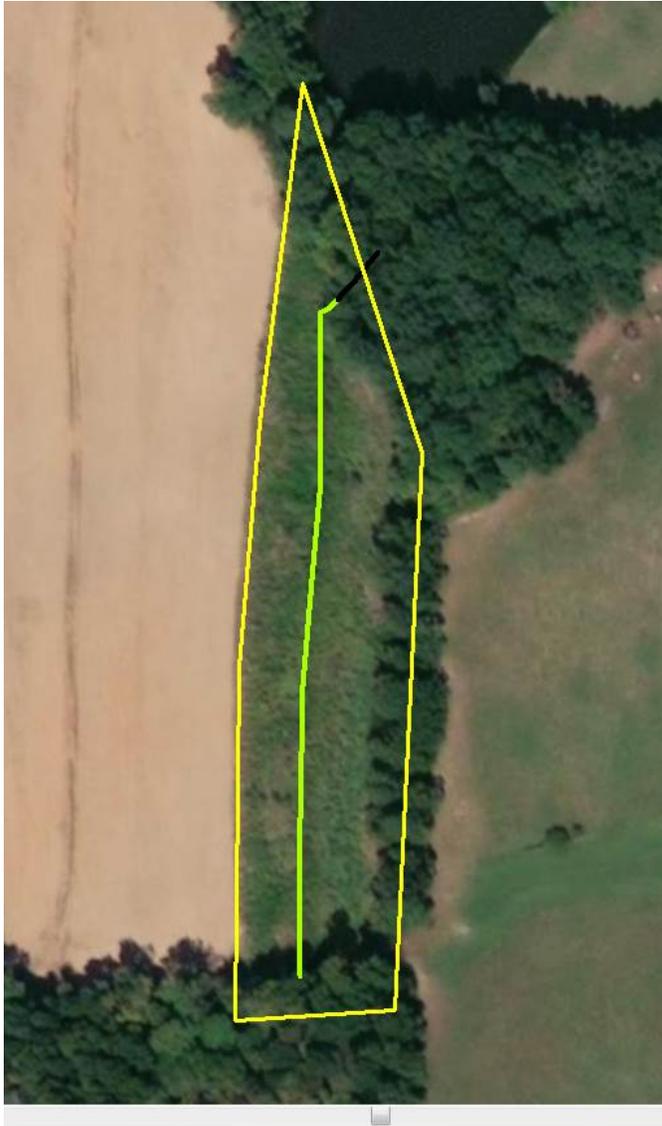
Stream mapping – It appears trib 4 may be migrating out of the easement before reentering it; this will need to be analyzed and rectified if necessary since any streams outside the easement will not yield assets.

This should not be an issue with asset generation. The very upper portion of Tributary 4 (shown in black) is not included in the asset calculations. As shown on the figure to the left only the lower 631 feet of Tributary 4 is generating credits (highlighted in green).

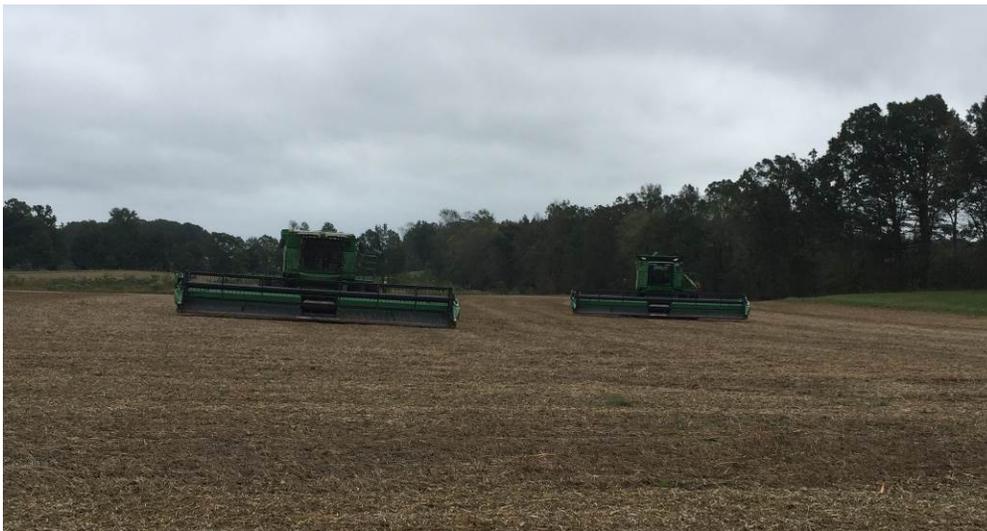
The crossing at the top of Tributary 2 remains problematic. A 35 wide easement was established at this crossing during the early stages of site development. When the easement was established AECOM assumed that the edge of the property was the edge of the treeline. The easement boundary was established in CAD prior to surveying the easement in the field. When the easement was finally surveyed and marked in the field it became apparent that there was not enough room between the edge of the easement and the treeline for the farmer to cross

the easement with his equipment. The photo below depicts that combines that the farmer utilizes to harvest crops on the property .

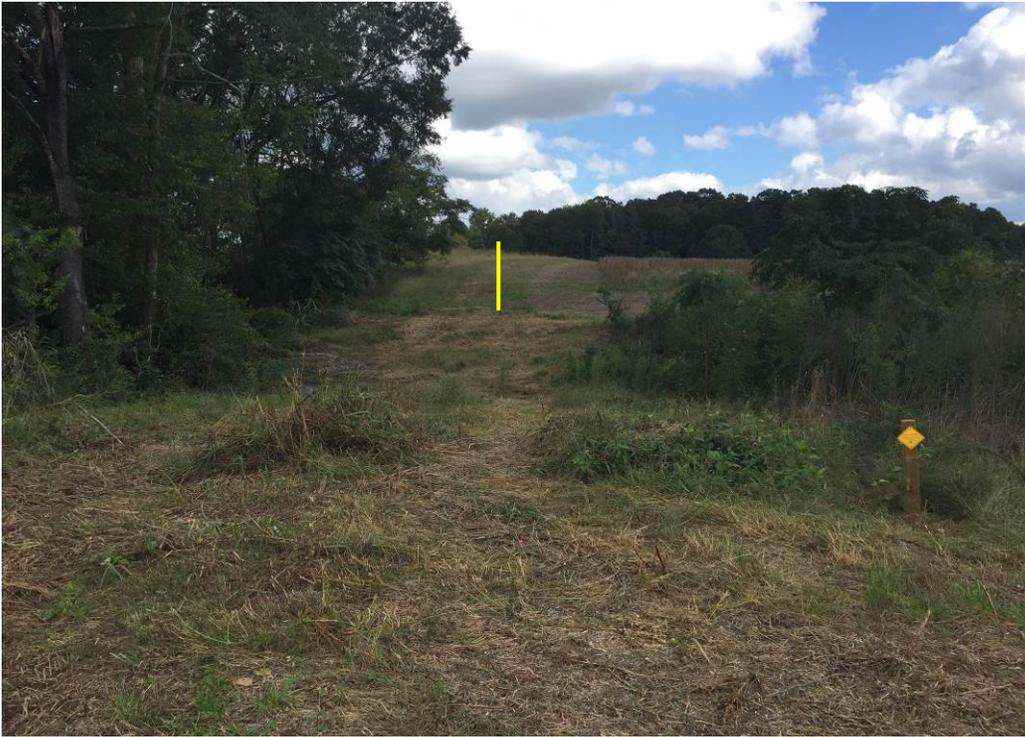
The above photo depicts the location of the corner of the easement at the top of Tributary 2 in relation to the treeline. The Yellow Line is the far (northeast) corner of the easement and the wood post with the sign is the northwest corner. There is sufficient room at the northeast corner but not at the southeast corner. The photo below shows the farm equipment crossing the easement.

AECOM would like permission to modify the easement to allow adequate room for the equipment. We would work with the farmer to determine the exact distance but anticipate that it would look something like the photo above. The above photo shows reducing the length of the easement by about 35 feet on one side and maintaining it on the other. This would reduce the easement by about 1530 square feet or 0.035 acre. It should be noted that the easement in this area is not actually buffering an asset. Tributary 2 is an ephemeral feature that does not generate any stream credits.
