**As-built report for the Bare Mitigation Site,
Unnamed Tributary to Peak Creek, Ashe County**

North Carolina Wildlife Resources Commission
Habitat Conservation Program

Joe Mickey and Staci Scott
Stream Mitigation Program

February 2002

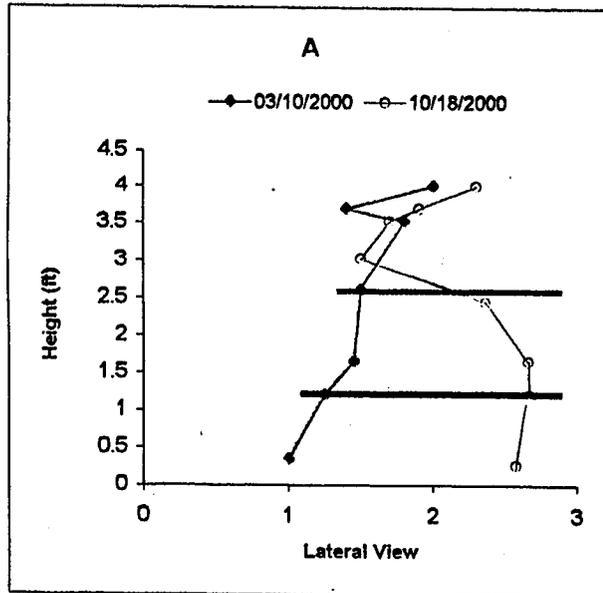
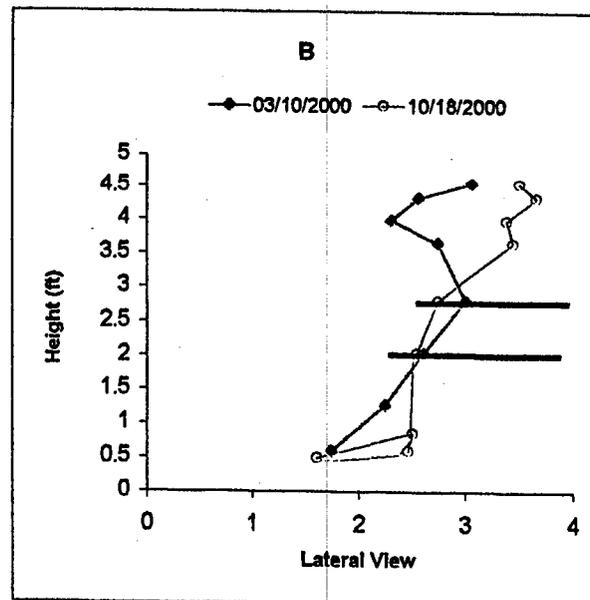
Figure 2 Bank Erosion Profile (pre-construction), Bare Site, Ashe Co.

The Stream Restoration Plan (NCWRC 3/2001/DWQ/COE/WRC files) contains the summary of the existing condition survey (longitudinal profile, cross-sections, pebble counts, reach parameters). Bankfull was determined using field-identified indicators, primarily a scour line and point bar height, and evaluated using regional curve information (NCSU-Stream Restoration Institute). Two reference cross-sections were analyzed to obtain reference dimensional data. Reference information was taken from cross-sections 1 and 9 that exhibited stable conditions and Meadow Fork Creek in Alleghany County. These existing sites were used as the only reference data since no change in pattern was planned. Sinuosity is very low at this site, stream length/valley length = 1.1 or valley slope/stream slope = 1.1. Sinuosity is not a good criteria to use for typing this stream since it is was altered in the past and does not reflect natural conditions. An entrenchment ratio of approximately 1.4 would indicate that this would be a B type stream. However, high width/depth ratios indicate that the stream would be a C or F stream type. Slope indicates a C or F stream type. Medium to coarse gravel is the bed material in the reach (20 mm = D50) and cross-section (11.3 mm = D50). Water surface slope is .0084, which is more indicative of a C or F stream type. When taken together with the valley type and past channelization, this stream is in transition from a B4 stream type to a F4 or C4 stream type. Altered, unstable F4 and C4 stream types erosion without a well vegetated riparian zone are susceptible to accelerated stream bank. The presence and condition of riparian vegetation influence rates of lateral adjustment in these stream types. Sediment supply can be moderate to high, depending on stream bank erodibility conditions. Prior to construction, bank erosion pins at two locations indicated a stream bank erosion rate of 10 tons year from a 50' x 4.5 foot bank and 10.5 tons year from a 100' x 5' bank (Figure 2).

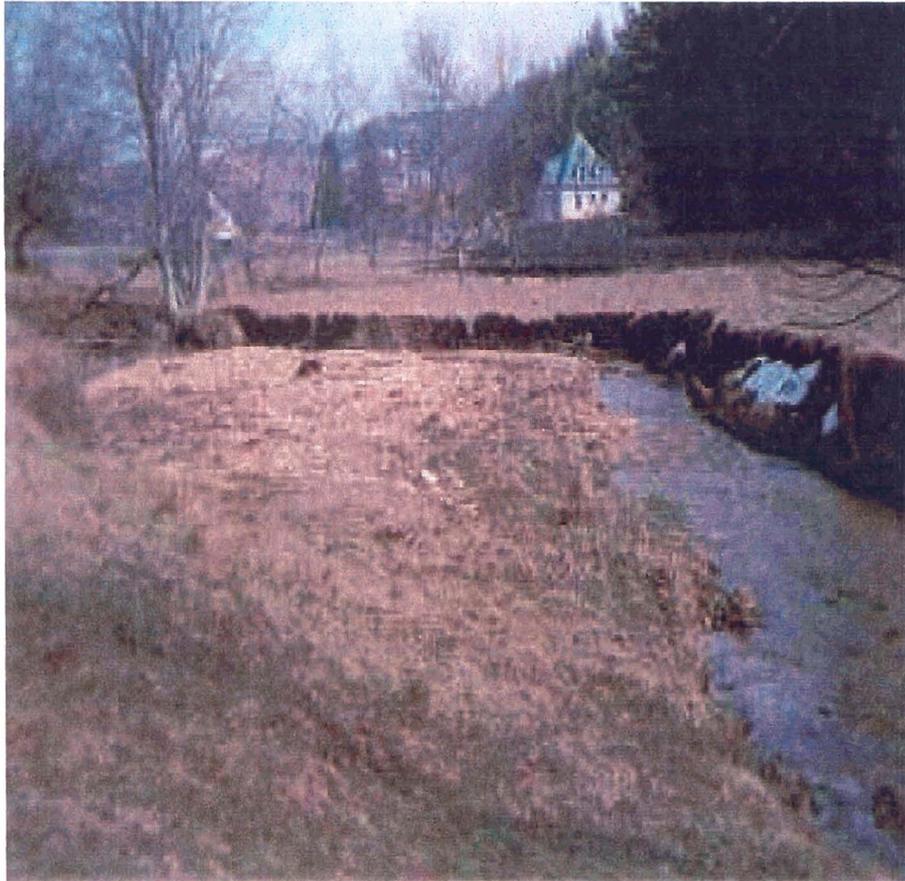
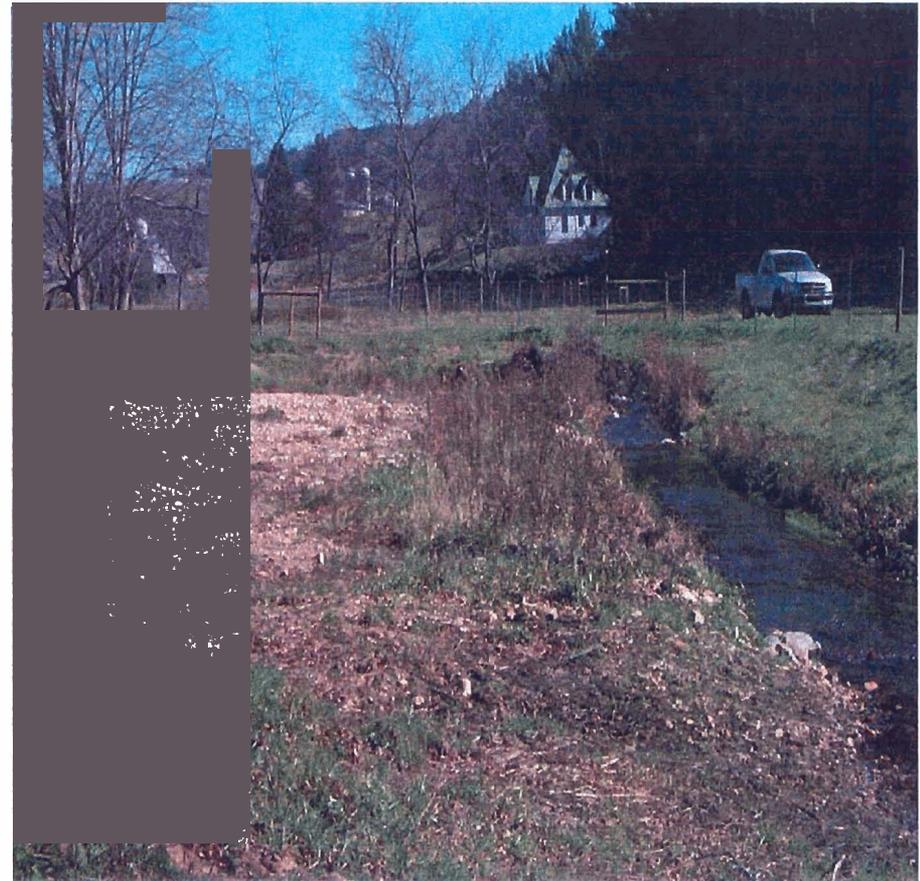
Figure 15. Bank Sloping and Root Wad Installation, STN 1+56 - 3+62

<u>Station #</u>	<u>Site condition</u>
1+56 - 3+62	eroding right bank, meander needs to be reconstructed
3+62 - 4+20	braided channel and eroding left bank
4+20 - 4+81	eroding right bank
5+85 - 7+81	eroding right bank, about to take access road, meander needs to be reconstructed
7+35 - 8+76	eroding left bank (station 7+35 - 8+76 need step/pool design)
11+32 - 16+19	eroding left bank (steep)
16+29 - 18+00	eroding right bank
18+56 - 21+50	eroding in sections along both banks & at white pines

1. Reconstruct the meander at stations 1+56 - 3+62 and 5+85 - 7+81 in order to reestablish proper dimension, pattern and profile to eliminate the severely eroding banks.

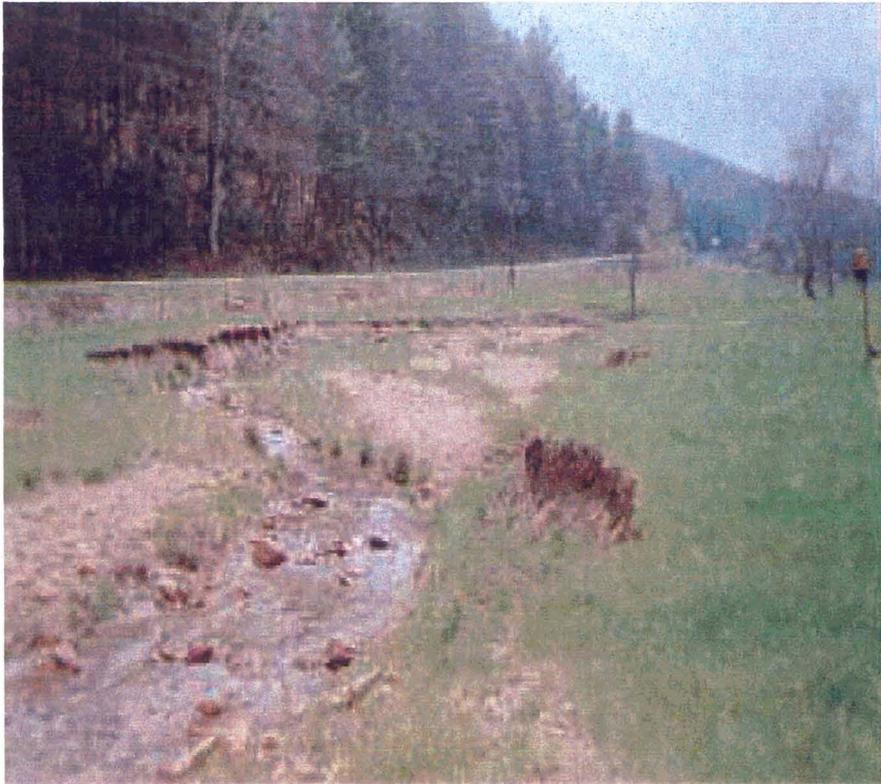
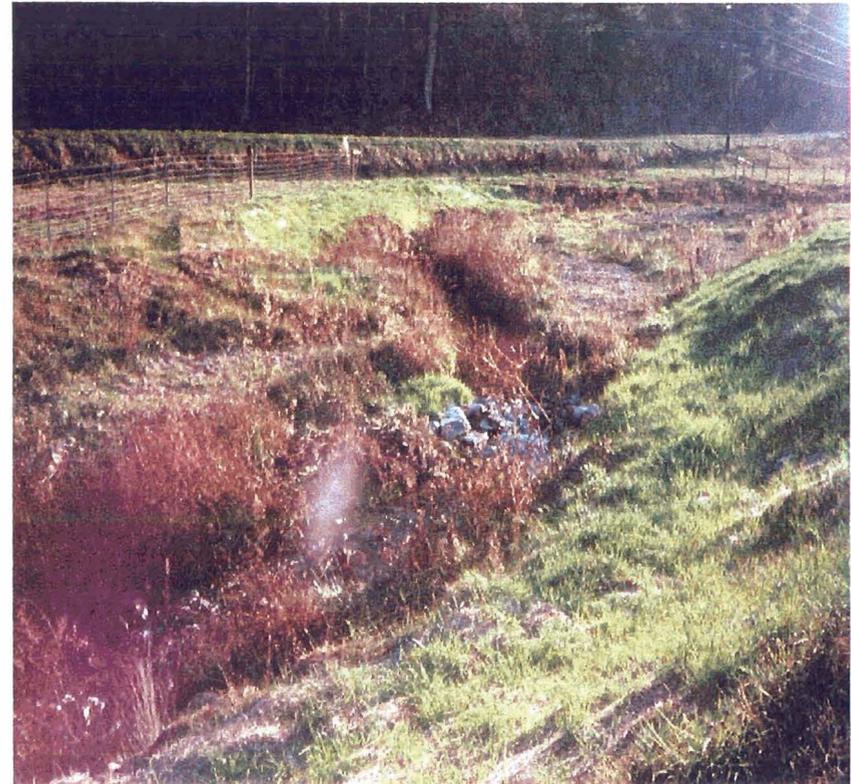
Figure 16. Long Eroding Bank

STN 7+35 - 8+76
