**As-built report for the Barnhill  
Mitigation Site, Little Ivy Creek,  
Madison County**

**North Carolina Wildlife Resources Commission**

**November 1, 2000**

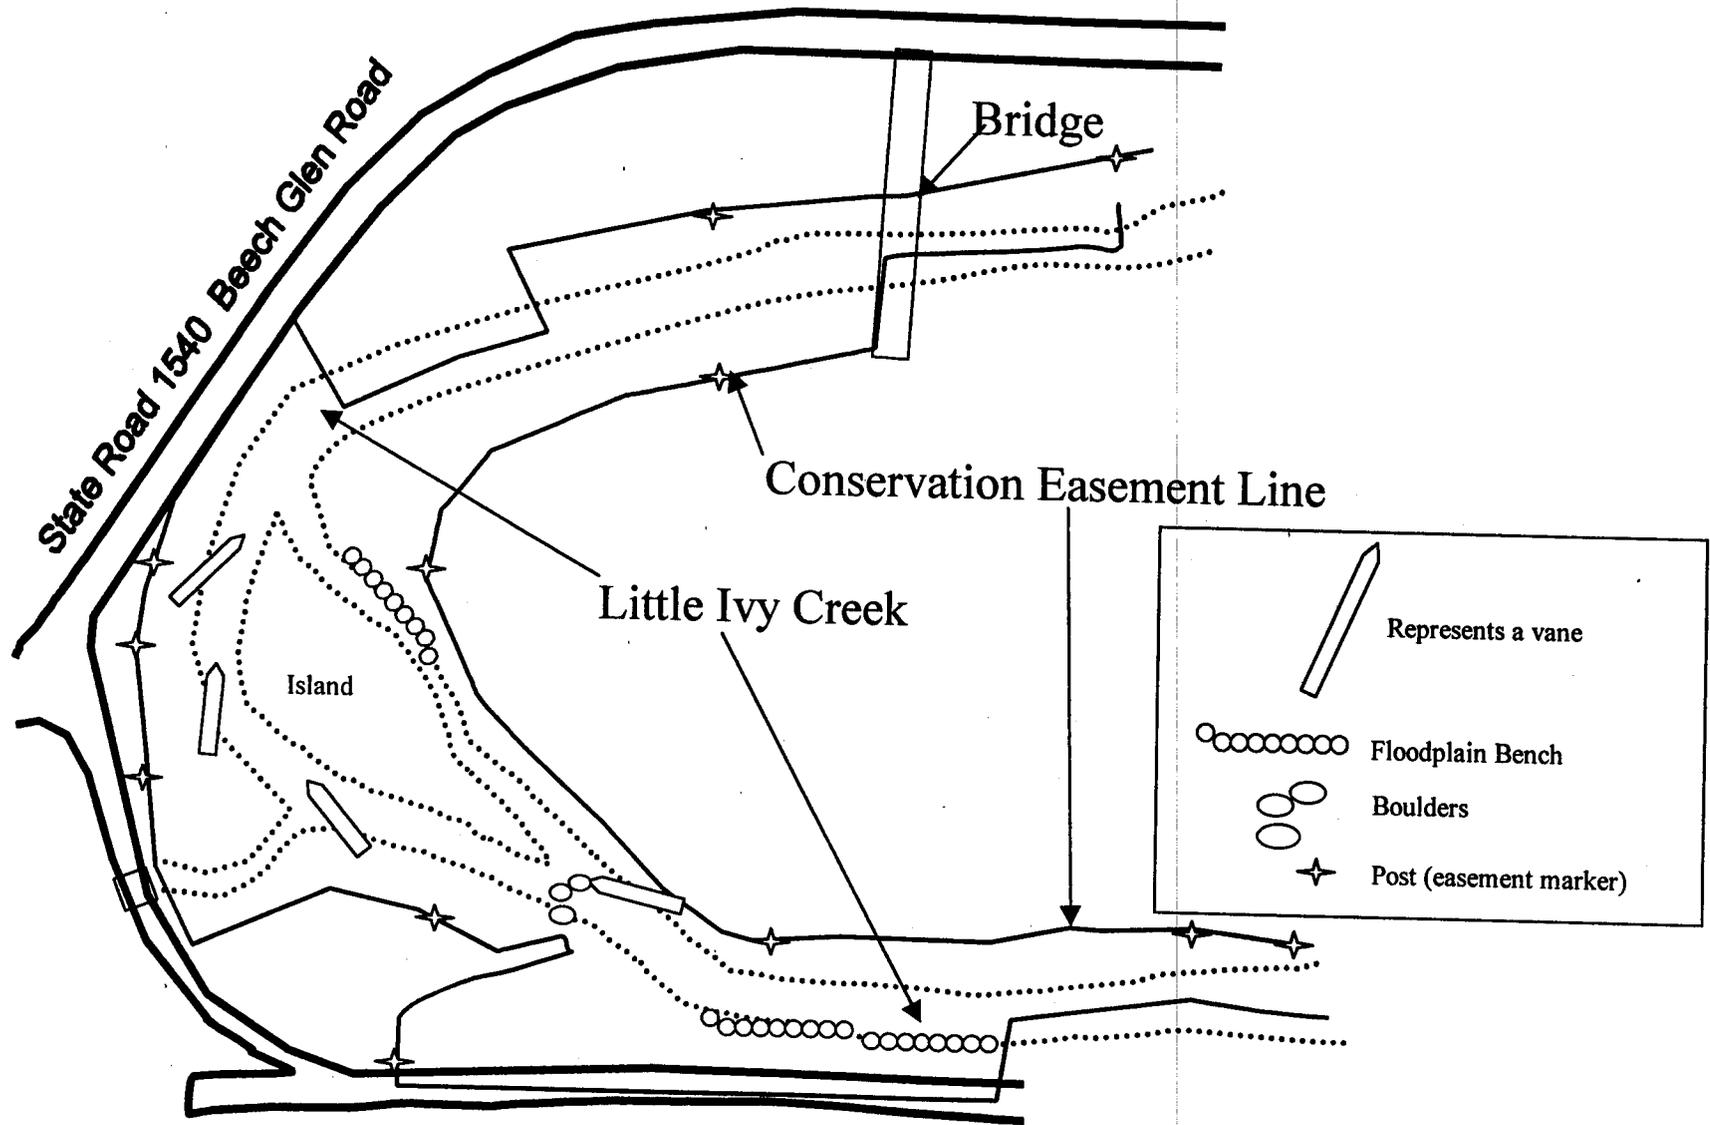
Location of vanes, boulders, floodplain benches and conservation easement markers at the Barnhill Site.

Three J-hook vanes were installed along the right bank and through the upper bend at this site (see the map showing all structure locations). Large boulders (500 to 1000 pounds) were used to construct these vanes. This was shot rock hauled from disposal areas on the A10 project. Vanes started with two or three offset boulders (J-hook) to create a scour pool and rose to the bankfull elevation on the bank. Large footer rocks supported all top rocks in the vanes. Holes were dug at the convergence points of the water vortices to accelerate pool formation. Excess bed material was placed near the bank, upstream of the vanes where natural deposition is expected. The second and third vanes were positioned relative to the water flow off of the vane upstream of them. The third vane was significantly longer and at a lower slope than vanes 1 and 2 because we attempted to cross the confluence with a tributary that enters at this point. This was done to capture the sediment that had been moving down this stream and accelerate its movement over the vane. The placement of this series of vanes was designed to reduce erosion in the upper bend and to create pool habitat below the vanes. The attached longitudinal profile shows how vane construction has increased the deep-water habitat at this site. The elevation of the front rocks in the vane were not measured in this profile, or it would show a shallow point where the water was spilling into the scour holes, but the scour action of these vanes can be observed from this profile. The attached pebble count information shows the decrease in fines below these vanes and the increase in smaller cobbles. To some extent this data reflects constructed conditions and not hydraulic influences; however, the site has had some high water over it since project completion, so direct alterations during construction do not account for all observed improved conditions. The vanes are creating the desired deep-water habitat and sorting bed material in a way that will provide needed spawning gravel. In addition, no further erosion has been observed at this site. The attached cross-sections show conditions at the end of construction and will be used to monitor channel stability. At least two additional cross-sections will be added to these.

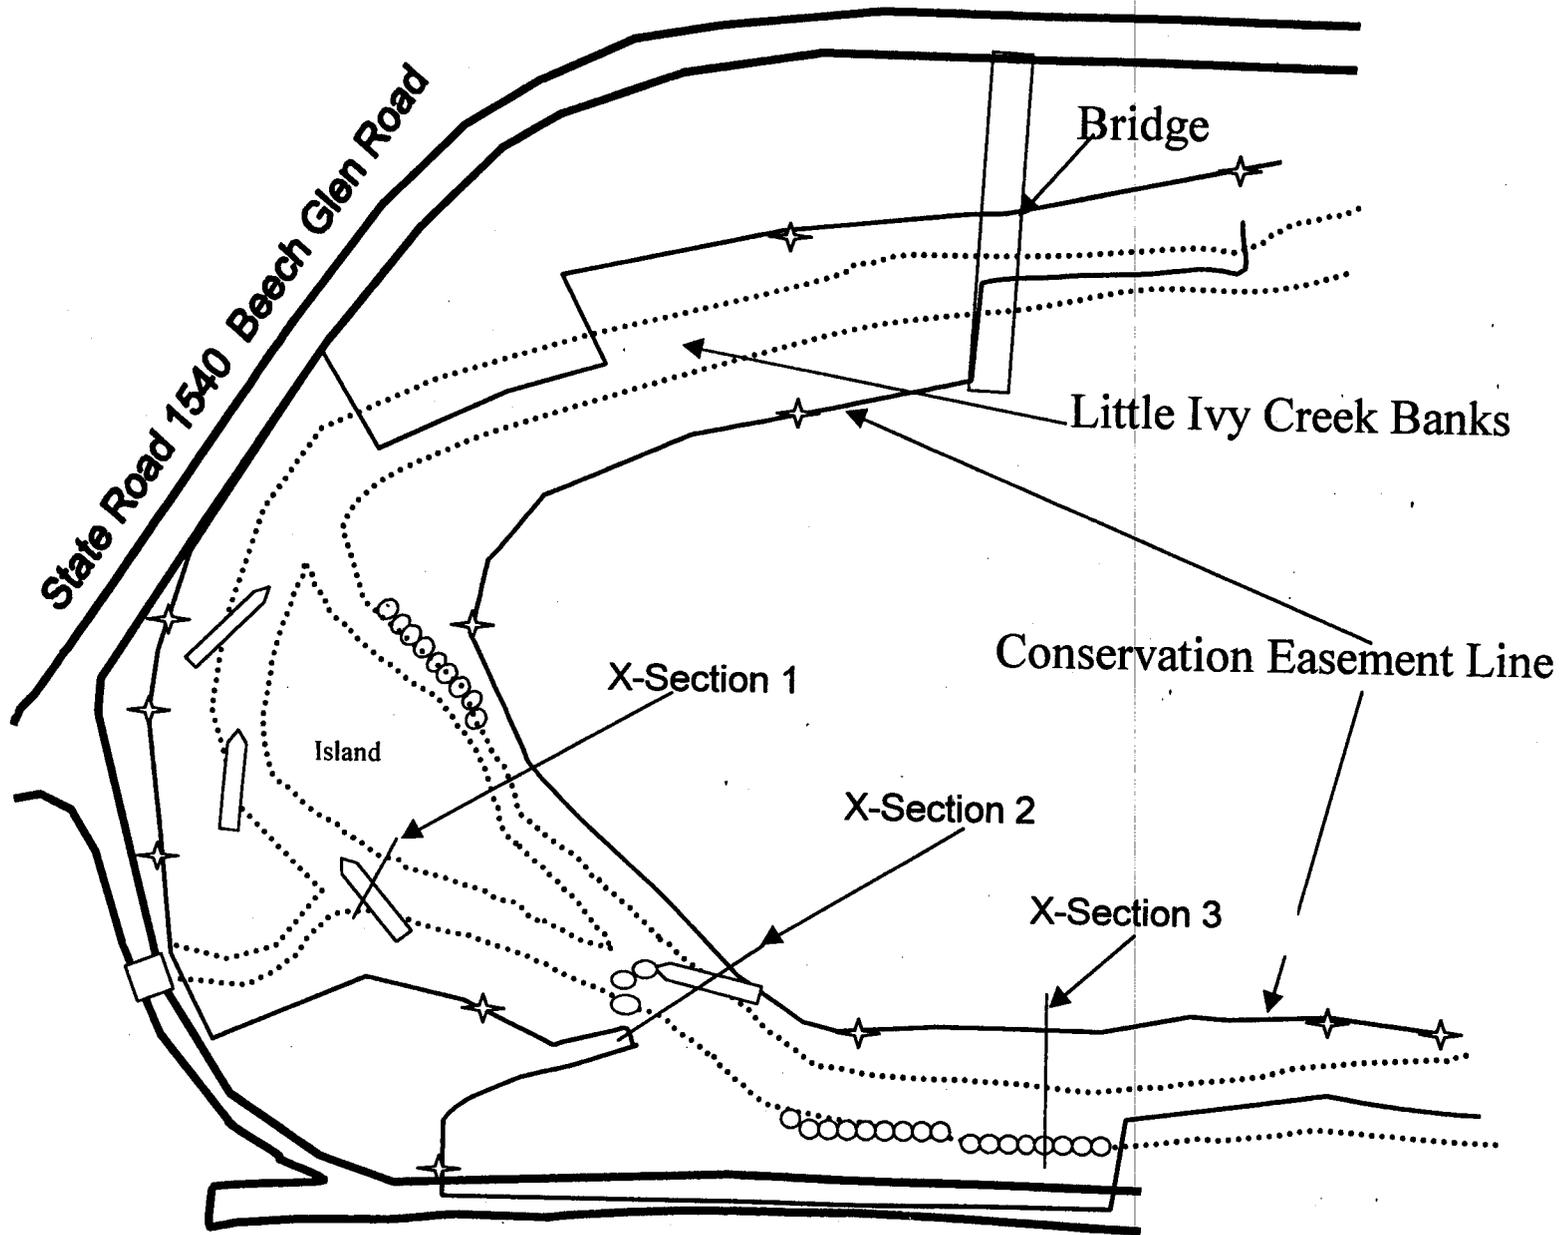
Location of cross-sections taken for monitoring postconstruction channel stability at the Barnhill Site.

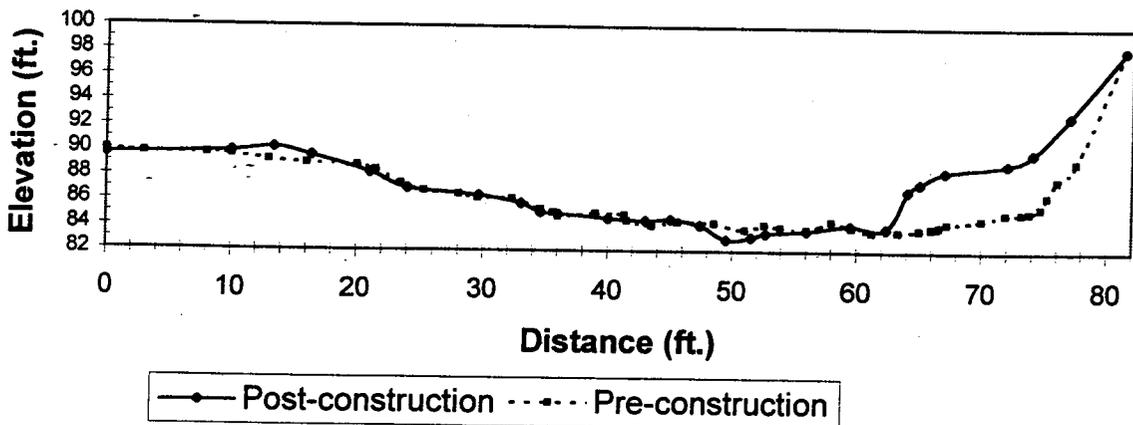
### Cross-section 3, bench on vertical bank

At two locations along this reach the stream was flowing against the toe of high (10-12 foot), clay banks. One of these sites was on the right bank of the main channel at the lower end of the project, the other site was along the left bank of the cutoff channel. Erosion was occurring along the toe of these steep slopes causing the upper banks to fail and fall into the stream. We addressed this problem by constructing floodplain benches at the base of the two banks. Large boulders were used to construct the bench and to bring it to within a few inches of the bankfull elevation. The top of the rock bench was then filled with soil excavated from a high ground source. At the lower site on the main channel, the soil was laid down over an erosion control fabric that was pulled back over the top of the soil, wrapping it in the fabric. This created a soil lift that had greater stability than the soil would have had alone. We felt that this was needed at this larger channel site because it would be exposed to high flows. In the cutoff channel we did not create a lift but we did cover the soil with an erosion control material. To date these sites have proven stable and are capturing soil that erodes from above the bench. Long-term stability will be assessed beginning next year, by implementing our monitoring protocol.

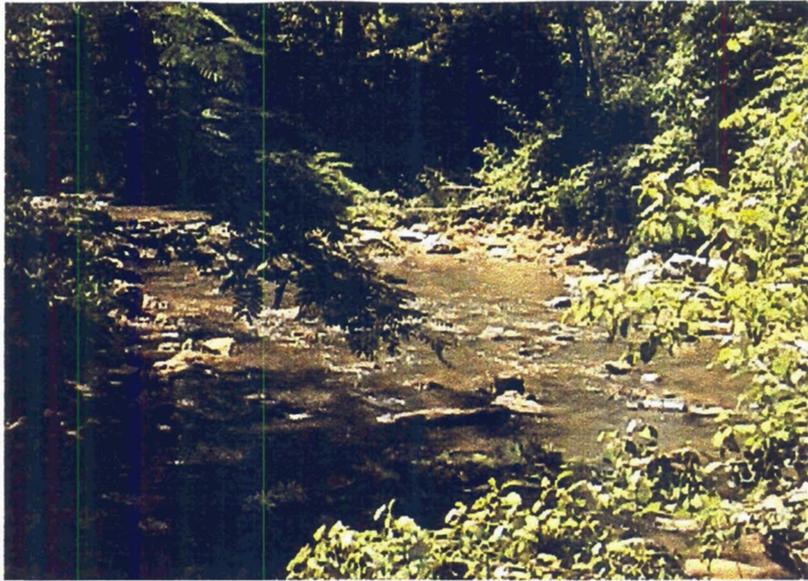
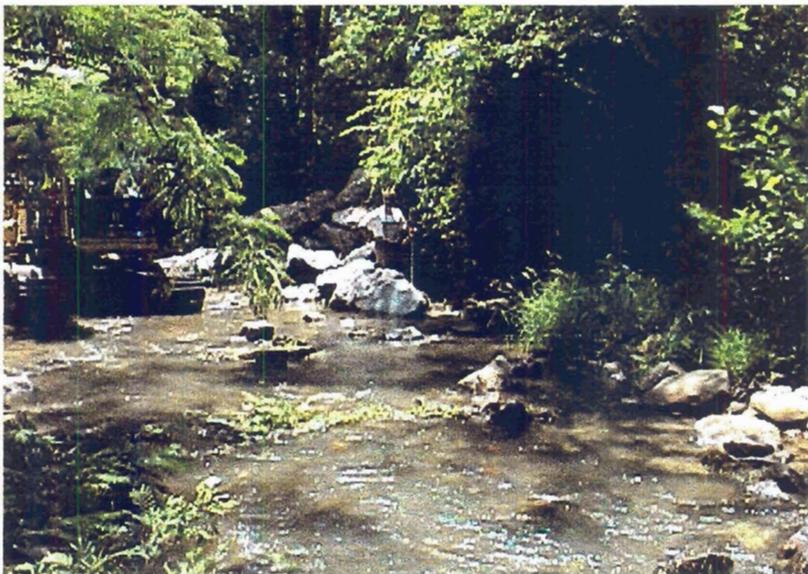
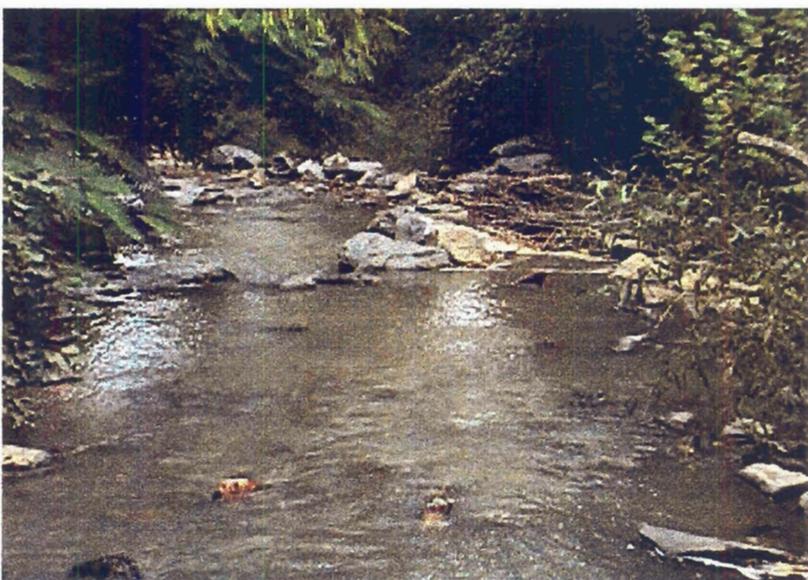
Site of the second vane, taken from the first vane downstream. Top photo shows site before construction, middle photo is the site during construction and bottom photo is three months after construction.

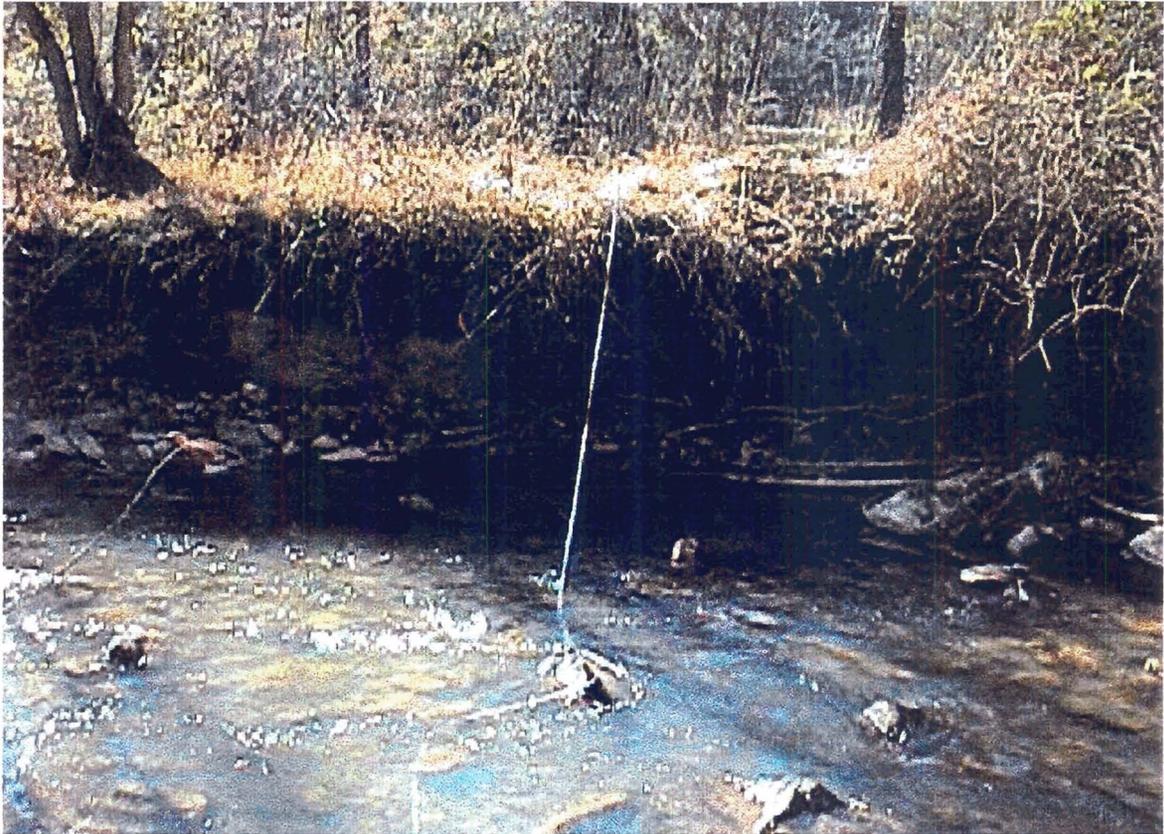
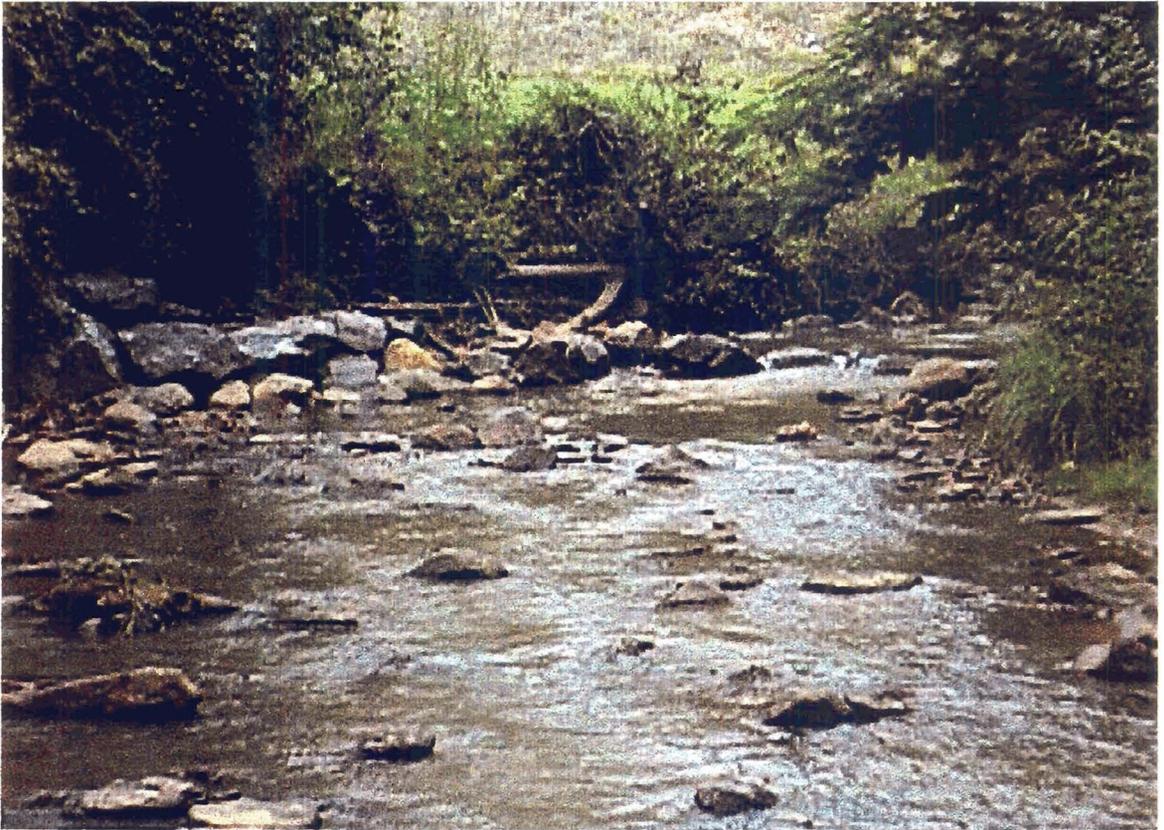
Site of second vane, taken from the third vane upstream. Top photo shows the area before construction and bottom photo shows the same area after construction, with scour hole developed.

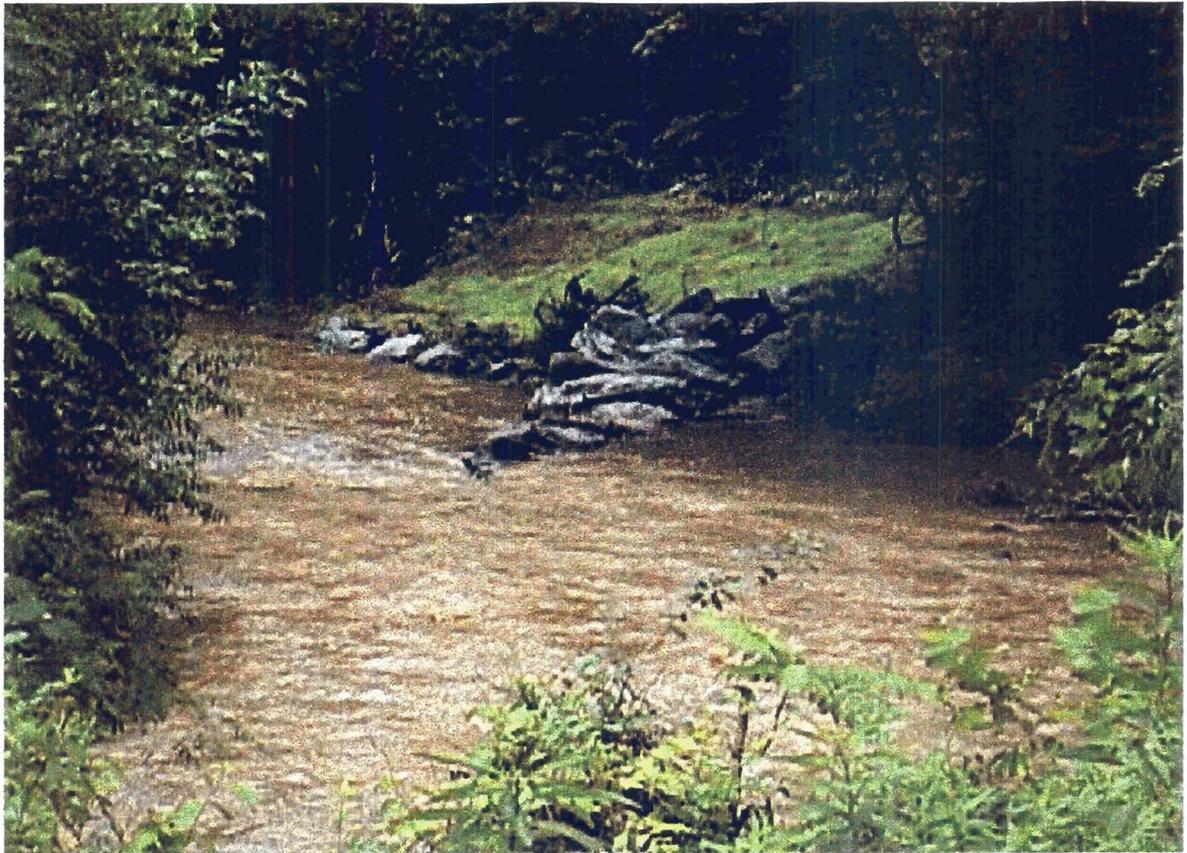
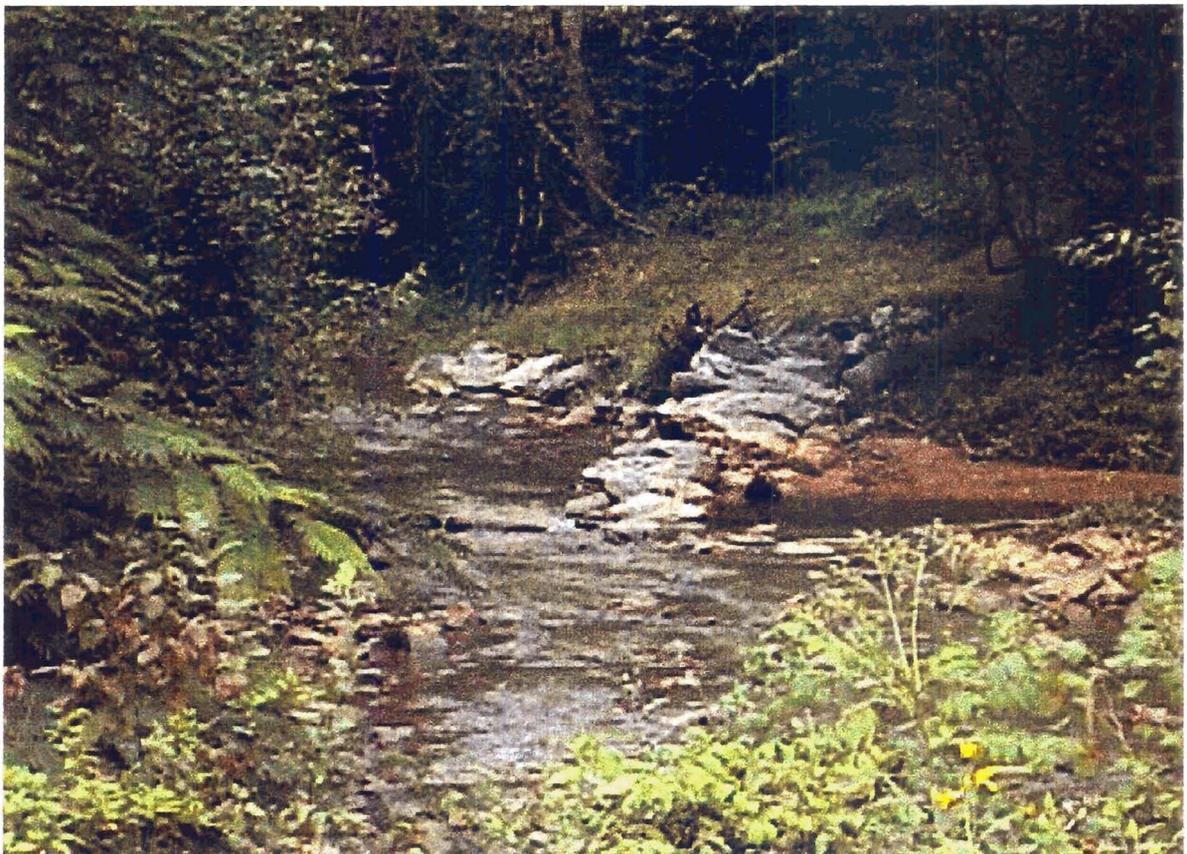
Upper photo - the third vane after construction showing high water pooling upstream of the vane and falling toward mid-channel. Bottom photo - shows the same vane with sediment deposited above the vane as water slows and the sloped, vegetated bank.

Bank sloping was not done extensively at this site because the riparian zone was in fair to good condition above the eroding areas. The stream bank below the second and third vanes was sloped by pushing the soil down to a more stable angle. This approach to bank sloping did not create waste soil that would have had to be removed. Placing smaller boulders and a log at the slope toe stabilized the bank in these two areas. These sloped banks and the created floodplain was fertilized, limed and seeded. After seeding, either an eight-foot wide, coir/straw blanket or coir "net" type blanket was used to cover the area above the log. Above these erosion control blankets a 4-foot width of jute fabric was also laid down. All of these erosion control materials were pinned using landscape staples. Two types of blankets were used to test which blanket would be better for this application on future projects.

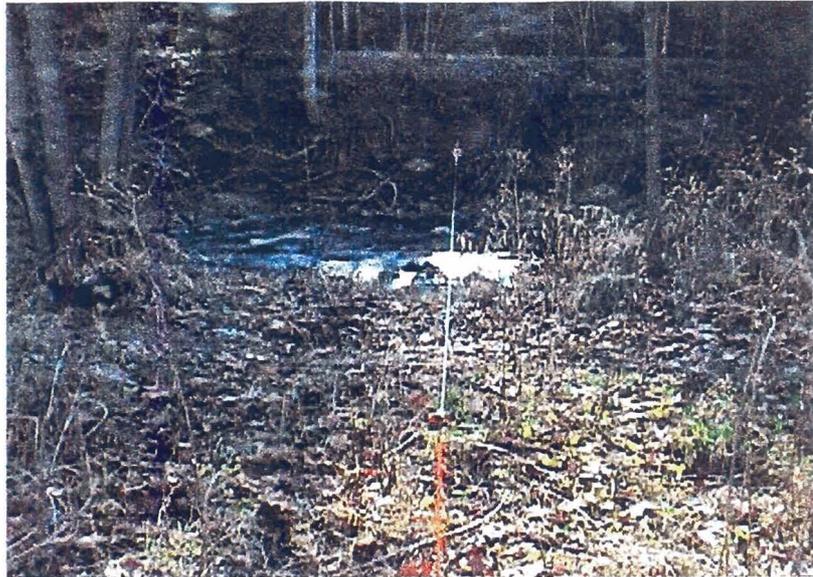
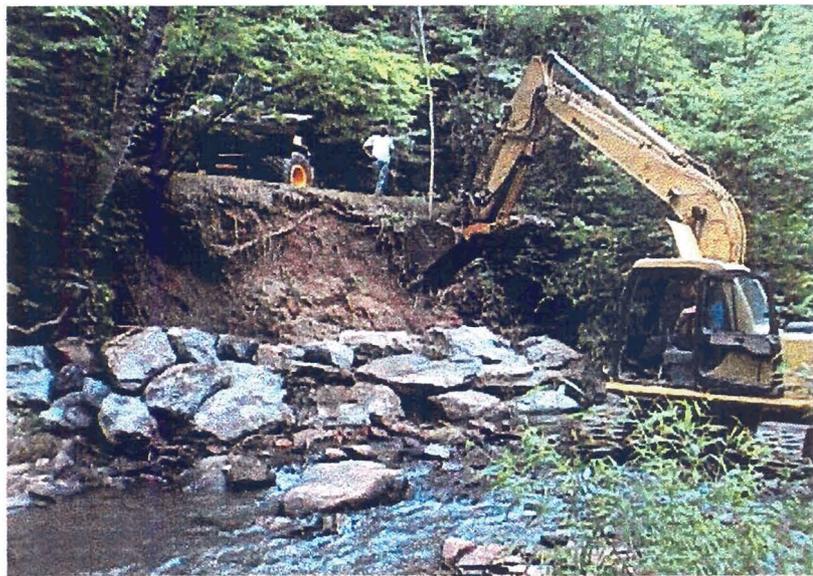
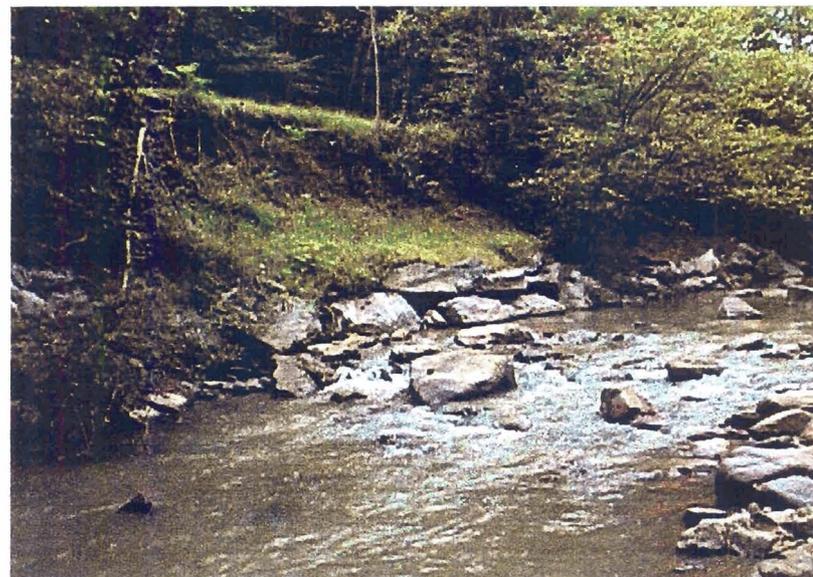
Bench construction at the lower end of the reach. Top photo shows the condition of the high vertical bank before construction. Middle photo shows construction and bottom photo shows site three months after construction.
