**UNNAMED TRIBUTARY TO BEAR SWAMP CREEK
STREAM RESTORATION SITE
2005 Annual Monitoring Report (Year 3)**

**Franklin County
EEP Project No. 27
Design Firm: Arcadis G&M of North Carolina, Inc.**

February, 2006

**Prepared by: ECOSCIENCE CORPORATION
1101 Haynes Street, Suite 101
Raleigh, NC 27604**

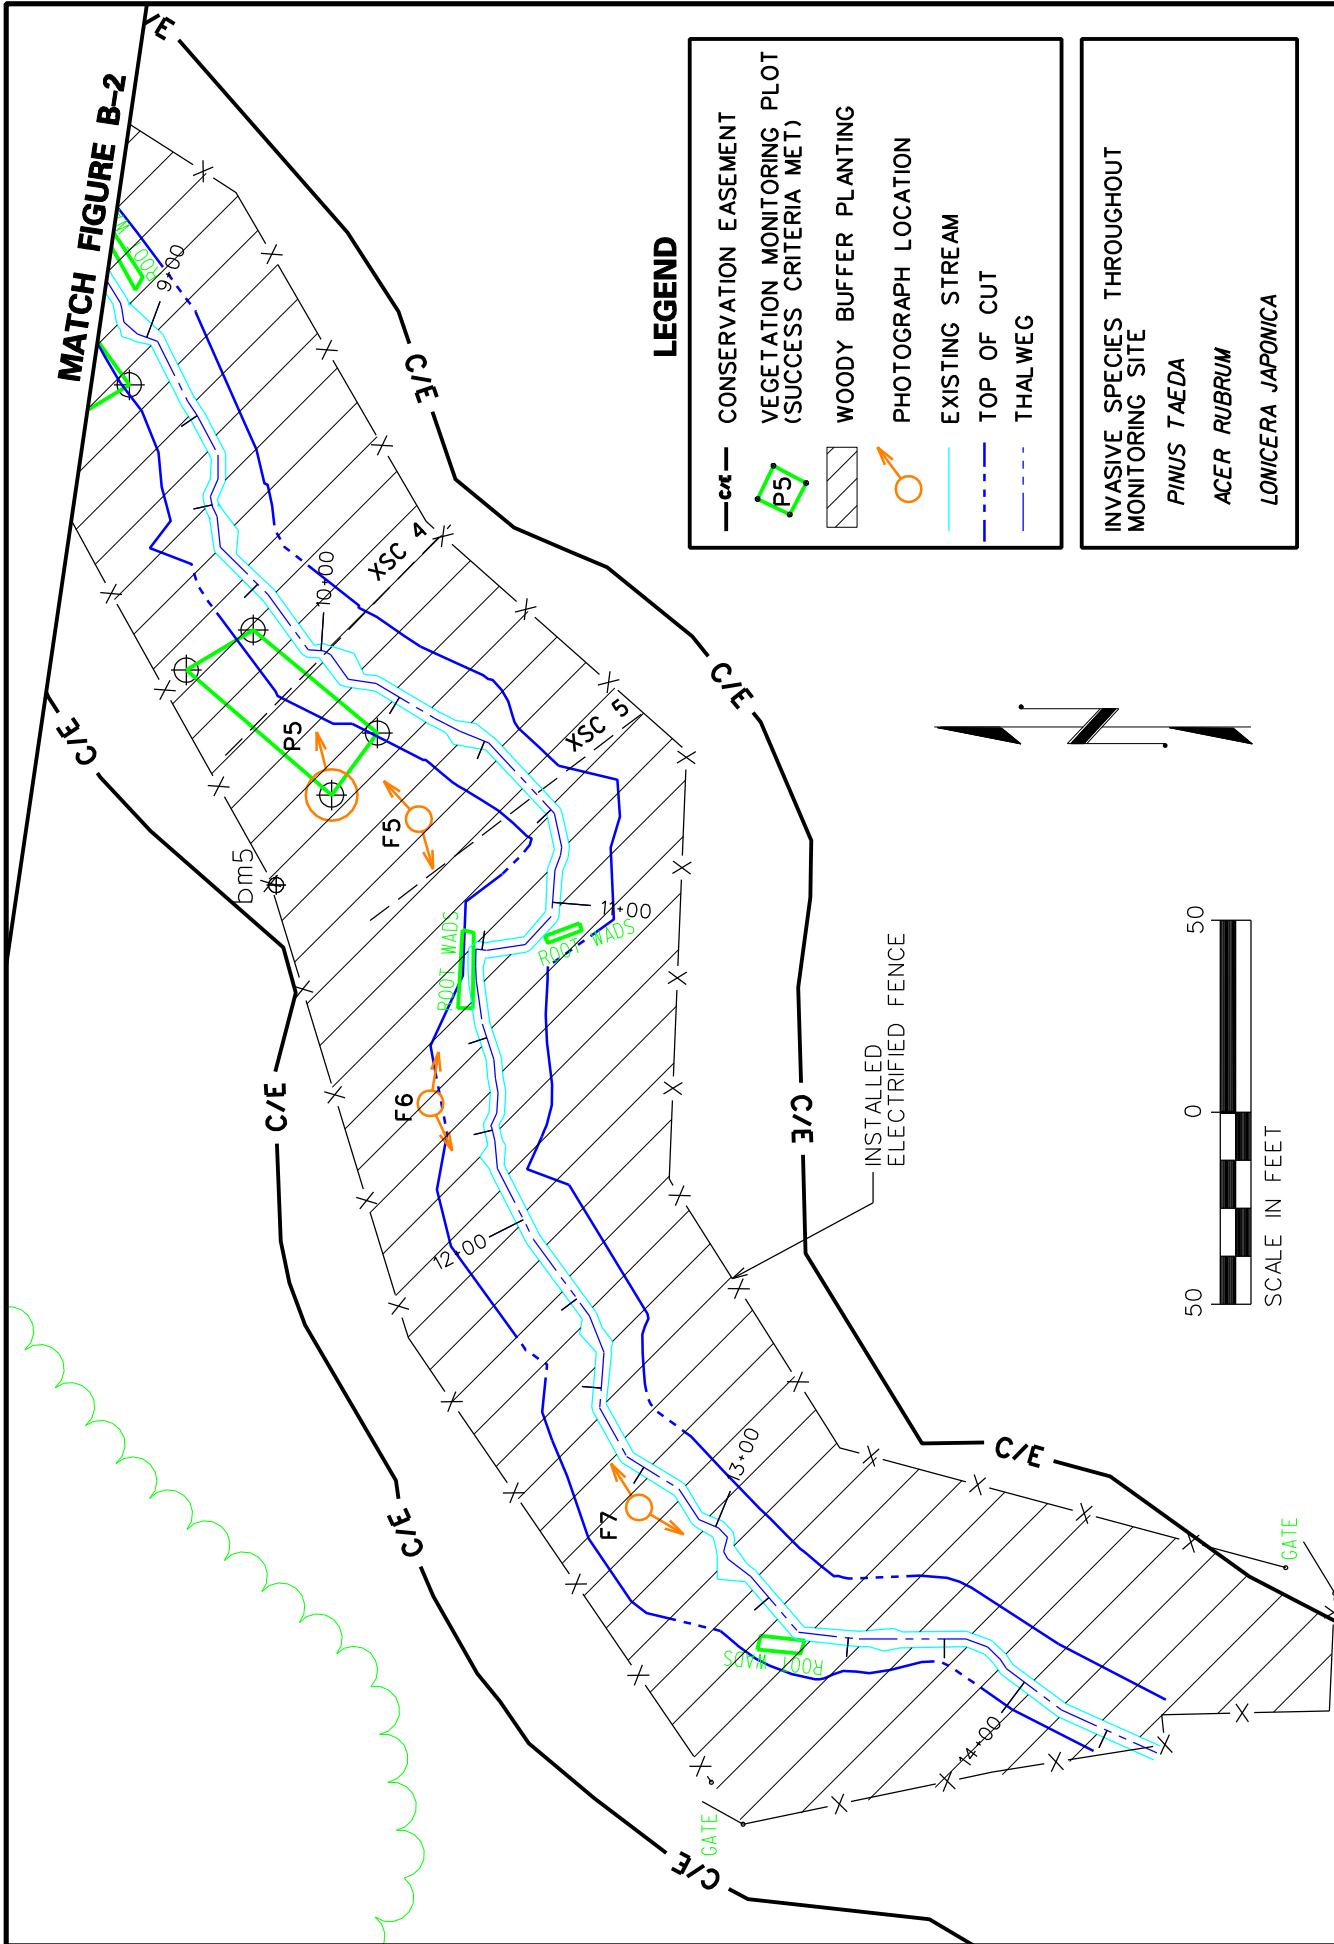
Feature / Issue	Station # / Range	Probable Cause	Photo #
Invasive Populations	Throughout, but especially at Vegetation Plot 1	<i>Pinus taeda</i> : seeding from adjacent stands	1 and 2
	Near Vegetation Plots 1 and 4	<i>Acer rubrum</i> : outside seed source	--
	Mainly at upstream end of site	<i>Lonicera japonica</i> : outside seed source	--
Bare Ground	0+50 to 1+00 and 1+50 to 2+00	Steep dry cut slope	3
