**Benbow Park
Stream Restoration
Closeout Summary Report
EEP Project # 29
2010**

April 2010

Project ID & Status	
Project Name and Number:	Benbow Park
EEP ID:	29
County:	Guilford
Project Type:	Stream Restoration
Current Status:	5 Years of Monitoring Complete

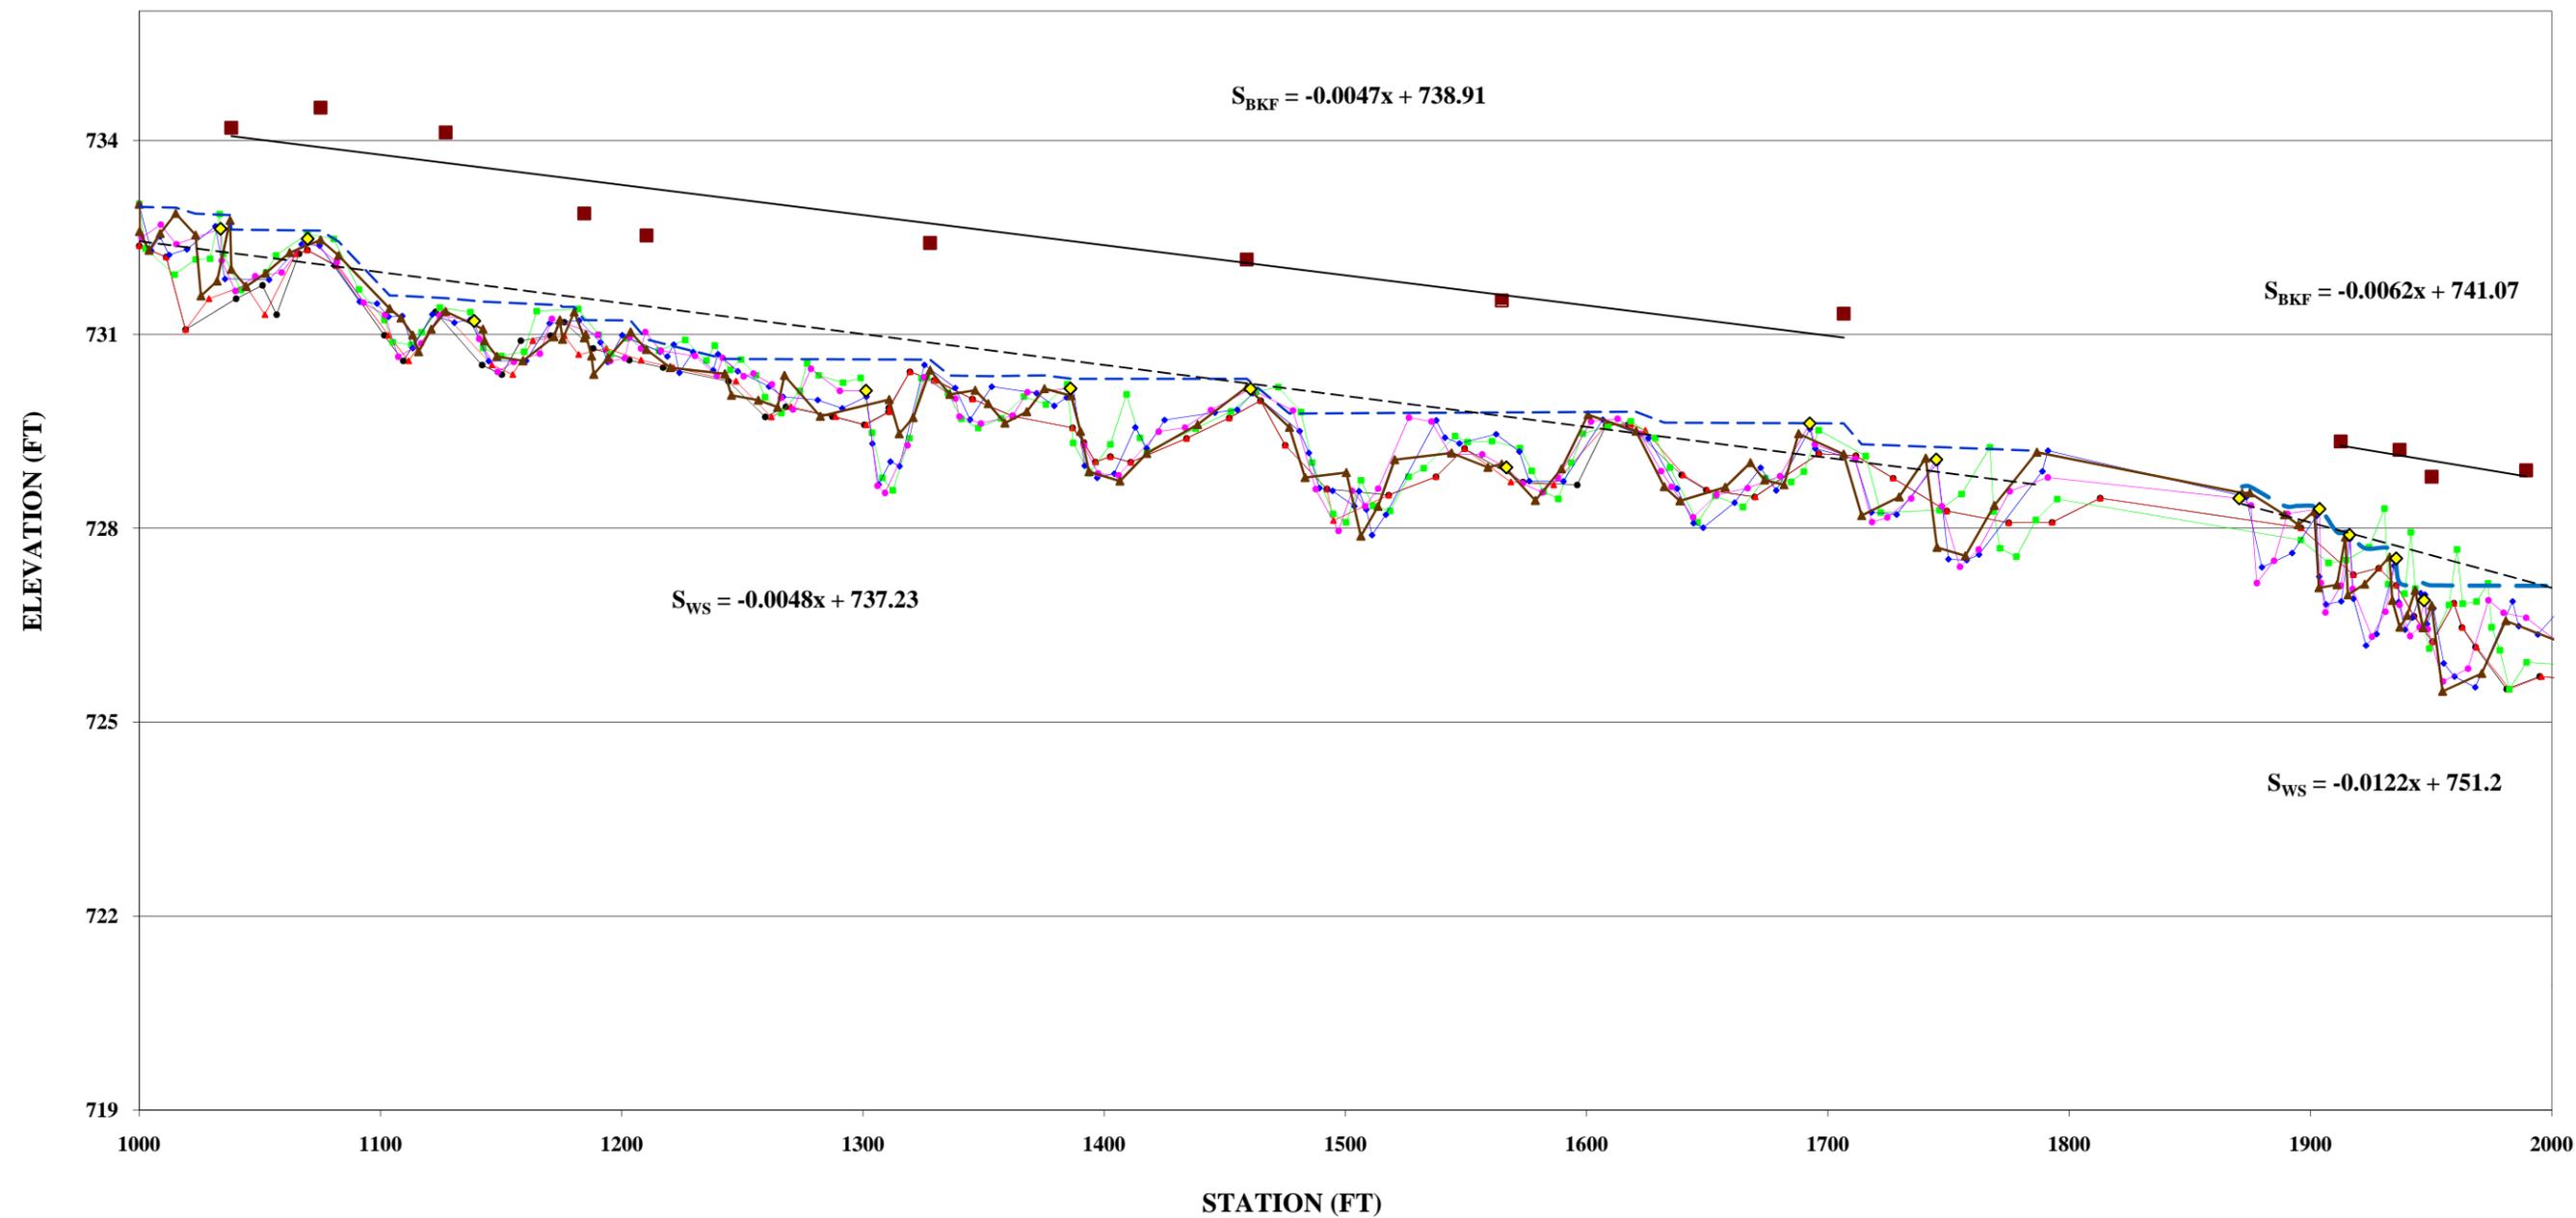
**Longitudinal Profile
Benbow Park
EEP Project Number 29 - MY05
Stations 10+00 - 20+00**

The profile has maintained its elevation, although a section of the stream immediately after the S. Benbow Road culvert has less well-defined bed features, while the remainder of the stream has maintained a riffle-pool pattern similar to the as-built survey. The in-stream structures are holding grade and stable. Almost all of the project structures are intact and have not been structurally compromised in any way.
