**AS-BUILT REPORT
for the
BRUSH and LITTLE PINE CREEKS
STREAM RESTORATION REPAIRS**

Alleghany County, North Carolina

EEP Project Number: 00054
Contract Number: D06082; Task Order: 06NW01-3

Submitted: May 2008; Resubmitted 17 June 2009

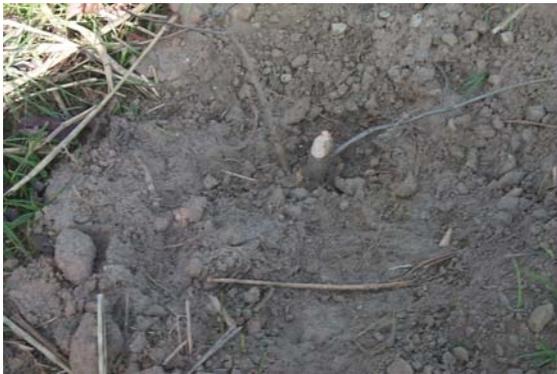
One vegetative problem area was observed at the time of the as-built survey. Beavers *Castor canadensis* had consumed some of the trees planted along BC. Approximately 54% of the trees and shrubs were destroyed in the BC vegetation monitoring plot. The U. S. Department of Agriculture eradicated three beavers from the project area. This area should be replanted with shrubs able to withstand browsing, and large trees.

Twenty-one percent of the total stems in the monitoring plots were identified as damaged. A majority of damage was caused by beavers (48%) and human trampling (23%). Beavers removed the tops of stems leaving stumps. Stumps were counted as live stems, but given a vigor rating of 1 – “unlikely to survive the next year”. Human trampling occurred mostly to live stakes. Damaged stems were identified in all plots; however, BC plot 1 accounted for the majority of damage to total stems. Beavers impacted 54% of the plants in BC plot 1.

VPA1: Example of beaver damage;
November 2006

To reduce further impacts from beaver, the U. S. Department of Agriculture was contracted and eradicated three beavers from the project area. The remaining woody vegetation appears to be in good condition and planted at high enough densities to tolerate some additional mortality without jeopardizing the site’s ability to meet future success criteria (320 stems/acre in monitoring year 3; USACE 2003).

It is recommended the problem area on BC be replanted with larger diameter containerized woody plant species such as silky dogwood *Cornus amomum* and silky willow *Salix sericea* that are adapted to being browsed. In addition, the monitoring and beaver eradication program should continue until tree and shrub species become fully established.

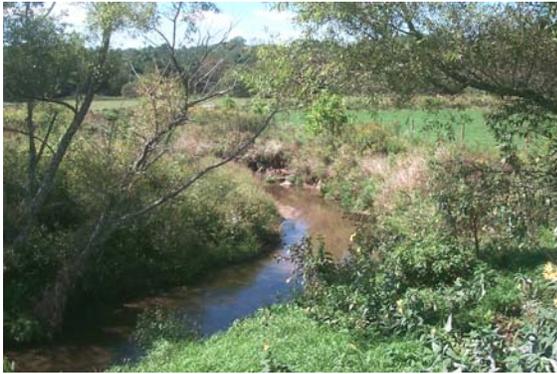
PS-1, bearing 240°: Pre-construction view of station 0+00 to station 3+00; September 2006.

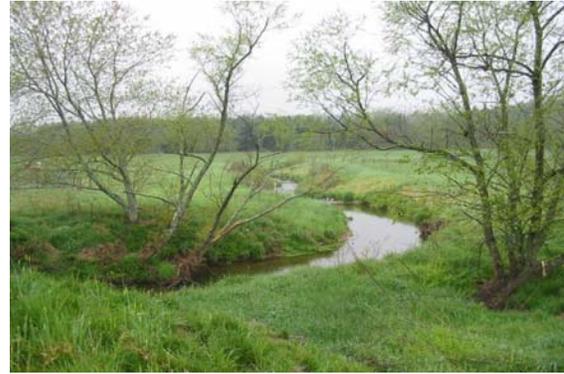
PS-1, bearing 240°: Post-construction view of station 0+00 to station 3+00; April 2007.

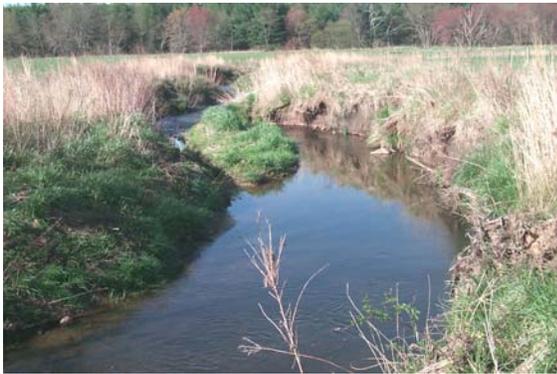
PS-2, bearing 270°: Pre-construction view of station 0+50 to station 1+00; April 2006.

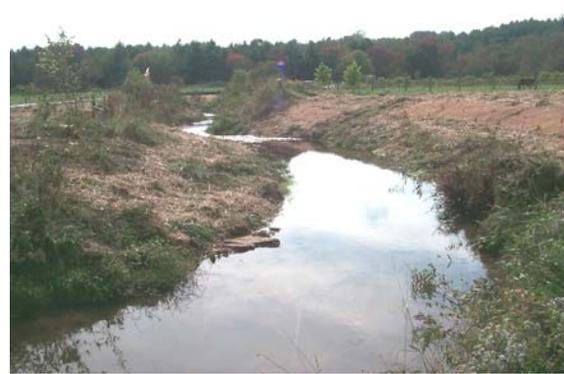
PS-2, bearing 270°: Post-construction view of station 0+50 to station 1+00; October 2006.

Little Pine Creek.-Between station 0+50.0 and station 0+75.0 on LPC the repair plan called for adding a root wad and mini-rock vane along the right bank. Two root wads were added to the right bank with logs in between the root wads. These logs fill in gaps between the root wads, help stabilize the bank, act as digger logs to help maintain pool depth, and provide fish habitat. The additional root wads made the proposed mini-rock vane at station 0+72.0 unnecessary.

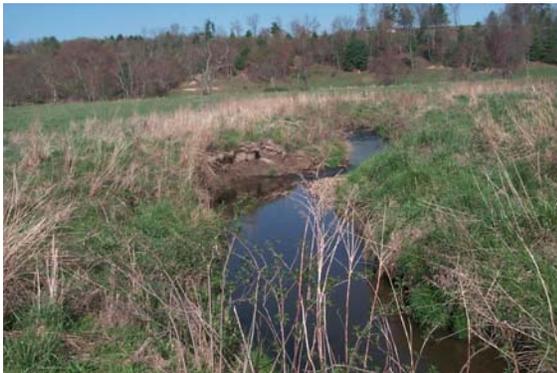
PS-4, bearing 276°: Pre-construction view of station 3+50 to station 5+00; April 2006.

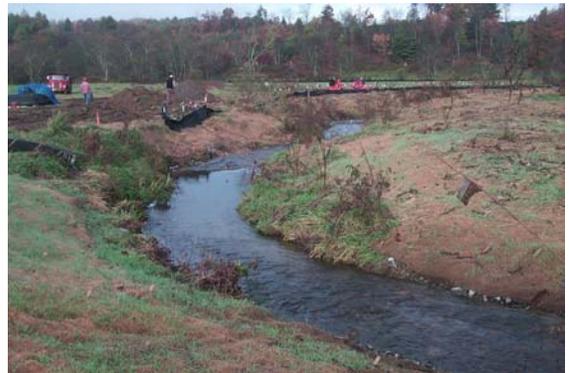
PS-4, bearing 276°: Post-construction view of station 3+50 to station 5+00; October 2006.

A log vane was installed along the left bank of LPC at station 3+79.0 to help direct water away from the bank and around the meander bend; this enhancement was not on the original repair plan. The toe of the left bank was protected with a coir log, while a bankfull bench was created along the right bank. With the other enhancements at this location, the proposed bankfull bench along the left bank between stations 3+70.0 and 4+20.0 was not necessary.

At the direction of EEP and HDR staff, a bankfull bench was built on both sides of LPC station 4+25.0 to its confluence with BC. The bench was built at a lower elevation than called for in the repair plan to accommodate the increased bank height in this area.

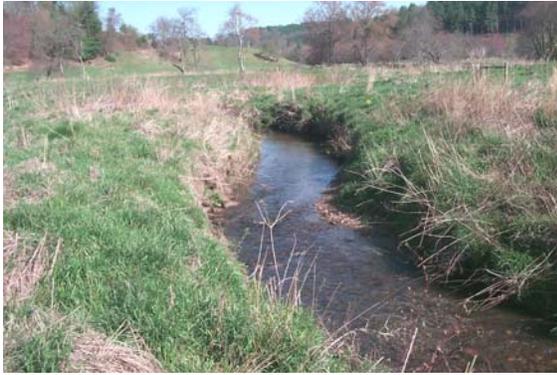
PS-6, bearing 314°: Pre-construction view of station 5+75 to station 7+00; April 2006.

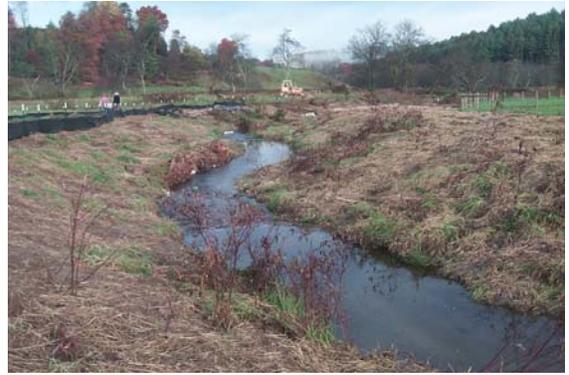
PS-6, bearing 314°: Post-construction view of station 5+75 to station 7+00; October 2006.

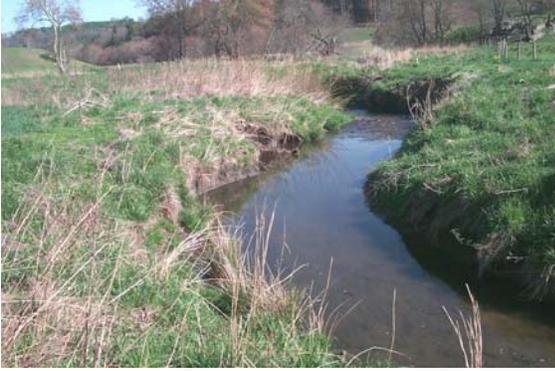
PS-8, bearing 322°: Pre-construction view of station 7+10 to station 8+00; April 2006.

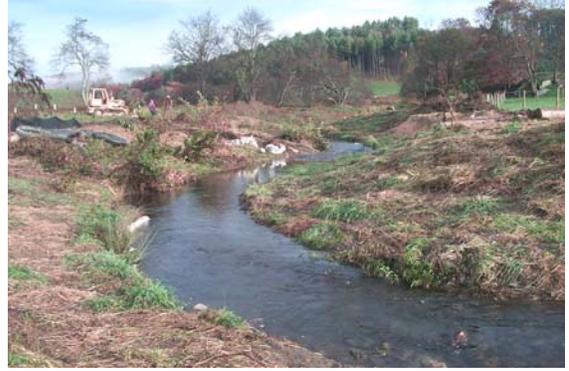
PS-8, bearing 322°: Post-construction view of station 7+10 to station 8+00; October 2006.

A mini-rock vane, 4 root wads, and a digger/footer log were installed along the left stream bank between station 7+00.0 and station 7+50.0. The repair plan called for a mini-rock vane and 6 root wads.

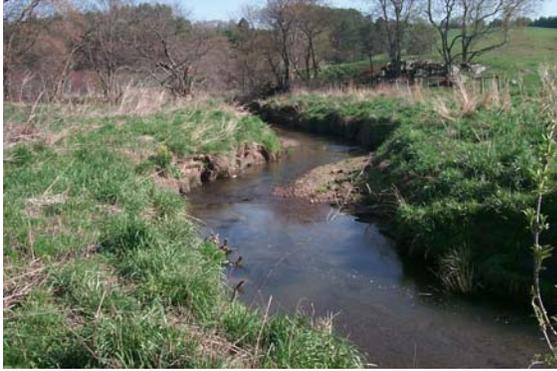
PS-10, bearing 4°: Pre-construction view of station 8+32 to station 10+00; April 2006.

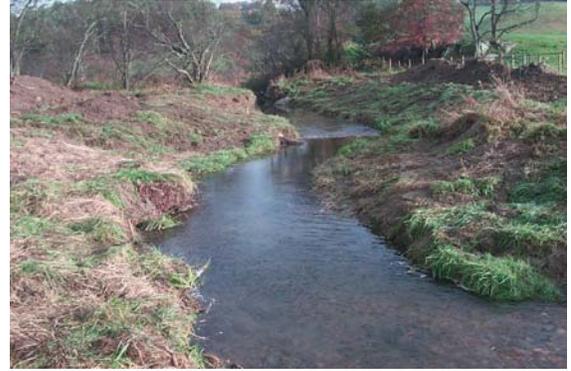
PS-10, bearing 4°: Post-construction view of station 8+32 to station 10+00; October 2006

Two additional log vanes were installed at stations 8+75.0 and 9+05.0 on LPC to help redirect water away from the banks and enhance aquatic habitat. Although not in the repair plan, the riffle at station 9+19.0 was augmented with larger rock at the request of the HDR engineer. The area between station 8+68.0 and the confluence with BC has little current (backwater) where fine sediment was being deposited. Five digger logs were installed in this area in an attempt to provide increased water velocity, improved habitat, and to help move sediment out of this area. A log/rock vane was installed on the left bank at station 9+70.0 to help stabilize the bank.

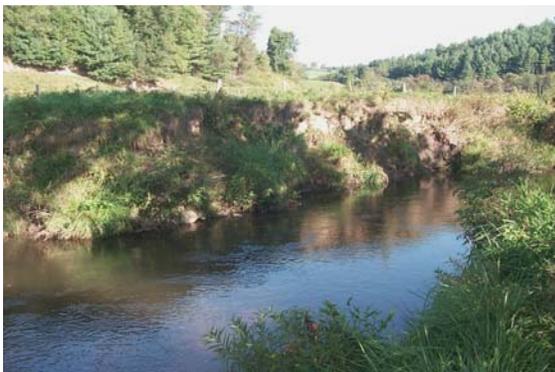
PS-14, bearing 340°: Pre-construction view of Brush Creek station 1+25 to station 2+00; September 2006.

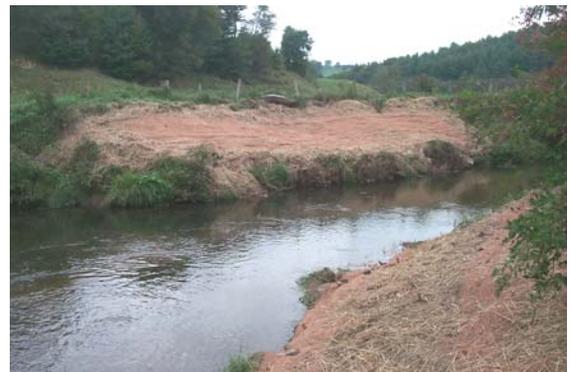
PS-14, bearing 340°: Post-construction view of Brush Creek station 1+25 to station 2+00; September 2006.

Brush Creek.-The repair plan called for extending the left bank into the existing stream channel and installing three root wads between station 1+50.0 and station 1+75.0. The bank at station 1+75.0 had previously been stabilized with large rock. This area was currently stable and provided backwater habitat for fish. Six root wads were installed on the left bank between

station 1+80.0 and station 2+10.0; only three were called for in the repair plan. An additional rock vane was installed on the left bank at station 8+40.0.

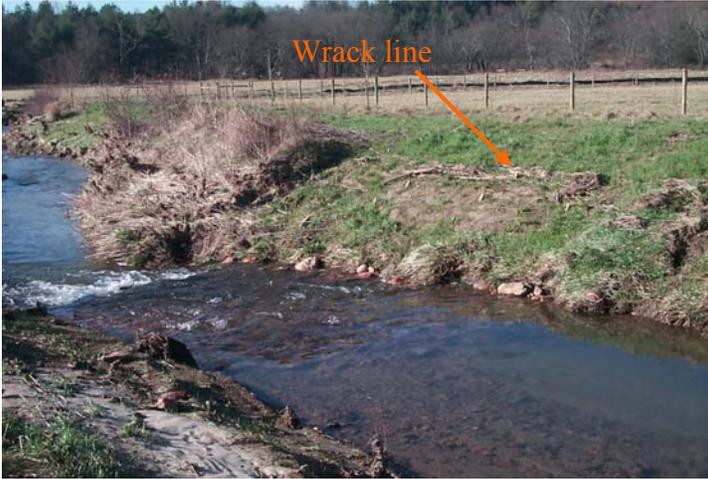
Wrack line following bankfull event identified on
January 24, 2007.
