EEP Project Closeout Summary	
Project ID & Status	
<u>Project Name/Number:</u>	Clear Creek
<u>EEP ID</u>	092
<u>County:</u>	Henderson
<u>Project Type:</u>	Stream Restoration
<u>Current Status:</u>	5 Years of Monitoring complete

Project Clear Creek Stream Closeout Report (2009) Henderson County, North Carolina	Prepared By

Kimley-Horn and Associates, Inc.	
	Date 06/25/2009	Project Number 092

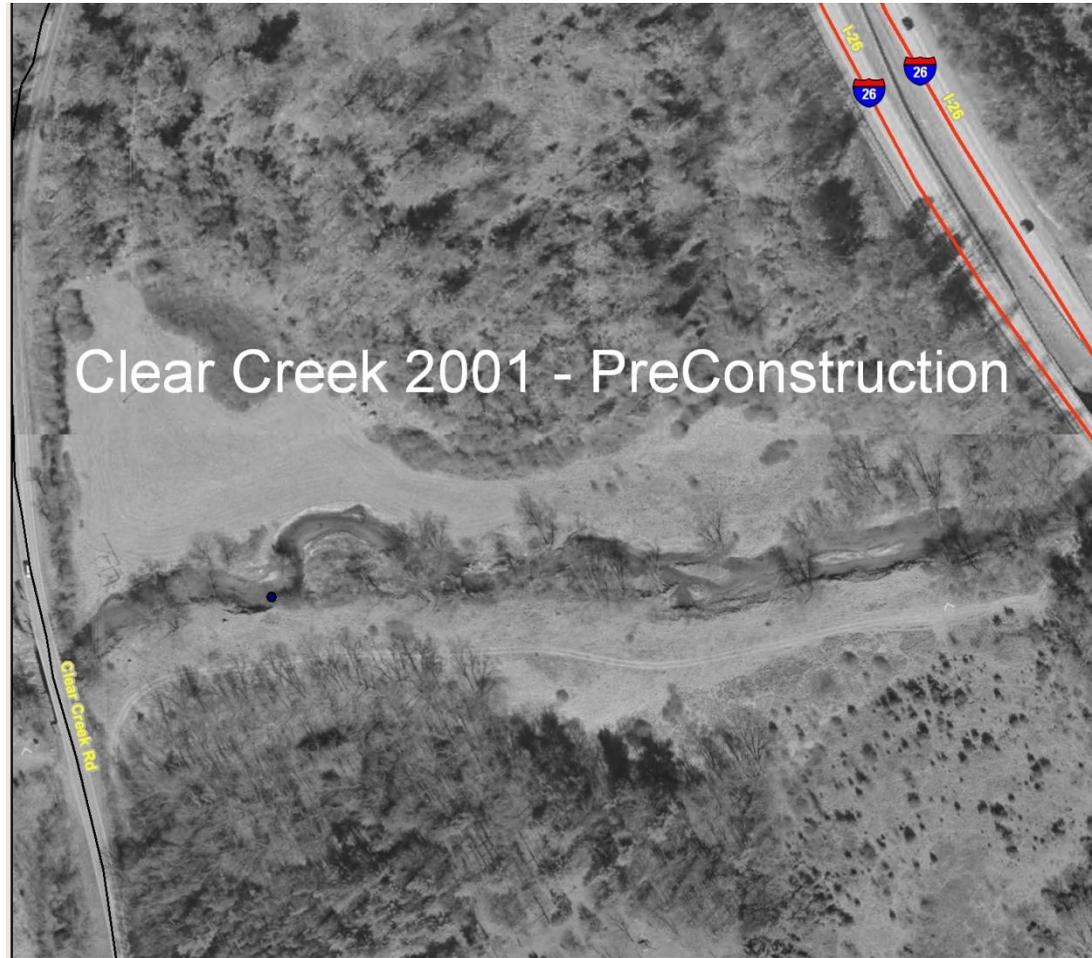
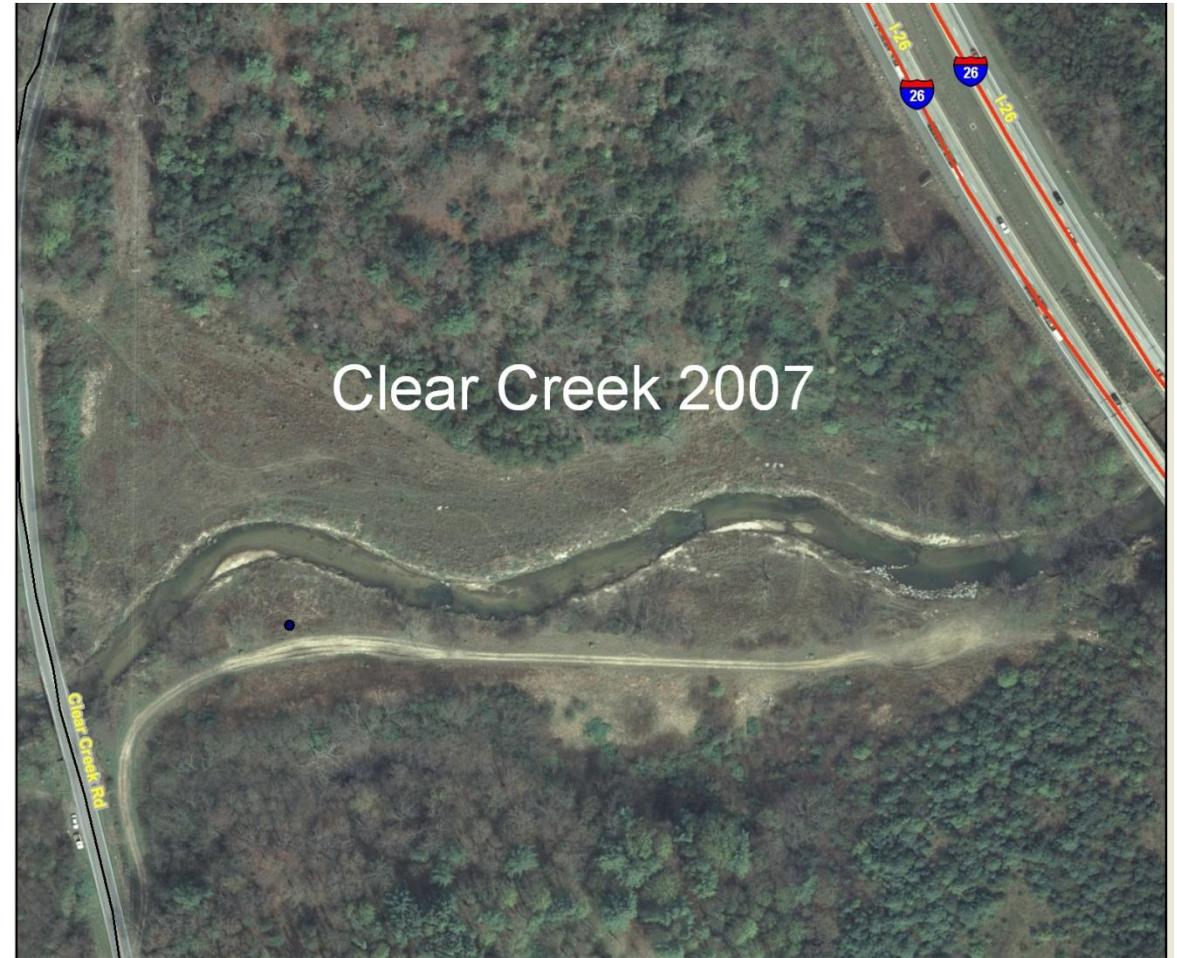
Figure 2: Pre-Post Construction Aerial Photographs

Prior to January 1951, the date of the oldest aerial photograph available at the Henderson County NRCS Office, Clear Creek was straightened. Presumably, it was straightened for agricultural purposes and for construction of a sanitary sewer line, as the county was predominantly rural at that time. Successive aerial photographs show the construction of I-26 in 1965. A 1969 aerial photograph (NCDOT) shows Clear Creek flowing straight, wide and shallow, typical of an F stream type. The 1994 photograph shows that Clear Creek is trying to re-establish meanders. See aerials from 2001 (pre-construction and from 2007 post-construction) in Figure 2.

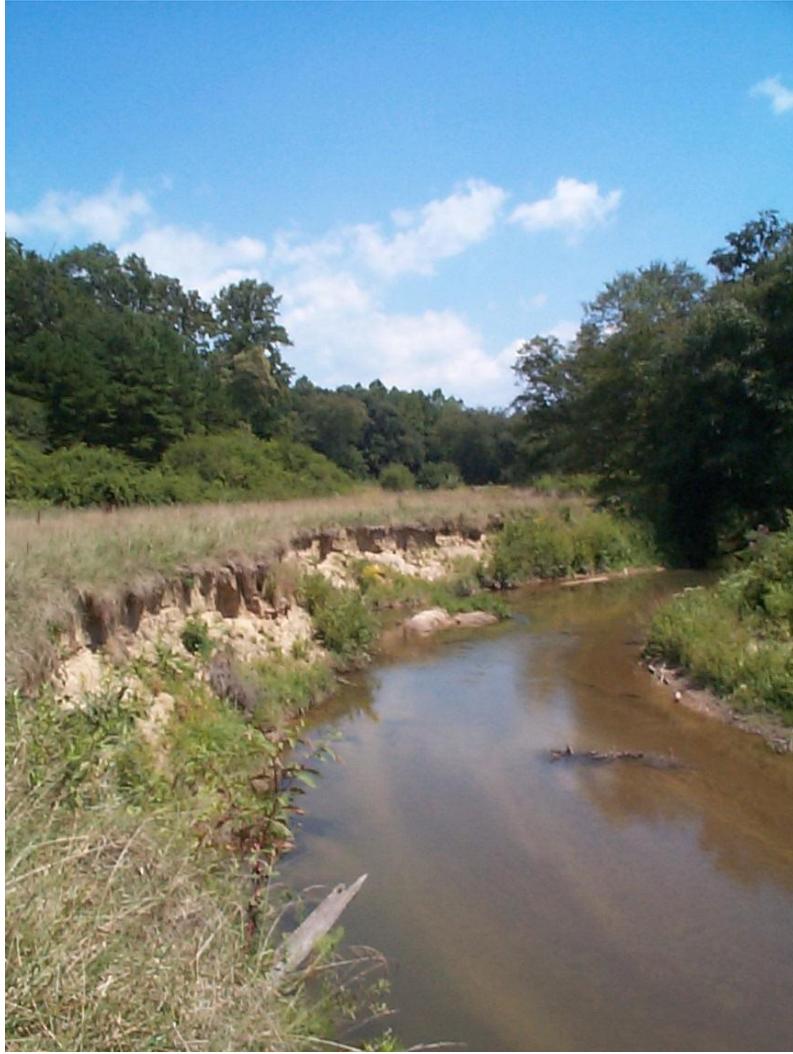
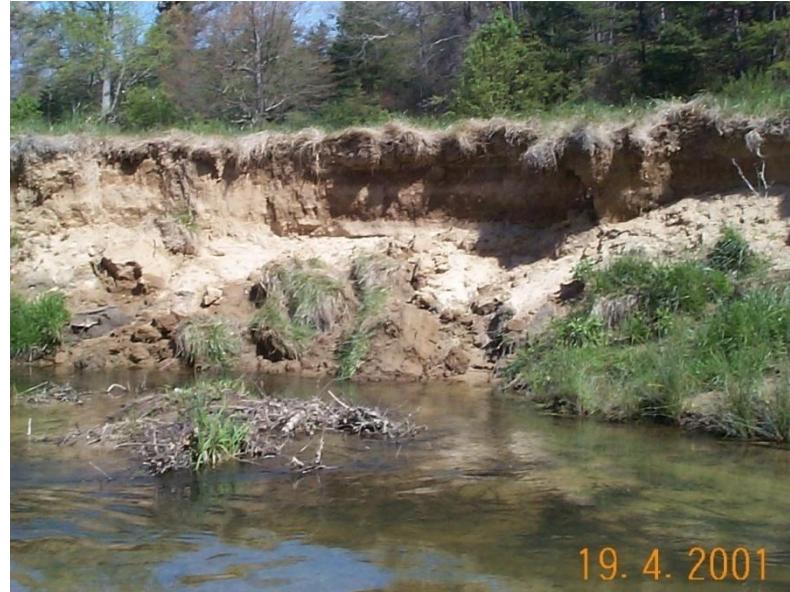
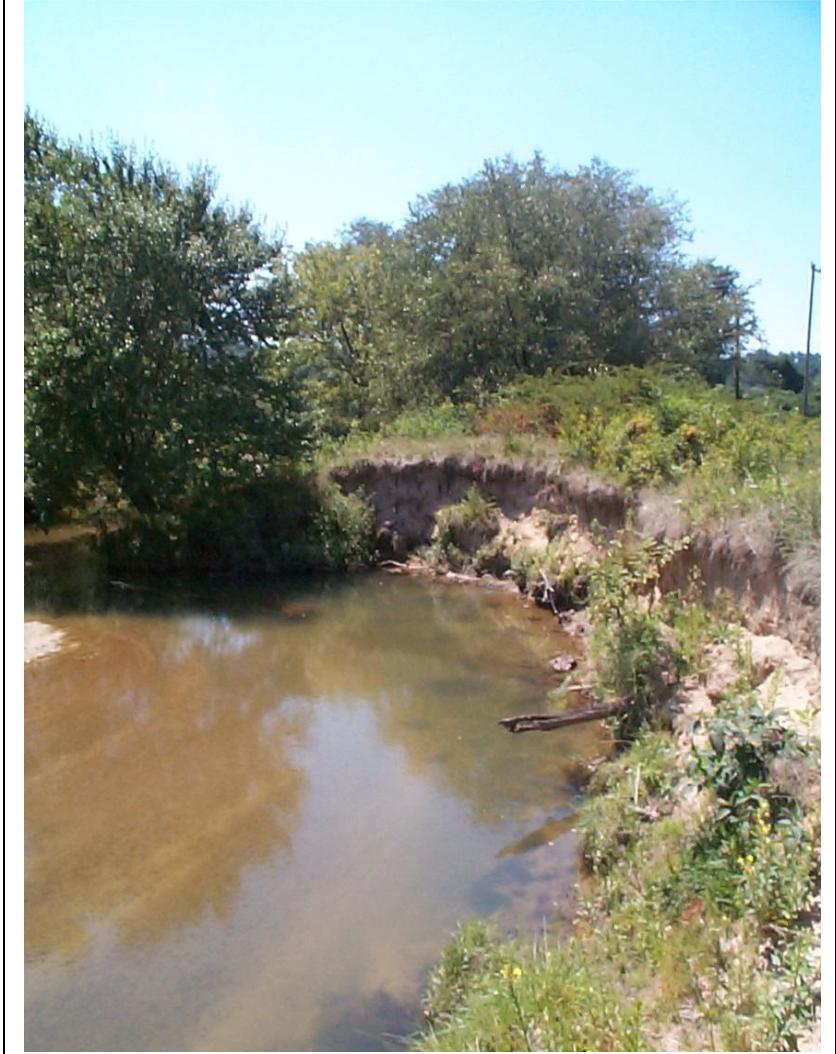
Figure 5: Pre-Existing Condition Photos

Clear Creek – Before Construction (2001)

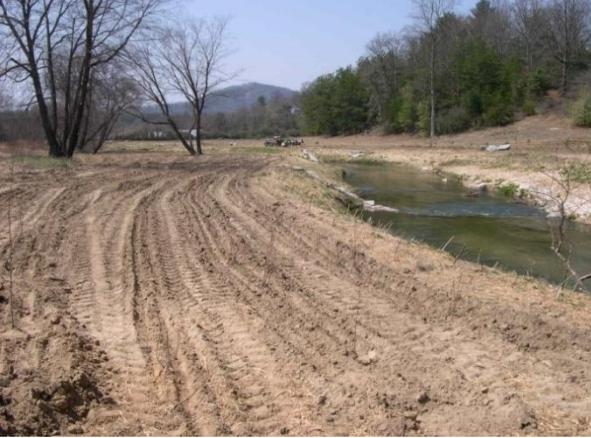
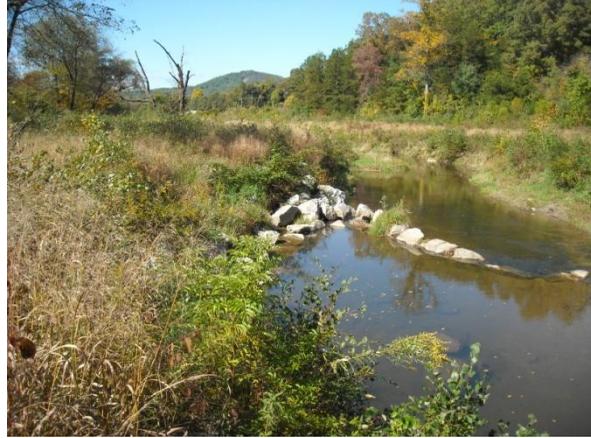
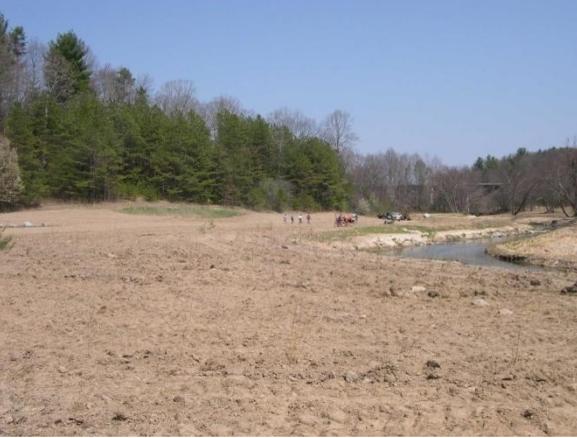
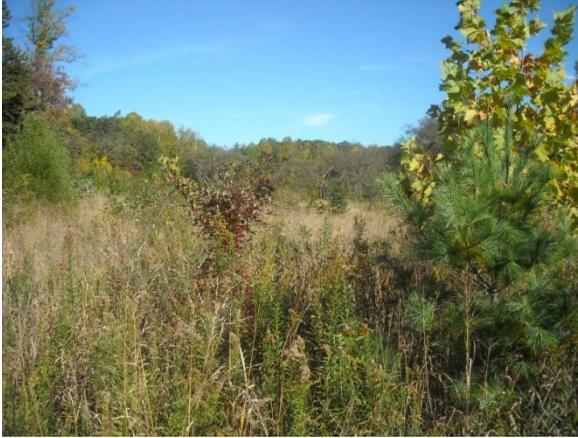
Figure 6: As-Built Photo Comparison

Clear Creek – As-Built Station 1+00 Facing Downstream	Clear Creek – Year 5 (2008) Station 1+00 Facing Downstream	Clear Creek – As-Built Station 7+80 Right Floodplain Facing Upstream	Clear Creek – Year 5 (2008) Station 7+80 Right Floodplain Facing Upstream

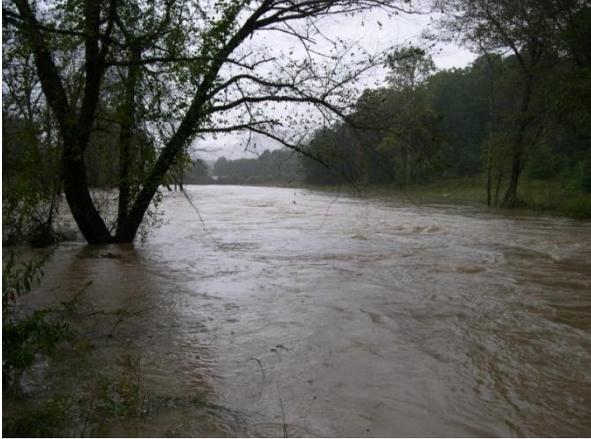
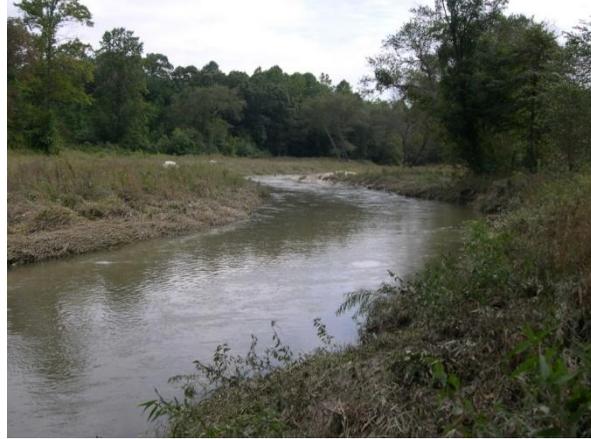
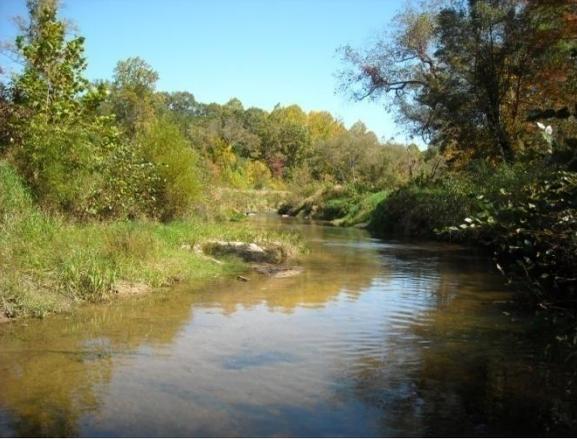
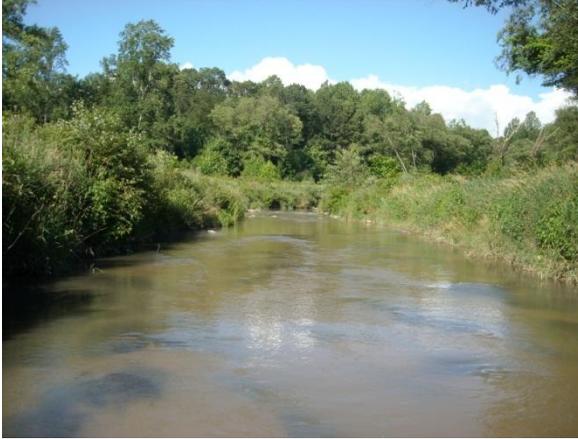
Figure 7: Stream Photos

Shortly after construction, successive Hurricane events in 2004 generated several isolated instances of bank scour, which have advanced little over the monitoring period. The percentage of bank exhibiting scour has maintained levels between 8 and 10% since that time, with little advancement. In between the large storms related to the remnant hurricanes of 2004, the bank was hardened in an emergency measure near the old channel plug at the top of the project. The flow vectors coming into the project under the I-26 bridge led to concerns after the first event that the forecasted, second event might re-enter or avulse into the abandoned channel on stream left. The North Carolina Ecosystem Enhancement Program (EEP) always intended to regrade and replant this area once additional observation provided confidence that the vectors and conditions would not lead to an avulsion. This was carried out in winter of 2008/2009 and while equipment was already on site, another area between station 9+00 and 10+00 on stream right was repaired as well. This area did not seem to completely arrest its advancement as with the other areas of bank scour and the adjacent floodplain exhibited poorer soil conditions and lesser vegetation success. This included bank resloping and root wrap installation to an area greater than the bounds of observed instability as well as installation of additional plantings.

Clear Creek – Hurricane Ivan (09/2004) Station 0+00 Facing Downstream	Clear Creek – Hurricane Frances (09/2004) Station 7+80 Facing Upstream	Clear Creek – Year 5 (2008) Station 7+80 Facing Upstream Compare to Hurricane Frances Photo	Clear Creek – Year 5 (2008) Station 5+50 Facing Upstream Note established vegetation along banks.

Three structures designed to provide bank protection exhibited some loss of structural integrity or did not provide complete bank protection as intended. These conditions are believed to be the result of flooding events from 2004 and 2005 (See figure 6 photos of Hurricanes Ivan and Frances) and have not noticeably advanced since their initial onset. Also, associated with the flooding events of 2004 and 2005 are several isolated instances of bank scour, which have advanced little over the monitoring period. Other in-stream structures are holding grade and directing the flow into the center of the channel properly.

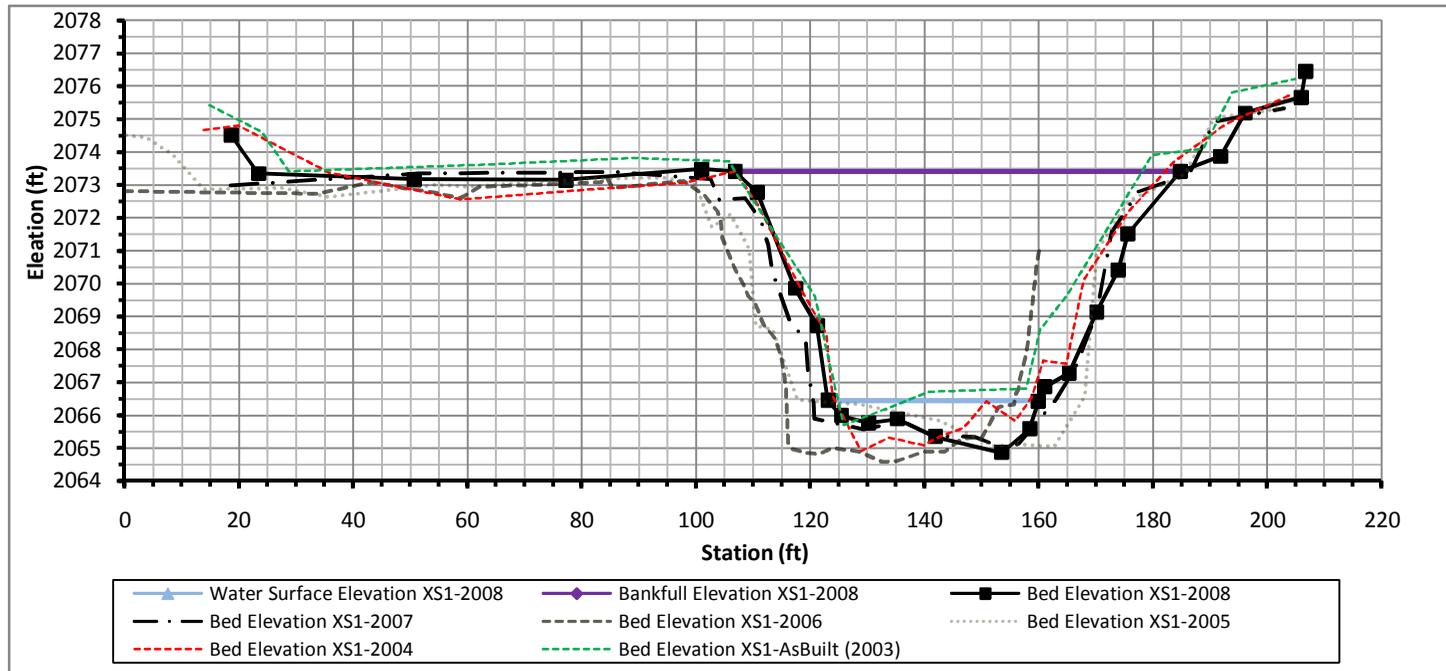
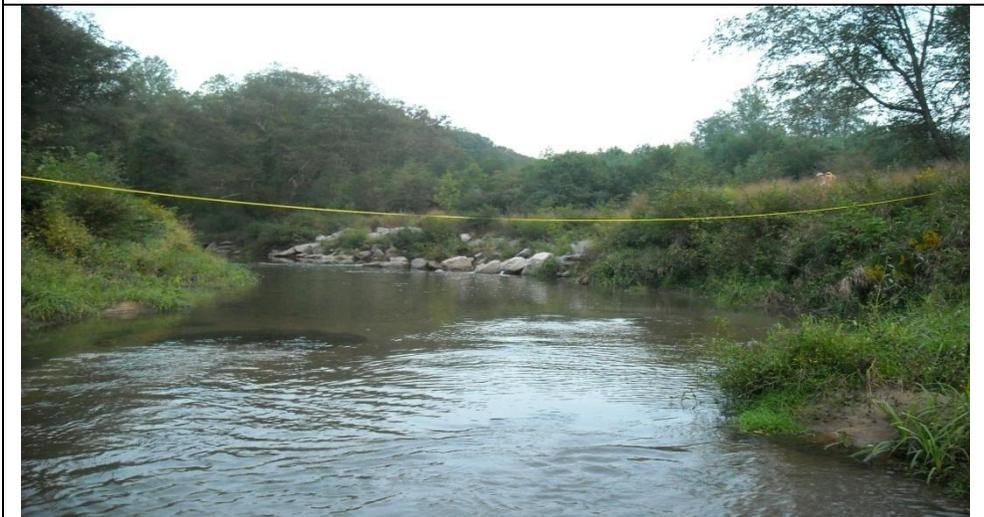
Figure 8. Cross Section 1 (Riffle)

Through the five year monitoring period, the riffle cross section areas have averaged 6% to 18% larger than the as-built conditions. A portion of this increase could be attributed to XS1 and XS2 being re-set during the monitoring year 2 morphological survey. Heavy flooding events in 2004 (see figure 6 photos of Hurricanes Ivan and Frances) generated several isolated instances of bank scour and some impact to three in-stream structures. These conditions have not noticeably advanced after their initial occurrence. The channel prior to restoration was classified as an F5 stream type, wide and shallow. The channel was constructed as a C4 stream type. The entrenchment ratio for the stream was maintained throughout the monitoring period, which indicates healthy floodplain capacity. There appeared to be some lateral migration in cross section three, but this may have been a lateral shift in the survey by the monitoring consultant. The bankfull area increased for XS1 and XS3 during monitoring year 2, however the subsequent years showed a trend towards as-built conditions. The pool cross section exhibited greater depth than that of the riffles, indicating the maintenance of distinct bedform features during the monitoring period. The project's dimensions currently represent an E/C channel and exhibit steep inner meanders, which can present pressure on the outer meander. Some meanders have exhibited modest, slow lateral migration, but this appears to be at a sustainable rate such that the inner meander builds at a complementary modest rate. Collectively, these conditions indicate stability or stable trends of the restored reach. The plots below show some of the conditions of the channel dimensions for the project.

XS1 – Riffle: 5 year mean – Very coarse sand (d50) to Medium gravel (d84).

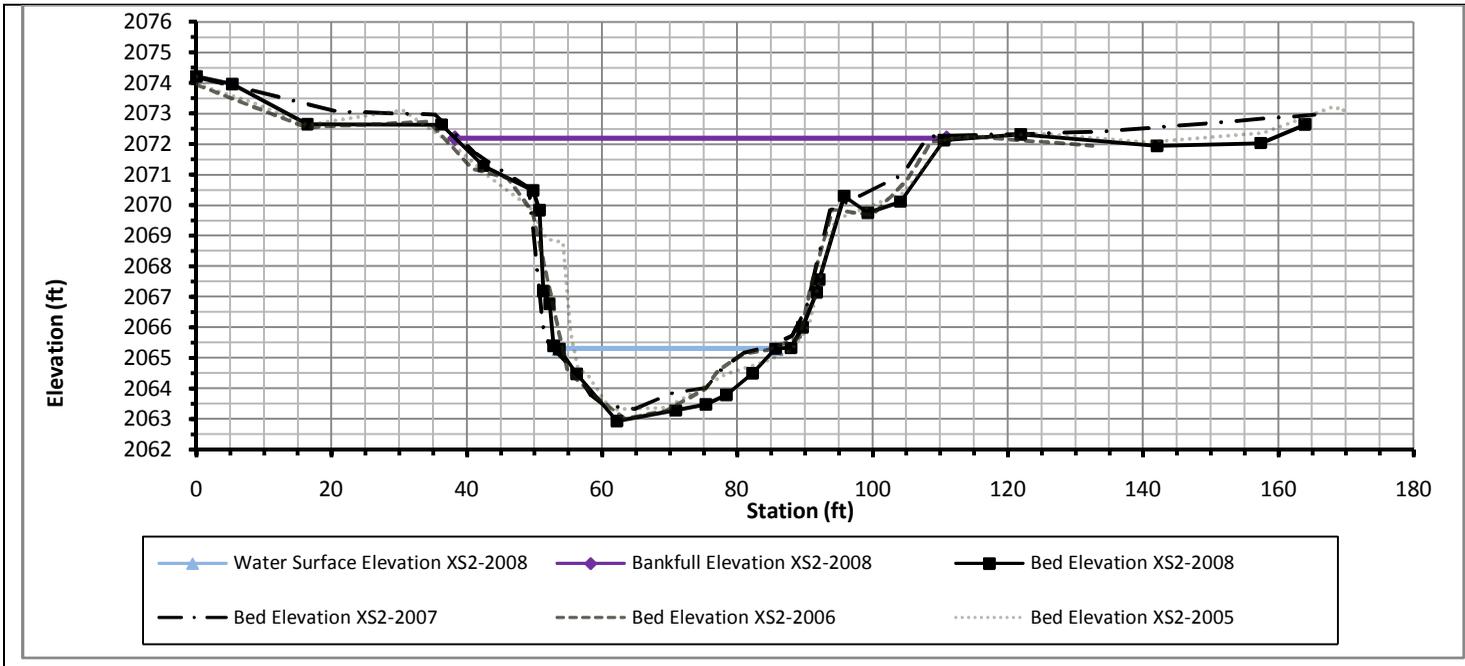
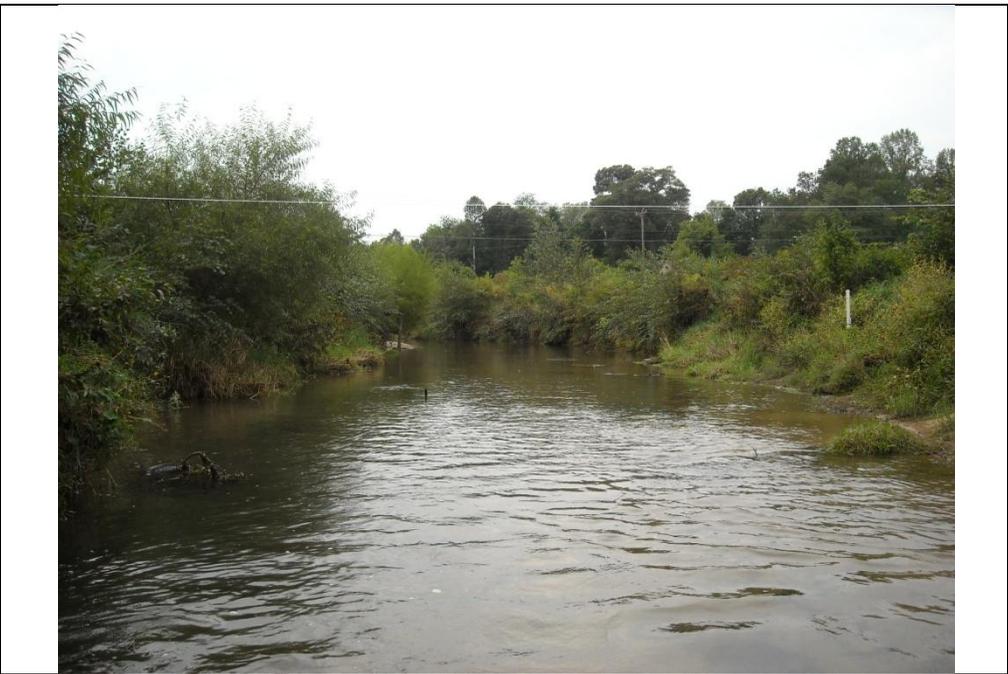
Figure 8. Cross Section 2 (Riffle)

XS2 – Riffle: 5 year mean - Very fine gravel (d50) to Medium gravel (d84).

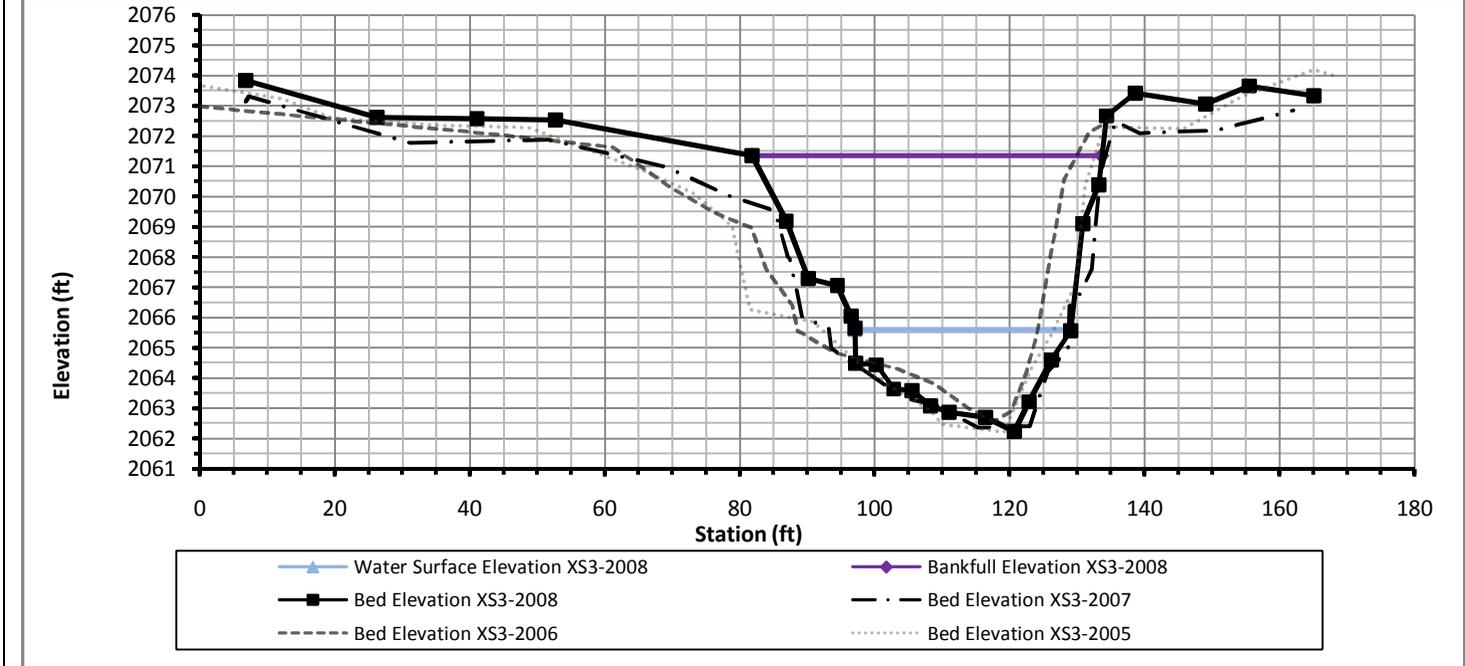
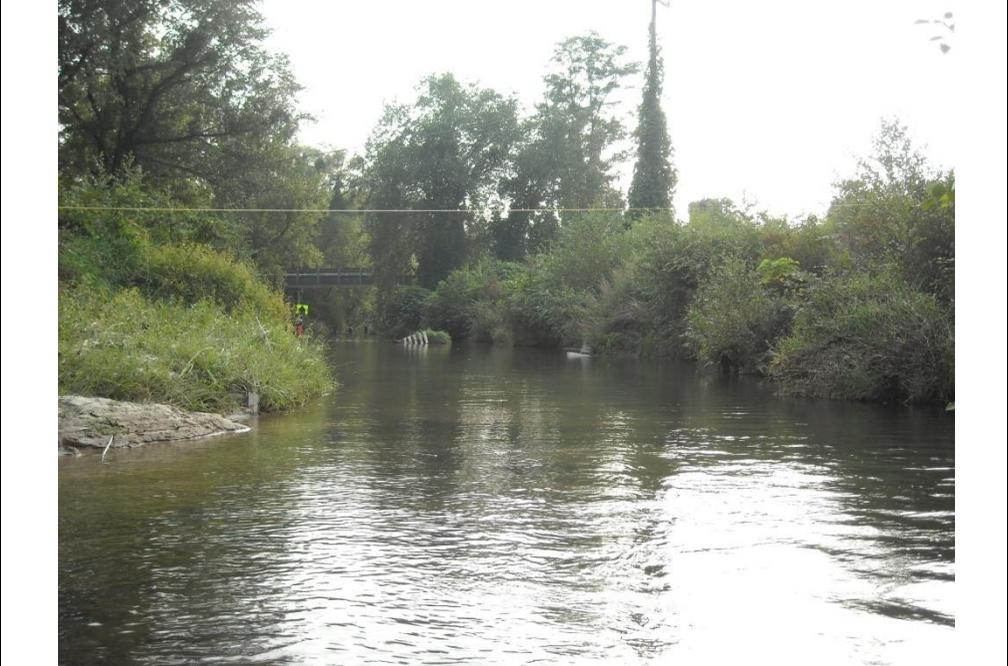
Figure 9. Cross Section 3 (Pool)

XS3 – Pool: 5 Year Mean – Coarse sand (d50) to Fine gravel (d84).

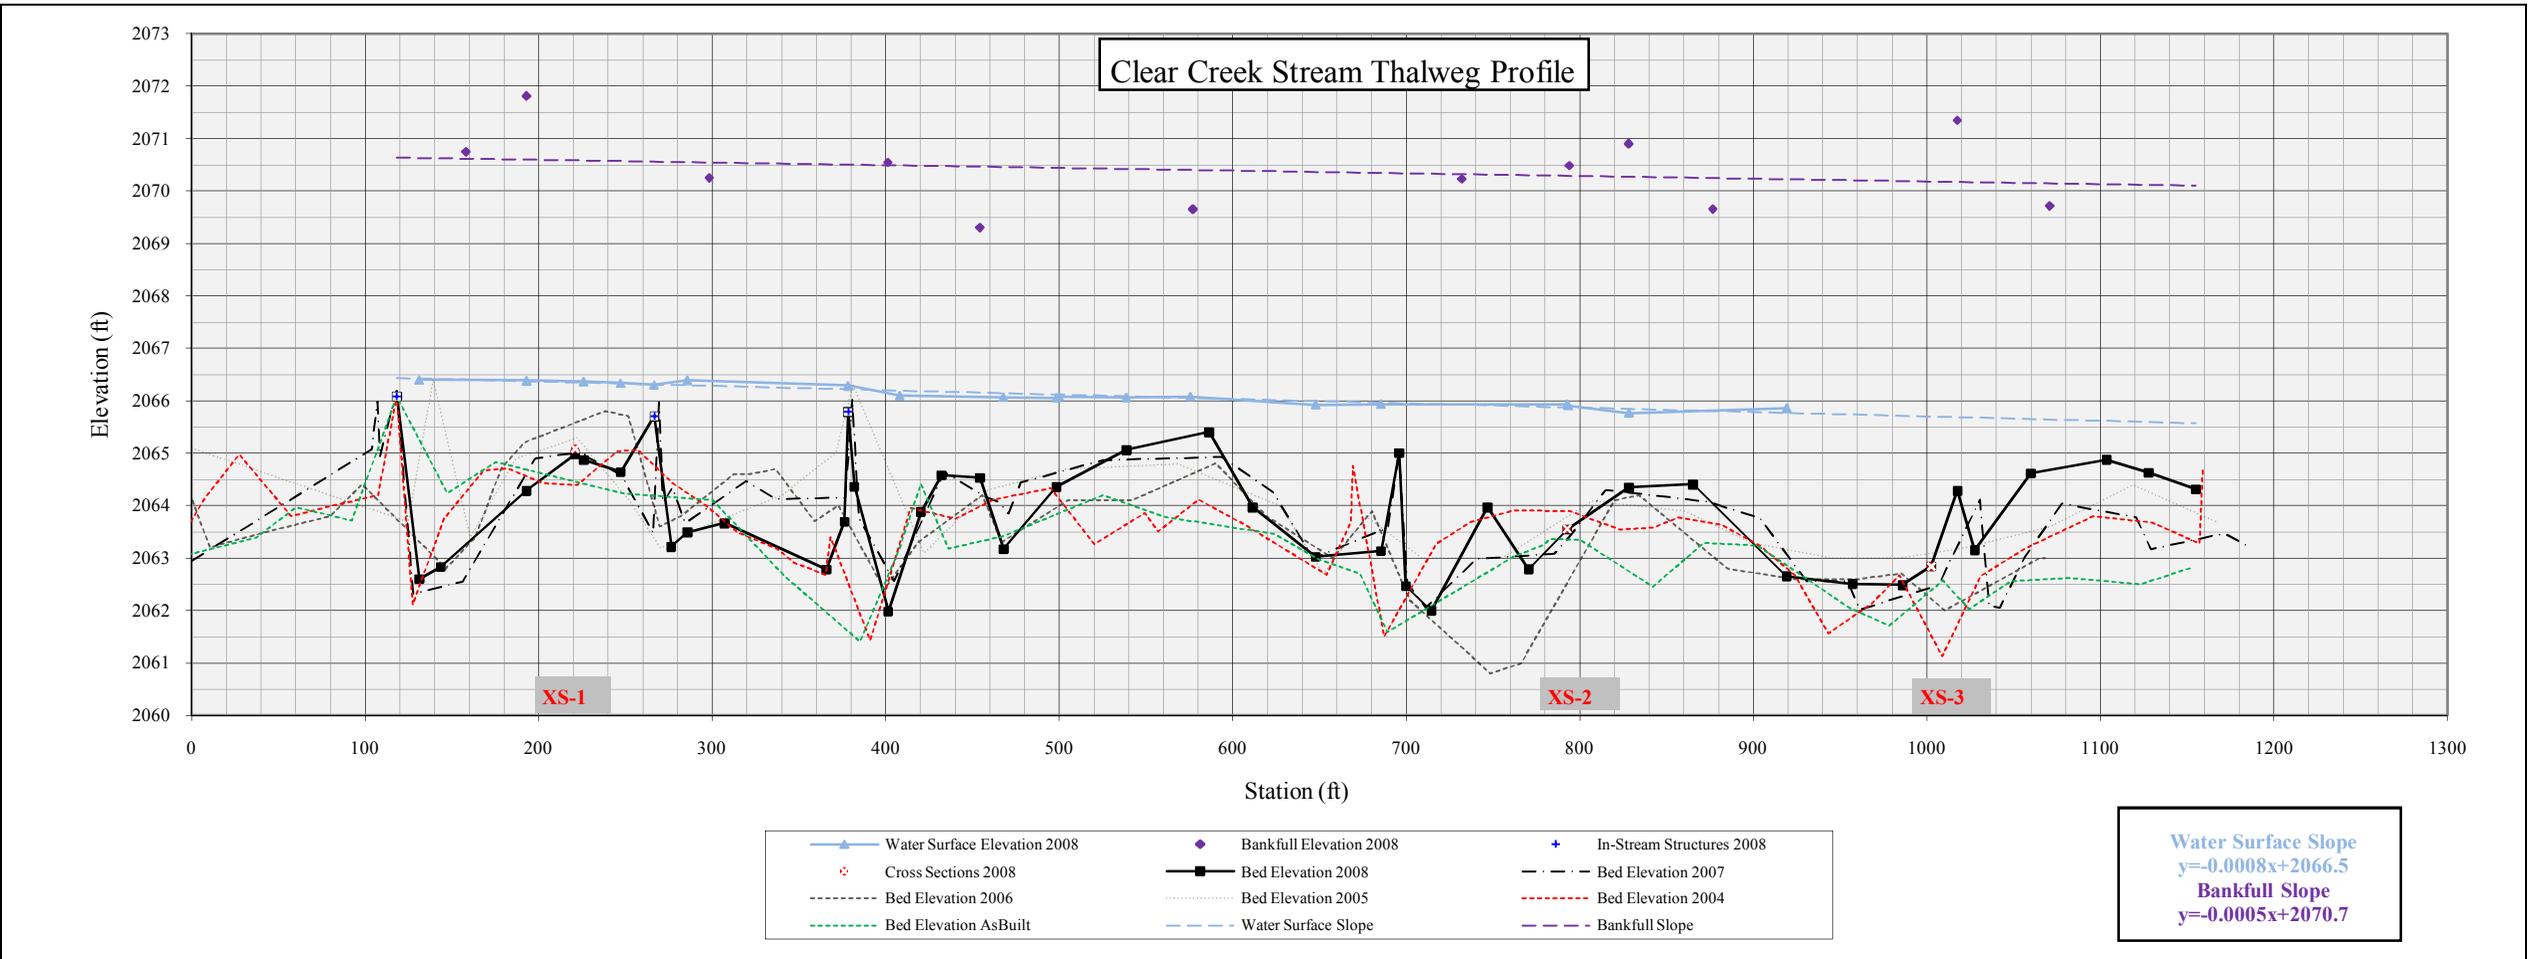
Figure 10. Clear Creek Longitudinal Profile

The riffles, pools, and thalweg have maintained or improved function over the course of the five year monitoring period. Overall the bed has maintained feature faceting, but has been subject to imports of sand and as a result the thalweg has been shifting. It has generally been controlled by the project structures and woody debris that has been introduced and passed through the reach at various points in the project's history. Pools and bed faceting have been maintained in overall quantity, but these bed features (other than those tied to the engineered structures) have oscillated in their longitudinal position in response to the above factors. Some of the variability exhibited with baseline and year-1 monitoring may vary due to a different method of survey with subsequent measurements.

As described previously the site has been subject to the import and presence of sand, which has contributed to a shifting thalweg and although the bed has maintained pools and a diversity of bed facets, the overlying material is definitively finer than intended, limiting coarser riffle bedforms.

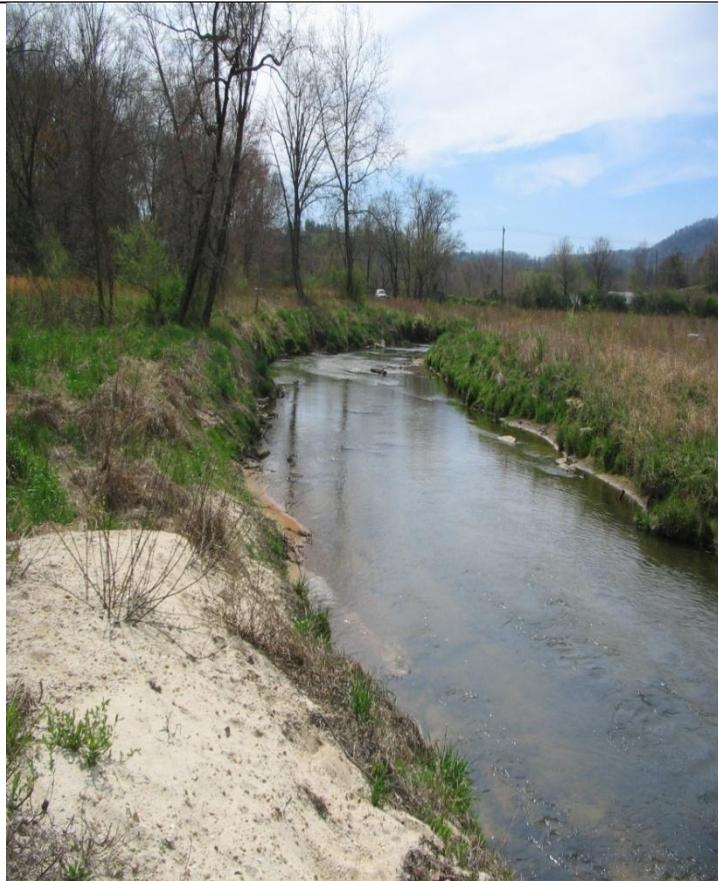
Figure 11. Evidence of Bankfull Event (10/13/2008)

There were three recorded bankfull events during the five year monitoring period, of which occurred on 07/02/03, 09/08/04, and 10/13/08. Alluvial deposition on the floodplain can be seen in figure 11 below.

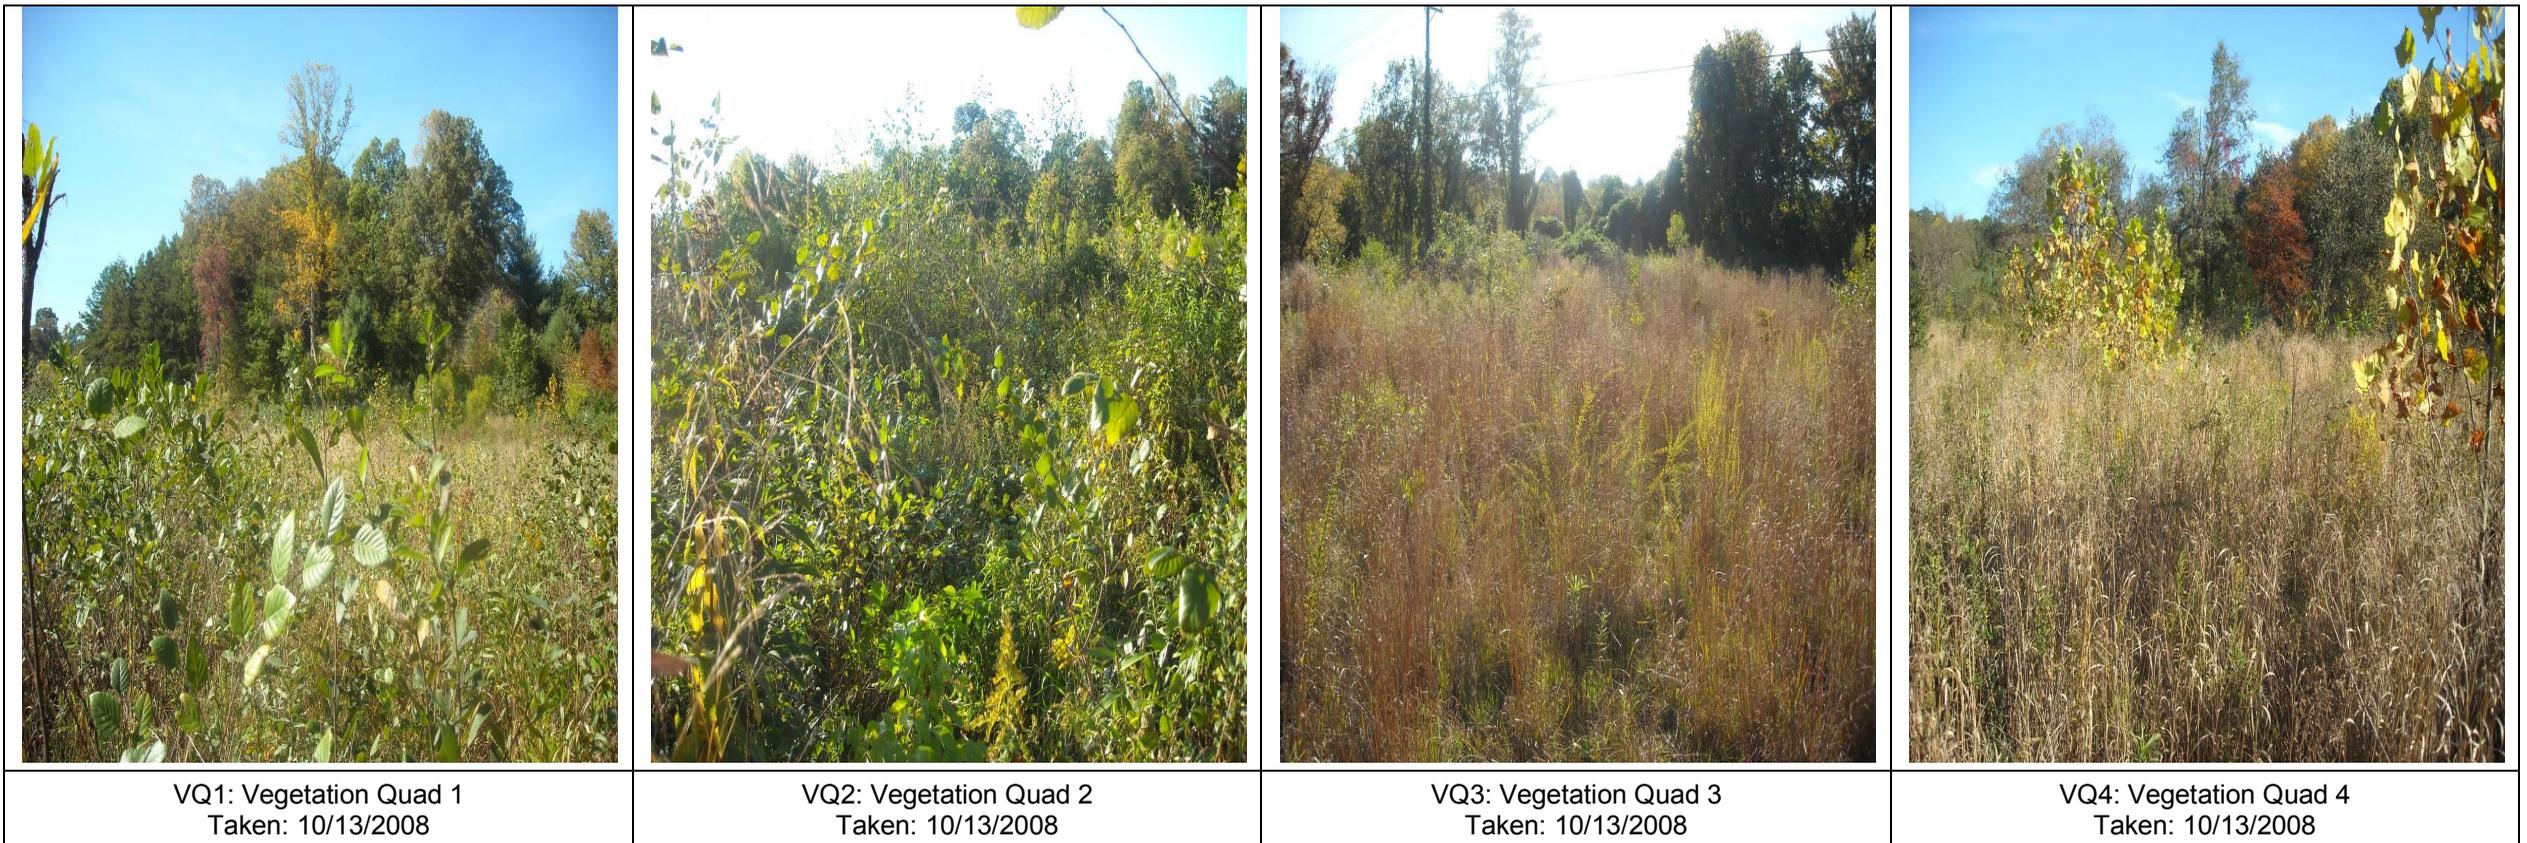
Figure 12. Vegetation Quad Photos (Year 5)

Success criteria for the project require 260 live stems per acre within the restoration area during year 5 of a 5-year monitoring period. The data in table 5 shows that the vegetation for the Clear Creek site has met the success criteria for the monitoring period. Plot 3 contains less planted stems, but total stems including volunteers exceed success criteria. The volunteer stems greatly outnumber the planted stems in plots one and two, because of the River Birch that is colonizing on that bank. Monitoring year 1 data is also significantly higher than other years, which may have been a result of using a different form of measurement. Overall the site is showing good vegetation growth and is meeting the success criteria.
