EEP Project Closeout Summary

Project ID and Status		Project Setting and Background			Project Timeline		
Project Name:	Ellerbe Creek	Basin:	Neuse		Restoration Plan:	March 2003	
EEP ID:	127	Physiographic Region:	Piedmont		Construction Complete:	March 2005	
County:	Durham	Ecoregion:	Triassic Basin		Monitoring Year 1:	Oct2005	
Project Type:	Stream	14-Digit HUC:	03020201050010		Monitoring Year 2:	Sept 2006	
Type:	Restoration	NCDWQ Sub-basin:	03-04-01		Monitoring Year 3:	Sept 2007	
Current Status:	5 years of monitoring complete	Thermal Regime:	Warm		Monitoring Year 4:	Sept 2008	
		Trout Water:	No		Monitoring Year 5:	July 2009	
		Designer:	Stantec Consulting				
		Monitoring:	Stantec Consulting Robert J. Goldstein & Associates

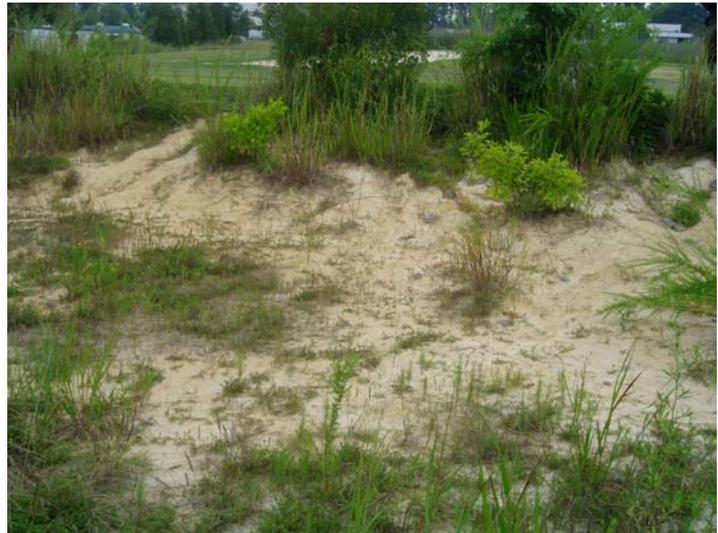
Figure 6. Bare soil associated with rill and gully erosion

Several small areas of bare soil persisted on the site, primarily due to erosion of the terrace riser slopes immediately adjacent to the golf course. As can be seen in Figure 6, herbaceous species have begun to establish themselves and these areas are expected to decrease over time. Several stands of mimosa (*Albizia julibrissin*) were found on the site, along with some other scattered invasive species. The project is scheduled for invasive vegetation treatment in 2010 and 2011, which should address this problem.
