## EEP Project Closeout Summary

Project ID and Status	Project Setting and Background	Project Timeline
<b>Project Name:</b> Forest Hills <b>EEP ID:</b> 139  <b>County:</b> Durham <b>Project Stream Type:</b> Restoration <b>Current Status:</b> 5 years of monitoring complete	<b>Basin:</b> Cape Fear  <b>Physiographic Region:</b> Piedmont <b>Ecoregion:</b> Triassic Basin <b>14-Digit HUC:</b> 03030002060120  <b>NCDWQ Sub-basin:</b> 03-06-05 <b>Thermal Regime:</b> Warm <b>Trout Water:</b> No <b>Designer:</b> KCI Associates of North Carolina <b>Monitoring:</b> KCI Robert J. Goldstein & Associates	<b>Restoration Plan:</b> February 2003  <b>Construction Complete:</b> Jan 2005 <b>Monitoring Year 1:</b> Sept 2005 <b>Monitoring Year 2:</b> Sept 2006  <b>Monitoring Year 3:</b> July 2007  <b>Monitoring Year 4:</b> July 2008 <b>Monitoring Year 5:</b> July 2009

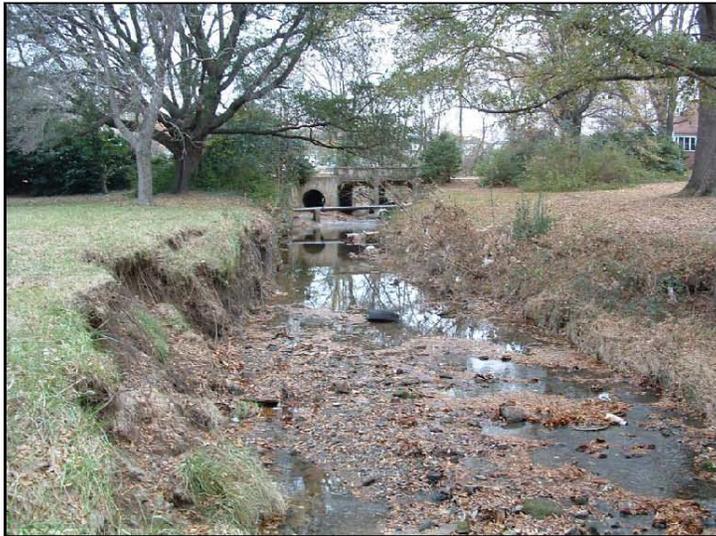
Upstream Project limits. (East Forest Hills Drive culvert/pipe, looking upstream.)

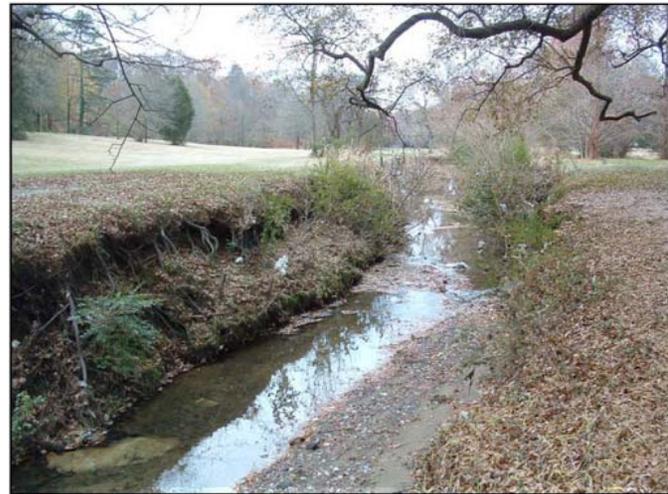
Incised stream section in upstream project area. (Near Sta. 13+00, looking downstream.)

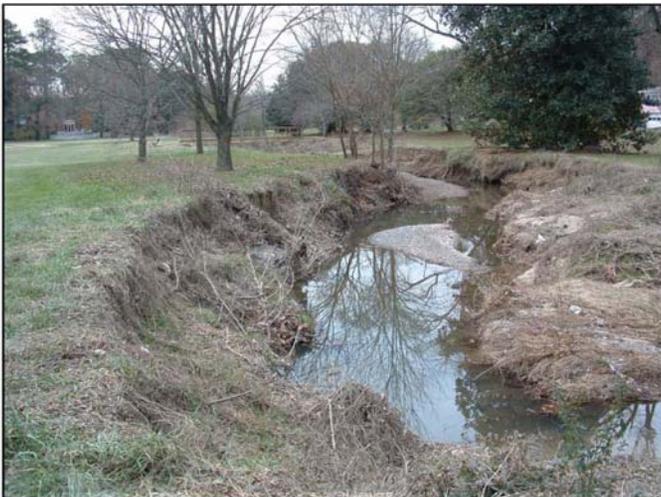
Typical degraded section in downstream project area. (Sta. 34+00, looking downstream.)

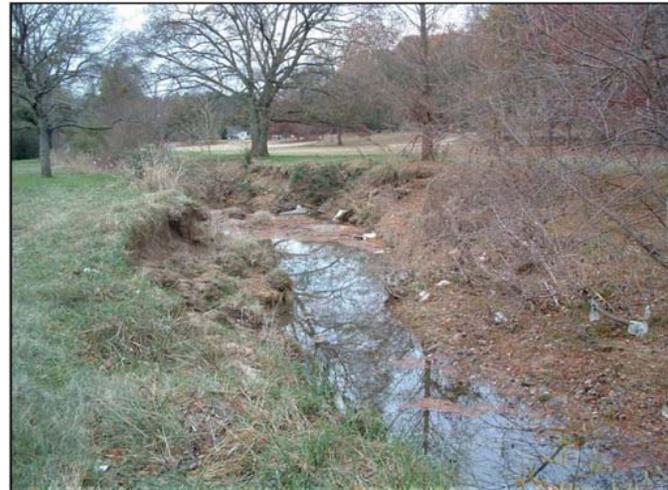
Typical degraded stream section in upstream project area. (Near Sta. 15+40, looking downstream.)

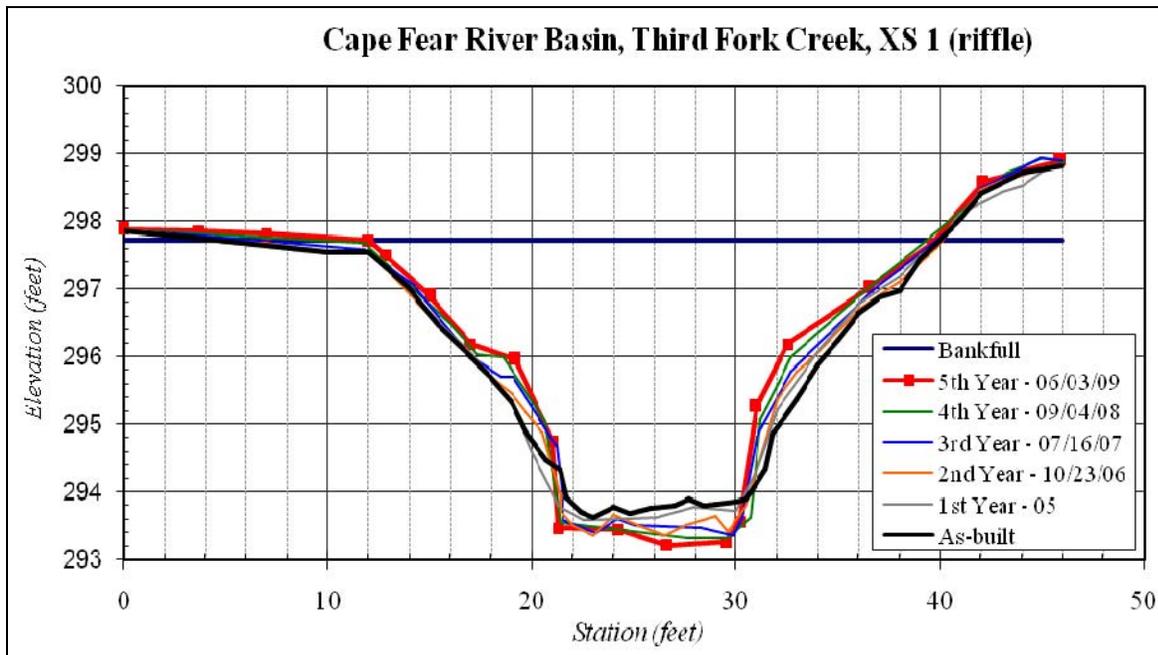
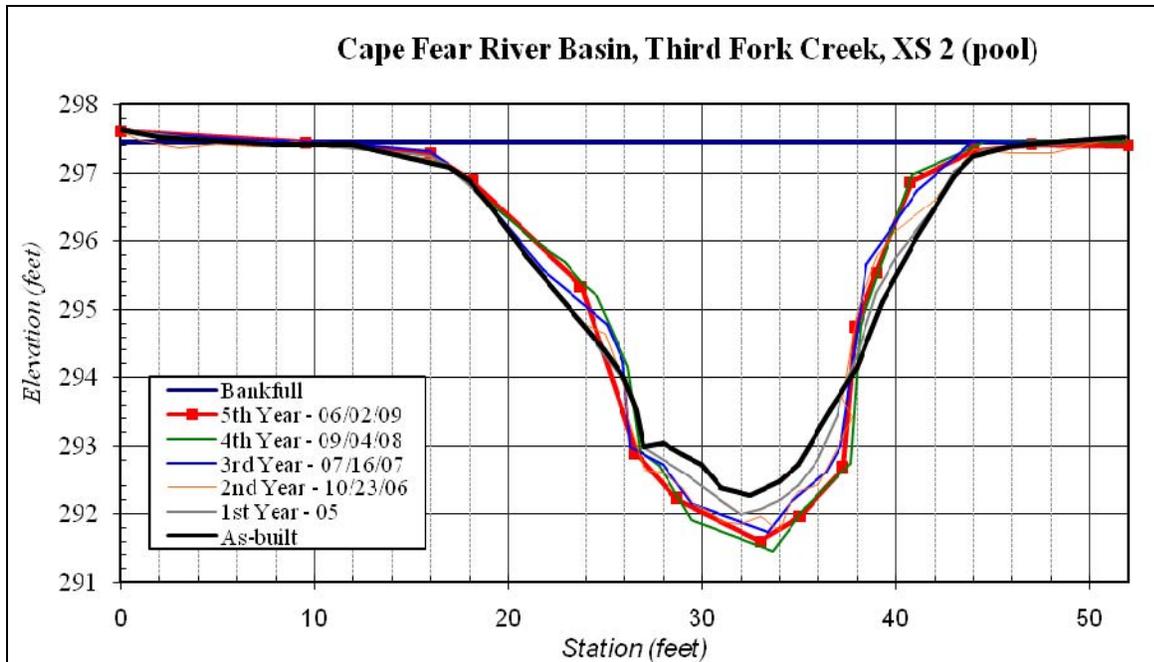
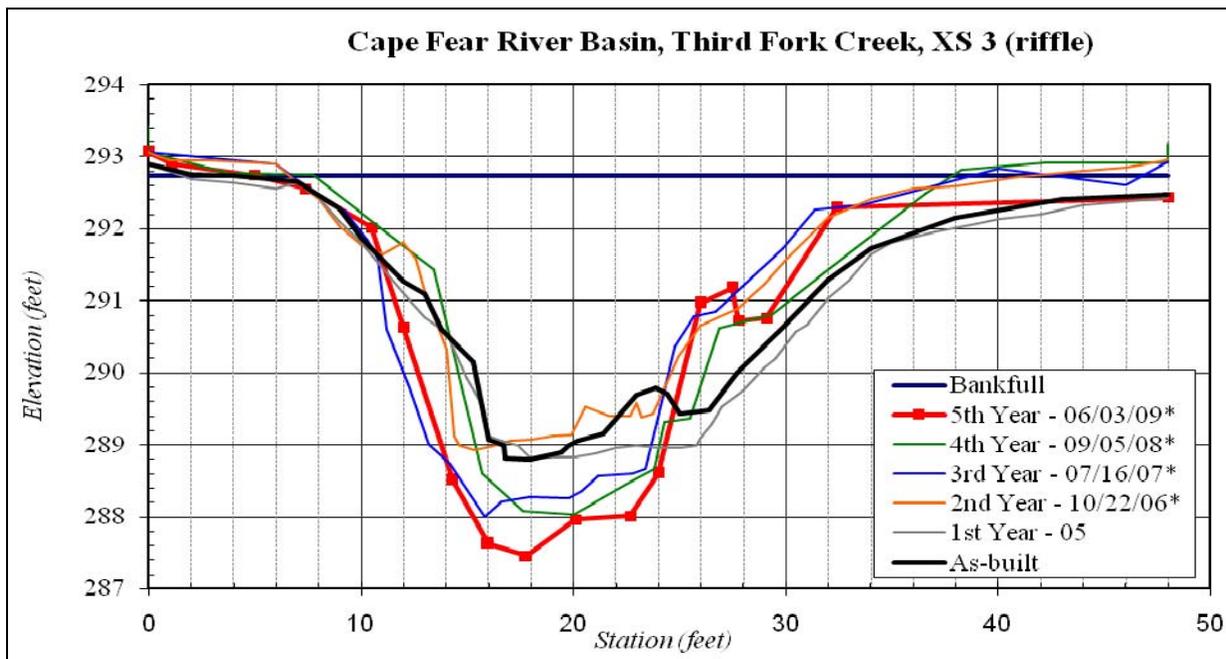
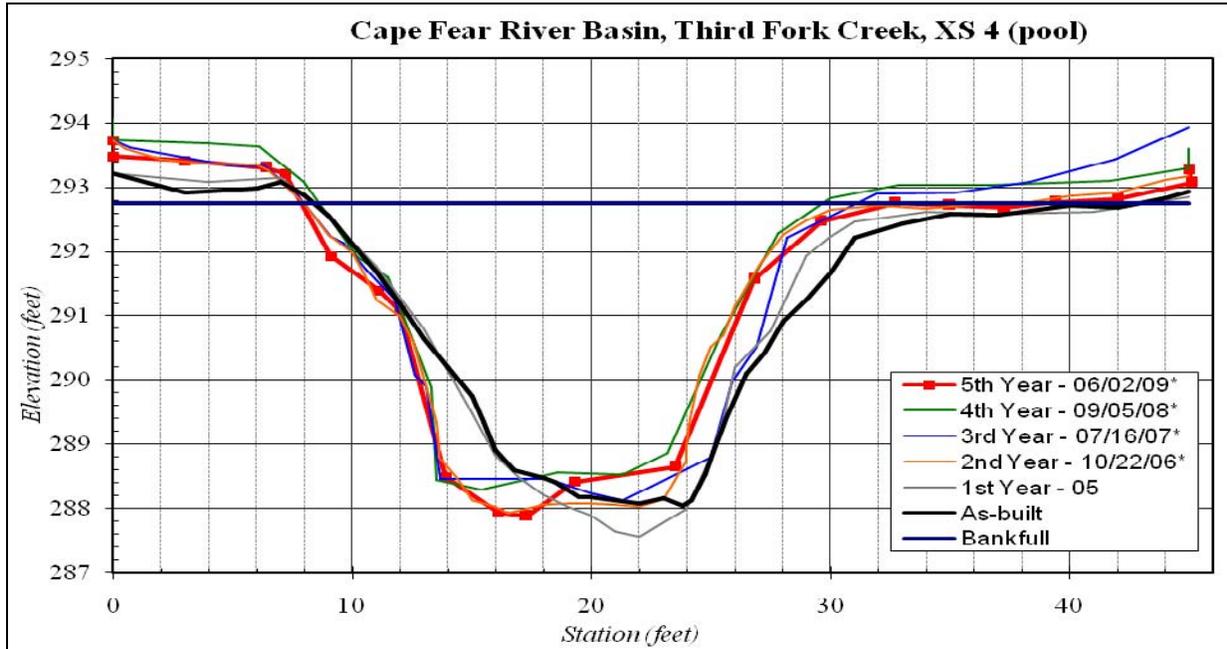
Figure 4. Annual X-Section Plots

Repeat survey data indicates project X-sections have been characterized by some incision and also channel narrowing. Despite the incision, grade control structures still rated at or above 95 % stable in the monitoring year-5 visual assessment indicating overall project stability. Narrowing was due in part to the success of stream bank vegetation (primarily *Salix nigra* and *Cornus amomum*). As the site has matured the system has stabilized and these problems declined. Four X-sections were installed on the site during the as-built survey and surveyed for all five monitoring years. The endpoints for X-sections three and four could not be relocated in 2006 and new endpoints were established based on available data. Figure 5 shows the change in channel appearance that occurred between Monitoring Years 1 and 5.

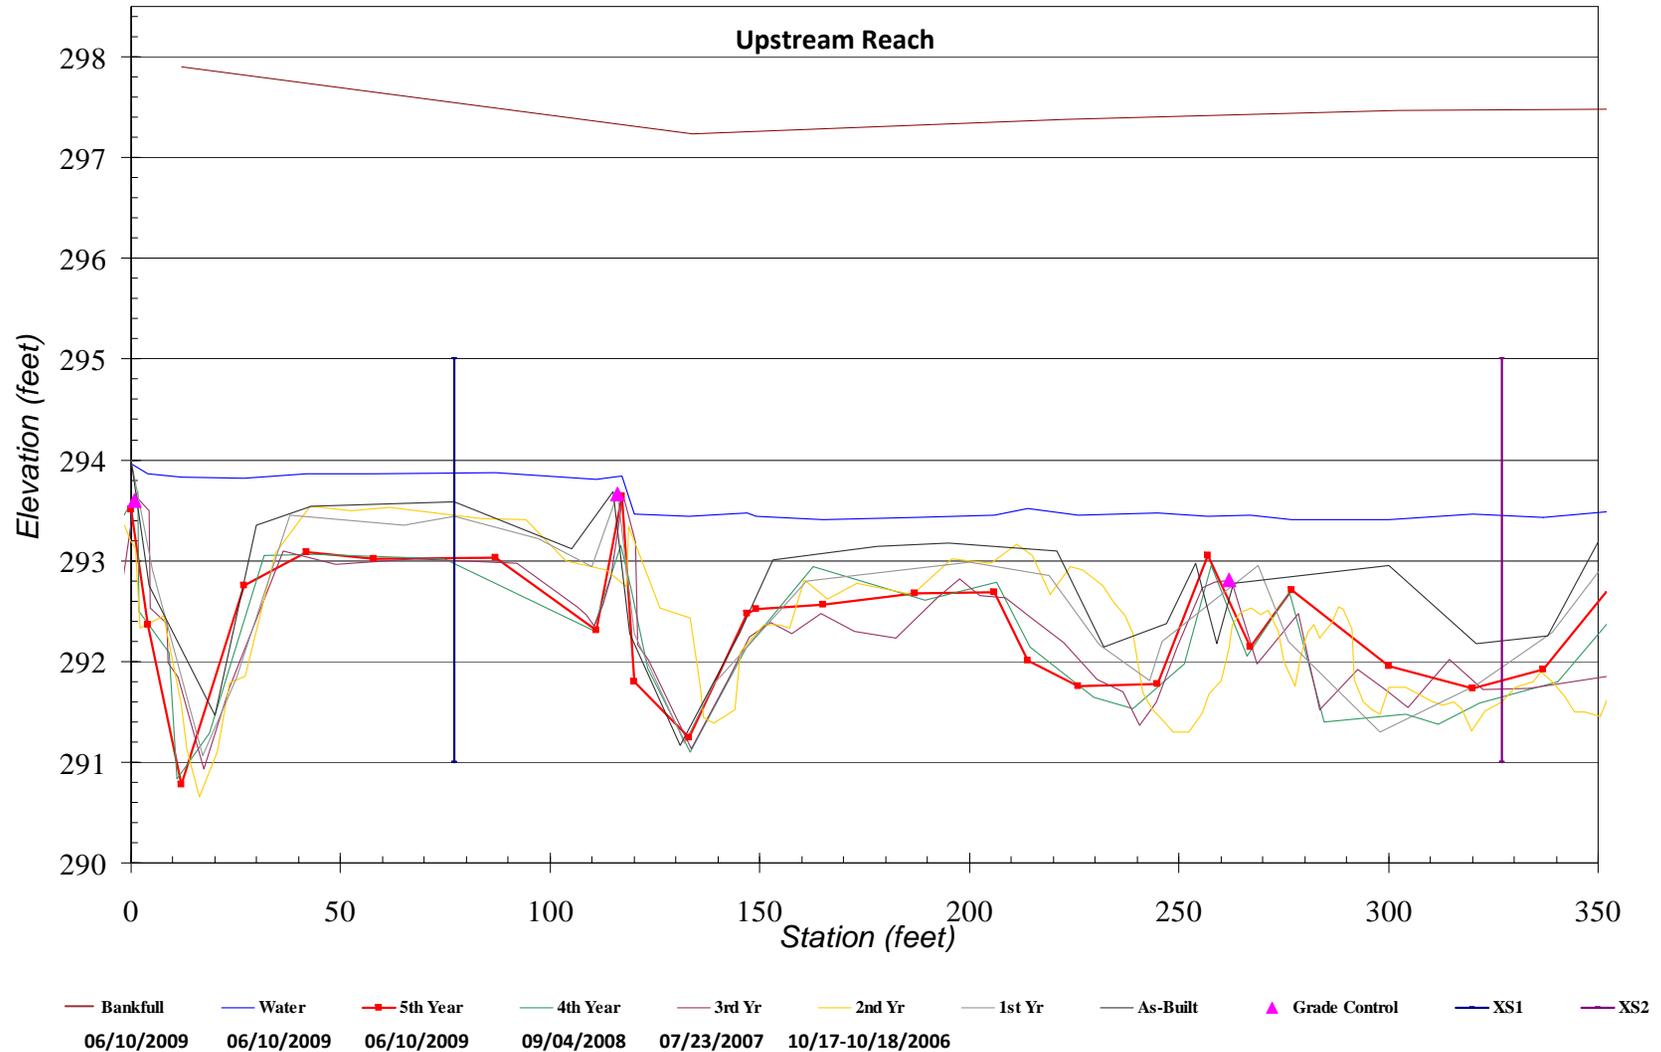
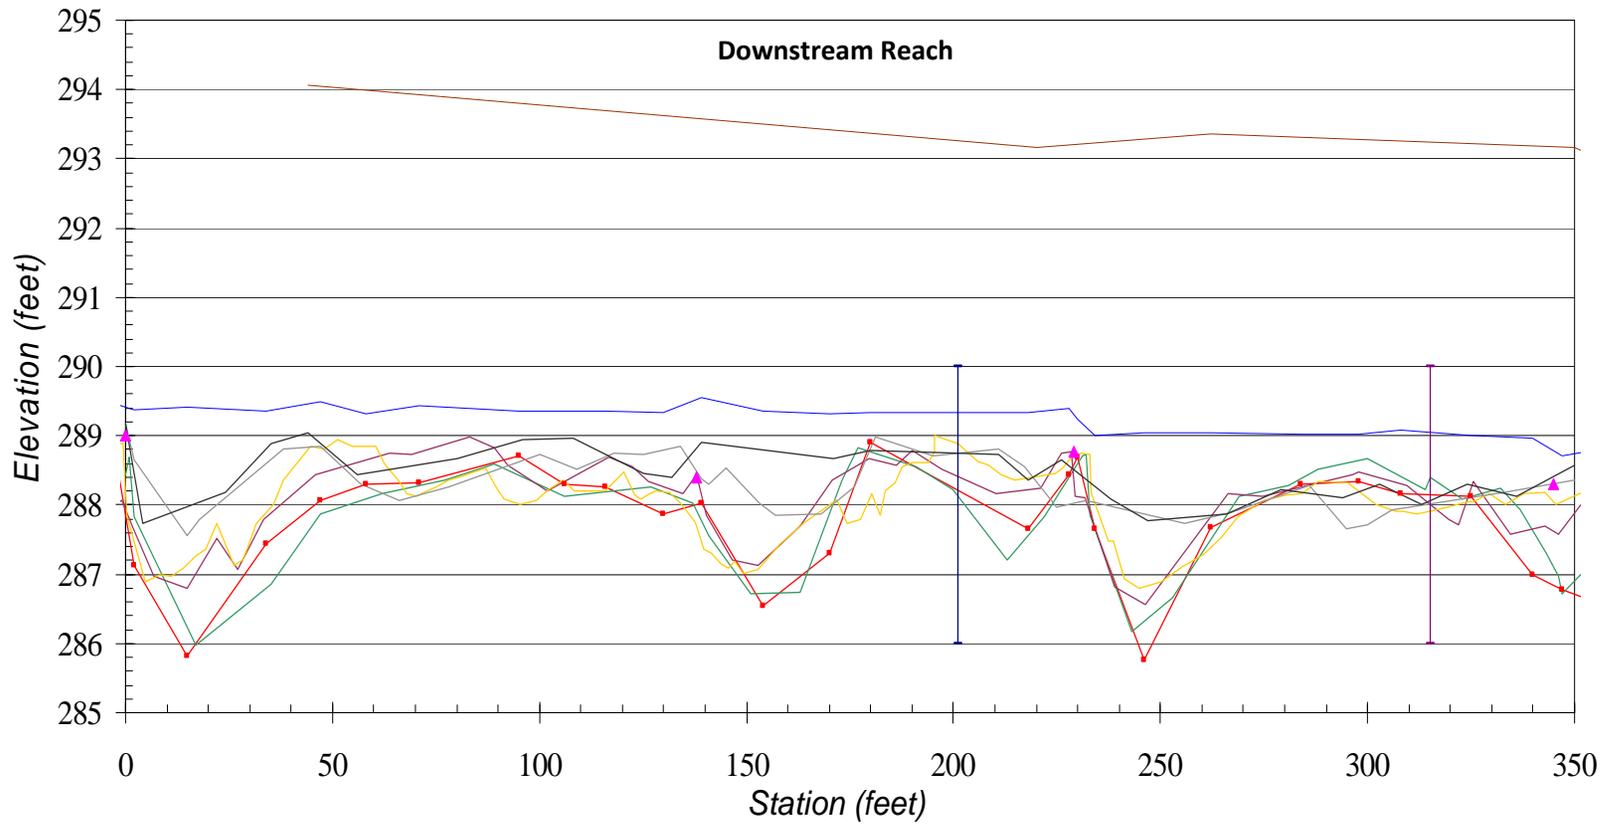
**Figure 7. Longitudinal Profile Plot for Upstream and Downstream Reaches**

Repeat longitudinal profile data indicates the site initially experienced some bed degradation, but stabilized in Monitoring Years 4 and 5. Approximately 350 feet of both the upstream and downstream reaches of the project were surveyed for all five monitoring years. Slope and spacing varied from year to year, but the overall riffle-pool morphology was maintained.

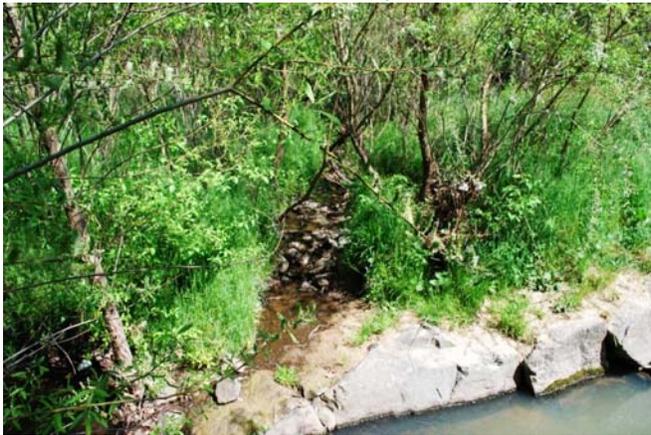
Grade control structures at the site consisted of rock cross vanes and j-hooks, and overall the structures were stable and functioning as intended. Due to upstream, off-site sources, the first three pools associated with cross-vanes at the northern end of the project are filled with fine sediment. However this condition is not considered a structural failure and the fine sediment may be expected to be mobilized out of pools depending on future reach sediment balances. A few j-hook structures have experienced backcutting but project structure stability rated at or above 95 % in the monitoring year 5 visual assessment (Figure 6).

**Figure 6. Grade-control structure at confluence of leftbank tributary (04/15/10)**
