**Kentwood Park (Bushy Branch)
Stream Restoration
Closeout Summary Report
EEP Project # 205
2010**

April 2010

Project ID & Status	
Project Name:	Kentwood Park (Bushy Branch)
EEP ID:	205
County:	Wake
Project Type:	Stream Restoration
Current Status:	5 Years of Monitoring Complete

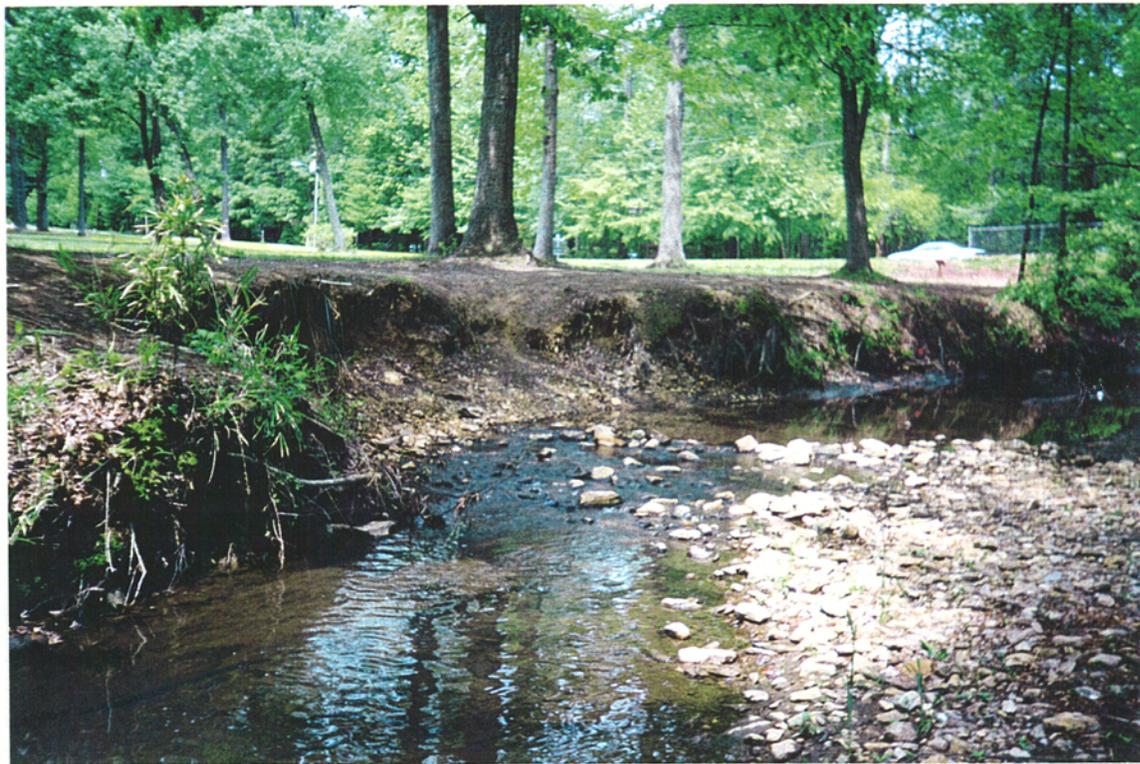
Photograph 3. Bank erosion along Bushy Branch at northeast corner at frisbee golf course

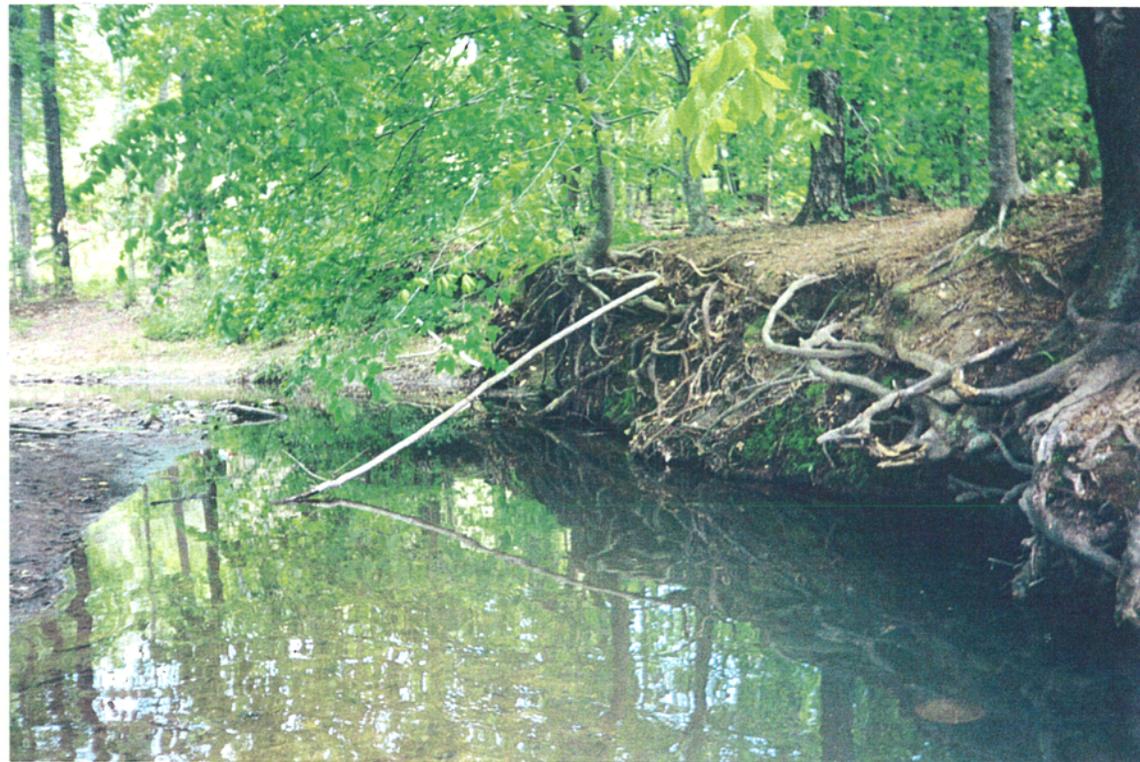
Photograph 4. Bank erosion along Bushy Branch just upstream of confluence of Bushy Branch and its unnamed tributary

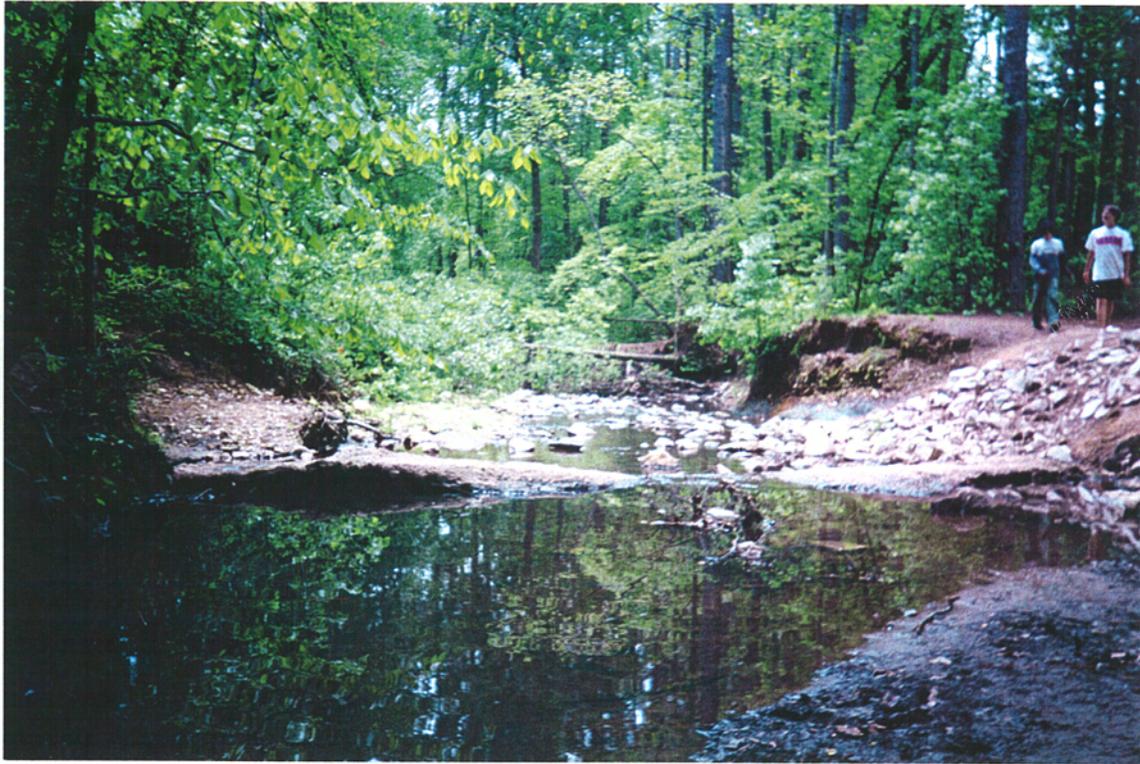
Photograph 5. Looking downstream along Bushy Branch at eroded bank at pedestrian access point just downstream of second sanitary sewer line crossing

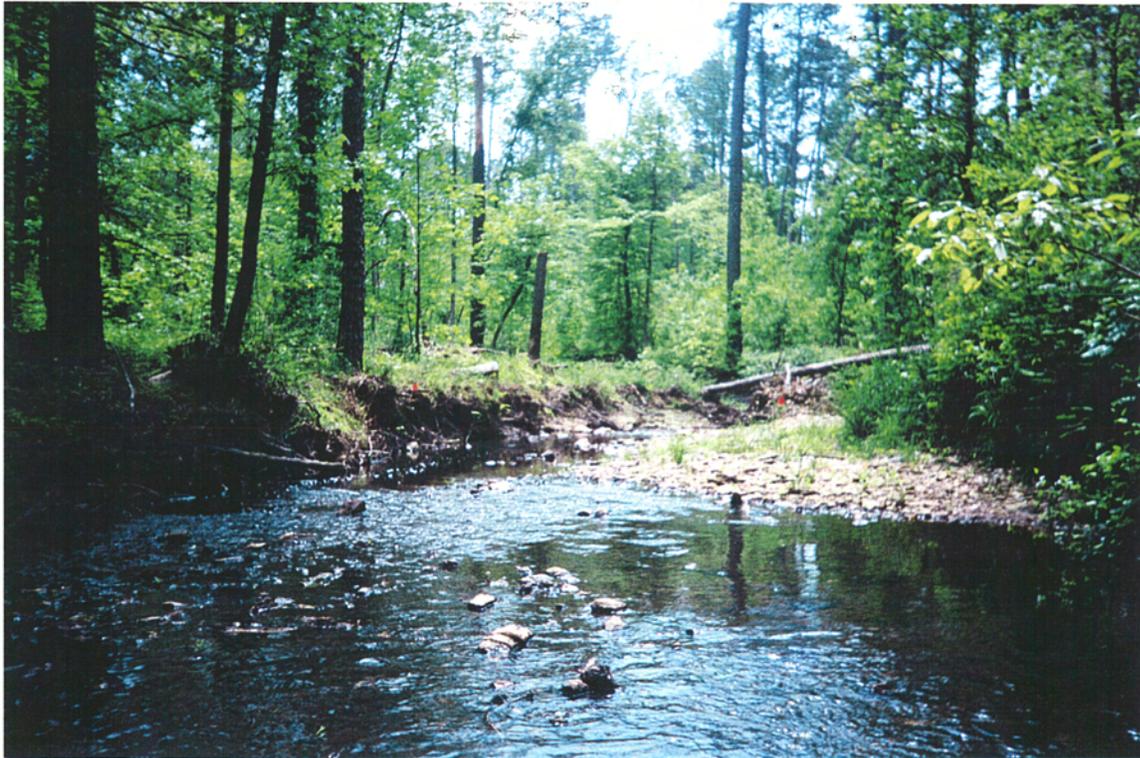
Photograph 6. Looking downstream along Bushy Branch at eroded left bank near middle of Kentwood Park reach

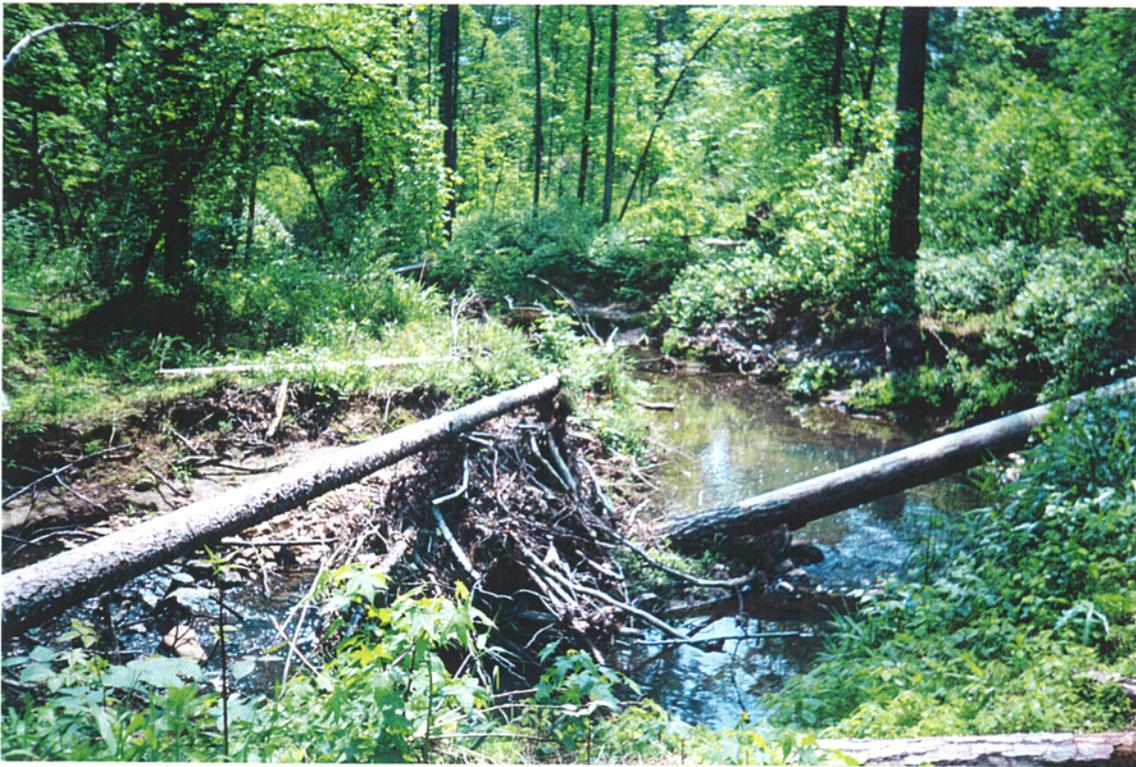
Photograph 7. Debris jam along Bushy Branch at southeast corner of Kentwood Park

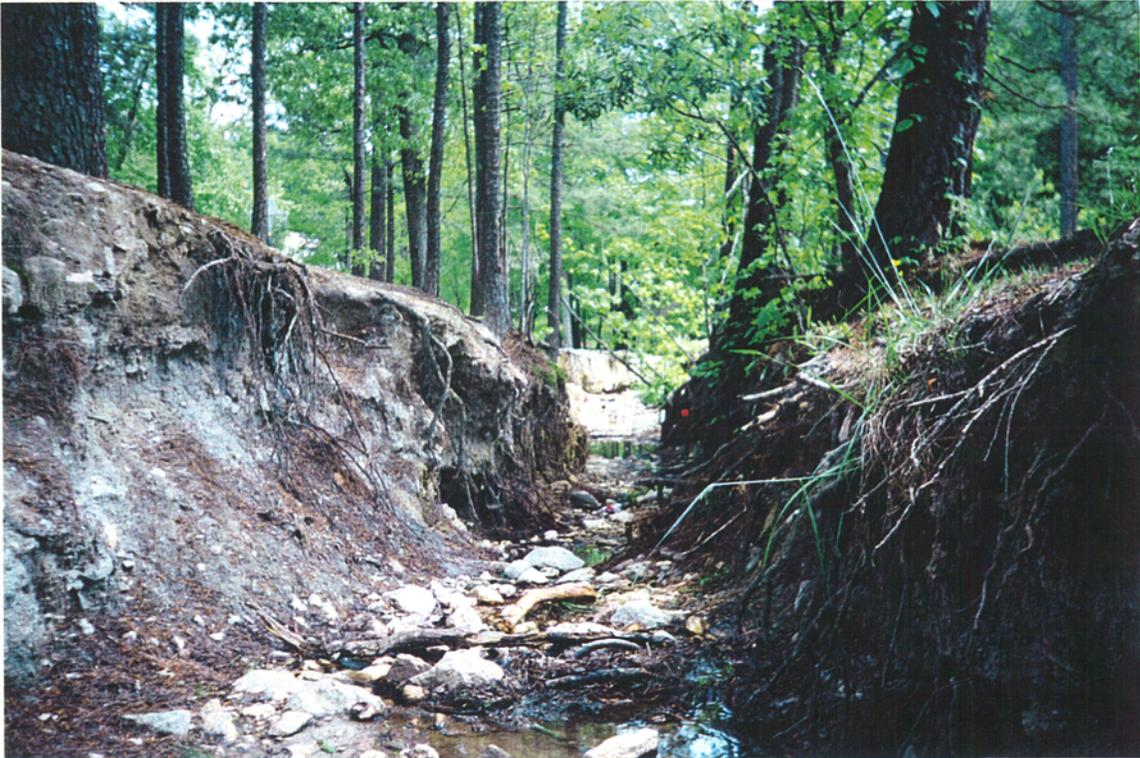
Photograph 12. Bank erosion along unnamed tributary of Bushy Branch looking downstream from culvert at concession stand

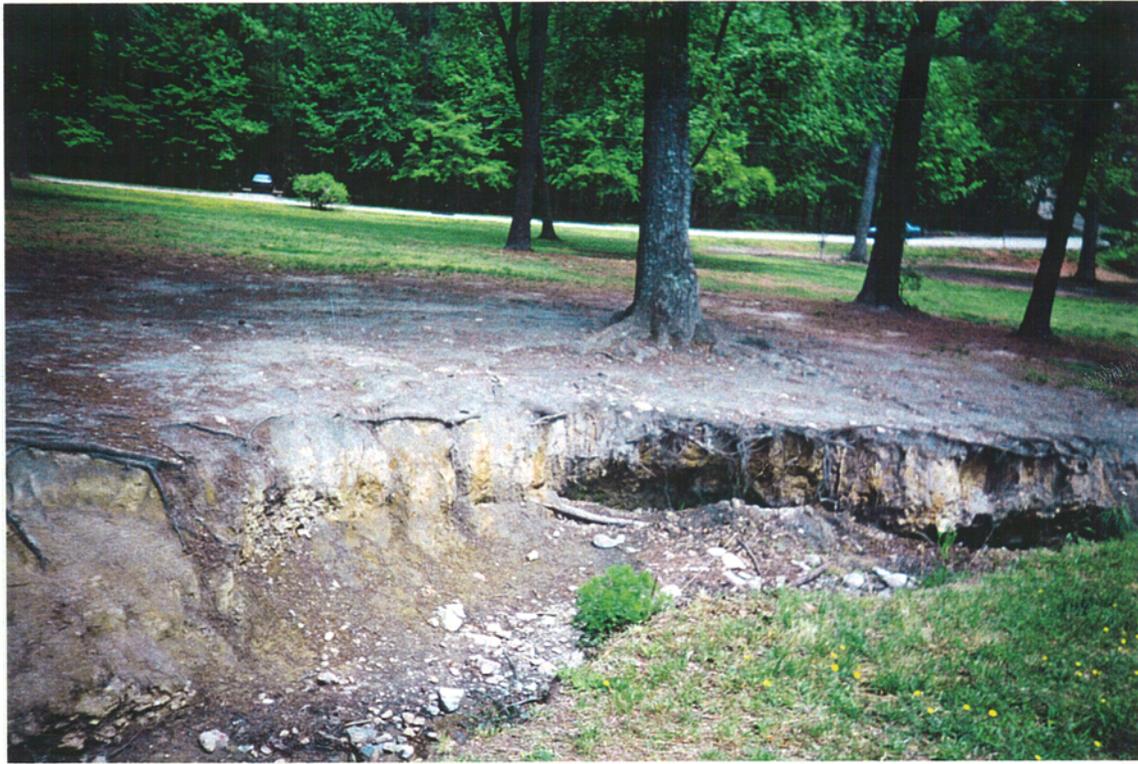
Photograph 13. Bank erosion along unnamed tributary of Bushy Branch at pedestrian access point

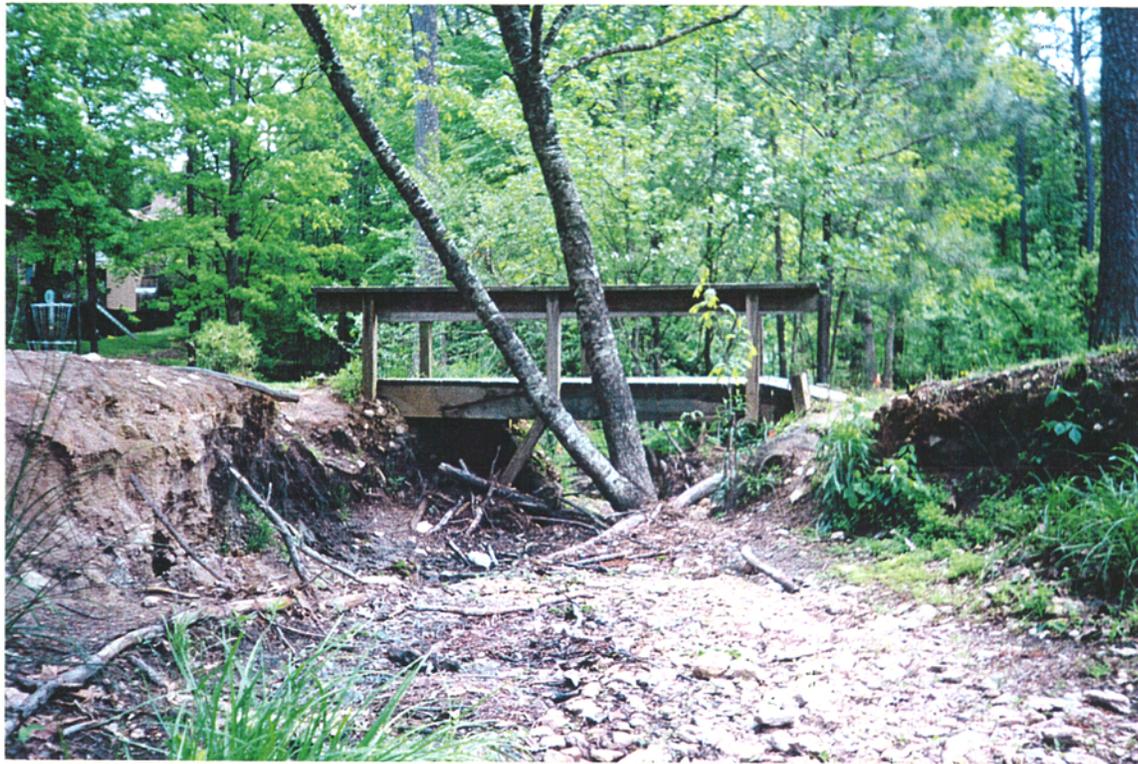
Photograph 14. Bank erosion and pedestrian bridge at unnamed tributary of Bushy Branch looking downstream from just upstream of confluence with Bushy Branch
