**LYLE CREEK STREAM RESTORATION SITE**  
**AS-BUILT CONSTRUCTION REPORT**  
**CATAWBA COUNTY, NORTH CAROLINA**  
(SCO ID# 00-05378-01)

**ECOSCIENCE CORPORATION**  
**1101 Haynes Street, Suite 101**  
**Raleigh, NC 27604**  
**Tel (919) 828-3433 Fax (919) 828-3518**

**August 2002**

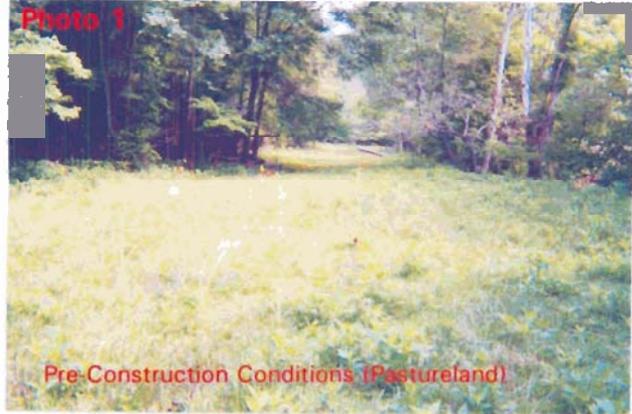
Prior to mitigation activities, the Site was characterized by pastureland actively grazed by livestock and disturbed hardwood forest. The stream had incised and downcut below the effective rooting depth of existing on-site vegetation. Both the mainstem channel and secondary tributary supported a transitional channel characterized by a G-type (gully) and F-type (widened gully) stream (Rosgen 1996). G-type streams are characterized as highly entrenched streams with a low width/depth ratio (<12). Typically, G-type streams downcut and widen by eroding laterally into channel banks during peak flows. Over time, the widened gully develops into an F-type channel that supports a relatively high width/depth ratio (>12) (Rosgen 1996a).
