<u>Project ID & Status</u>	<u>Project Setting & Background</u>	<u>Project Timeline</u>																
Project Name/Number: Lyle Creek EEP ID: 423 County: Catawba Project Type: Stream Restoration Current Status: 5 Years of Monitoring complete	Basin: Catawba Physiographic Region: Piedmont Drainage Area: 0.47 Impervious cover: <10% USGS Hydro Unit: 03050101 NCDWQ Subbasin: 03-08-32 Thermal Regime: Warm Trout Water: No Designer: Ecoscience

Project Background and Summary

Figure 1. Project Location and Watershed Map
Lyle Creek Stream Restoration
Catawba County, NC
Monitoring Report Year 4 of 5

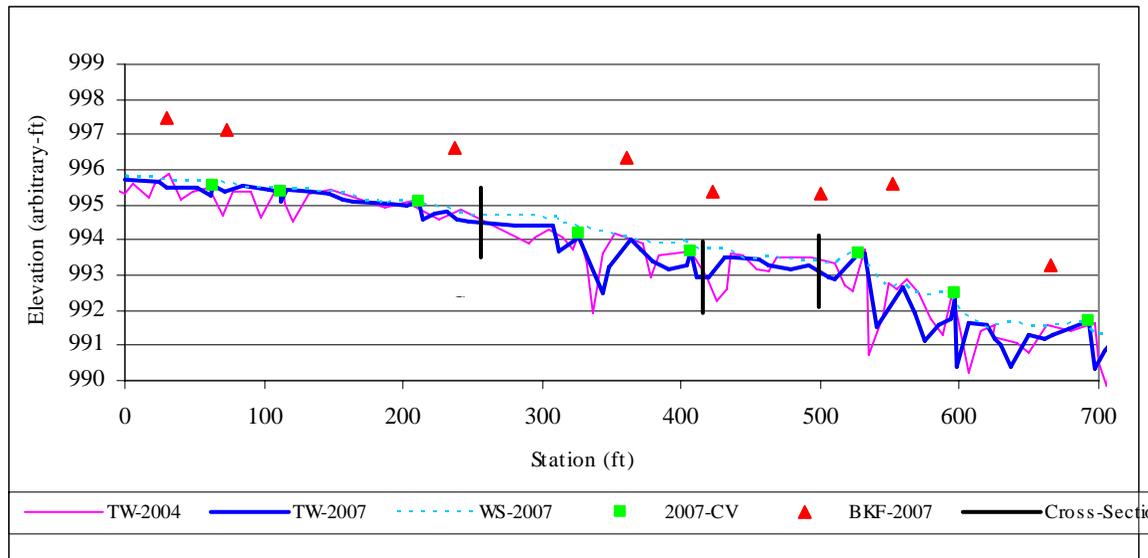
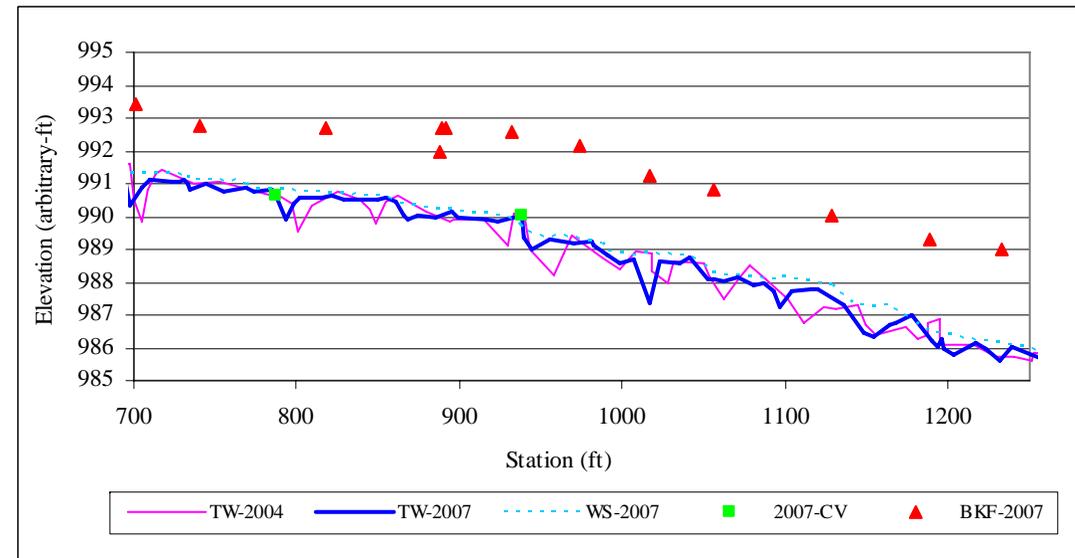
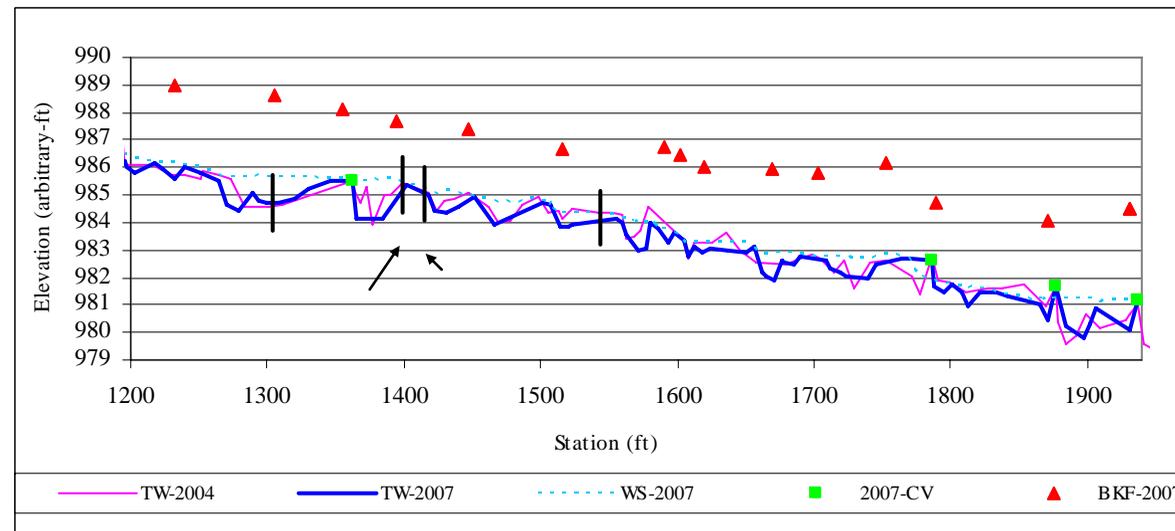
Profile

The aforementioned methodological differences prompted the monitoring consultant to utilize data from 2004 and 2007 to describe the stability of the projects profile. These two years utilized a total station with a fixed CAD stationing (see Figure) that permitted consistent comparison. The profile over this time period has generally maintained distinctiveness of the bed, with the exception of the top 100 feet, which is the transition point for the fine material that is entering the reach from the watershed above. Approximately 97% of the pools and 75% of the riffles have maintained their respective forms based on the 2007 visual assessment. The profile over this period has exhibited no systemic changes in elevation. However, there was a small headcut in the lower reach, and some of the aforementioned bed feature migration, which has since arrested.
