**EEP Project Closeout Summary**

<b>Project ID &amp; Status</b>	
Project Name:	Trout Cove Branch and Tributary
EEP ID:	388
County:	Clay
Project Type:	Stream Restoration
Current Status:	5 years of monitoring complete

<p>Trout Cove Branch &amp; Tributary Restoration Closeout Clay County, North Carolina</p> <p>NCEEP # 388</p> <p>Date September 2010</p>	<ul style="list-style-type: none"> <li>

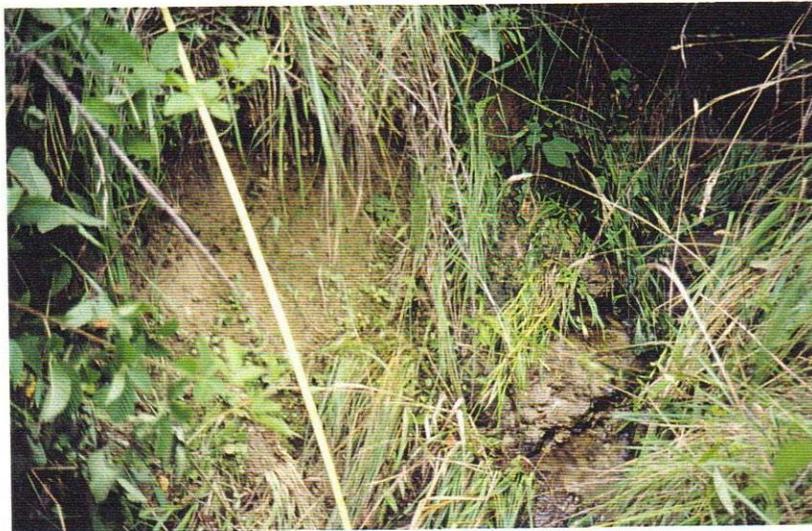
Photograph 3. Trout Cove Branch undercut and eroding bank. Bank height approximately 4 feet

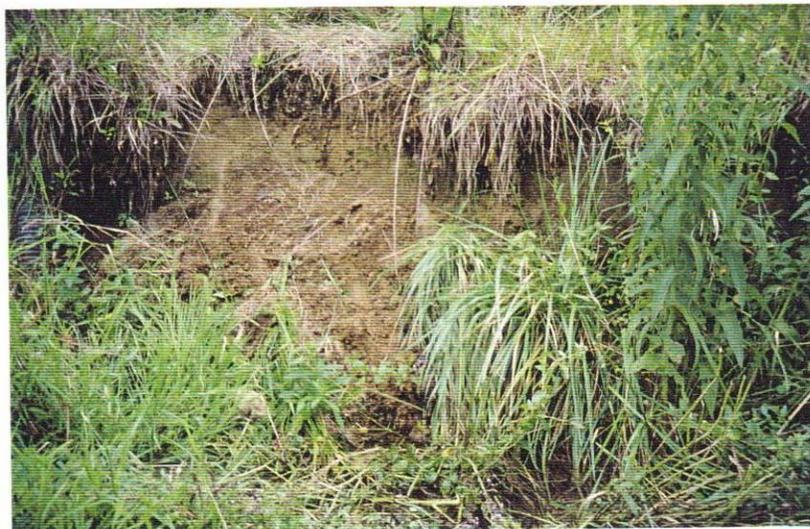
Photograph 4. Trout Cove Branch eroding bank. Bank height approximately 5 feet.

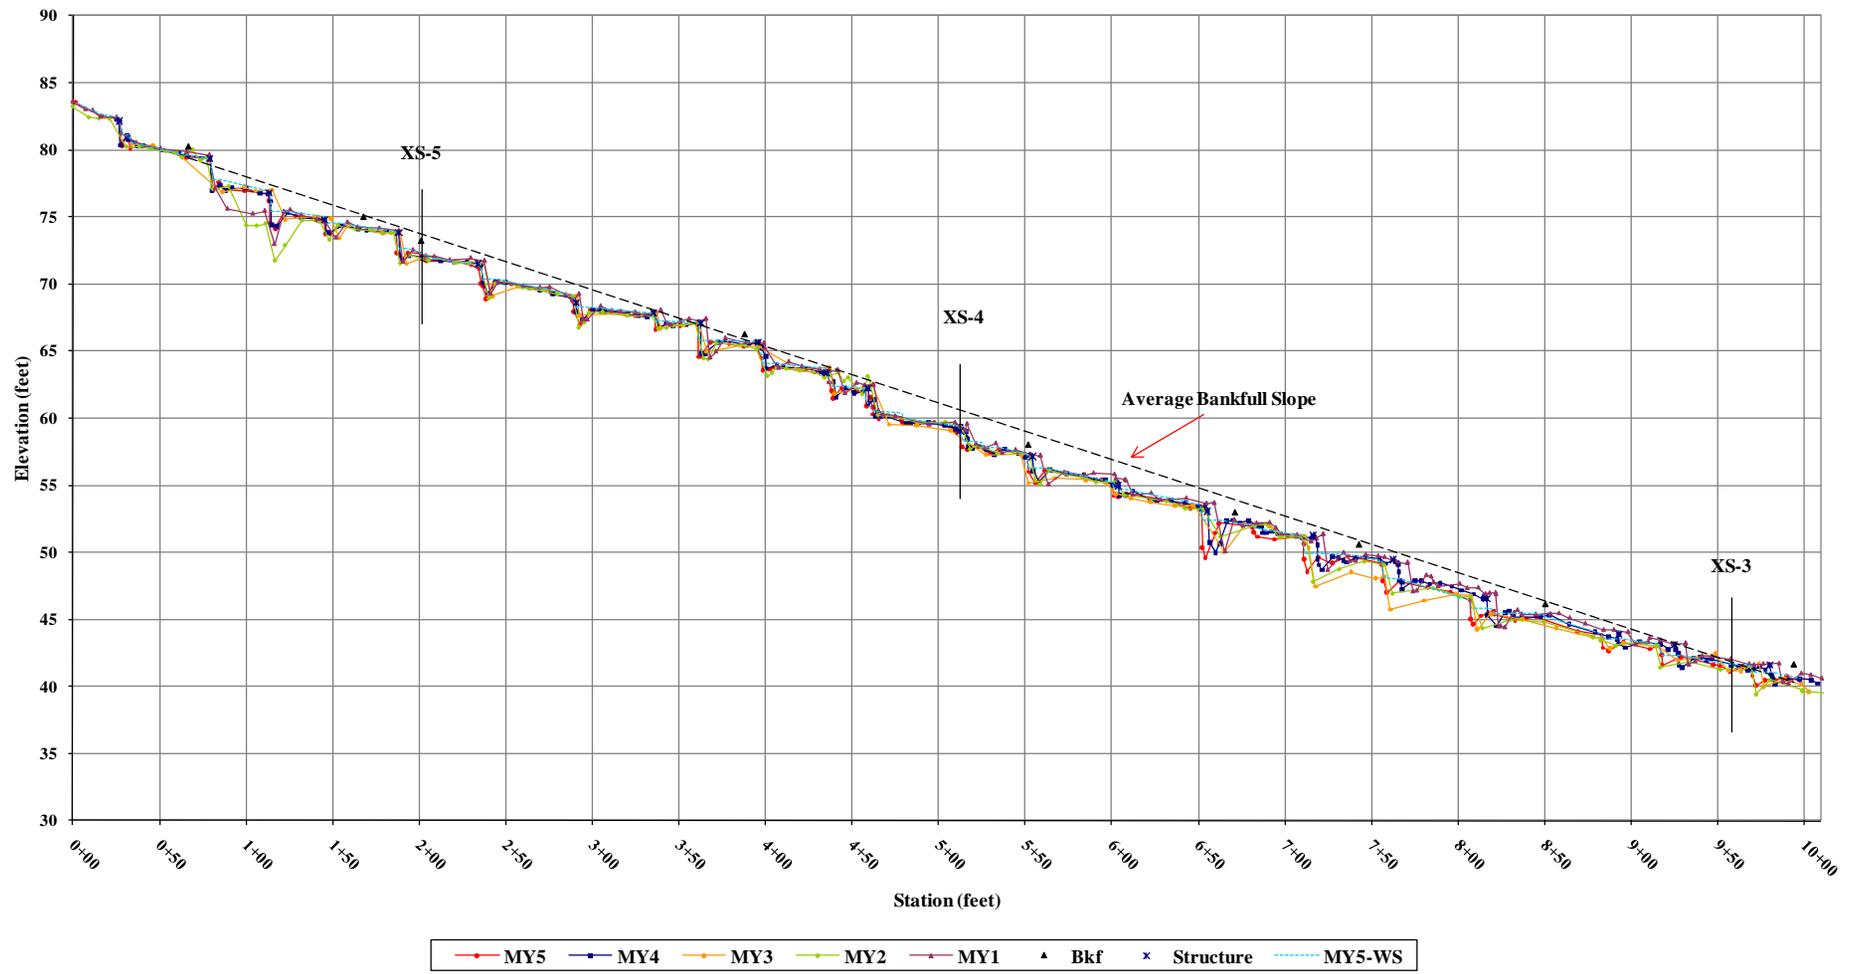
**Trout Cove Branch  
Longitudinal Profile - Upper Reach**

**Profile:** The stream profile has remained stable among monitoring years and indicates no significant or systemic loss of grade. The two main issues observed during monitoring year 5 and as seen in previous years were some pool aggradation and some level of piping through approximately half the structures. All other morphological metrics during monitoring year 5 indicated performance percentages averaging between 92 and 99%. The extent of pool aggradation observed during monitoring years 3 and 4 was primarily attributed to historic low flows preventing pool scour and sediment transport. While stream flows in monitoring year 5 appeared normal and included two bankfull events, pool aggradation was still common and was independent of structure condition. Limited upstream observations indicated poor land use activities which may be importing fines even at normal discharges that are accumulating in portions of some of the pools. Approximately half the structures surveyed in monitoring year 5 had some level of piping, but the visual observations and the profile plots indicate no significant or systemic loss of grade and the number of structures in the profile represents a very high level of grade control redundancy.
