**5-YEAR INDEPENDENT CONSULTANT INSPECTION
MAYO CREEK DAM
ASH POND DAM
MAYO ELECTRIC GENERATING PLANT
PERSON COUNTY, NORTH CAROLINA**

Prepared for:
PROGRESS ENERGY
Raleigh, North Carolina

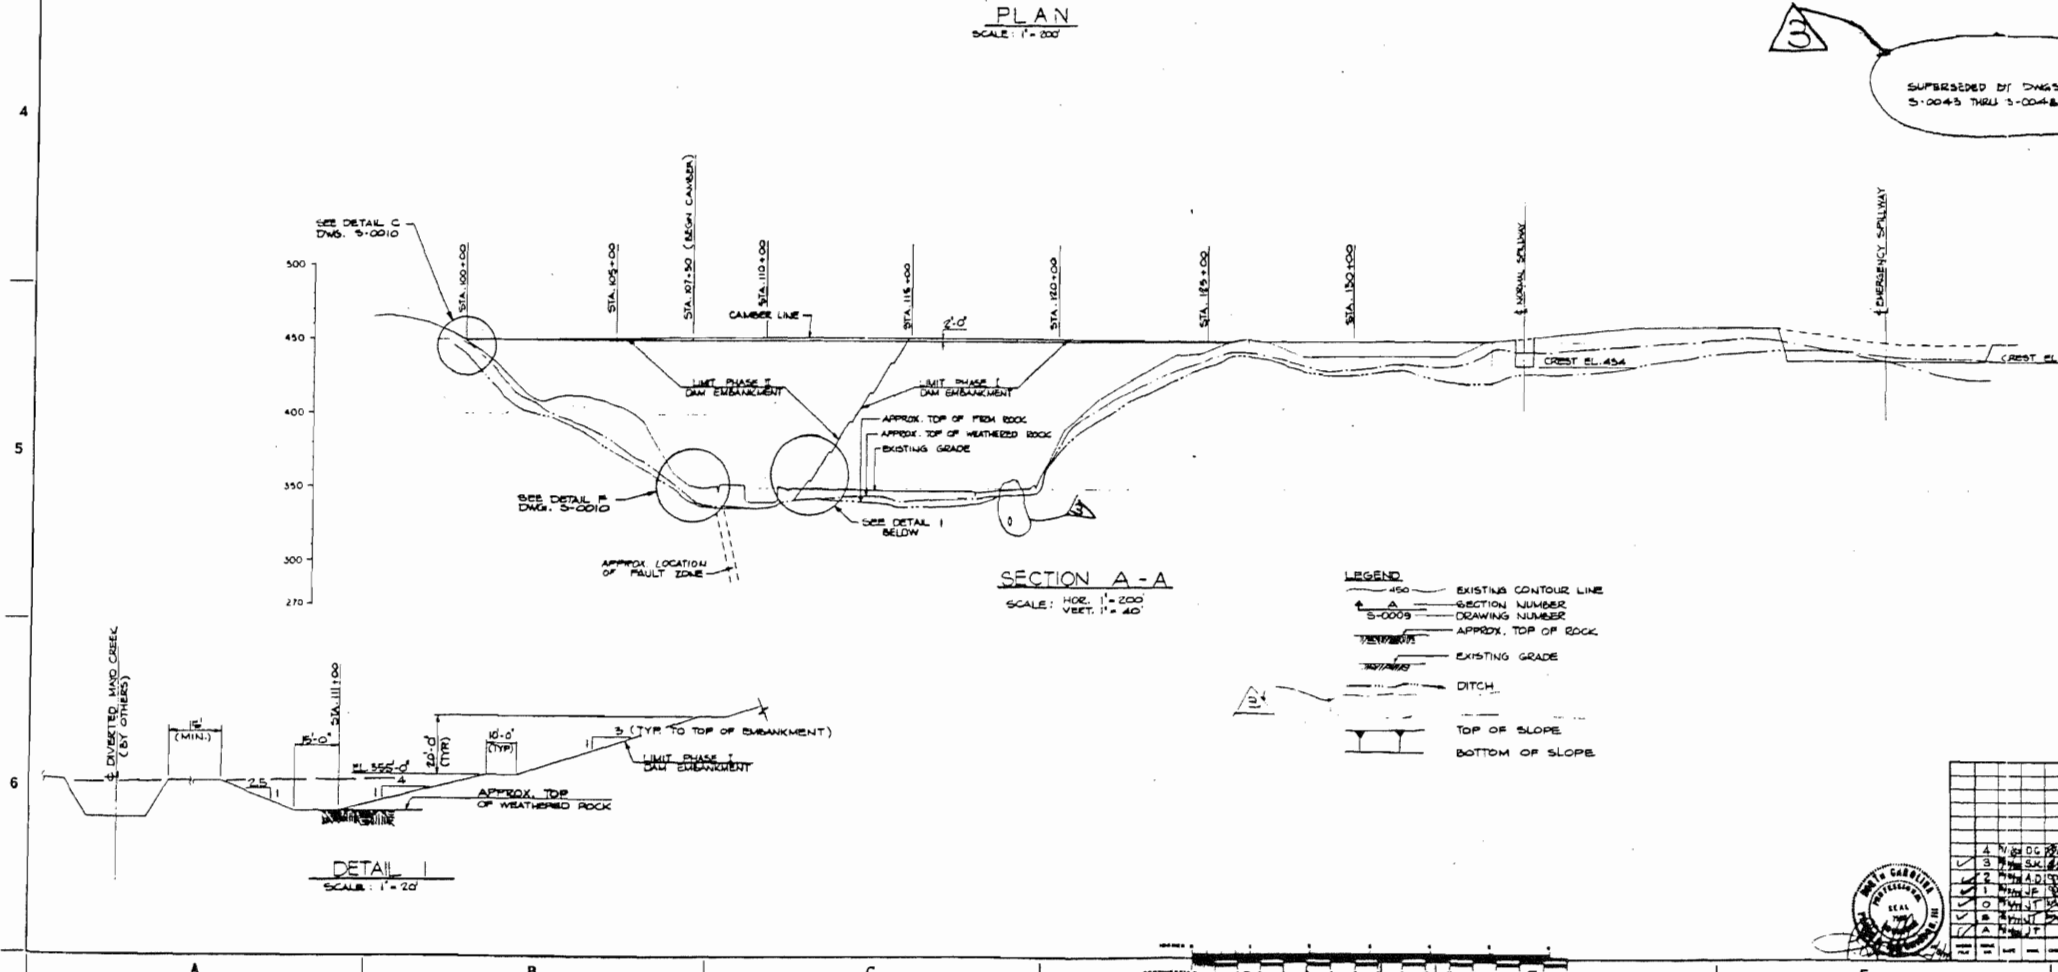
- GENERAL NOTES:**
- CONTOUR INTERVAL IS 10 FEET
 - ELEVATIONS REFER TO MEAN SEA LEVEL 1929
 - HORIZONTAL DATUM BASED ON NORTH CAROLINA STATE PLANE COORDINATE SYSTEM
 - 100% BASED ON SURVEY BY MOORE, GARDNER & ASSOCIATES INC., DATED MAY 1976
 - THE LINES INDICATING TOP OF WEATHERED ROCK & TOP OF FIRM ROCK ON SECTION A-A ARE GENERALIZED FROM & INTERPOLATED BETWEEN THE TEST BORINGS. IT IS POSSIBLE THAT SUBSURFACE CONDITIONS BETWEEN THE TEST BORINGS MAY VARY FROM THOSE INDICATED.
 - QUANTITIES SUMMARIZED ON DRAWINGS ARE ESTIMATED. ACTUAL NET QUANTITIES WILL BE DETERMINED IN THE FIELD.

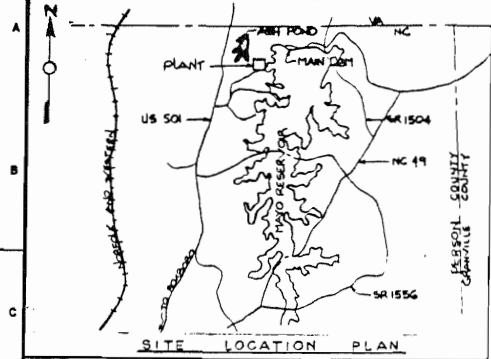
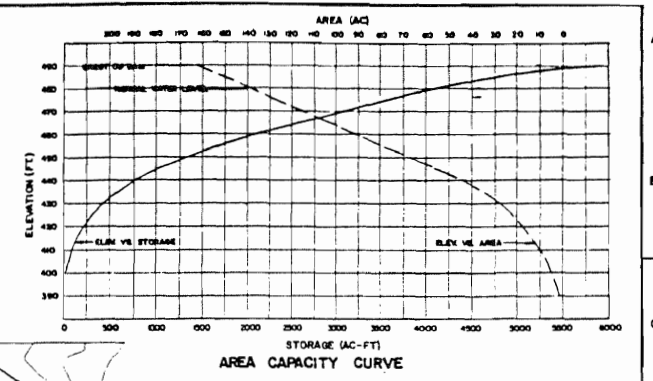
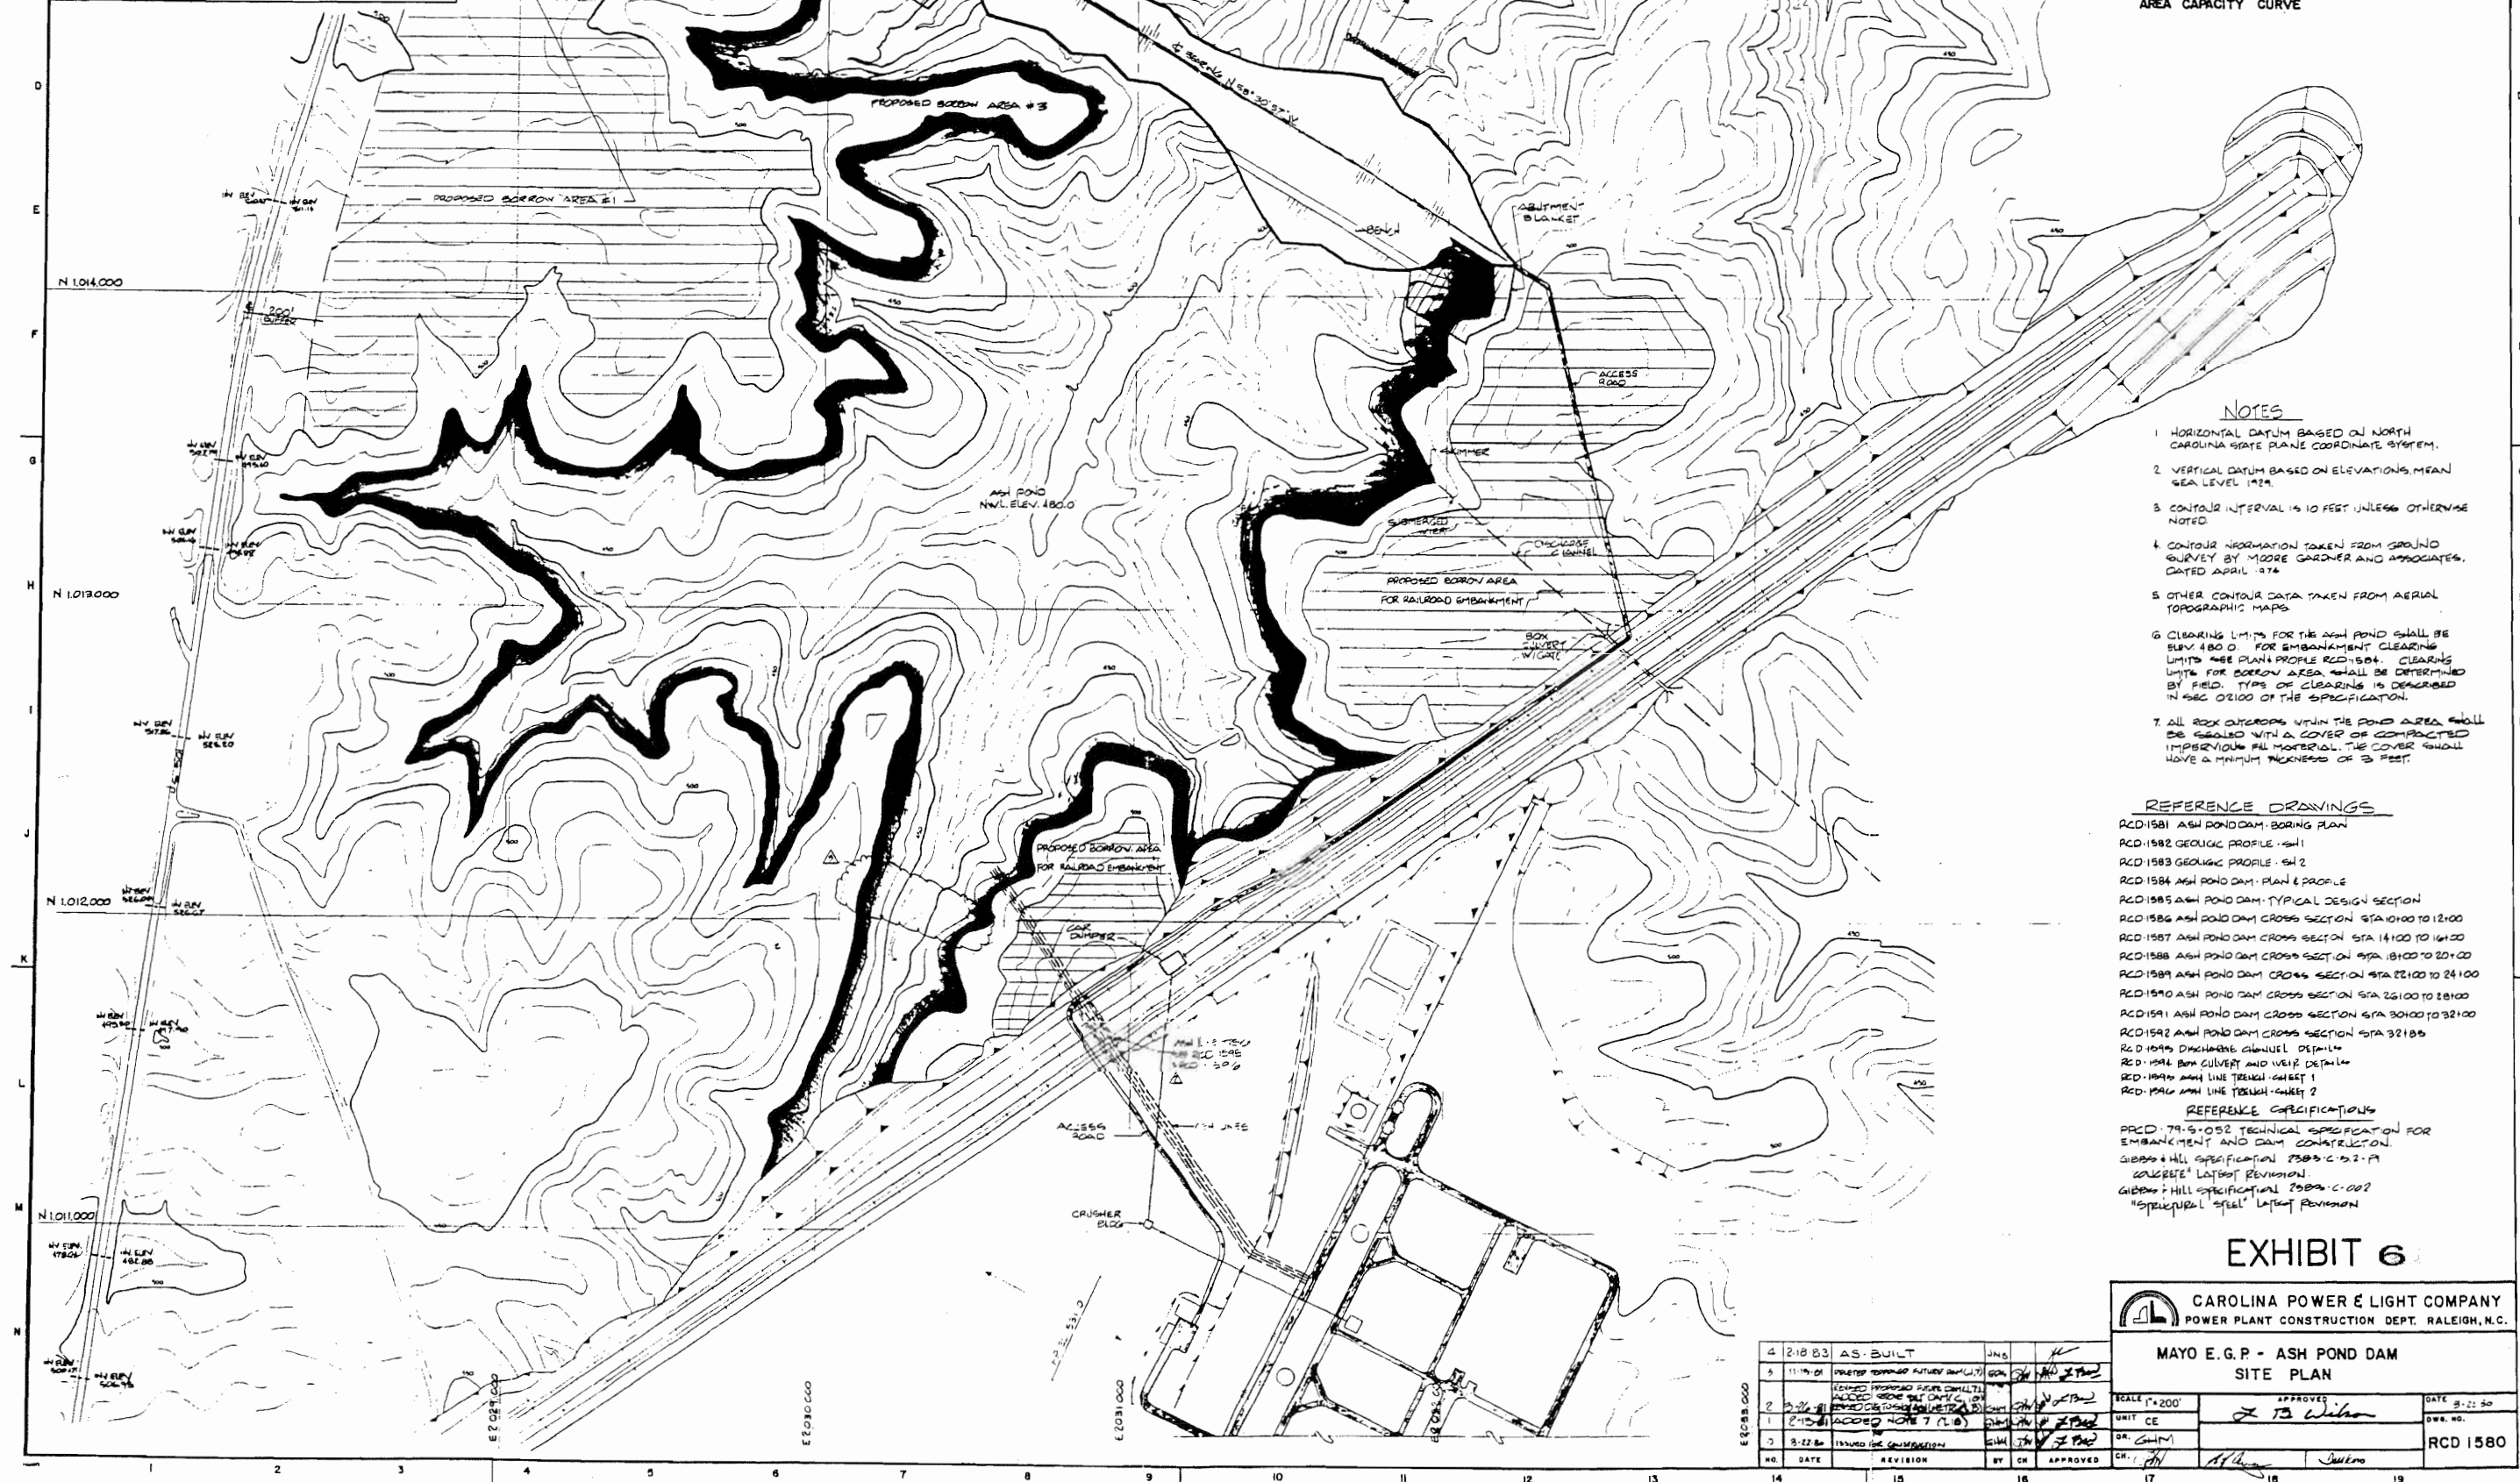
- NOTES**
- HORIZONTAL DATUM BASED ON NORTH CAROLINA STATE PLANE COORDINATE SYSTEM.
 - VERTICAL DATUM BASED ON ELEVATIONS MEAN SEA LEVEL 1929.
 - CONTOUR INTERVAL IS 10 FEET UNLESS OTHERWISE NOTED.
 - CONTOUR INFORMATION TAKEN FROM GROUND SURVEY BY MOORE GARDNER AND ASSOCIATES, DATED APRIL 1974.
 - OTHER CONTOUR DATA TAKEN FROM AERIAL TOPOGRAPHIC MAPS.
 - CLEARING LIMITS FOR THE ASH POND SHALL BE ELEV. 480.0 FOR EMBANKMENT CLEARING LIMITS SEE PLAN PROFILE RCD-1504. CLEARING LIMITS FOR BORROW AREA SHALL BE DETERMINED BY FIELD. TYPE OF CLEARING IS DESCRIBED IN SEC. 02100 OF THE SPECIFICATION.
 - ALL ROCK OUTCROPS WITHIN THE POND AREA SHALL BE REMOVED WITH A COVER OF COMPACTED IMPERVIOUS FILL MATERIAL. THE COVER SHALL HAVE A MINIMUM THICKNESS OF 3 FEET.

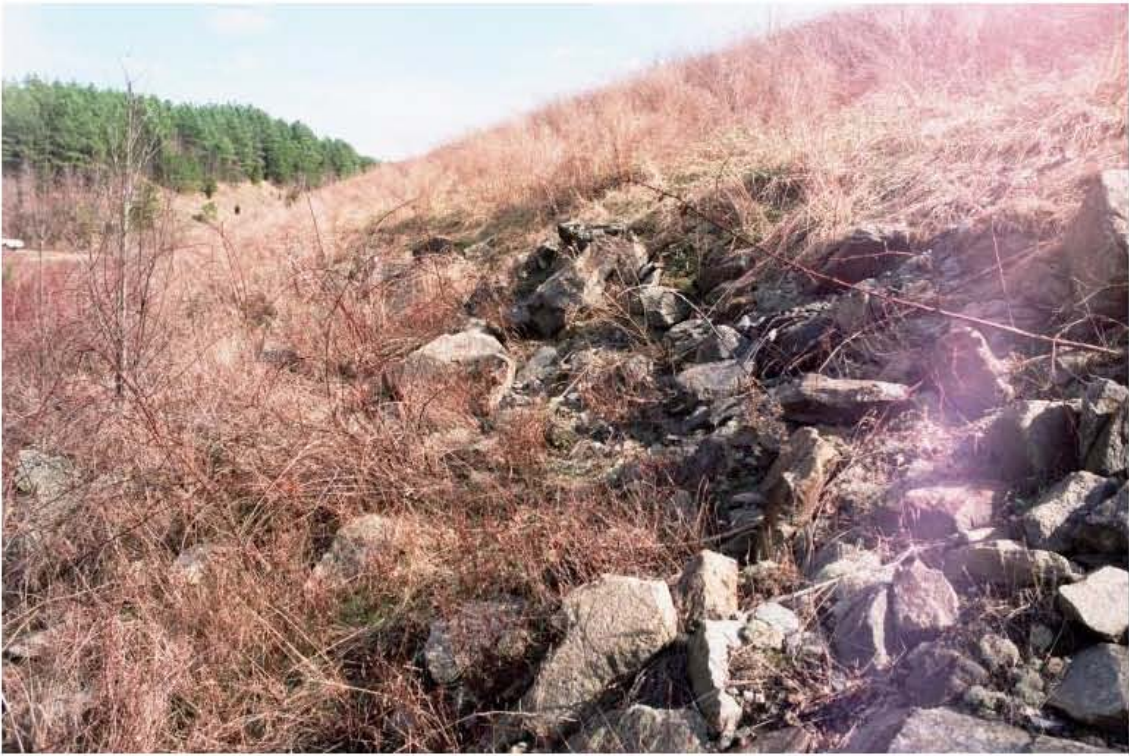
7. Mayo Creek Dam. Rock toe in area noted as disturbed in 1994. No apparent change.

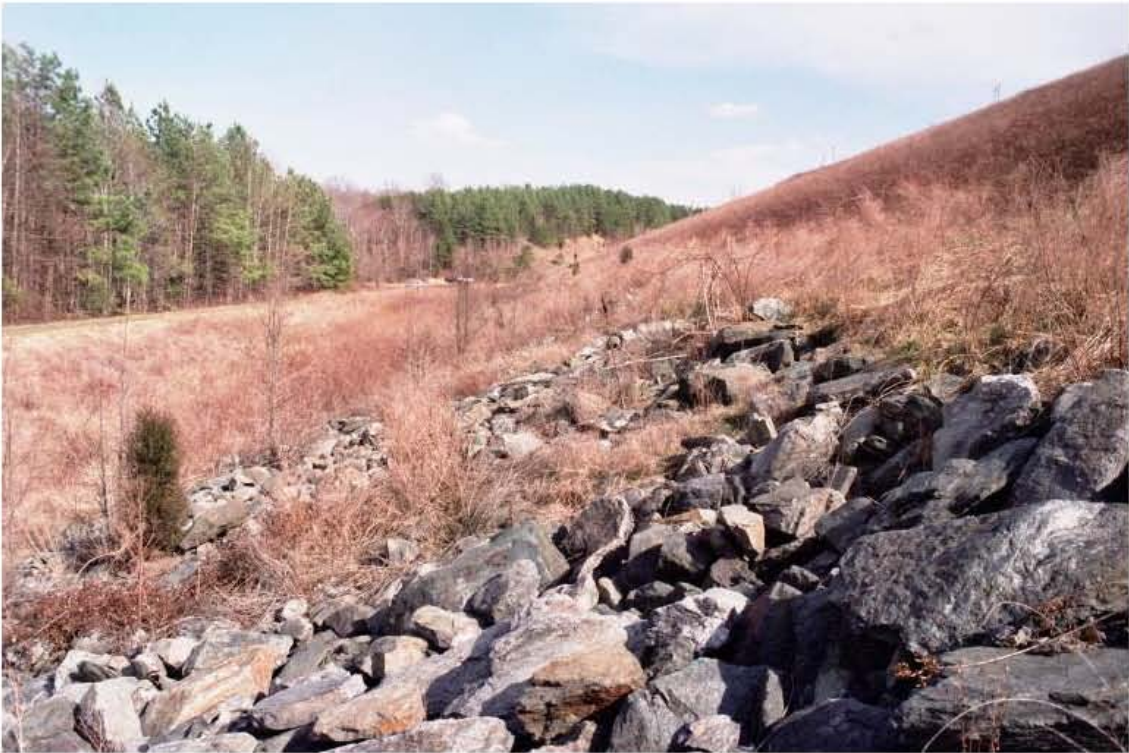
8. Mayo Creek Dam. General view of rock toe.

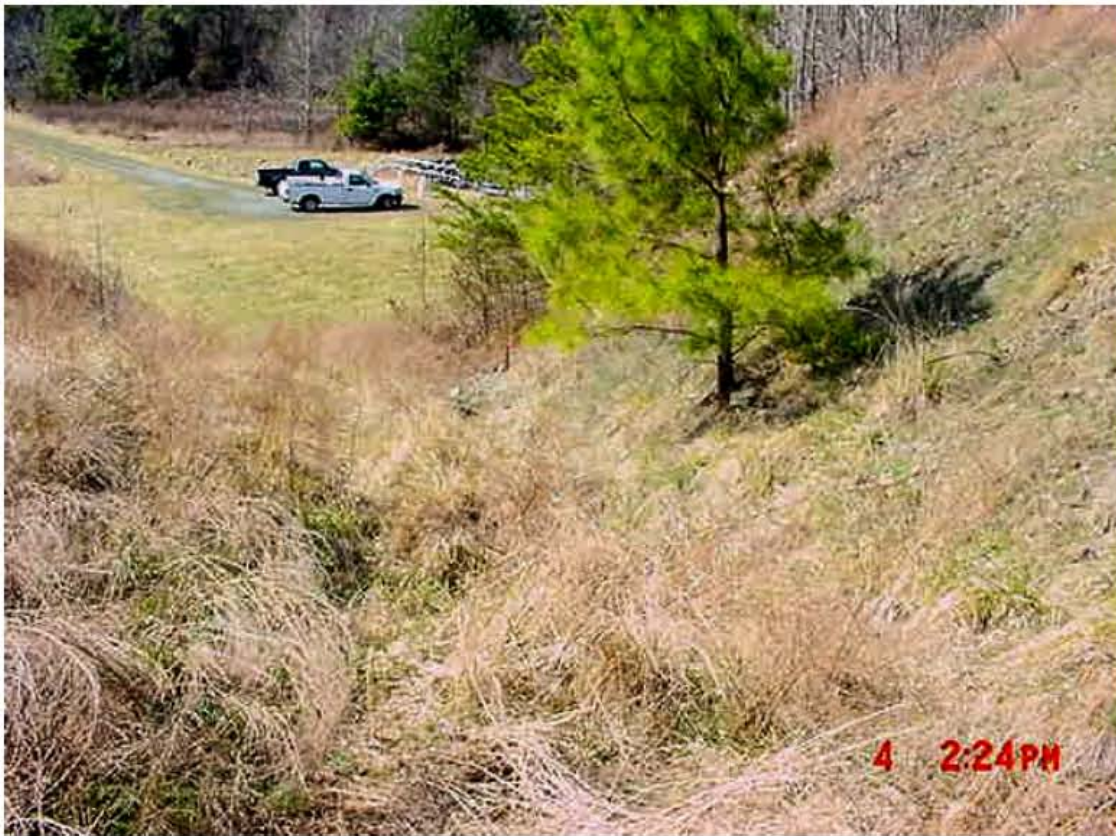
13. Mayo Creek Dam. East abutment-dam toe junction where slight seepage flow noted.

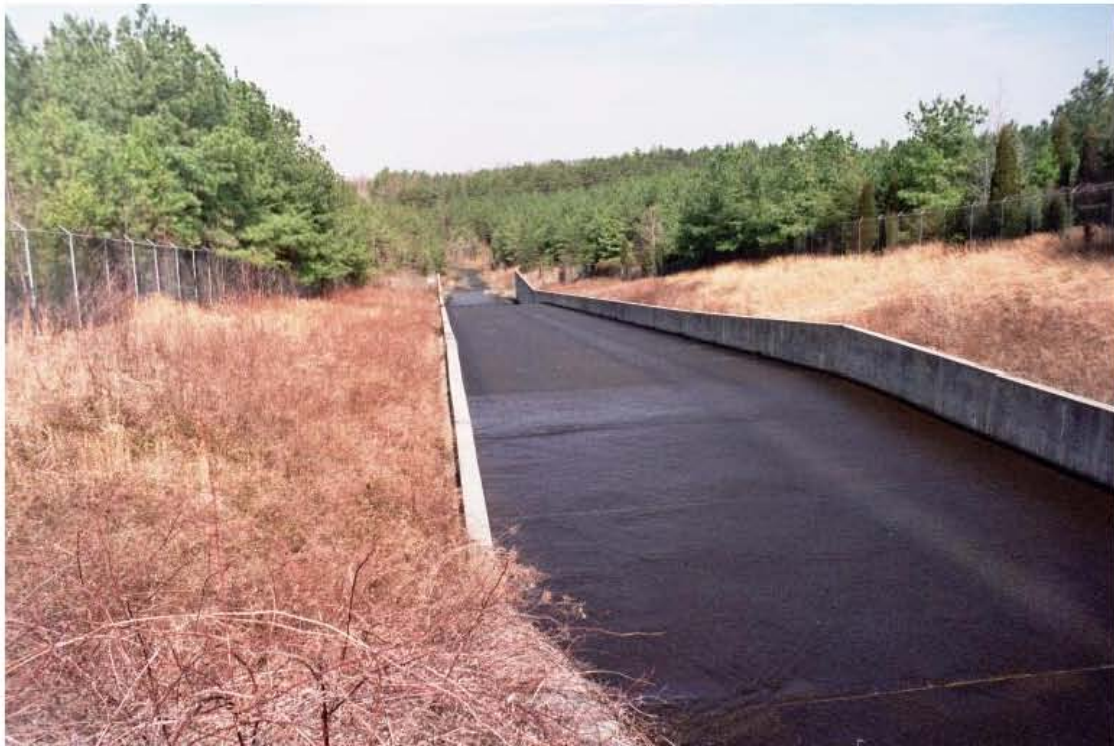
14. Mayo Creek Dam. Primary spillway looking downstream from near ogee section. Note smooth flow of water.

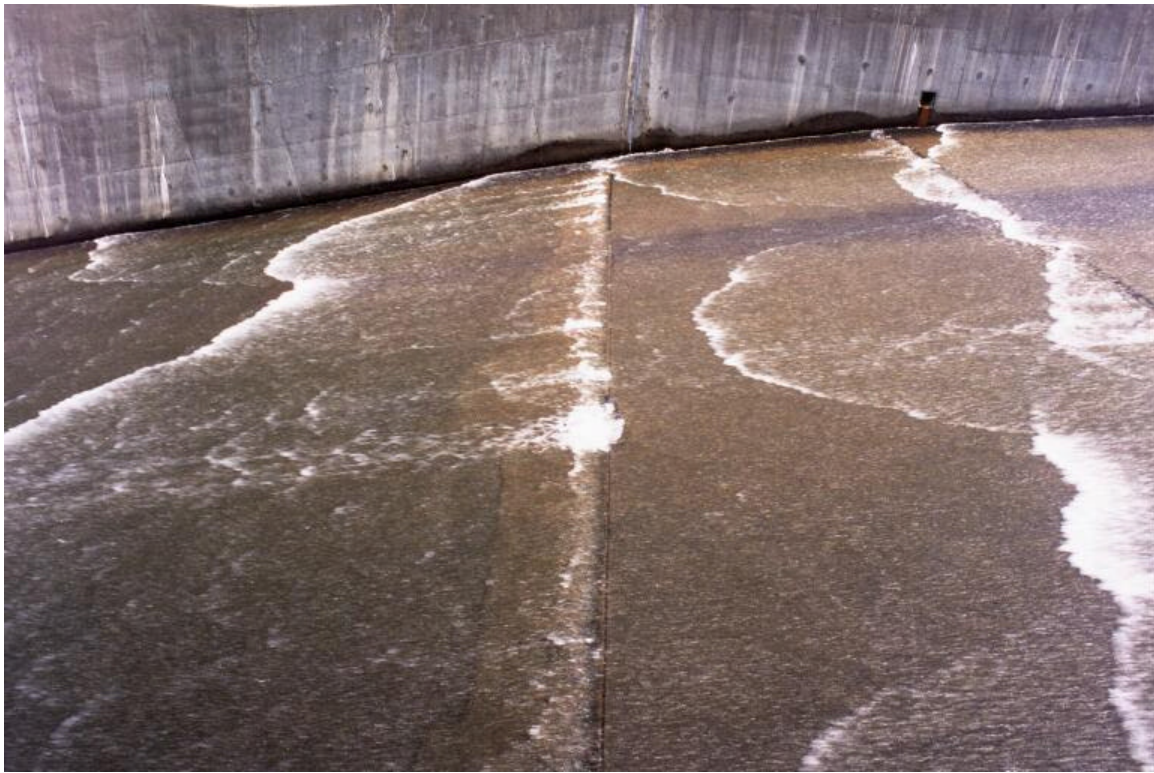
19. Mayo Creek Dam. Flow across joint 19. Disruption of flow at spalled concrete areas seen previously.

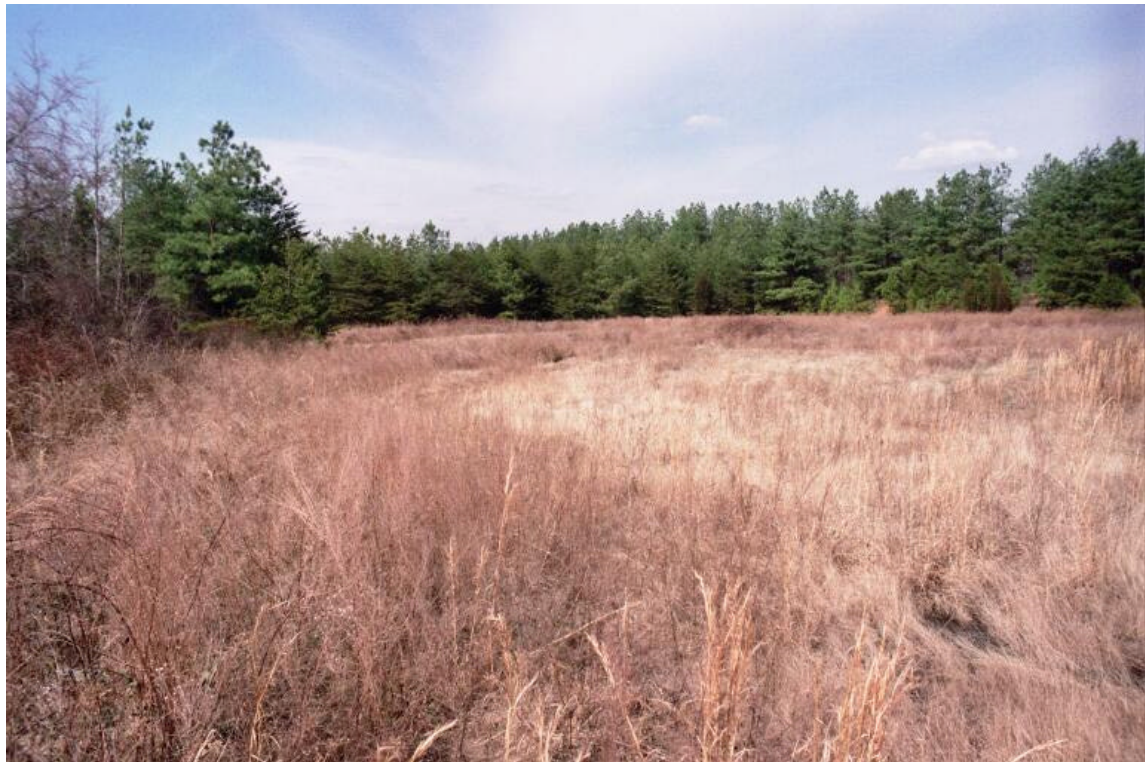
20. Mayo Creek Dam. East side of emergency spillway. Trees in spillway cut after field visit.
