**INDEPENDENT CONSULTANT INSPECTION  
MAIN COOLING LAKE DAM,  
WEST ASH POND DAM AND AFTERBAY DAM  
ROXBORO ELECTRIC PLANT  
PERSON COUNTY, NORTH CAROLINA**

**PROGRESS ENERGY CAROLINAS**  
Raleigh, North Carolina

**MACTEC ENGINEERING AND CONSULTING, INC.**  
Raleigh, North Carolina

December 29, 2008

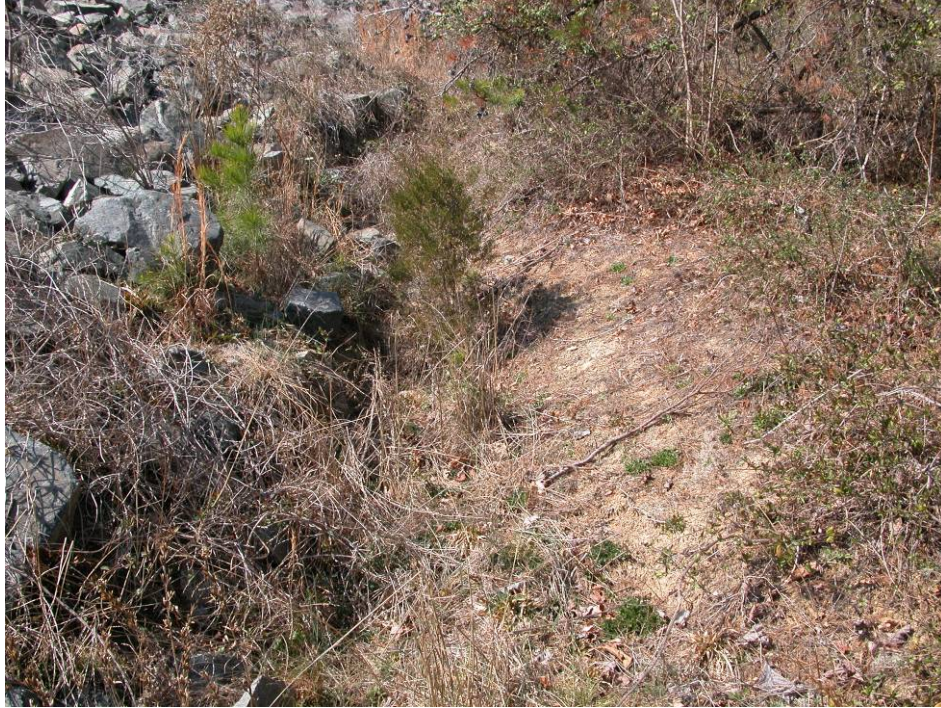
On the west end of the dam, some erosion was noted at the junction between the dam and the natural ground of the abutment during the 1993 and 1998 inspections. The erosion is still present, but has shown little change since the 2003 inspection (Photo 3). The erosion is along the natural flow line of surface runoff. The erosion has cut up to two feet below the original ground level, exposing mainly hard residual soil or soft weathered rock. The ditch is thickly overgrown with vegetation. In one or two spots, the erosion has created a near-vertical slope directly adjacent to the rip rap layer on the downstream slope. No indications of slumping or loss of ground in the downstream slope were seen. There does not appear to be any immediate risk of damage to the dam.

The lack of significant change in the erosion since first noted in 1993 indicates that the erosion is not progressing. This erosion area should continue to be observed during the normal inspections conducted by the plant. In this case, the vegetative growth is beneficial to retarding the erosion. Trimming bushes back to allow visibility should be done, but the vegetation should not be removed or killed. If progressive deepening of the ditch is seen or if any loss of ground from the toe of the dam adjacent to the ditch is seen, repairs to the ditch will be needed.

3. Main Dam – Old erosion channel on west end of downstream slope of abutment with vegetation.

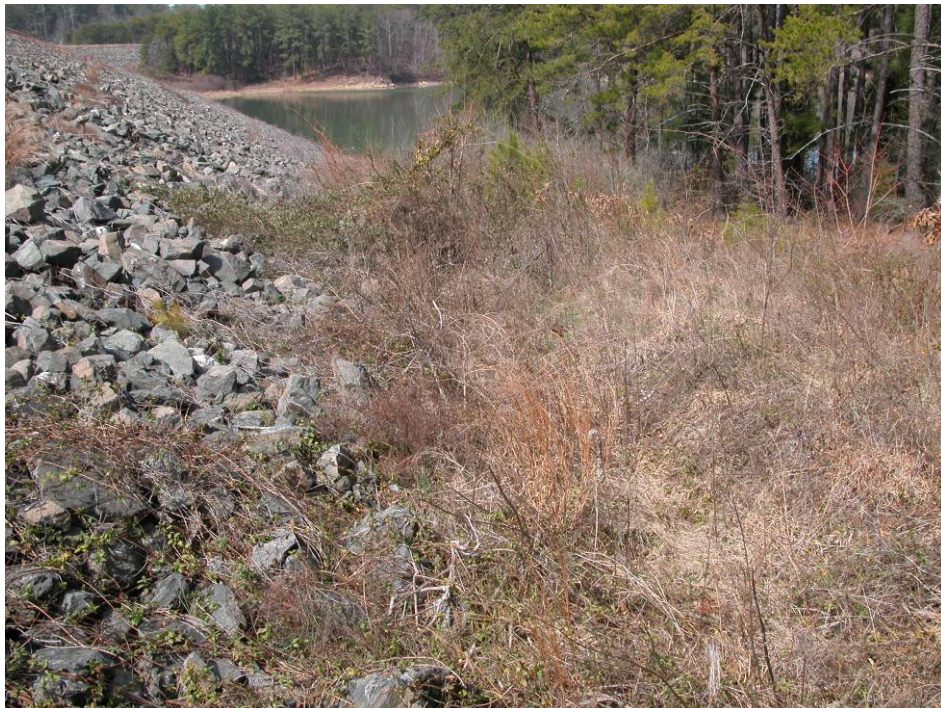
4. Main Dam – Old erosion channel on east end of downstream slope of abutment with vegetation.

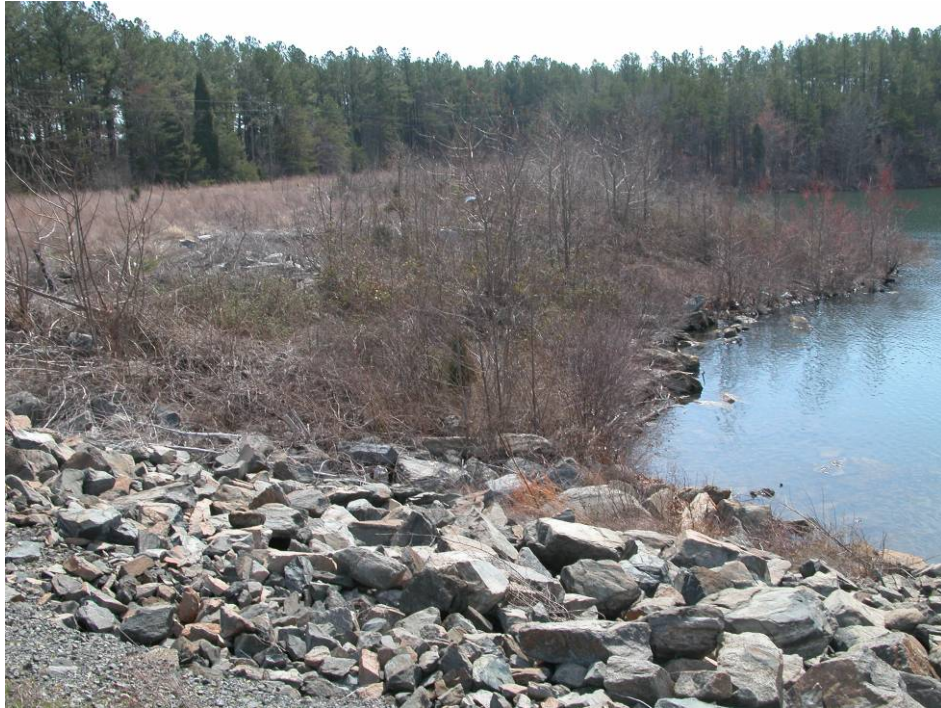
The main dam has a clay blanket on the upstream east abutment area for seepage control. Tree growth on the clay blanket has been noted in the past, and trees have been cut or sprayed as maintenance control; the last work was in 2007. As shown in Photograph 5, most of the trees appeared dead. Examination of branches revealed some with green underbark, indicating some trees remain viable. The conditions of the trees should be checked during the spring and summer months and trees remaining alive should be sprayed.

5. Main Dam – Tree growth in area of clay blanket on east upstream abutment.

1. Continue a regular schedule for trimming trees and brush on the downstream slope and on the clay cap area of the east abutment. Vegetation on the dam slopes will need trimming about every three years. The clay cap area may need trimming more frequently depending on the rate of regrowth.
2. Erosion along the junction of the downstream slopes of the Main Cooling Lake Dam and the natural ground should be observed by Progress Energy during the semi-annual inspections by Progress Energy personnel to see if progressive activity is occurring.
3. Plan for a repair and refurbishment of caulked joints in concrete spillway to occur within the next five years.

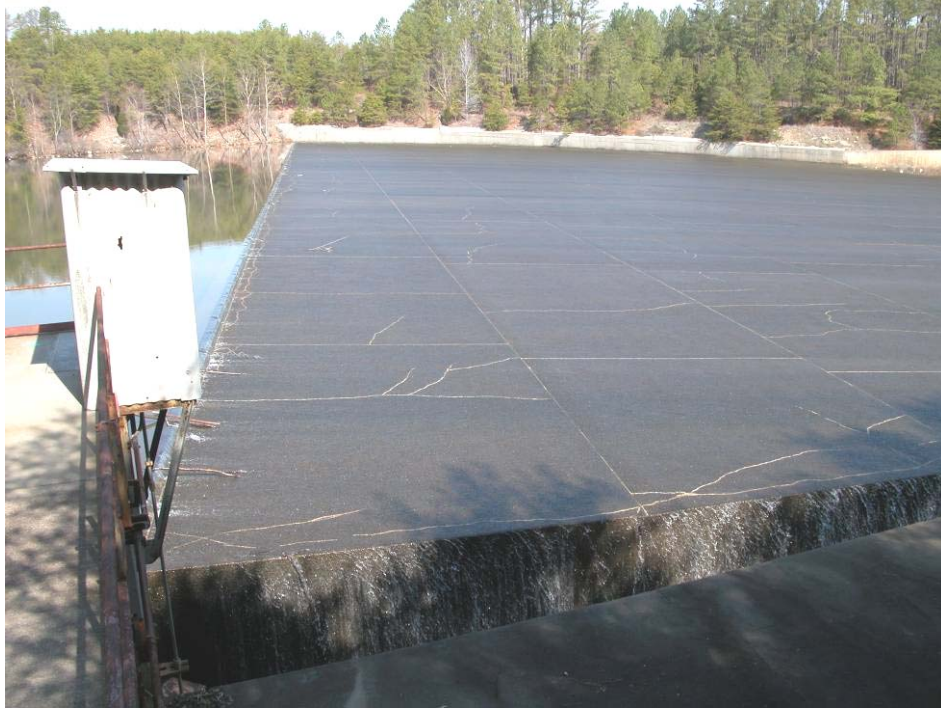
The primary spillway was observed during the August 5, 2008 site visit when no water was flowing. At the time of the March 13, 2008 visit, with the lake level at approximately elevation 410.7 feet (MSL), the flow pattern down the spillway was smooth (Photos 7 and 8). Overviews of the spillway are shown in Photos 9 and 10. The broken slab sections in Photo 9 are the result of cavitation during early flooding as described in Section 2.2 and more completely in the Historical Volume<sup>(3)</sup>. The drop wall constructed as a result of the 1975 failures is shown in Photos 11 and 12. No concerns were seen. The weep holes and underslab drain outlets were generally dry, but signs of past water flow were visible, and one underslab drain outlet showed a slight trickle of seepage flow.

7. Main Dam – Primary spillway looking north. Note smooth water flow pattern, approximately 2 inches of overflow.

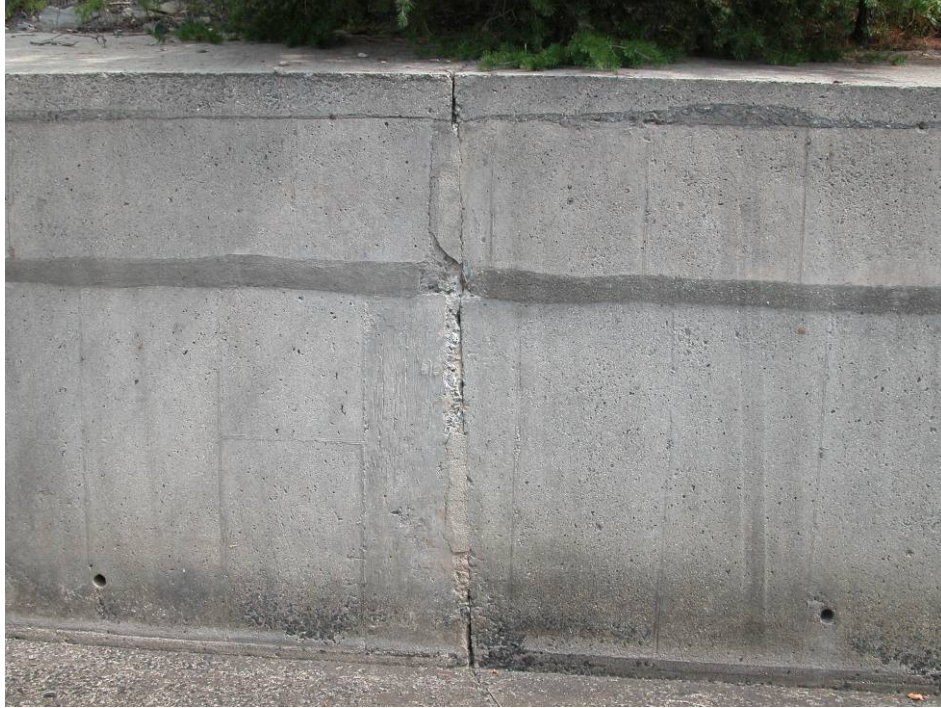
The right spillway concrete walls are in good condition. The left spillway walls have some scaling concrete at two vertical joints where past repairs were made (Photos 13 and 14), but these areas are old and show no change from past observations. Photos 15 through 17 show the left spillway

13. Main Dam – Left spillway retaining wall joint at slab E12 missing concrete patch piece (August 5, 2008).

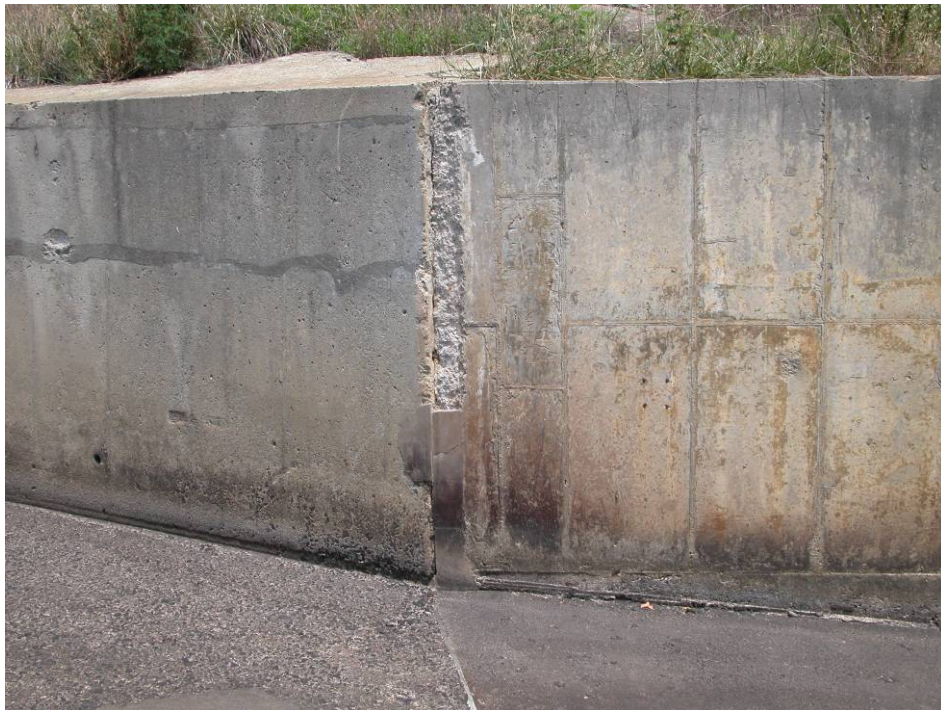
14. Main Dam – Left spillway retaining wall joint at slab J11/K12. Portion of concrete patch missing (August 5, 2008).

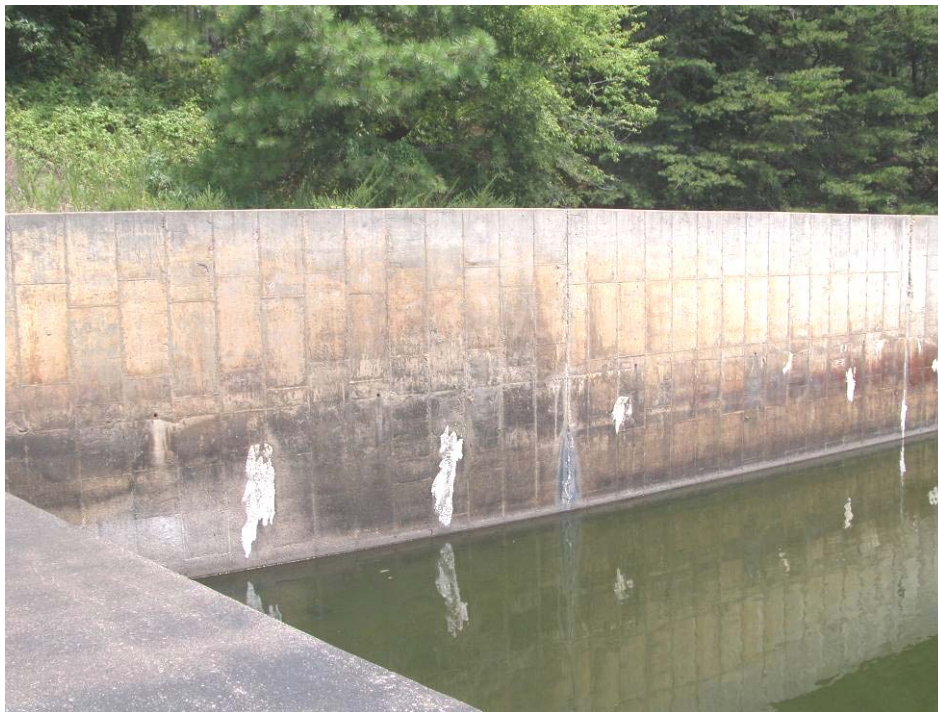
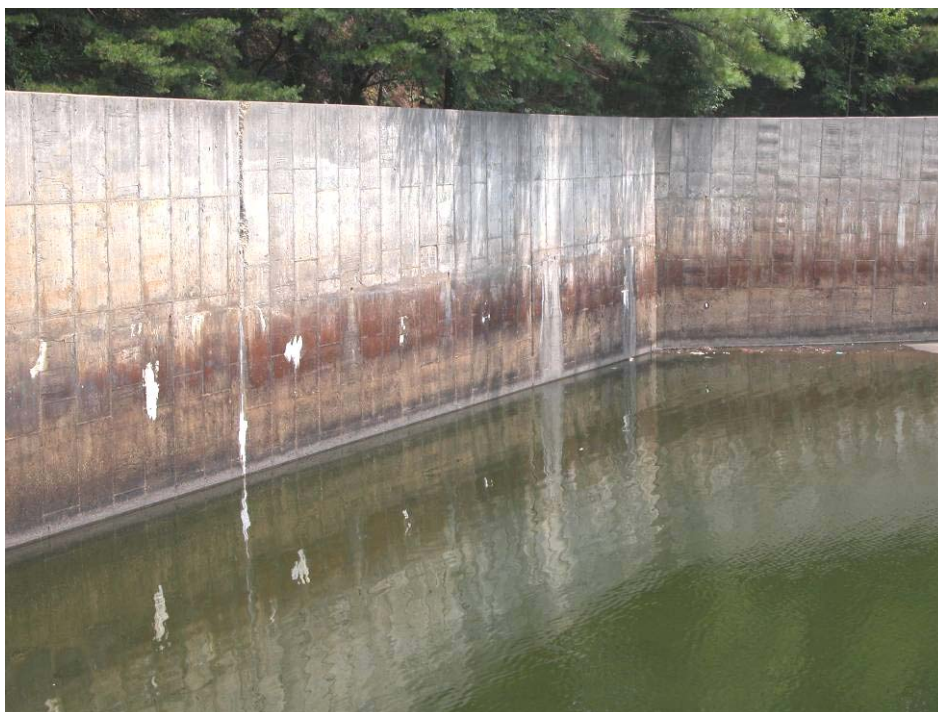
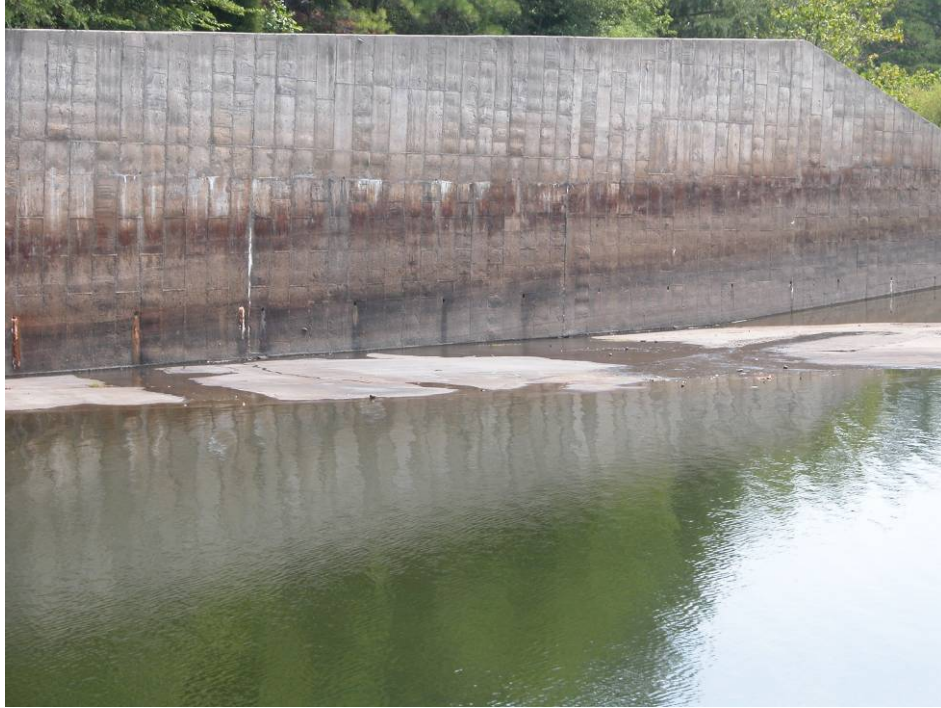
retaining wall downstream from the drop wall. No significant cracks or concerns were noted. Some minor efflorescence was observed at some locations. Downstream from the end of the left retaining wall there is a lower height retaining wall with a concrete-paved slope above (Photo 18). Movement of the low-height retaining wall has created a crack about 1-inch wide in the concrete paving. This crack has been observed in past inspections, and shows no noticeable change.

15. Main Dam – Spillway left wall (August 5, 2008).

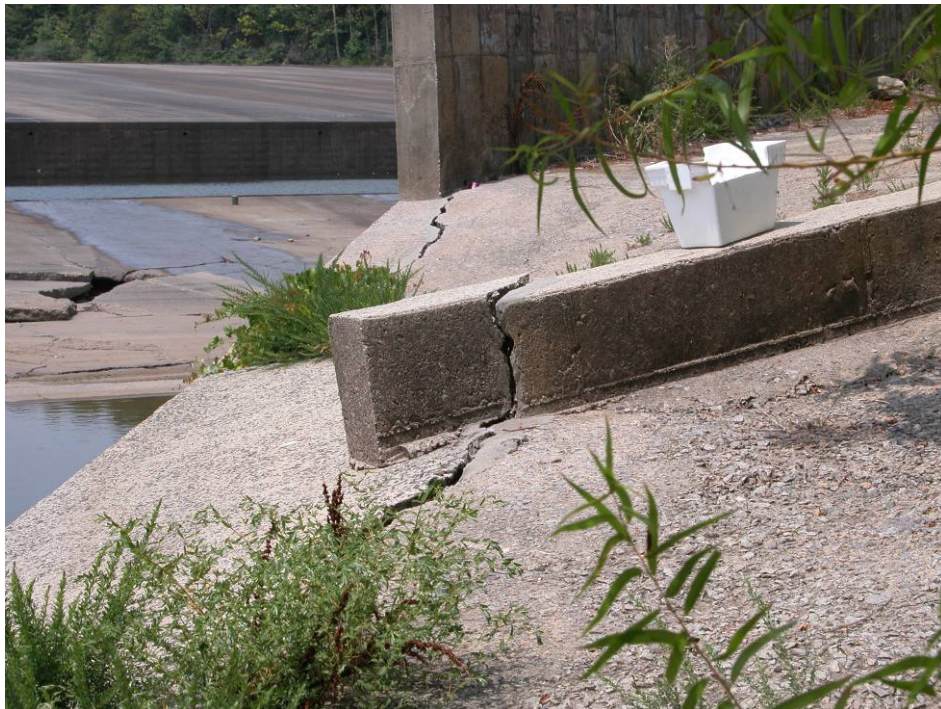
18. Main Dam – Old crack in concrete slope paving behind downstream end of spillway left retaining wall (August 5, 2008).

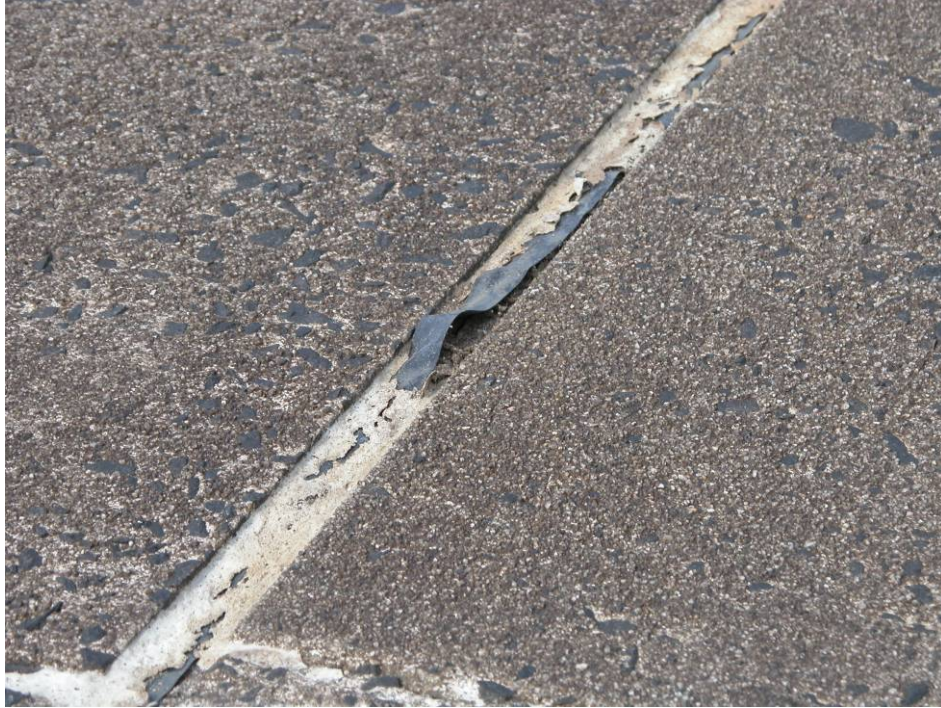
The spillway slab was walked during the August 5, 2008 visit to document conditions at the joints. Exhibit 8 shows the slab numbering pattern used in the following discussion. No new cracks of significance were seen; only an occasional extension of an existing crack by a few inches or a hairline new crack near an existing one were found. The main observations were missing or abraded joint tape and some loose crack patches on the left side. Some surface loss of cement mortar around the aggregate was seen on the surface of a few slabs, suggesting concentrated flow is more common across these sections, and an occasional small hole due to an aggregate popout was seen. Photos 19 through 26 document typical conditions. A summary of the field notes is attached in Exhibit 22. While the overall condition of the spillway slab is excellent for its age, the deterioration in caulk and joint tape is progressing. A general refurbishment of the joint caulking should be planned for implementation over the next five years.

19. Main Dam – Example of tape over caulked joint pulled off (joint B11/B12 - August 5, 2008).

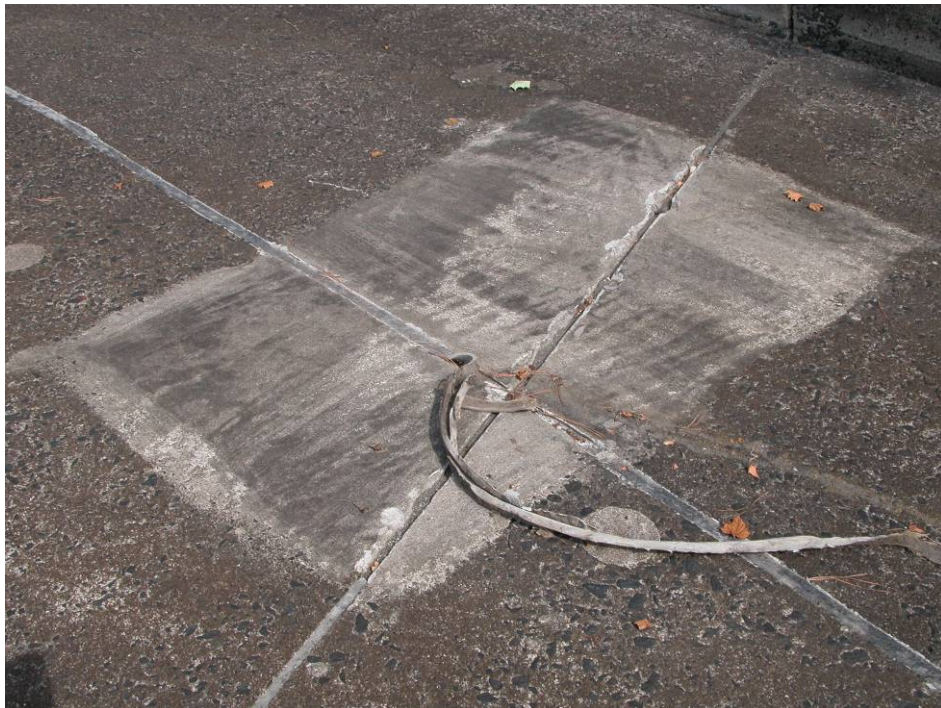
20. Main Dam – Patch at joint D12/D13 to joint D13 torn out; E11/E12 caulk torn out at D13 joint (August 5, 2008).

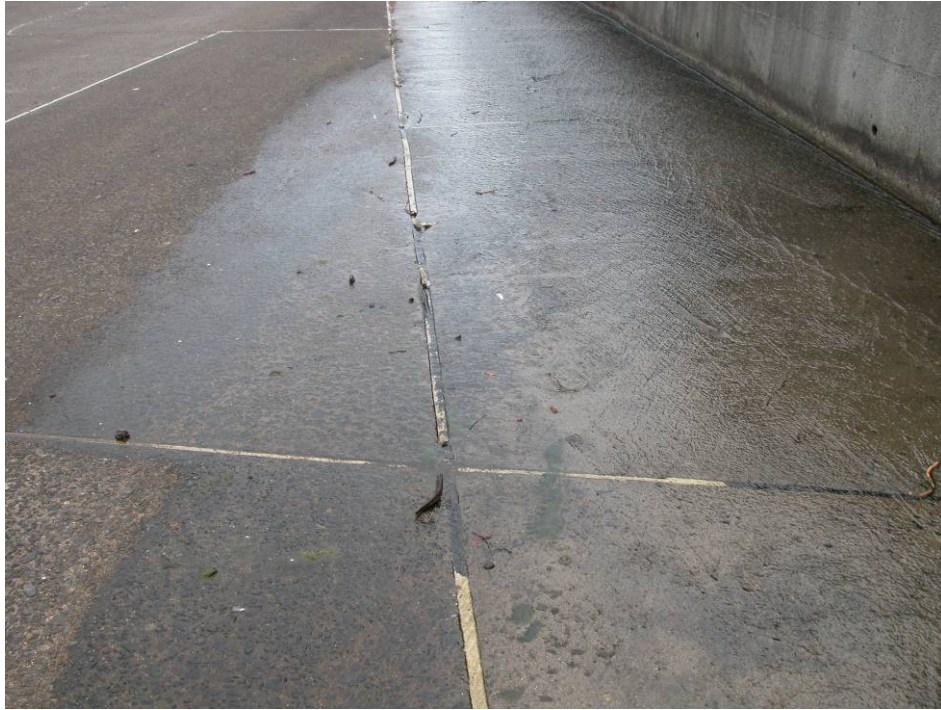
21. Main Dam – Weir flow channel caulk separated (slab F1 looking upstream - (August 5, 2008).

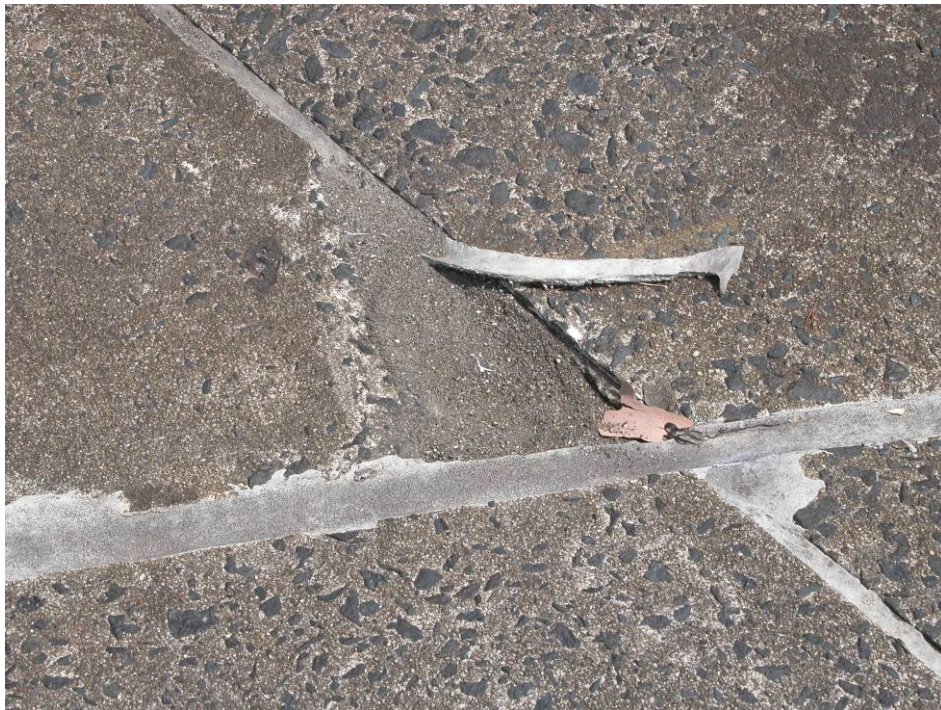
22. Main Dam – Patch eroded out and caulk pulled up (I11/J11 - August 5, 2008).

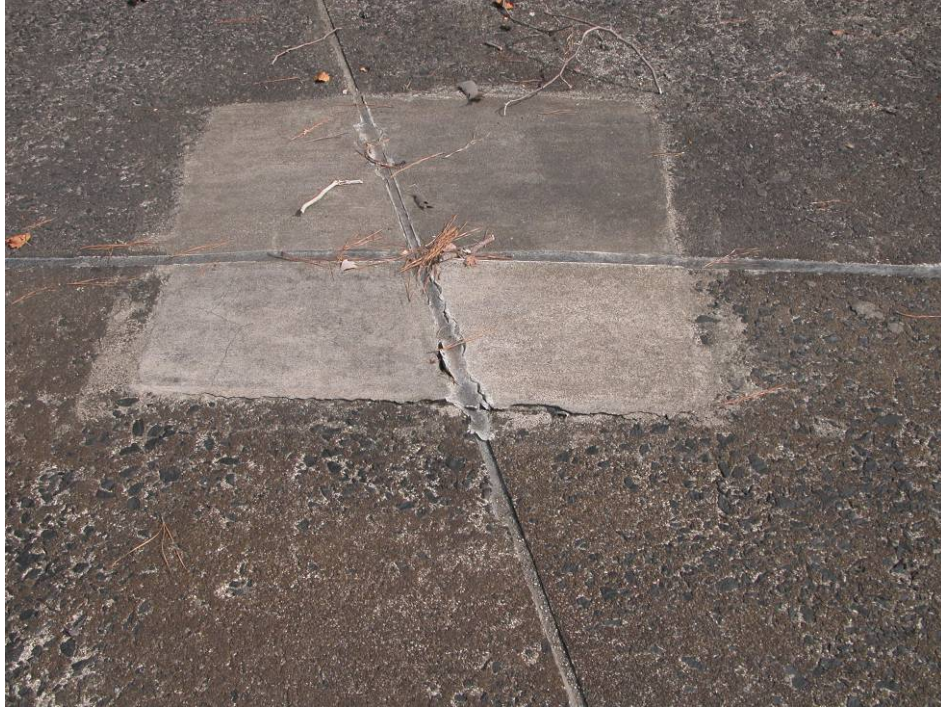
23. Main Dam – Patch with loose caulk on C12, D12, tight C13, D13 at junction C12, C13, D12, D13 (August 5, 2008).

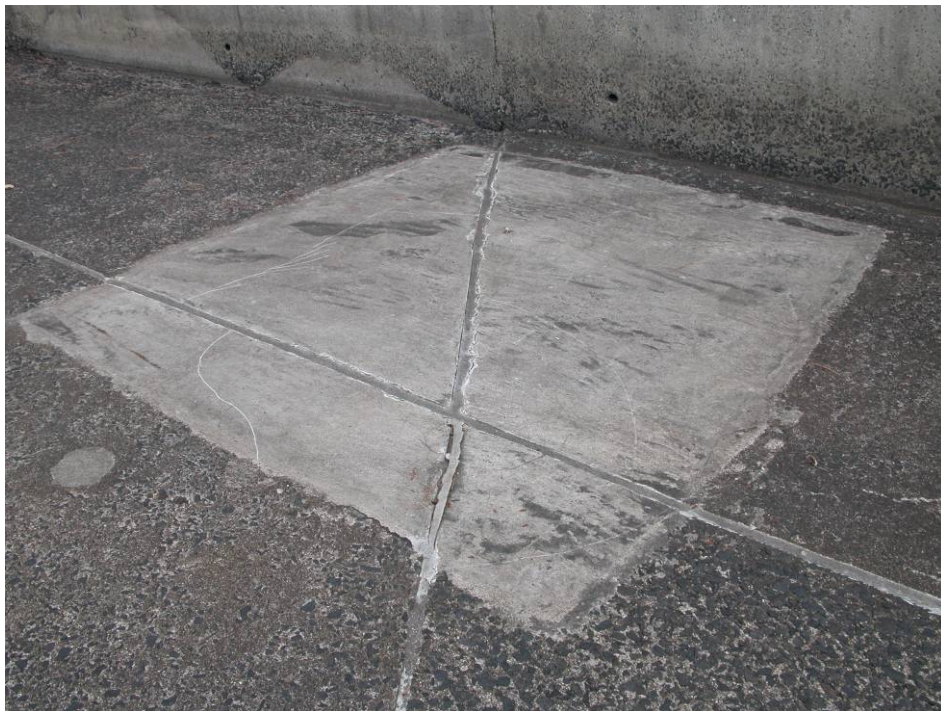
24. Main Dam – Patch over intersection G12/G13/H11/H12 has hollow sounds (August 5, 2008).

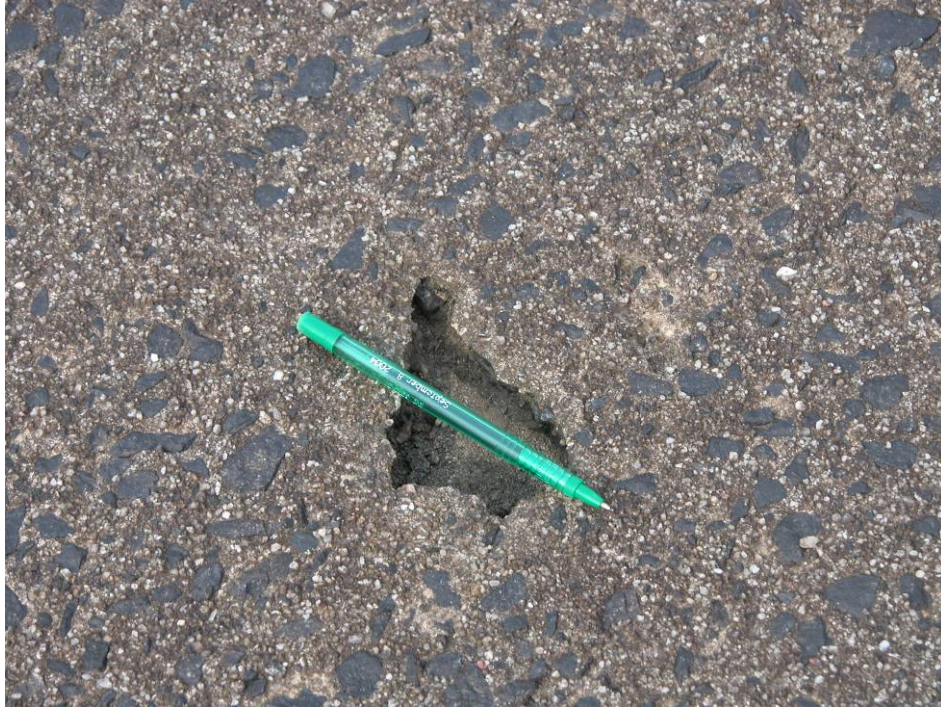
25. Main Dam – Aggregate popout hole 2 inches by 3 inches and 1.5 inches deep in section B5 (August 5, 2008).

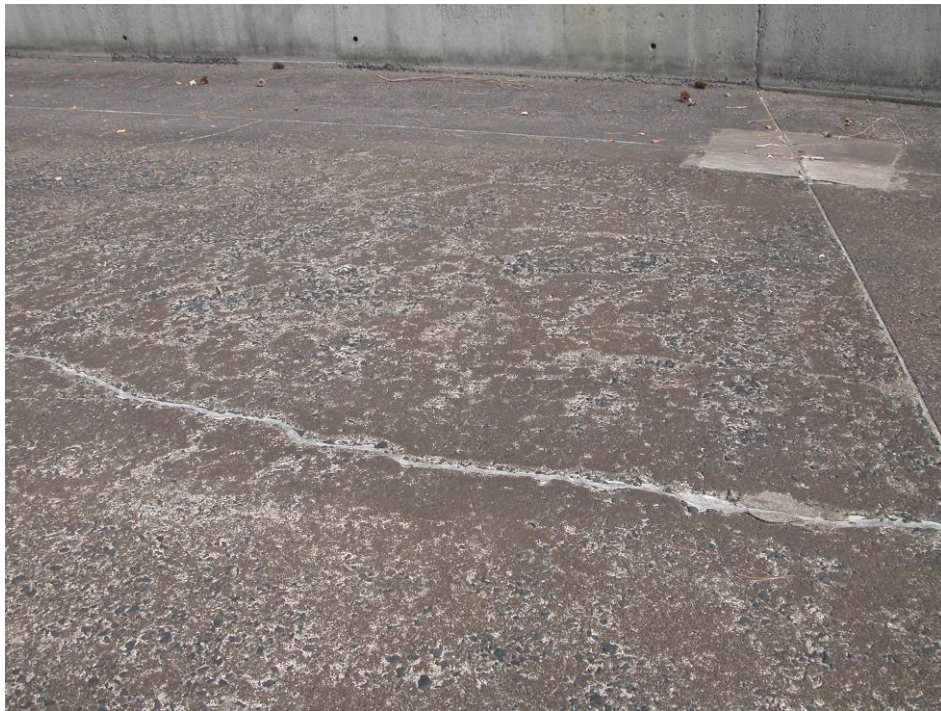
26. Exposed aggregate in section C12 (August 5, 2008).

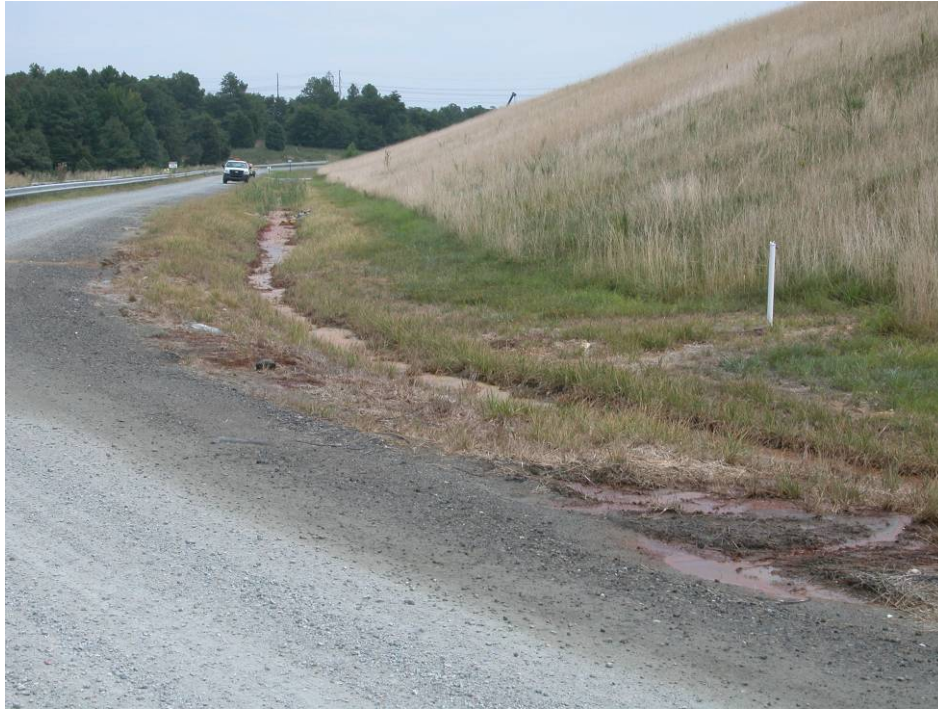
The dam is in good condition with no significant concerns seen. The crest of the dam is relatively level and shows no unusual cracks or settlement (Photo 27). The upstream slope is now covered by the new WWTP dam. (Photo 27).

27. West Ash Pond Dam – View along crest of dam from west abutment. Toe of slope and drainage swale for new wastewater treatment pond is to the north (August 5, 2008)

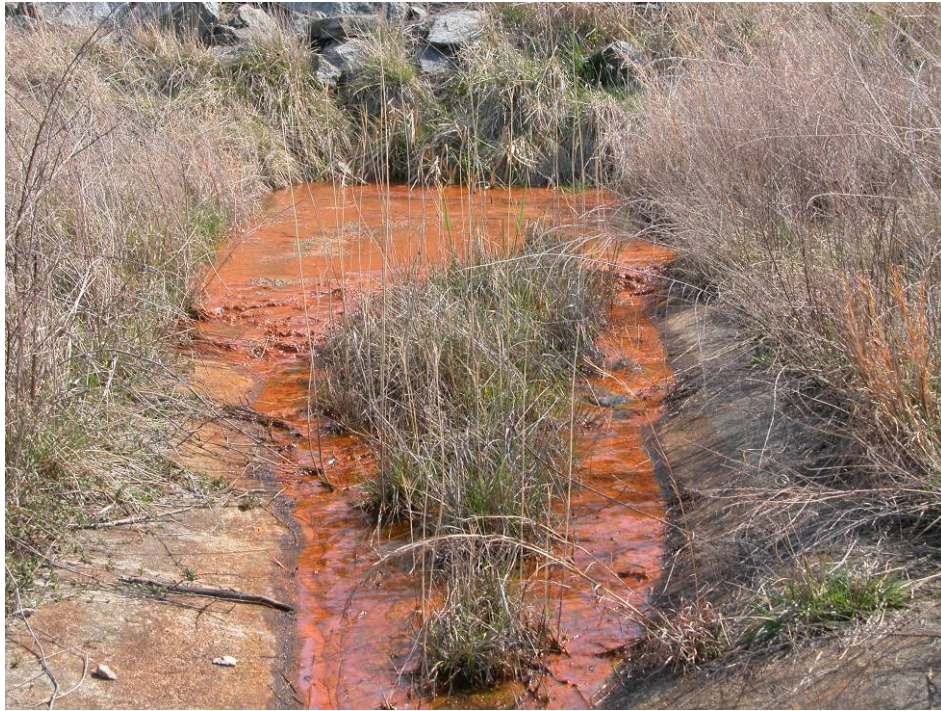
The exit points for the internal drainage of the dam are mounds of drainage stone with no pipe outlet. Water from these points flows down concrete swales to discharge into Hyco Lake. Minor flow amounts were emerging from six of the seven exit points; flow volumes were estimated at less than ½ gallon per minute, with slightly greater flow from the fifth drain from the west end of the toe. These flow amounts are consistent with past observations. The seepage appeared clear, but orange-stained sediment in the outlet channels has accumulated. No indications of soil loss were seen. The sediment and orange staining is likely due to the vegetative growth that has accumulated around the outlets.

29. West Ash Pond Dam – Typical condition of toe drain outflow channels where flow is present.

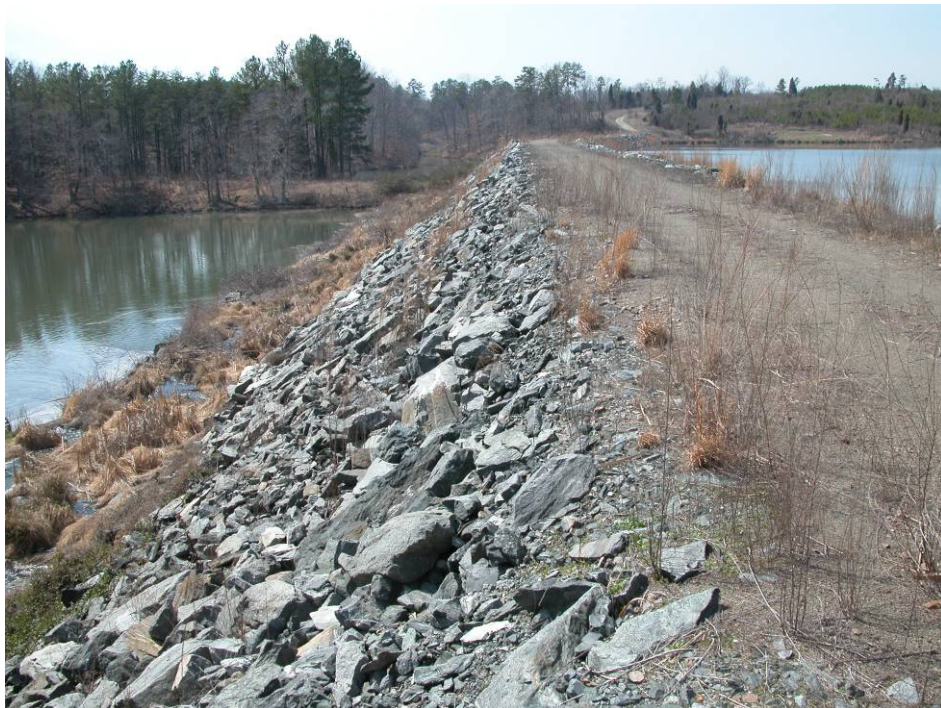
The crest of the dike is relatively level with no indications of settlement or cracks (Photo 30).

Overall, the exterior slope is in good visual condition (Photos 30 and 33). Due to the method of construction, there are several locally steeper areas where minor rock surface slides have occurred.

30. West Ash Pond Dike No. 1 – Crest and exterior slope looking toward west abutment.

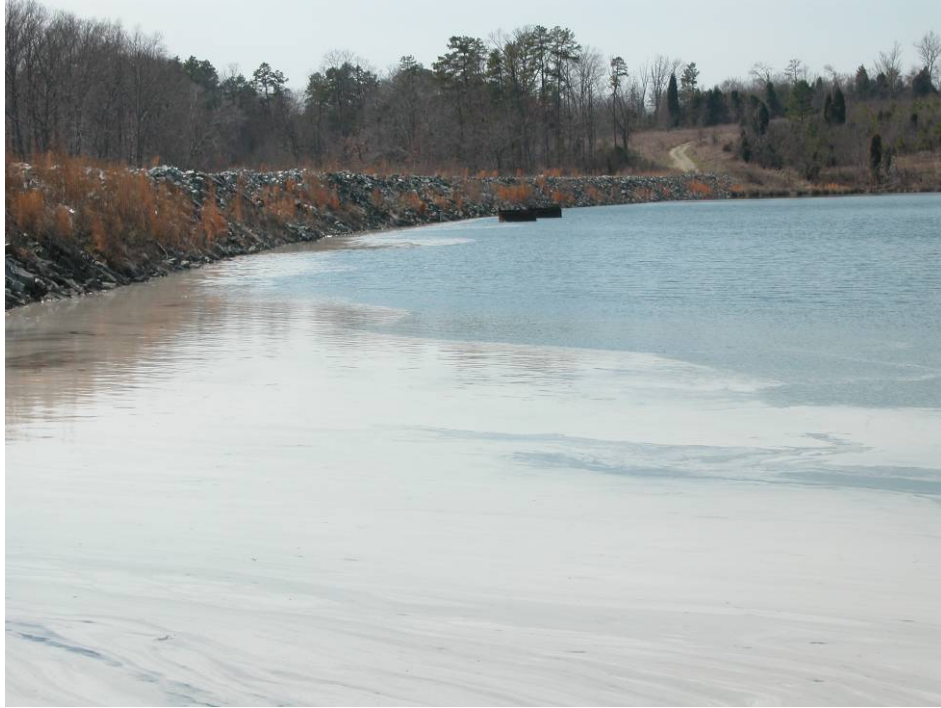
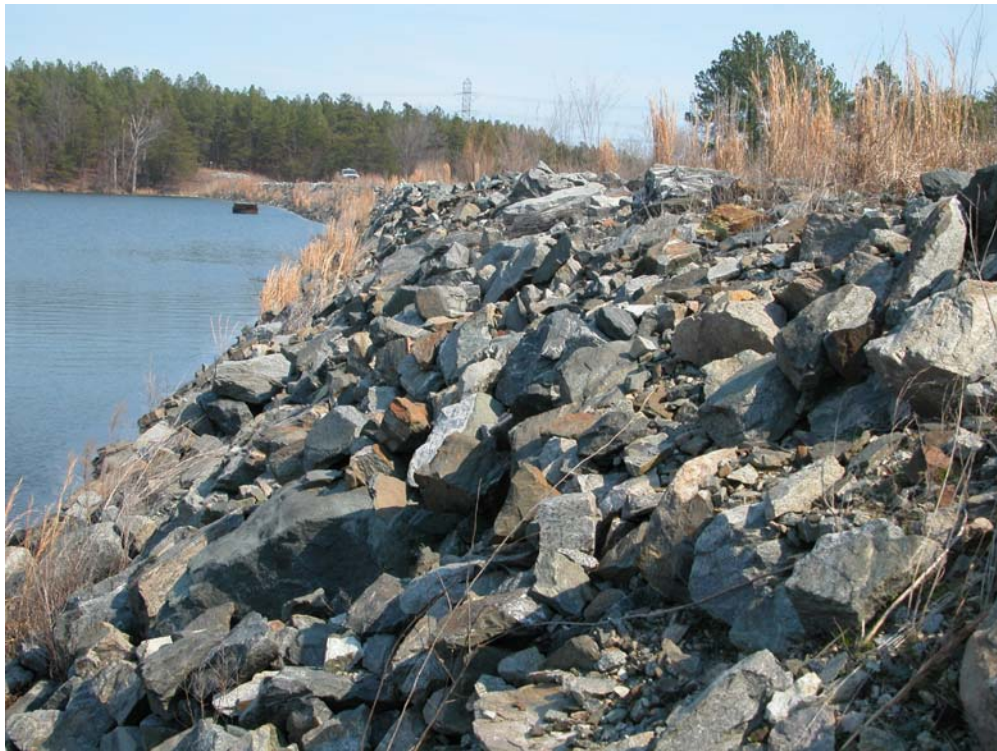
The interior slope appears in generally good visual condition; the steep slopes were formed by end-dumping rock and the slope is irregular (Photos 31 and 32). Three areas previously noted on the interior (north) slope of the eastern part of the dike which appear to indicate recent shallow-seated rock slides have had additional rip rap placed to reduce risk of further movement above the slide areas. At two of the areas, some additional rip rap still needs to be placed. Changes in ash pond water level related to the WWTP construction caused completion of the rip rap placement to be deferred for lack of access by a work barge. The additional rip rap was left on the crest and is to be placed in 2008.

31. West Ash Pond Dike No. 1 – Interior slope looking toward west abutment.

32. West Ash Pond Dike No. 1 – Rip rap on interior slope

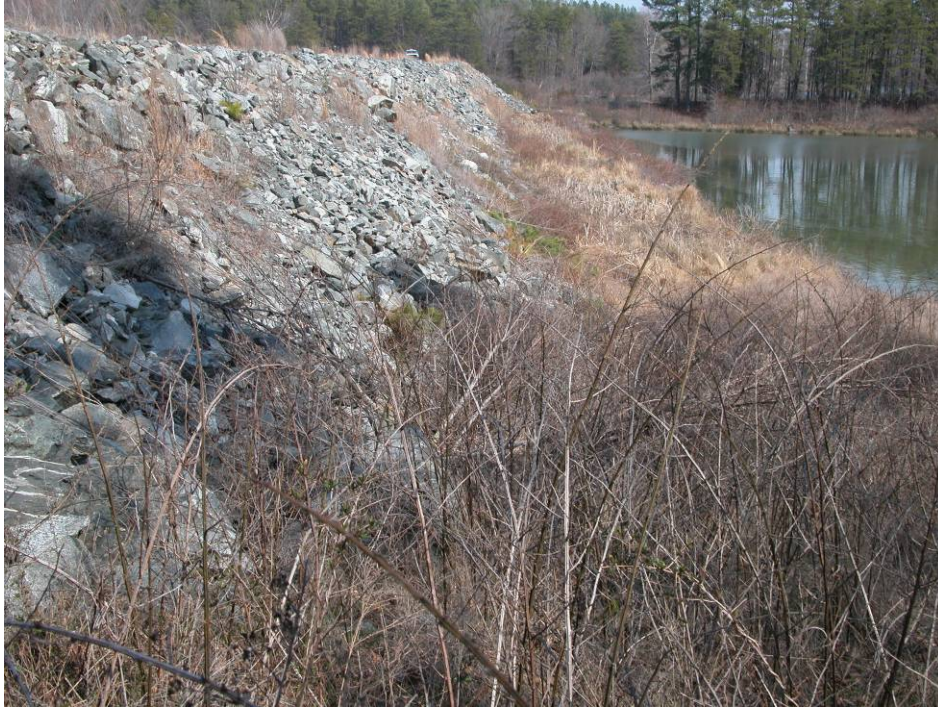
33. West Ash Pond Dike No. 1 – Riprap and toe of exterior slope looking toward east.

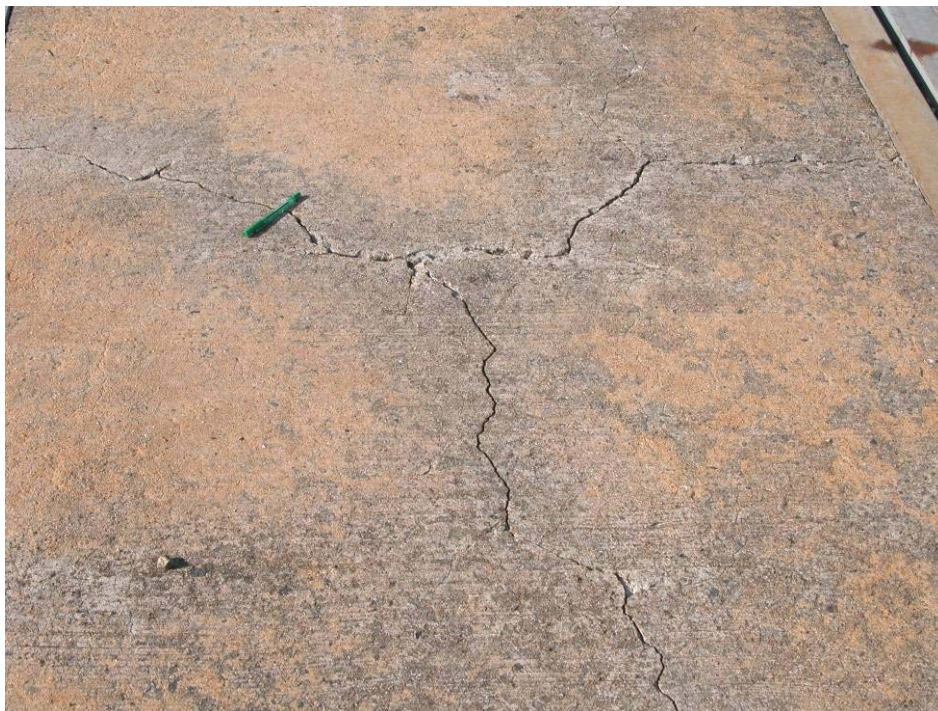
62. Afterbay Dam – View of cracking at crest of Pier 2.

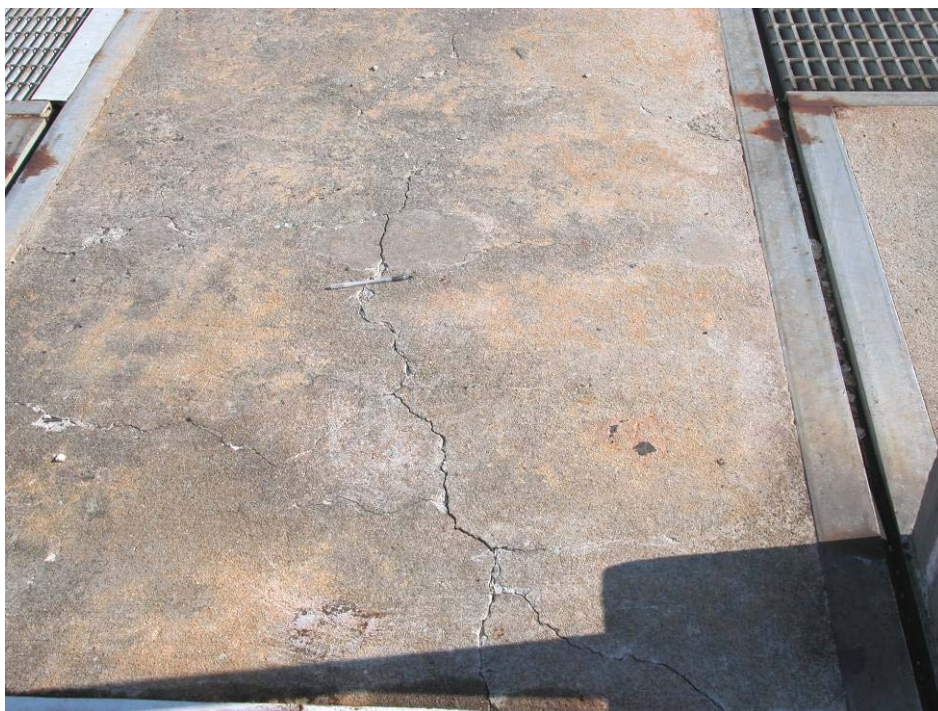
63. Afterbay Dam – View of cracking at crest of Pier 3.

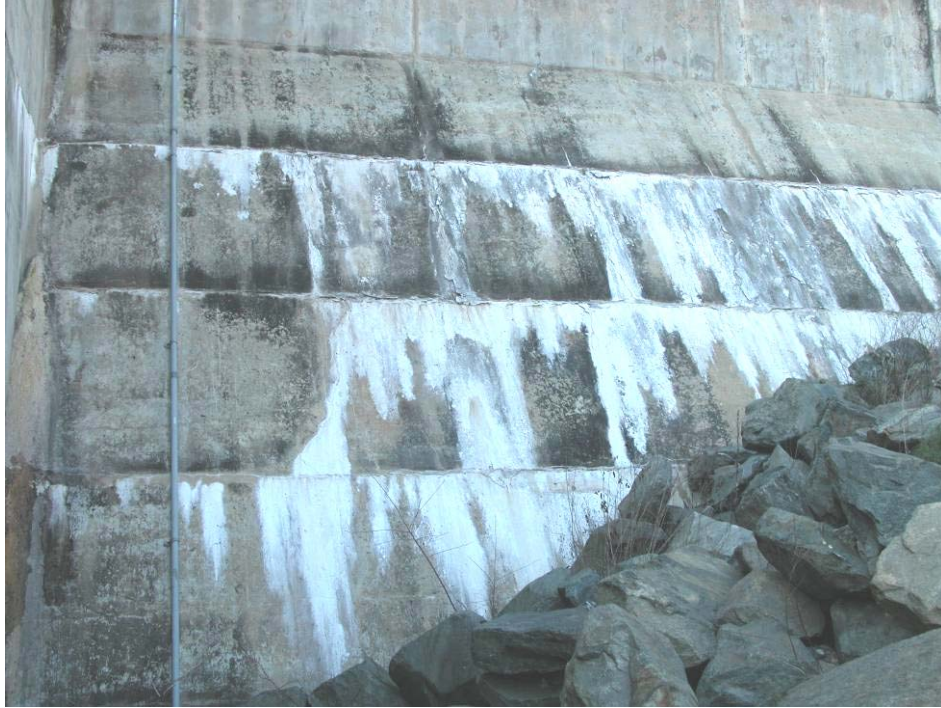
64. Afterbay Dam – View of efflorescence and minor surface scaling on east gravity section.

1. Continue to maintain vegetation growing on the downstream side of the east gravity section.
2. Observe the area downstream of the earth section where seepage has been noted previously for signs of recurrence or change as part of regular inspections.

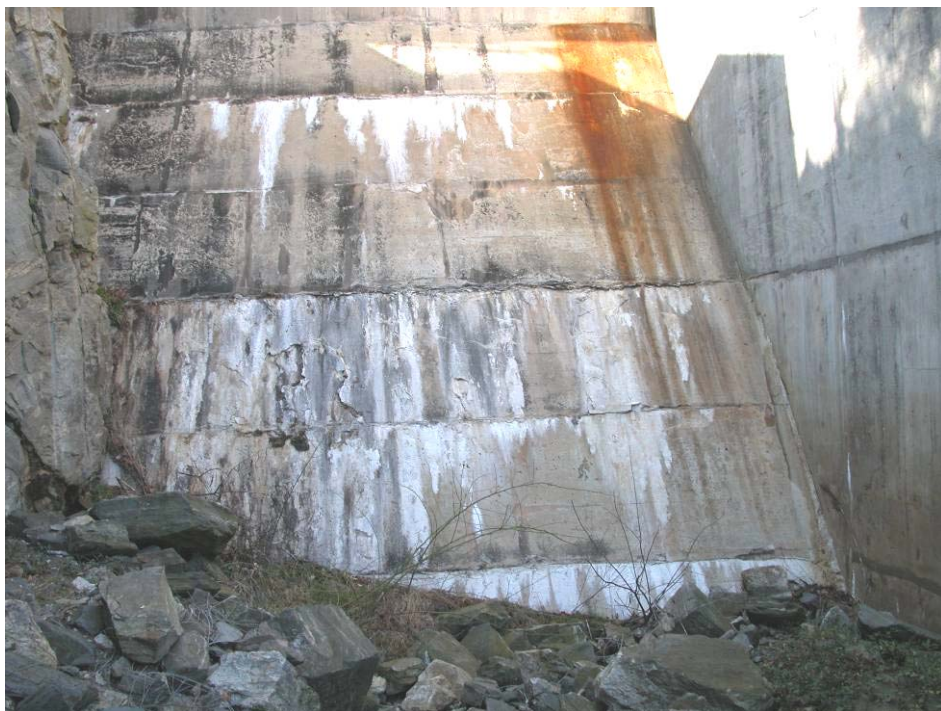
65. Afterbay Dam – View of efflorescence and minor surface scaling on west gravity section;  
slight dampness at junction of gravity section and Pier 5.

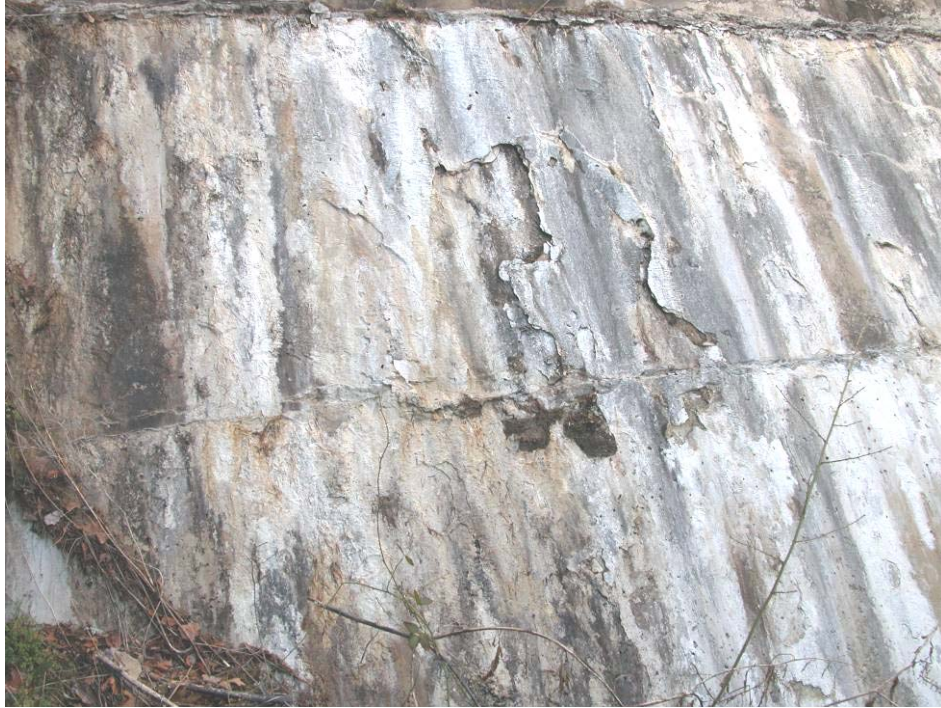
66. Afterbay Dam – View of bulging concrete and maximum efflorescence on west gravity section.
