**SEVENTH
FIVE-YEAR INDEPENDENT CONSULTANT
INSPECTION REPORT
(PER THE NORTH CAROLINA UTILITIES COMMISSION)**

**DUKE ENERGY
ALLEN STEAM STATION
253 Plant Allen Road
Belmont, North Carolina 28012
S&ME PROJECT NO. 1411-07-152**

Reference: **Five-year Independent Consultant Inspection Report**
Ash Basin Dikes, Allen Steam Station
Belmont, North Carolina
S&ME Project No. 1411-07-152

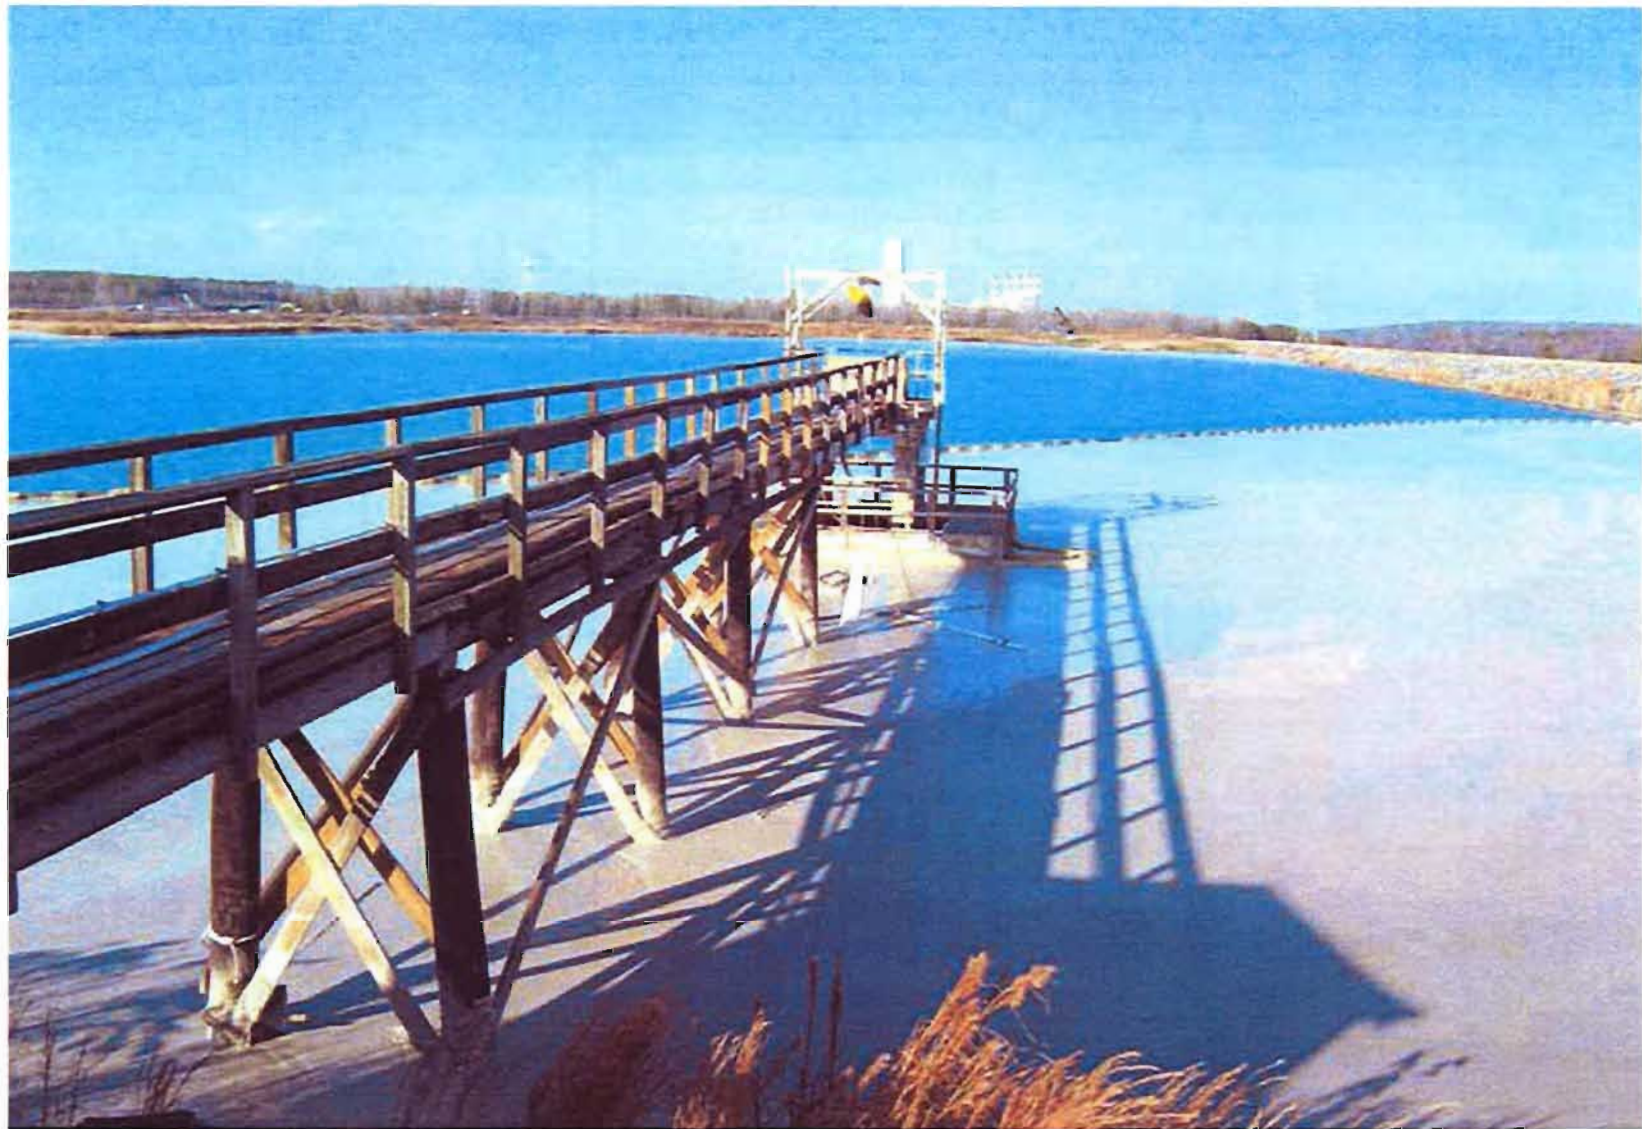
FIGURE NO.
5

The outlet structure for the Active Ash Basin appears to function as designed (Figure 5). We noted no deficiencies in the ash tower structure. However, the condition of the stop logs could not be observed. Repairs to the walkway were noted. We noted no signs of seepage around the spillway conduit or internal erosion through the conduit in our observations at the outlet end of the conduit. Previously documented damage to the end of the spillway conduit is still evident (Figure 7).

Location: East Dike - southern end

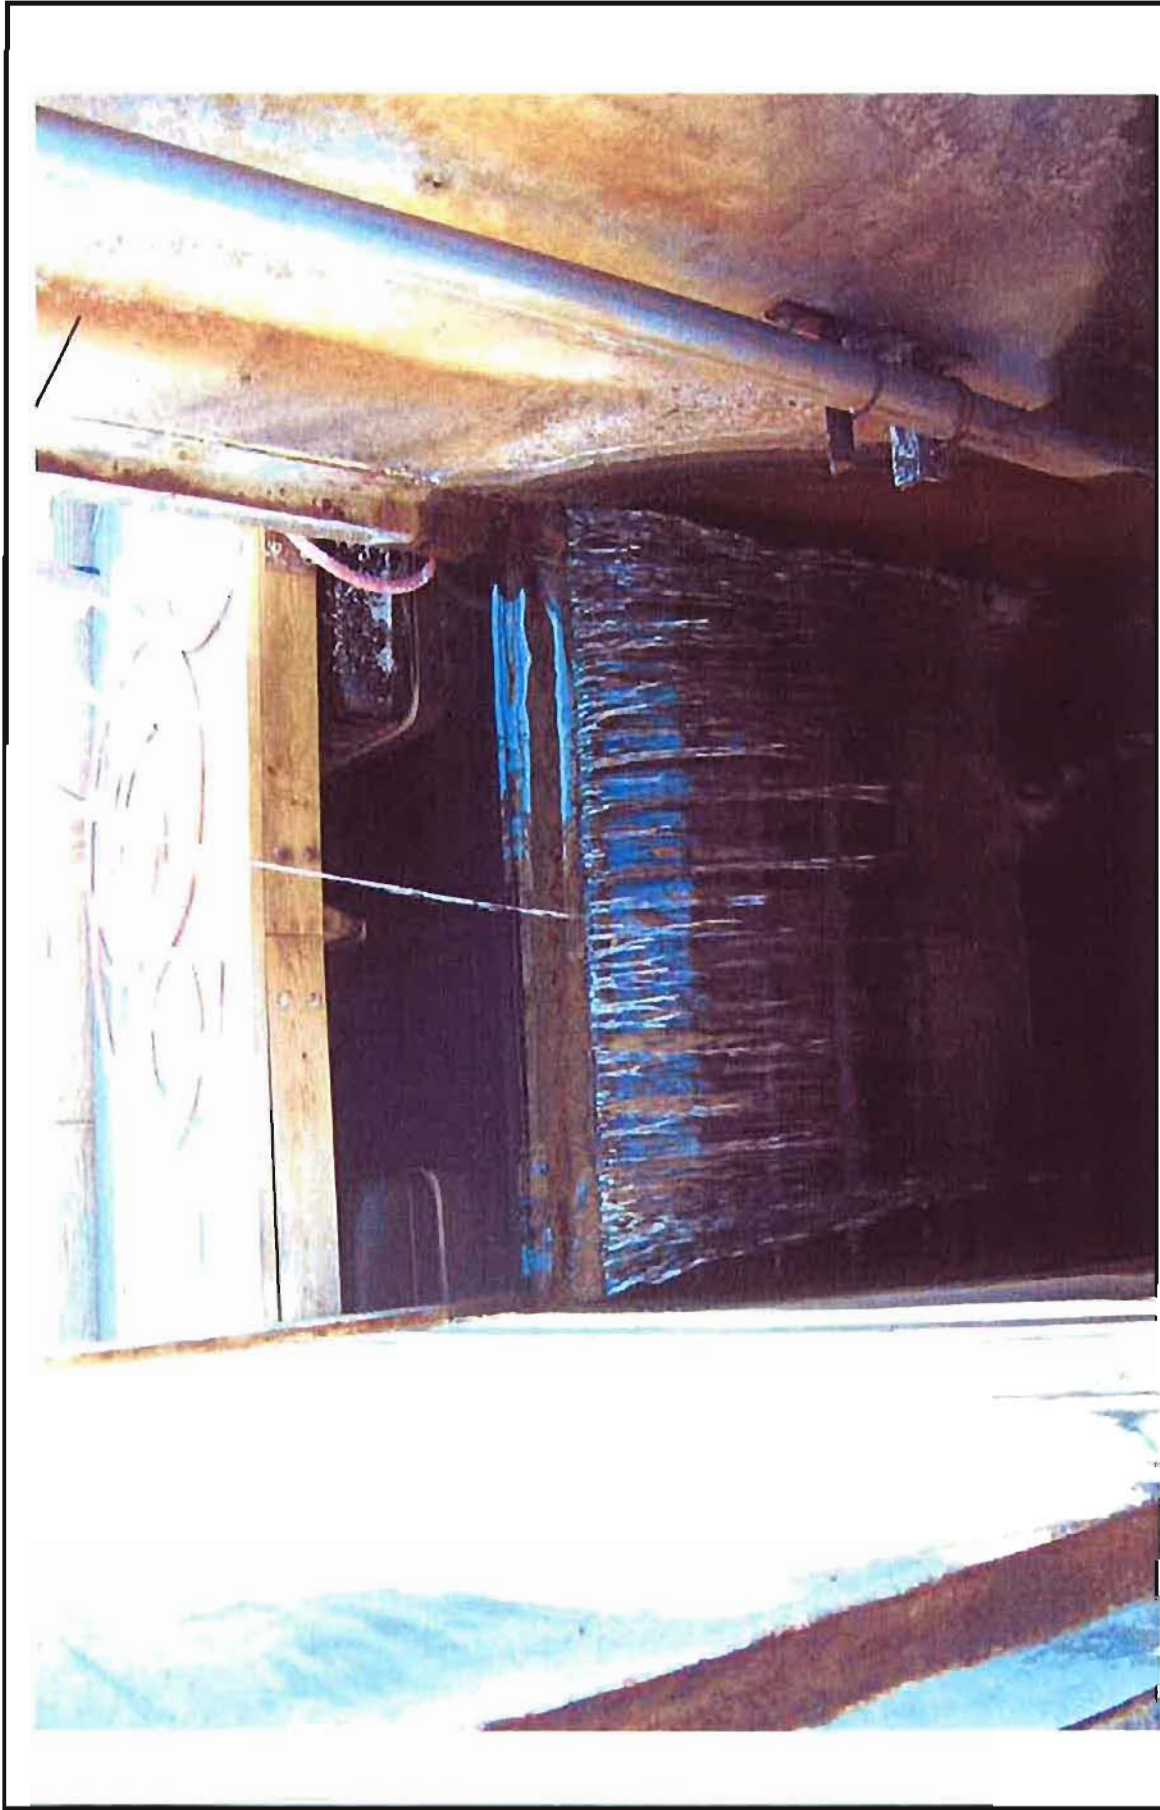
pool at the desired operating level (Figure 6). A 42-inch diameter reinforced concrete pipe serves as the outlet conduit (Figure 7). No emergency overflow spillway section was observed.

SCALE:	NTS	Location: East Dike - Ash Tower	Active Ash Basin Dikes	FIGURE NO.
CHECKED BY:	JFG			
DRAWN BY:	JFG	Description: Stop log weir	Five-year Indep. Consultant Inspection	6
DATE:	5/15/2008		JOB NO. 1411-07-152

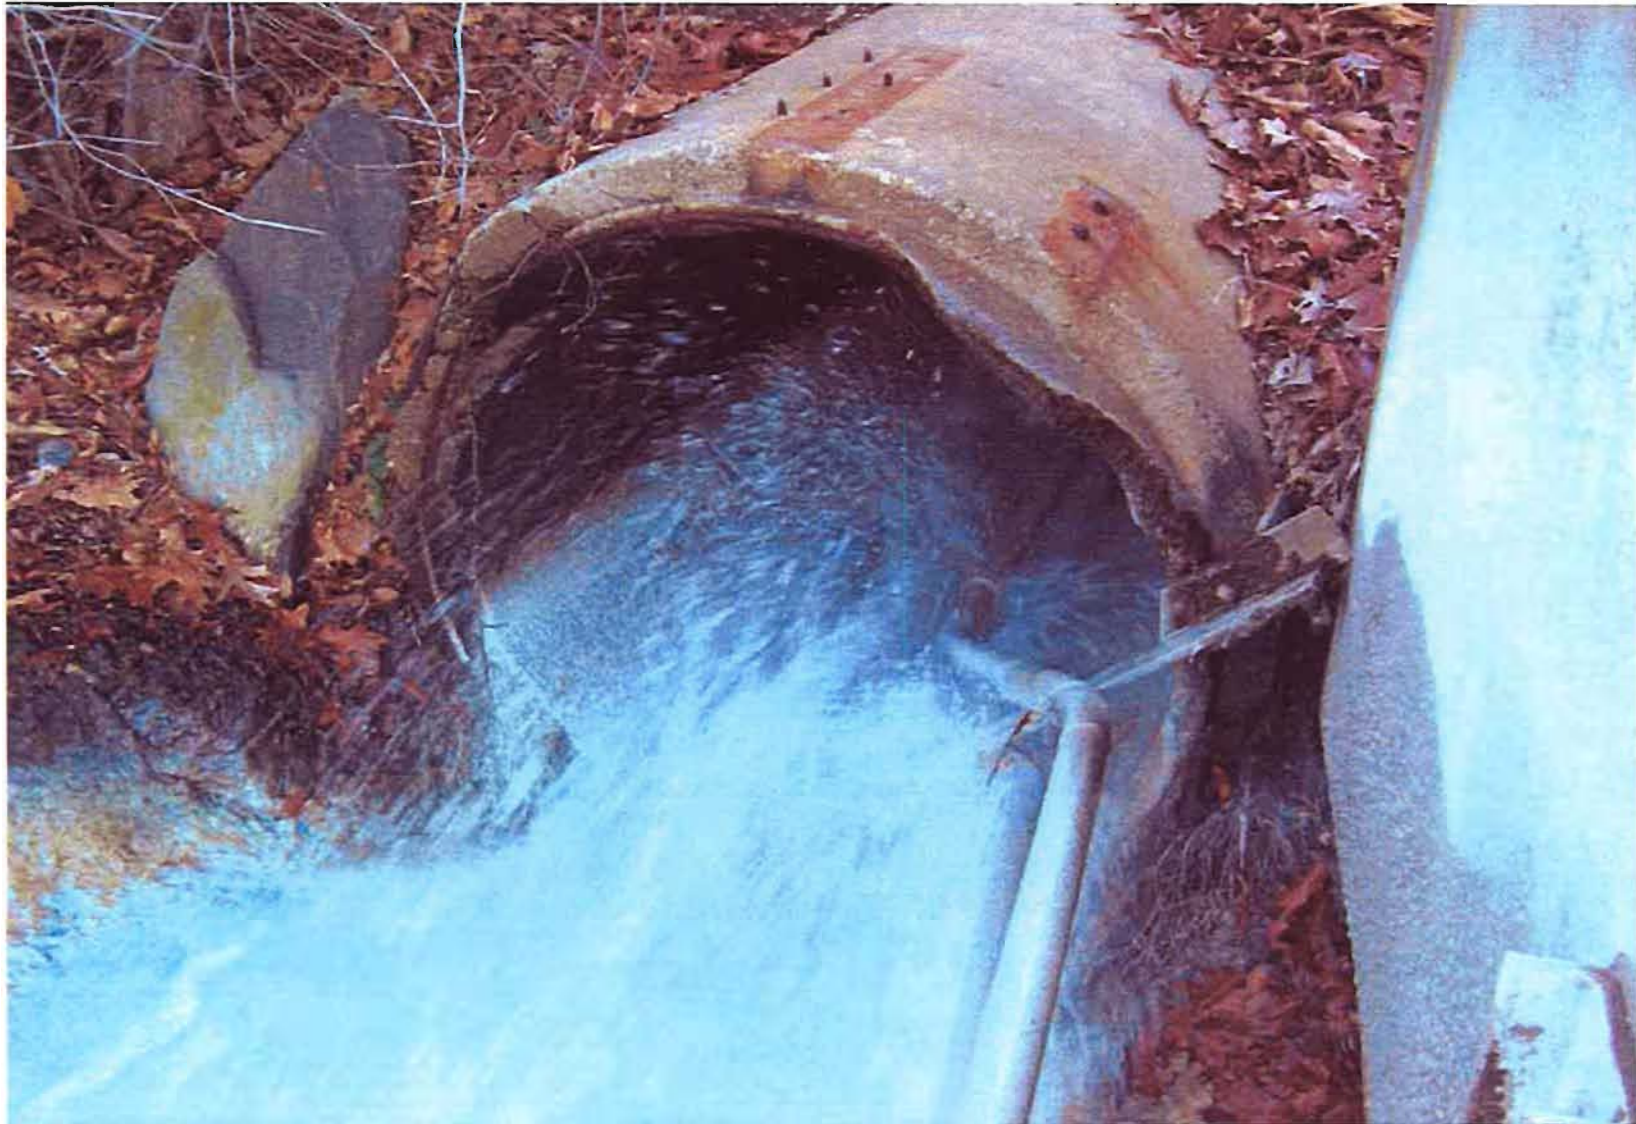
FIGURE NO.
7

Location: East Dike - southern end
Description: 42-inch RCP conduit outlet

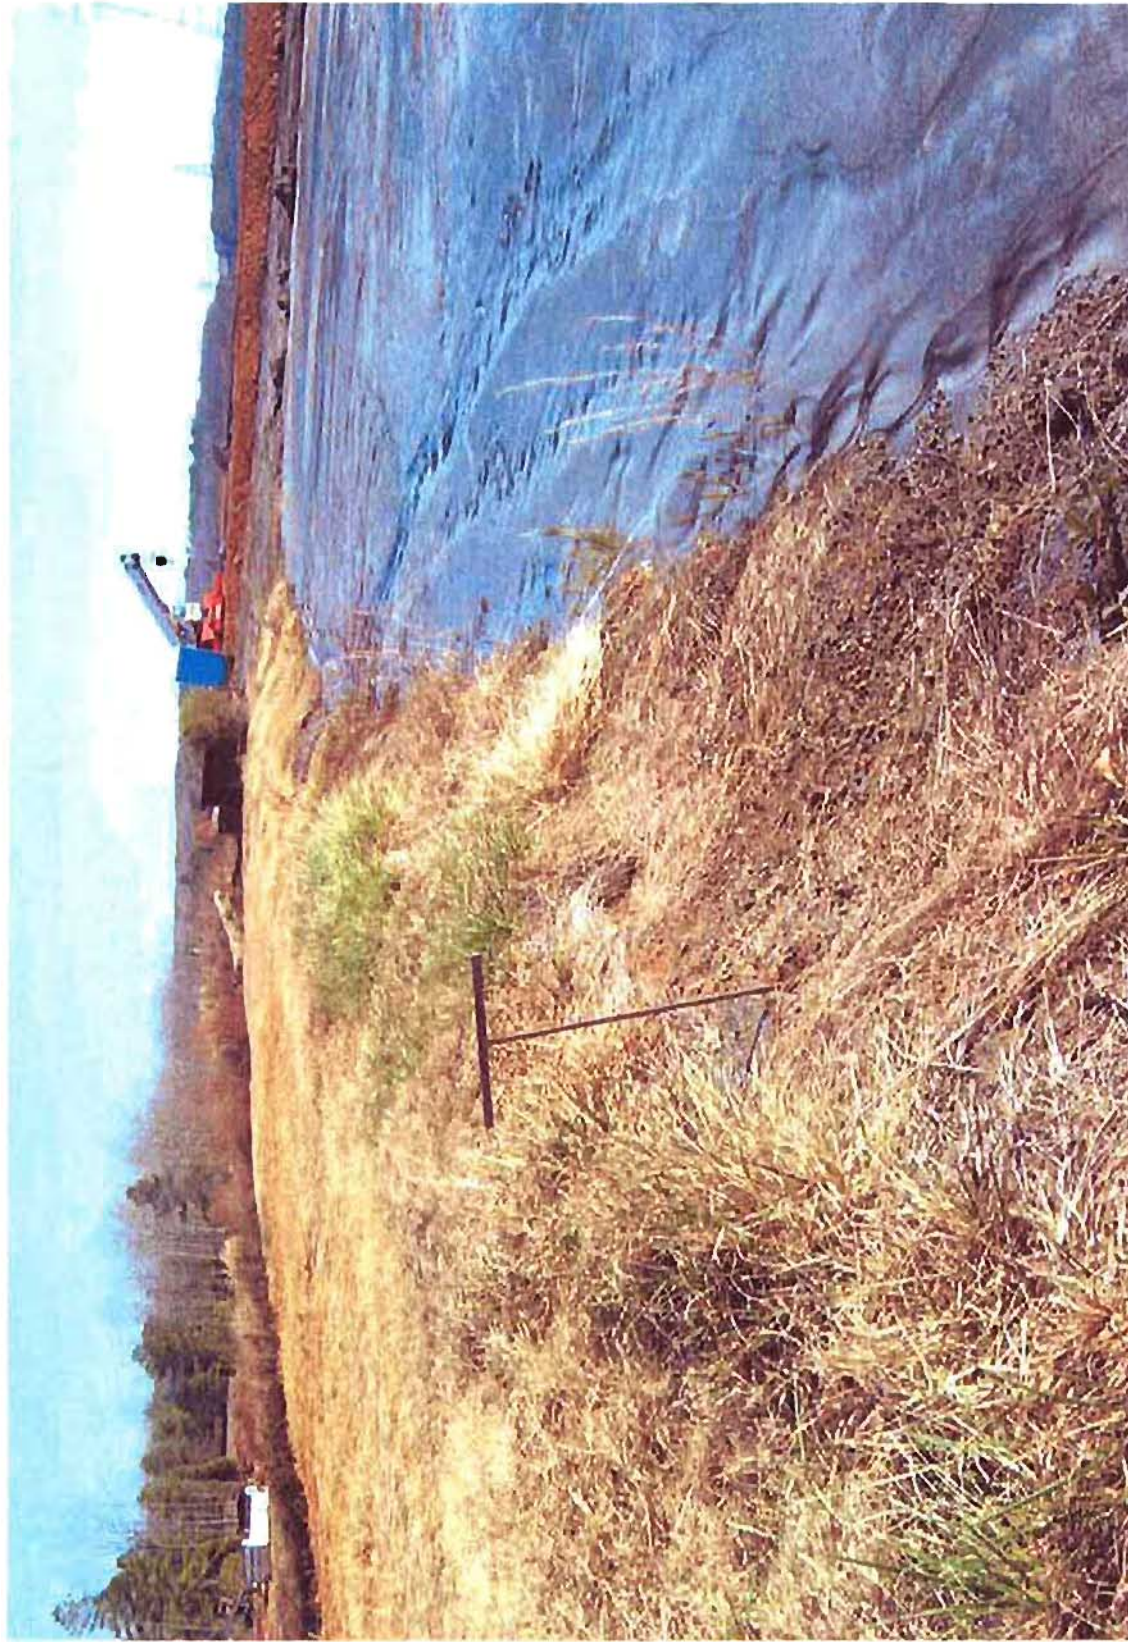
FIGURE NO. **8**

Operations procedures may affect the storage volume of the ash basin. Portions of the ash basin have been allowed to fill with sluiced ash at or above the design operating water surface elevation of 642 feet MSL (Figure 8). In this condition, stormwater storage volume is reduced. The reduced storage volume results in higher water surface elevations during storm events. Therefore, overfilling the ash basin with sluiced ash results in greater risk of embankment overtopping during storm events. We recommend installation of monitoring devices to indicate water surface elevations relative to the design operating normal pool elevation.

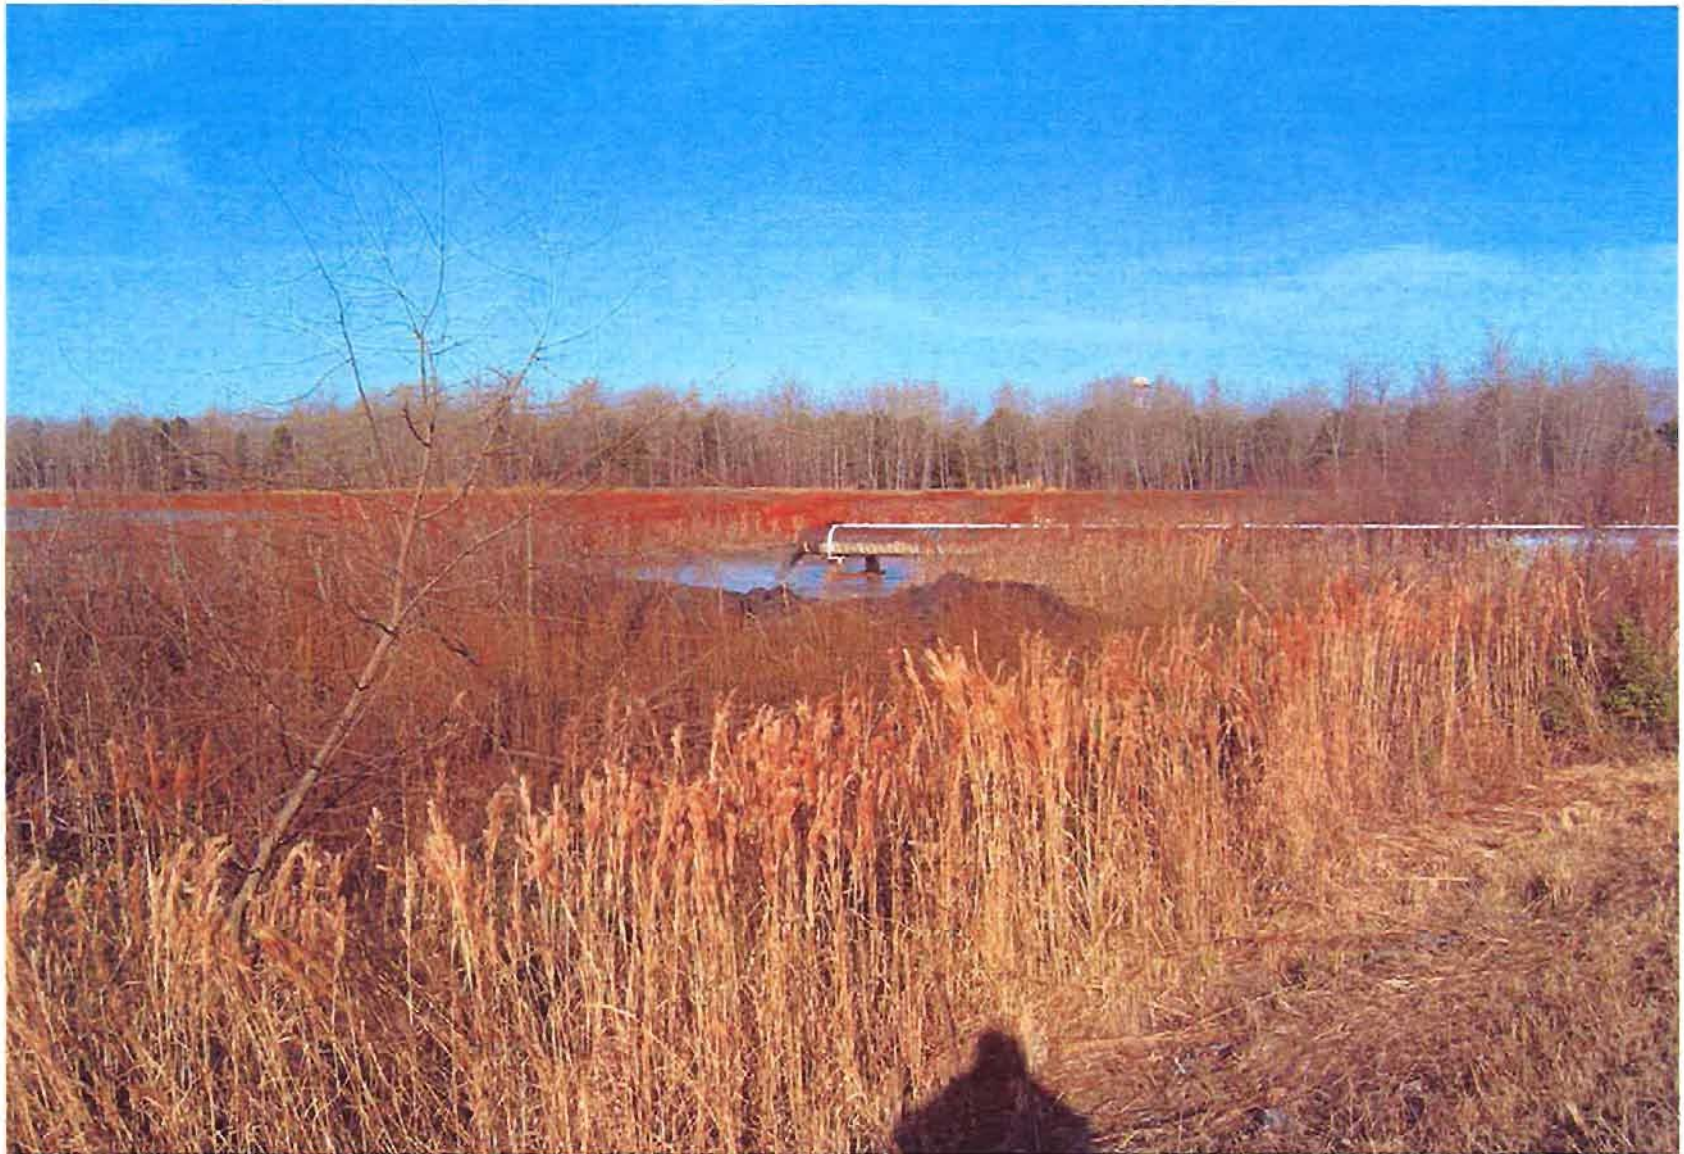
FIGURE NO.
11

Currently, all sluiced ash and plant yard drainage is routed directly into the Active Ash Basin (Figure 11). Water levels vary across sections of the Active Ash Basin as ash is periodically excavated and removed on a section by section basis. Recent ash excavation was reported at the western end of the North Dike. Excavation work reportedly encroached within the immediate vicinity of the upstream slope of the North Dike near the area of the southern jog in the dike axis near its western end (Figure 12). Increased seepage rates and embankment movements were noted in this area and are discussed further in Section 4 of this report. We also noted the crest elevation in this area appeared slightly lower (Figure 13).

Location: East Dike looking north

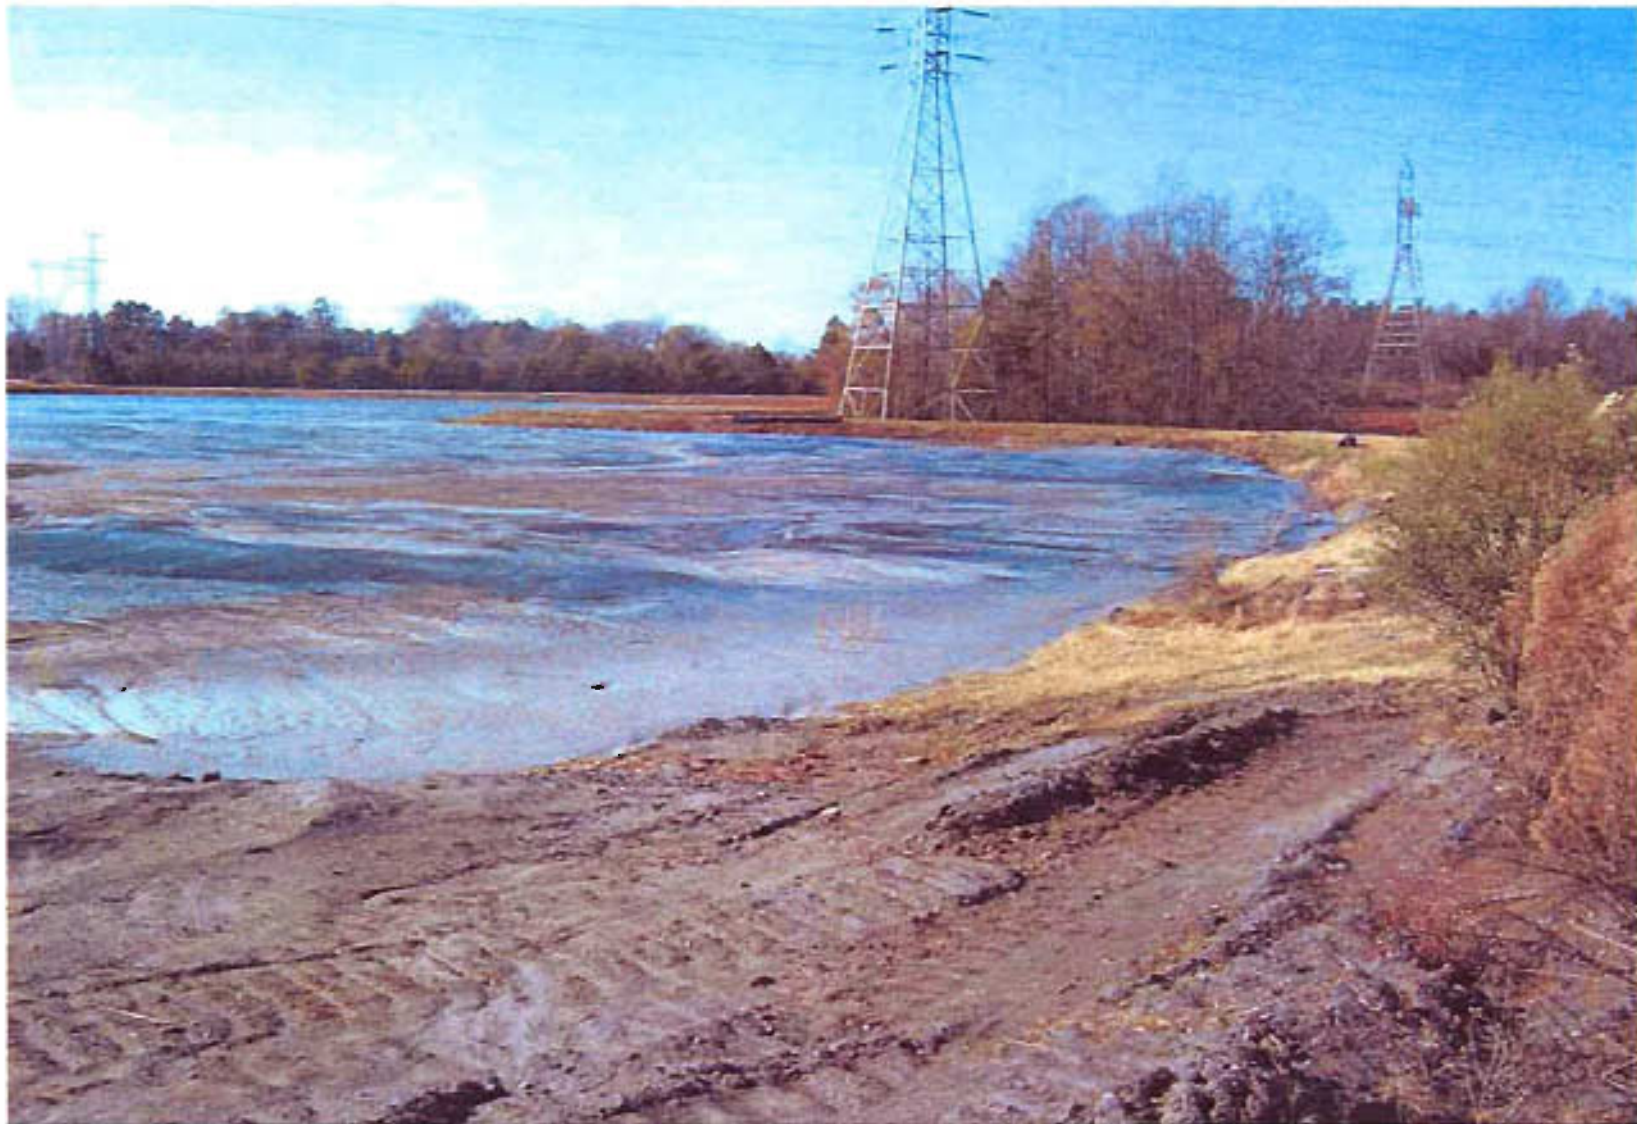
12

Location: North Dike looking west from access road
Description: Area of past excavation work near dike crest

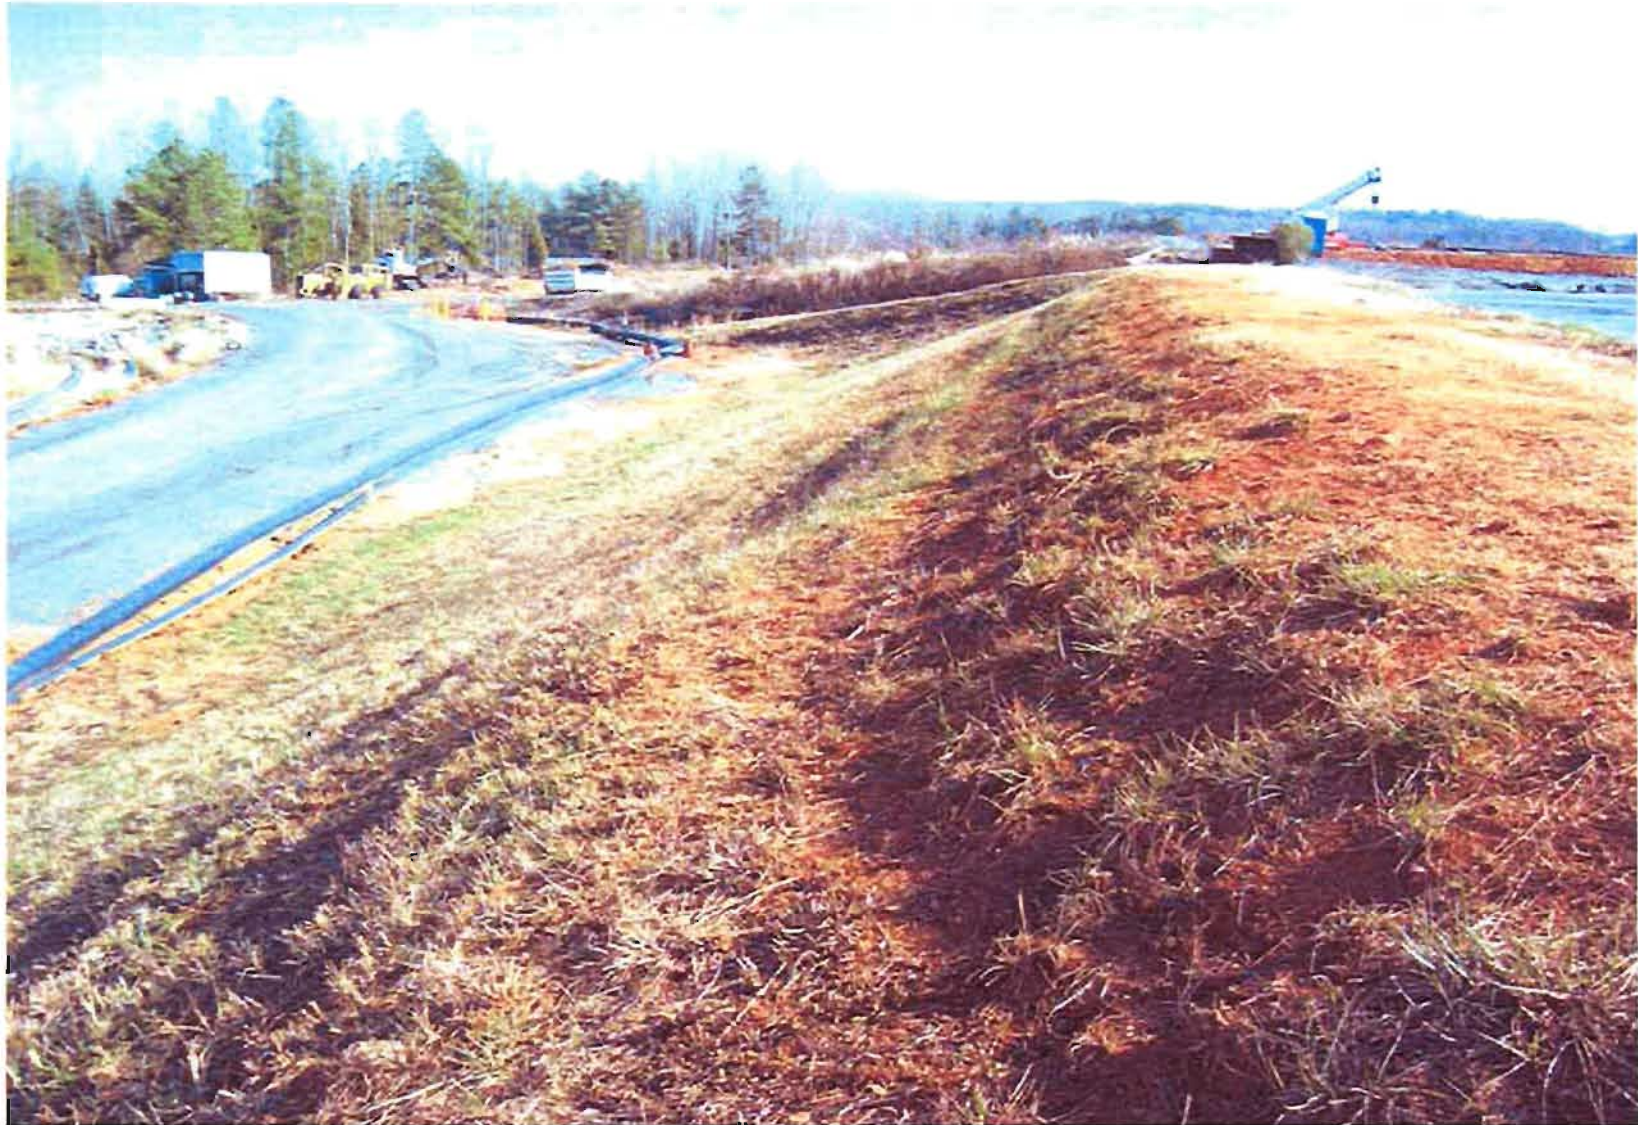
FIGURE NO.
13

Location: North Dike looking east toward access road
Description: Irregular crest elevation

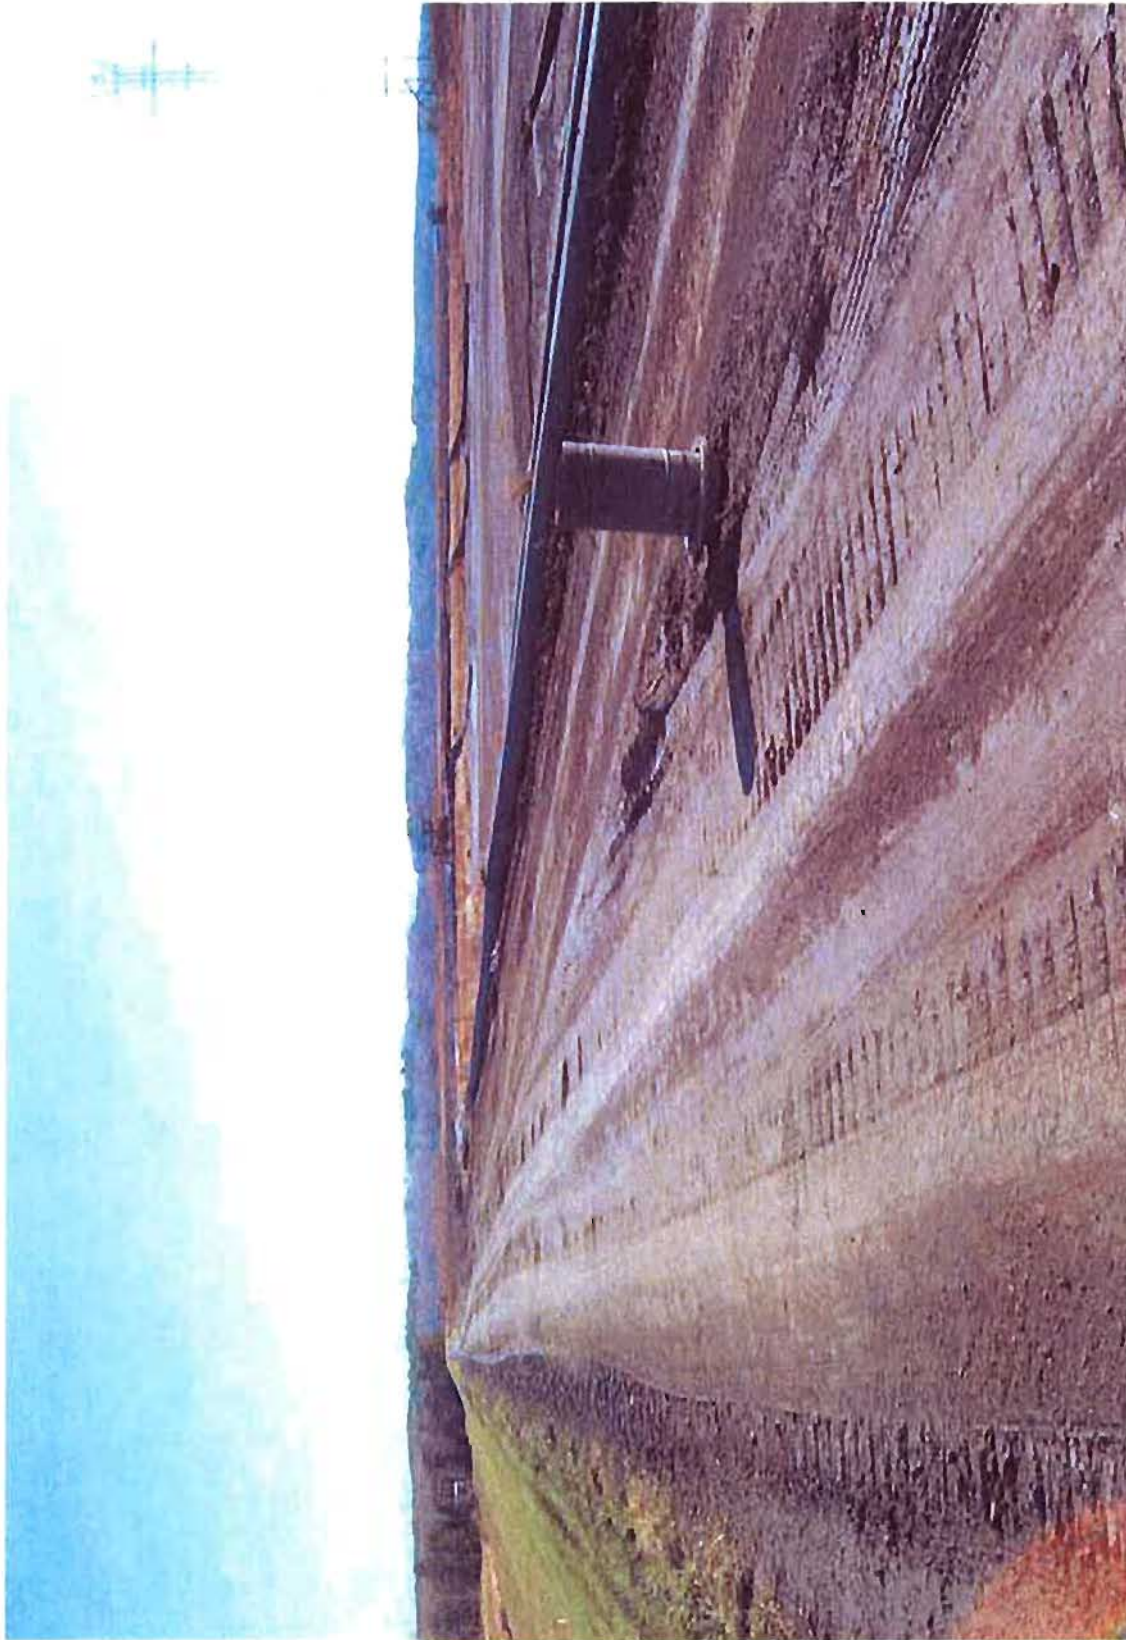
14

Ash sluice lines were discharging into the Active Ash Basin in the section located just east of the transmission tower peninsula (Figure 14). The sluice lines follow the access road which broaches the crest of the dike just east of the bend in the dike axis near its western end. Areas of sparse vegetation were noted just west of the access road previously described (Figure 15). The dike crest east of the access road supports constant construction traffic and the roadway is under continuous maintenance. The crest appears to have been widened significantly to the upstream side to accommodate additional equipment access (Figure 16).

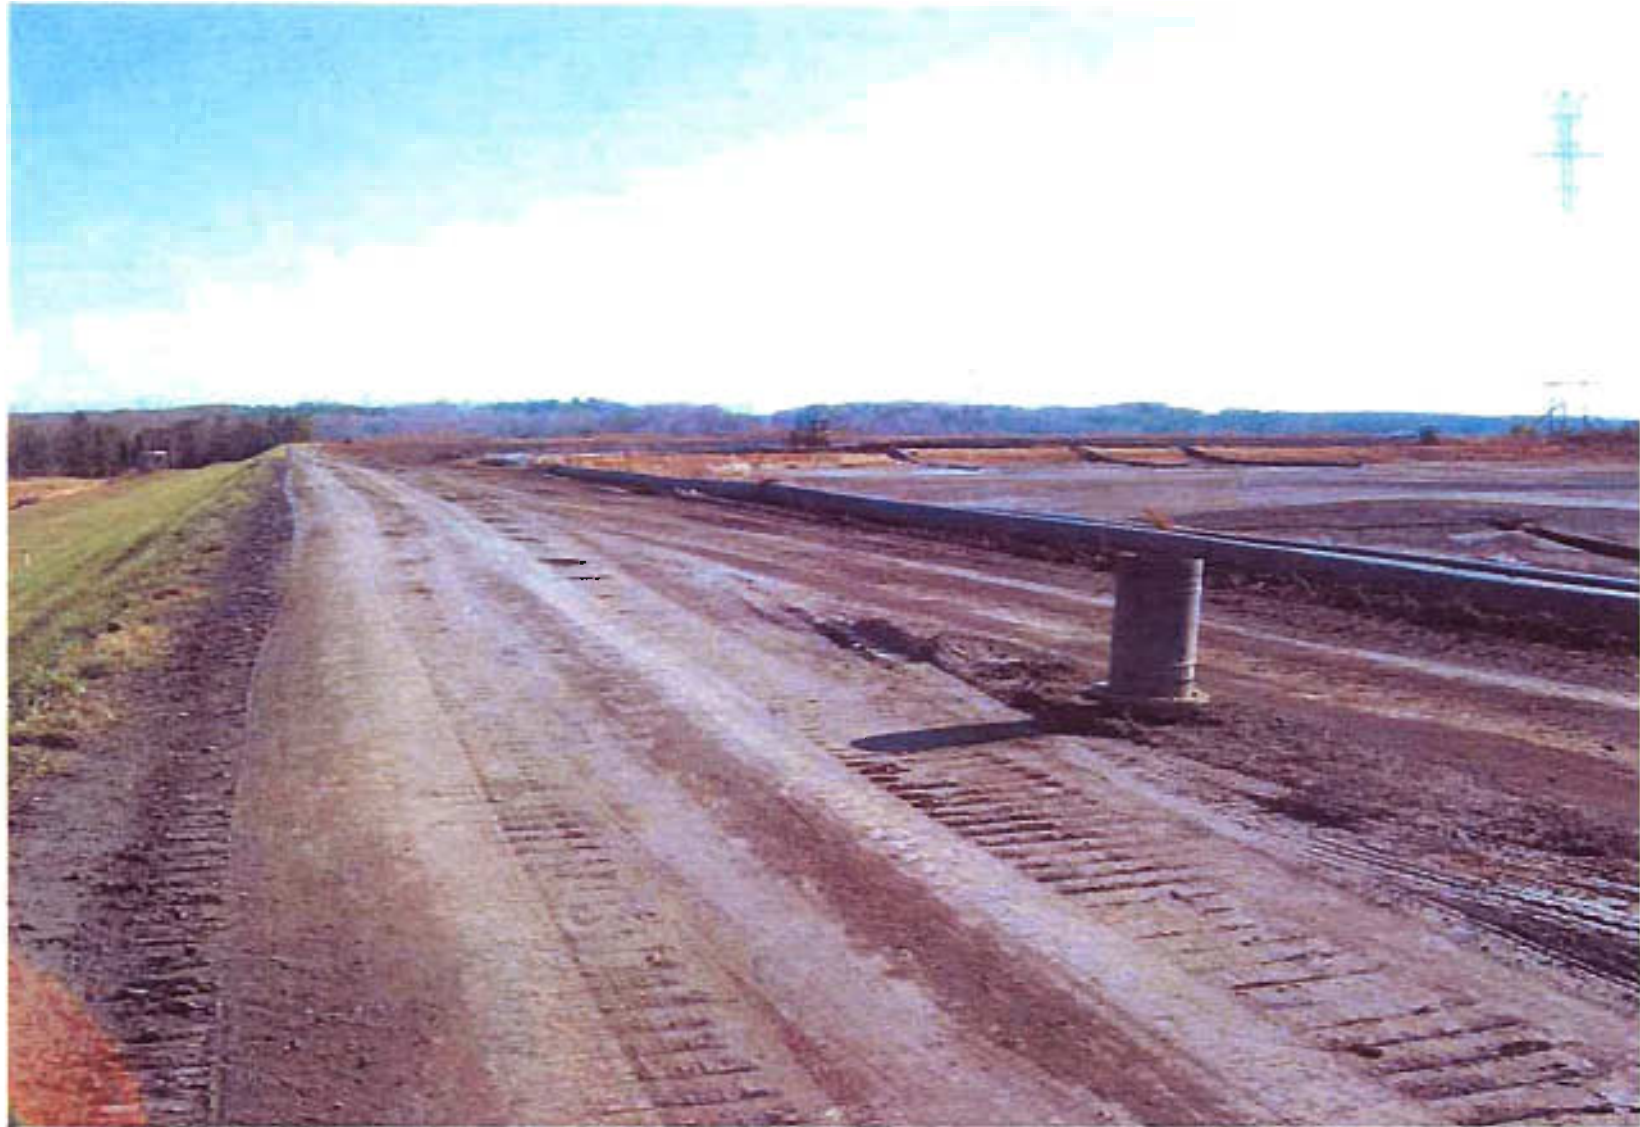
FIGURE NO.
16

Location:	North Dike looking east from access road
Description:	Crest widened for construction traffic

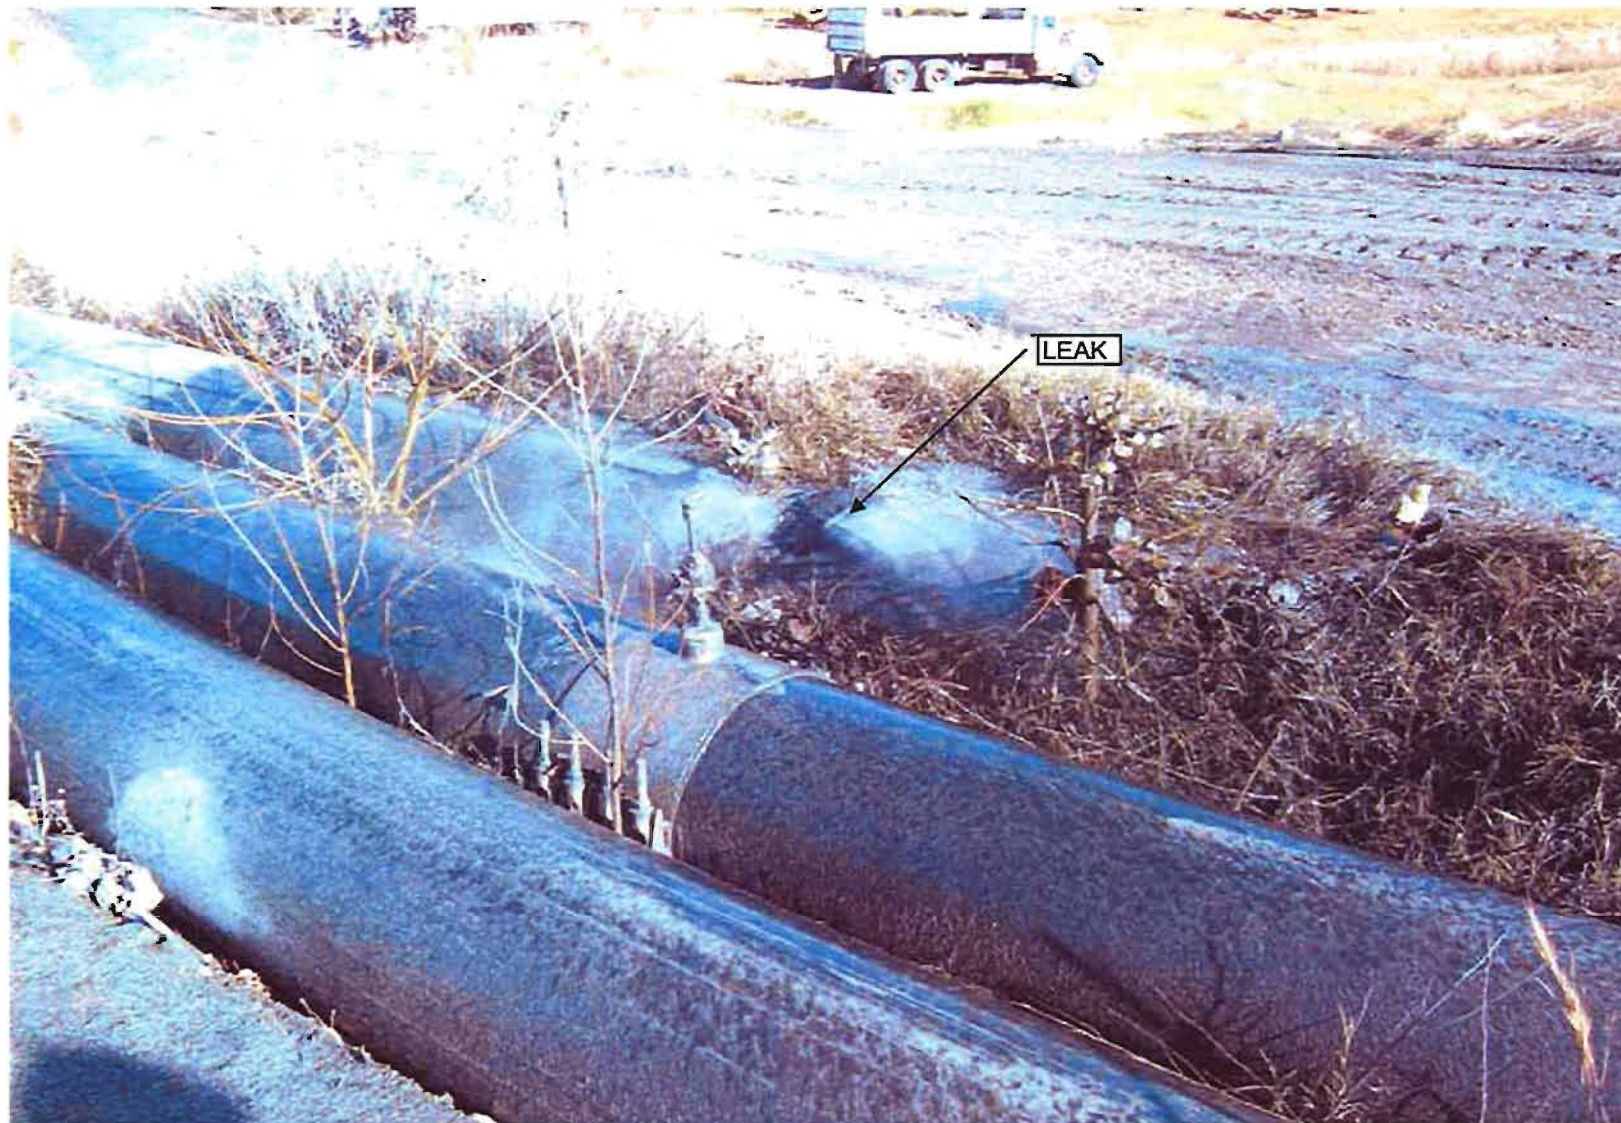
17

A significant leak was noted in the sluice pipes at the location where the access road crests the North Dike embankment, just east of the southward bend in the dike axis (Figure 17). The leak had resulted in minor, localized erosion on the downstream slope.

Location: North Dike near crest along west access road

Description: Leak in ash sluice line

The ash sluice lines have been previously described. We documented a leak in one of the discharge lines which could lead to erosion problems on the downstream embankment of the North Dike. Ash sluice lines should be continually monitored for additional leaks.

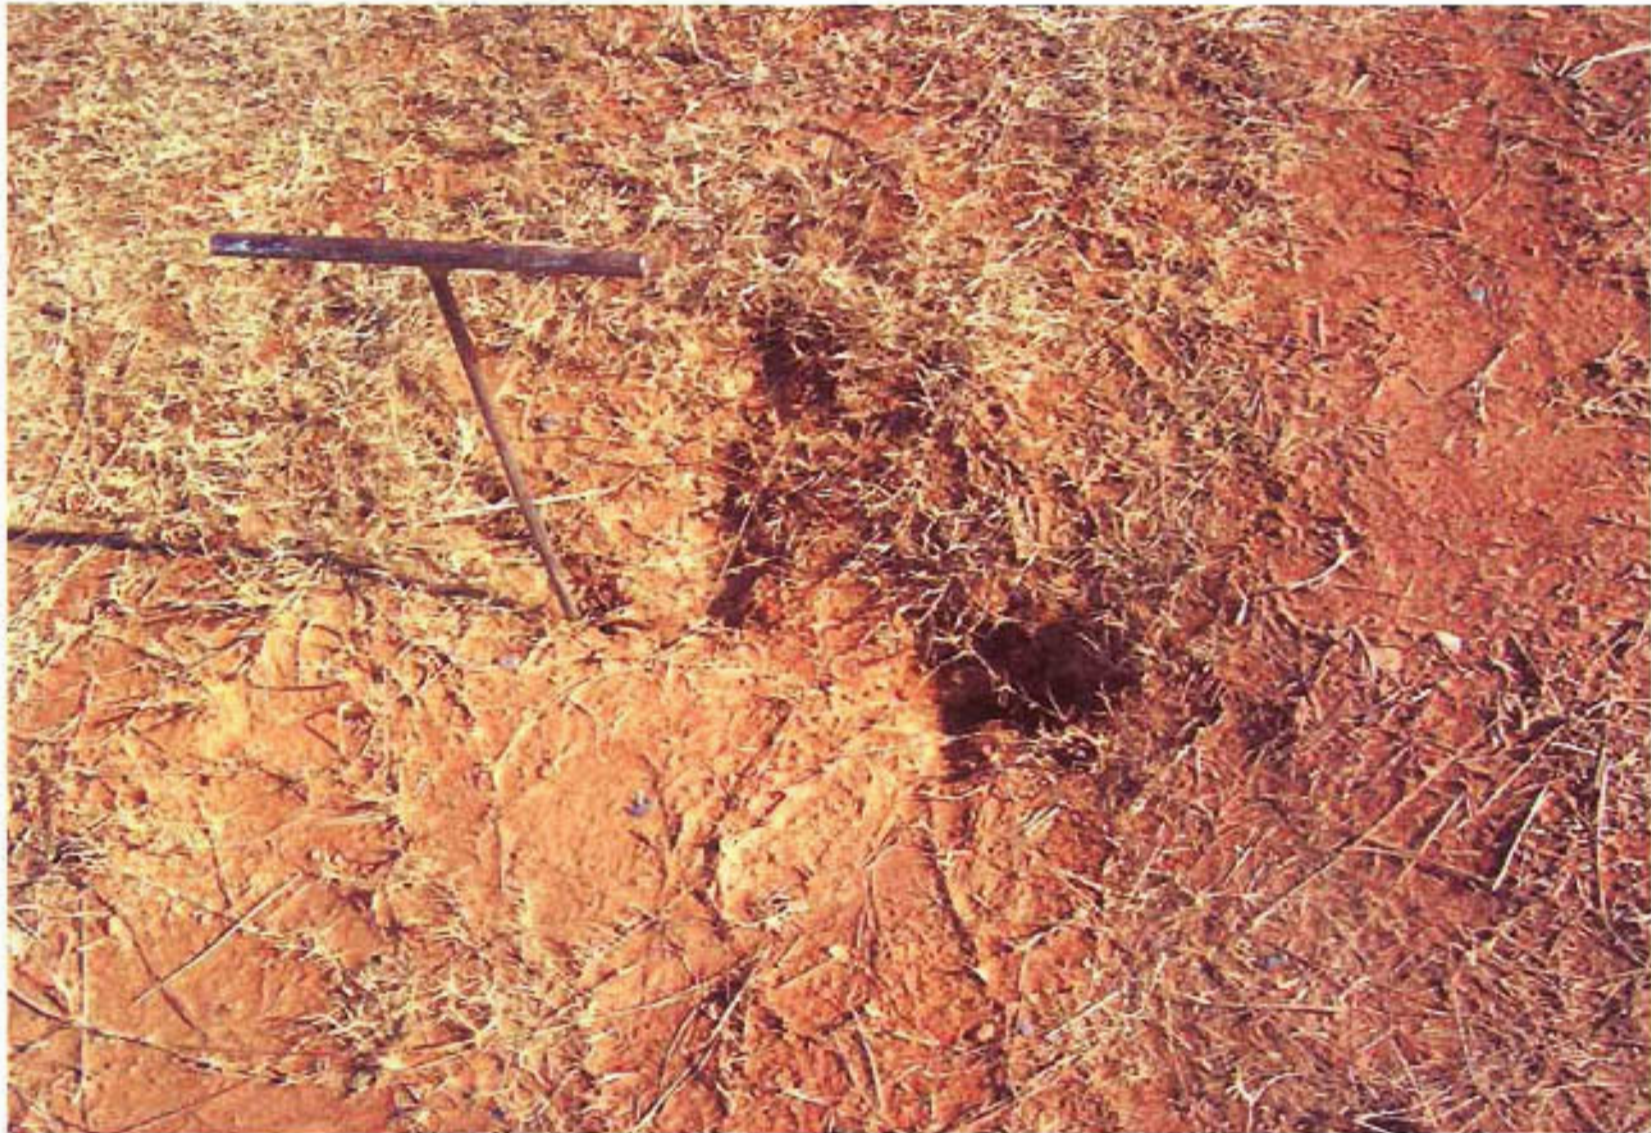
FIGURE NO.
18

We noted transverse (perpendicular to the dike axis) cracks in the crest of the dike embankment between the access road and the southward bend in the dike axis to the west of the access road. These cracks were generally a few inches to a foot deep (Figure 18). In some locations, these cracks transected longitudinal cracks near the downstream edge of the crest. The upstream pool area along this portion of the North Dike was filled with saturated ash approximately two to three feet below the dike crest (Figure 19). Similar cracks were less prevalent to the west beyond the bend in the dike axis.

Location:	North Dike crest near bend in dike axis
Description:	Transverse cracking in embankment materials

6.	Cracking in North Dike embankment crest between access road and axis bend.	Establish a monthly routine of embankment observation noting changes in crack size and geometry.
