**SEVENTH
FIVE-YEAR INDEPENDENT CONSULTANT
INSPECTION REPORT
(PER THE NORTH CAROLINA UTILITIES COMMISSION)**

**DUKE ENERGY
ALLEN STEAM STATION
253 Plant Allen Road
Belmont, North Carolina 28012
S&ME PROJECT NO. 1411-07-152**

Reference: **Five-year Independent Consultant Inspection Report**
Ash Basin Dikes, Allen Steam Station
Belmont, North Carolina
S&ME Project No. 1411-07-152

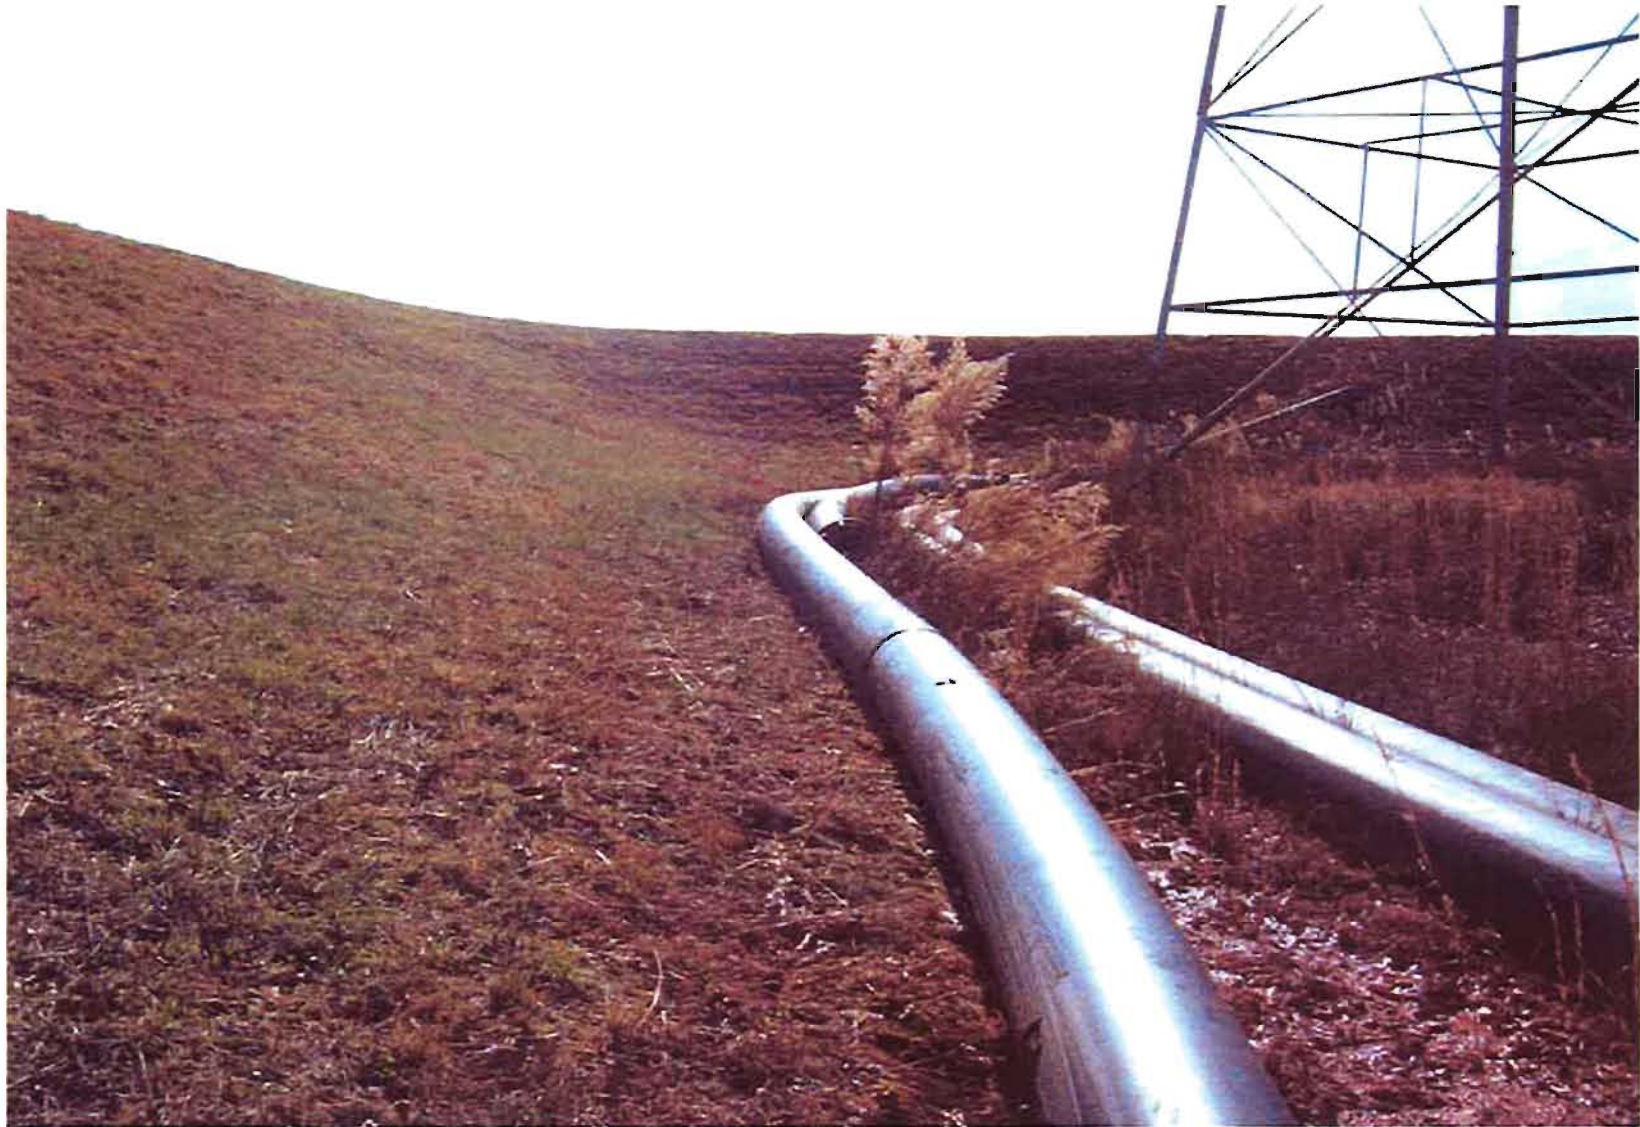
FIGURE NO.
20

We noted saturated soils and seepage at the downstream embankment toe beginning at the location of a road cut into the toe, just west of the access road and extending around the southward bend in the embankment axis. Seepage appeared more concentrated in the section of the bend where the downstream slope is in a concave configuration (Figure 20). Seepage in this area was noted in the 2002 five-year inspection report. Mr. Blevins noted that the seepage appear greater in flow than in his past observations. We noted that a 15-inch HDPE roadway culvert intended to pass flow from the toe area of the dike at the location of the access roadway cut appeared partially clogged, resulting in standing water along the downstream toe. Also, seepage through the embankment appears to be causing minor erosion near the toe of the embankment, at the location where the downstream toe has been cut to accommodate a roadway drainage ditch (Figure 21). The seepage appeared clear and we noted no boils along the downstream embankment.

Location: North Dike toe along bend in dike axis
Description: Seepage from dike toe (Note wet area between pipes)

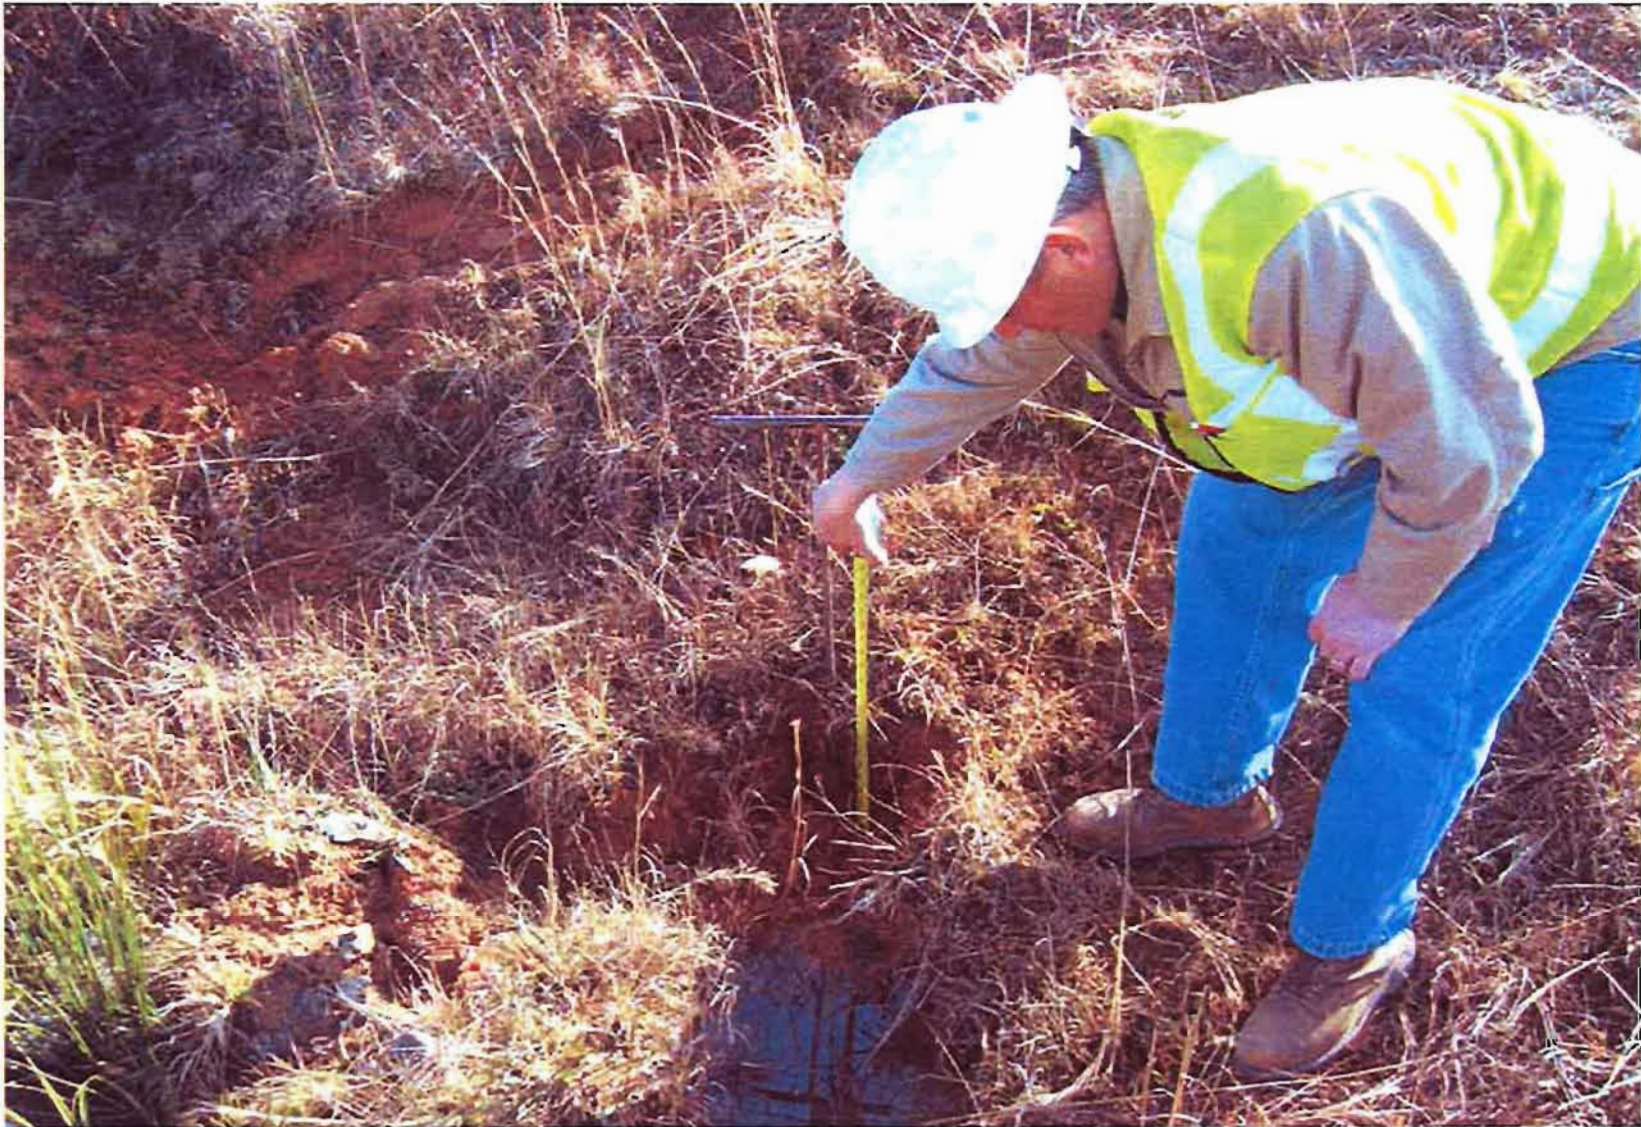
21

Location: North Dike toe west of access road @ ditch bank
Description: Seepage from dike toe (Note embankment sloughing)

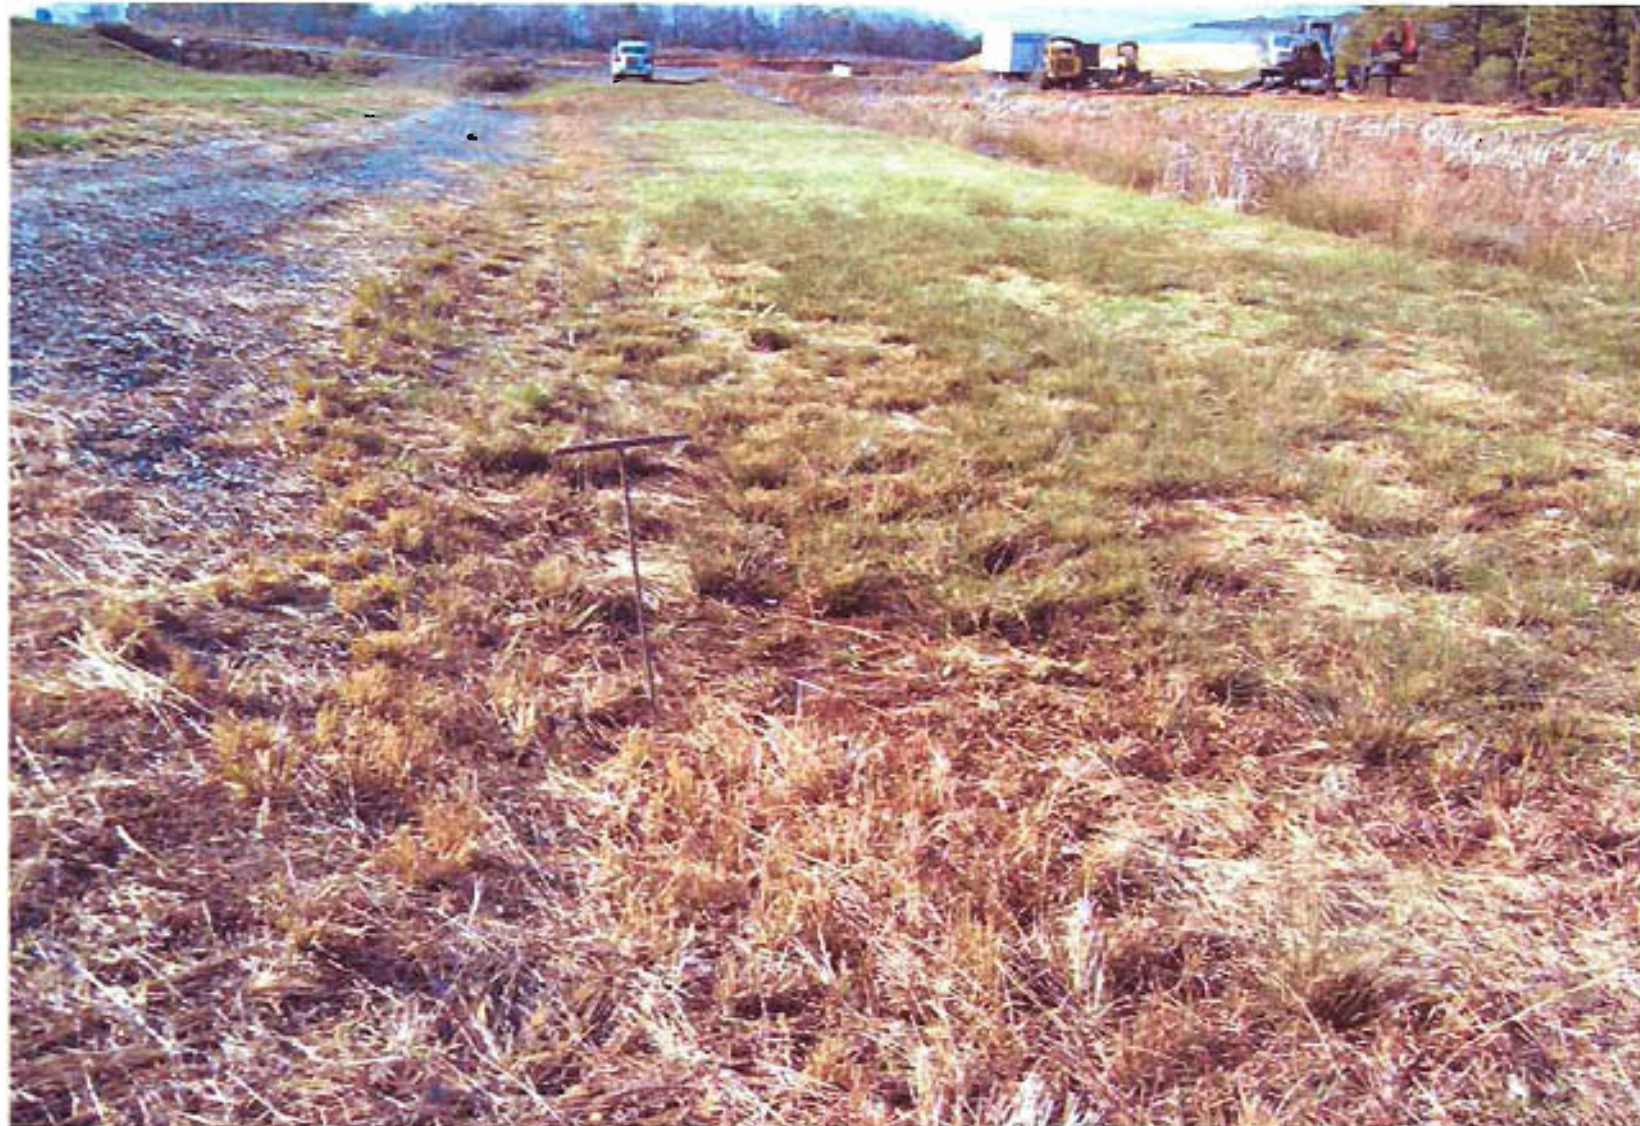
FIGURE NO.
22

We noted a localized area of saturation along the downstream toe of the North Dike in the vicinity of OW-16 (Figure 22). Mr. Blevins reported that this area of saturation was not always evident in past observations. We observed no other areas of seepage or saturation along the North Dike downstream embankment during the site visit.

Location: North Dike toe looking west toward access road

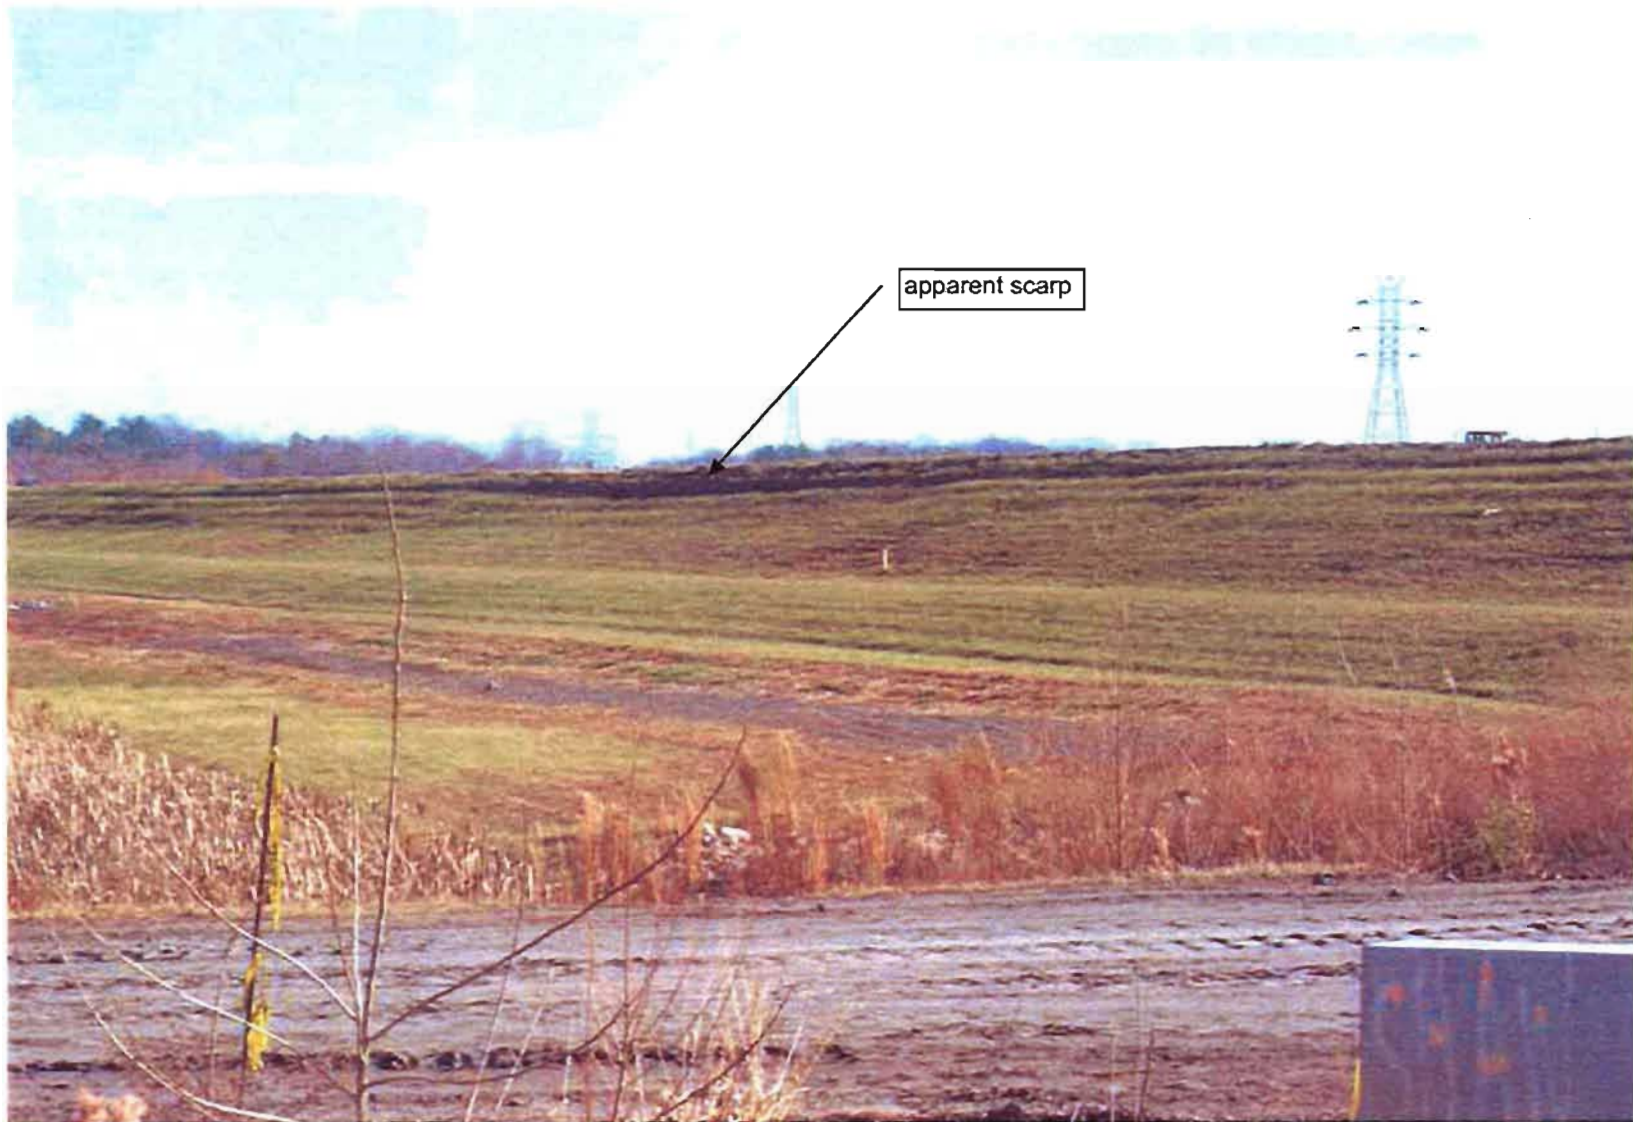
FIGURE NO.
23

We noted an inconsistency in the downstream embankment geometry approximately 90 feet east of the transmission tower peninsula. The apparent scarp is at or near the elevation of the downstream crest of the dike (Figures 23, 24). This inconsistency in the embankment surface may also be partially attributable to wheel rutting by mowing equipment. We noted no other scarps, slumps or major geometry inconsistencies on the downstream slope of the North Dike.

Location: North Dike downstream slope
Description: Geometry irregularity

We noted areas of apparent embankment movement during our site visit. These areas have been mentioned in the previous five-year inspection report. Routine visual monitoring of slope and embankment movements in these areas should be part of each annual inspection going forward. We recommend that evaluation of additional movement monitoring be made in conjunction with the annual inspection report.

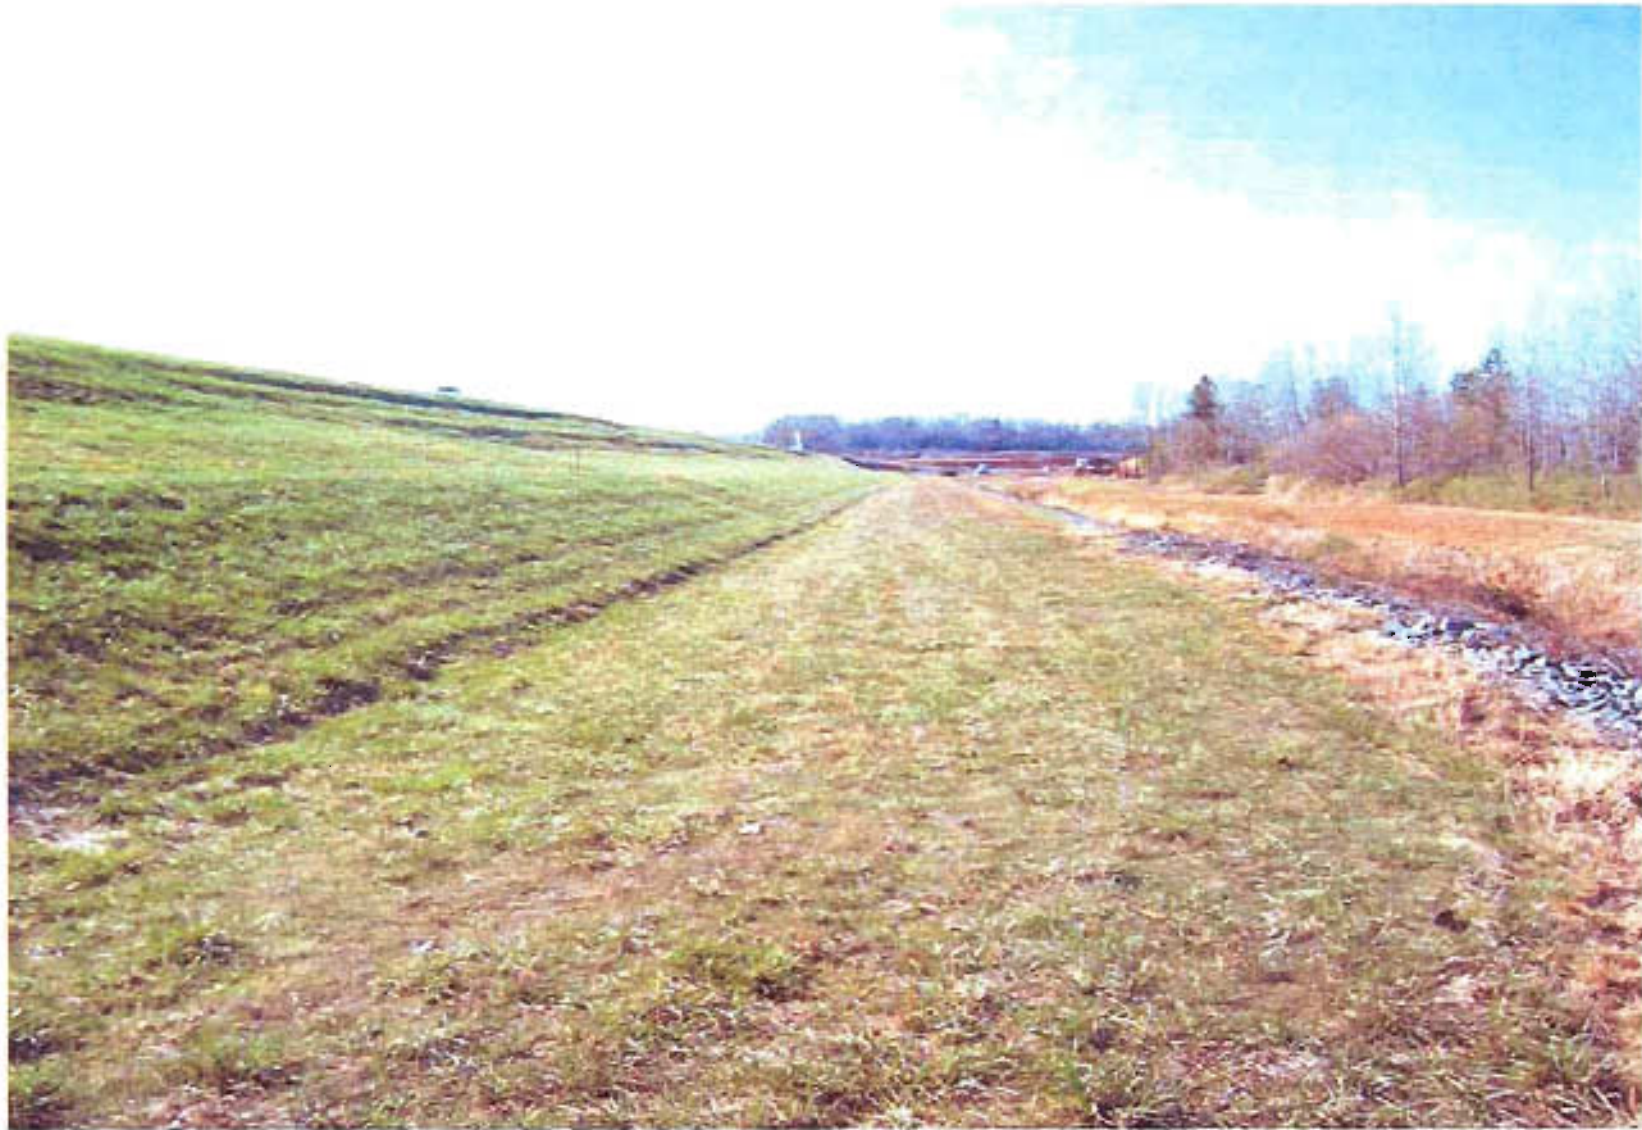
FIGURE NO.
25

The downstream toe of the North Dike was relatively free of heavy vegetation due to recent clearing activities. The clearing work was extended beyond the toe several feet in accordance with past recommendations (Figure 25). The washed stone drainage blanket was exposed and observed to be generally consistent in condition and placement. We noted some localized areas of inconsistent rip rap cover over the drainage stone. We noted the vegetation was not well established in some surface drainage channels which run perpendicular to the downstream slope (Figure 26).

Location: North Dike toe looking west
Description: Rip Rap at toe drain outlet and clearing around toe.

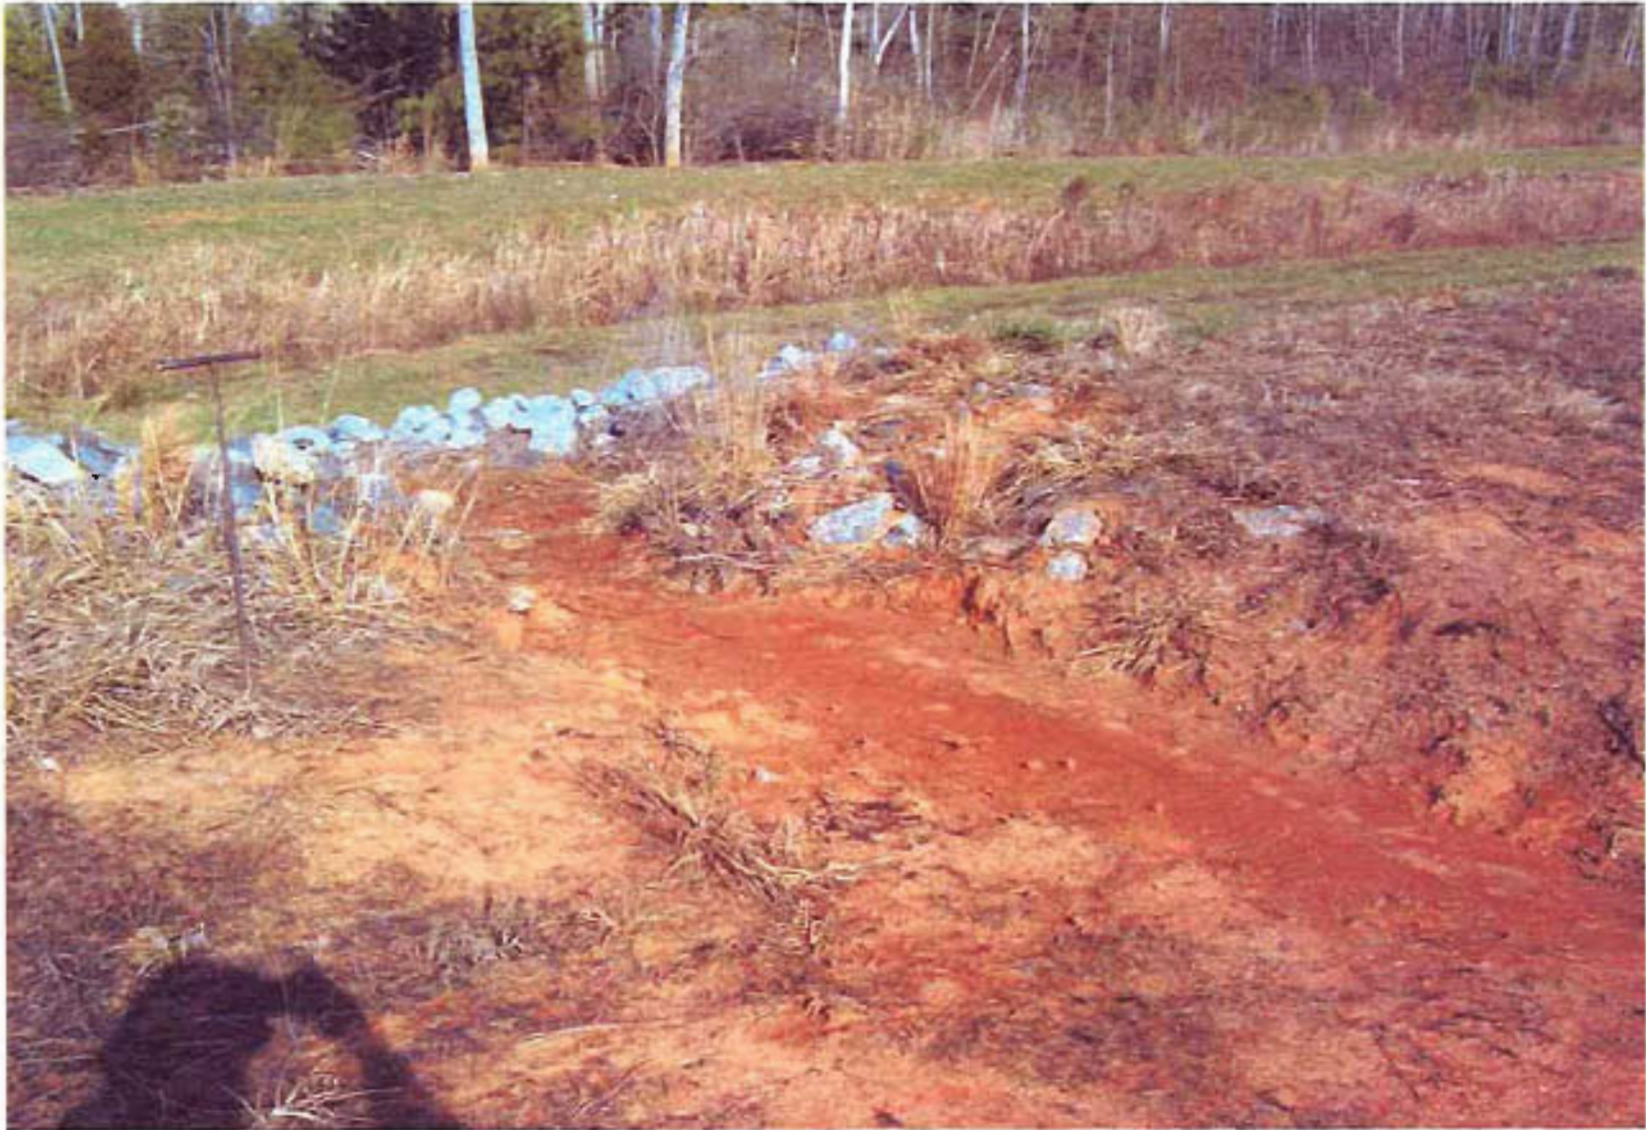
FIGURE NO.
26

Location: North Dike toe
 Description: Lack of vegetation in drainage ditch outlet

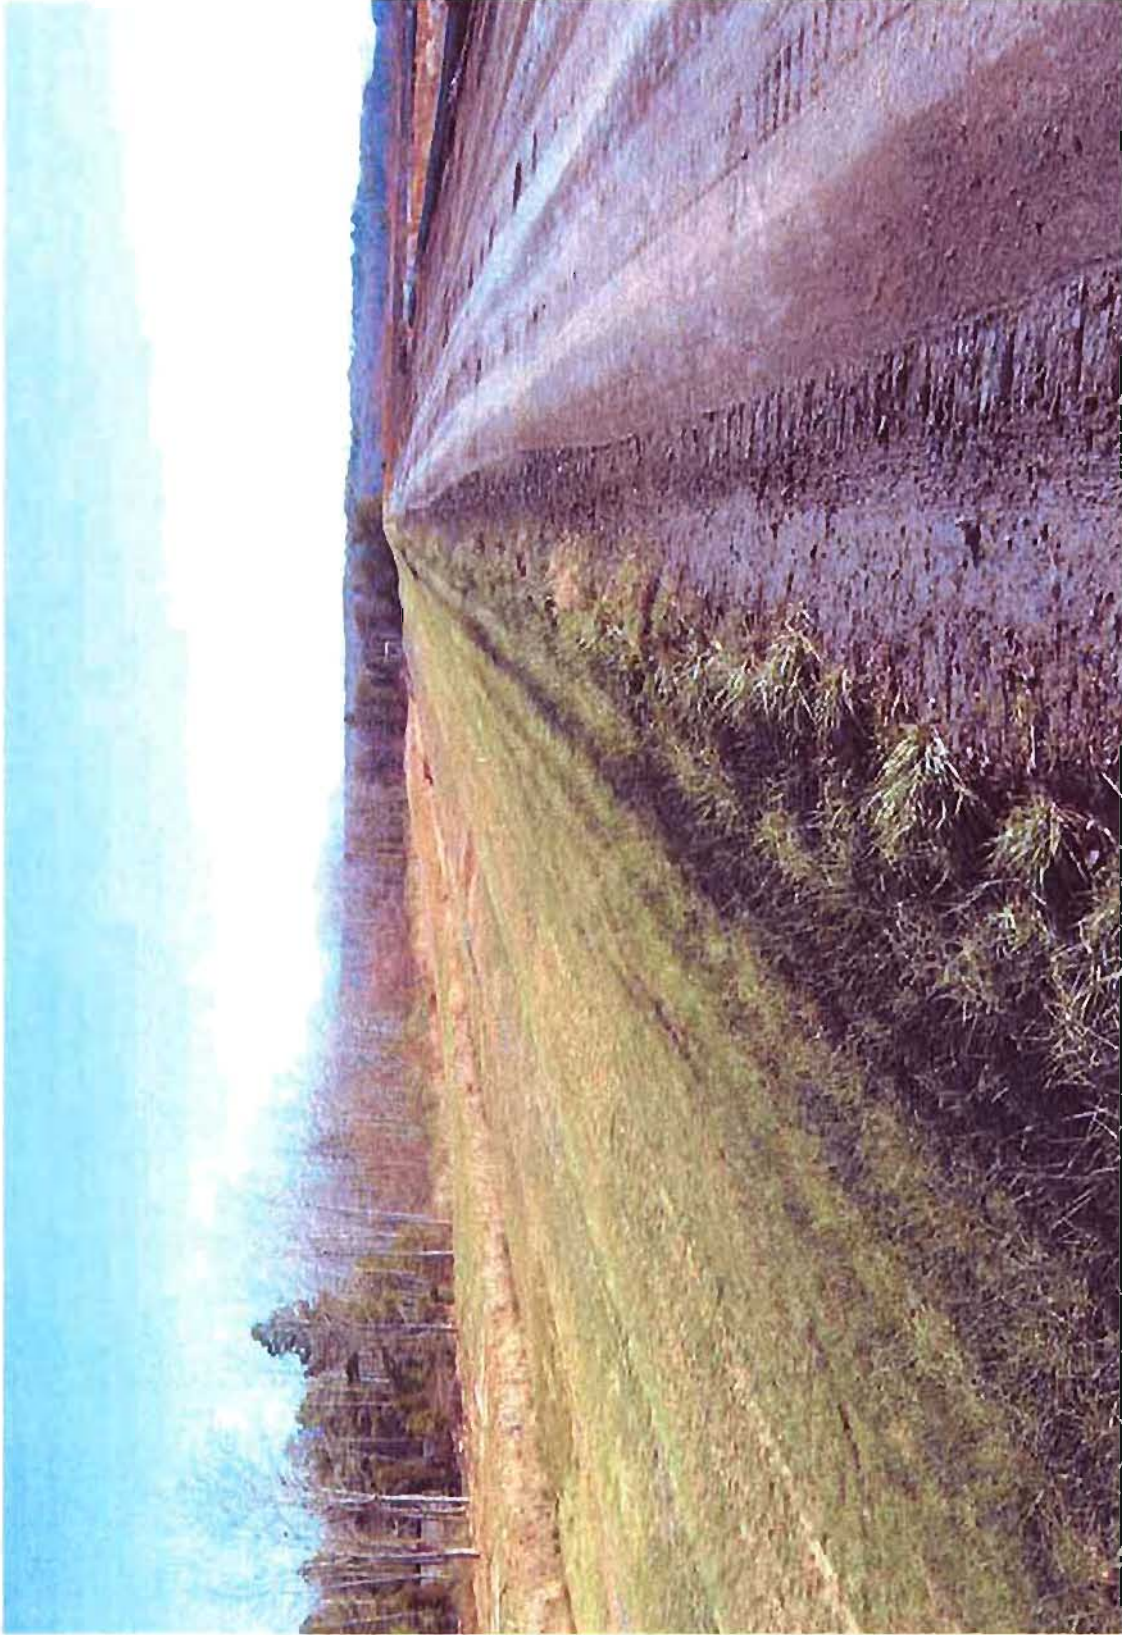
FIGURE NO. **27**

The upstream slope of the North Dike was covered by vegetation, earth fill materials, or ash fill materials and could not be observed. The rock rip rap wave protection noted in past reports was not documented during the site observation visit. We note that constant construction work along the crest may have impacted the crest geometry (Figure 27).

Location: North Dike crest looking east
 Description: Crest geometry - embankment steepness near crest

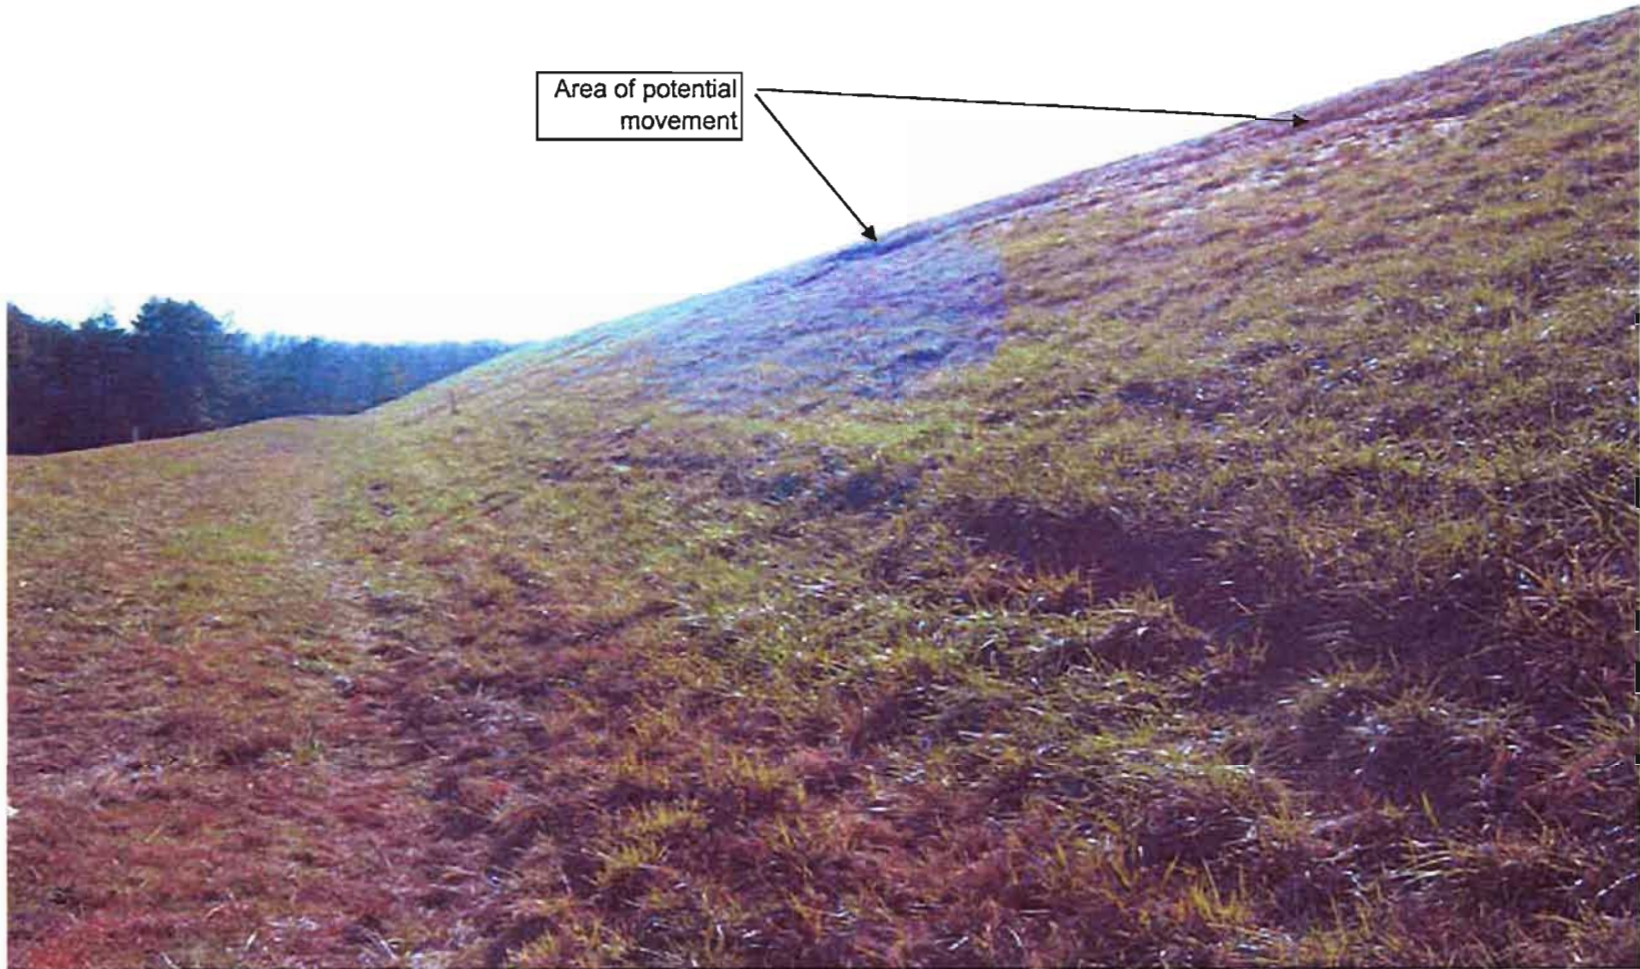
FIGURE NO.
29

We noted two apparent scarps on the downstream embankment 40 feet north of OW-11 (Figure 29). The irregularities appear limited to an area just lower than the dike crest and extend laterally several feet. Vegetation is less dense relative to the surrounding embankment. No significant erosion problems were noted within the areas of exposed soil. The area should be monitored visually for signs of movement and erosion.

Location: East Dike looking south 40 feet north of OW-11
Description: Area of potential movement and sparse vegetation

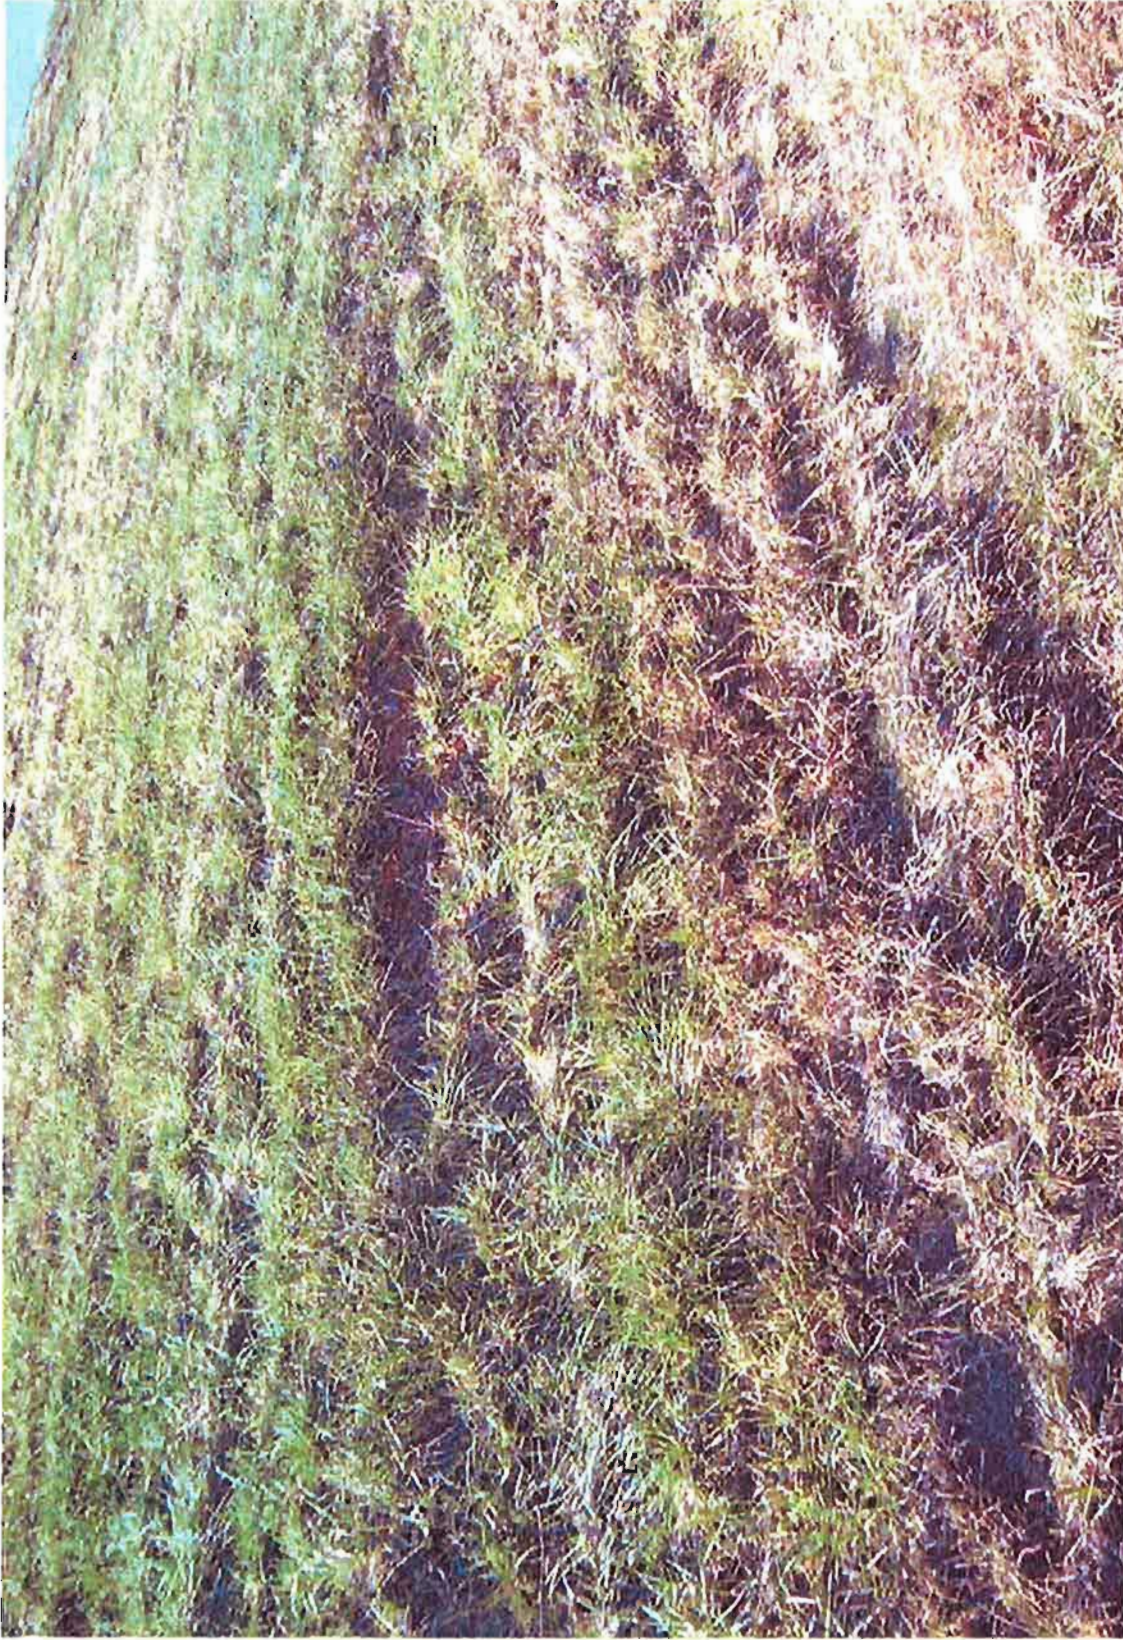
30

There is also exposed soil on the downstream embankment approximately 5 feet above the elevation of the crest of the stabilizing berm (Figure 30). These exposed areas could be due to rutting from mowing equipment. We noted no other signs of slope instability, scarps, slumps, or excessive surface erosion on the downstream slope of the East Dike.

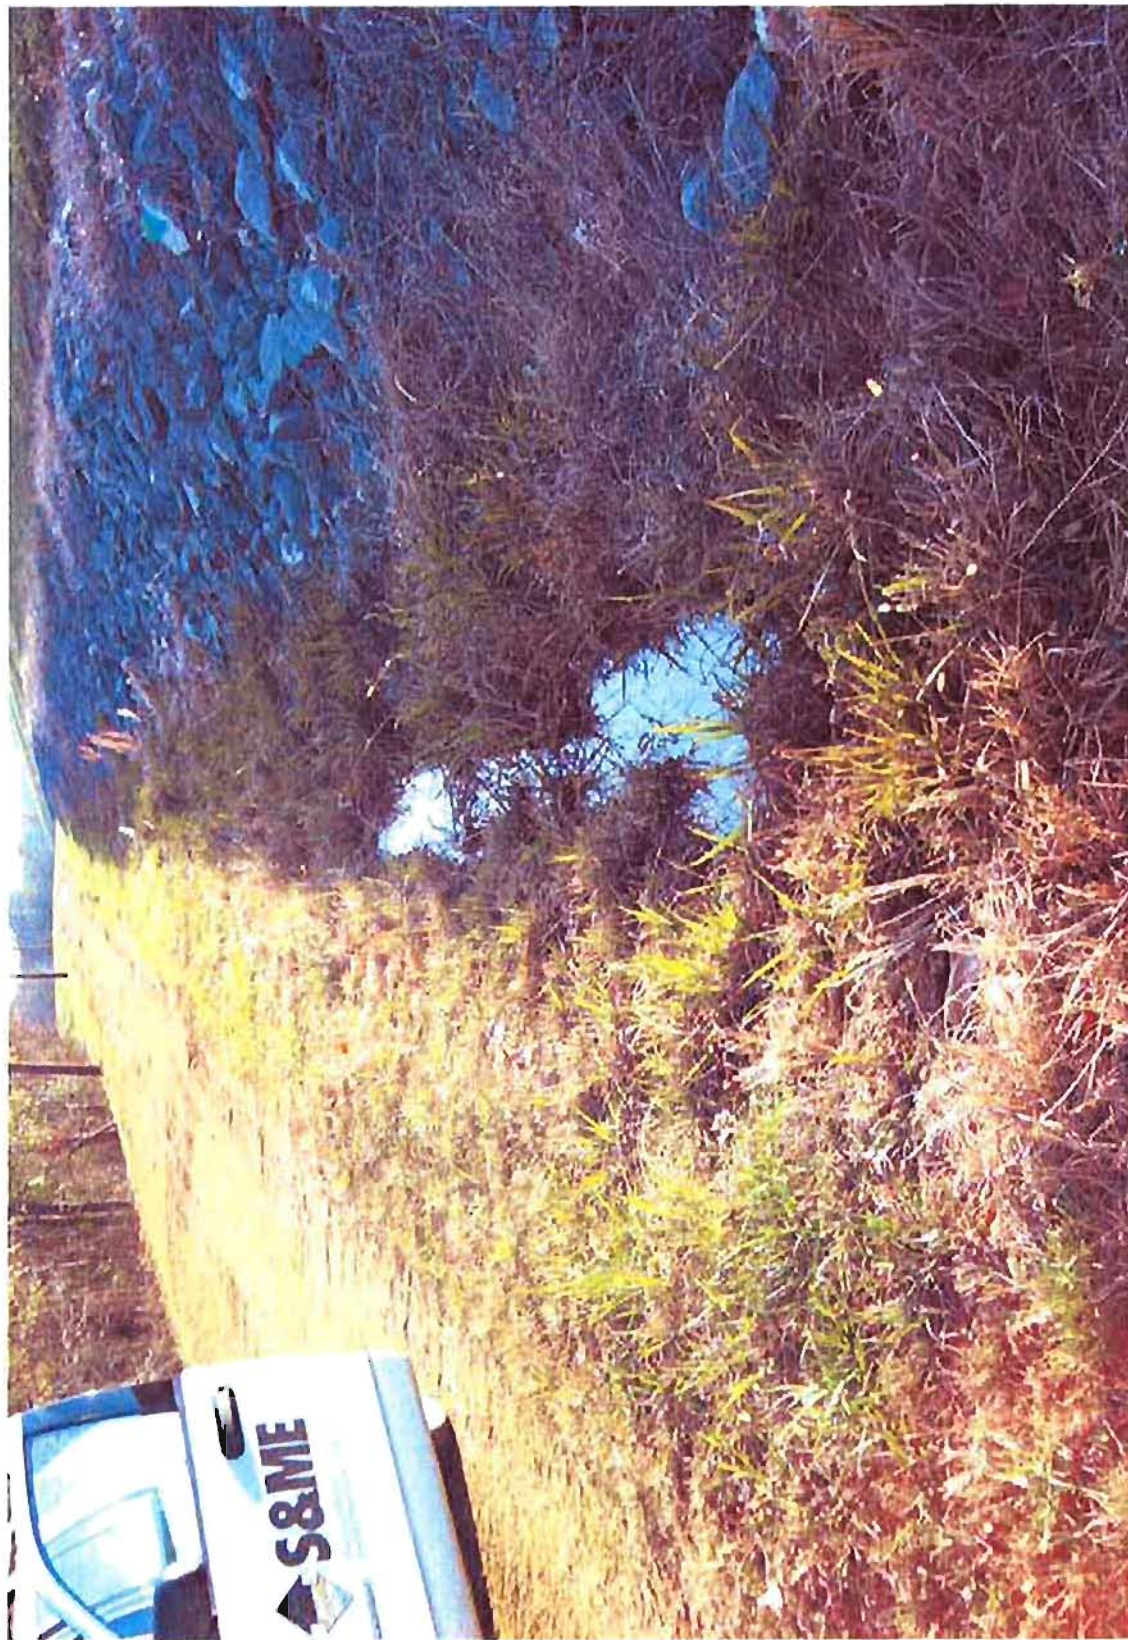
FIGURE NO. **31**

We noted seepage and standing water in the drainage ditches along the toe of the East Dike from the vicinity of observation well OW-6 extending southward approximately 180 feet (Figure 31). The seepage appeared clear and of a relatively slight volume. We noted no boils or surface erosion associated with the seepage. We noted that culverts intended to convey surface water to Lake Wylie may be partially clogged by debris and vegetation. It also appears that ditch slopes combined with heavy vegetation are not allowing free drainage to the culverts. These conditions appear to contribute to the saturated conditions at the toe. We recommend further monitoring of this area

Location: East Dike toe @ OW-6
 Description: Seepage at toe

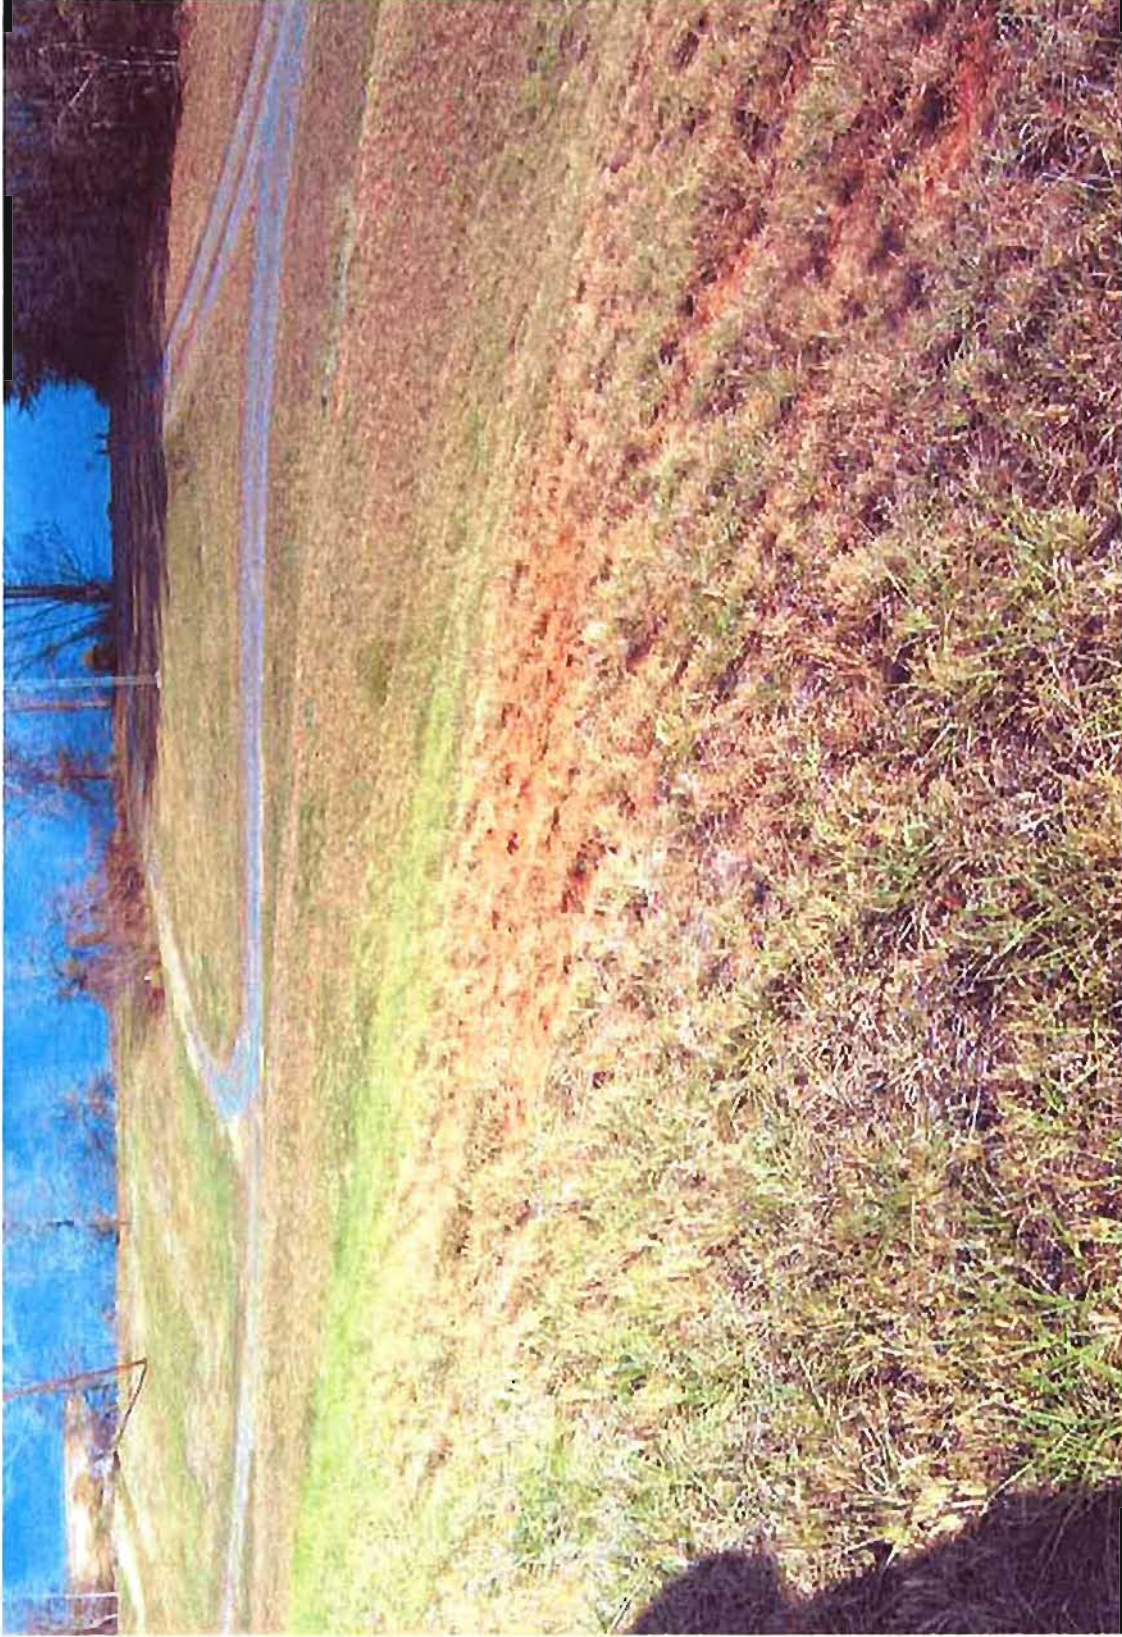
FIGURE NO. **32**

Location: East Dike at the southern bend
Description: Sparse vegetation
