**SEVENTH
FIVE-YEAR INDEPENDENT CONSULTANT
INSPECTION REPORT
(PER THE NORTH CAROLINA UTILITIES COMMISSION)**

**DUKE ENERGY
ALLEN STEAM STATION
253 Plant Allen Road
Belmont, North Carolina 28012
S&ME PROJECT NO. 1411-07-152**

Reference: **Five-year Independent Consultant Inspection Report**
Ash Basin Dikes, Allen Steam Station
Belmont, North Carolina
S&ME Project No. 1411-07-152

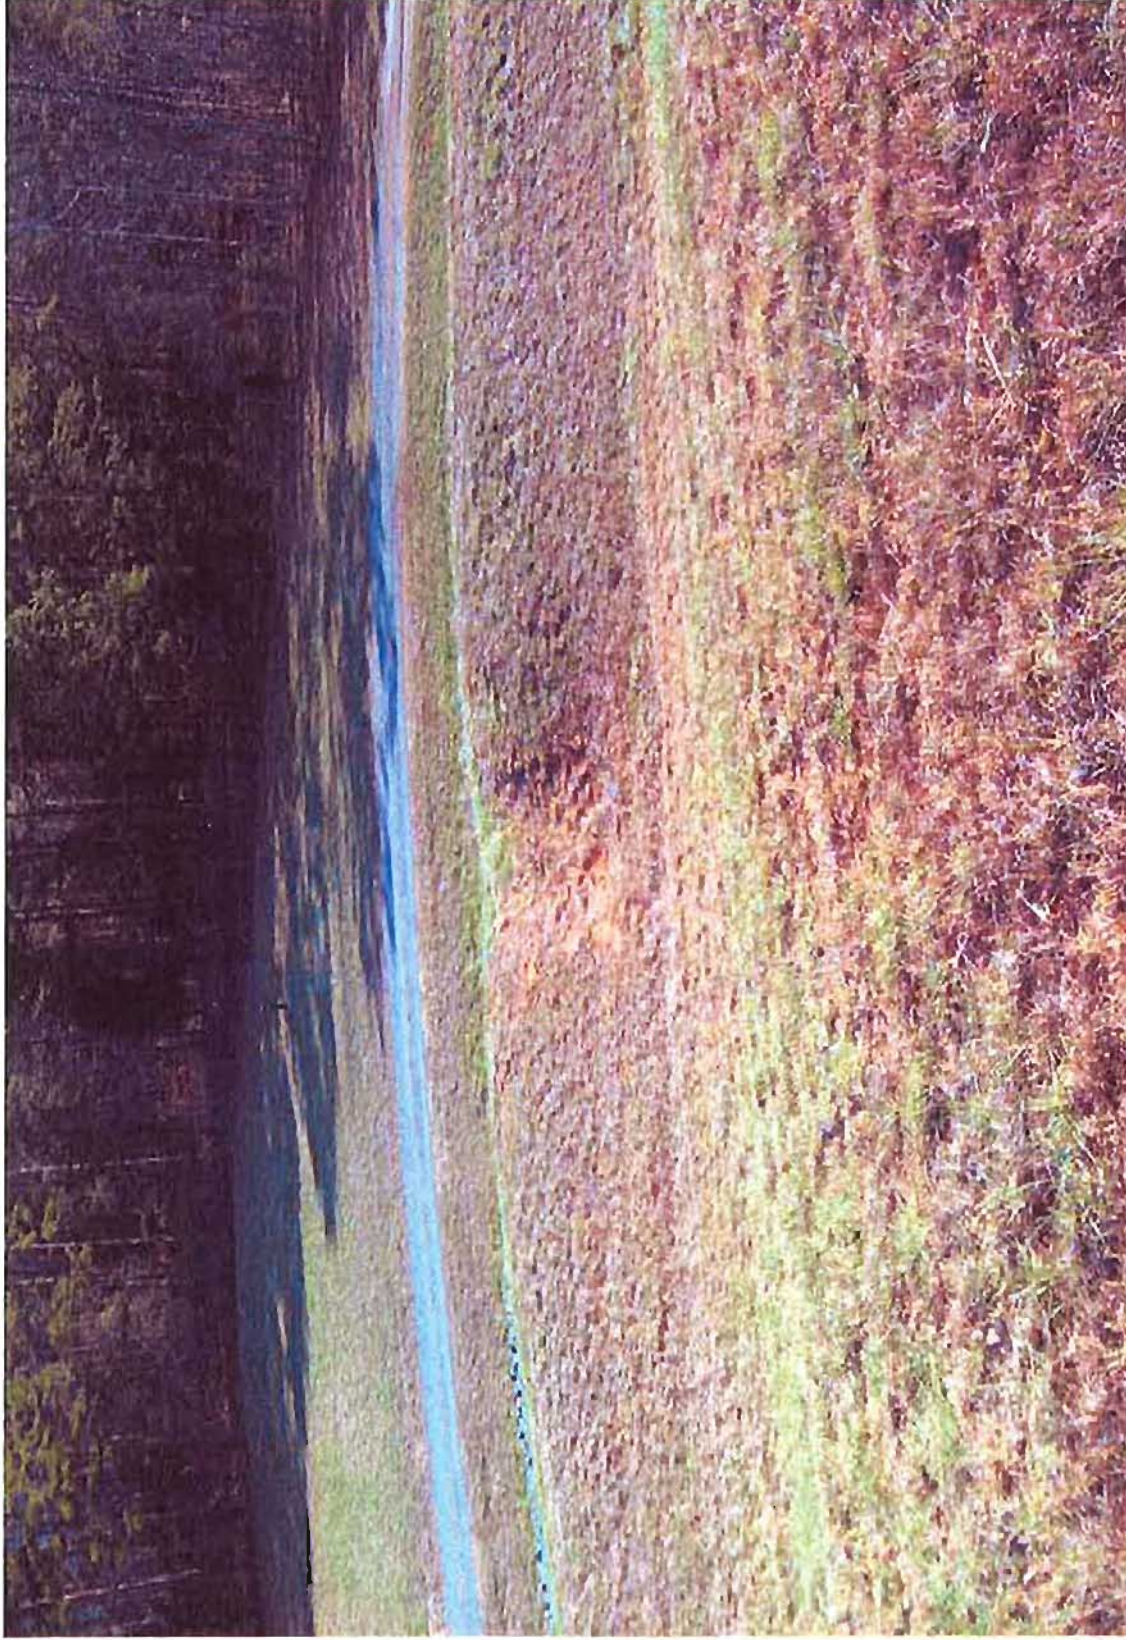
FIGURE NO. **33**

Location: East Dike at southern bend
 Description: Sparse vegetation in drainage ditch.

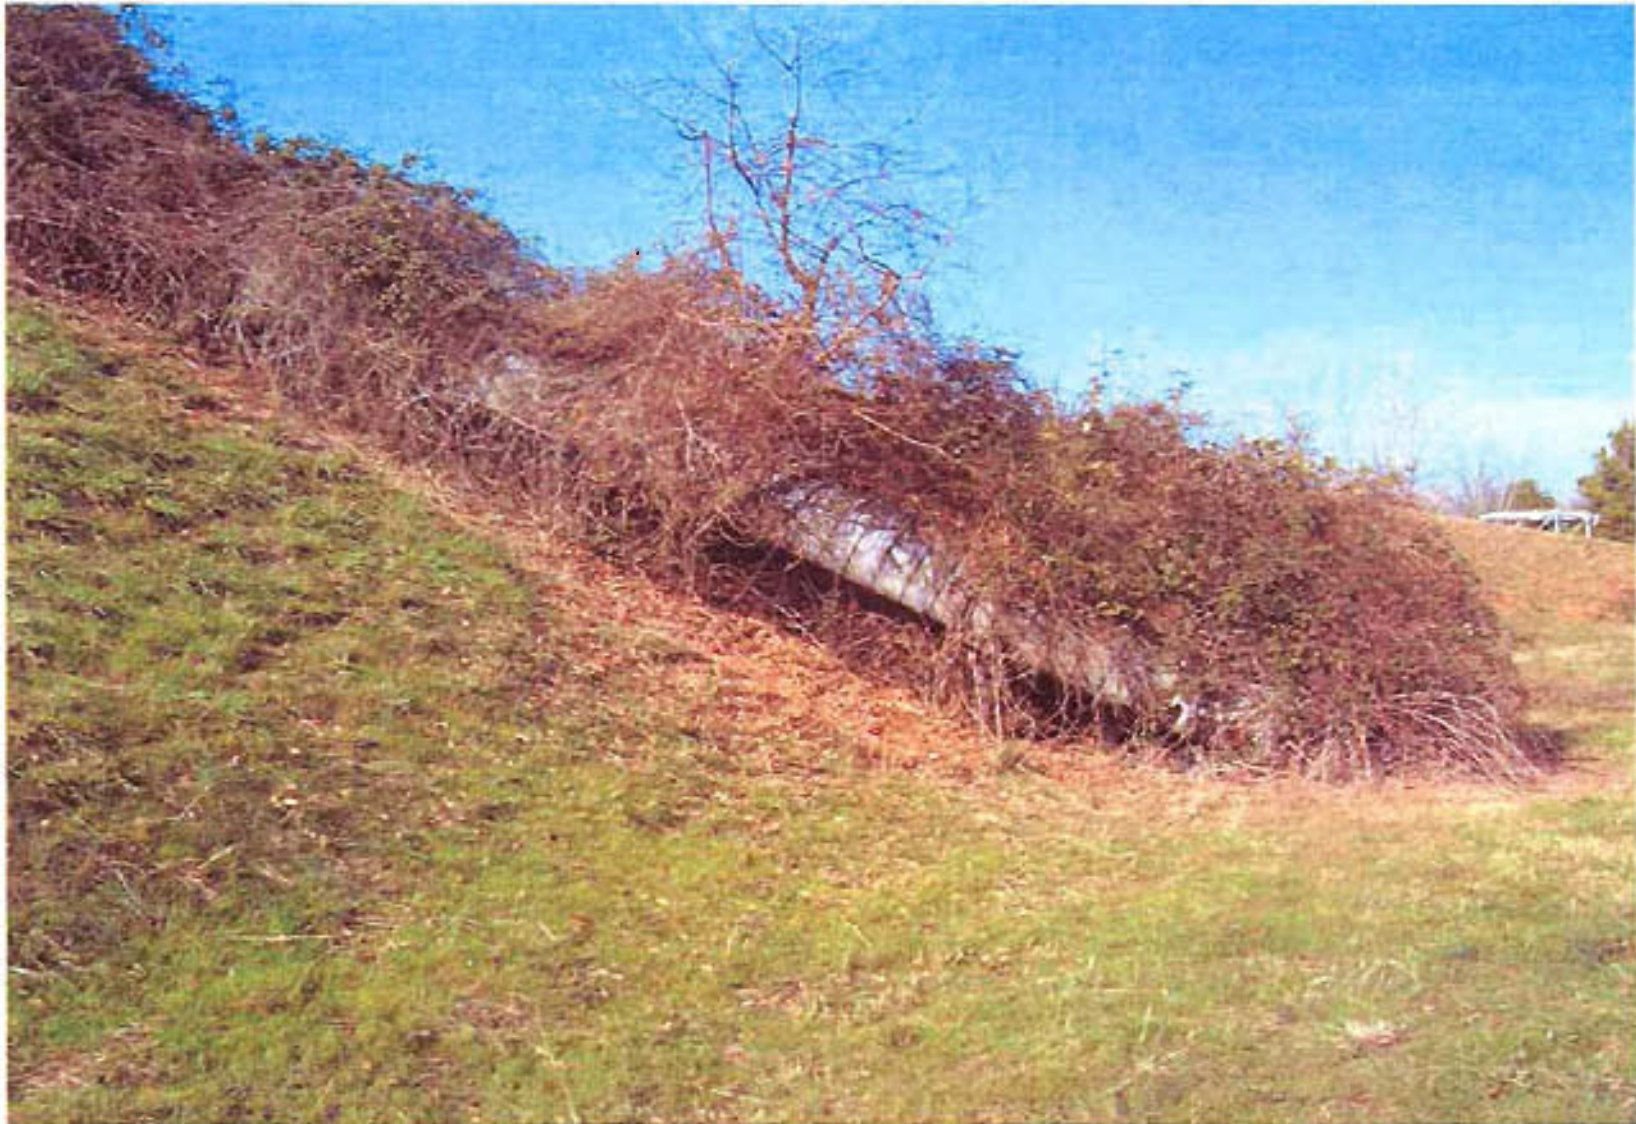
FIGURE NO.
34

Two yard drainage lines discharge into the Active Ash Basin at the northern end of the East Dike. The lines are routed below ground surface until they emerge from the stabilizing berm on the downstream slope of the East Dike (Figure 34). We noted no areas of instability related to the dike embankment in this location.

Location:	East Dike looking north at northern end
Description:	Yard drainage discharge pipes on downstream slope

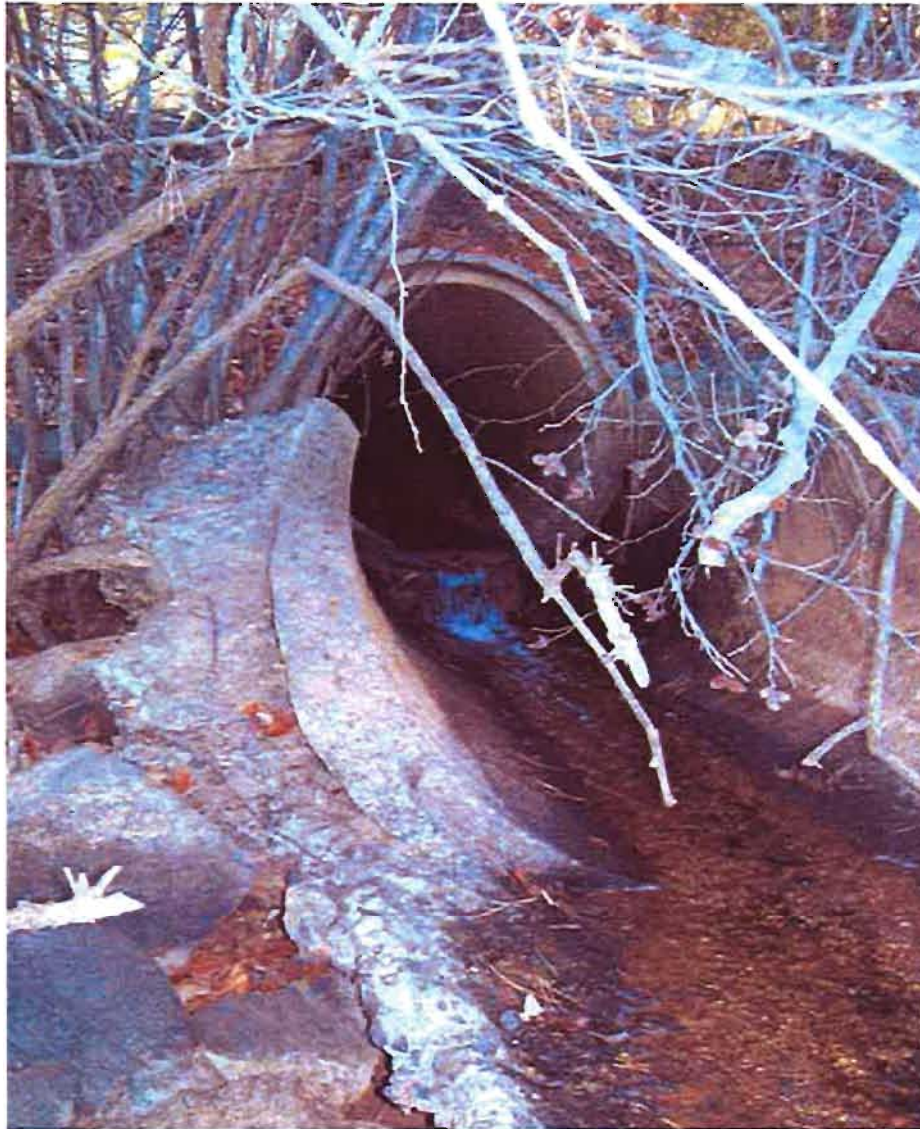
FIGURE NO.
36

Existing dikes at a lower crest elevation form the perimeter of the Retired Ash Basin, which lies just north of the Active Ash Basin. The Retired Ash Basin dikes are covered with mature pine trees on both the upstream and downstream slopes (Figure 35). The outlet structure tower requires some maintenance for any use beyond maintaining surface water at a low elevation (Figure 9). The outlet conduit discharges surface water flows to Lake Wylie. We observed no signs of seepage around the pipe or joint deterioration (Figure 36).

Location: Retired Ash Basin Tower Outlet on Lake Shoreline
Description: Outfall conditions

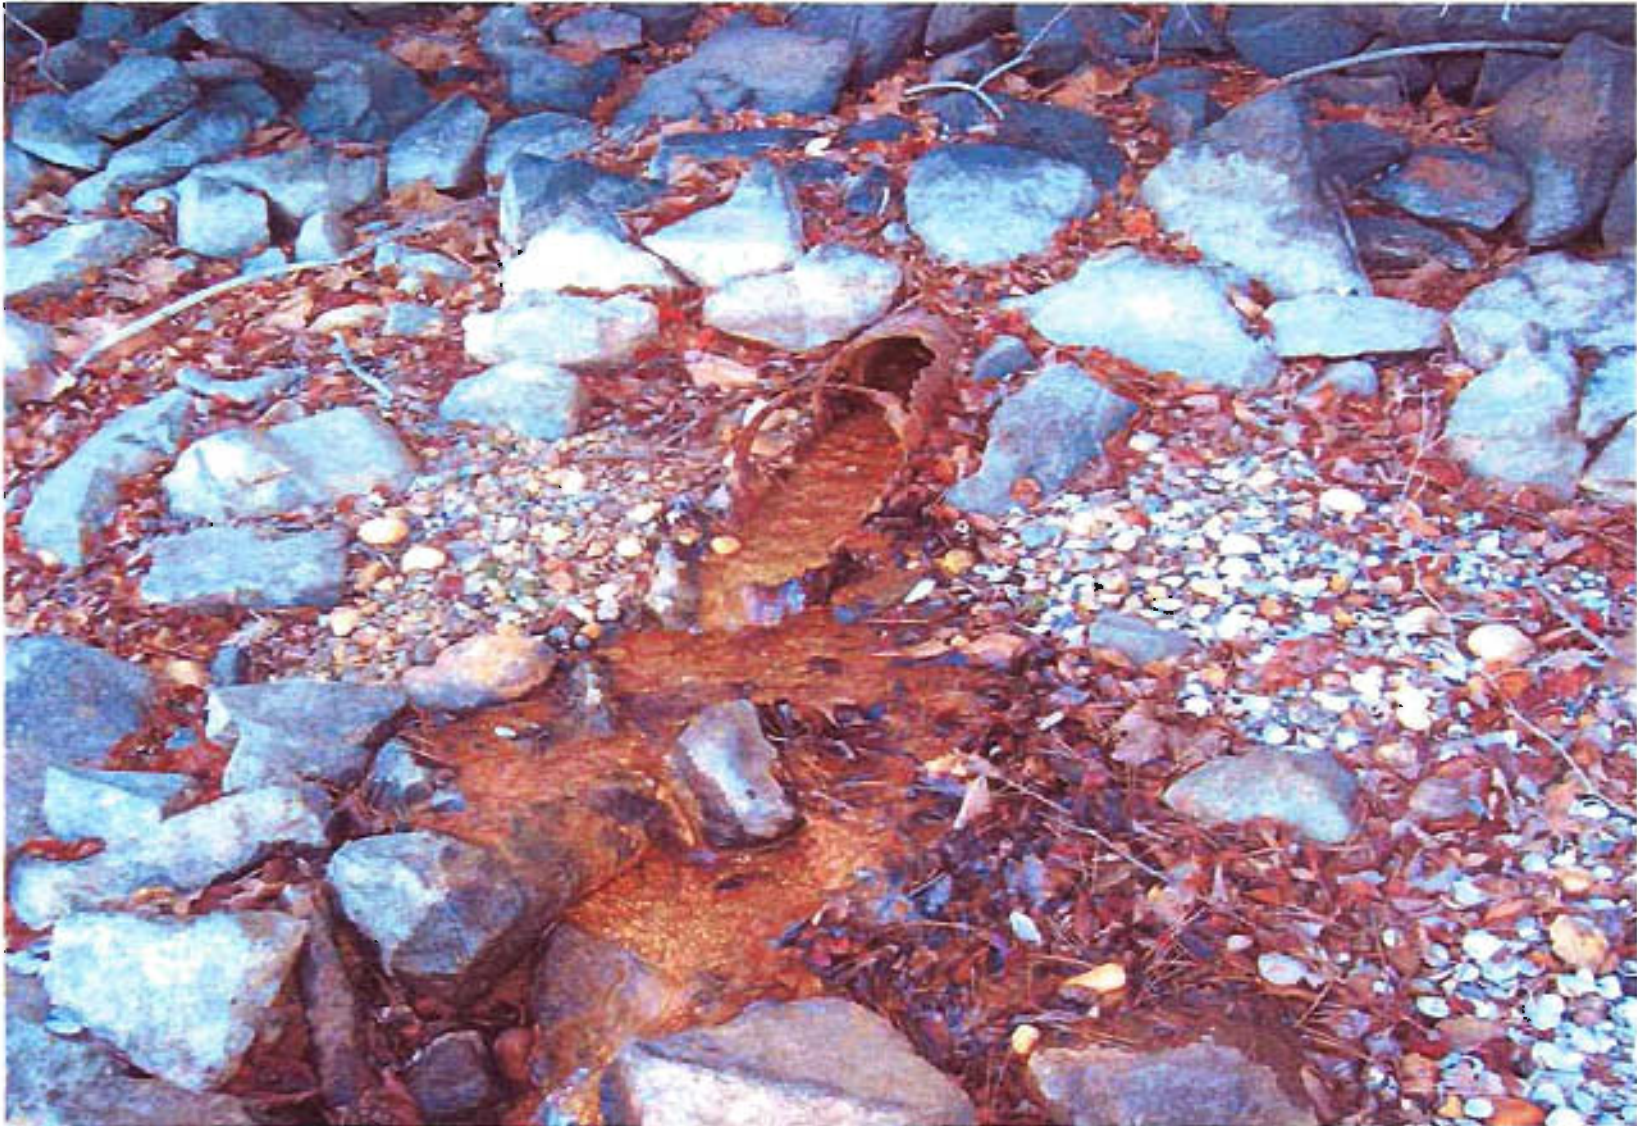
FIGURE NO.
37

Just south of the Retired Ash Basin outlet conduit, we observed flow discharging from a deteriorating 8-inch corrugated metal pipe (Figure 37). The flow appeared clear but steady. We were not able to identify the source of the flow while on the site. Record drawings indicate that the 8-inch pipe is the outfall for catch basins in the rail yard and serves as the outlet for the track drain system. We noted a sinkhole in the railroad track embankment slope, upslope of the CMP outlet (Figure 38).

Location: Track Drain Outlet on Lake Shoreline

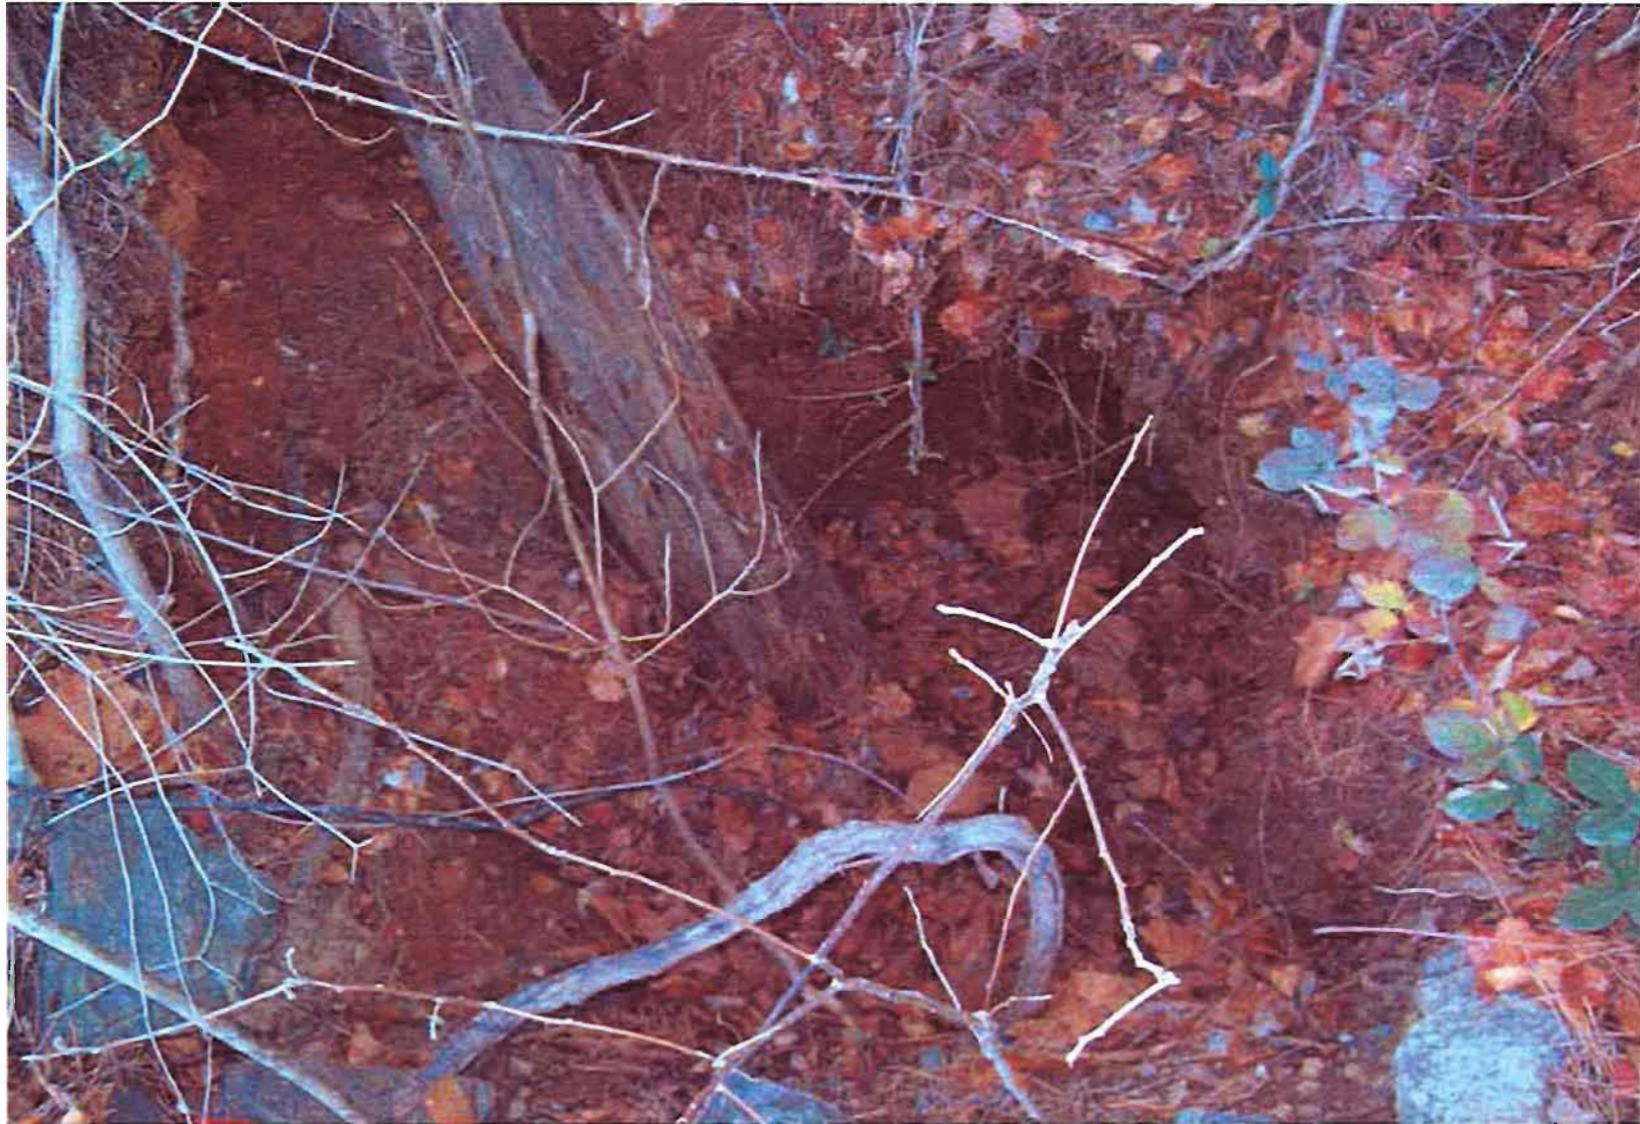
Location: Upslope from Track Drain
Outlet
