Re: Task 3 Dam Assessment Report
Project #0-381
Allen Steam Station Coal Ash Retention Dam
Belmont, North Carolina

FINAL REPORT

EXECUTIVE SUMMARY

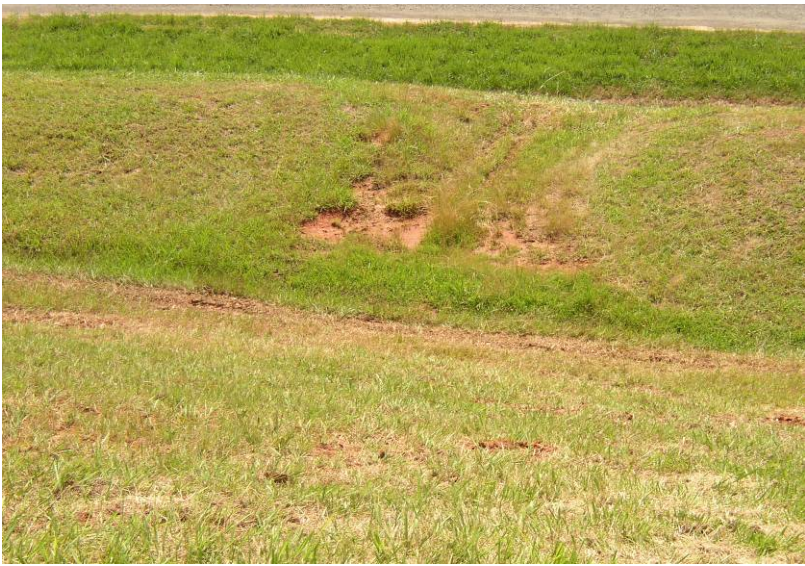
**#4 Local Erosion on Top of Downstream Stability Berm –
Southern Portion of East Dike**

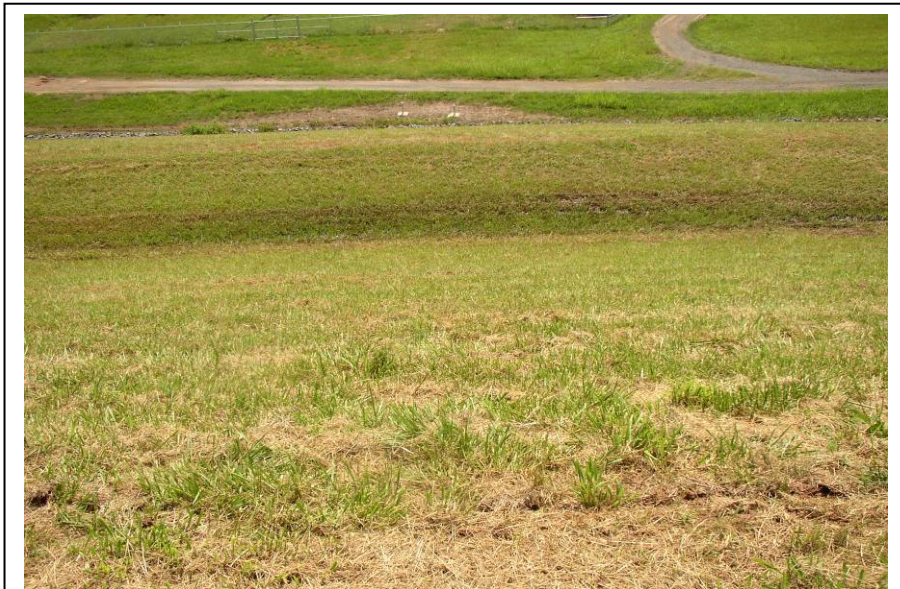
#8 Ponded Water on Bench of Downstream Stability Berm of East Dike

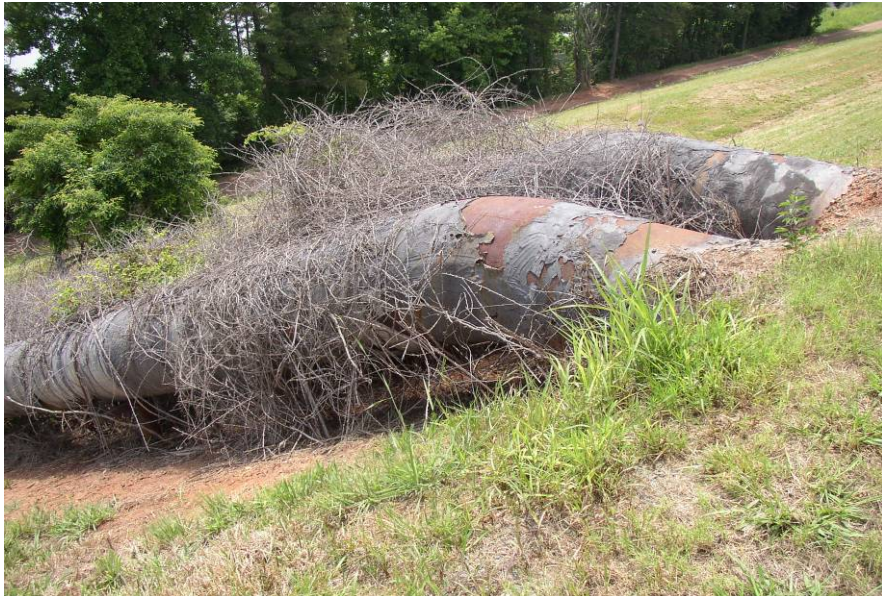
#16 Wastewater Sump Discharge Pipes @ Cell 3

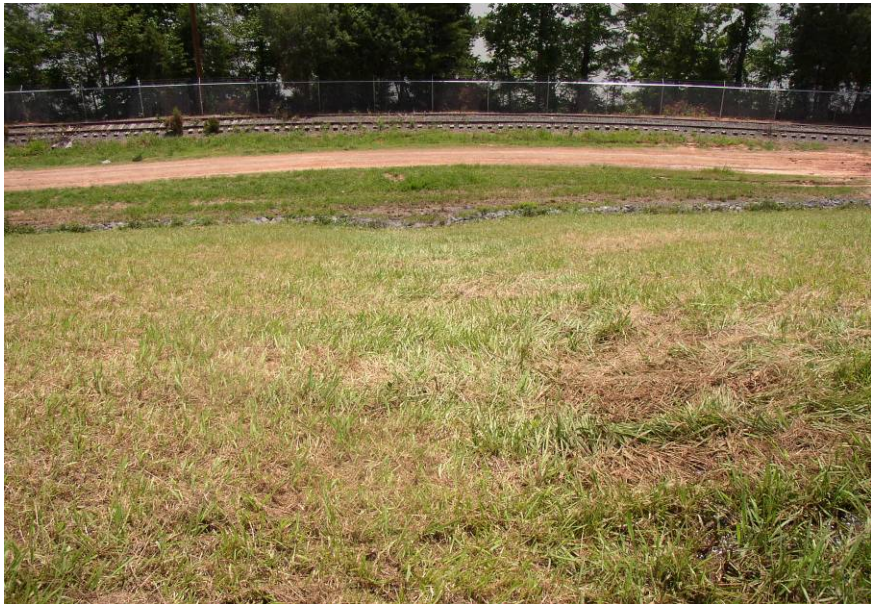
During the visual inspection, potential seepage was observed as part of the downstream blanket drain system along the toe of the North Dike Berm and near the maximum section for the East Dike.

#24 Note Seepage/Ponded Surface Water at Downstream Toe of North Dike

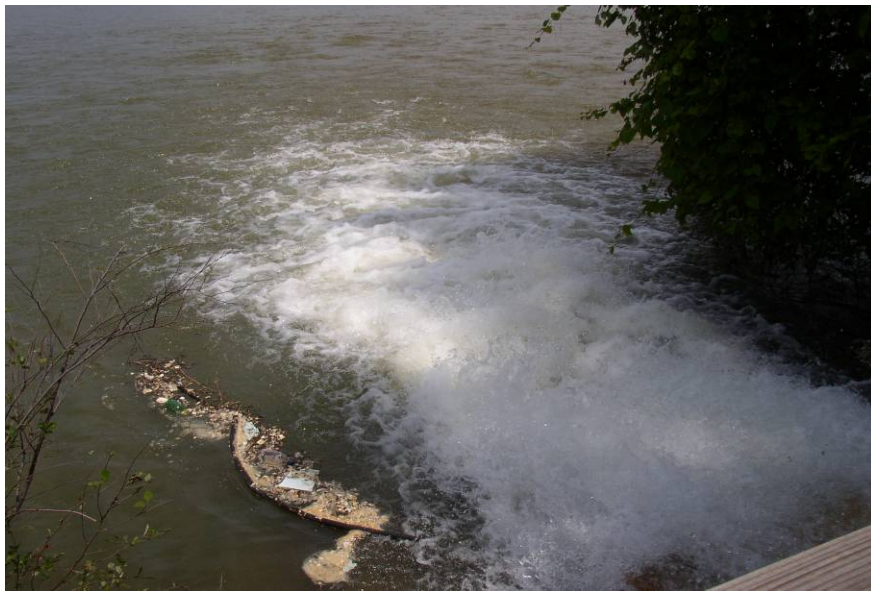
#31 Discharge at Outlet Pipe

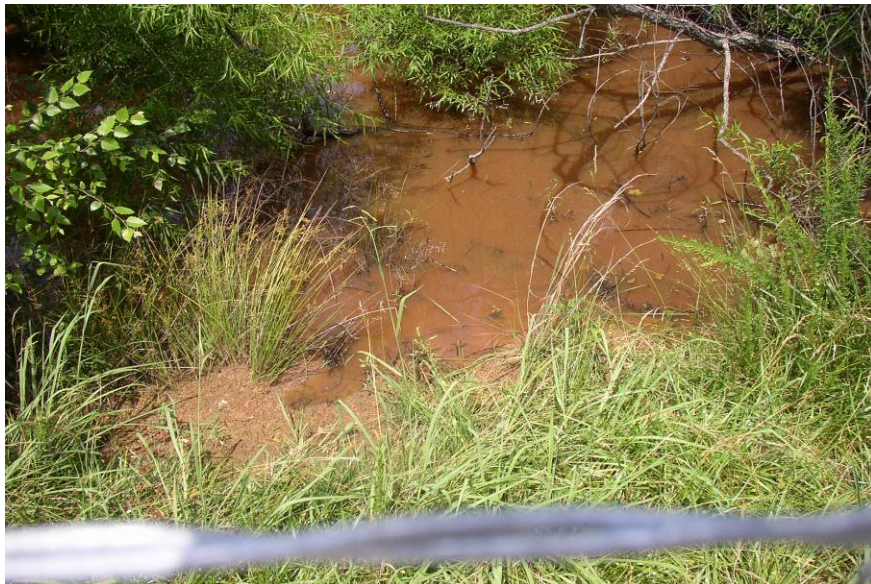
#32 Ponded Surface Water East of Downstream Toe Near Outlet

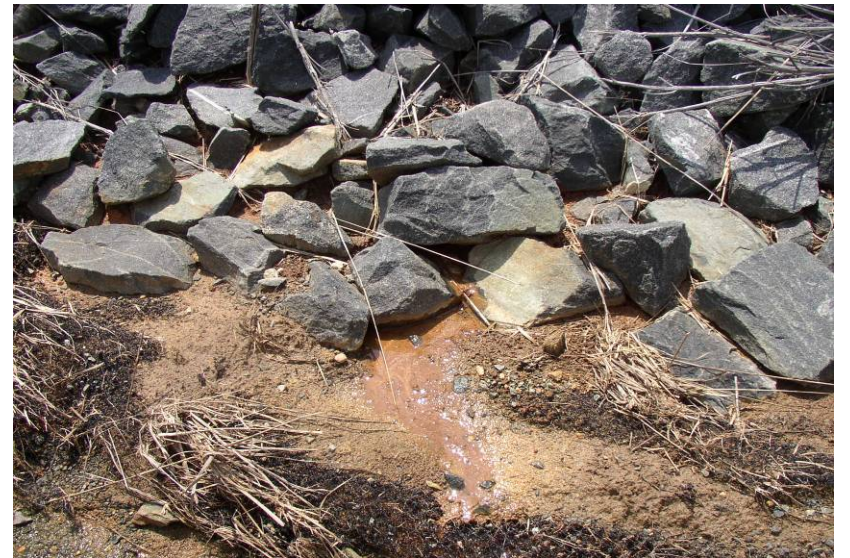
#34 Minor Local Clear Seepage Discharges from Downstream Rock Toe at South End of East Dike

- Quantity of clear seepage observed at downstream toe in several areas, primarily near maximum redacted section, redacted. Appears to emanate from base of riprap toe and drainage blanket under stability berm.

4. Observations of the upper downstream toe of the East Dike should be made during periods of low rainfall to determine whether the standing water observed at the toe was due to surface water runoff or internal seepage. Seepage conditions should be monitored regularly.

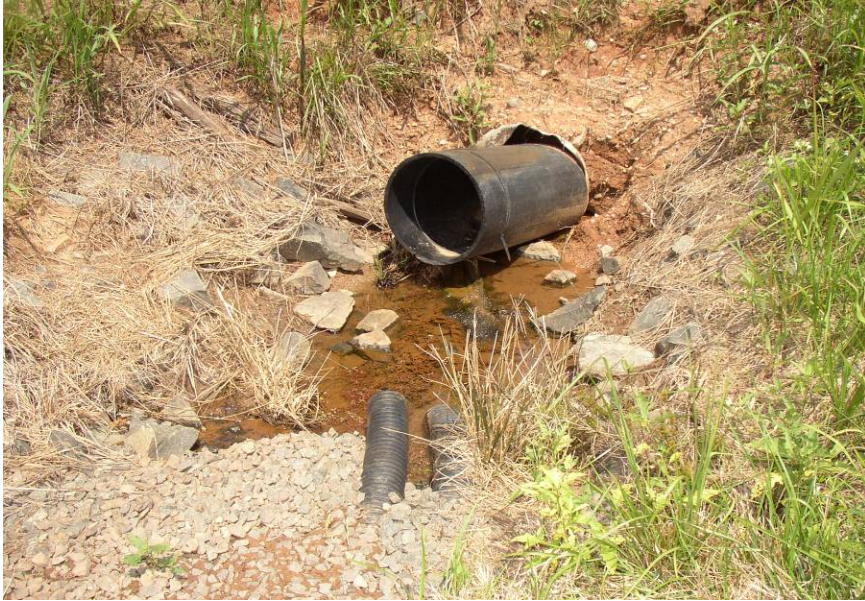
#35 Seepage Collection Area Near Maximum Section of Downstream Toe of East Dike

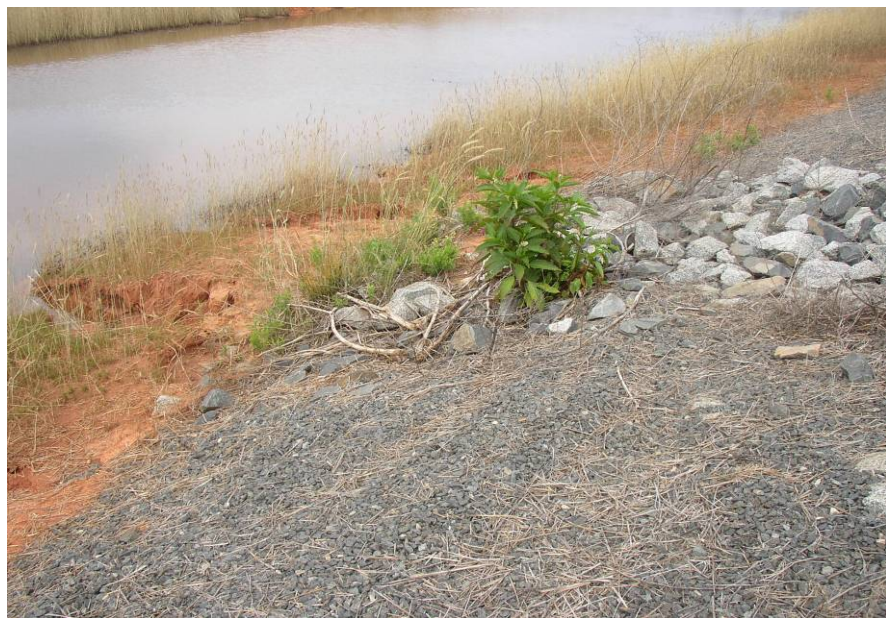
#46 Local Erosion @ Toe of Crushed Stone Drainage Material

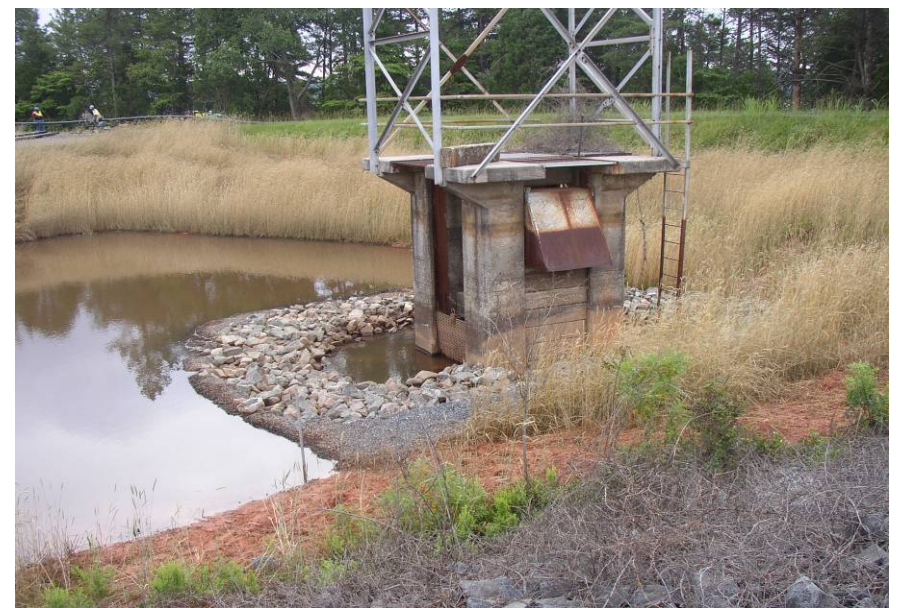
#55 Drop Inlet for Retained Ash Basin

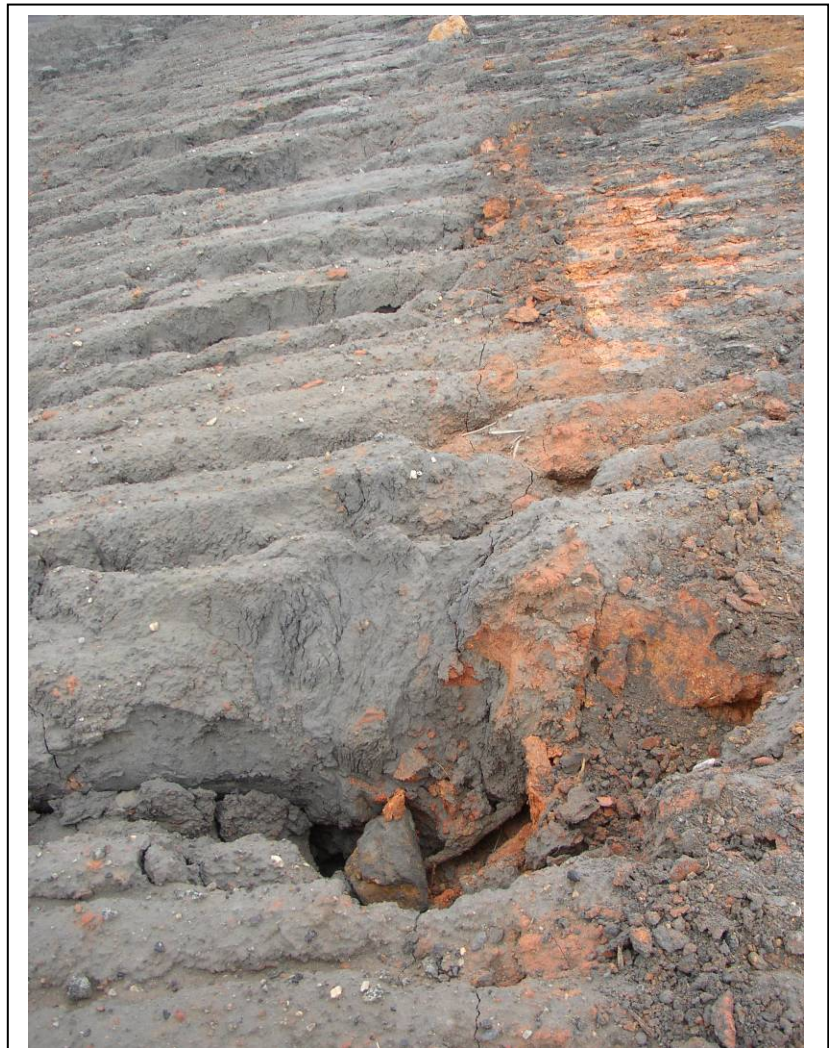
#59 Erosion in Ashfill in Upstream Excavated Slope of Cell 3

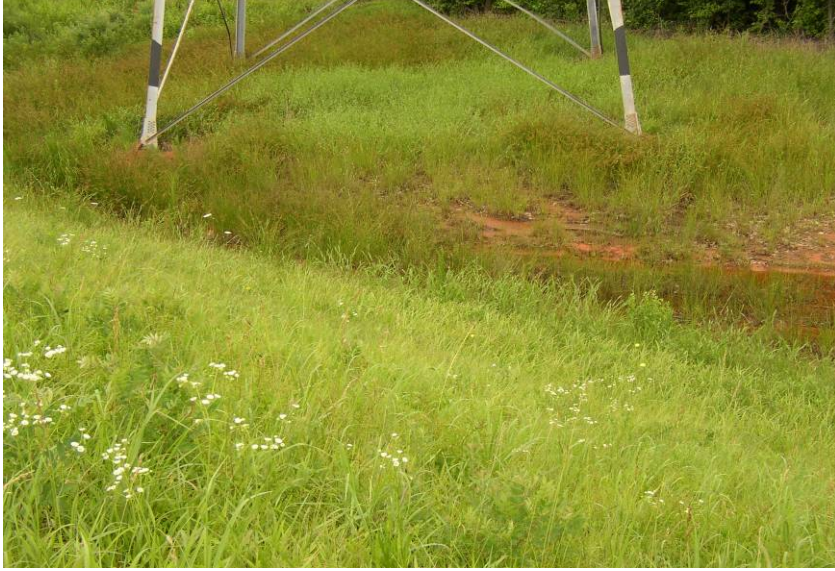
#68 Poned Water Near Downstream Toe of North Dike
