Assessment of Dam Safety Coal Combustion Surface Impoundments (Task 3) Final Report

Duke Energy
Riverbend Steam Station
Mt. Holly, North Carolina

September 14, 2009

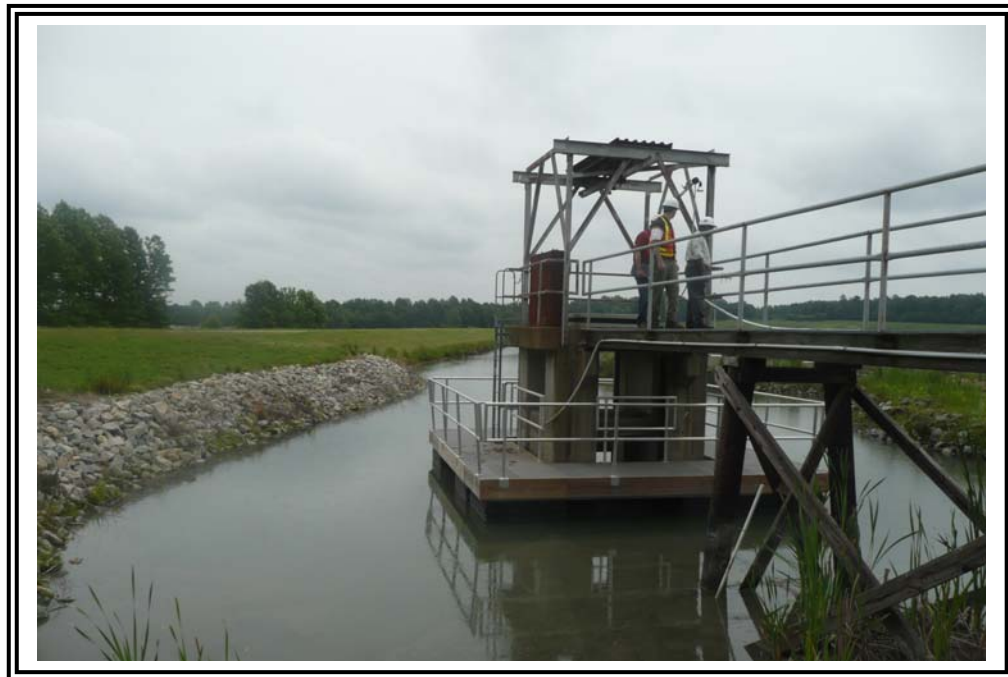
Primary pond outlet tower at north corner of the pond.

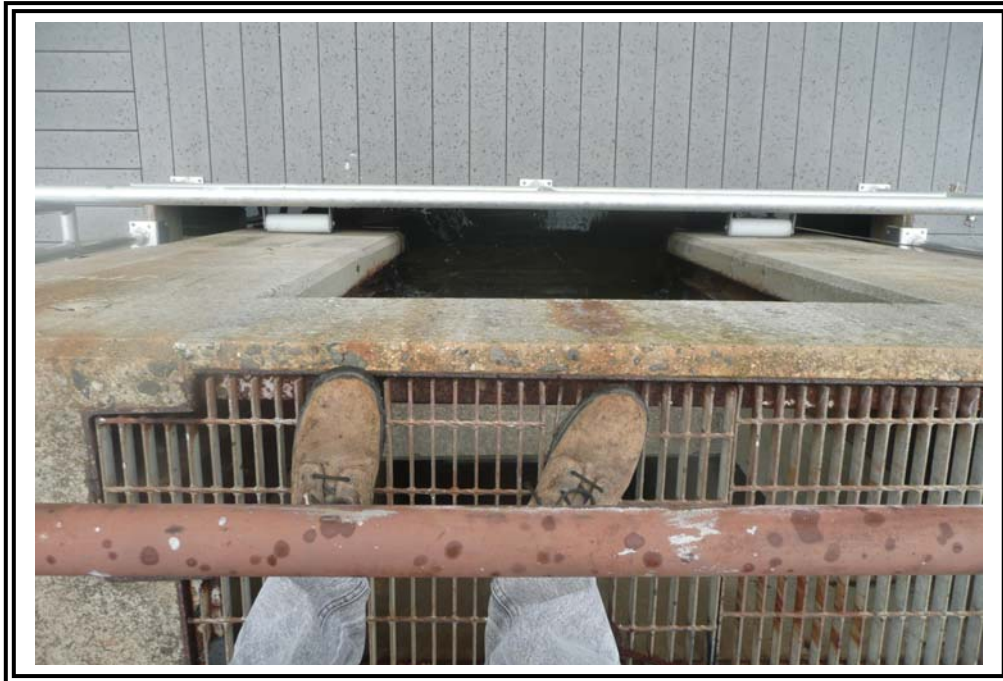
21

Open weir in primary cell outlet tower.

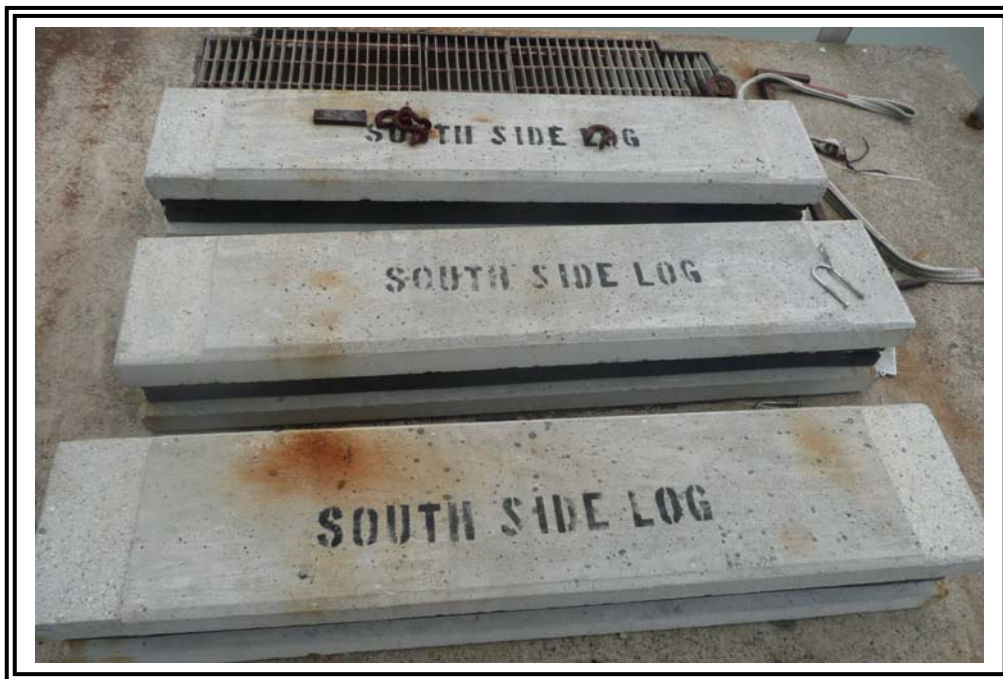
22

Concrete stop logs used to regulate water level in the primary pond.

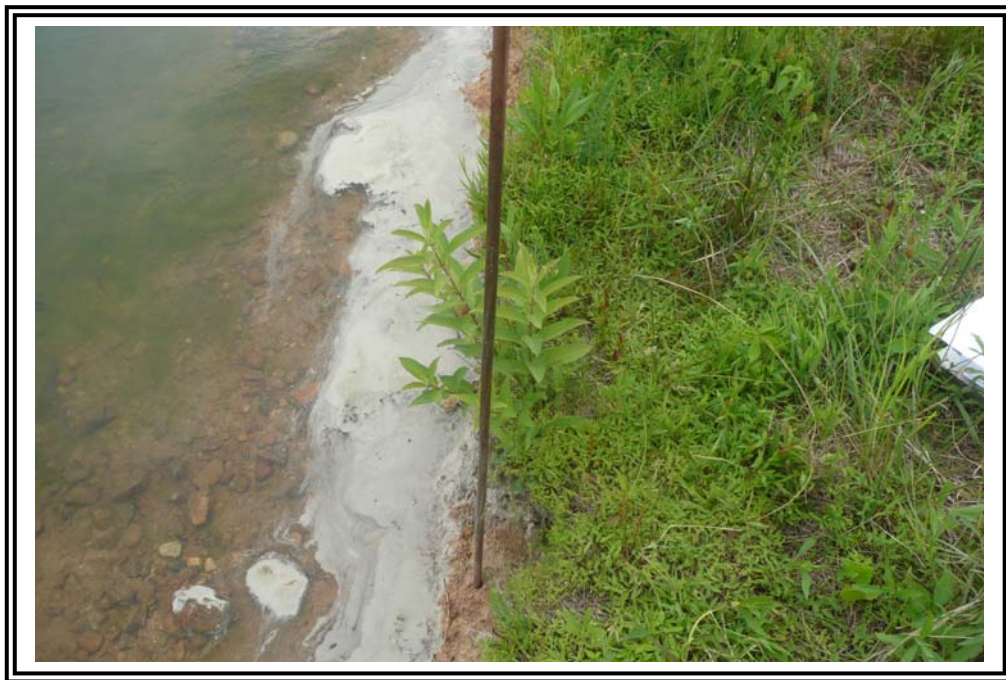
Along the upstream slope, an inboard ash diverter dike was constructed during previous dredging operations and left in place to create a dewatering channel for future dredging operations. Photos 25 through 27 show this dewatering channel. A breach in this diverter dike, as shown in Photo 31, is filled in during dredging operations, and then rebreached to allow normal operating flows to reach the outlet control structure for the primary ash pond. Slight beach erosion was noted at the water line of the upstream slope.

Upstream slope intermediate dike beach erosion. Floating material is composed of cenospheres.

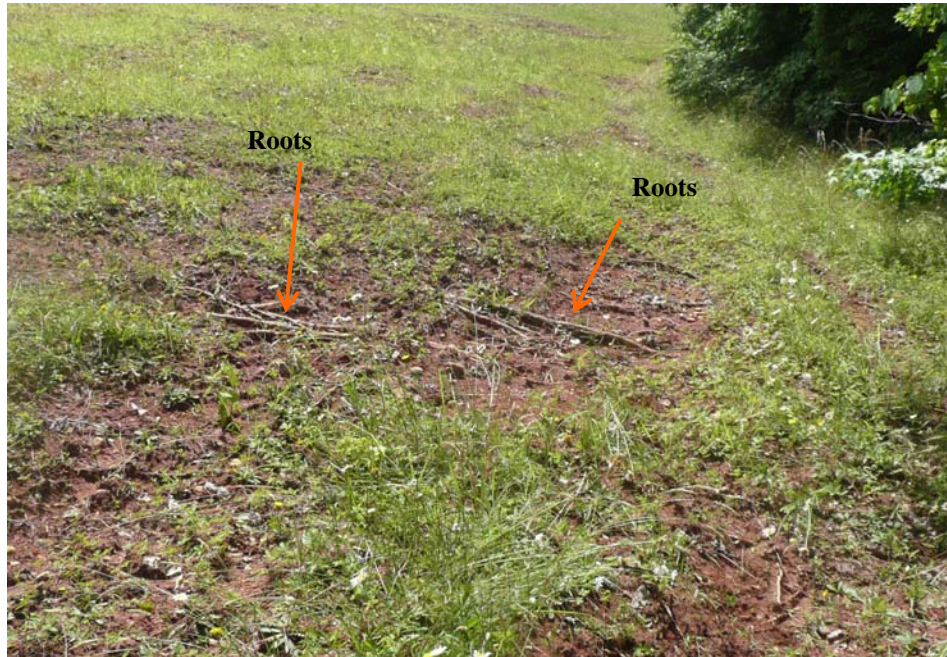
47

The downstream slope was reasonably uniform and predominantly covered with appropriate grass vegetation although areas of sparse grass were noted in isolated areas, some of which appeared related to mower wheels sliding on the slope. Photos 45 through 52 and 57 through 59 show the condition of the downstream slope. Near the tree line at the northwest edge of the high embankment, roots were noted on the ground surface. It appeared these roots were growing from trees located immediately beyond the toe.

Close up of root growth shown in Photo 46.

Tree roots were observed at the slope surface near the northwest end of the secondary dike. These tree roots appear to be from trees growing beyond the toe of the dam. CHA recommends that Duke Energy, under the direction of a professional engineer, remove trees from beyond the toe of the dam, and remove large root masses in the embankment toe.

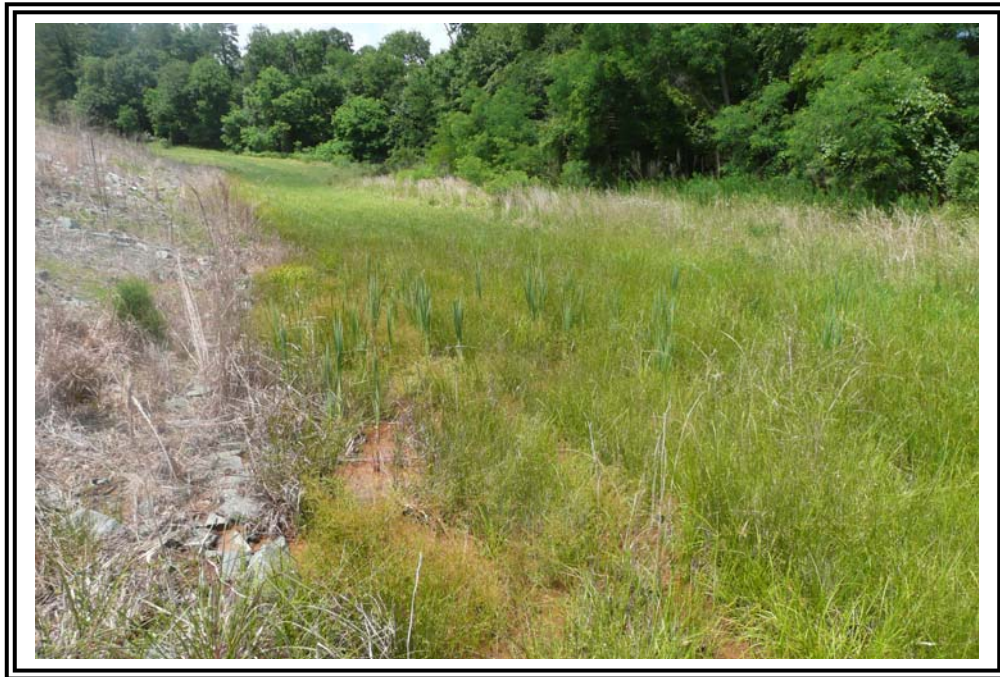
Seepage, as shown in Photos 54 and 55, was observed from the toe drain between redacted northwest of a rip rapped swale extending beyond the toe of the dam (see photo 56).

Flowing water was observed in these seepage areas, and the type of vegetation at the toe was indicative of perennially wet conditions. The observed flow was clear.

Reeds growing in area of seepage at the toe of secondary dike.

As discussed in Section 2.3.1, flowing seepage was observed at the toe of the secondary dike. Duke Energy was aware of this seepage and makes observations of this area during their routine inspections. CHA recommends a collection trench or pipe and monitoring weir be installed in this area to facilitate quantifiable volume measurements and sample collection. Quantifiable measurements will allow Duke Energy and outside consultants to see changes if they occur.. Any changes would need to be addressed.

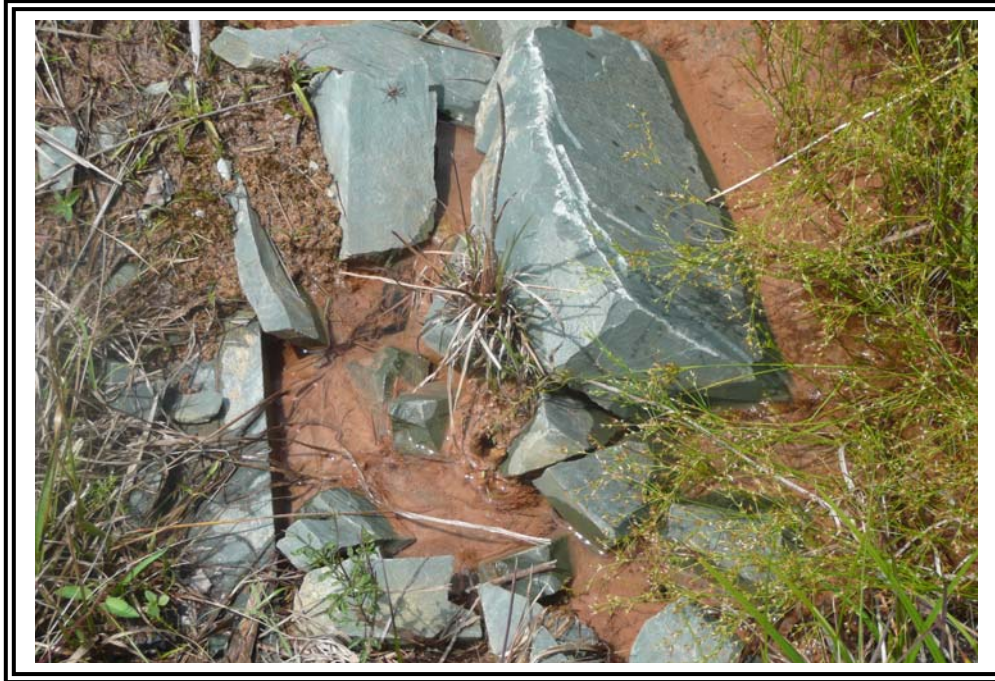
55

Seepage at the toe of the secondary dike about 300 feet from piezometer row. Water is clear.

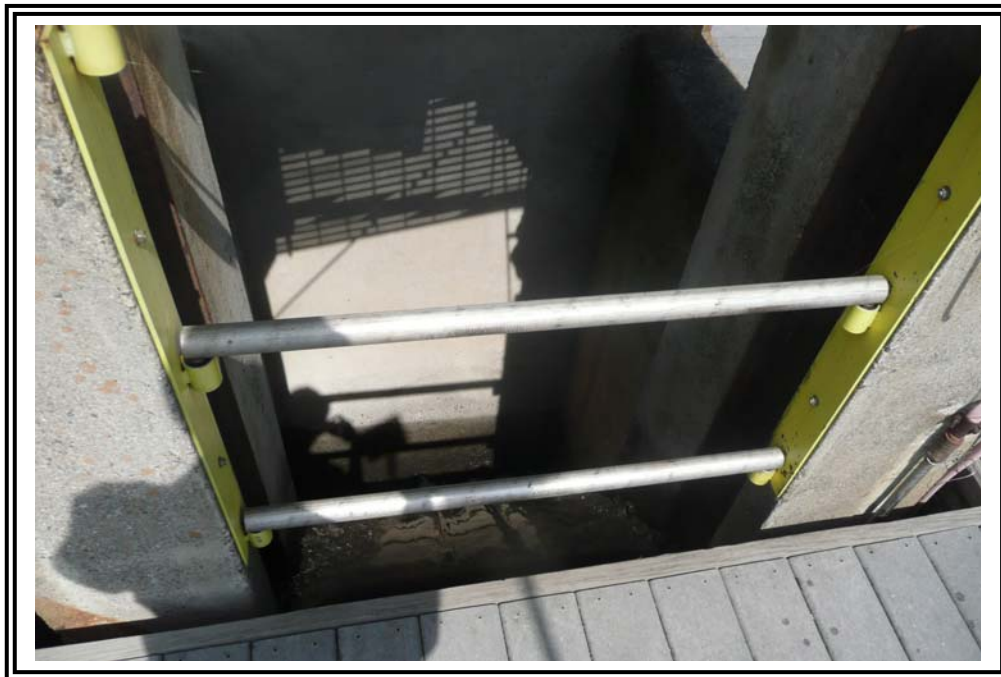
60

Intake tower in secondary pond.

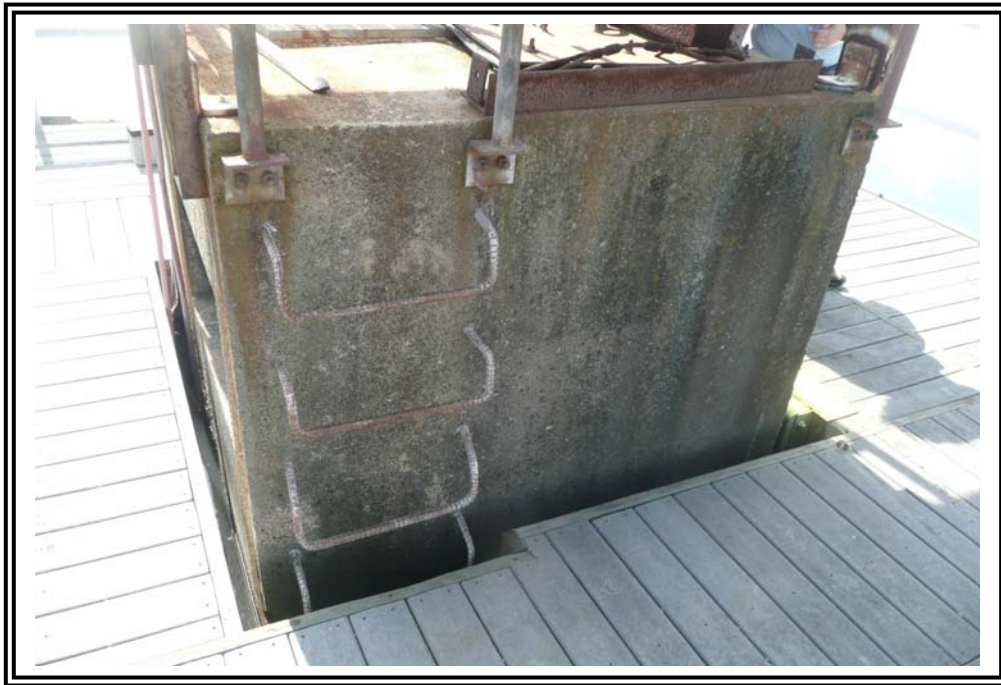
61

Intake tower in secondary pond.

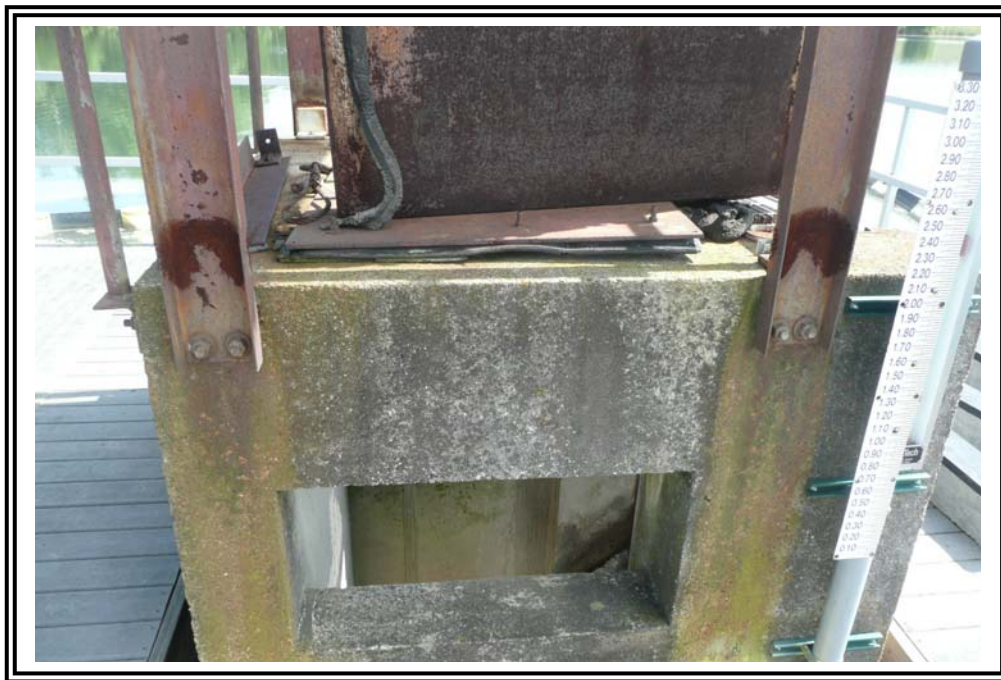
62

Intake tower in secondary pond.

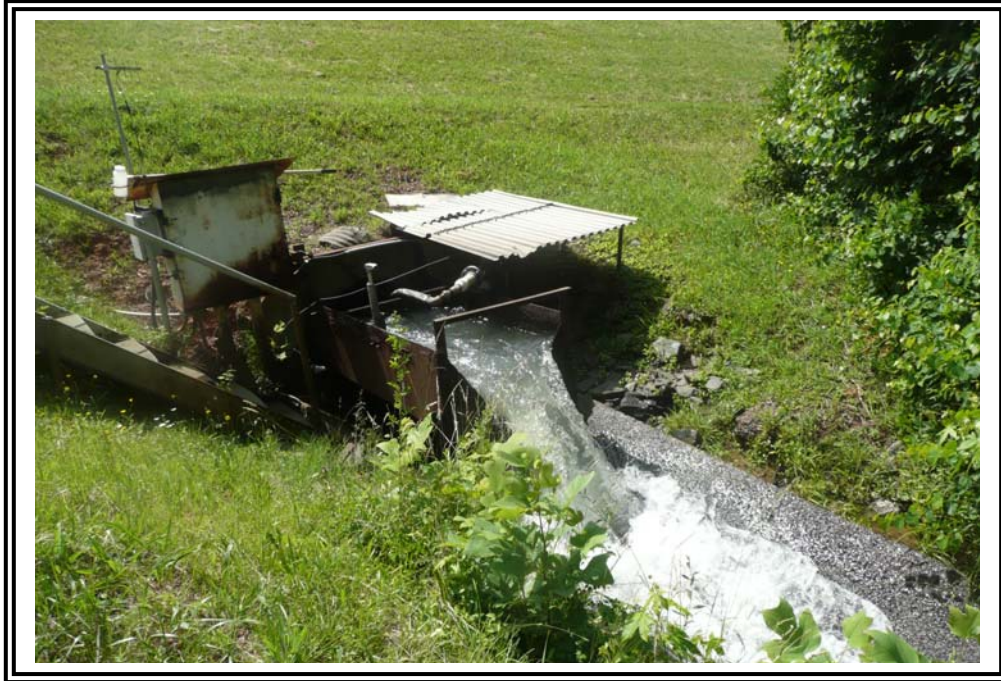
63

Outlet structure at toe of secondary dike, looking upstream to the south-southwest (towards secondary cell).

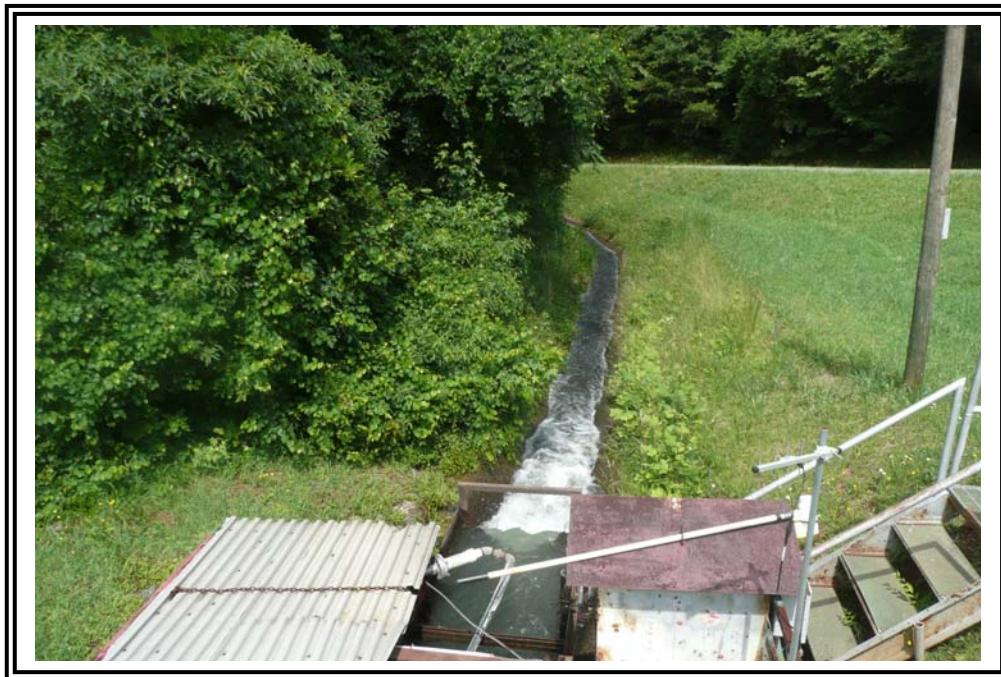
64

Outlet channel of secondary dike, looking downstream to the north-northeast (towards the Catawba River).
