ANNUAL REPORT FOR 2006

Croatan Wetland Mitigation Bank Craven County, North Carolina

**The Ecosystem Enhancement Program
EEP Project No. 103**

January 2007

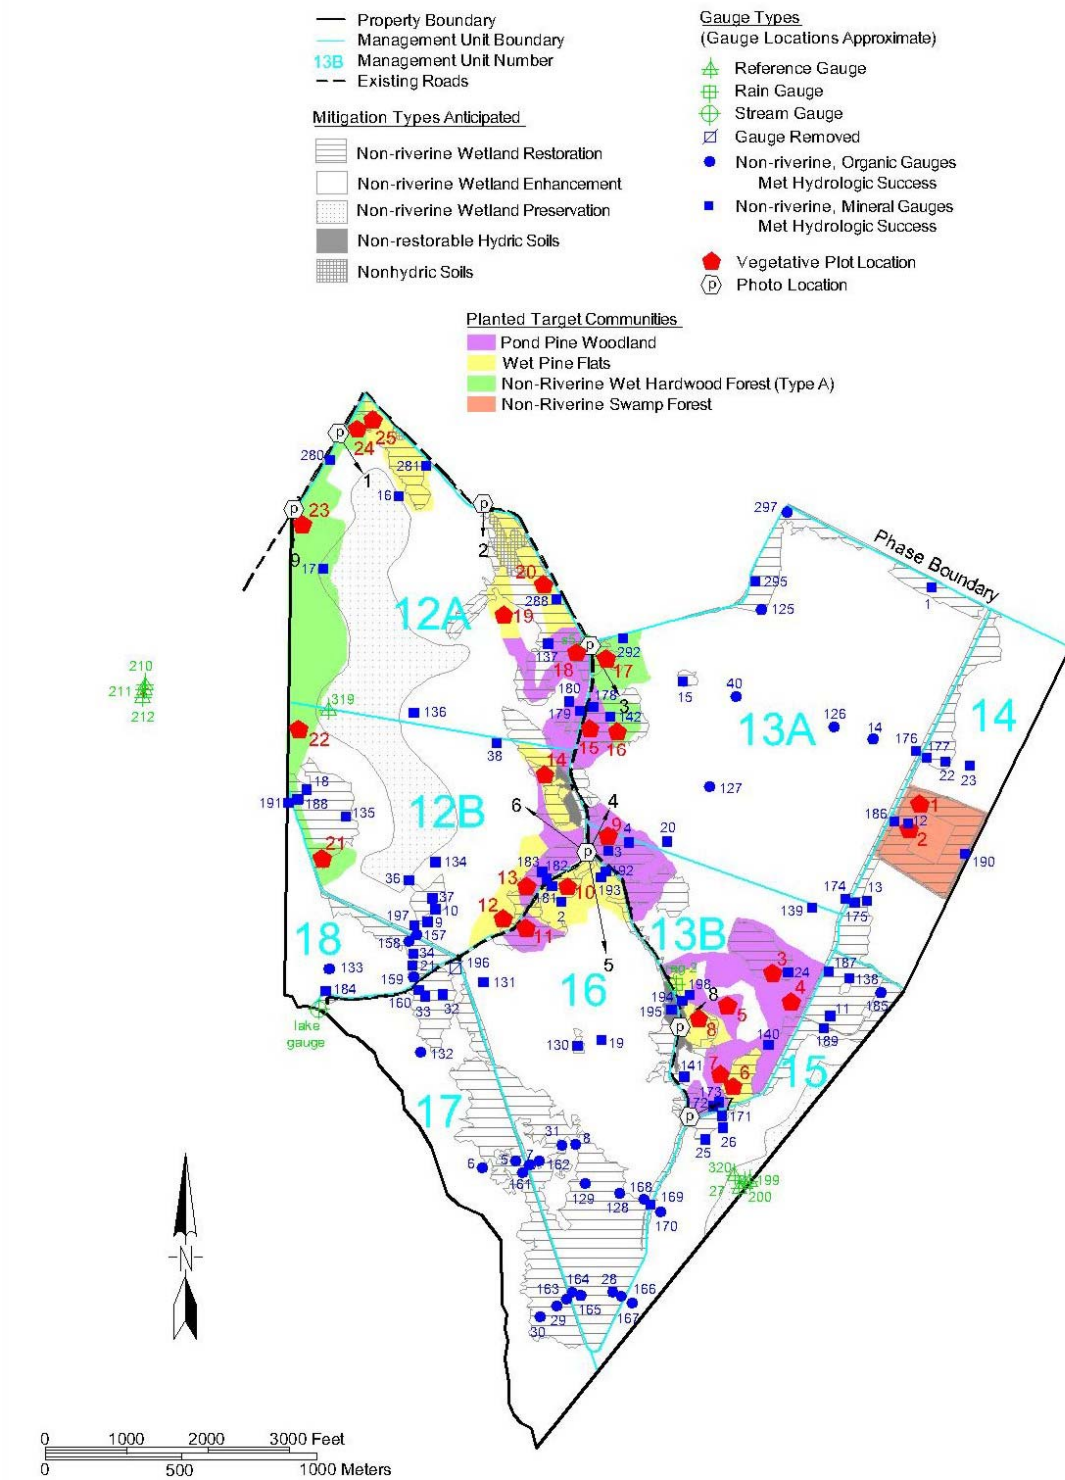
Figure 2. Hydrologic Monitoring Gauge and Vegetation Plots, Croatan WMB, Phase I

Five of the seven gauges (Gauges 3, 11, 182, 183, and 191) that did not meet jurisdictional hydrology for $\geq 12.5\%$ of the growing season are located adjacent to point plugged ditches and as predicted these gauges were not returned to jurisdictional status. The zone of influence in these areas may be greater than 3 meters. Gauges along other transects confirmed the predicted zone of influence or indicated that the zone of influence is less than predicted. The remaining two gauges (Gauges 24 and 137) are located on topographic highs. These gauges should be reviewed to determine the extent of the non-jurisdictional areas around these gauges

The only area of concern in MU 12A is the area represented by Gauge 137. This gauge site should be reviewed to determine the extent of the non-jurisdictional area surrounding Gauge 137 and a contingency plan developed for the area that has not been returned to jurisdictional status.

Gauges 182 and 183 should be reviewed to determine the extent of the non-jurisdictional area surrounding these gauge sites and a contingency plan developed for the areas that have not been returned to jurisdictional status. Credit should be evaluated for restoring jurisdictional status to the previously non-jurisdictional area around Gauges 18 and 135.

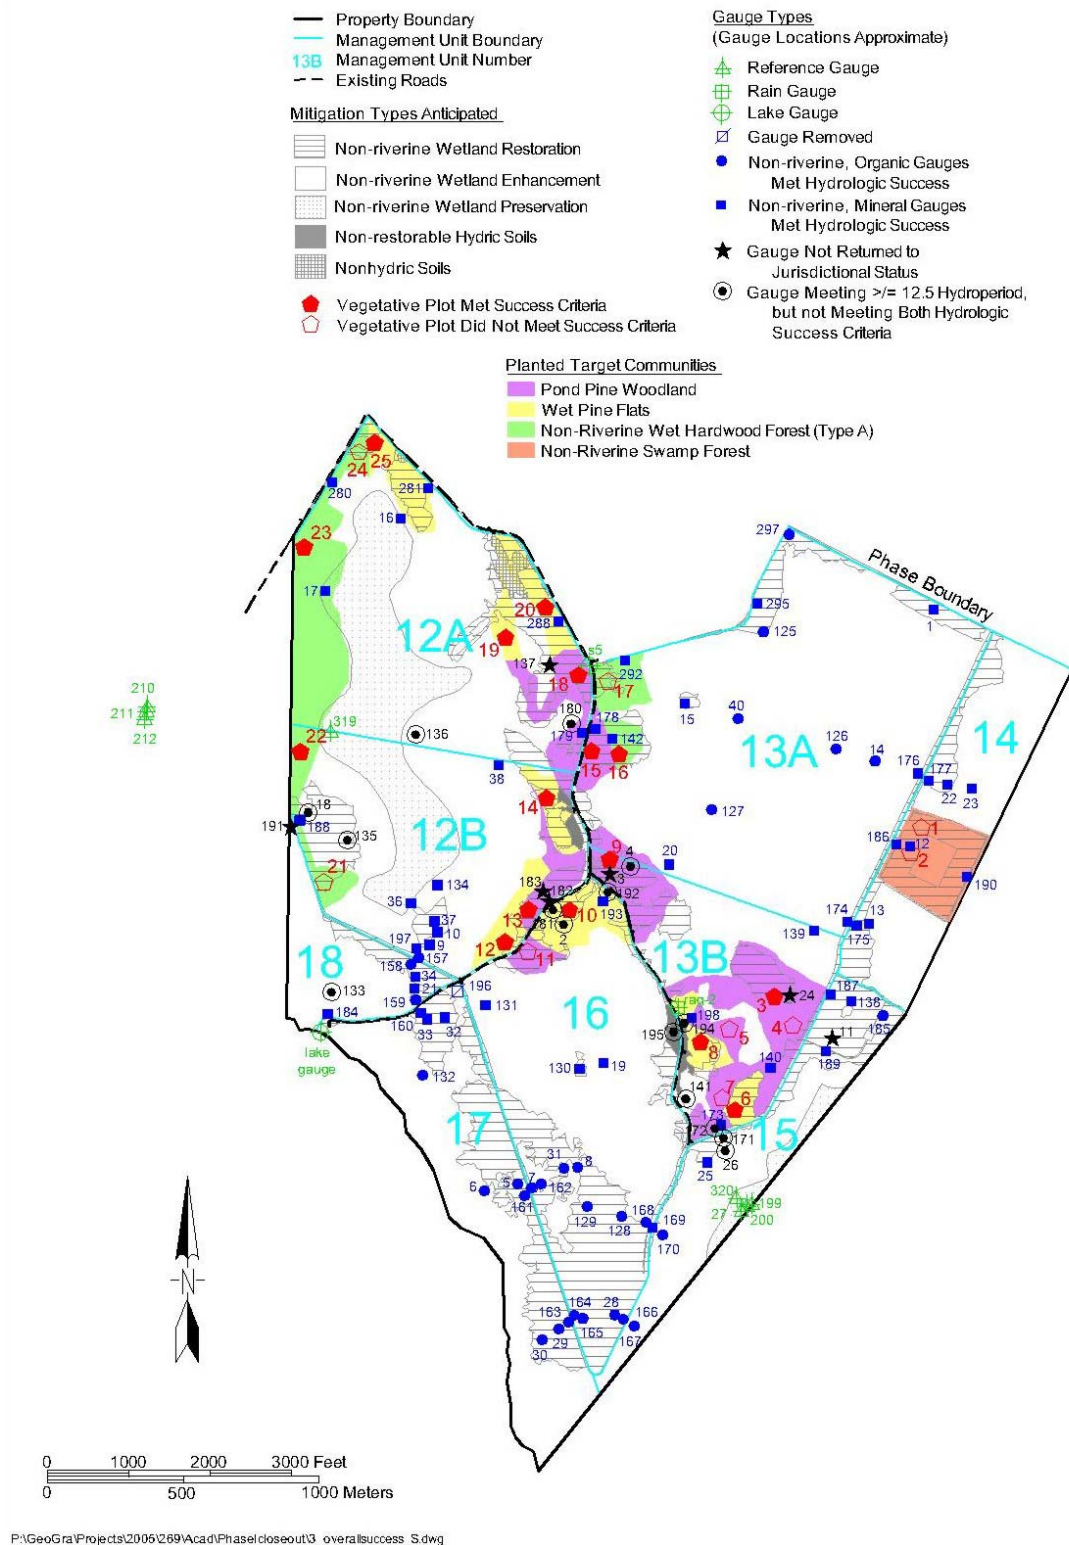
Figure 3. Summary of 5 Years Monitoring, Croatan WMB, Phase I

Hydrologic monitoring showed 80 of 102 (78.4%) monitoring gauges in the CWMB met both respective hydrologic success criteria [$\geq 12.5\%$ (mineral soils) or $\geq 25\%$ (organic/riverine soils) of the growing season and within 20% of Reference Range] consistently throughout the five year monitoring period (**Figure 3**). Of the 22 gauges that did not meet both respective success criteria consistently, 15 made jurisdictional hydrology for $\geq 12.5\%$ of the growing season, and only seven (Gauges 3, 11, 24, 137, 182, 183, and 191) did not meet jurisdictional hydrology for $\geq 12.5\%$ of the growing season.
