As-Built Baseline Monitoring Report

Rhapsody Mitigation Project

DMS Project #: 100110 | Contract #: 7864 | DWR # 2019-1405 | RFP: 16-007703

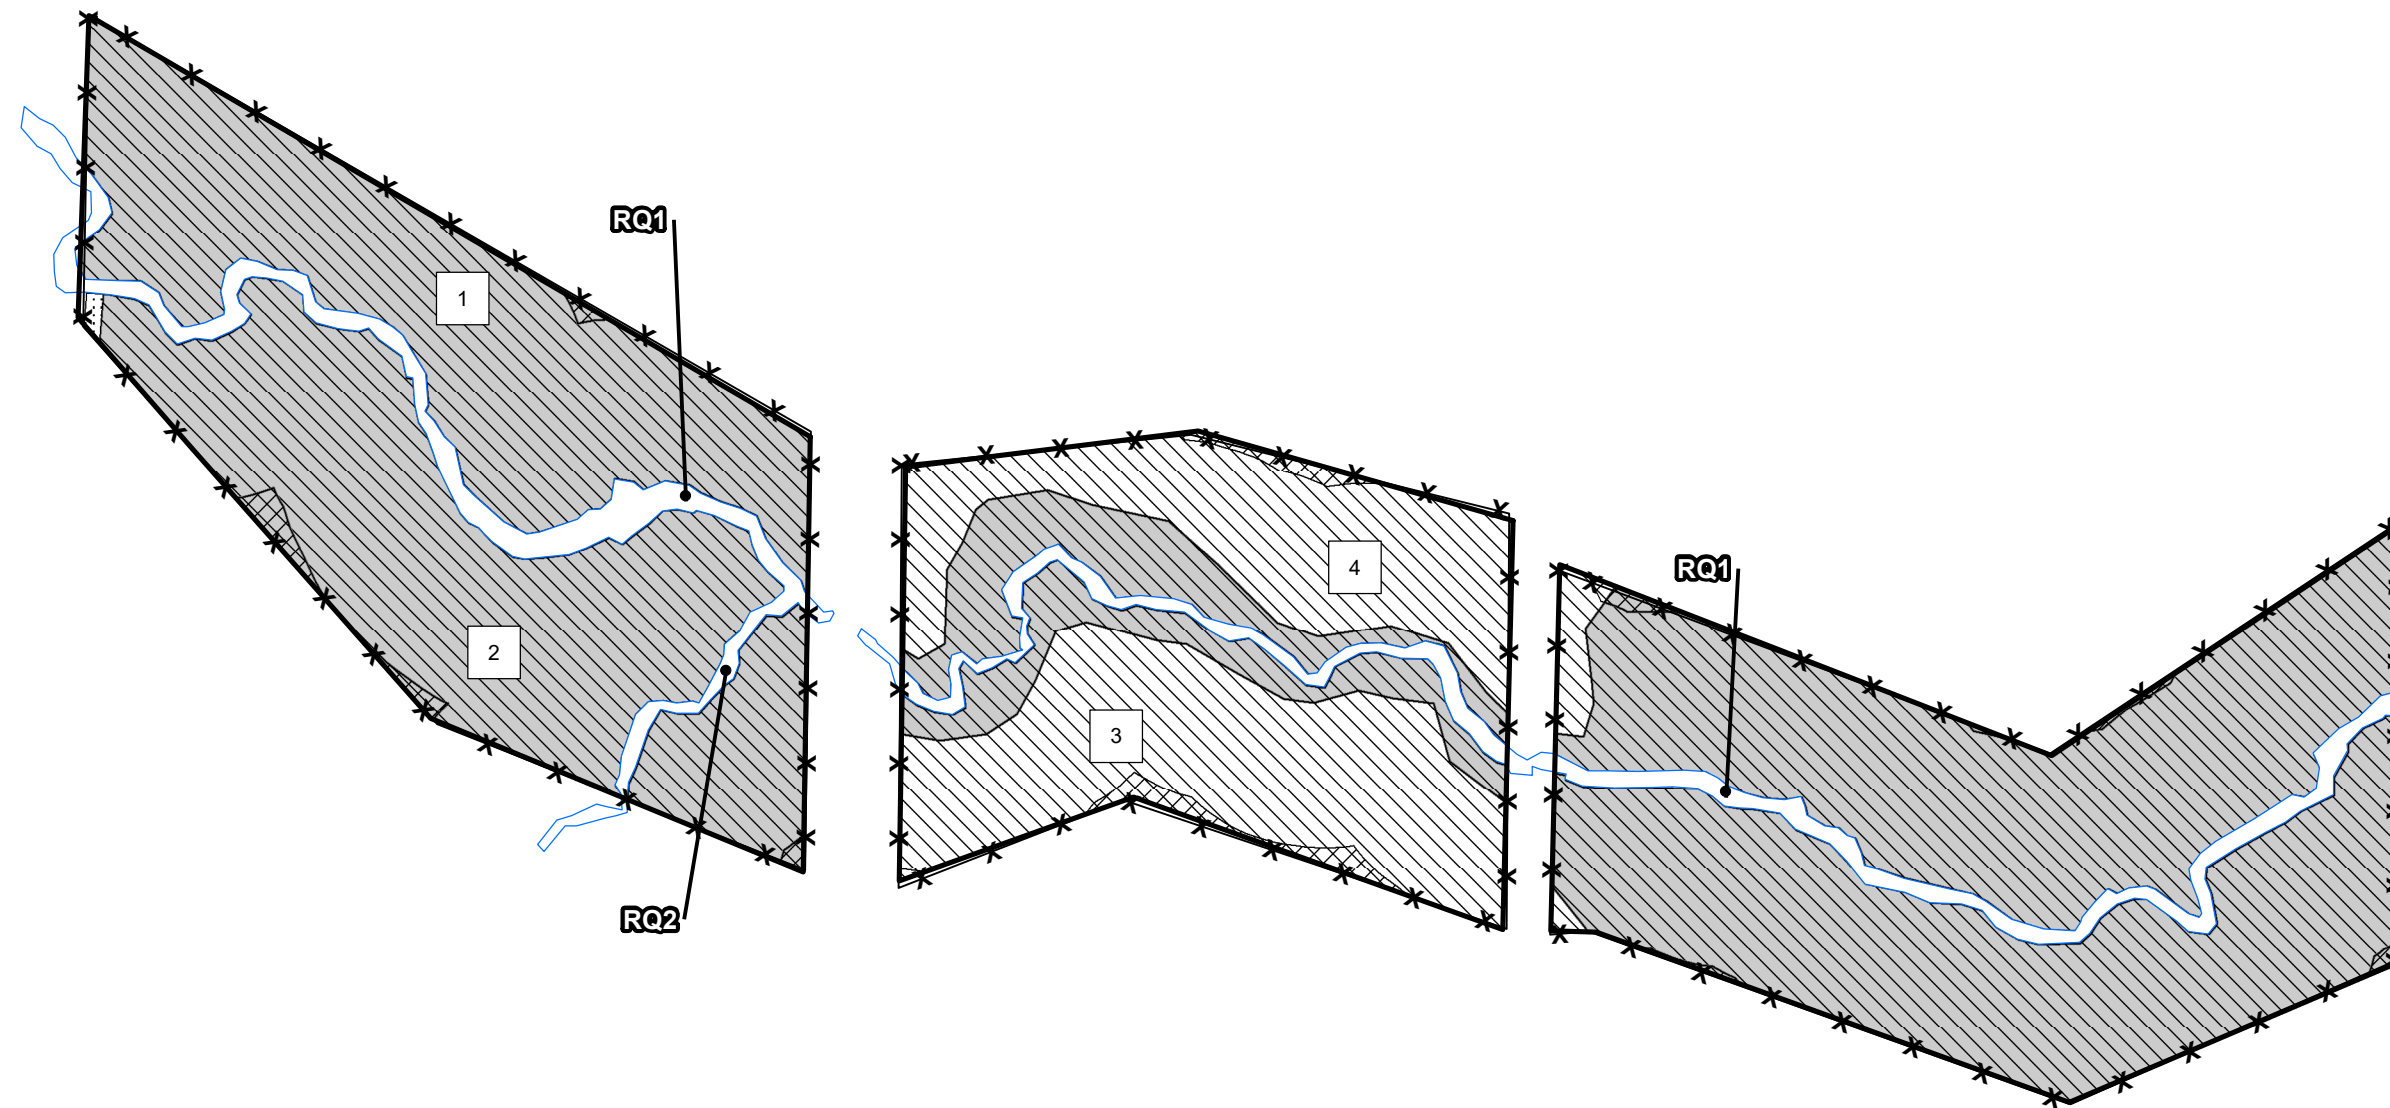
Figure 3 - As-Built Map

Figure 3 – Any fencing installed at the site should be shown on the As-built Map.
[New fencing was installed. The As-built map has been updated.](#)
