Reedy Branch Restoration Design Report

Alamance County, North Carolina

North Carolina Wetland Restoration Program

EcoLogic Associates, PC

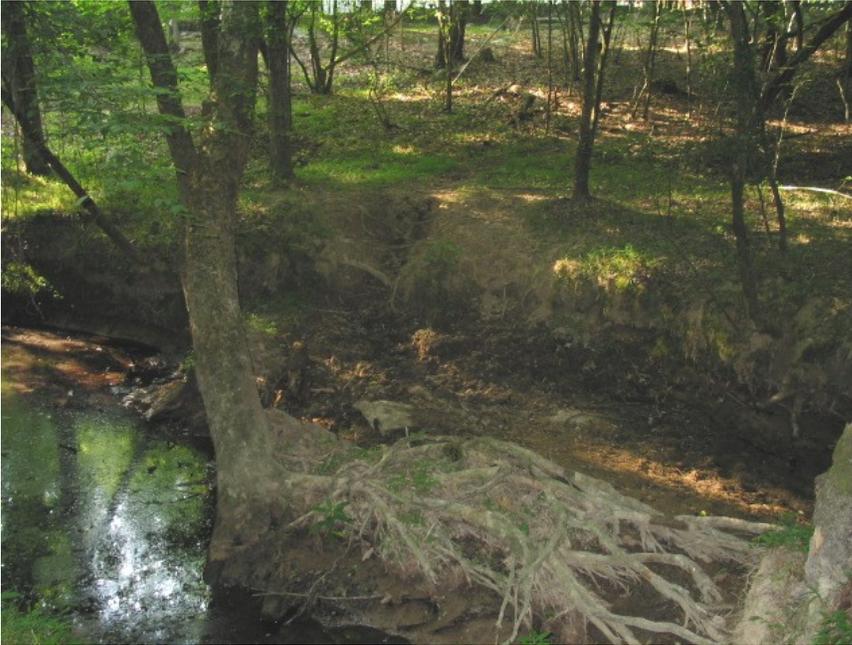
Local bank failure where channel is shifting laterally.

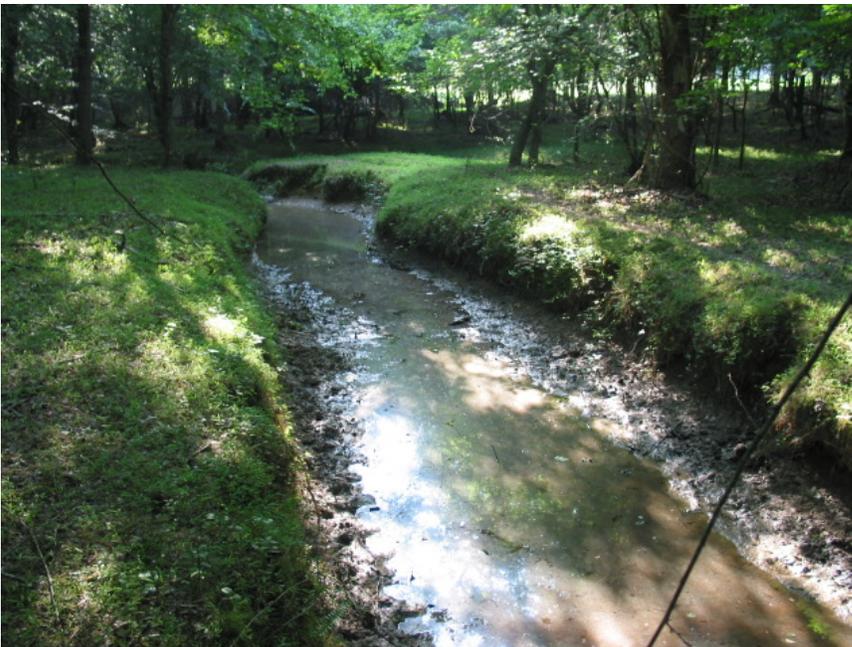
Long, straight pool with unstable banks. Note cattle tracks in mud.

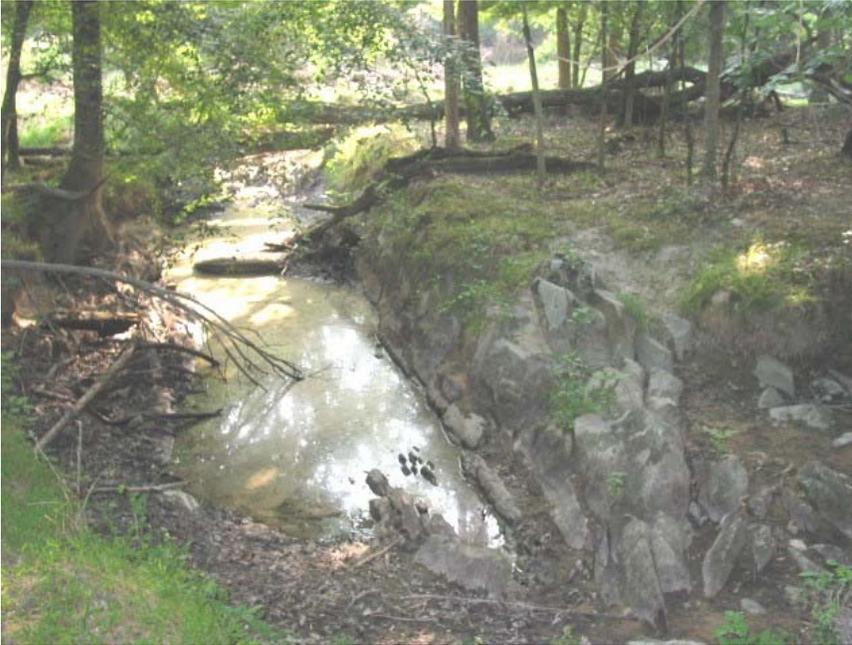
Bedrock constraining bed and bank

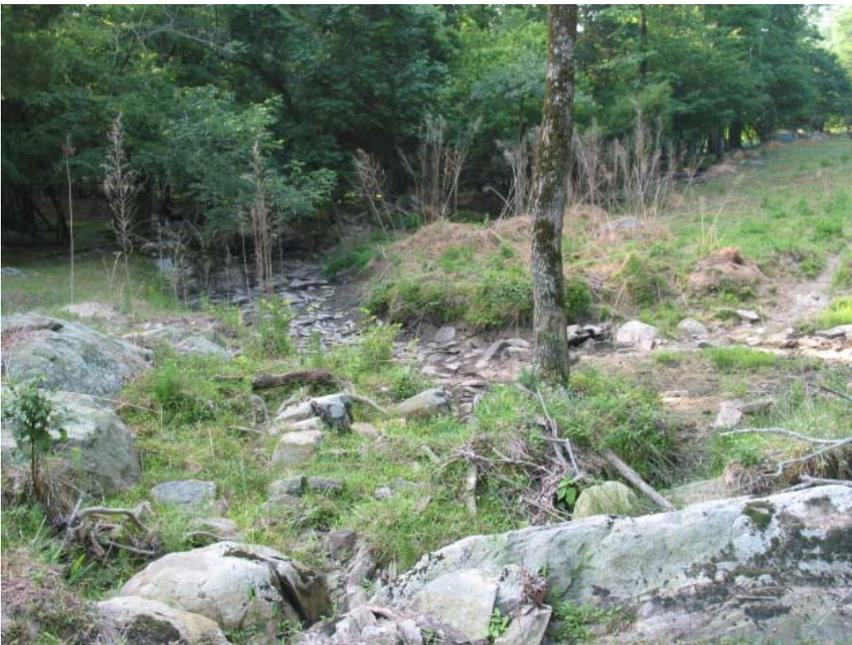
Bedrock and boulders on floodplain. Riparian vegetation cleared.

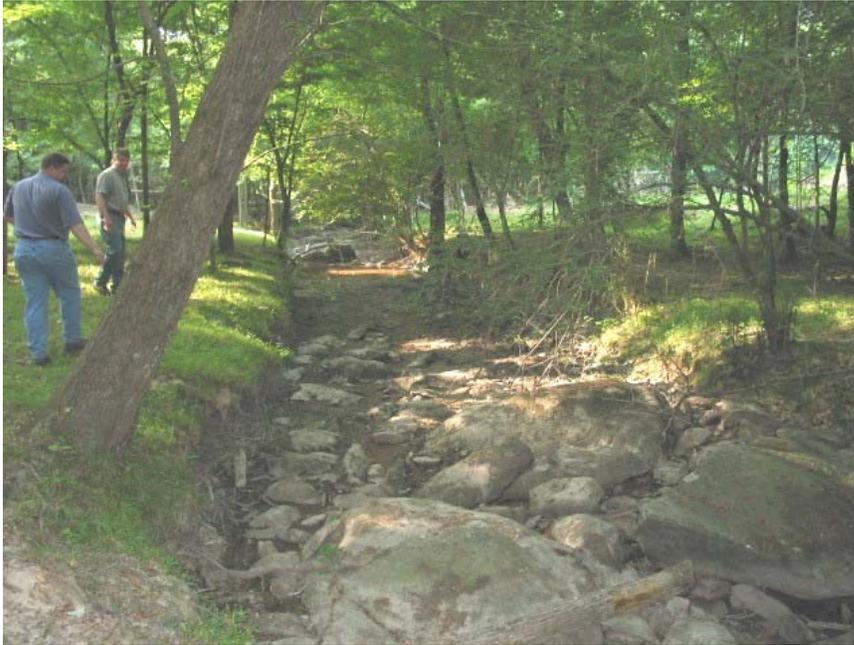
Substrate alternates between boulders, fines, and bedrock. Note absence of shrubs and herbaceous species, channel pattern, and 36" to 42" vertical banks.

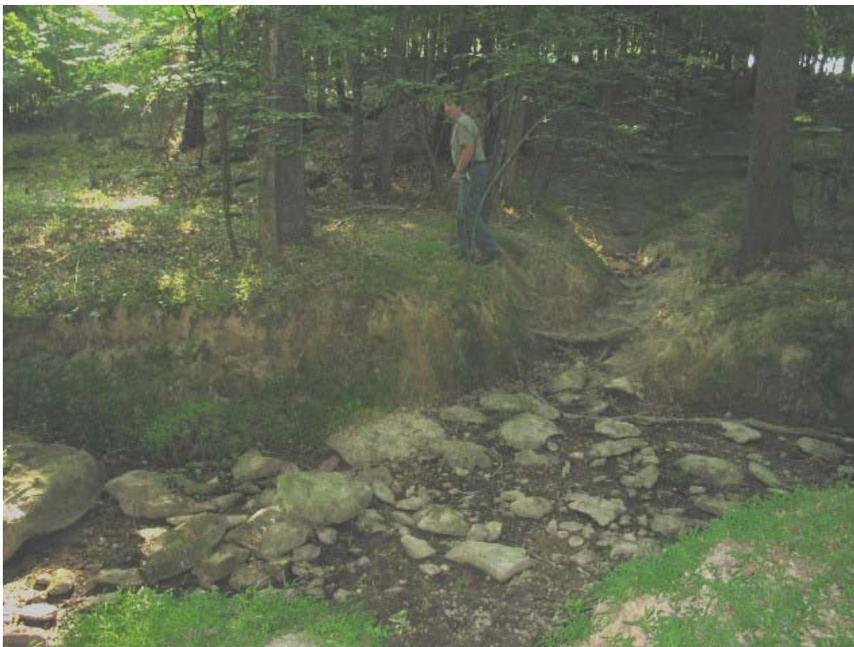
One of many cattle crossings
