# Local Watershed Plan for the French Broad River Basin: South Hominy Creek Watershed

## Technical Memorandum 3: Field Assessment and Functional Status Report

North Carolina Department of Environment and Natural Resources  
Ecosystem Enhancement Program

May 2005

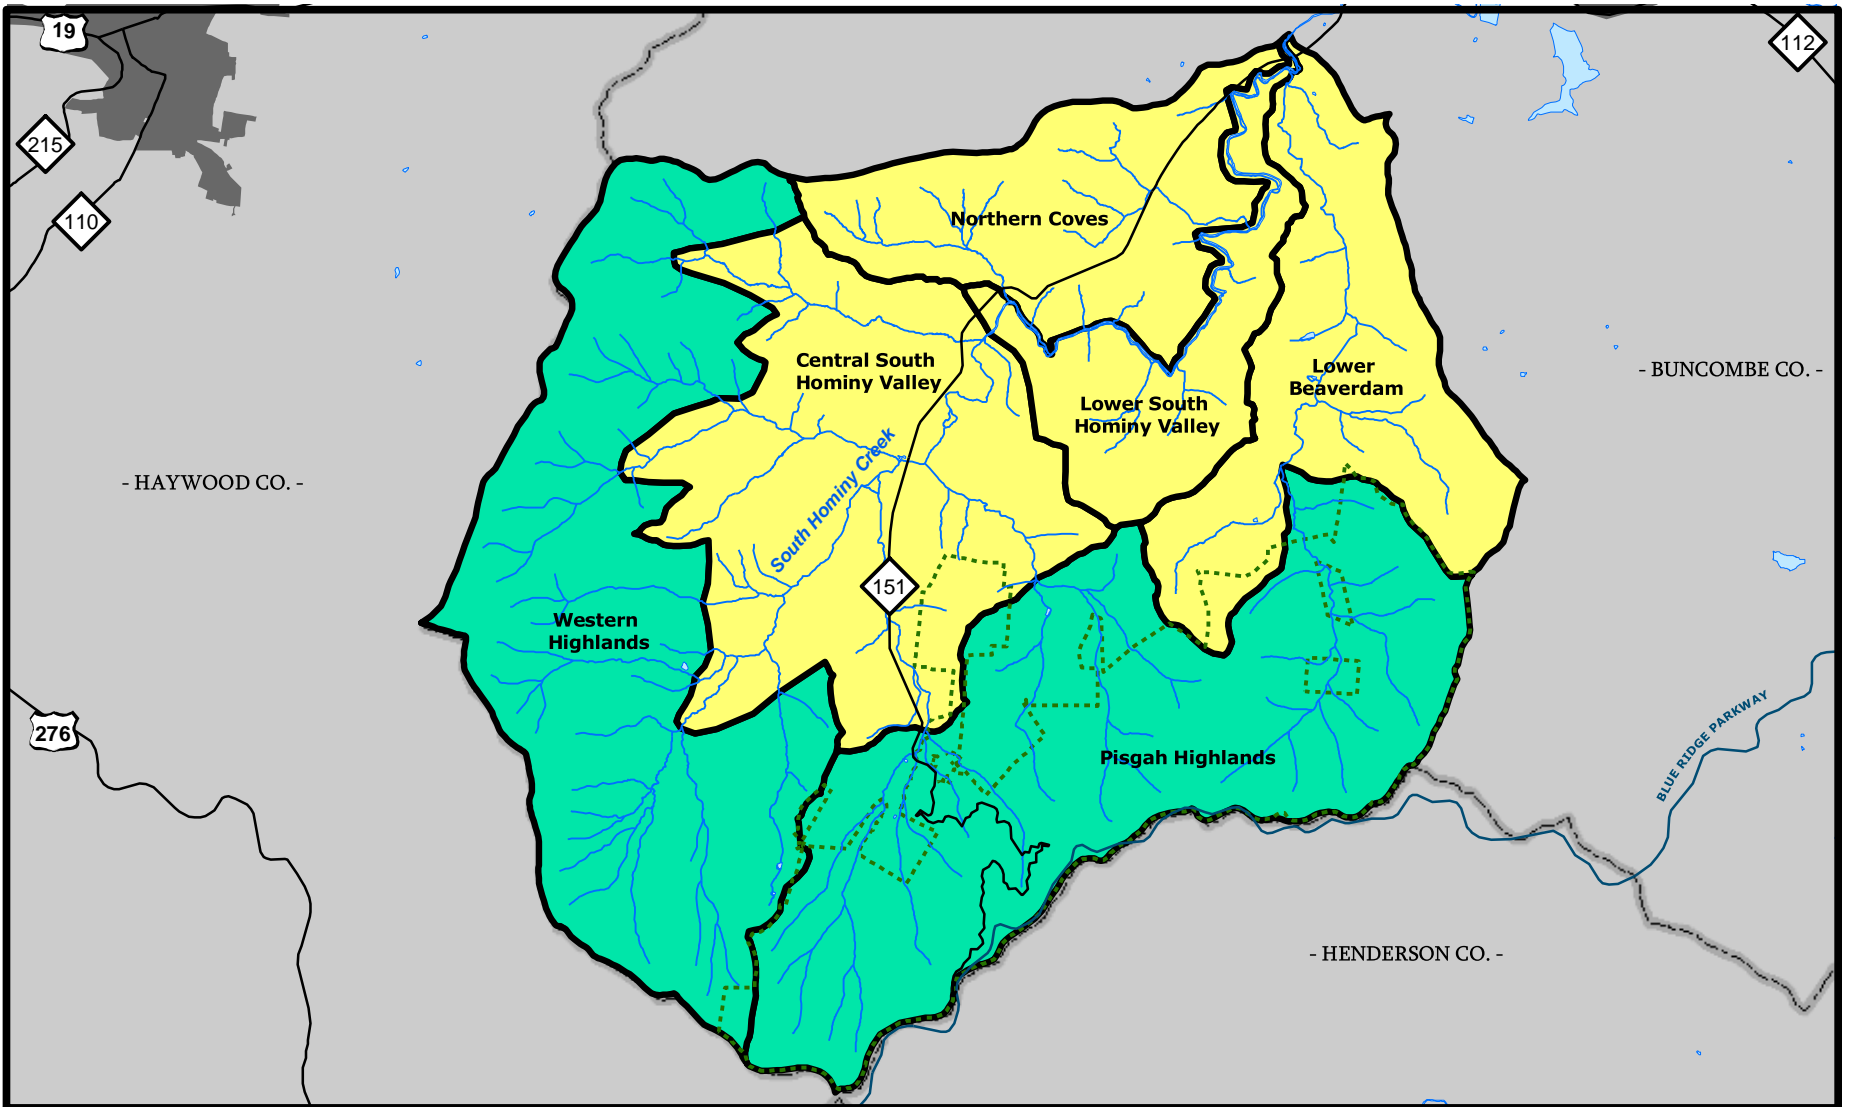
Figure 3.1A : Overall Habitat Function by FAU

Habitat field assessment, habitat fragmentation, and riparian corridor condition are all considered *Functioning* within the Pisgah Highlands FAU. Substrate is considered to be high-level *Functioning at Risk*, due to the amount of fine sediment sampled in representative RACs. Overall, the Pisgah Highlands FAU is considered *Functioning* for habitat.

The primary cause of degradation in this FAU is sediment, probably from unpaved forest roads and localized landslides within the headwaters of heavy precipitation events associated with Hurricanes Ivan and Frances in the fall of 2004. Braided and active overflow channels were observed along portions of several reaches, indicating large sediment loads transported from the headwaters by higher-magnitude storm flows. Because they are in colluvial valleys, these steep-gradient, high-energy streams tend to transport large amounts sediment downstream over time.

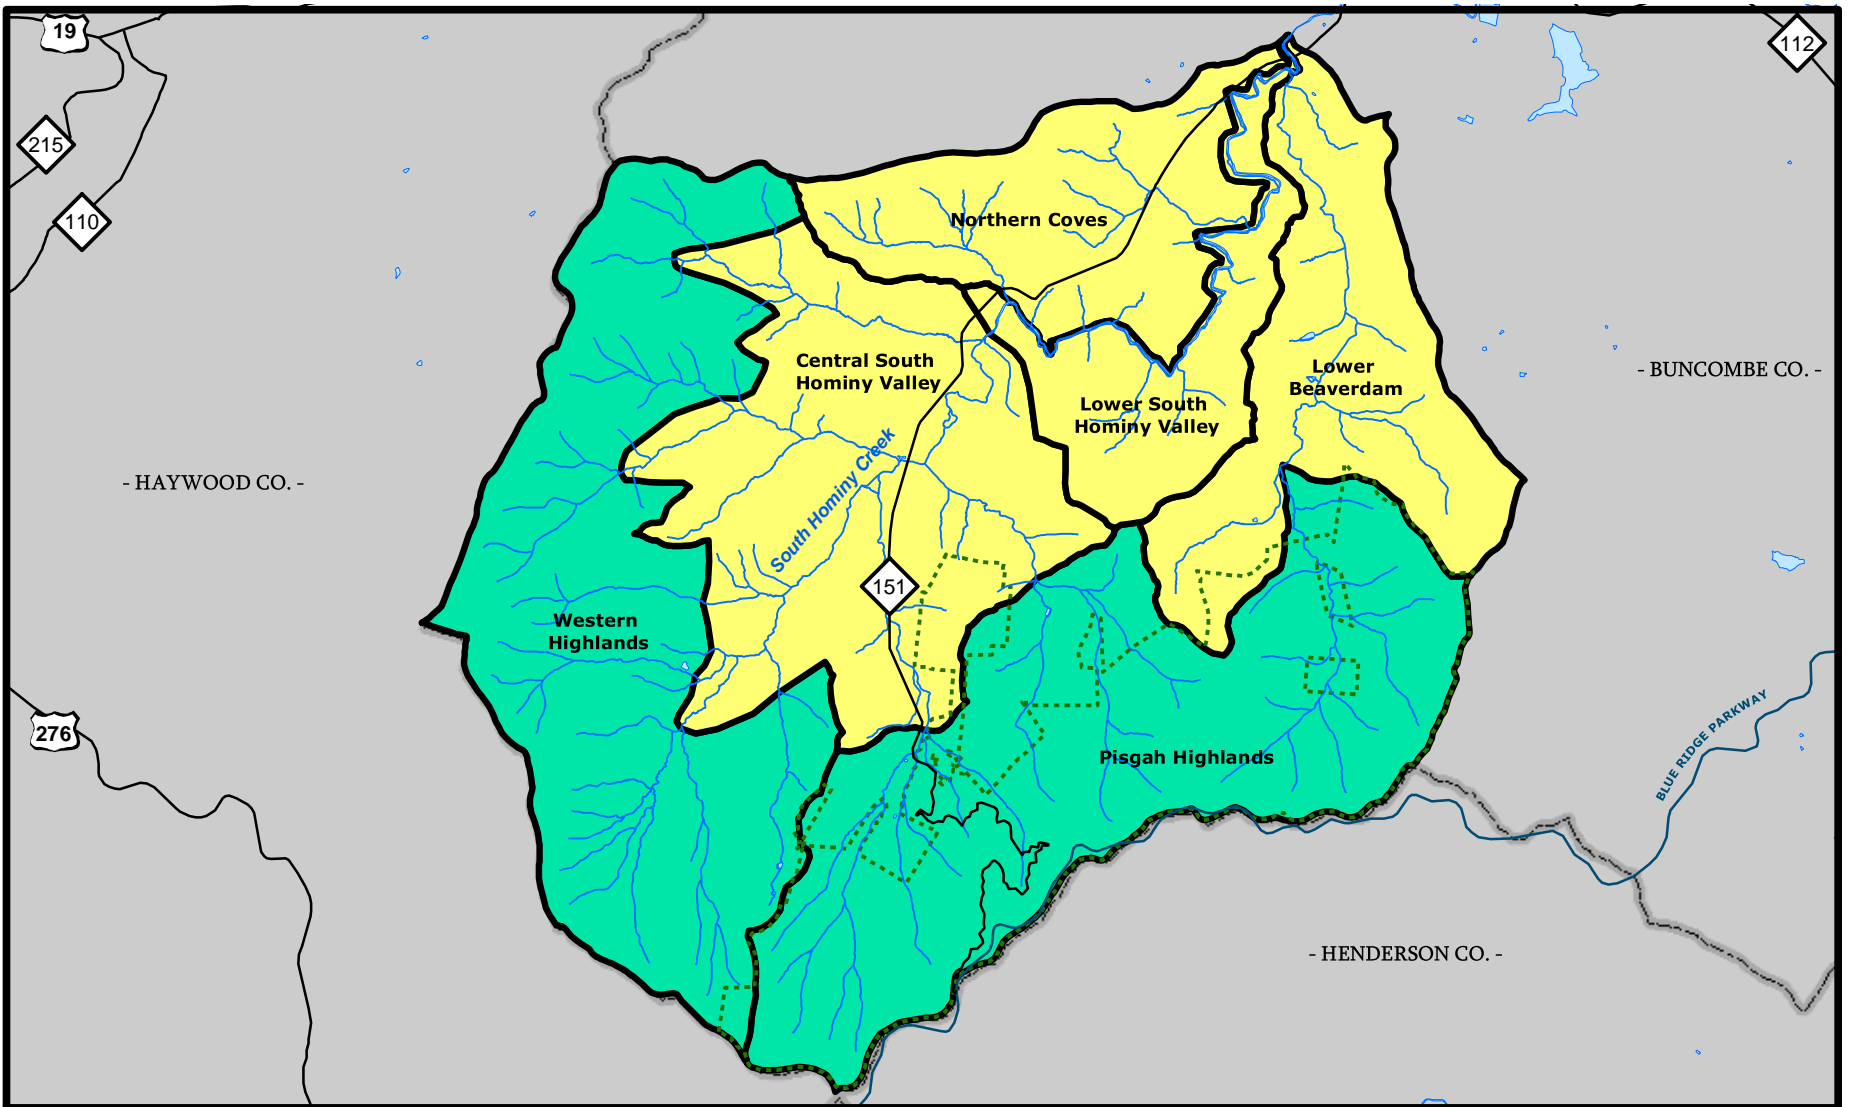
Figure 3.2A : Overall Hydrology Function by FAU

Land use is categorized as *Not Functioning* in the Lower South Hominy FAU. The other seven metrics are considered *Functioning at Risk*. Taking all eight metrics into consideration, the Lower South Hominy Valley FAU hydrology rating is *Functioning at Risk*.

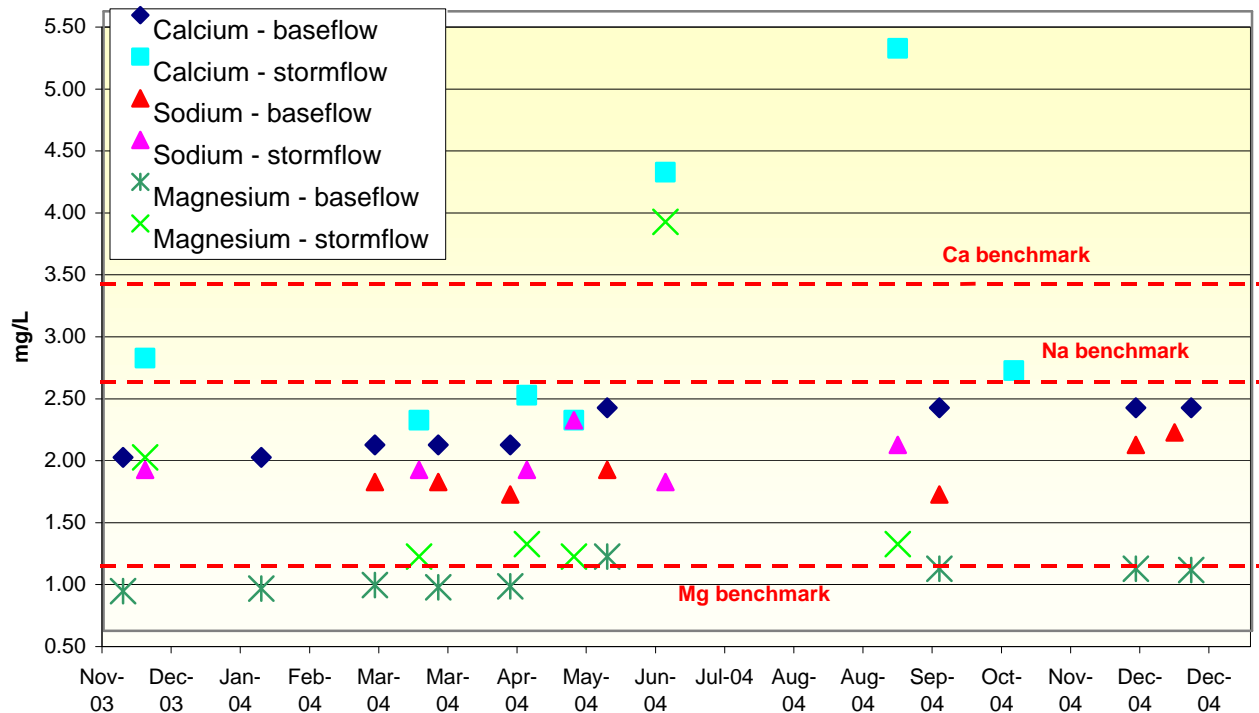
Magnesium (Mg) was highly influenced by flow. Magnesium was recorded at concentrations below the benchmark concentration of 1.1 mg/L in every baseflow sample, but exceeded benchmark concentrations in all but one of the seven storm samples (Figure 2). Baseflow calcium (Ca) concentrations ranged from 1.5 to 2.5 mg/L. With the exception of two stormflow samples, which exceeded the benchmark value of 3.4 mg/L, stormflow concentrations were only slightly higher than baseflow concentrations, ranging from 2.0 to 3.0 mg/L. Sodium (Na) concentrations exhibited minimal fluctuation between baseflow and stormflow events. All sodium concentrations varied from 1.6 to 2.2 mg/L and were below the benchmark value of 2.6 mg/L.

**Figure 2:** Concentrations of major cations (calcium, sodium, and magnesium) at baseflow and stormflow.

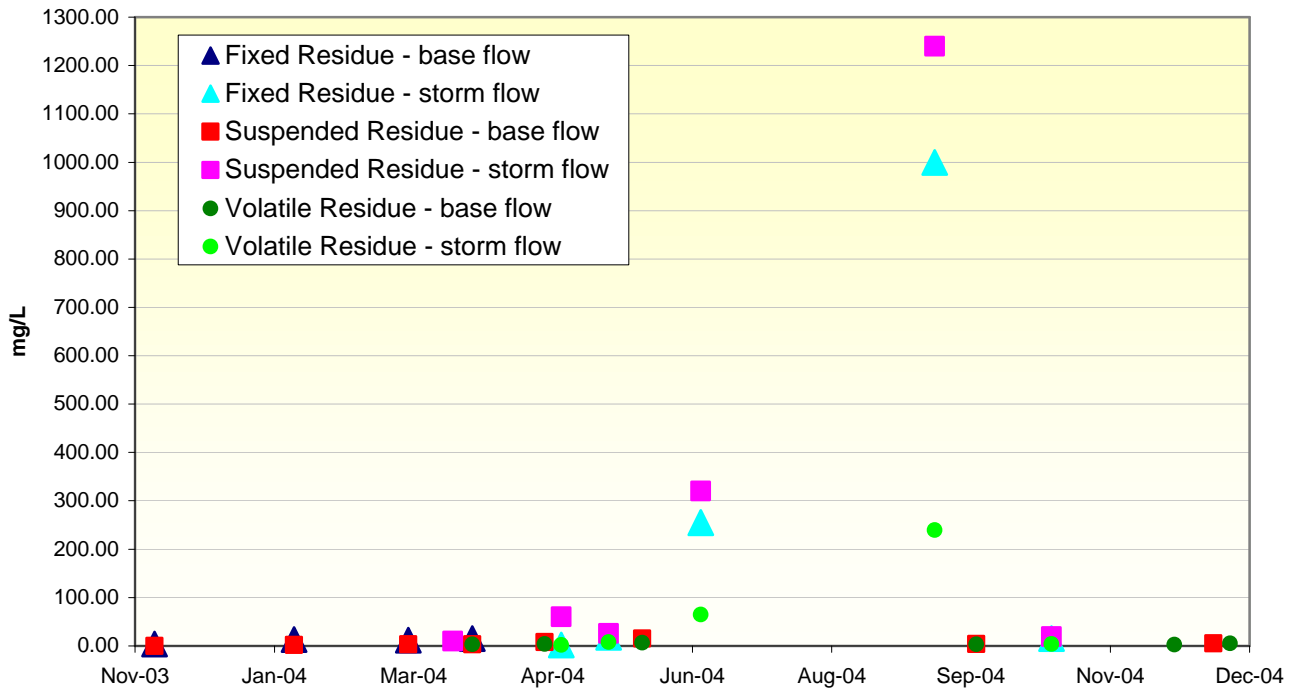
Suspended, volatile, and fixed residue concentrations were at or below 15 mg/L in all baseflow samples (Figure 3). Stormflow suspended residue concentrations were more variable. The median stormflow suspended residue concentration (43 mg/L) was almost 1,000% higher than the median baseflow concentration (4.5 mg/L). During extreme storm events, suspended residue increased to concentrations as high as 1,240 mg/L.

**Figure 3:** Suspended, fixed, and volatile residue concentrations at South Hominy Creek at Old Hwy 151.

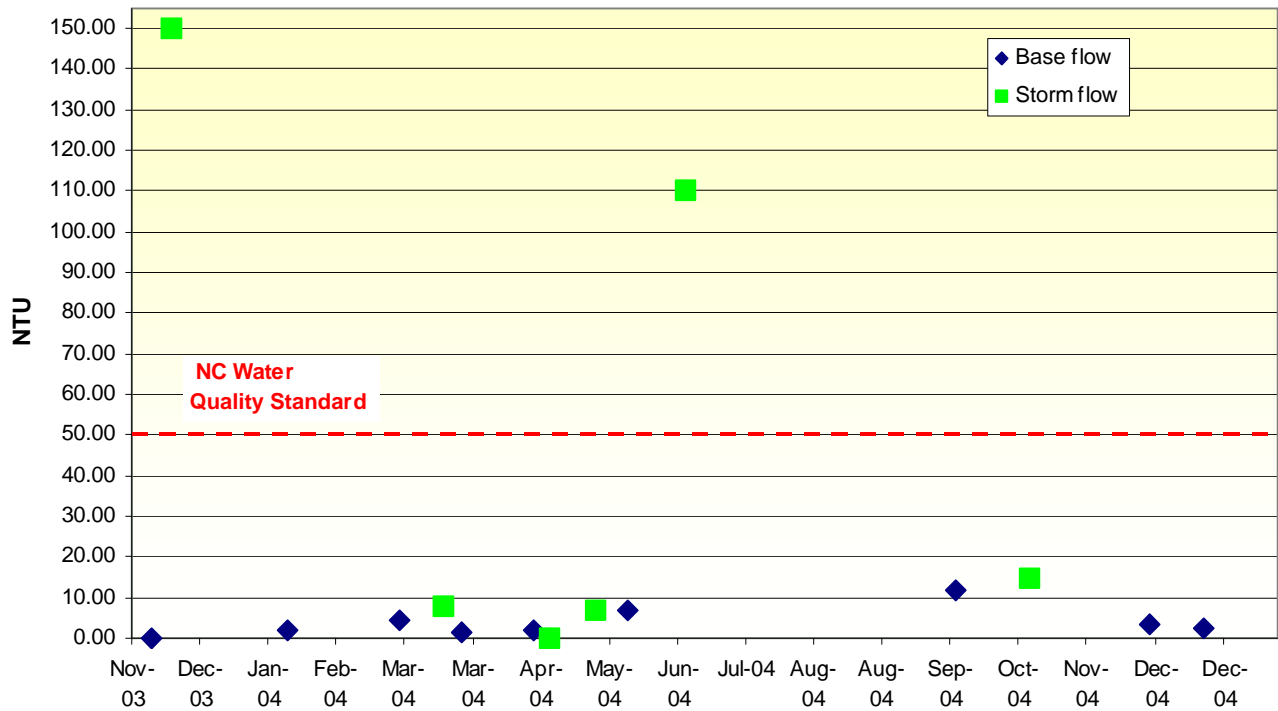
Stormflow turbidity exceeded the state standard of 50 NTU in fifty percent of sampling events (Figure 4). All baseflow turbidity measurements were below 12 NTU with the exception of a turbidity recording of 500 NTU taken downstream of a direct discharge into the stream on 10/28/04. As observed in metals concentrations, turbidity was highest (550 NTU) in a sample taken during Hurricane Frances on 9/7/04.

**Figure 4:** Turbidity recordings at South Hominy Creek at Old Hwy 151.

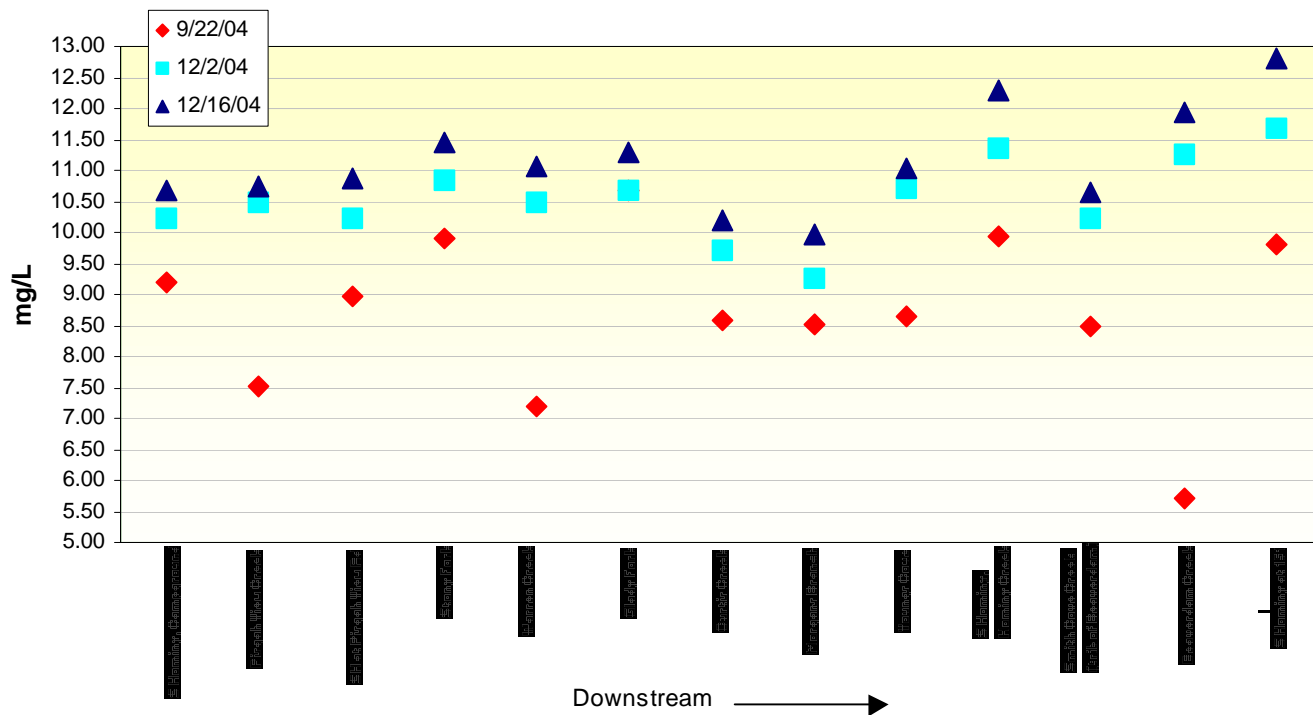
Dissolved oxygen concentrations followed a similar trend on 12/2/04 and 12/16/04. On both dates, DO remained fairly constant at the six most upstream sites, decreased over the next several sites, and gradually increased at the most downstream sites in the watershed (Figure 5). This pattern was not repeated on 9/22/04, when greater variability in DO concentrations was exhibited.

**Figure 5:** Dissolved oxygen concentrations at all sites at baseflow.

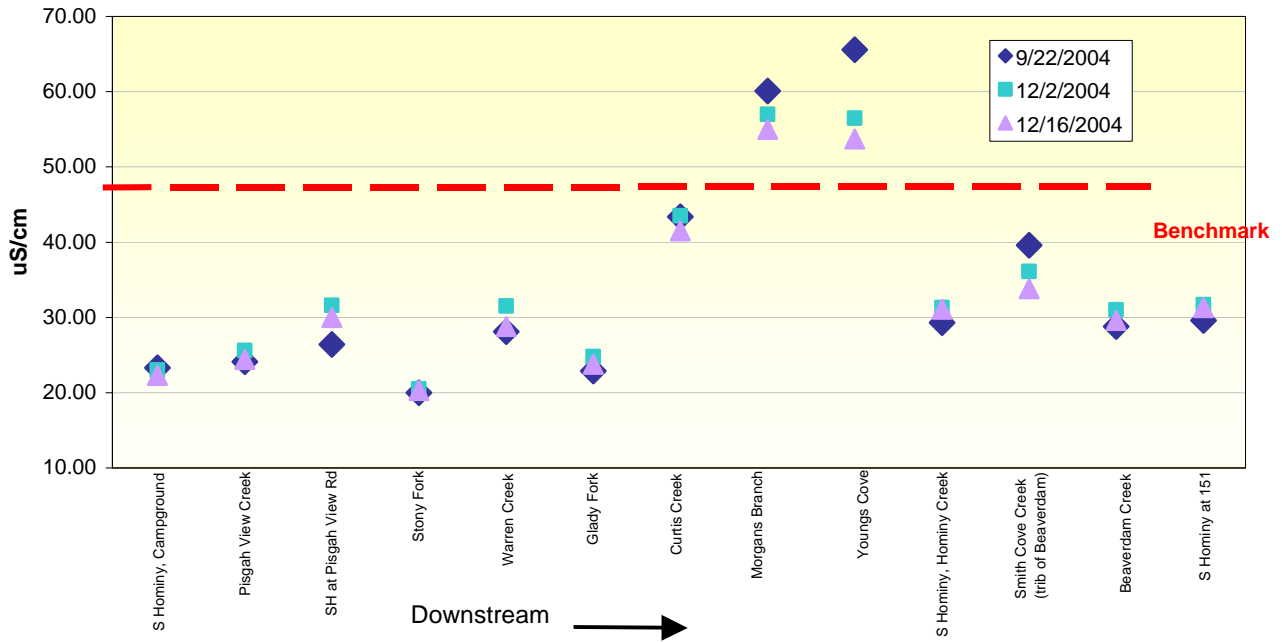
Specific conductance exceeded the benchmark value of 45  $\mu\text{g/L}$  in all three samples taken at Morgans Branch and at Youngs Cove (Figure 7). All samples at the other eleven sites had specific conductance concentrations

below the benchmark value. Excluding Morgans Branch and Youngs Cove, there is a gradual increase in specific conductance from the upstream to the downstream sites.

**Figure 7:** Specific conductance at all sites at baseflow.

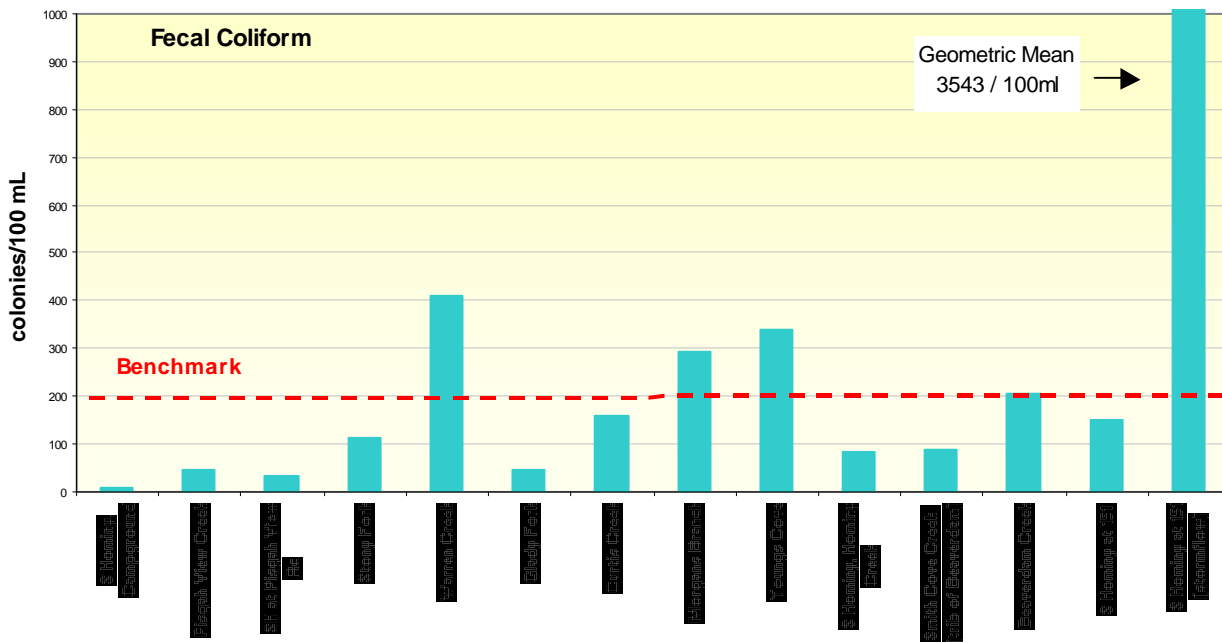
Four sites, Warren Creek, Morgans Branch, Youngs Cove, and Beaverdam Creek, exceeded the NC Water Quality Standard for fecal coliform of 200 colonies/100ml as a geometric mean (Figure 10). Stormflow samples taken at the South Hominy Creek at Old Hwy 151 site exhibited an extremely high geometric mean concentration of 3,543 colonies per 100 mL.

Figure 10: Fecal coliform geometric means for all sites.

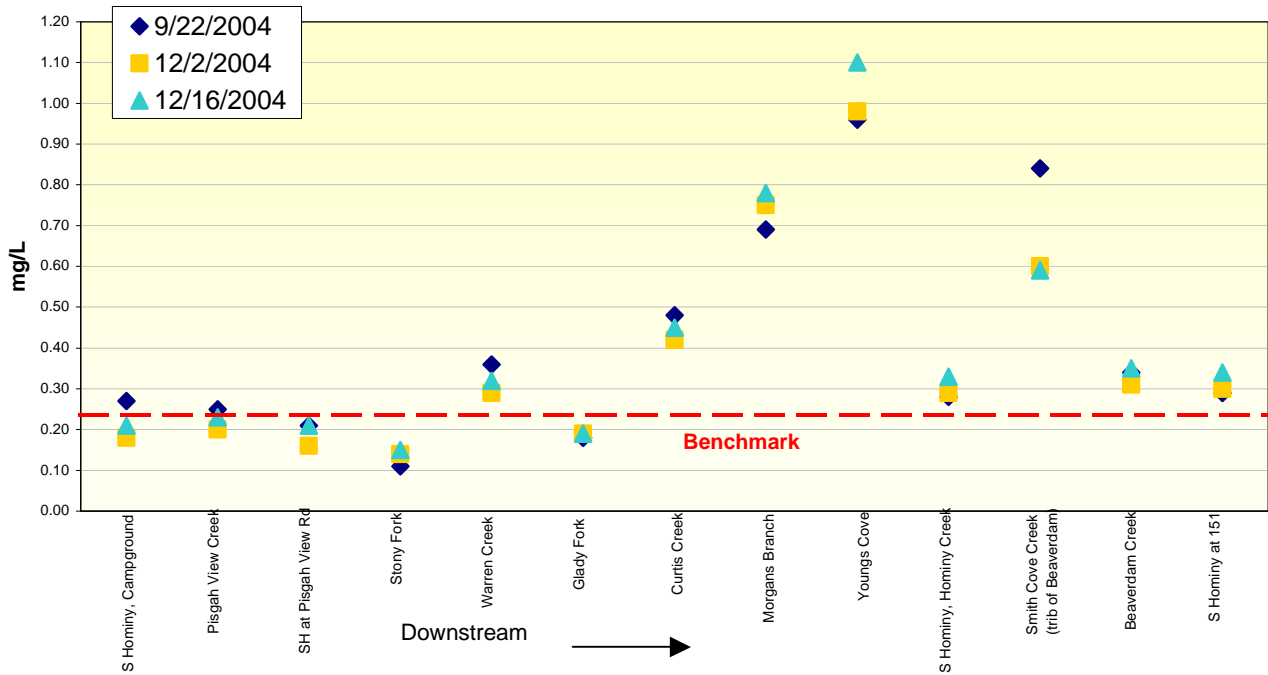
Nitrate plus nitrite nitrogen concentrations exceeded the benchmark value of 0.23 mg/L on all three sampling dates at eight of the thirteen sites (Figure 13). Only three sites, South Hominy at Pisgah View Road, Stony Fork, and Glady Fork, had nitrate plus nitrite concentrations below the benchmark value in all samples.

**Figure 13:** Nitrate plus nitrite nitrogen concentrations at all sites at baseflow.

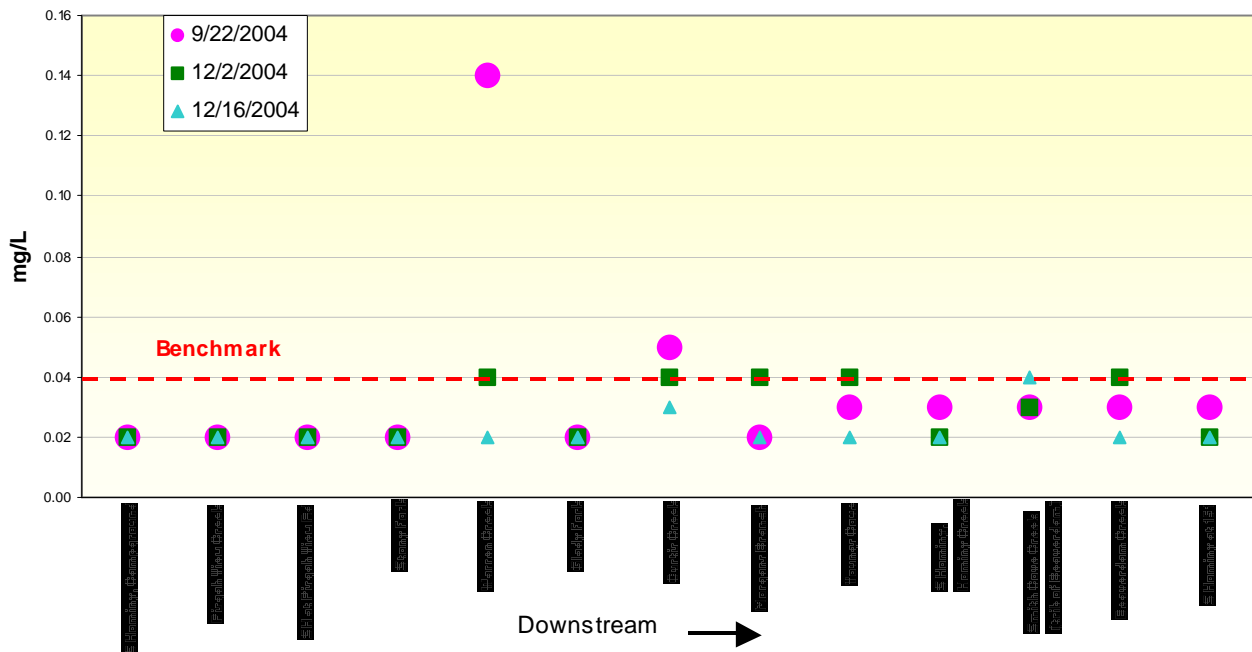
Phosphorus was undetected at the four most upstream sites in the South Hominy watershed (Figure 14). The highest phosphorus concentration (0.14 mg/L) was observed at Warren Creek. Curtis Creek and Smith Cove Creek were the only sites at which phosphorus was detected on all three sampling dates. Phosphorus concentrations were recorded at or above the benchmark value of 0.04 mg/L in at least one sample at Warren Creek, Curtis Creek, Morgans Branch, Youngs Cove, Smith Cove Creek, and Beaverdam Creek (Briel, 1997).

**Figure 14:** Phosphorus concentrations at all sites at baseflow.
