**Green River Watershed Assessment
Isothermal Planning and Development
Commission**

September 30, 2013

Prepared for
Isothermal Planning and Development Commission
111 West Court Street
Rutherfordton County, North Carolina 28139
Project Number 2354.03

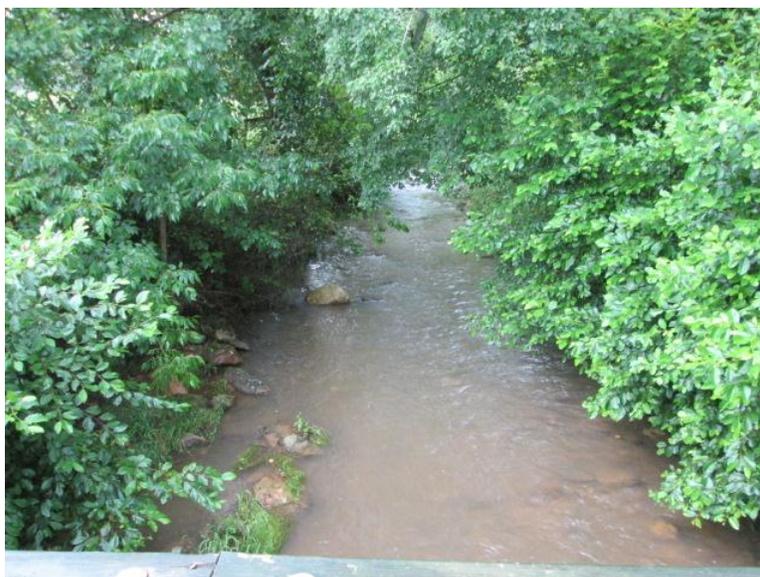
Site 5 is located on Brights Creek within the Brights Creek residential and golf development just downstream of a detention pond located on the golf course. The channel was observed to be in stable condition with a good riparian buffer. The substrate of the channel appeared to be cobble and sand. This site was observed during a rain event and the water was slightly turbid.

Photograph 2: View of Site 5 at Brights Creek just downstream of the Brights Creek Development detention pond observed immediately following a rain event.

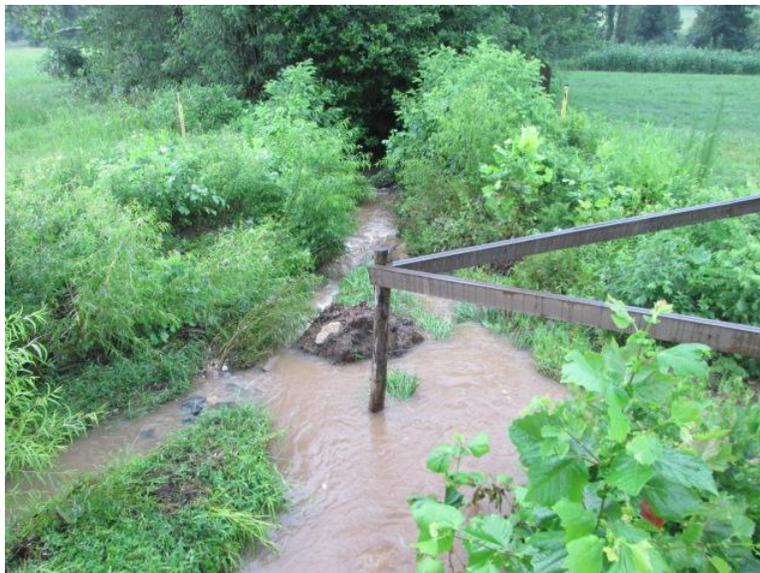
Additional unnamed tributaries to Brights Creek located on the Brights Creek development were observed during a rain event. The tributaries were turbid during the rain event and likely contribute sediment to the GRW. Additionally, it is likely that the Brights Creek development contributed sediment to the GRW during the construction phase of the project.

Photograph 3: View of turbid runoff from an unnamed tributary of Brights Creek, slightly downstream of Site 5, observed during a rainfall event.

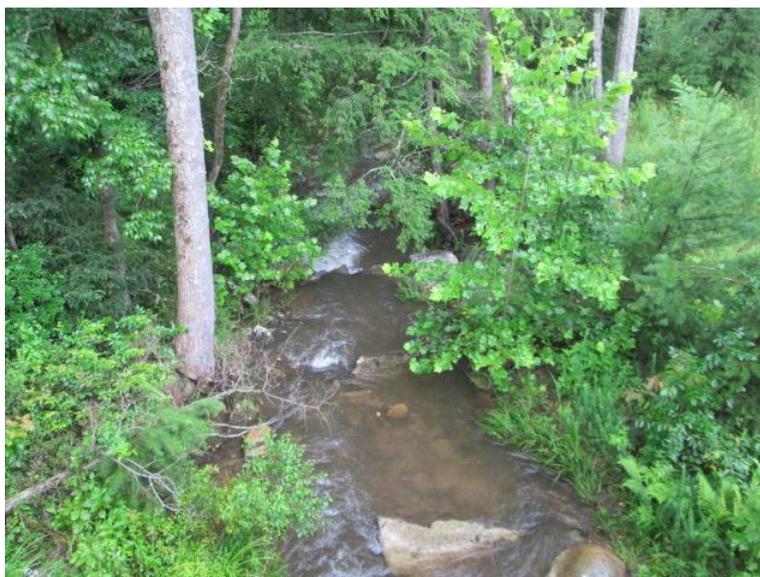
Photograph 4: View of Brights Creek observed during a rainfall event on the Brights Creek Development.

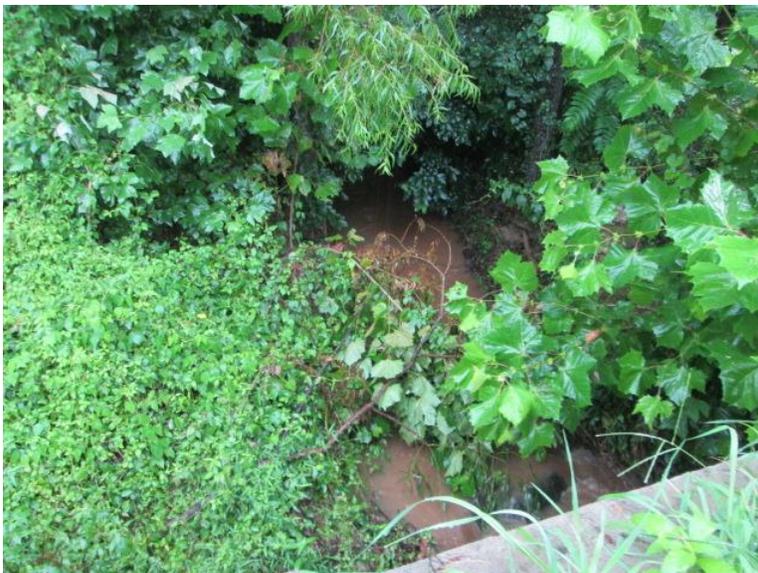
Photograph 5: View of turbid unnamed tributary to Brights Creek observed during a rainfall event on the Brights Creek Development.

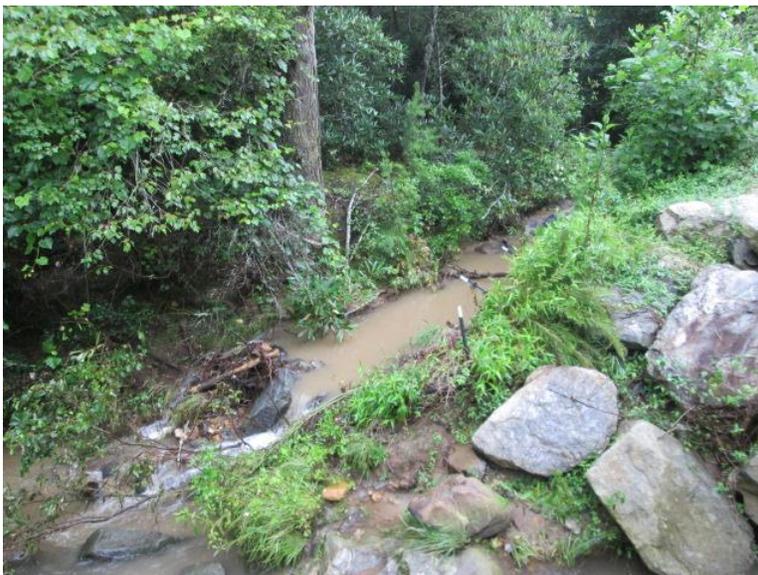
Photograph 6: View of turbid unnamed tributary to Brights Creek just downstream of the Bright's Creek Development.

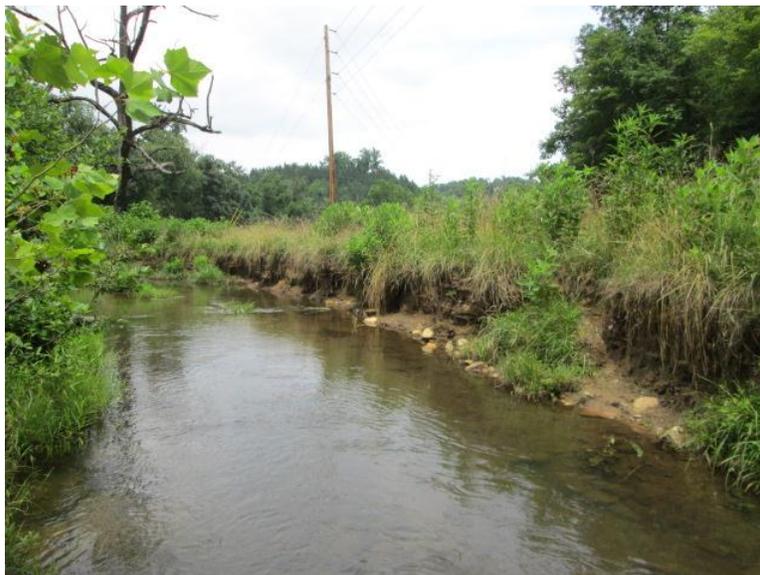
Site 29 is located approximately 0.8 miles downstream of Site 5 on Brights Creek on Palmer Road just outside of the Brights Creek development. The channel was observed to be moderately incised with healthy vegetation and an adequate stream buffer. Riffles and pools were observed in the predominately cobble and gravel substrate of the channel. Just downstream of Site 29, on Palmer Road Brights Creek was observed to be actively eroding. This reach flows through a corn field on private property and it was not possible to directly observe the entire channel. However, tall and eroding banks with exposed soil were observed, and are likely inputs of sediment to the GRW.

Photograph 8: View of eroding bank on Brights Creek located just downstream of Site 29.

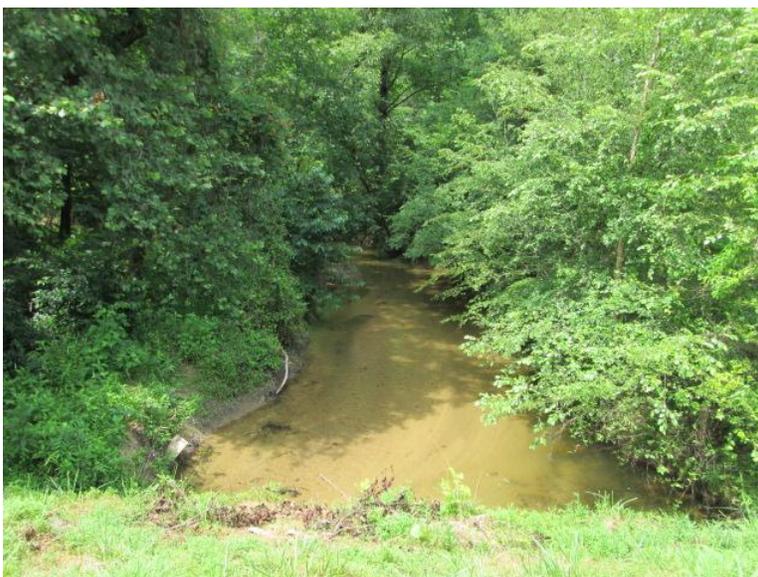
Site 21 is located downstream at the Palmer Road bridge over Brights Creek, just upstream of the confluence with the Green River. Large amounts of sediment were observed in the channel. The sediment is likely from upstream sources and from a backwater effect of the larger Green River. The riparian vegetation was a mix of woody and shrubby species; however, some trees were falling into the channel. The buffer width was adequate.

Photograph 10: View at site 21 from Palmer Road Bridge facing upstream onto Brights Creek.

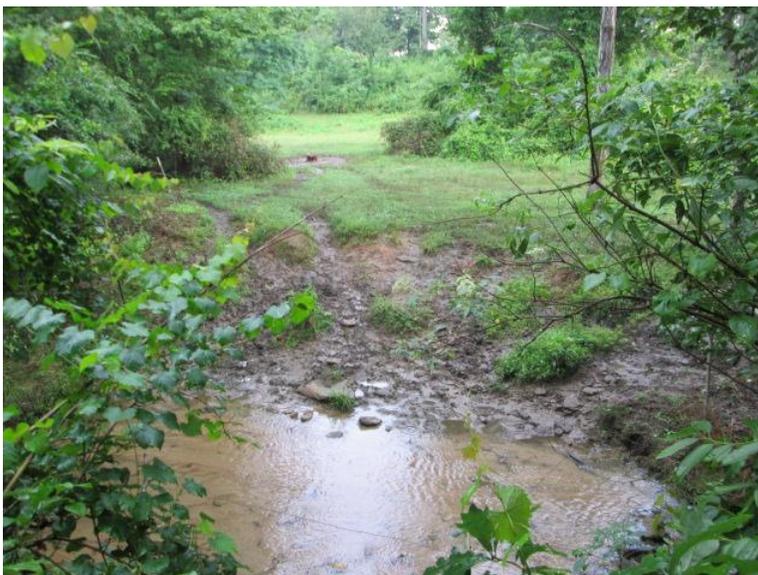
Site 7 is located on an unnamed tributary to Cove Creek off of Howard Gap Road. Site 7 was observed to be stable with adequate stream buffer in most locations, with the exception of a few areas adjacent to agricultural property. Livestock was observed adjacent to Site 7, and a fence was observed in most locations except in one area where livestock had access to the stream and bank erosion was observed. The substrate was predominately gravel and sand.

Photograph 13: View of unrestricted cattle access point along the leftbank at Site 7. Cows were observed on the property adjacent to the stream.

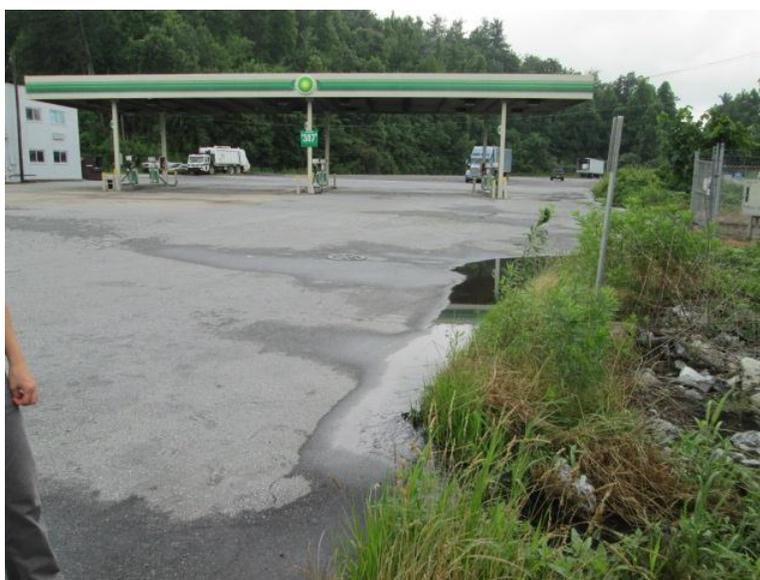
Site 8 is located approximately 0.1 miles downstream of Site 7 on an unnamed tributary at the intersection of Howard Gap Road and Ozone Drive. A gas station is located directly adjacent to the stream at Site 8. The parking lot is paved, and a section of the parking lot was observed to be cracked and crumbling; the debris likely erodes to the tributary. The channel appeared to be incised. Access to the channel was not possible, and the channel substrate could not be observed. The stream buffer vegetation was fair; however the buffer width was constricted by the road and gas station.

Photograph 15: View of adjacent gas station to the stream at Site 8. Asphalt was observed to be eroding on the far side of the parking lot.

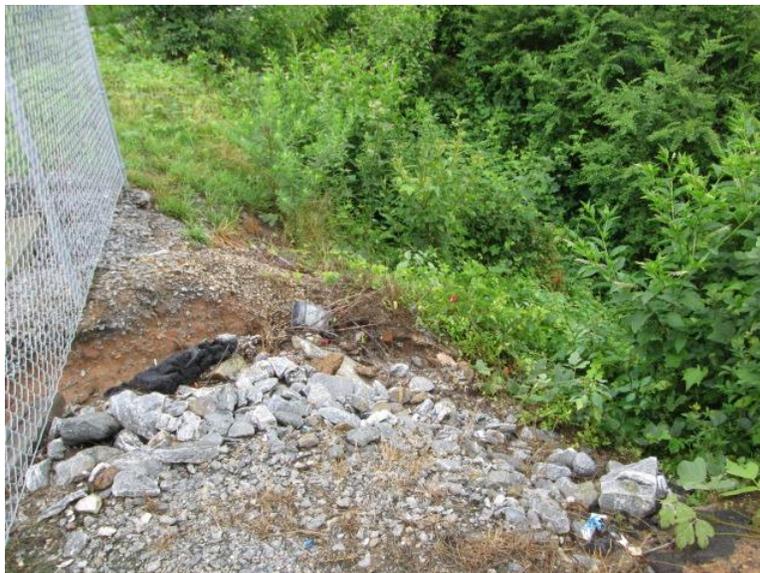
Photograph 16: View at Site 8 of eroding gully leading to an unnamed tributary to Cove Creek at the gas station.

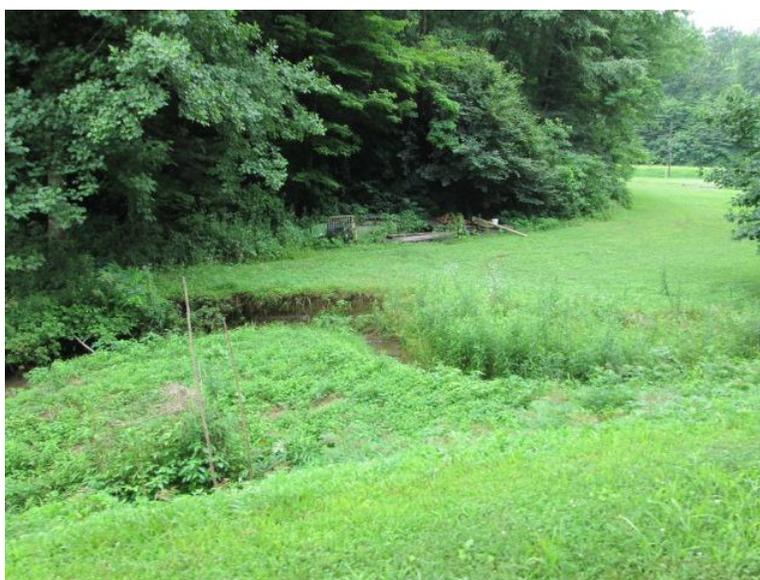
Site 9 on Cove Creek is situated on private property on Thomson Road. The channel was observed to be eroded. The substrate of the channel appeared to be cobble, gravel, and sand. Cove Creek did not have an adequate riparian buffer at this location. Furthermore, the stream buffer was lacking vegetation diversity and woody vegetation. It appeared that the buffer, which was predominantly grass, had been mowed to the water's edge.

Photograph 17: Representative view of Cove Creek on private property at Site 9; the bank was observed to be eroding.

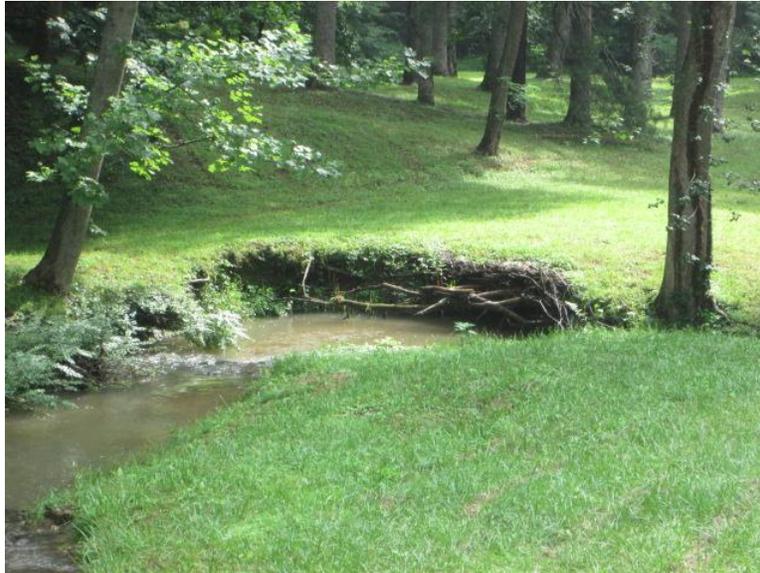
Cove Creek was observed again, slightly downstream on Canary Road. The streambanks appeared to be eroded and the channel was incised. Lack of riparian corridor, like that of Site 9, was also observed.

Photograph 18: Representative view of eroding bank of Cove Creek on private property on Canary Road.

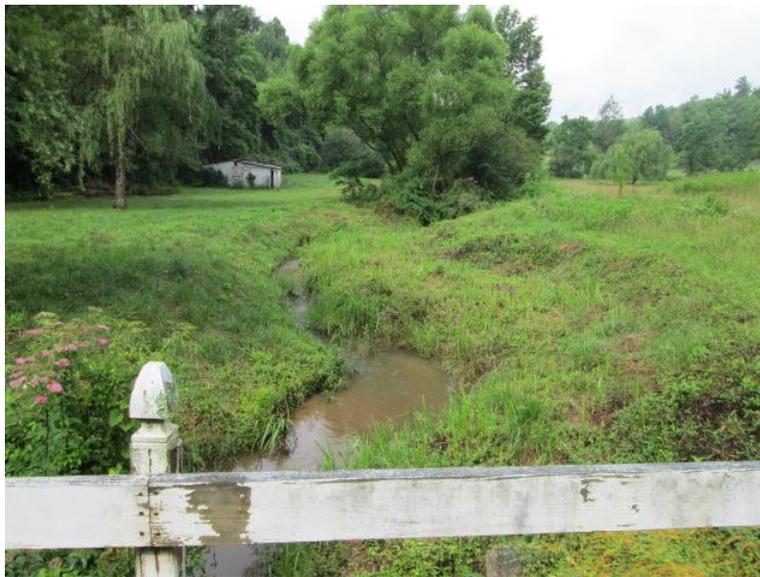
Photograph 19: Representative view of Cove Creek with no riparian buffer on private property observed from Aaybe road.

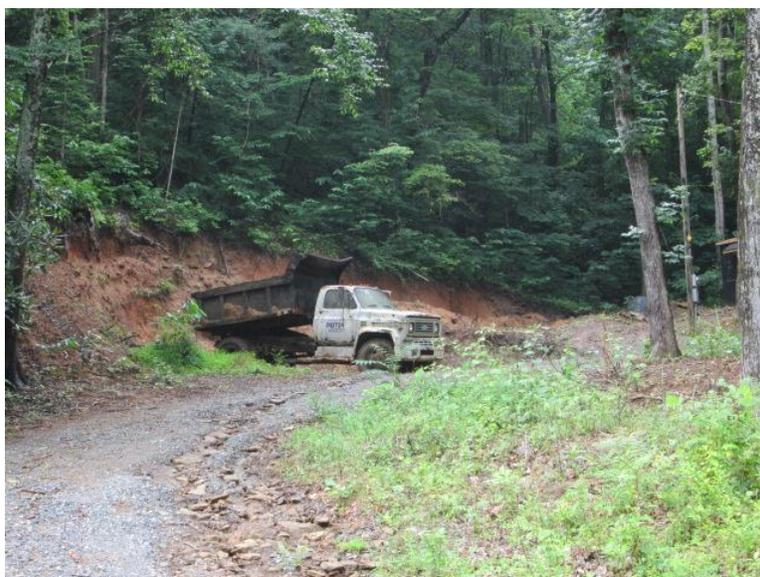
Photograph 21: View of exposed dirt area adjacent to Green River Cove Road parallell to the Green River. The open land appears to be under construction or in the process of being graded.

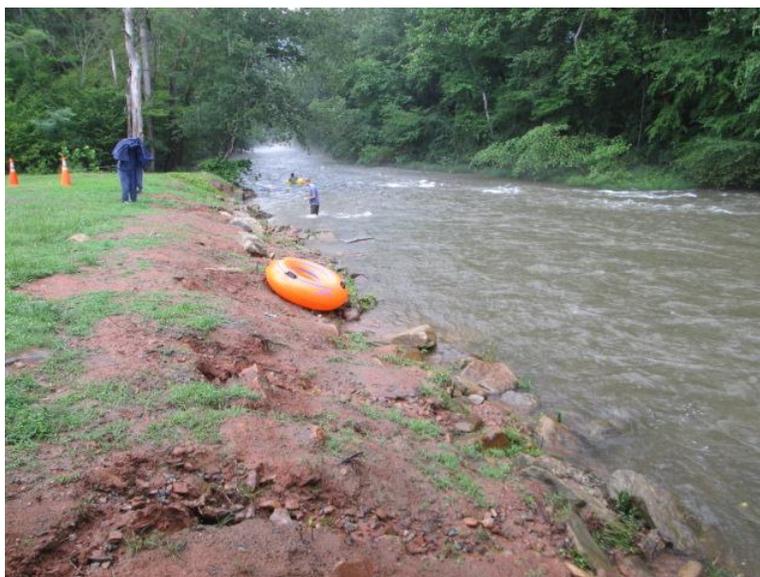
Photograph 25: View at the Green River Cove Tubing, facing downstream on the Green River. Banks were observed to be eroding.

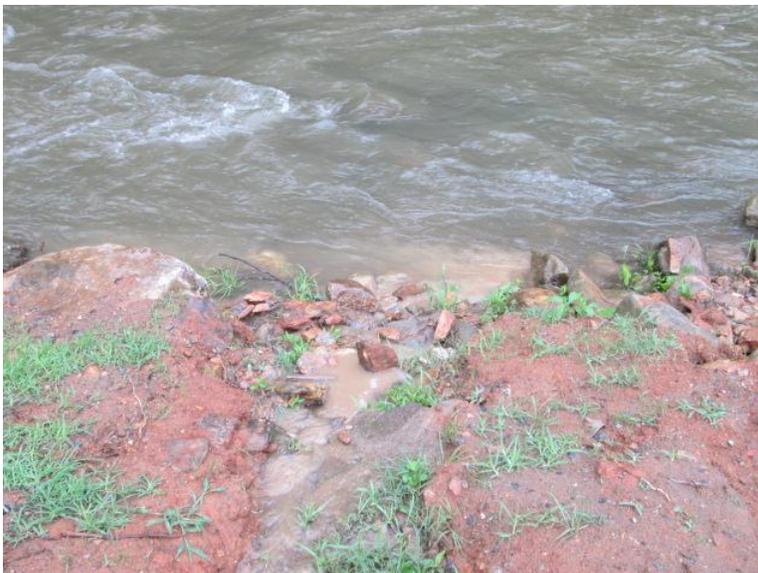
Photograph 26: View of sediment erosion on the Green River at the Green River Cove Tubing.

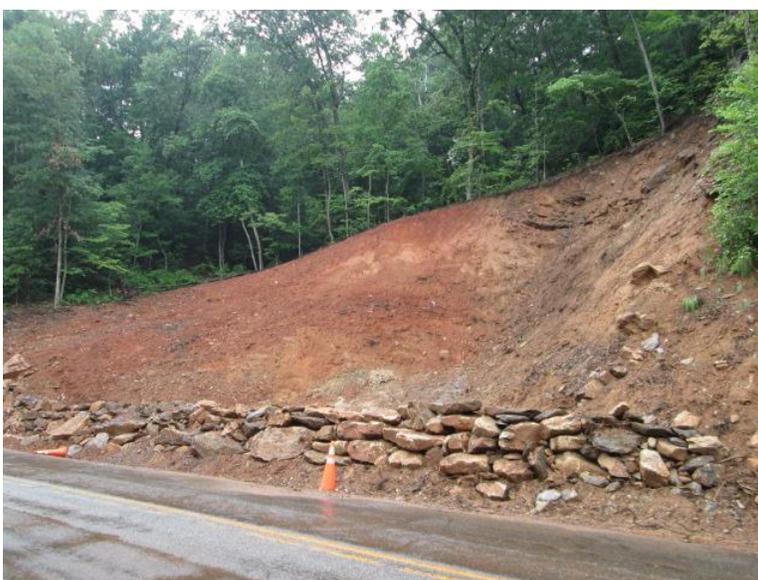
Photograph 27: Representative view of Site 28 exposed soil along Green River Cove Road adjacent to the Green River.

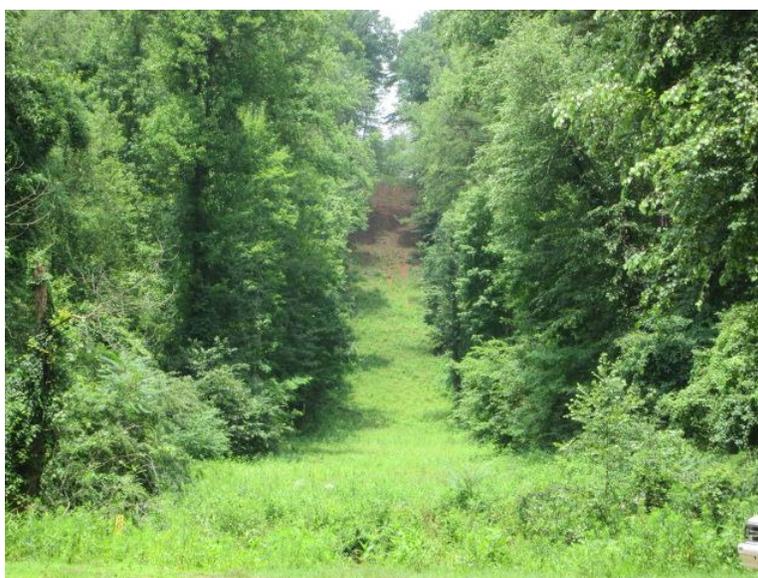
Photograph 31: View of cleared grass at gas pipe-line right of way located just downstream of tuber exit location. Note the exposed dirt near the top of the hill that is likely draining to the Green River.

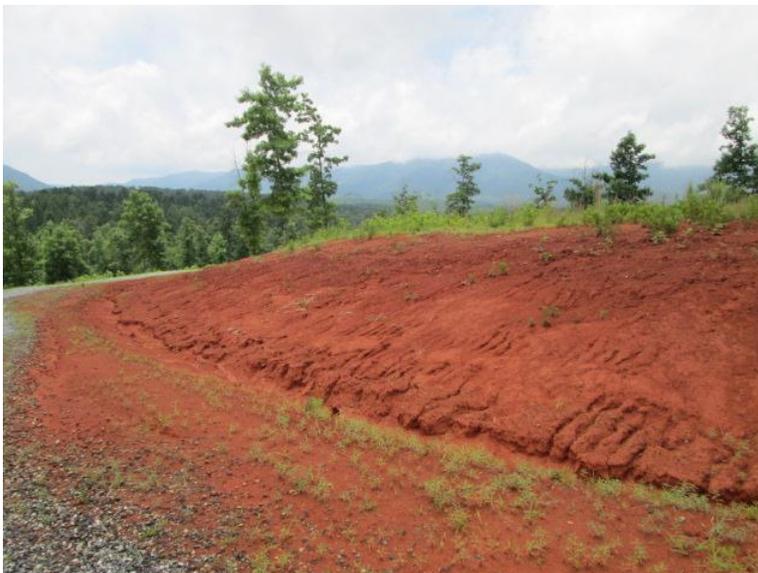
Photograph 36: Representative view of open dirt area located at Site 3. This area is located in an upland area proximate to the Green River.

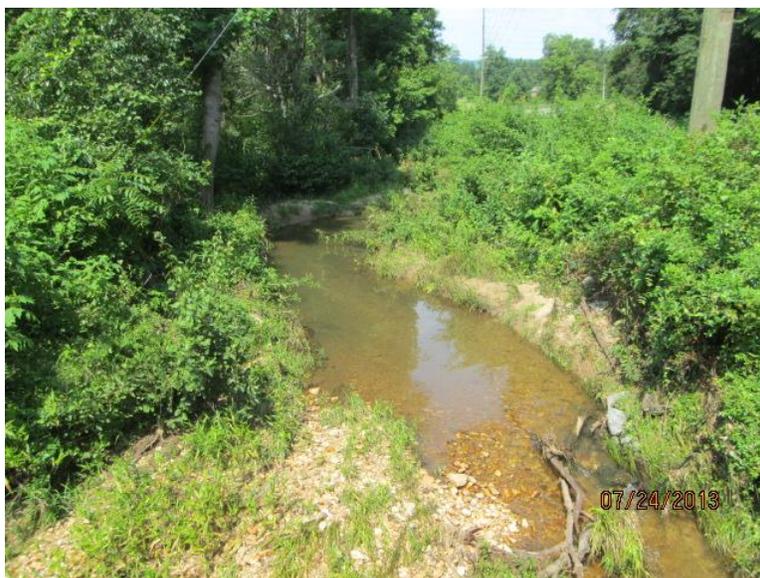
Photograph 49: View of Ostin Creek near intersection of Holbert Cove Road and Silver Creek Road (slightly upstream of Site 14). Sediment in the bed has the potential to migrate downstream.

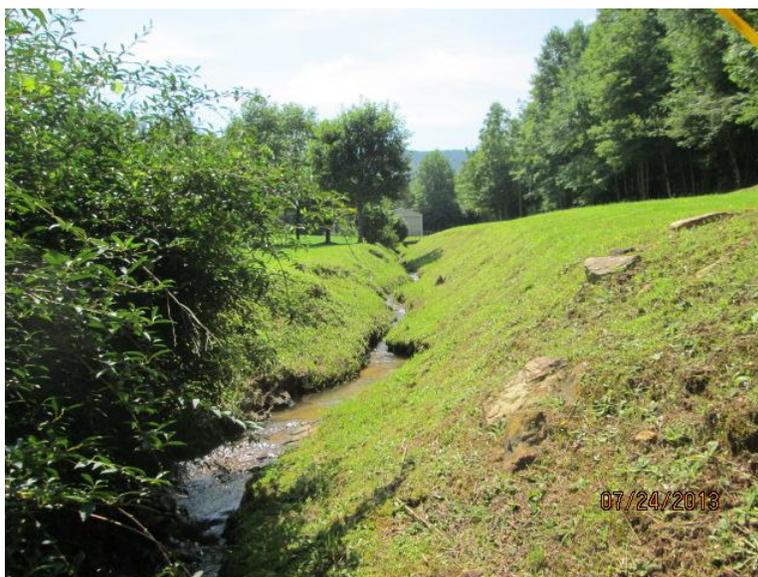
Photograph 53: View of tributary to Ostin Creek on private property. The buffer appears to have been mowed to the water's edge.

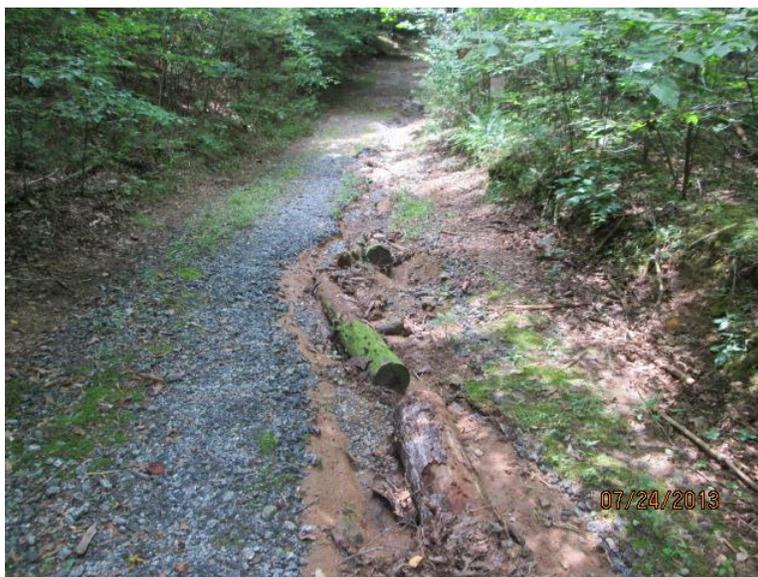
Photograph 55: Representative view of erosion along the Ostin Creek trail near Site 30 on the Lake Adger Development.

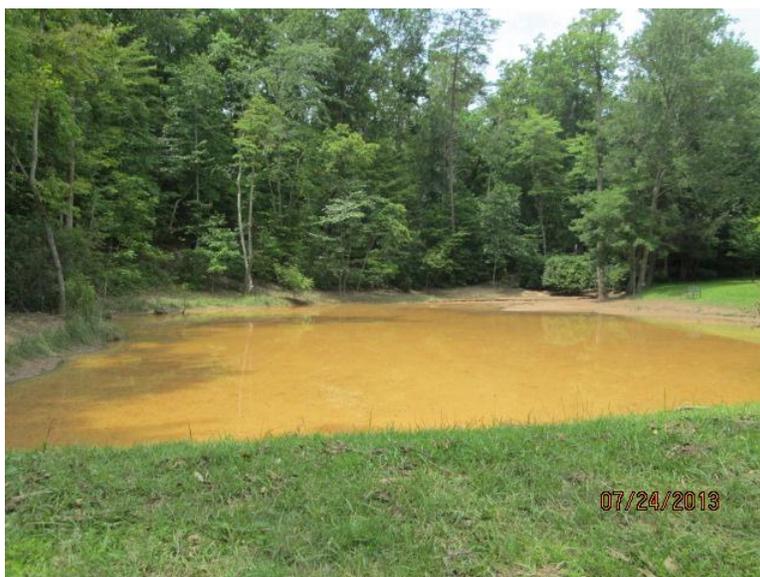
Large depositional islands were observed at the Ostin Creek entrance to Lake Adger. Stressors to Ostin Creek include exposed soil hillside erosion and a sediment-laden inline pond (Site 22), lack of riparian buffers along portions of the reach, erosion along gravel and dirt roads within the watershed, and eroding banks (Site 14 and proximate to Site 15) along the stream. Moreover, the abrupt change in channel

Photograph 59: View of pond at Site 22. The muddy pond discharges to an unnamed tributary of Ostin Creek near Hitching Post Road.

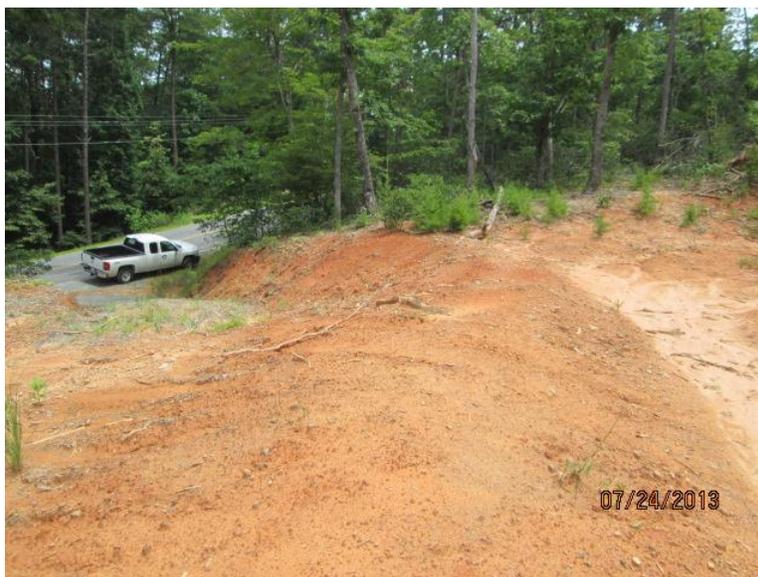
Photograph 61: View of upland area near Site 22. The exposed soil is likely contributing sediment to the pond and Ostin Creek

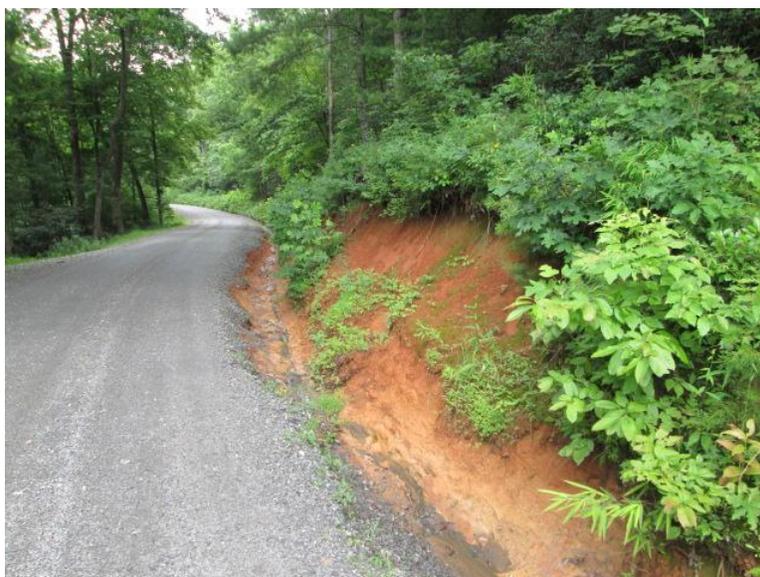
Large depositional islands were also observed at the Panther Creek entrance to Lake Adger. Some stressors to Panther Creek include an eroding roadside ditch (near Site 6), livestock access to the creek, and lack of riparian buffer (Site 27). Additionally, the Brights Creek Development appears to have cleared some land and installed service roads near Panther Creek, stockpile areas, and construction entrances. The construction staging areas and past construction activity could be potential sources of sediment to Panther Creek.

Photograph 63: Representative view of eroding ditch along Raegan Jackson Road near Panther Creek Site 6.

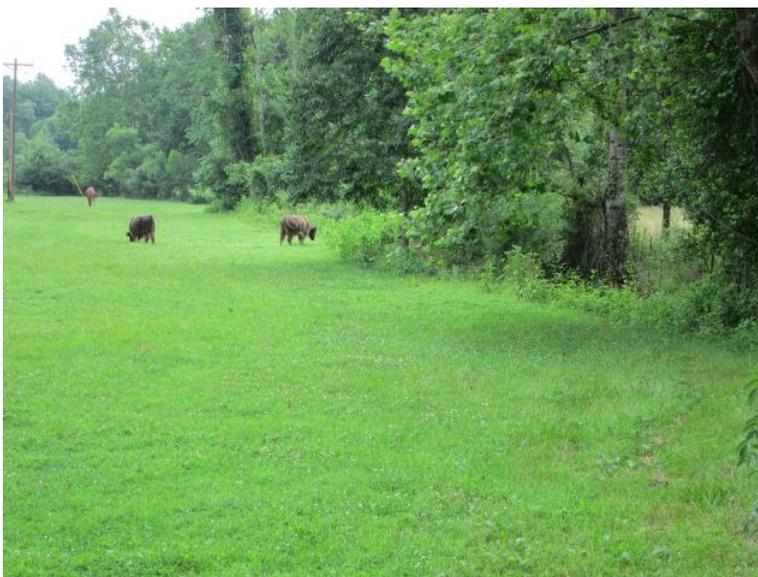
Photograph 65: View of Panther Creek just downstream of Site 27. Limited buffer width and livestock with unrestricted access to creek.

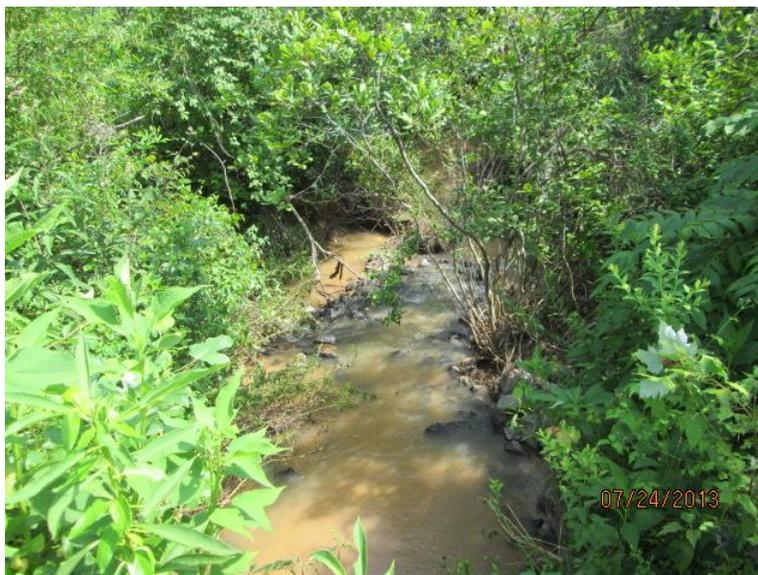
Some sediment accumulation was observed at the Rotten Creek entrance to Lake Adger. Rotten Creek was observed to be heavily impacted by sediment pollution. Stressors to Rotten Creek include runoff from agricultural areas (Site 12), lack of riparian buffer (Sites 12 and 31), and clear-cut land (Site 12).

Photograph 68: View of Rotten Creek at Site 12. The stream was observed to be very turbid, even though a recent rain event had not occurred.

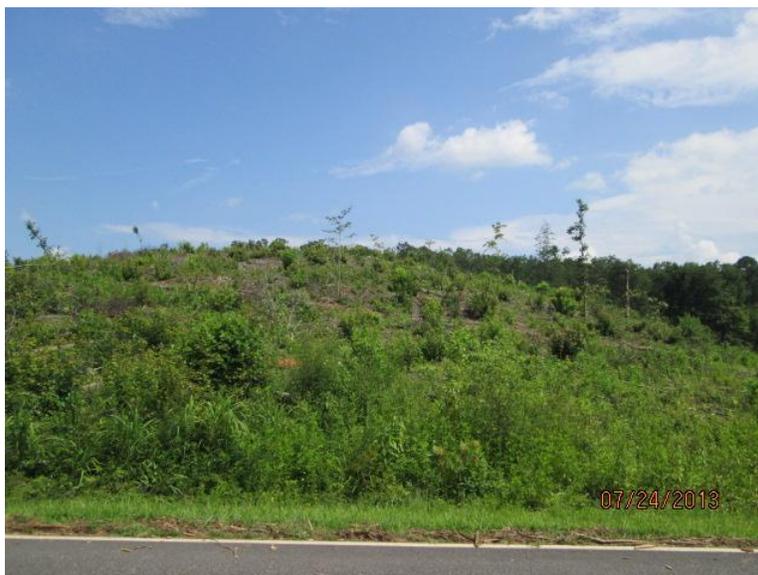
Photograph 69: View of clear-cut area near Site 12.

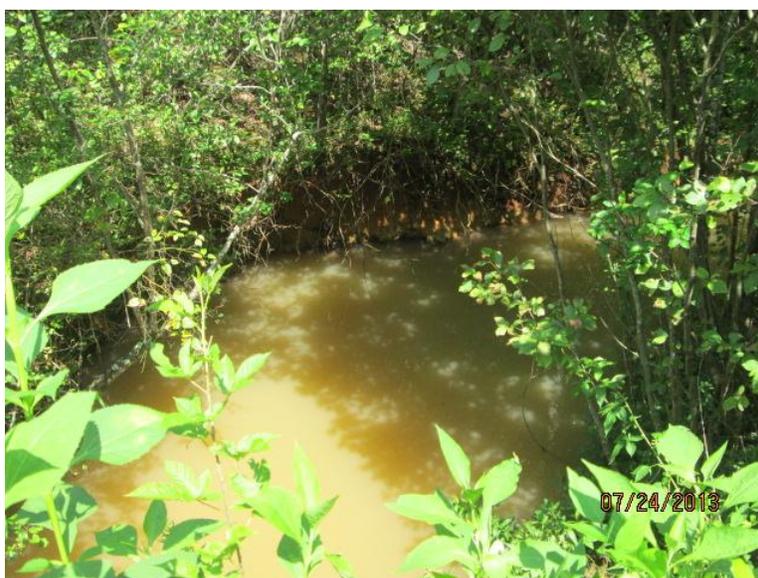
Photograph 71: View of tributary to Rotten Creek at Site 31. Sand was observed to be embedded in the channel.

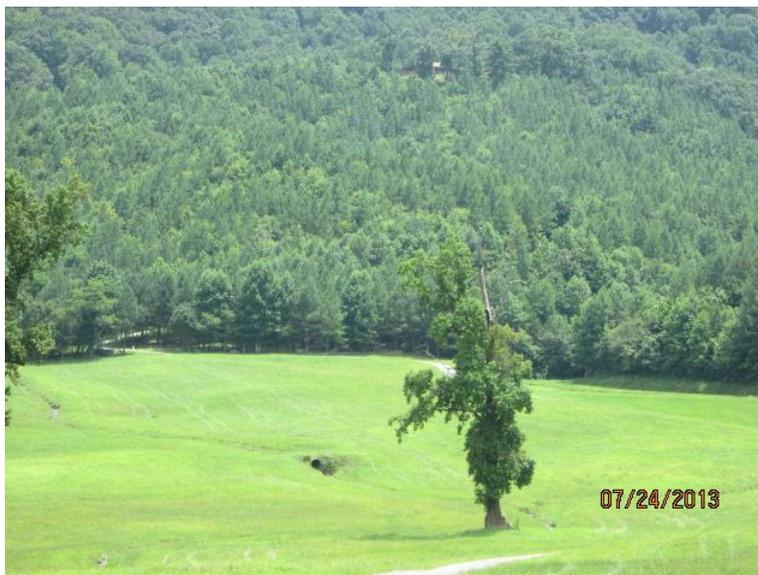
Photograph 72: View of Site 16 at the headwaters of Silver Creek on private property. No woody riparian buffer. Limited access due to private property.

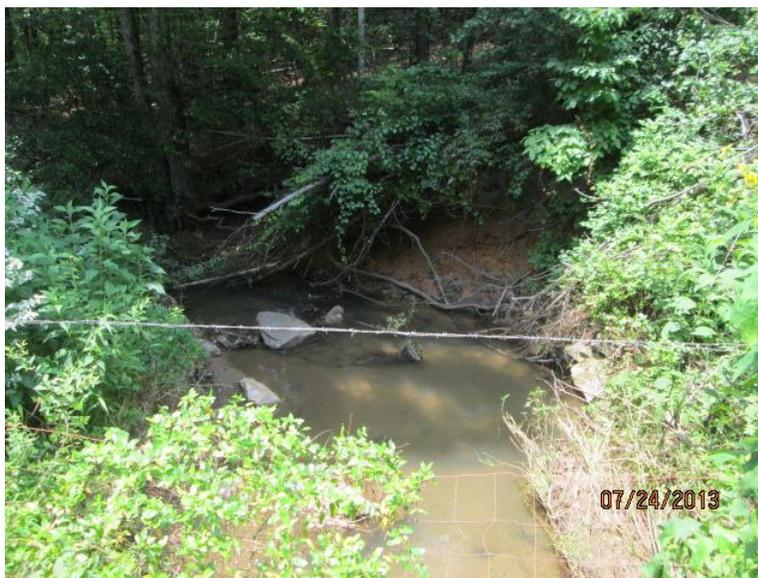
Photograph 73: View of Site 23 on Silver Creek. A tight meander and eroding bank were observed.

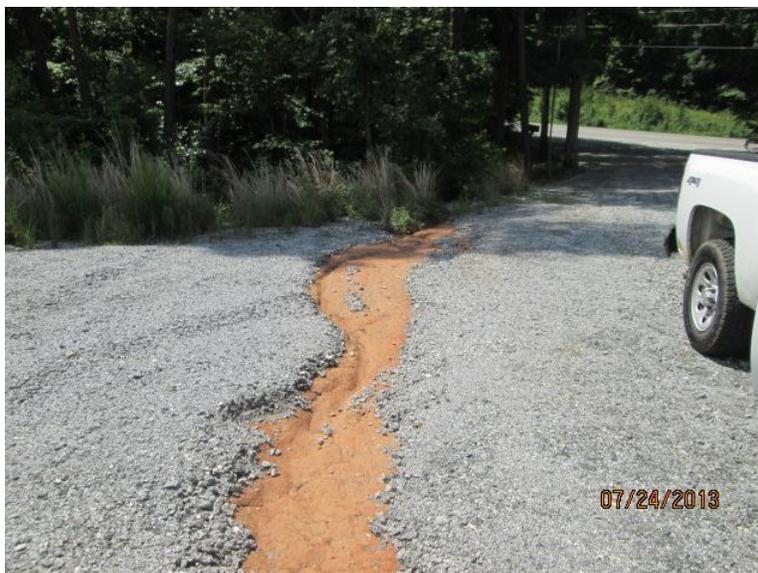
Photograph 74: Representative view of erosion on gravel road near power station near the intersection of Sylvan Lane and Silver Creek Road. Runoff from this area drains to Silver Creek.

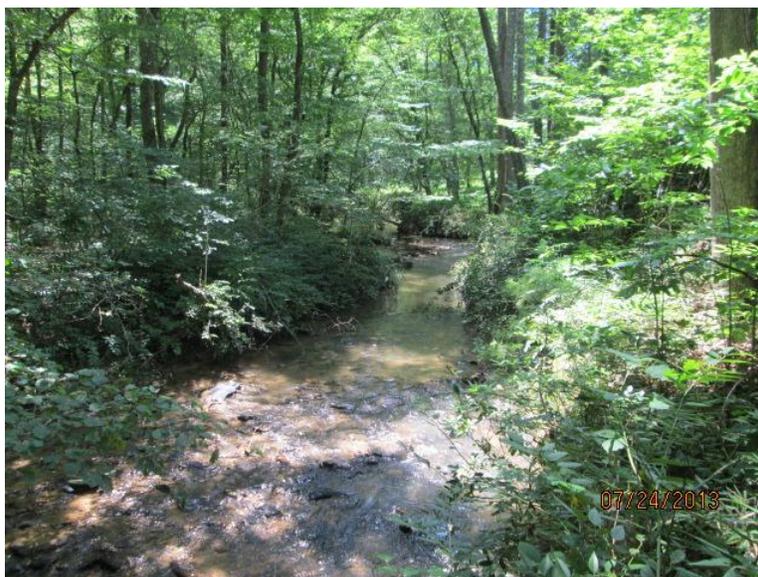
Photograph 75: View of Silver Creek at Site 25 facing downstream. The stream was observed to be clear and have some sand embedded in the channel, likely from upstream sources.

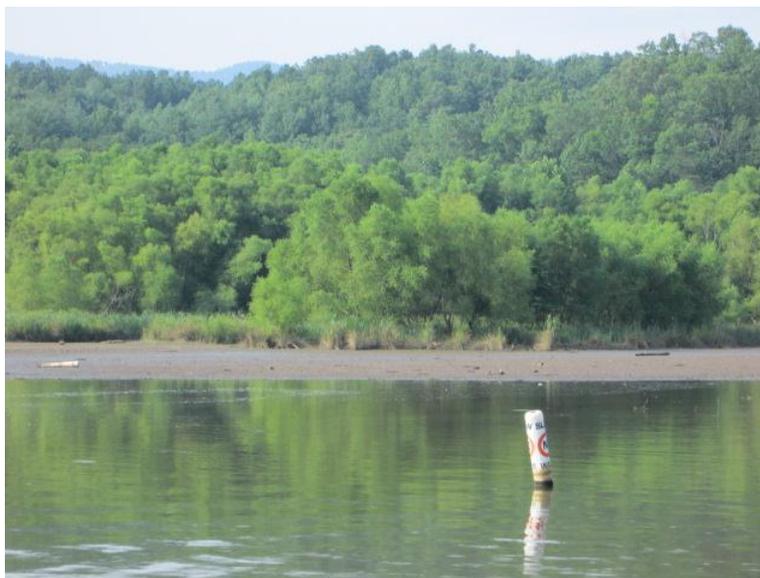
Lake Adger was observed to be shallow in multiple locations throughout the marina and at multiple tributary entrances to Lake Adger, actively eroding banks were also observed throughout the lake. Depositional islands were also observed throughout the lake. The sedimentation buildup in Lake Adger appears to be primarily attributed to cumulative watershed effects of sediment inputs to the Green River which lead to Lake Adger.

Photograph 79: View of public marina entrance to Lake Adger. Note the sediment build up in the background.

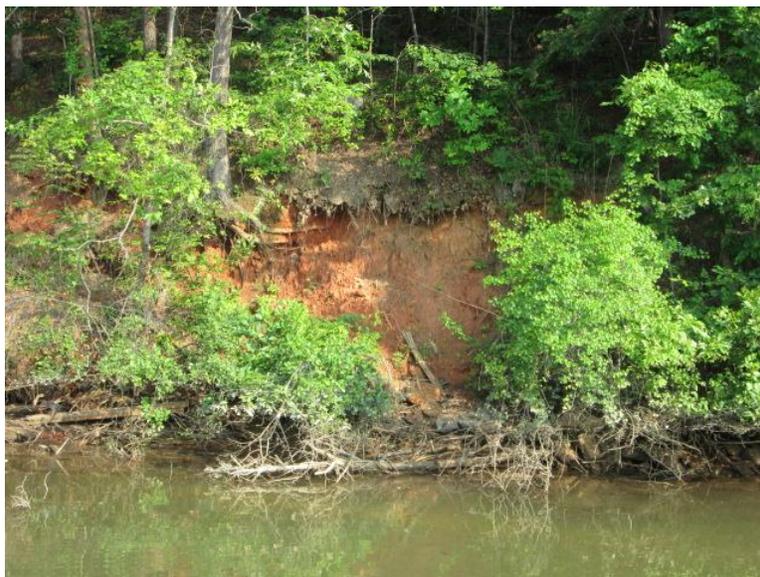
Photograph 80: View typical bank erosion on Lake Adger.

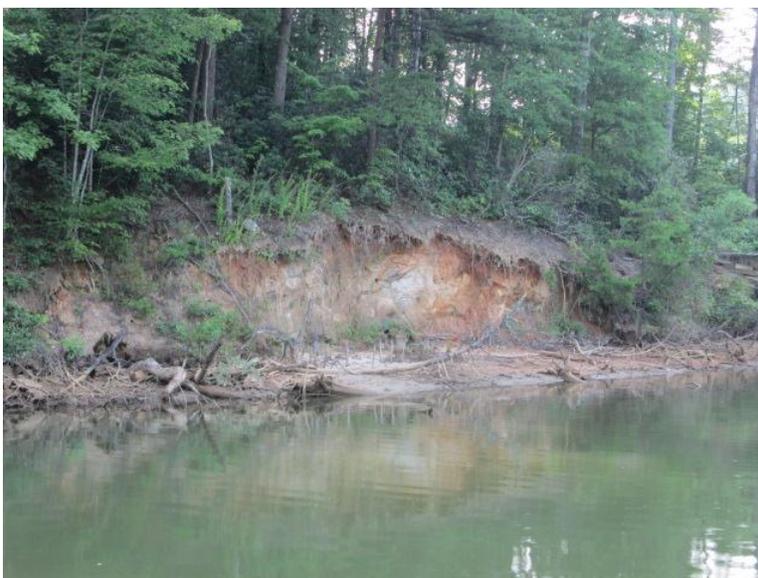
Photograph 82: View of eroding banks on Lake Adger.

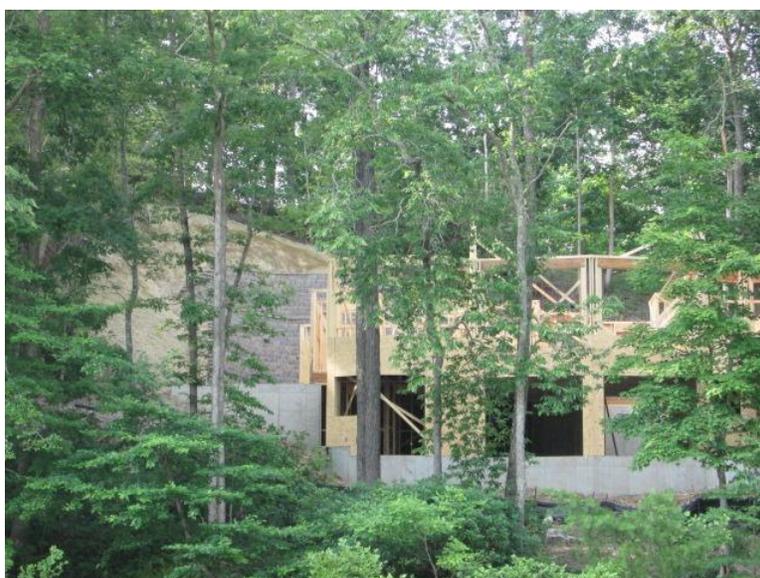
Photograph 84: View of active construction site on Lake Adger. Note the large retaining wall and cut slope behind the building.

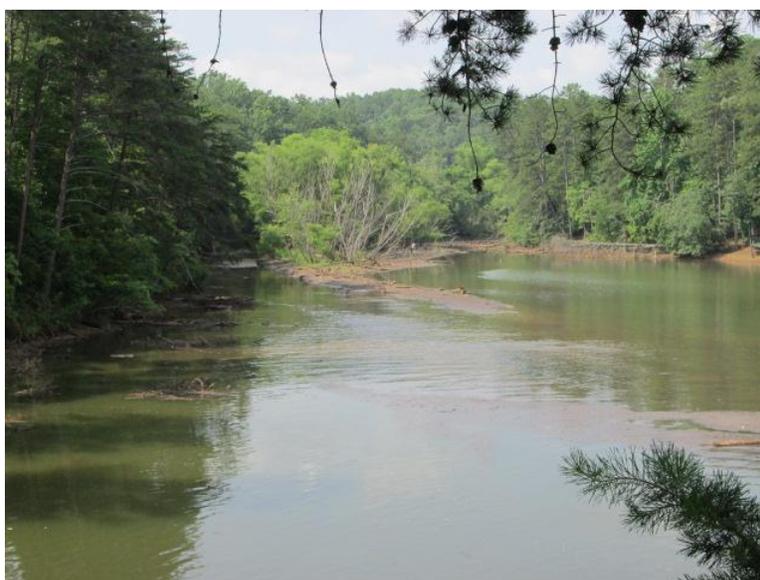
Photograph 88: View from Duelkan's property facing Ostin Creek Cove on Lake Adger. Note the sediment accumulation in the background.

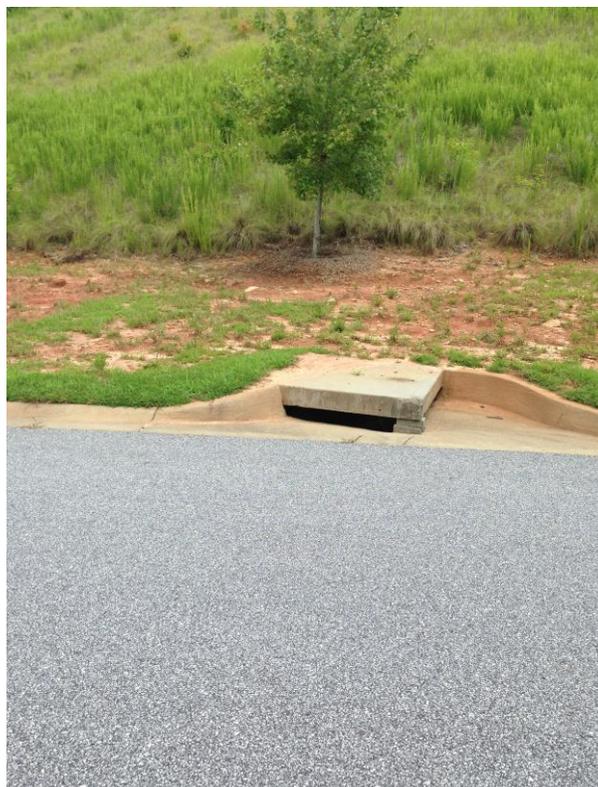
Photograph 91: View of exposed soil and stormdrain on Lake Adger development.

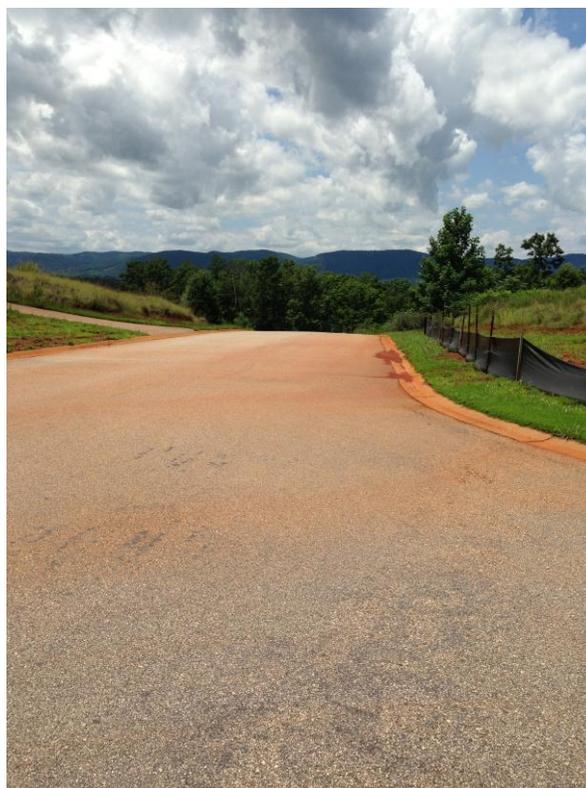
Photograph 92: View of street within Lake Adger Development following a rainfall event. Note the red sediment stained pavement indicative of sediment laden runoff.

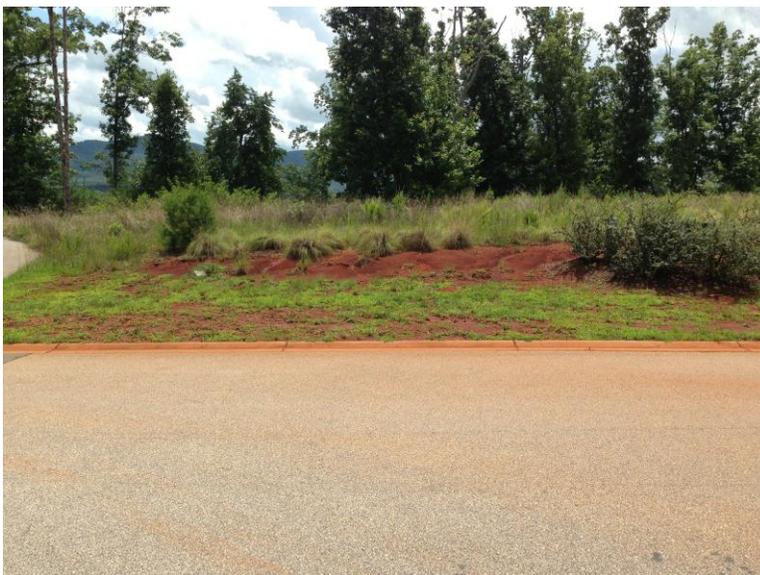
Photograph 93: View of exposed dirt and sediment stained pavement within Lake Adger Development following a rainfall event.

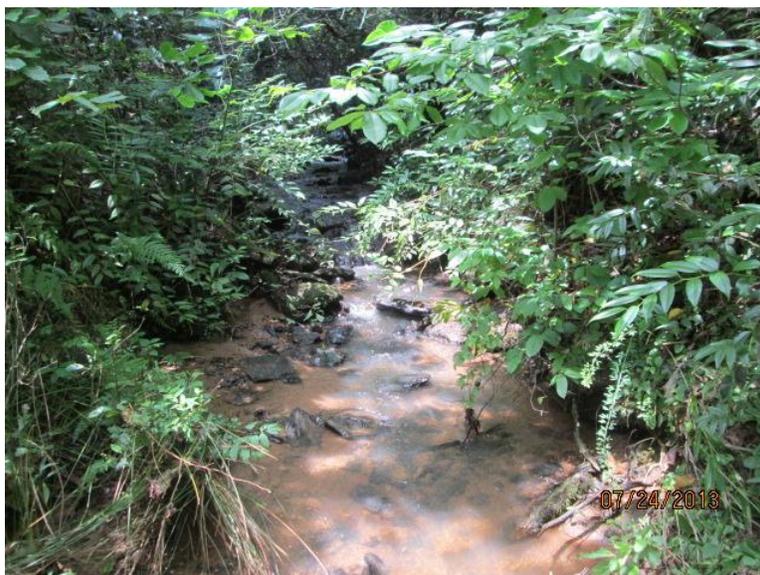
Photograph 94: View of tributary to Lake Adger at Site 4 facing upstream. This stream appeared stable, although the sediment observed in the stream was more turbid than other locations observed on the same day.
