**HOWELL WOODS**  
**WETLAND RESTORATION SITE**  
**AS-BUILT CONSTRUCTION REPORT**  
**JOHNSTON COUNTY, NORTH CAROLINA**  
**(SCO ID# 00-05434-01)**

**HOWELL WOODS WETLAND**  
**RESTORATION SITE**  
**AS-BUILT CONSTRUCTION REPORT**  
**JOHNSTON COUNTY, NORTH CAROLINA**  
**(SCO ID# 00-05434-01)**

**HOWELL WOODS WETLAND RESTORATION SITE**  
**AS-BUILT CONSTRUCTION REPORT**  
**JOHNSTON COUNTY, NORTH CAROLINA**

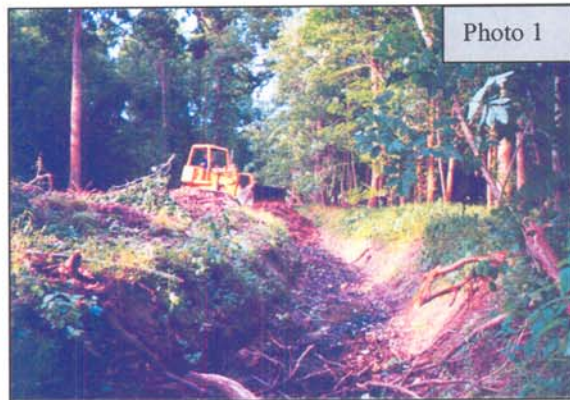
Photo 1

The canal and adjacent ditches within the easement boundary were backfilled using material excavated from littoral shelves and isolated oxbow depressions (Photo 1). The ditches/canals were filled, compacted, and graded to the adjacent floodplain elevation.

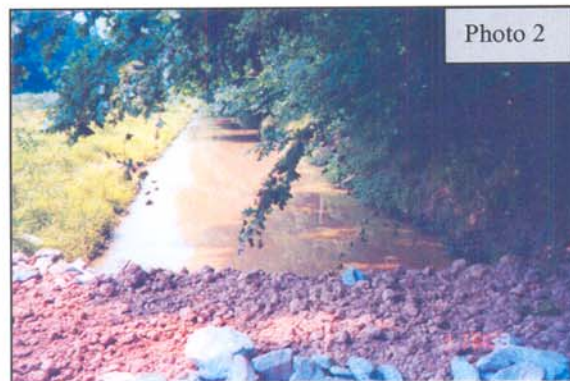
Photo 2

Two man-made ponds were left within the Neuse River floodplain to maintain diverse aquatic habitat. The ponds were isolated from construction activities through the use of temporary, impermeable dikes. (Photo 2). Prior to backfilling water was pumped from ditches/canals into the forest using proper sediment collection measures.

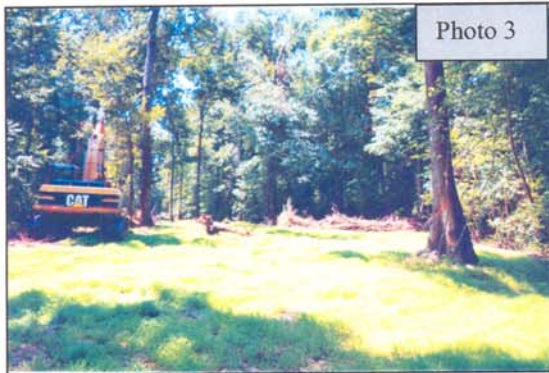
Photo 3

All exposed soil adjacent to backfilled ditches and canals was seeded with millet and covered with straw to prevent erosion (Photo 3-4). Soil borrow areas are mapped as Udorthents atop Altivista soils and may be more permeable than clay material in other locations; therefore, this material was utilized in conjunction with impermeable channel plugs and suitable floodplain clays.

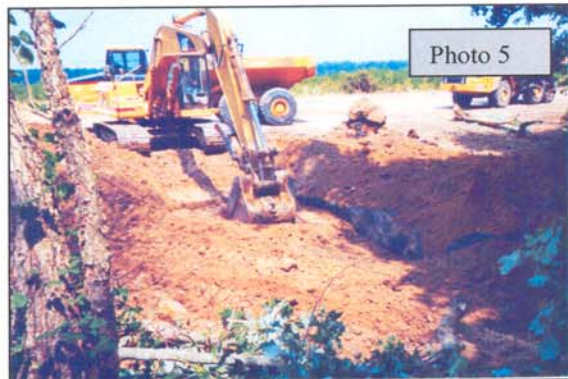
Photo 5

Impermeable ditch plugs were installed along the main canal at five locations throughout the Site (Figure 5). The plugs consist of a core of impervious material lined with filter fabric. The plugs are sufficiently wide and deep to form an imbedded overlap in the existing canal banks and canal bed (Figure 6). The plugs were designed to withstand erosive forces associated with river floods.

Channel Plug material was excavated from the adjacent floodplain, littoral shelves, and isolated depressions and stockpiled at select locations. Impermeable select material was placed in the canal in 6 to 8 inch lifts and compacted (Figure 6). At each plug location, a core was then excavated from the compacted material (Photo 5). The upstream face of the excavated core was then lined with filter fabric from top to bottom. Once the filter fabric was installed, the excavated core was backfilled and compacted. The channel plugs prevent backfilled material from functioning as a hydrologic conduit of on-site hydrology. Hydrological flows will instead be diverted into the historic floodplain and backwater sloughs.

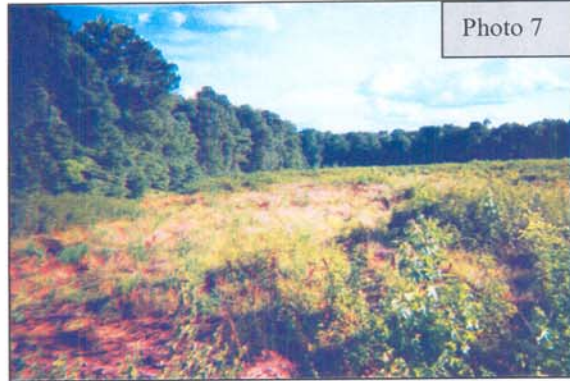
Photo 7

Construction of the littoral shelves was conducted to promote suitable habitat for establishment of emergent wetland species. Initially, topsoil (A horizon) and vegetation were removed from the ground surface and stockpiled (Photo 7 and 8). After stockpiling the A horizon and vegetation, the subsurface (B horizon) was excavated to the target range of the littoral shelf elevations (Photo 9). The excavated B-horizon was stockpiled and used as backfill for the canal and ditches. Surficial soils and stripped vegetation were redistributed across the littoral shelf (Photo 10). Surficial soils and vegetation were distributed to diversify microtopography within the littoral shelf. Based on GPS data, approximately 4 acres of littoral shelf was created within the site boundary (Figure 5).

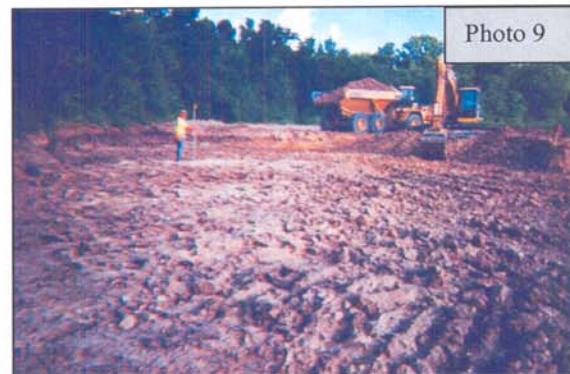
Photo 9

The upstream littoral shelf, above and to the north of the pond, measures approximately 0.6 acre. The downstream littoral shelf, adjacent to the downstream pond, measures approximately 3.4 acres. Water depth on these littoral shelves will vary between 0.5 and 3 feet.

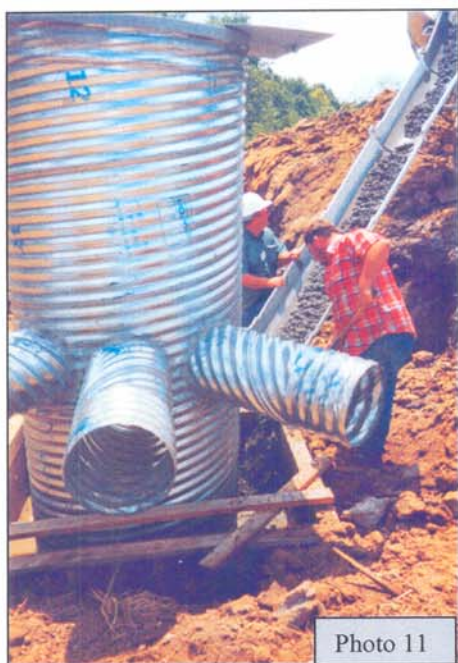
Photo 11

In an effort to reduce impacts from resident beavers, the structure was designed with three intake pipes that are expected to reduce on-site maintenance and clearing (Photo 11 and 12). The

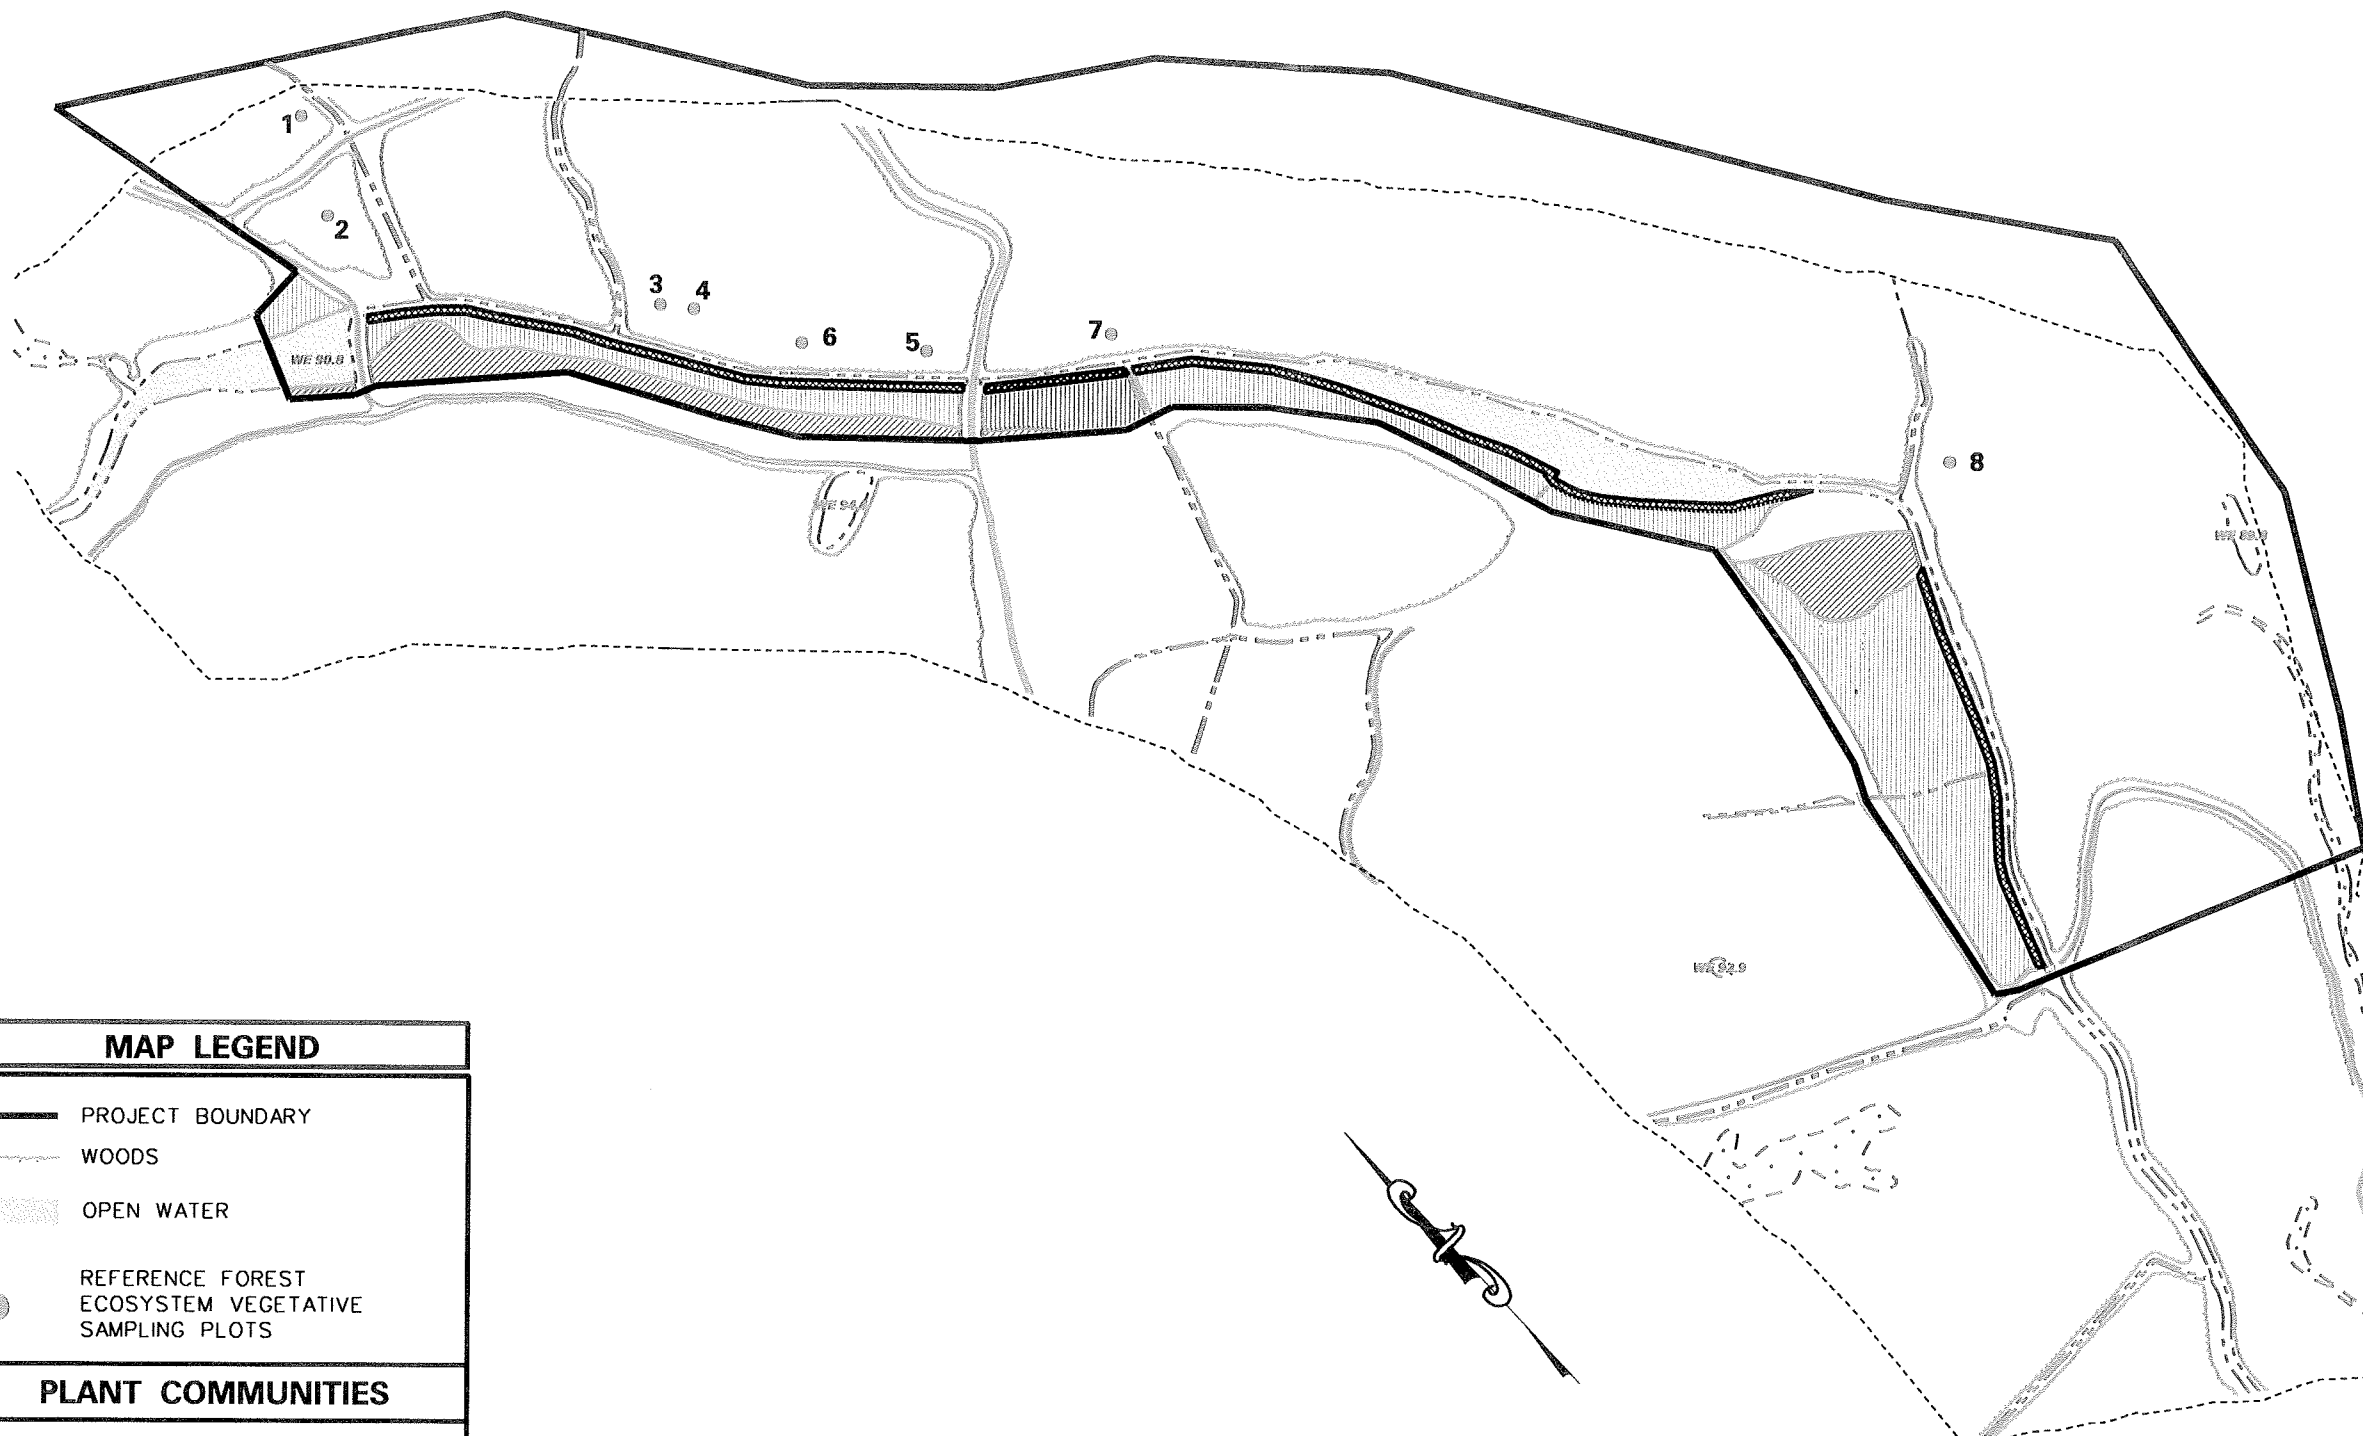
**8**

**PLANTING  
AREAS  
(2000)**

acres
FLOODPLAIN BOTTOMLAND HARDWOOD	12.5±
STREAM EDGE	2.2±
MESIC UPLAND SLOPE	4.1±

Species assemblages were determined by both the topography and soils of the Site. Wehadke soil (hydric) occurs along the stream and is indicative of the frequently flooded, poorly drained Neuse River floodplains. Altavista and State loams (non-hydric) are found on escarpments and upland slopes. The boundaries of these soils largely determined the boundaries of the species assemblages, described below (and illustrated in Figure 8). An unplanted buffer of 25 feet was
