Indian Creek and Howards Creek Local Watershed Plan *Watershed Assessment Report*

April 2010

This document was prepared by Mike
Herrmann and Hal Bryson, NC EEP
Watershed Planning.

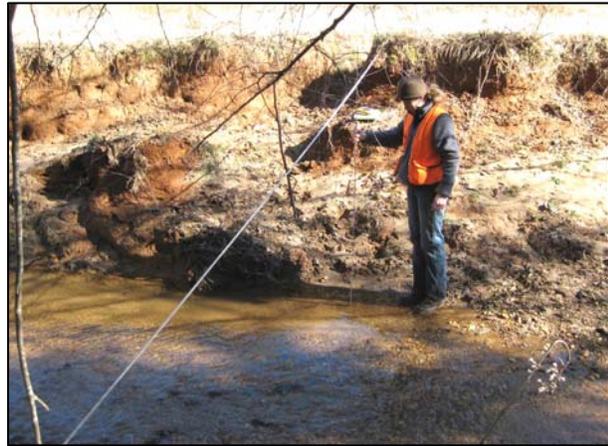
Figure 2. ENTRIX staff measuring stream channel capacity and incision.

or too large, leaving 43 sites where stream incision was measured. During Phase 1, NC EEP used GIS to select the sites for field assessment based on their need for restoration/ enhancement (35 streams) and preservation (8 streams). Site selection criteria included the condition of riparian vegetation, land use, number of landowners, and the sites proximity to other features (e.g., protected lands or other project opportunities). ENTRIX used a Channel Capacity Ratio (CCR) to then determine the ability of high stream flow events to access the floodplain. The CCR compares field measurements of stream channel capacity against expected discharge estimates

developed by the United States Geologic Survey (Pope et al., 2001). The result is a ratio of the cross-sectional area at the top-of-bank at a representative riffle section divided by the flow area of an estimated discharge of specific recurrence interval. ENTRIX (2009) further describes the CCR as follows:

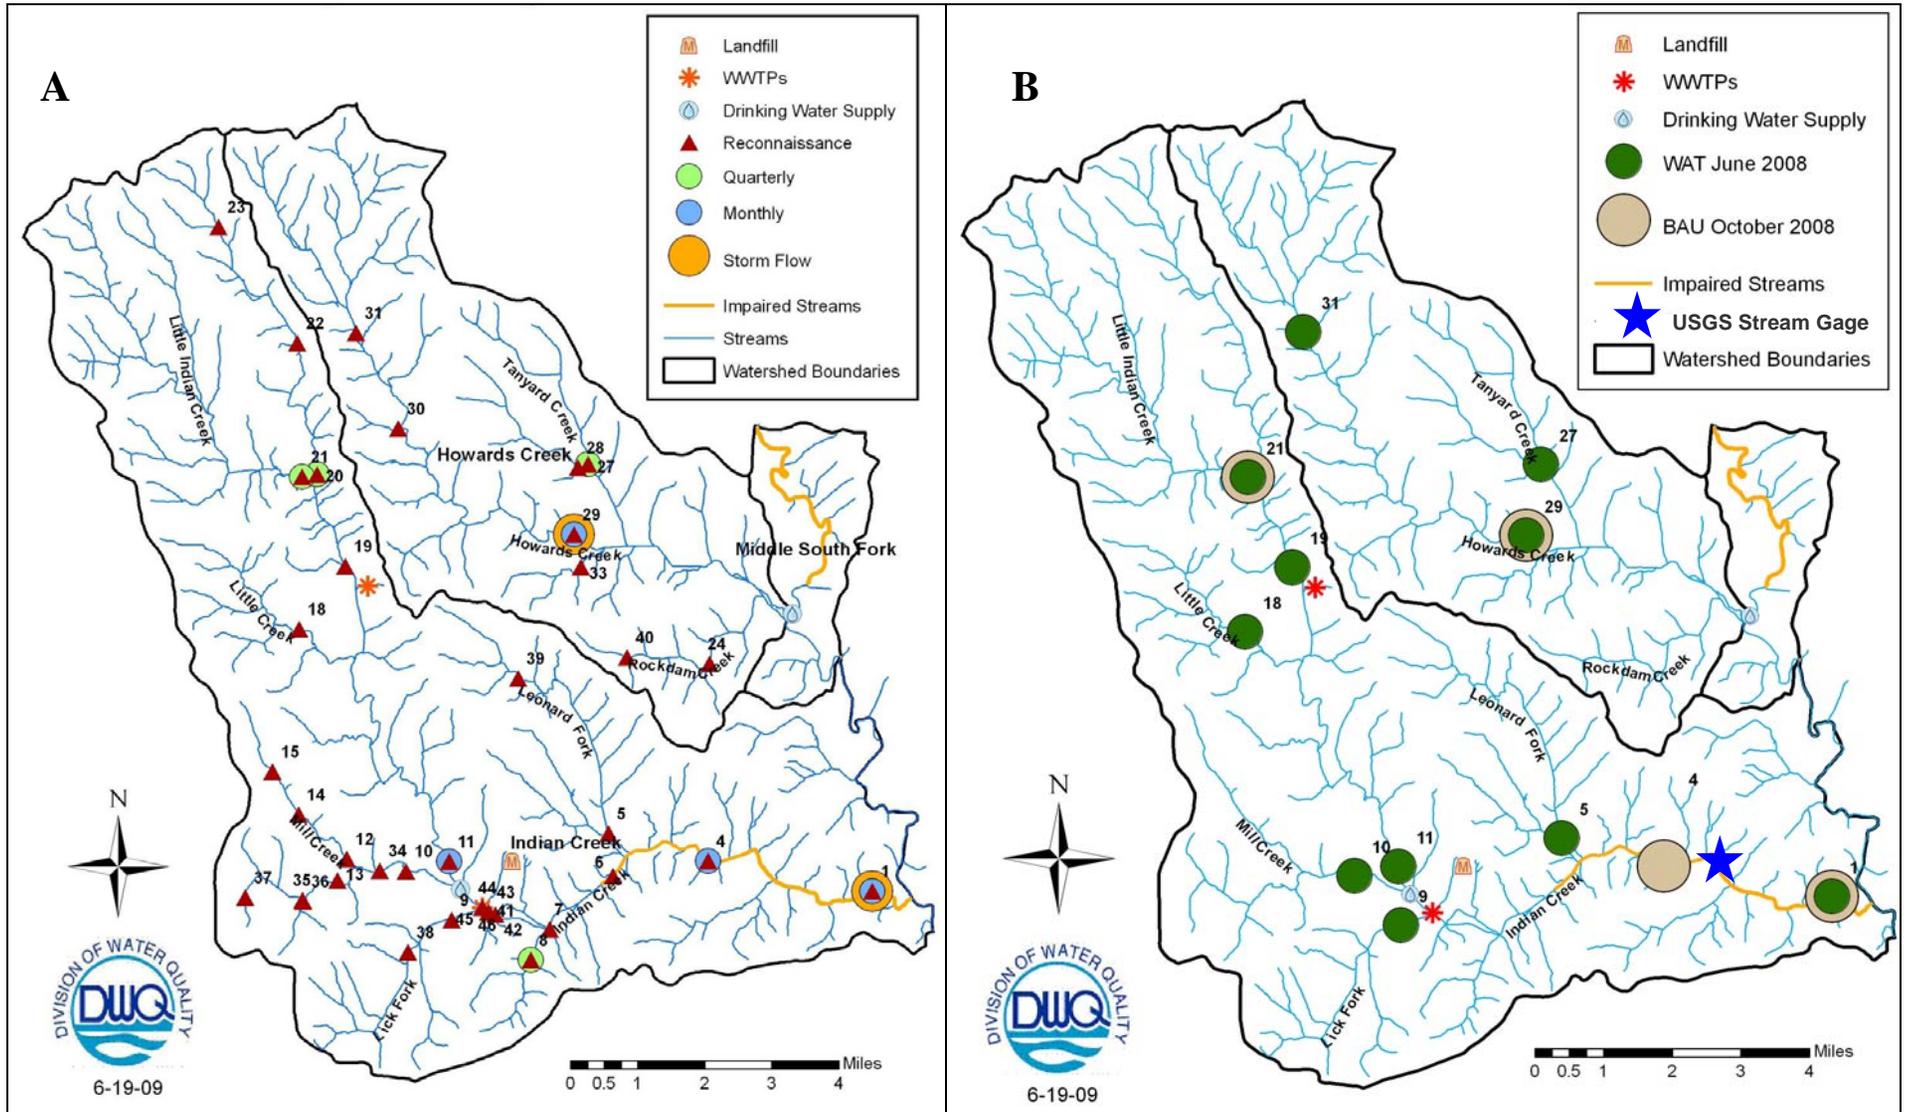
Figure 4. **A)** Locations of NC DWQ Chemical monitoring sites. During Phase 1, 37 “reconnaissance” sites were sampled to help screen for potential water quality problems and establish longer-term quarterly and monthly monitoring locations for Phase 2. **B)** Benthos assessment sites and USGS Stream Gage (Note: Leepers Creek, the biological reference site, is not shown).

Finally, a US Geological Survey (USGS) stream gage is located on Indian Creek at Laboratory Road (see Figure 4B). While assessment of adequate water supply and flow volume were not part of Phase 2 watershed assessments, the gage served to understand flow conditions during the study. In particular, the flow data helped illustrate drought conditions present in the LWP area prior to, and during, the study.

The highest bioclassification scores were in the headwaters of Indian Creek (Little Indian Creek at SR1129 - Site 21 on Figure 4B). BAU noted that this site had “the highest total taxa (87) and EPT taxa (26)”. They also noted the biotic index suggests a benthic community not tolerant of pollution. This site also had a high habitat score (scoring 93 out of 100).

Leonard Fork at SR 1180 (Site 5 on Figure 4B) also has highly rated benthic macroinvertebrate communities. Like Little Indian Creek at SR1129, it is a headwater system flowing into Indian Creek. WAT staff who assessed the site state that it “received a Good bioclassification with more taxa (67) and higher abundance of EPT (103) than any other Qual 4 sample in this study. The 5.10 Biotic Index at this site was the second lowest (most intolerant), indicating healthy biotic conditions at the site (NC DWQ, 2009b).

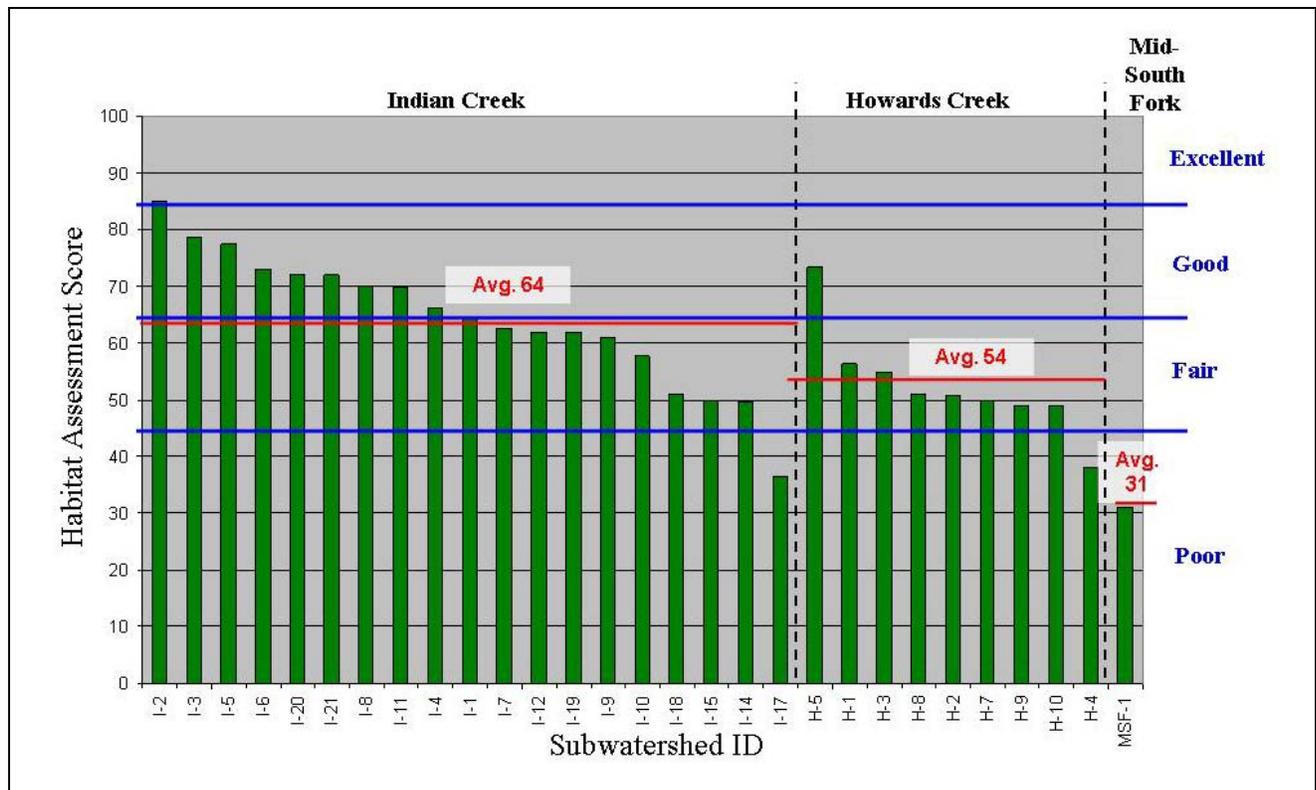
Figure 6. Total Habitat Scores by Subwatershed. Average scores for Indian, Howards, and Mid-South Fork are shown in red. Watersheds where no streams were evaluated are not shown.

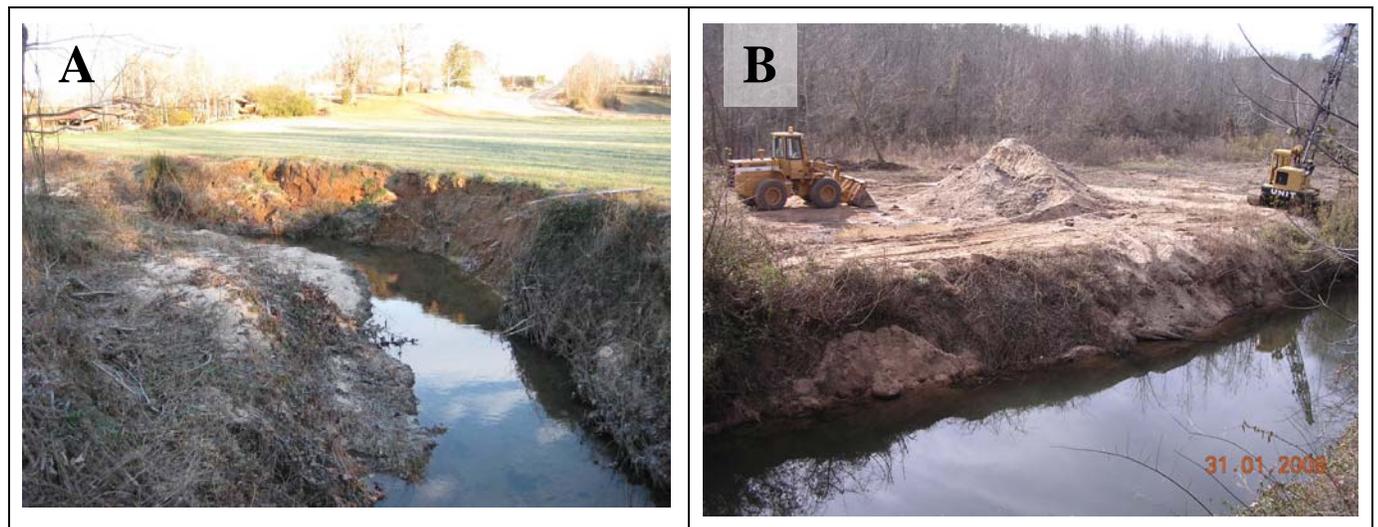
Figure 7. **A**-Poor riparian vegetation (Upper Howards Creek). **B**. Crane extracting sand in lower Howards Creek. Poor riparian vegetation and substrate are key contributors to depressed stream habitat scores in the Howards Creek Watershed.

Two submetrics of the habitat assessment protocol with significant statistical difference between Indian Creek and Howards Creek are bottom substrate and riparian vegetation zone (NCDWQ, 2009a). Substrate is affected by an abundance of silt and sand that can be found in the LWP area streams, but particularly in Howards Creek. Indeed, several “sand dipping” (i.e., in-stream sand mining) operations have taken advantage of these excess materials and extract sand from the creeks for commercial purposes (see Figure 7B). In comparison, Leepers Creek, the biological reference site, the Bottom Substrate submetric scored better than both Indian Creek and Howards Creek (See Figure 8). This result suggests that sand and sediment levels may be abnormally elevated in the LWP area. A map of stream habitat assessment locations and a summary of scores by subwatershed are included in Figure 9.

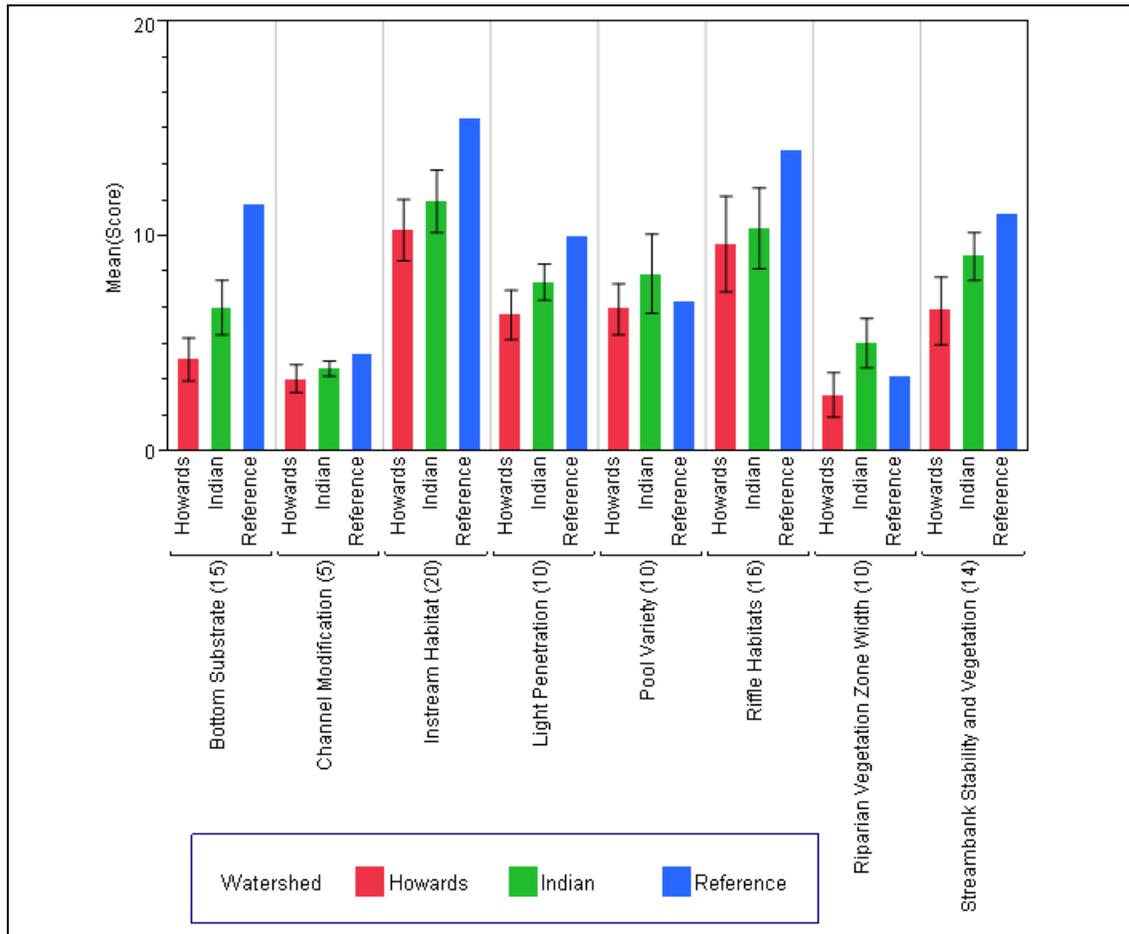
Figure 8. Comparison of habitat metrics between the Howards Creek watershed and the Indian Creek watershed. Metric scores from the reference site at Leepers Creek are provided for comparison. (N=39 in Indian Creek and N=27 in Howards Creek)

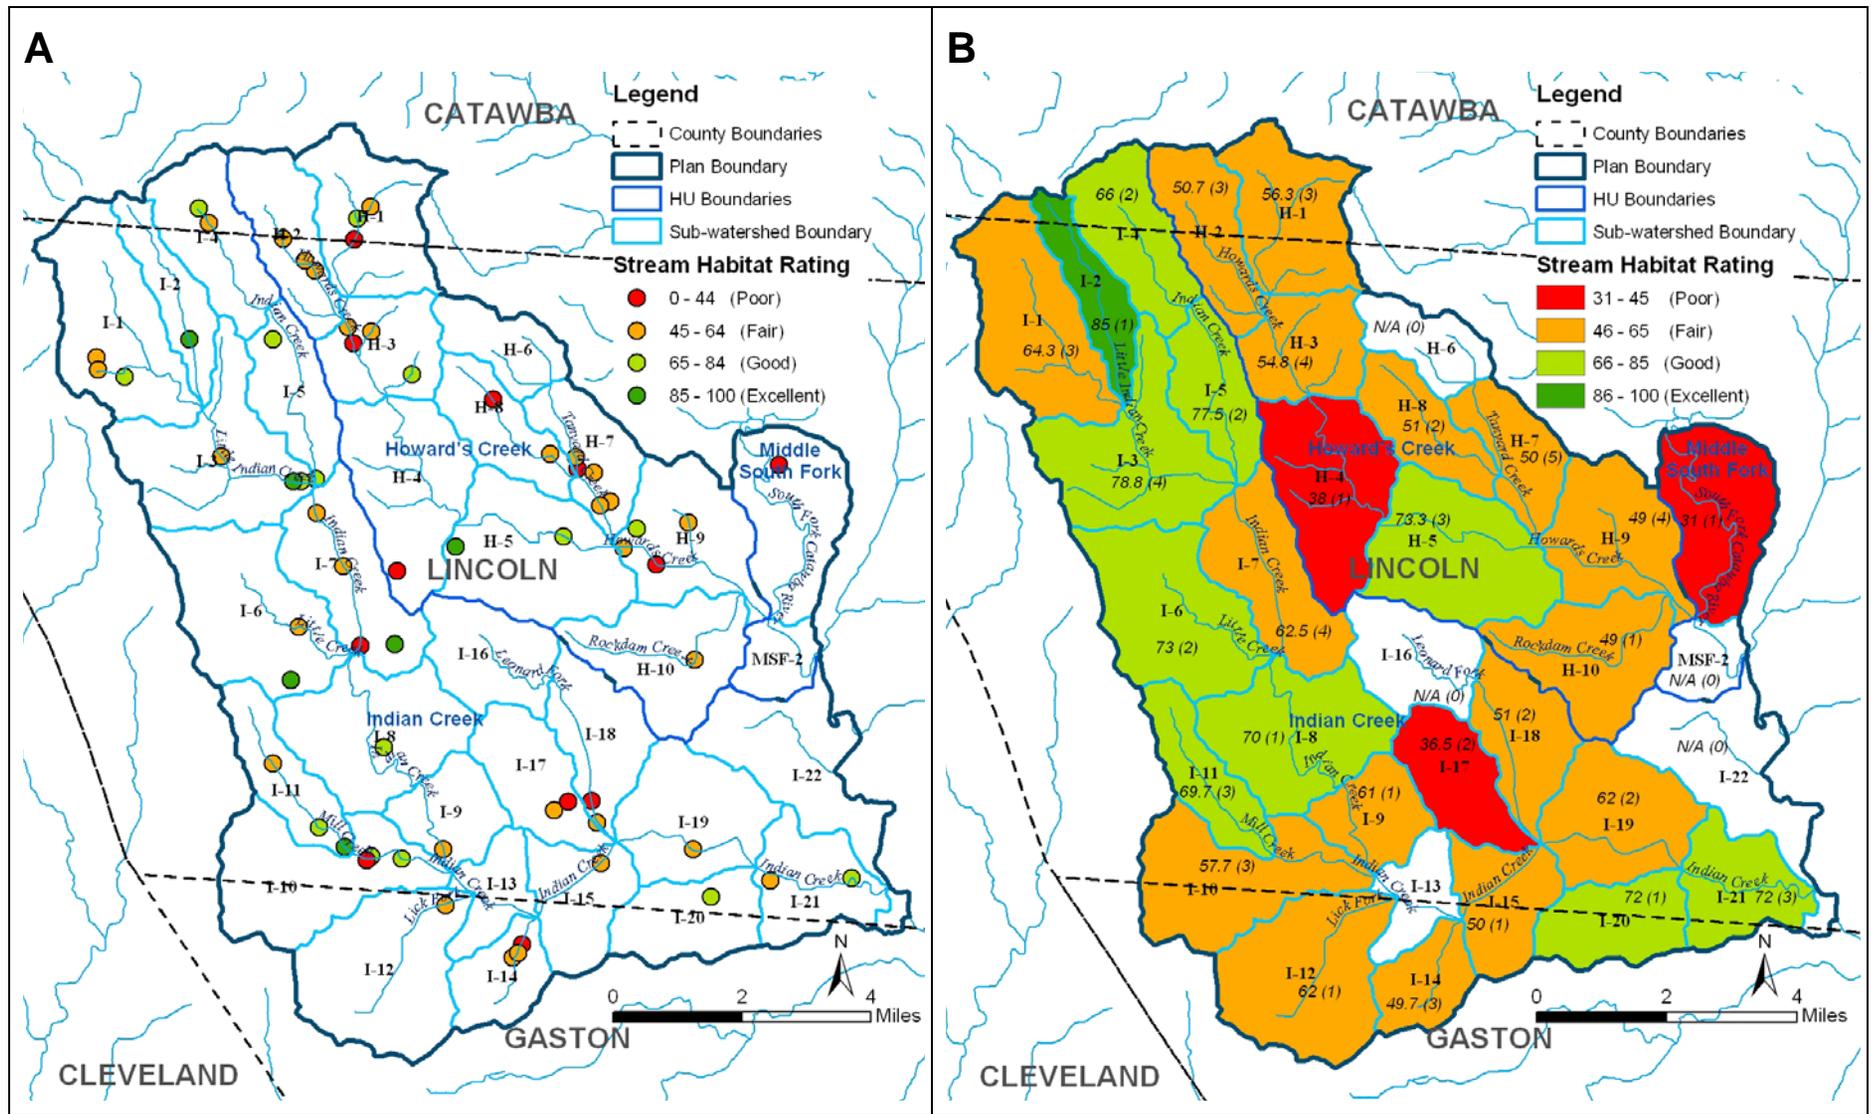
Figure 9. **A)** Location of habitat assessments, scores and subwatersheds. **B)** Summary of stream habitat scores by Subwatershed. Average subwatershed score is shown in italic and the number of assessments per subwatershed is shown in parenthesis.

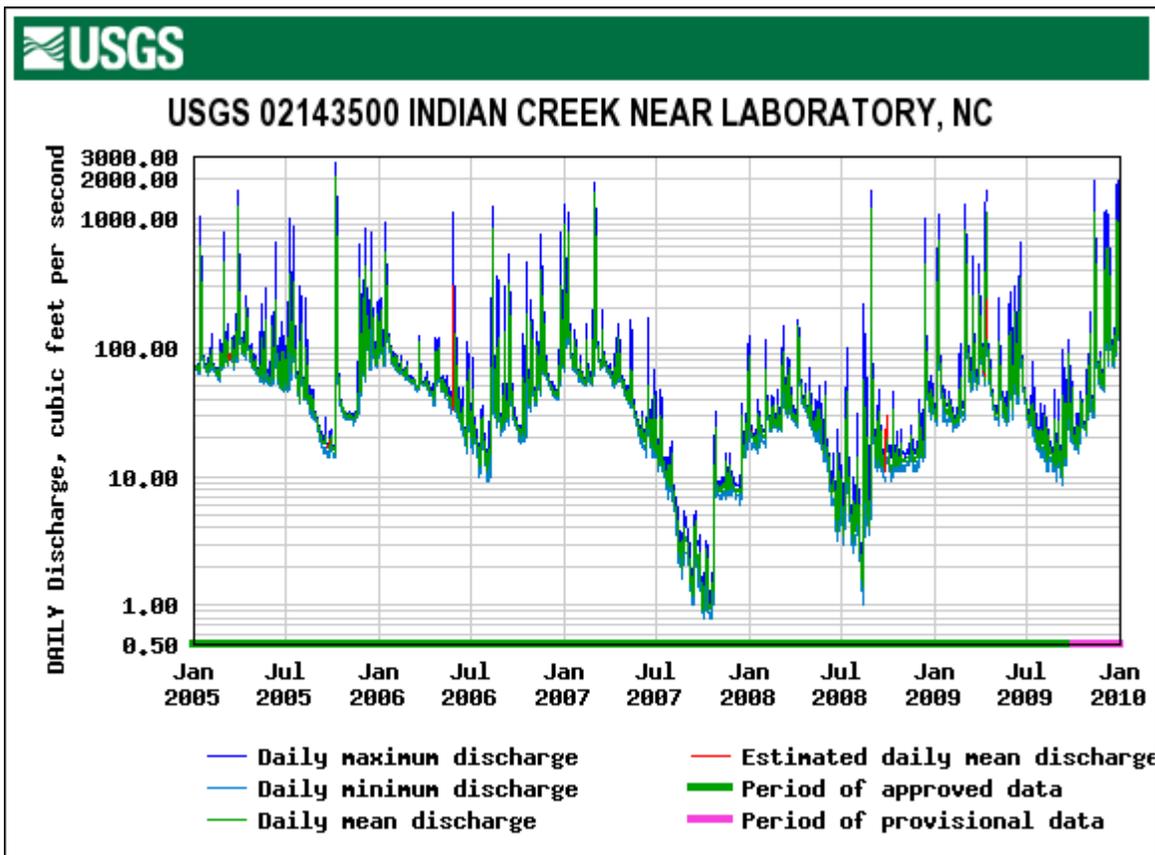
Figure 10. Stream discharge statistics at the USGS gage on Indian Creek at Laboratory Road, 2005-2009. (Note: Drought conditions beginning in 2007 preceded this study and persisted through the Fall of 2008, the early portion of the LWP's watershed assessment fieldwork.

The effects of the drought were evident during fieldwork that occurred during this study. In the fall of 2008, total stream bug taxa showed a sharp decline at the long term monitoring site (i.e., at Indian Creek at SR 1252). Wetlands in the area were also stressed from lowered ground water table conditions partially related to the drought. To the degree possible, local conditions at each site have to be taken into account when being described in this report.

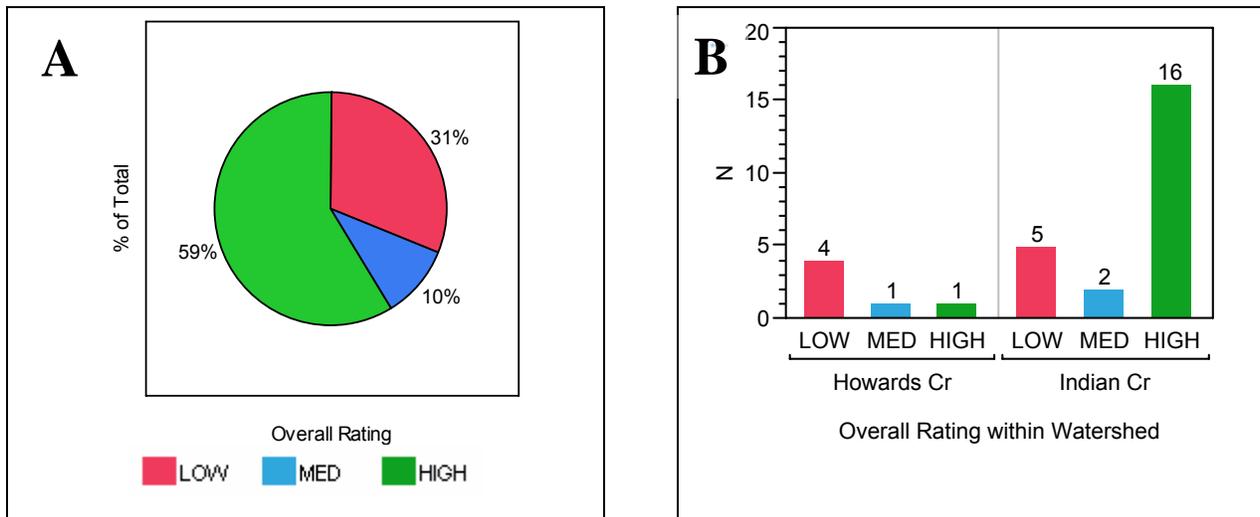
Figure 11. **A)** NC WAM Overall Function ratings as a percentage of assessments. **B)** NC WAM Overall Function rating by Watershed. The number of sites assessed is indicated above each rating's bar. (Source: NC DWQ, 2009a)

Wetlands in Indian Creek tended to rate higher than those in Howards when their functions were evaluated using NCWAM (See Figure 11). Of the 29 wetlands identified and evaluated, 23 were located in the Indian Creek watershed and 6 were in Howards Creek watershed. Over 70% of the wetlands were in the geomorphic floodplain or in close proximity to streams (i.e., Bottomland Hardwood, Riverine Swamp Forests). Of the wetlands found in Indian Creek, 70% were rated as High functioning (16 wetlands). In Howards Creek, however, 67% of wetlands were rated as Low (4 wetlands).

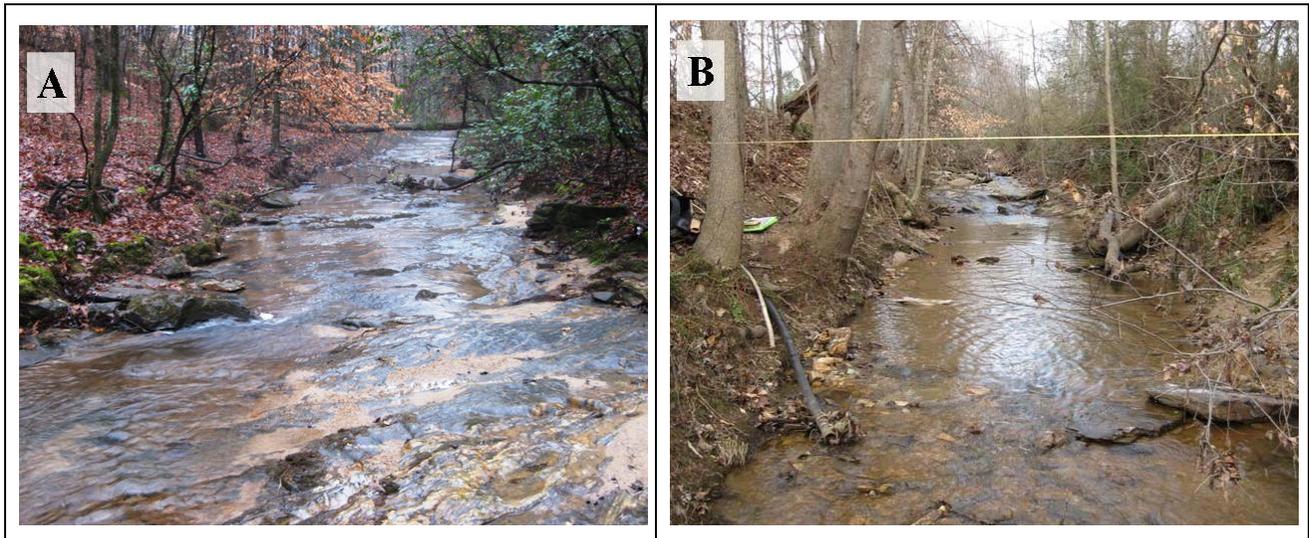
Figure 14. Channel Capacity Assessments. **A)** Low CCR value site on upper Mill Creek. **B)** High value site on an unnamed tributary (UT) to Howards Creek. Note the difference in the bank angle from Site A to Site B. High CCR value sites tend to have incised channels which inhibit flood flows from accessing the floodplain. A value of one or less suggests storm flows are capable of accessing the floodplain.

ENTRIX assessed the level of stream incision at 43 sites in the LWP area. Figure 14 provides photos of high and low scoring sites. Generally, less incised sites have a lower CCR. Ideally, the CCR should be close to one meaning that flood flows are accessing the floodplain, thereby reducing stress on stream banks. Sites with a greater CCR values tend to have confined channels where flood flows have difficulty accessing the floodplain. These channels are often incised with steep stream banks.

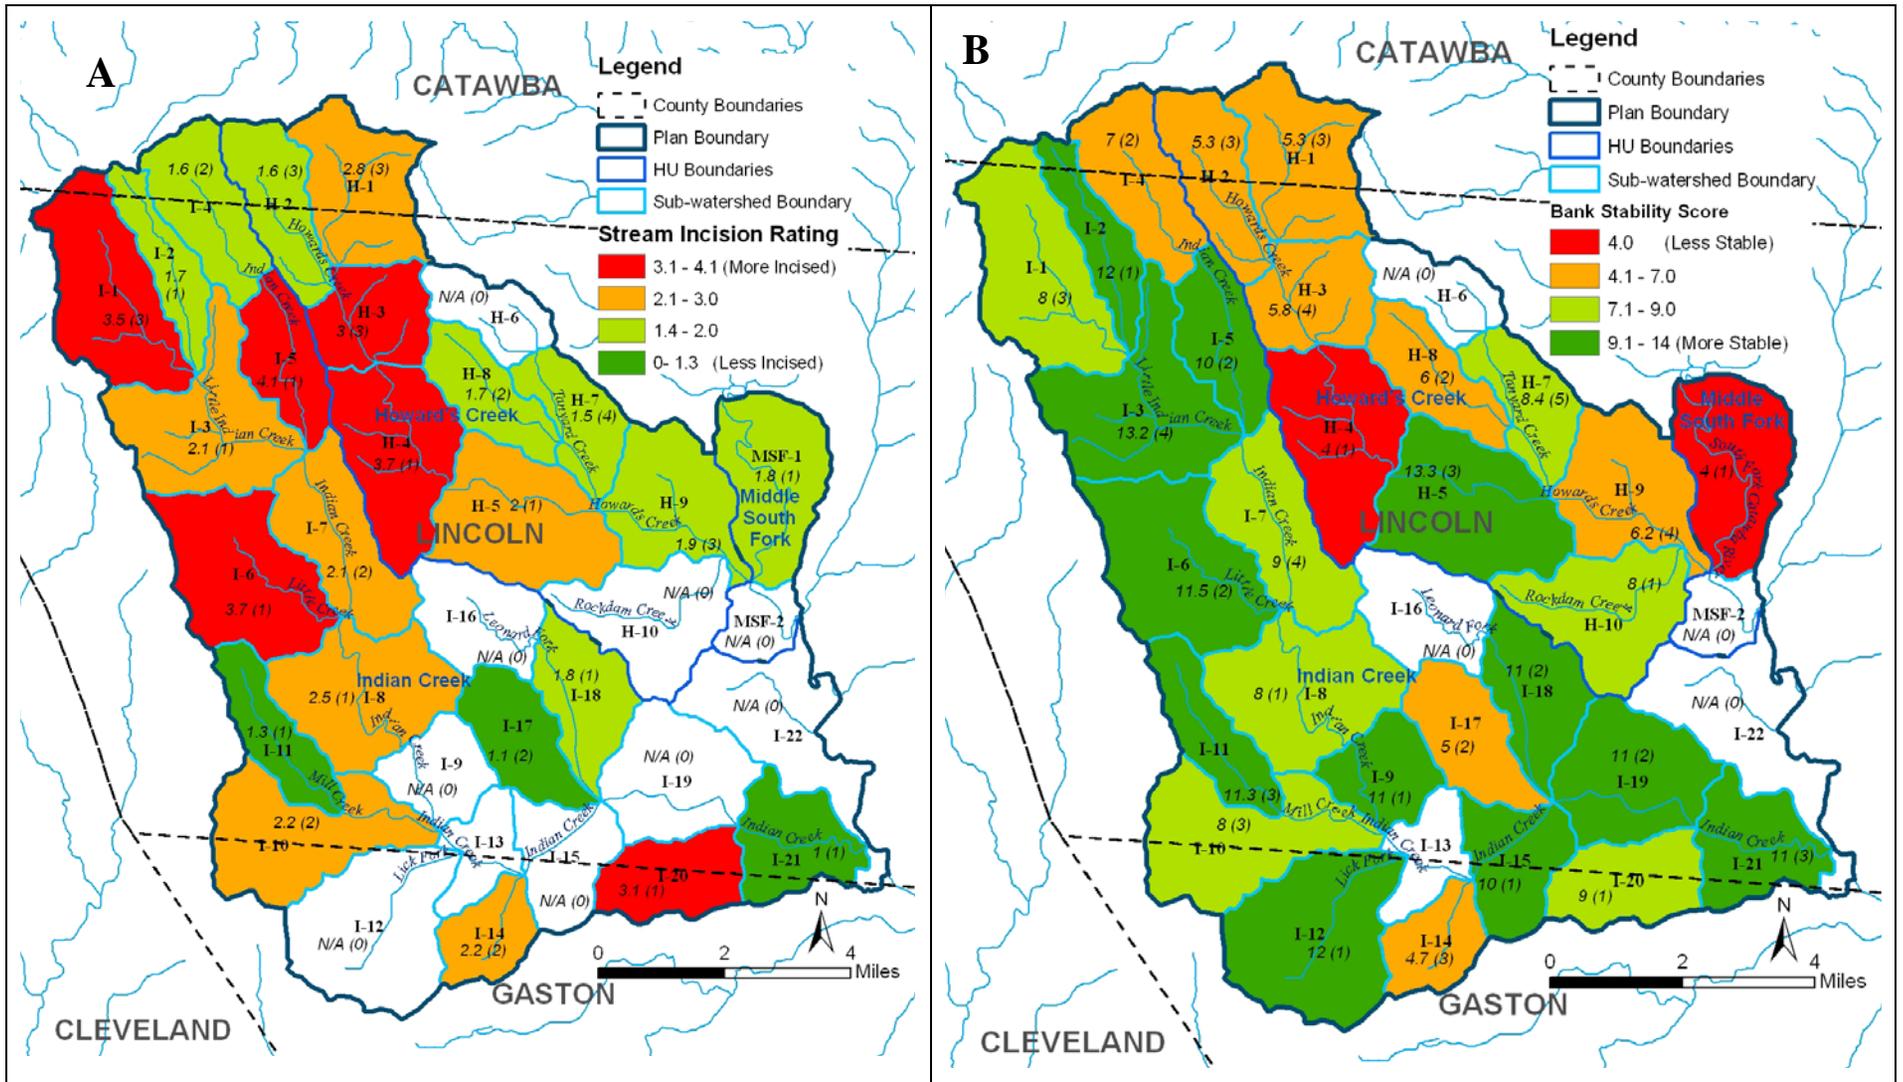
Figure 15. Field Hydrologic Measures by Subwatershed. **A)** Channel Incision Rating. A value of one indicates flood flows should have access to the floodplain. **B)** Bank Stability Submetric. Scores range from zero (unstable) to 14 (stable). (Note: Average subwatershed score is shown in italic and the number of assessments per subwatershed is shown in parenthesis.)

Figure 15A shows the average score for subwatersheds where one or more streams were measured for their level of incision using the CCR. Subwatersheds in both Indian Creek and Howards Creek had streams that were highly incised. Indian Creek, however, had an average CCR of 2.3 which was slightly higher than Howards (2.1) (See Table 6).

A second field measure was used to assess hydrologic condition. This measure, the Bank Stability submetric of the DWQ Stream Habitat Assessment Protocol, was utilized to help evaluate stream bank stability at 68 sites in the LWP area. Values of the submetric range from zero (unstable) to 14 (stable). Figure 16 provides examples of good and poor scoring sites. Figure 15B shows the Bank Stability average score by subwatershed. Overall, bank stability scores at sites in Indian Creek were higher than those in Howards, 9.5 versus 7.2, respectively

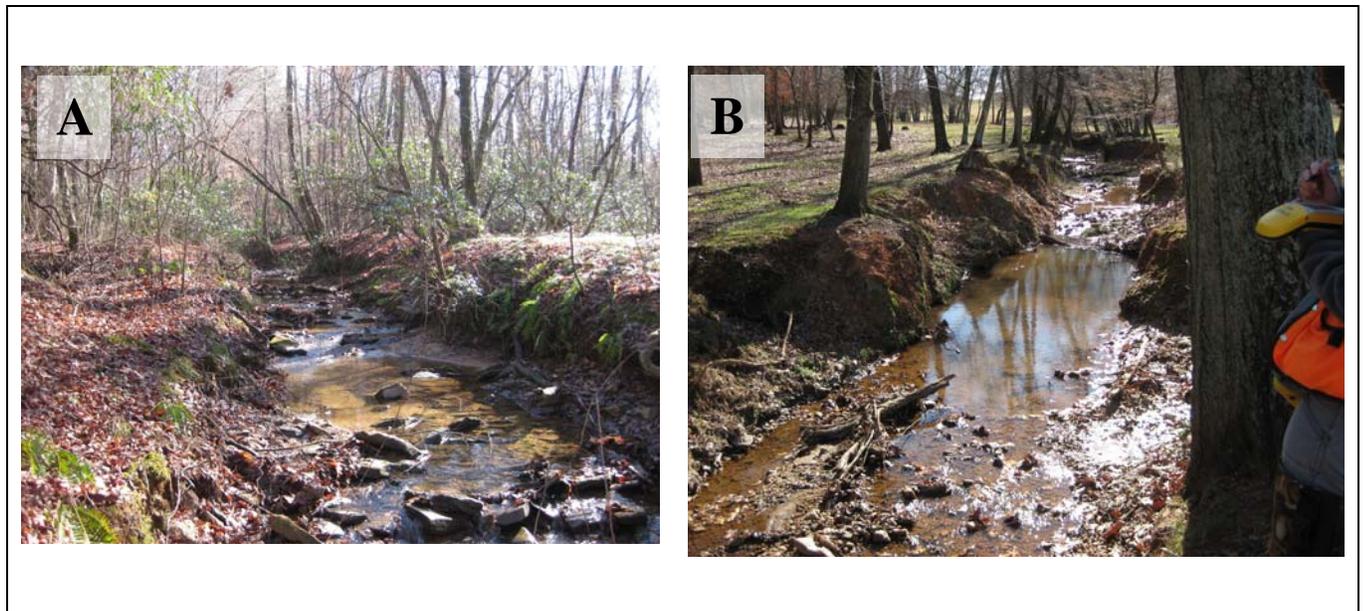
Figure 16. Bank Stability Assessments. A. Good Bank Stability scoring site on a UT to Indian Creek. B. Poor Bank Stability scoring site on a UT to Howards Creek. Generally, good scoring sites have well vegetated stream banks and little exposed or eroding soil.

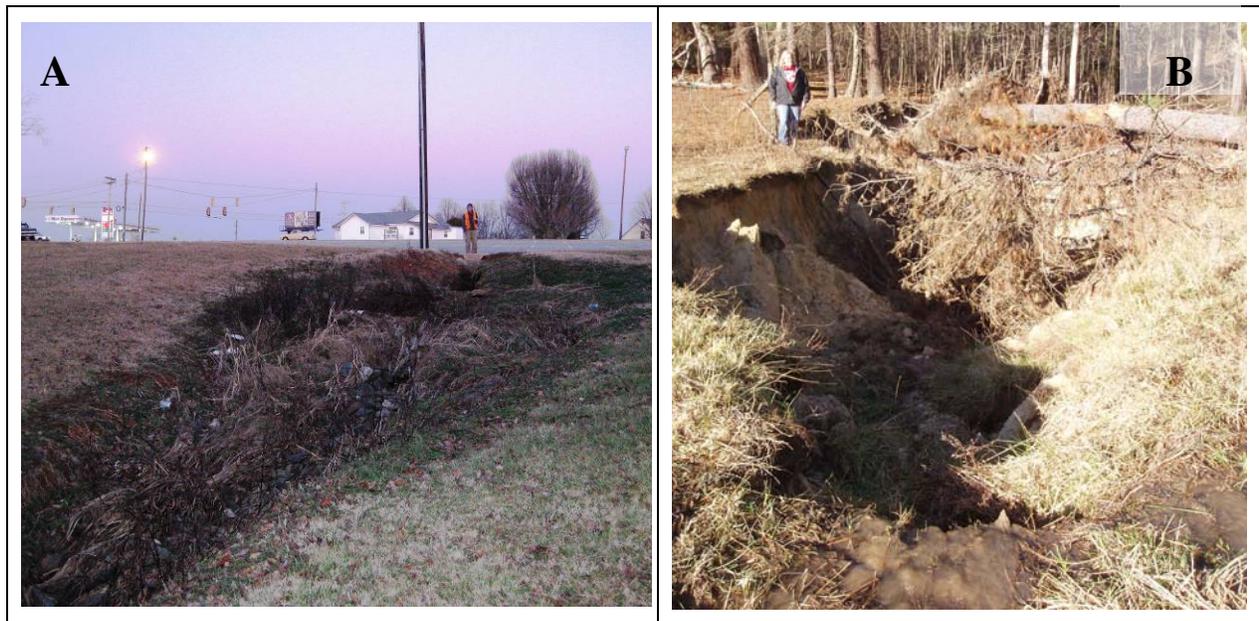
Figure 17. Stormwater Runoff Impacts. A-Gully forming from parking lot runoff at West Lincoln High School. B – Gully migrating upstream due to poorly designed stormwater BMP upstream at the Cherryville WalMart.

During the study, a concerned landowner contacted NC EEP to report a severe erosion problem associated with flow from a poorly designed stormwater treatment BMP draining the Cherryville WalMart in subwatershed I-15. Visits to the site revealed that extreme channel erosion was occurring and transporting many tons of sediment to Indian Creek (see Figure 17B). Stormwater runoff from impervious surfaces at the WalMart in Cherryville had contributed to the erosion downstream of the stormwater detention basin. Holding time in the basin appeared to be inadequate and flow out of the basin was overwhelming the channel capacity of the small UT receiving the runoff. The result is that a large gully has formed on the impacted parcel and erosion has damaged the habitat of the small UT, along with sending tons of sediment to the lower portion of Indian Creek. The landowner of the affected site was in negotiation with WalMart to fix the problem but the site illustrates the problems that can arise from stormwater runoff associated with poor development practices.

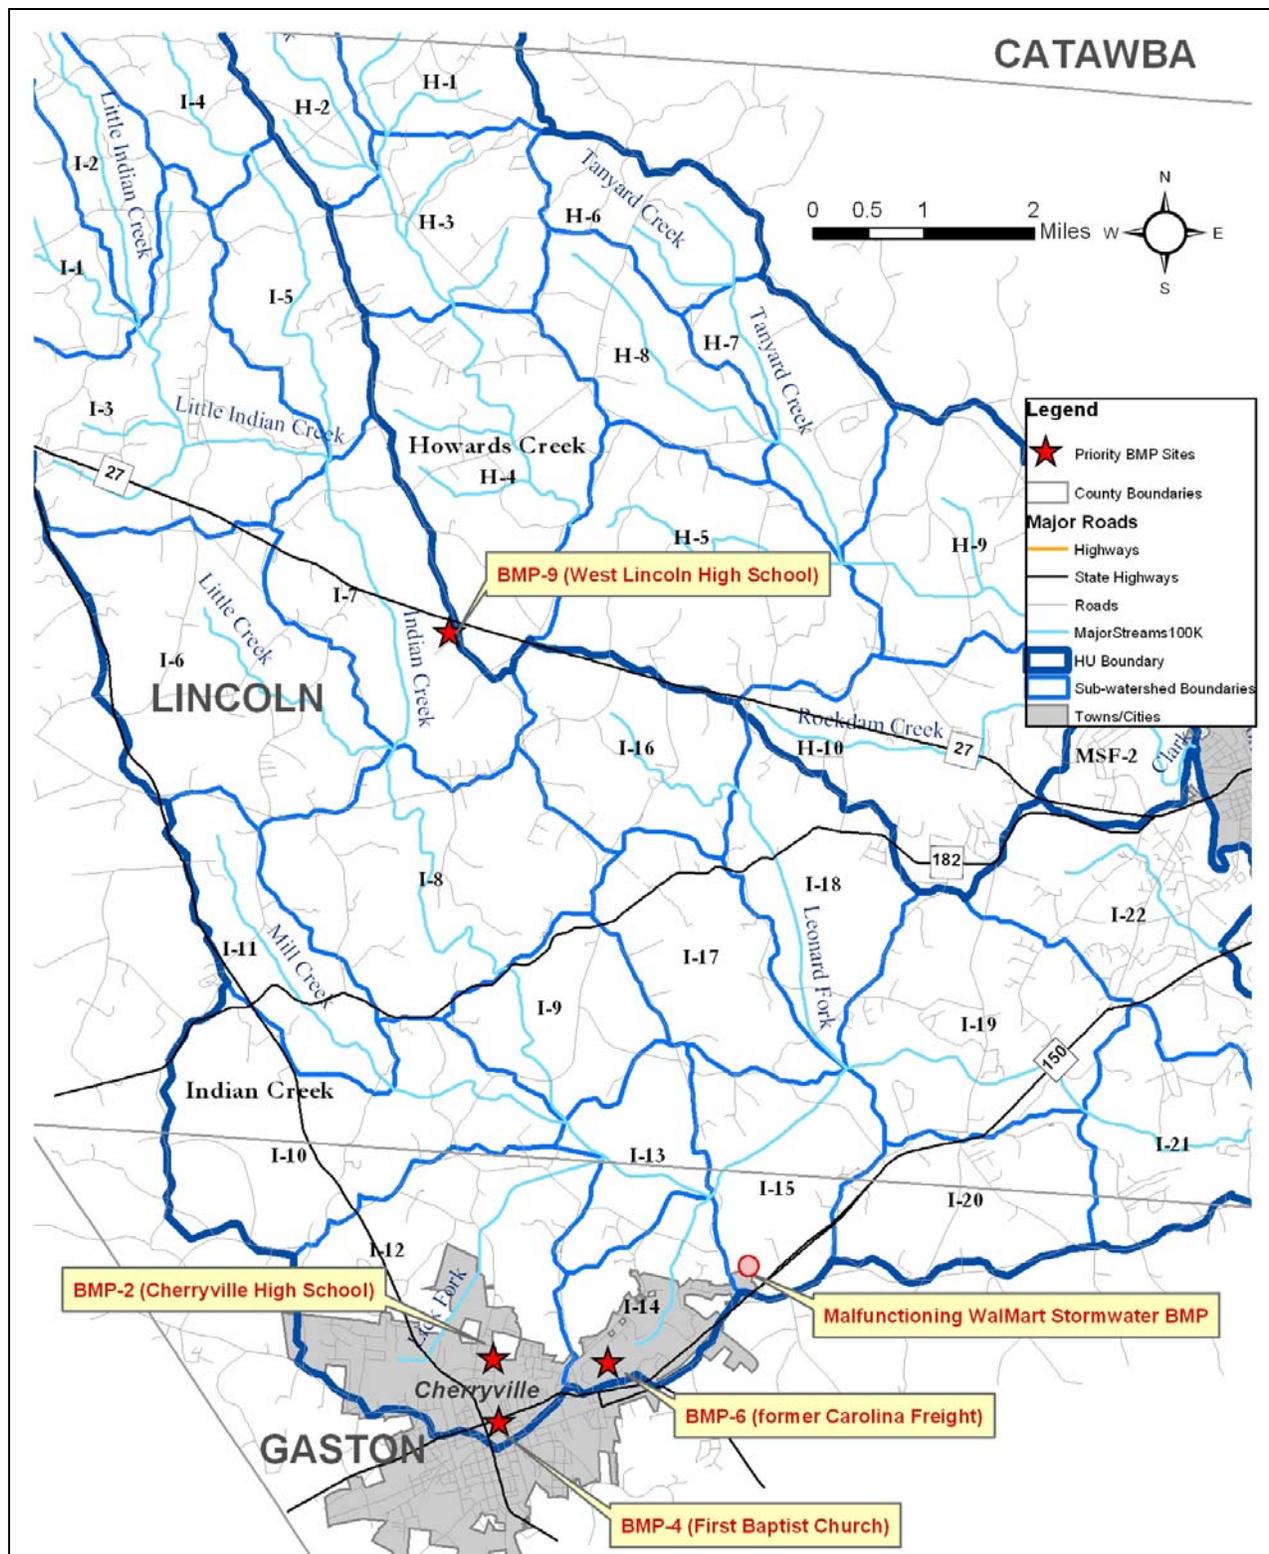
Figure 18. Location of priority stormwater BMP sites and malfunctioning Wal-Mart stormwater BMP. Priority sites were identified using field observations of topography, land use, drainage patterns, available space for stormwater treatment, and assessment of implementation feasibility.

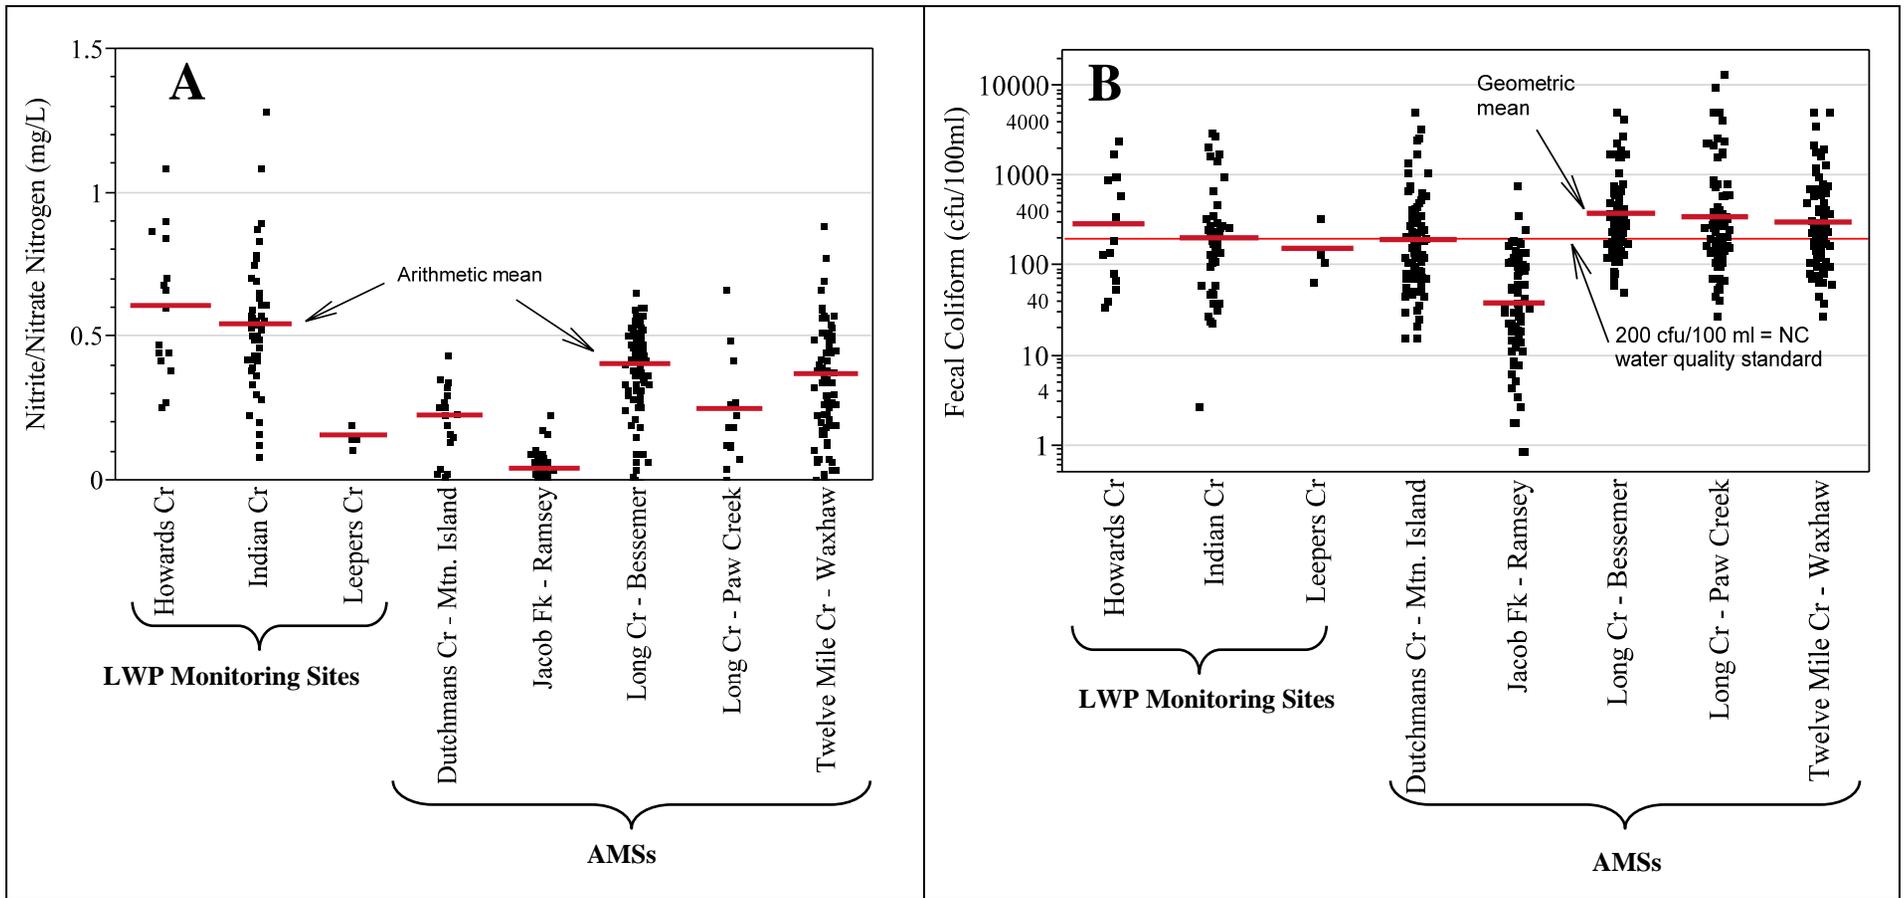
Figure 19. **A)** Nitrite+Nitrate concentrations compared against regional AMS data. The dark red line identifies the arithmetic mean concentration for the watershed.

B) Fecal Coliform concentrations. Geometric mean values for both Indian Creek and Howards Creek (i.e., dark red line) are both above 200 cfu (i.e., light red line). Geometric means of 200 CFU or greater indicate that there may be a violation of NC water quality standards. Bacteria levels in the LWP, however, are not violating water quality standards because the sampling did not meet NC DWQ requirements to assess whether or not water quality standard are being met (i.e., *fecal coliforms shall not exceed a geometric mean of 200/100 ml based upon at least five consecutive samples examined during any 30 day period, nor exceed 400/100 ml in more than 20 percent of the samples examined during such period*).

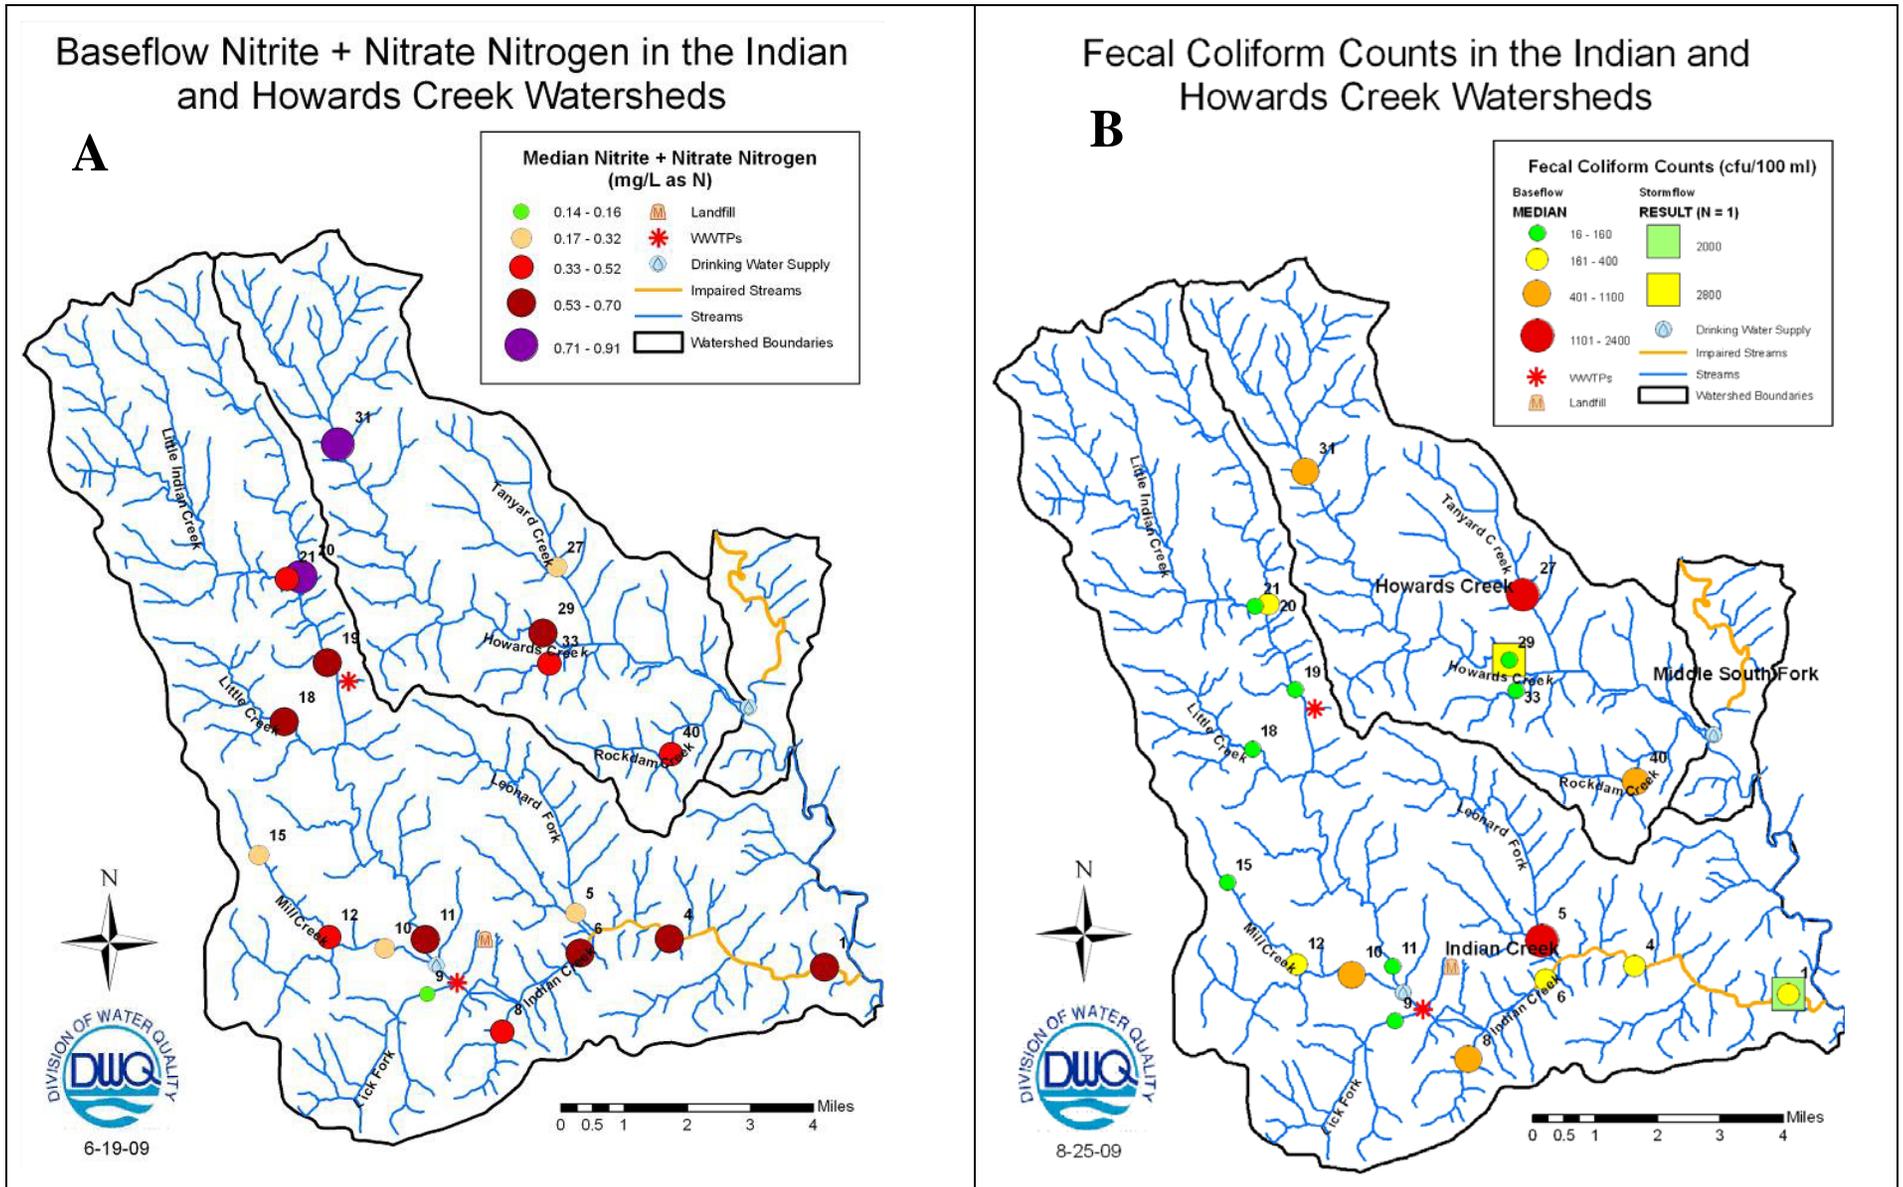
Figure 20. **A)** Median nitrite + nitrate concentrations at LWP monitoring sites. **B)** Median fecal coliform concentrations at LWP monitoring sites.

These data suggest that streams in Indian Creek and Howards Creek may contain pathogenic organisms that could be harmful to both the health of humans. Figure 20B provides median fecal coliform counts by monitoring site in the LWP area.

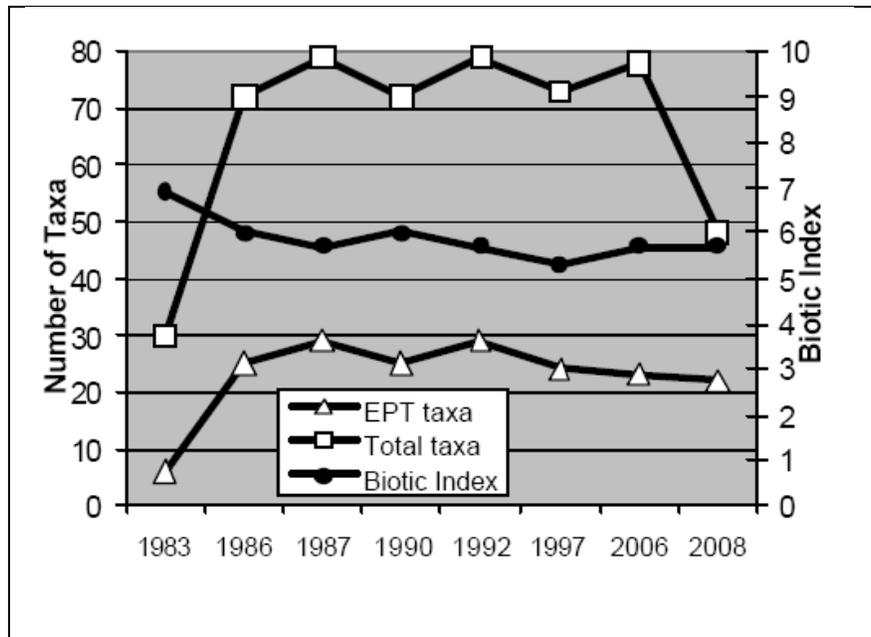
Figure 21. Current and historic Biologic Data at Indian Creek at SR 1252. BAU staff note that drought in 2007/2008 likely contributed to the drop in total taxa between 2006 and 2008.
