Indian Creek and Howards Creek Local Watershed Plan *Watershed Assessment Report*

April 2010

This document was prepared by Mike
Herrmann and Hal Bryson, NC EEP
Watershed Planning.

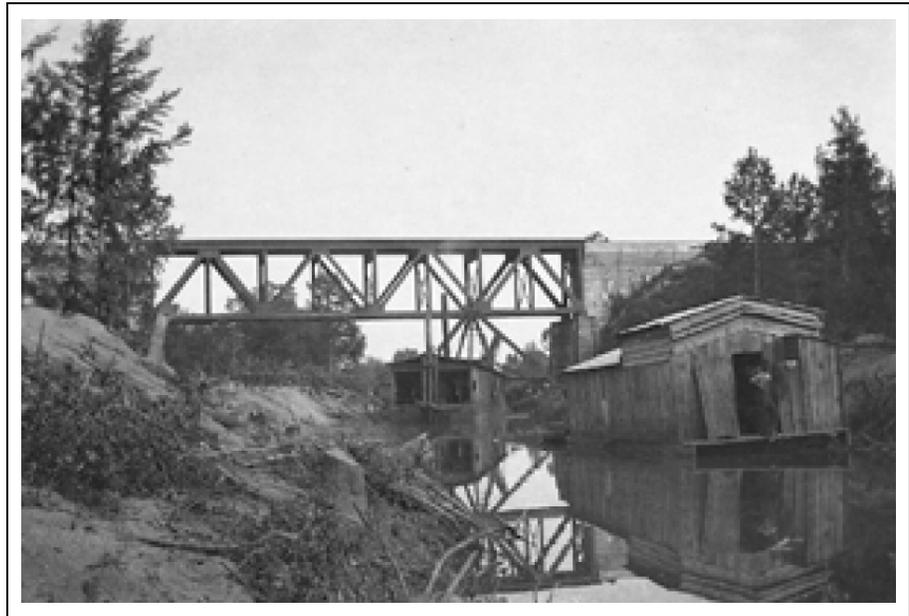
Figure 22. Lower Indian Creek stream dredging circa 1915 (Photo courtesy of the Lincoln County Historical Society.)

The area noted in the article starts at the terminus of Indian Creek at the South Fork of the Catawba River and continues upstream to near Cherryville. Figure 22 is a historic photo of the dredging operation. Its impacts included the draining of swamps, removal of riparian vegetation, levee building, and channelizing of streams. These activities stress stream and wetland functions, necessitating environmental restoration or enhancement.

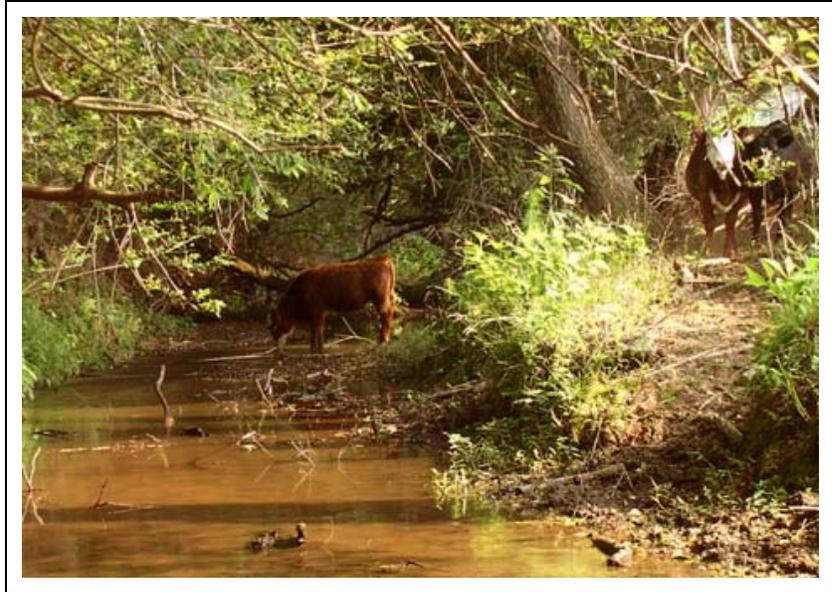
Figure 23. Cattle accessing the stream at Tanyard Creek.

Data collected during Phase 2 of the LWP illustrate the how cattle accessing streams can result in severe impacts to stream health. The geometric mean for bacteria levels in the LWP area exceeded 200 cfu/100 ml, an evaluation level used to gage the health of streams. Five of the six sites with the highest bacteria counts had livestock either accessing the stream or inadequate stream buffers in livestock pasture upstream of the monitoring site. As a result, there was little filtering of runoff and direct input of animal waste to the stream, threatening human health and stressing the aquatic ecosystem.

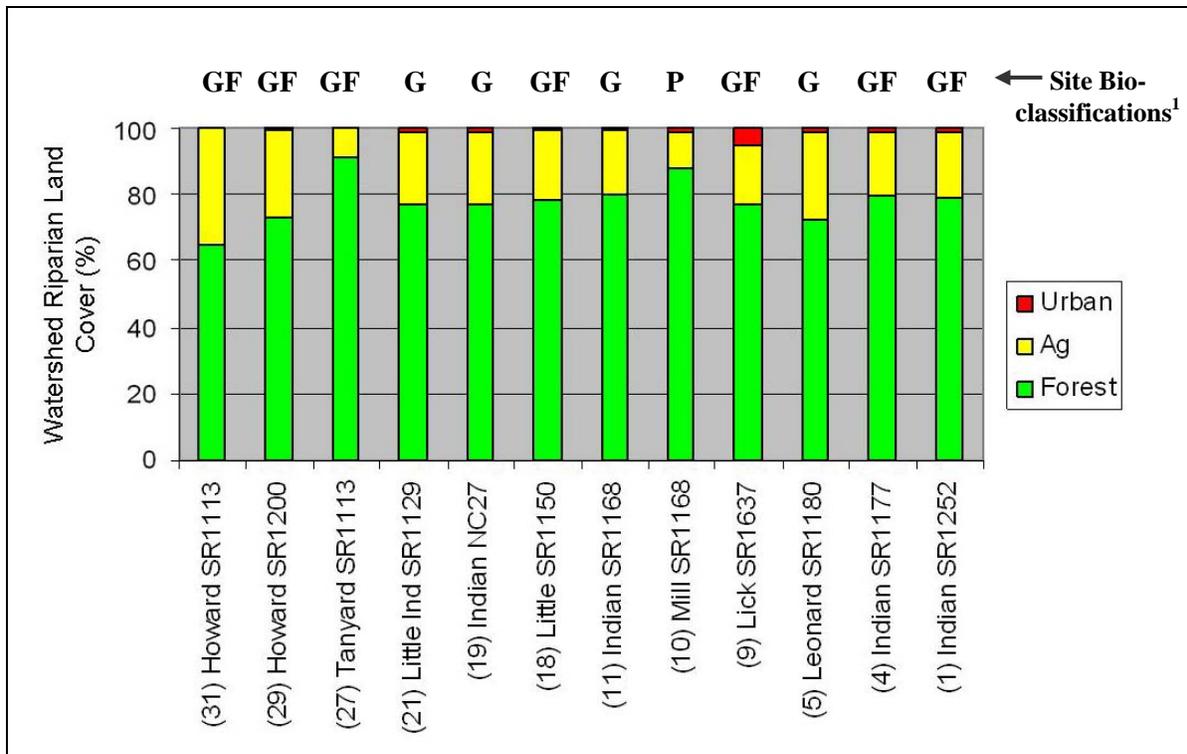
Figure 24. Bioclassifications and watershed riparian land cover for biological monitoring sites. Cattle related impacts at sites 27 and 10 contributed to their lower ratings.

¹Site Bioclassifications based on the most recent rating from Table 7. Bioclassifications: E = Excellent; G = Good; G-F = Good-Fair; F = Fair; P = Poor.

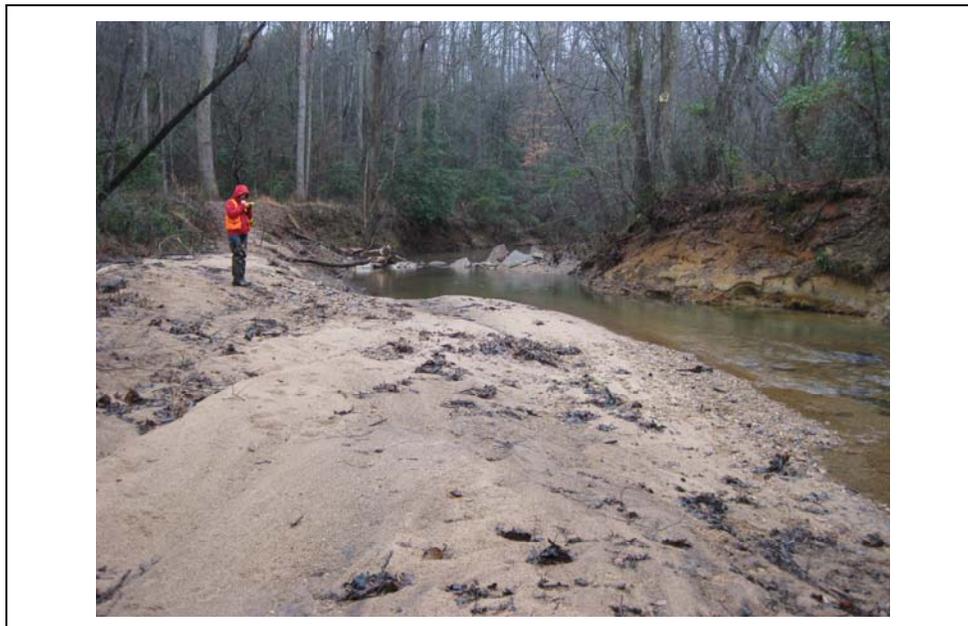
Figure 25. Side bar sediment deposition. Substrate habitat is hindered by an overabundance of sand and silt in streams (Upper Howards Creek).

During stream habitat assessments, an excess level of sediment was noted in many the LWP area streams. Evidence of this condition includes sand dipping operations, sand bars in streams, and poor substrate scores recorded during stream assessments. As show in Figure 25, streams with excess sediment will often have large depositional areas within the stream banks. Problems for aquatic habitat arise when streambed habitat such as riffle areas become embedded with sand or silt, killing off aquatic organisms that live and reproduce on the stream bottom. Sources for this sediment are often unstable stream banks that are eroding due to high velocity flows, a lack of streamside woody vegetation, or hoof sheer from livestock accessing streams. These stressor sources were noted throughout both watersheds, but were more frequently observed in Howards Creek.

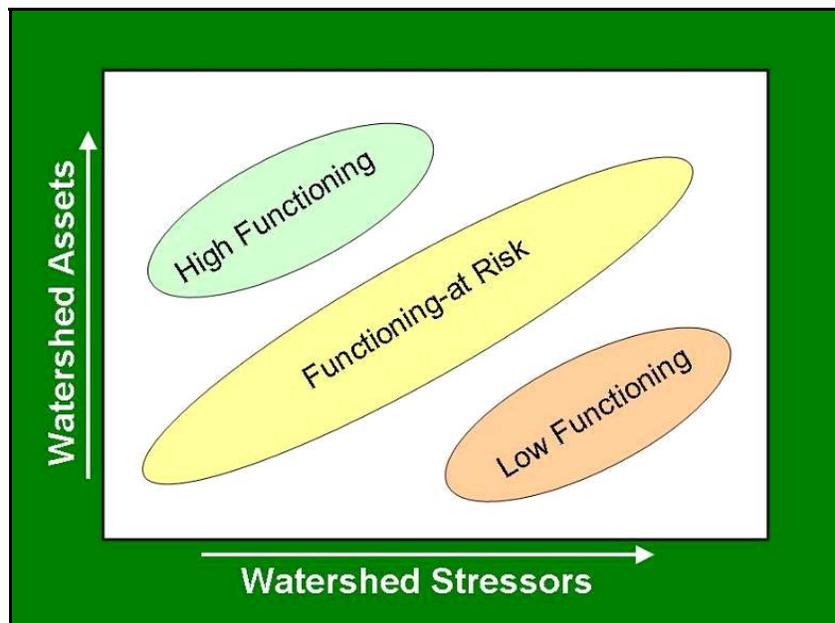
Figure 26. Conceptual Diagram for Rating Watershed Function.

The concept of rating watershed functions is illustrated in Figure 26. Generally, those watersheds with more assets (i.e., high-quality habitat, forested riparian and floodplain area, stable banks, undisturbed uplands, etc.) and few stressors are classified as high-functioning watersheds. These watersheds are likely to be good candidates for preservation opportunities. Watersheds with impacted streams, wetlands, and floodplains are under increased stress and unable to sustain functions. These lower functioning systems have little high quality habitat to preserve, but are more likely to contain stream and wetland restoration and enhancement opportunities. Watersheds in the middle, functioning-at risk, require a mix of conservation and restoration actions to maintain or improve their functions.

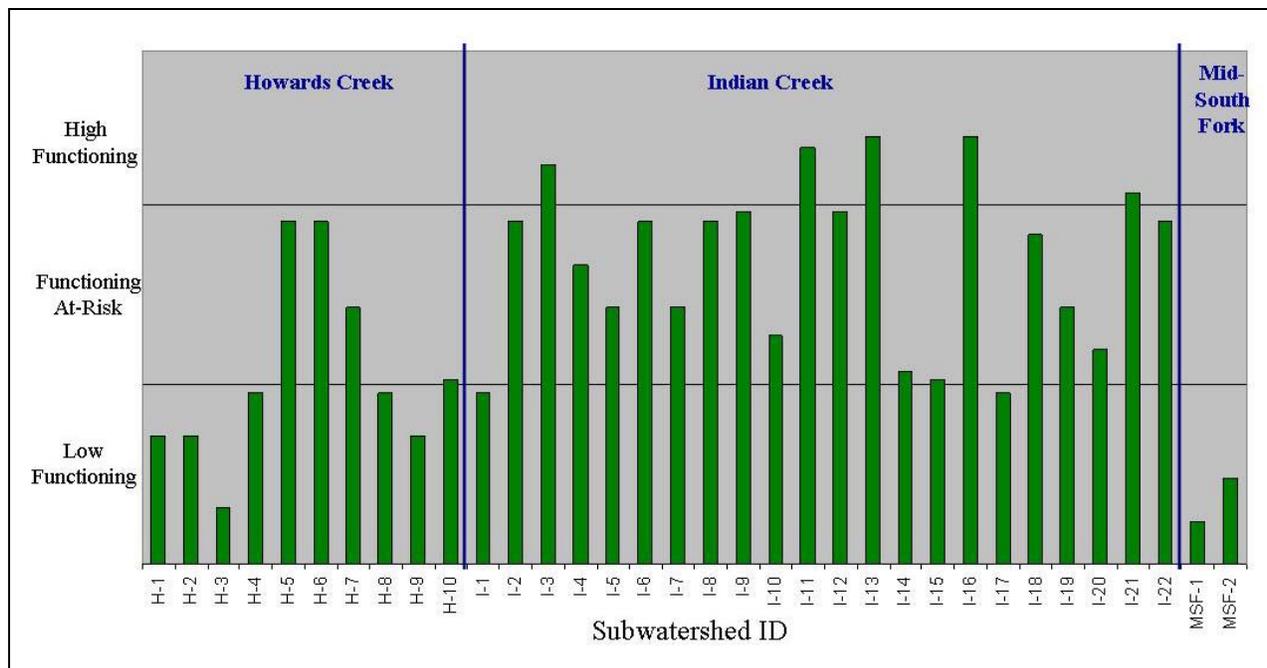
Figure 27. Overall Subwatershed Function Ratings (Based on data in Appendix C).
