# National Register Eligibility Evaluation of the Phillips-Baker House for the Replacement of Bridge 196 over Moccasin Creek on SR 2308 (Fowler Road/Henry Baker Road)

*Wake and Franklin Counties, North Carolina*

TIP No. B-4662  
WBS No. 38457.1.2

November 11, 2016 • **Final Report**  
New South Associates Technical Report 2630

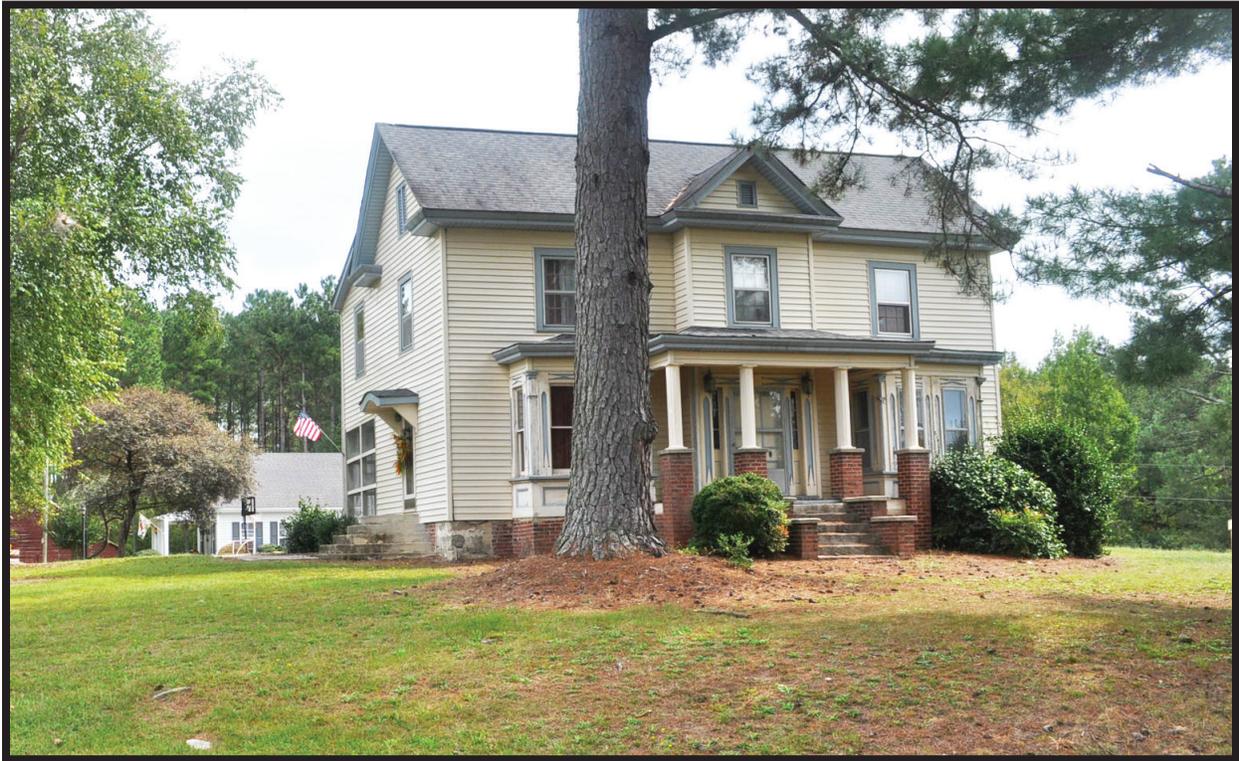
Figure 4. Phillips-Baker House, View from Henry Baker Road Looking Southeast With Garage/Office and Livestock Barn in Background

The circa 1870 Phillips-Baker House is a two-story dwelling with a one-story rear ell (Figures 4 and 5). It is notable for the vernacular decorative detailing of the façade, which consists of a two-story pedimented central entry bay, flanking window bays and a front porch. The Phillips-Baker House began as an I-house around 1870 and was expanded and remodeled several times. The dates of these changes are estimates based on knowledge of local building traditions. A significant portion of the house's original form and building materials have been lost or obscured; however, enough remains to understand the phases of construction.

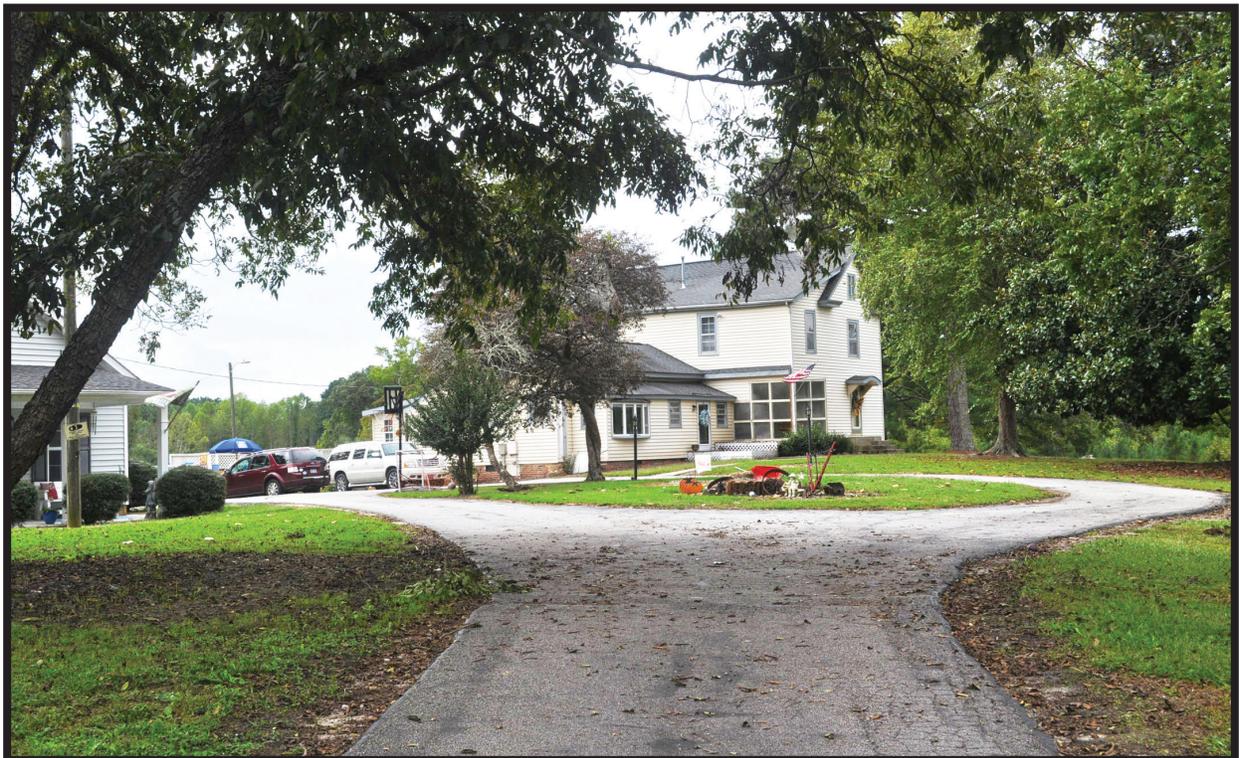
Figure 5. Phillips-Baker House, View from Driveway Looking Southwest With Front of Garage/Office in Foreground

The oldest sections of the Phillips-Baker House are the two-story, I-house main block and the one-story, hipped-roof rear ell projecting from the east side (Figures 5-8). The gable end returns in the main block suggest a post-Civil War date of construction. The hipped roof form and one remaining decorative corner pilaster of the ell suggest it began as a detached kitchen, or perhaps an earlier Greek Revival cottage, which was later joined to the main block (Figure 9). The earliest addition, a two-story shed off of the east side (rear) of the main block, is estimated to have been built after 1900 given the presence of its four-over-four windows. The visible remnant of a roofline above the screened porch at the house's southeast corner may be a clue that the house was built with a full-width rear shed, which was raised to two-stories (Figure 10). At this same time, the detached kitchen was extended to the west and connected to the main block.

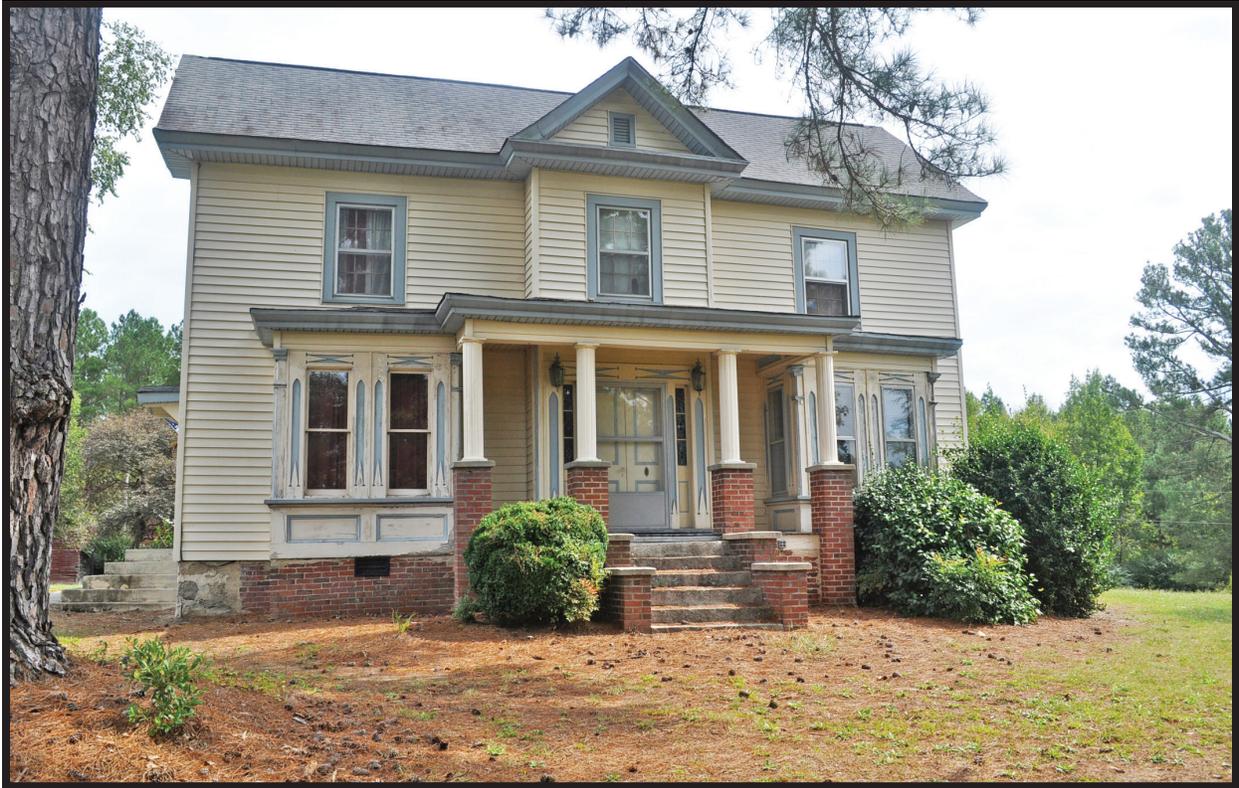
Figure 6. Phillips-Baker House West Side

ell's original shed room (see Figures 6 and 7). The circa 1995 addition is distinguished from the older parts of the house by its six-over-six vinyl windows.

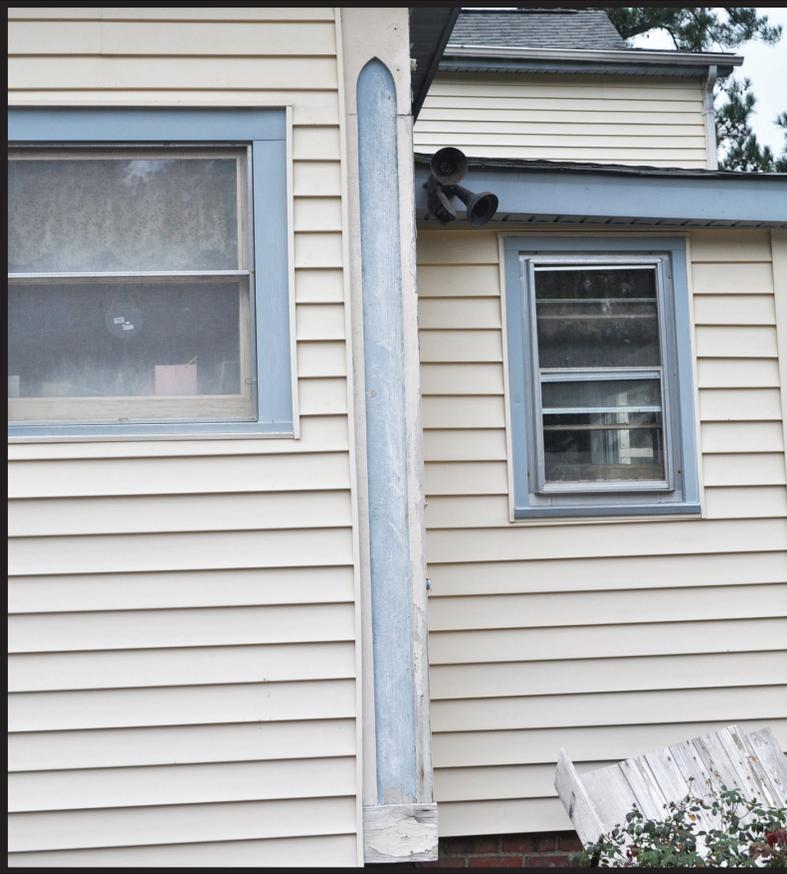
The hipped-roof porch on the north side of the ell was enclosed at an unknown date (see Figure 10). The original wood siding is visible under the porch enclosure. The ell's roofline indicates it originally had a shed room across its south side (see Figure 7). Also supporting this hypothesis are the rough-cut granite piers that underpin the shed room and are similar to those supporting the main block. Most recently, around 1995, a shed addition was constructed on the south side of the

Figure 10. Decorative Pilaster at Northeast Corner of Rear Ell

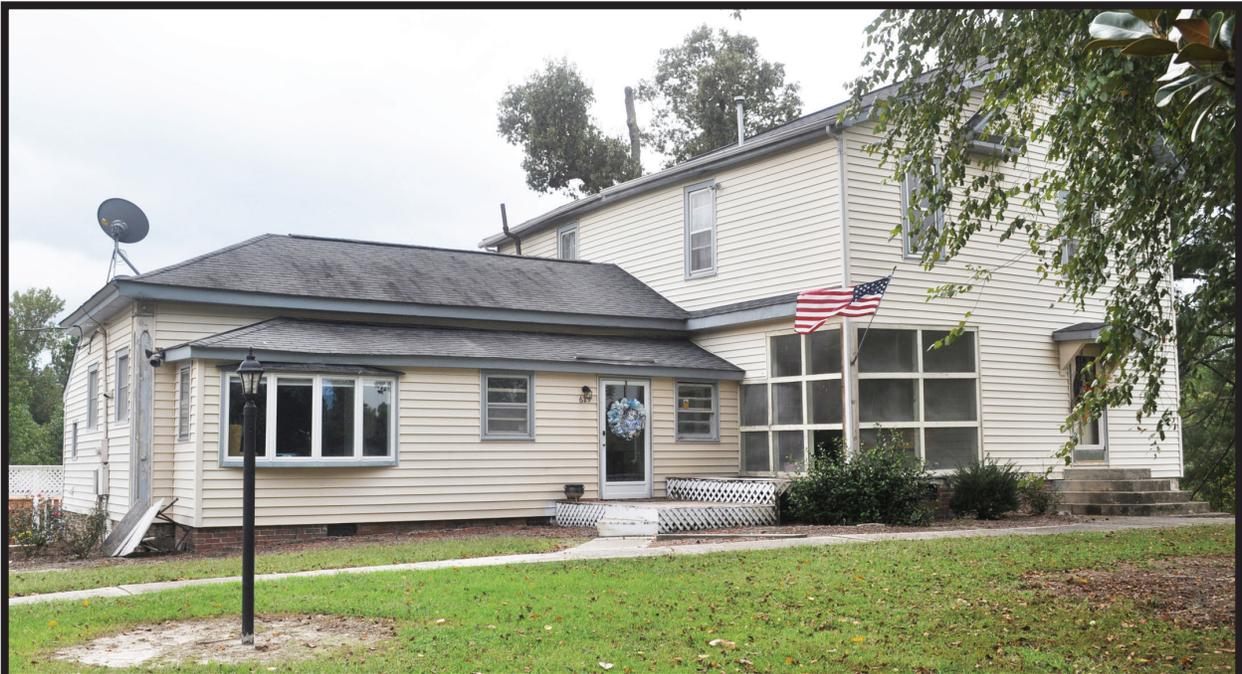
Vinyl siding covers the exterior of the house including the eaves, window trim and soffits and unifies the various additions and alterations (Figure 11). The decorative pointed-arch corner board of the rear ell and the door and window trim of the façade were not covered with vinyl (Figure 12 and 13). The façade features two projecting window bays with paired one-over-one replacement window sashes over paneled aprons. Between the two bays is a projecting porch supported by four, round, vinyl-wrapped half-height columns on square brick piers with concrete caps. A set of granite steps with brick sidewalls leads from the ground to the porch (Figure 14). The porch, from the roof down at least, is a later replacement and appears to date from the 1910s or 1920s. The Greek Revival double-leaf doors are flanked by three-part sidelights with leaded glass (see Figure 13). Both the door and window surrounds of the façade are trimmed in Gothic-influenced pointed arched cut-outs with triangular “legs” and half-round “feet” (Figure 15). Above the window openings the trim board is incised with an x-pattern with the leg-and-foot motif turned horizontally.

Figure 11. Phillips-Baker House Looking Southwest To Screened Porch and Roof Line Remnant

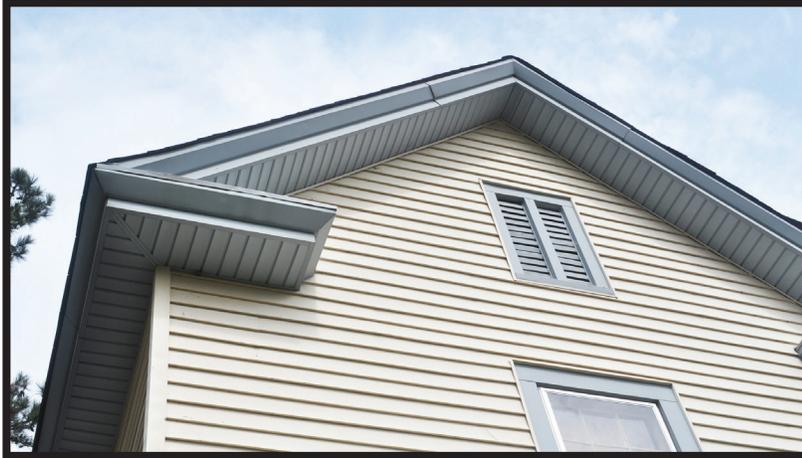
Figure 12. South Gable Showing Vinyl Siding

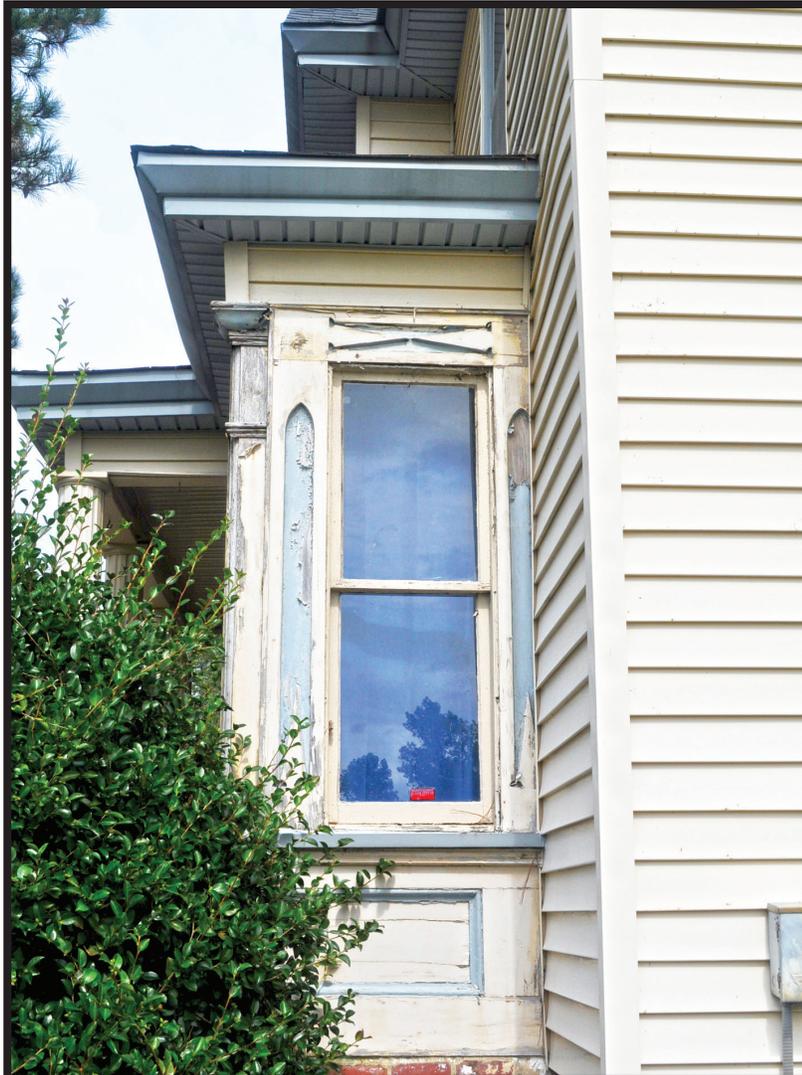
Figure 13. Trim Detail of Bay Window at Southwest Corner of Façade

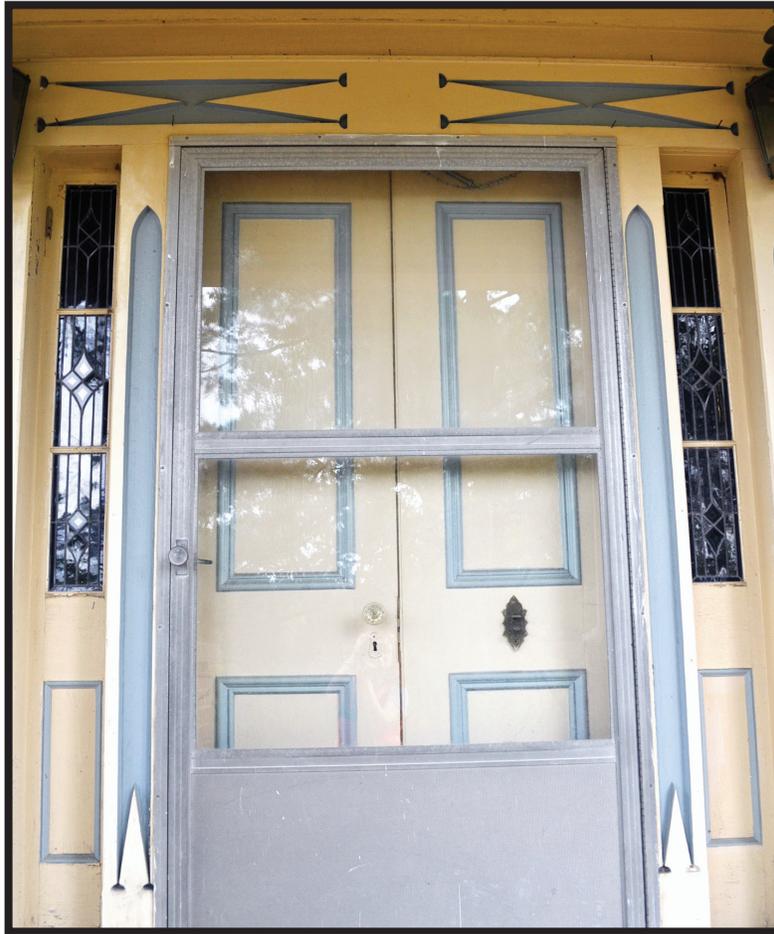
Figure 14. Entry Doors

A number of window types are present and reflect the renovations to the dwelling. The I-house has six-over-six windows. The two-story shed addition has two-over-two windows. All of the windows in the ell and its various enclosures and additions are non-historic and include wood one-over-one and two-over-two sashes, a four-sided projecting bay window, and vinyl windows in both six-over-six and four-over-four configurations. An earlier fixed, four-light sash remains in the rear (east) wall of the ell's shed room. In addition to the facade entry, there are two entries in the ell; a modern door at the east end of the north side and a metal door with a fanlight on the east wall of the ell addition. On the north side of the I-house section the first floor window opening was replaced with a wood paneled door with a fanlight (Figure 16). This opening is surmounted by a bracketed arched pent. A three-sided set of poured concrete steps leads to the doors. This door opening was probably added the same time as the front porch in the 1910s or 1920s.

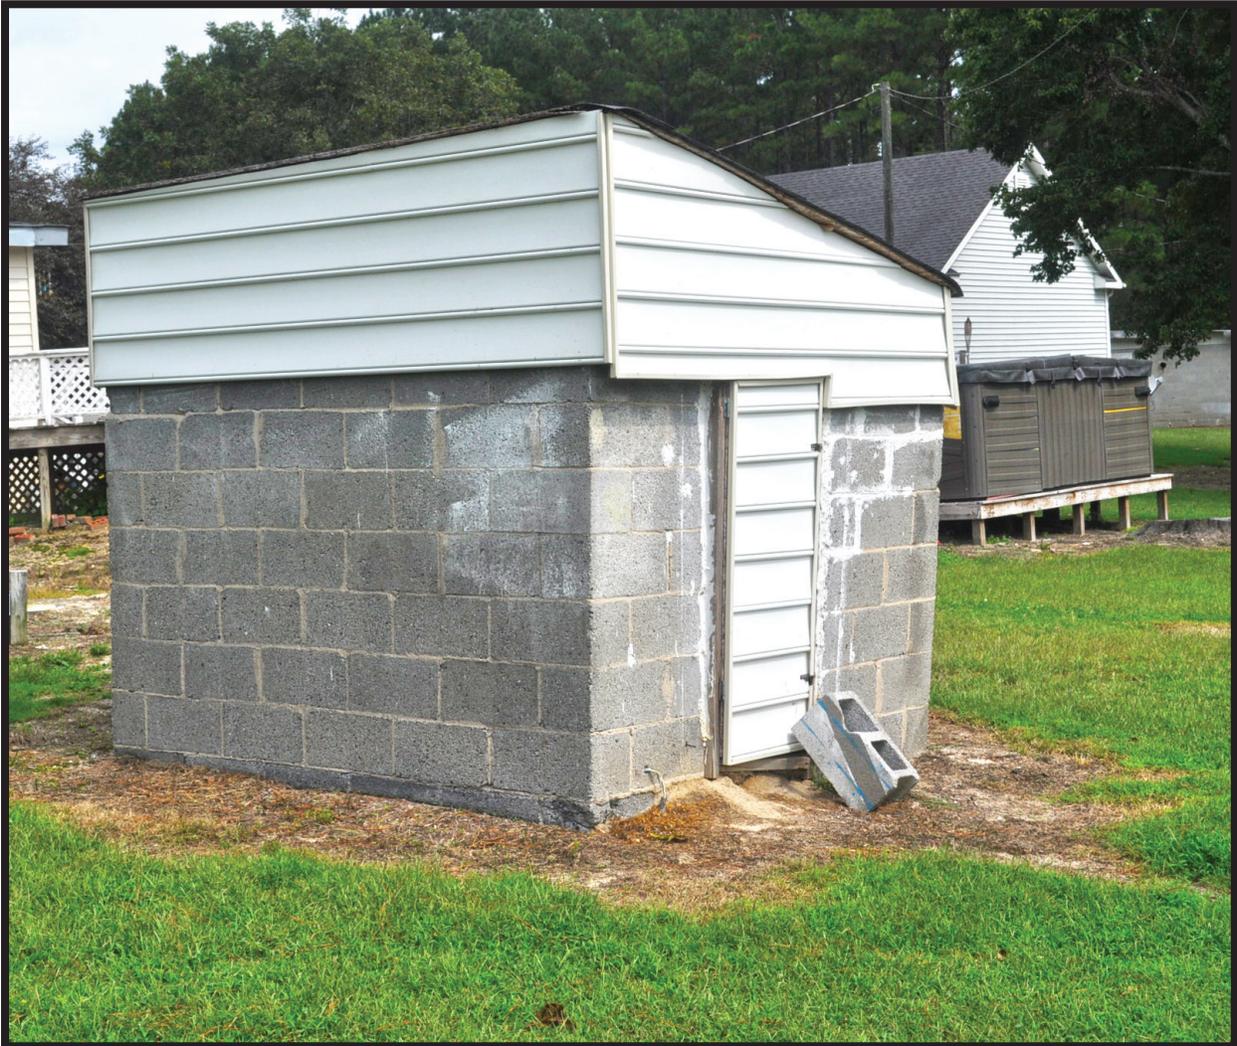
This low shed-roof pump house has concrete block walls and a composite shingle roof (Figure 18). The eaves and door are covered with vinyl siding.

Figure 18. Pump House, South and West Sides

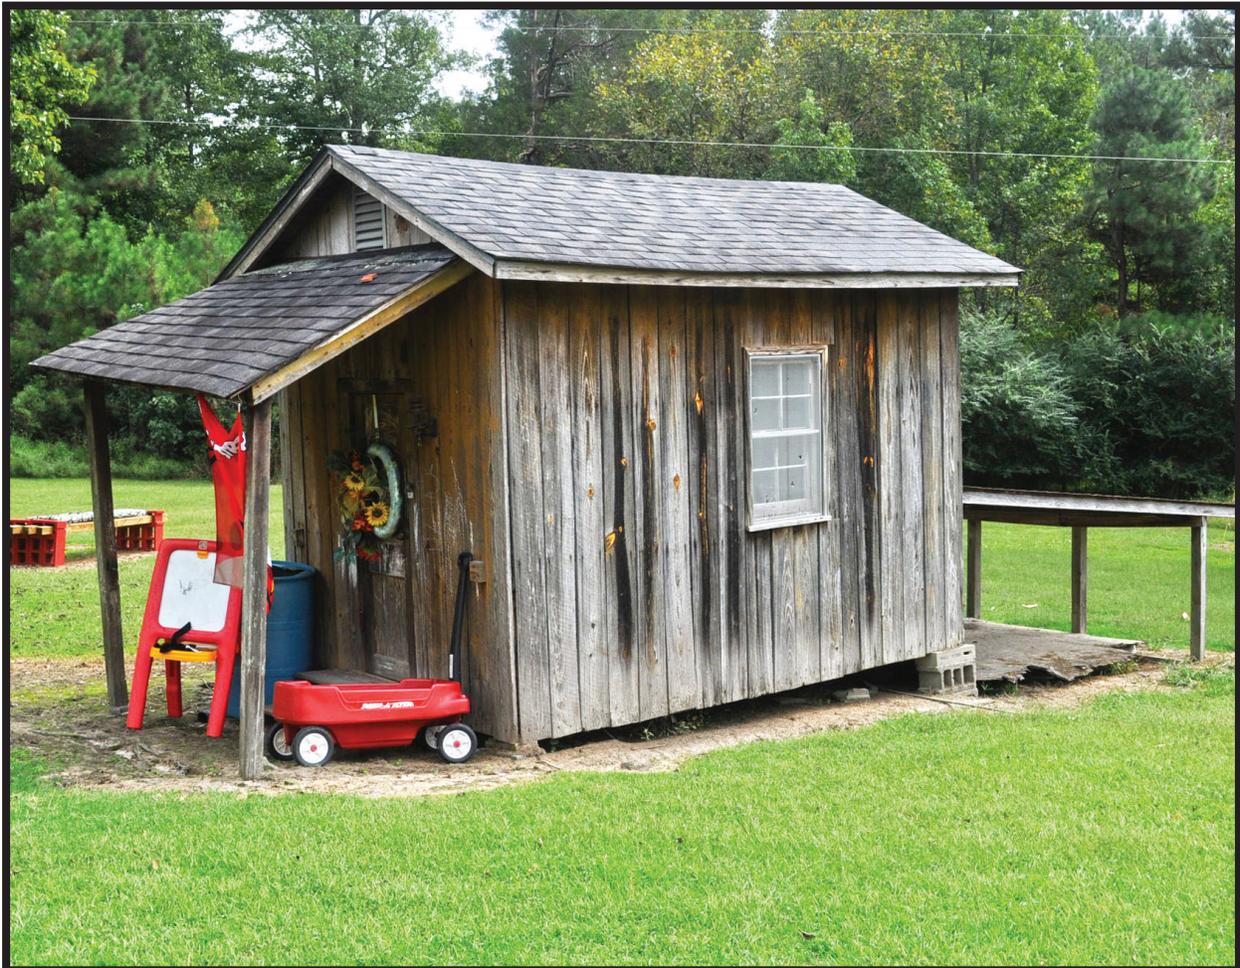
This front-gable shed has plank walls and a composite shingle roof (Figure 19). The building sits on a foundation of concrete block piers. Open sheds project from the gable ends. A rectangular gabled vent and paneled entry door are in the north gable end. The east and west sides have a four-over-four window sash.

Figure 19. Plank Shed, West Side

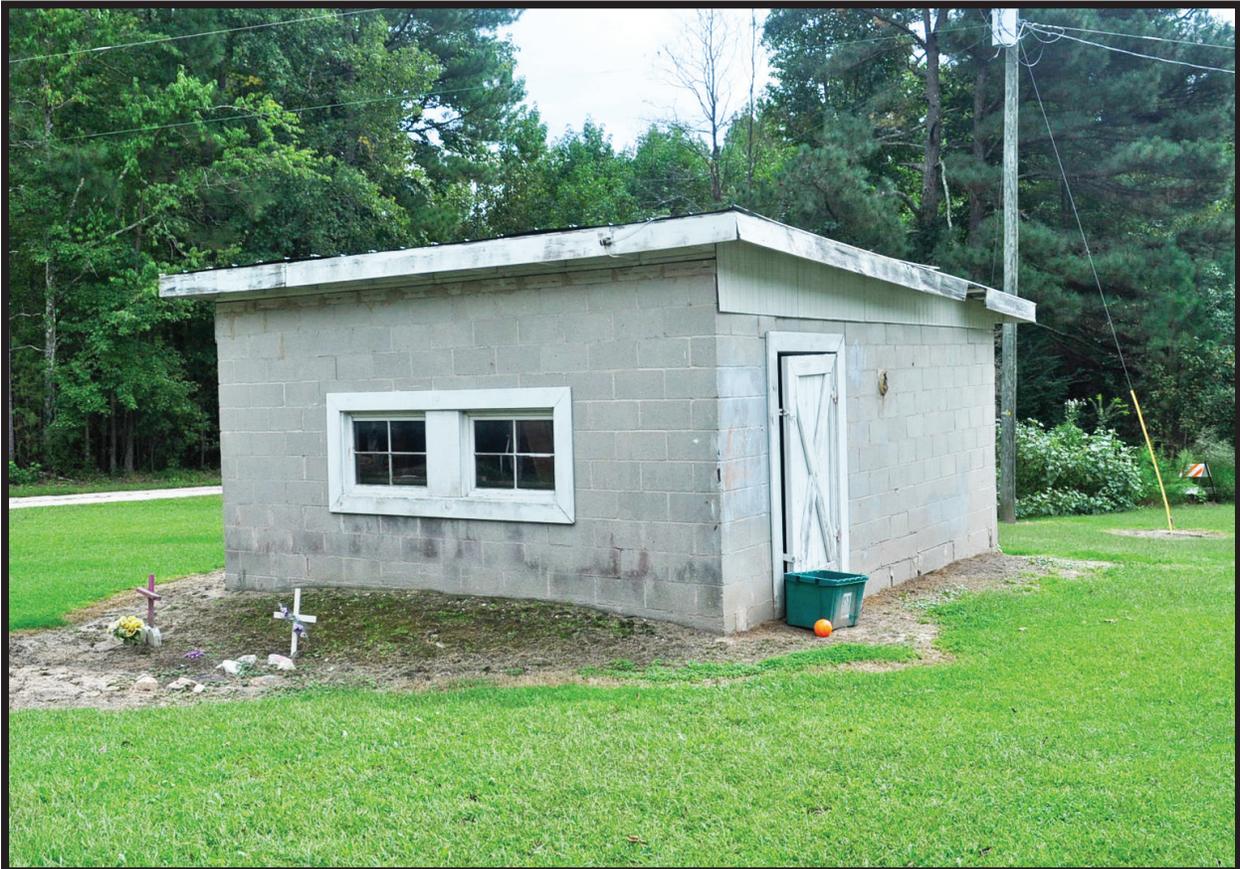
This square concrete block storage shed has a shed roof covered with composite shingles (Figure 20). The entrance is an X-batten door on the east side. The only window is a paired four-light slide window on the north side.

Figure 20. Concrete Block Shed, North and West Sides

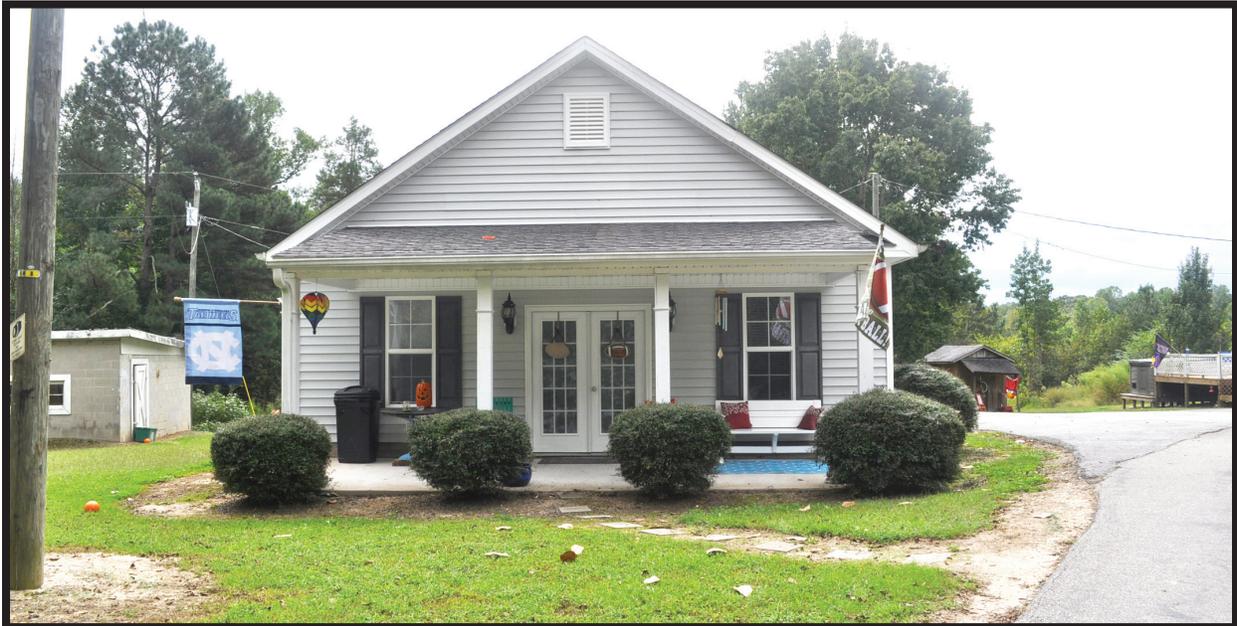
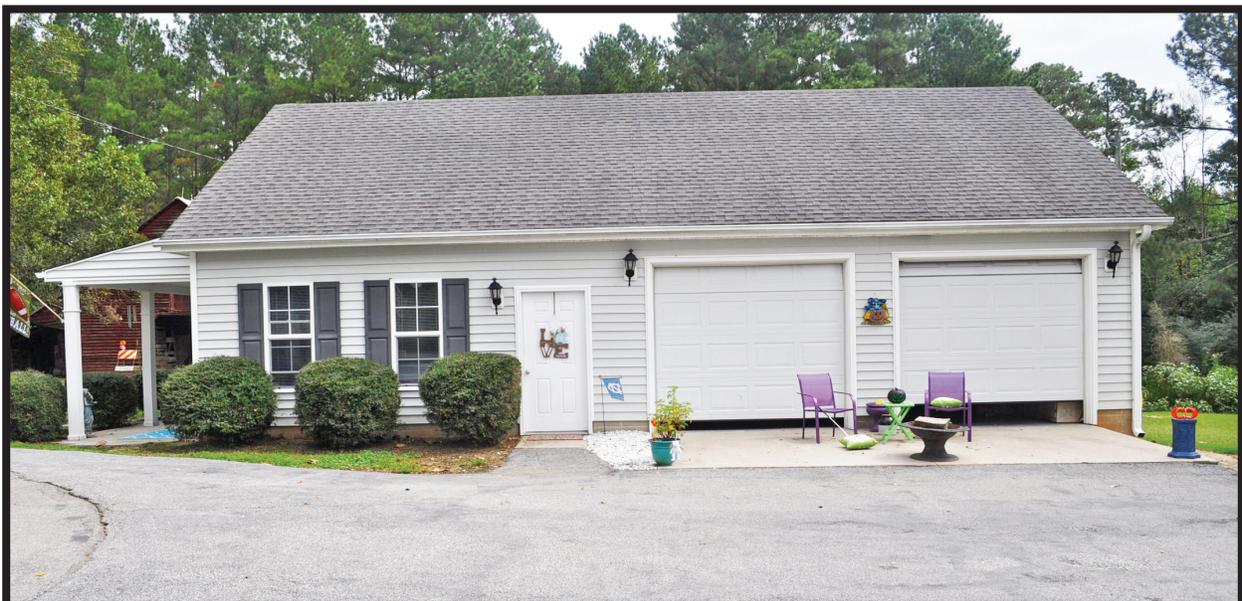
This one-story front-gable building has dual uses. An office occupies the north end and a two-car garage takes up the south end of the building (Figure 21 and 22). The office has been crafted to look like a residence with a central French door entry flanked by four-over-four vinyl windows set under a shed porch. Two garage doors are on the west elevation. The building is covered with vinyl siding, the roof is composite shingle, and the foundation is poured concrete.

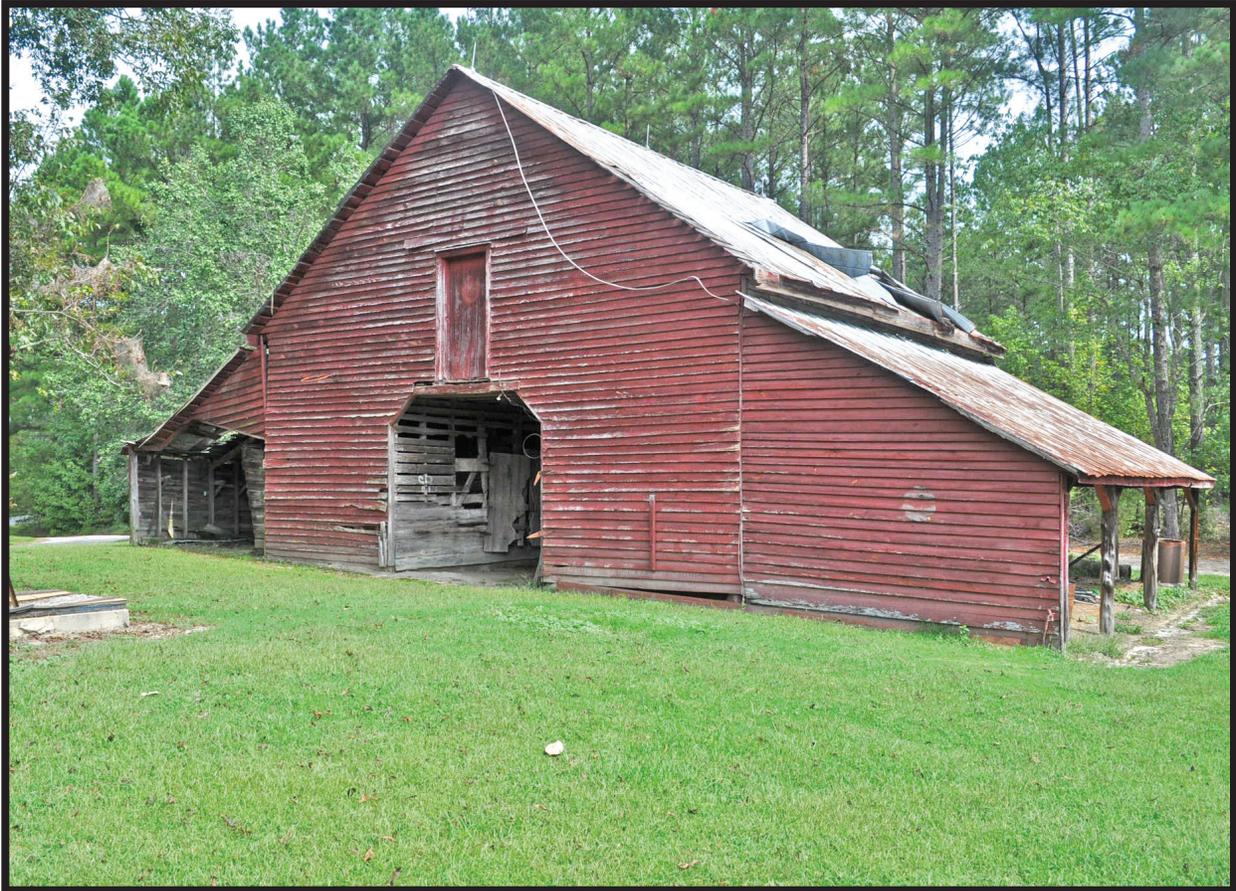
This weatherboarded gabled livestock barn has a central passage parallel with the roof ridge and partially enclosed sheds on the north, east and south sides (Figure 23). On either side of the central passage are livestock stalls. The hayloft is accessed by a doors in the gabled ends. The metal sheathing of the roof has been dislodged in some places exposing the roof's skip sheathing.

Figure 23. Livestock Barn, West Side

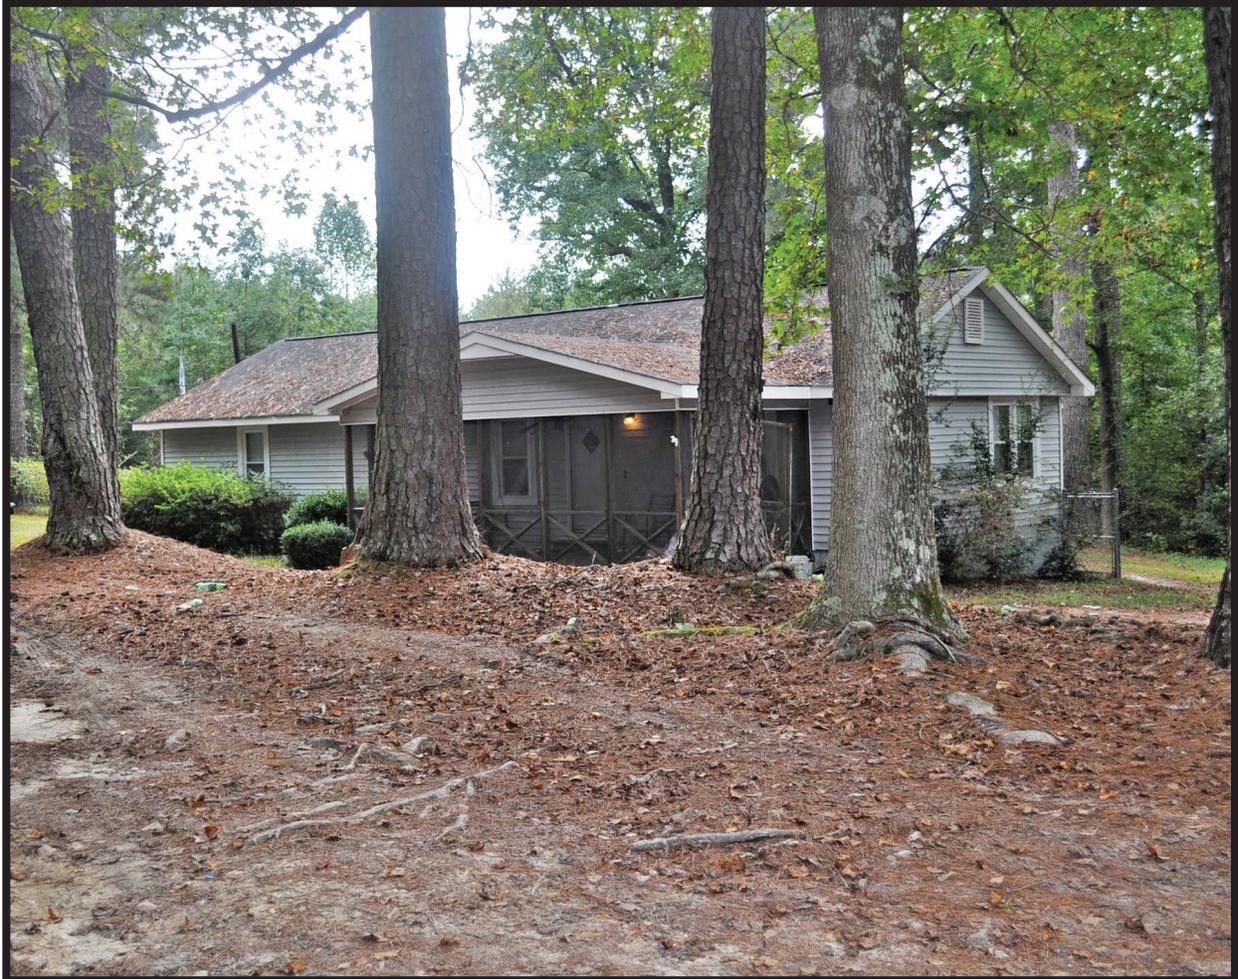
This one-story side-gable house has a screened front porch on the north side (Figure 24). The house has vinyl siding and windows and is topped by an asphalt shingle roof.

Figure 24. Modern House, Northwest Side

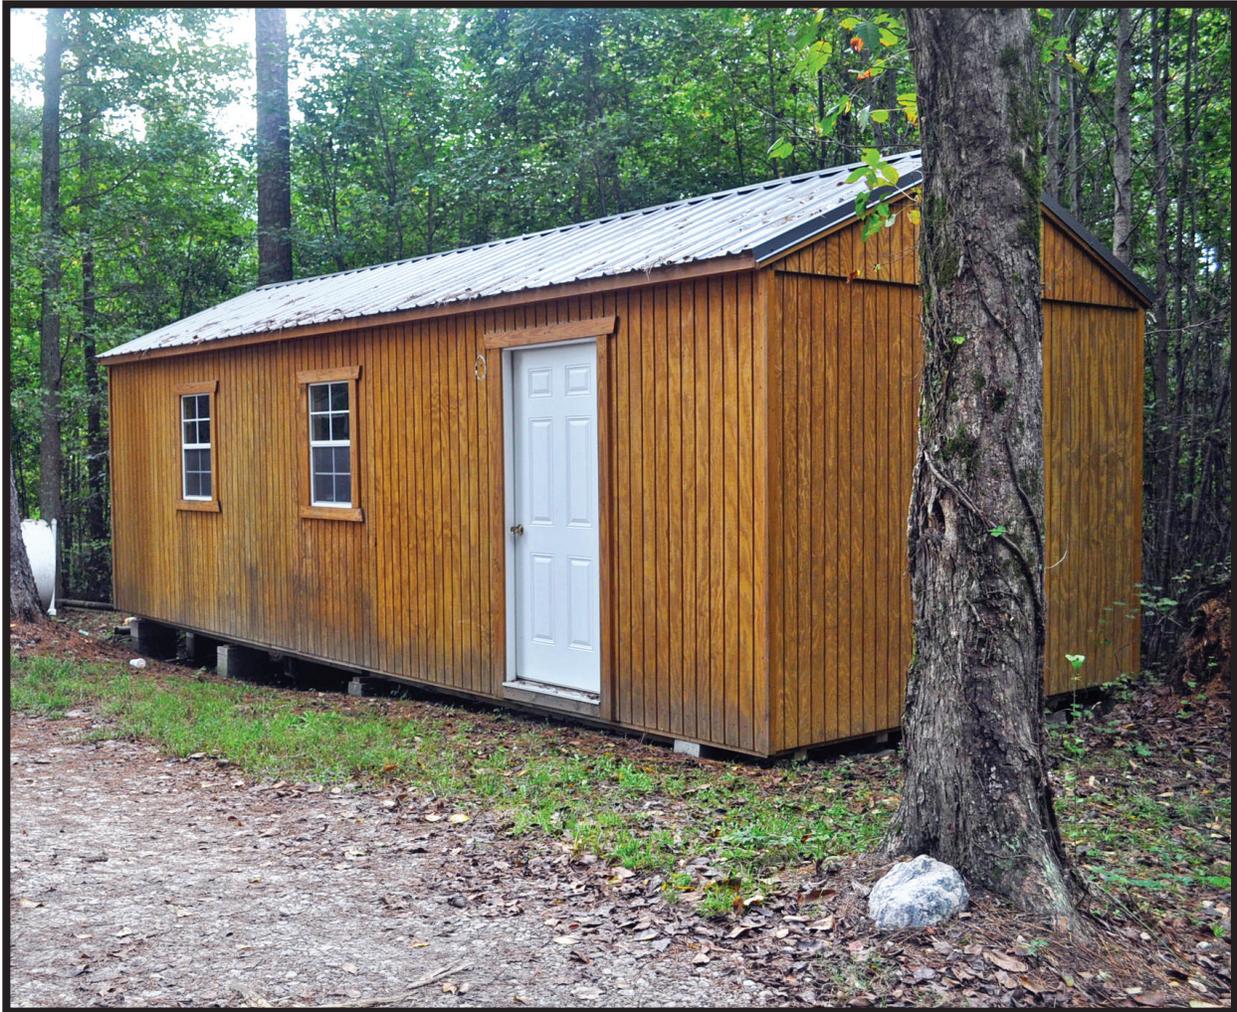
West of the circa 1995 house is a prefabricated storage shed with T-111 type wall sheathing and a metal roof (Figure 25). The shed sits on concrete block piers. A metal door and two vinyl windows are on the north side.

Figure 25. Prefabricated Shed Northeast Side

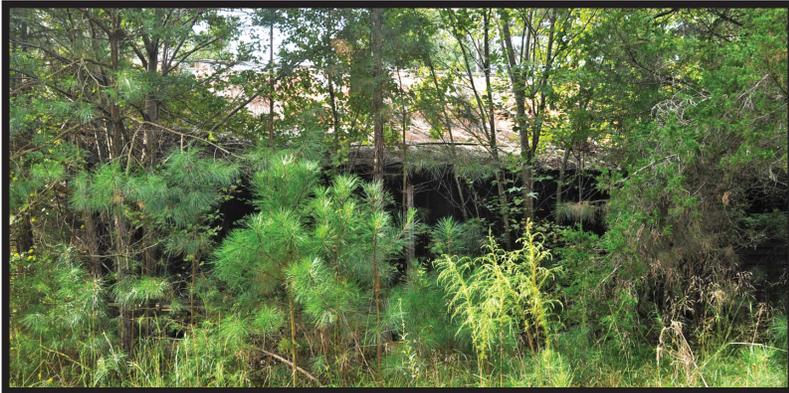
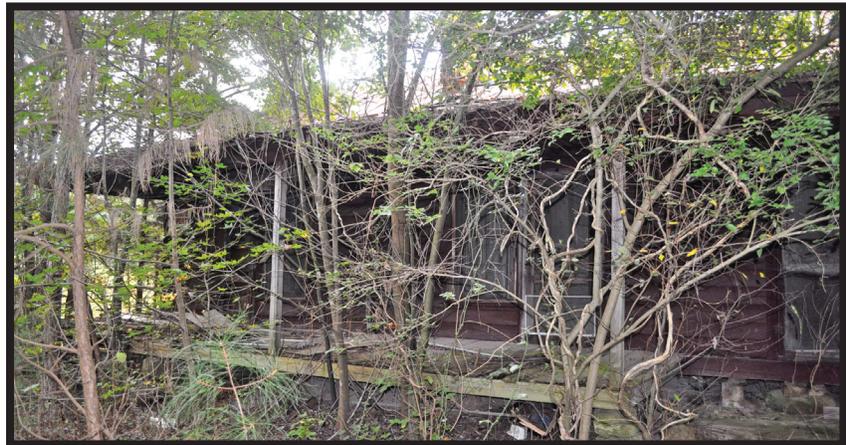
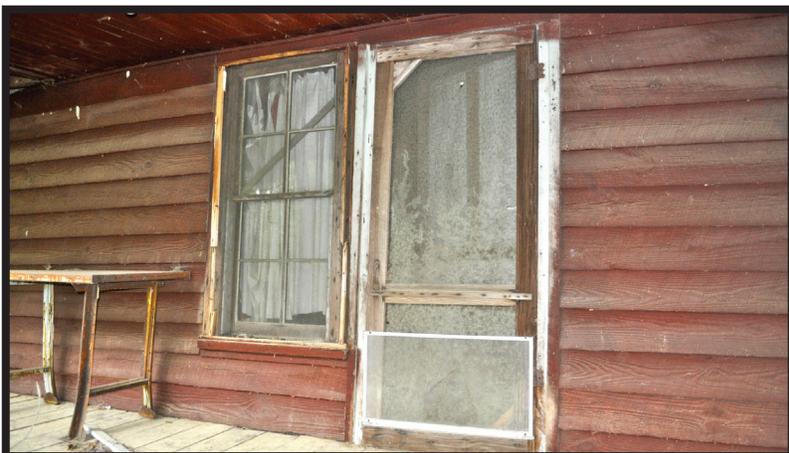
On the south side of Henry Baker Road and approximately 650-feet northeast of the main dwelling is a one-story side-gable tenant house with a partial width shed porch (Figure 26 and 27). Vegetation has overtaken the house making it difficult to photograph. The house rests on stone piers and has weatherboard siding and a deteriorated metal roof. There appear to be three dwelling units based on the fenestration of the north side. There are two door-and-window combinations under the porch, each with four-over-four windows a glazed entry (Figure 28). A single entry, without a window, is at the east end of the façade. A central chimney flue projects from the roof ridge.

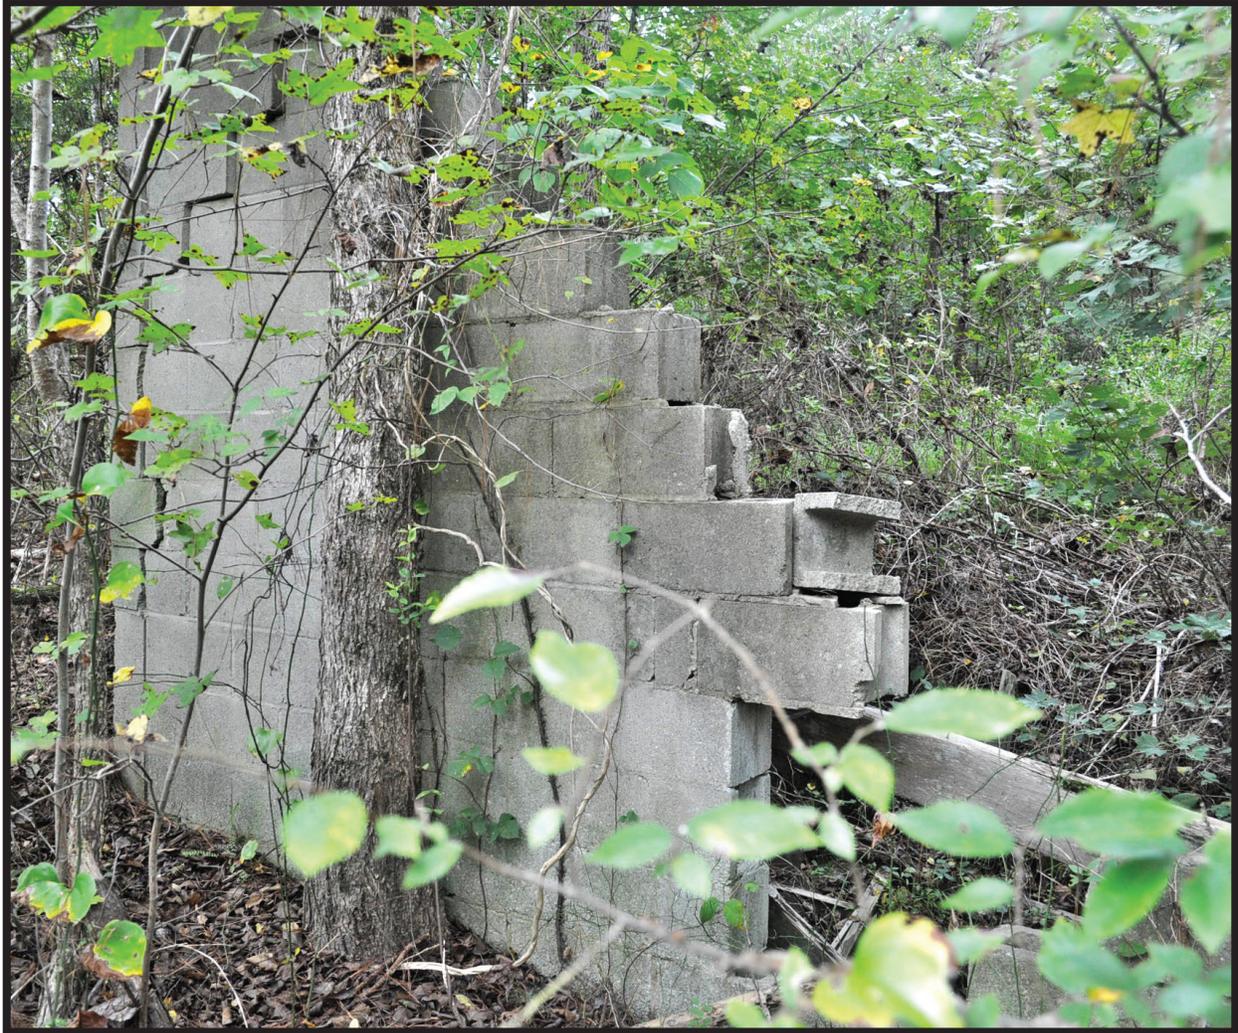
Two standing walls of a concrete block building were observed in an overgrown area south of the tenant house (Figure 29).

Figure 29. Concrete Block Building Ruin

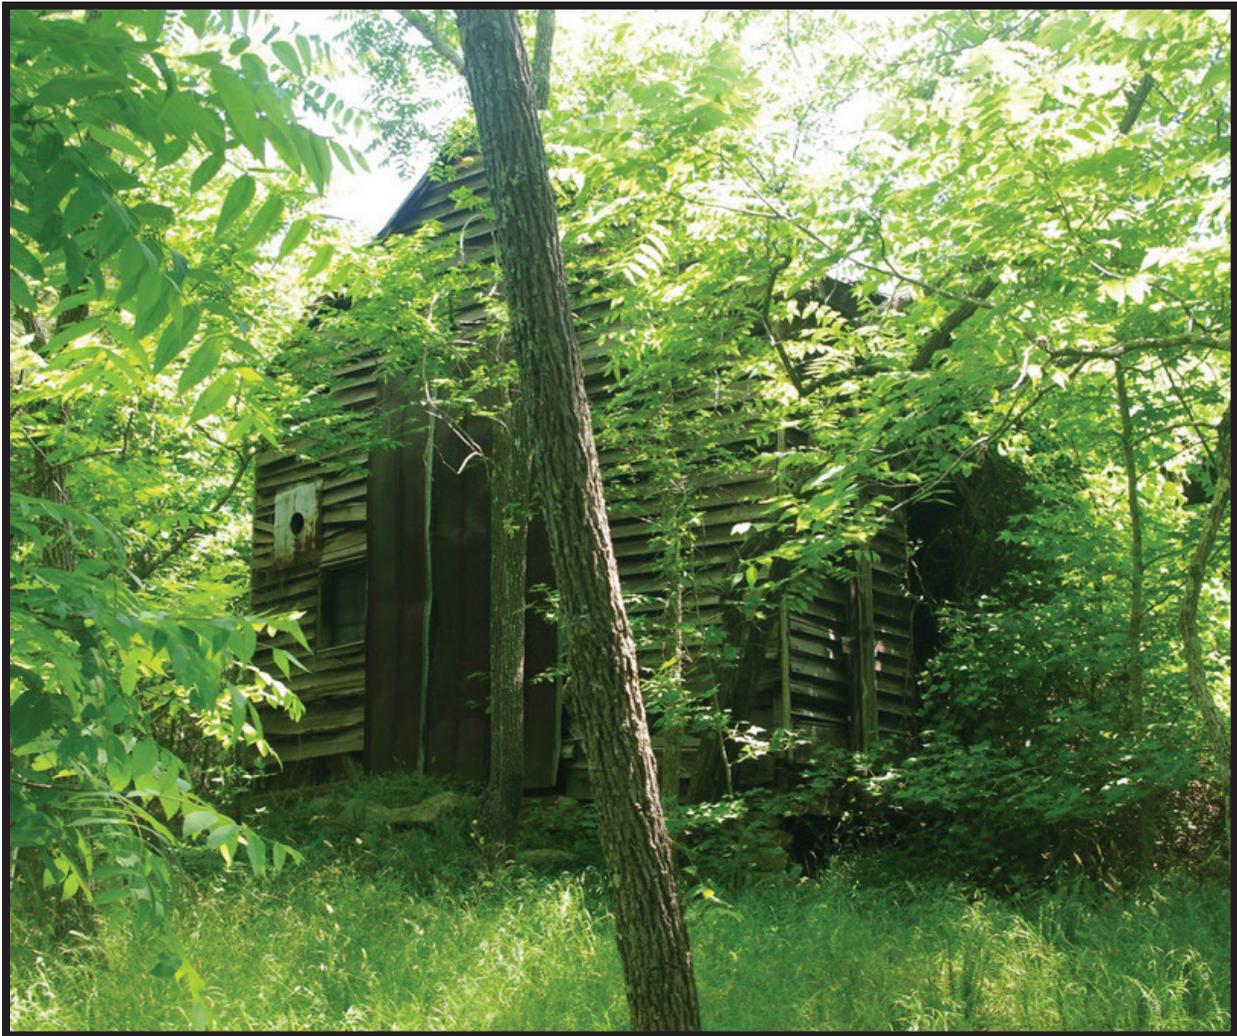
This outbuilding was observed in the woods on the north side of Henry Baker Road near the rock sluice of the mill pond. It is a one-story, side-gable rectangular frame building with weatherboard siding. It has a metal roof and is raised on piers (Figure 30). An opening for a stove flue is one of the gable ends. The building may be associated with milling activities that took place at the on Moccasin Creek.

Figure 30. Outbuilding

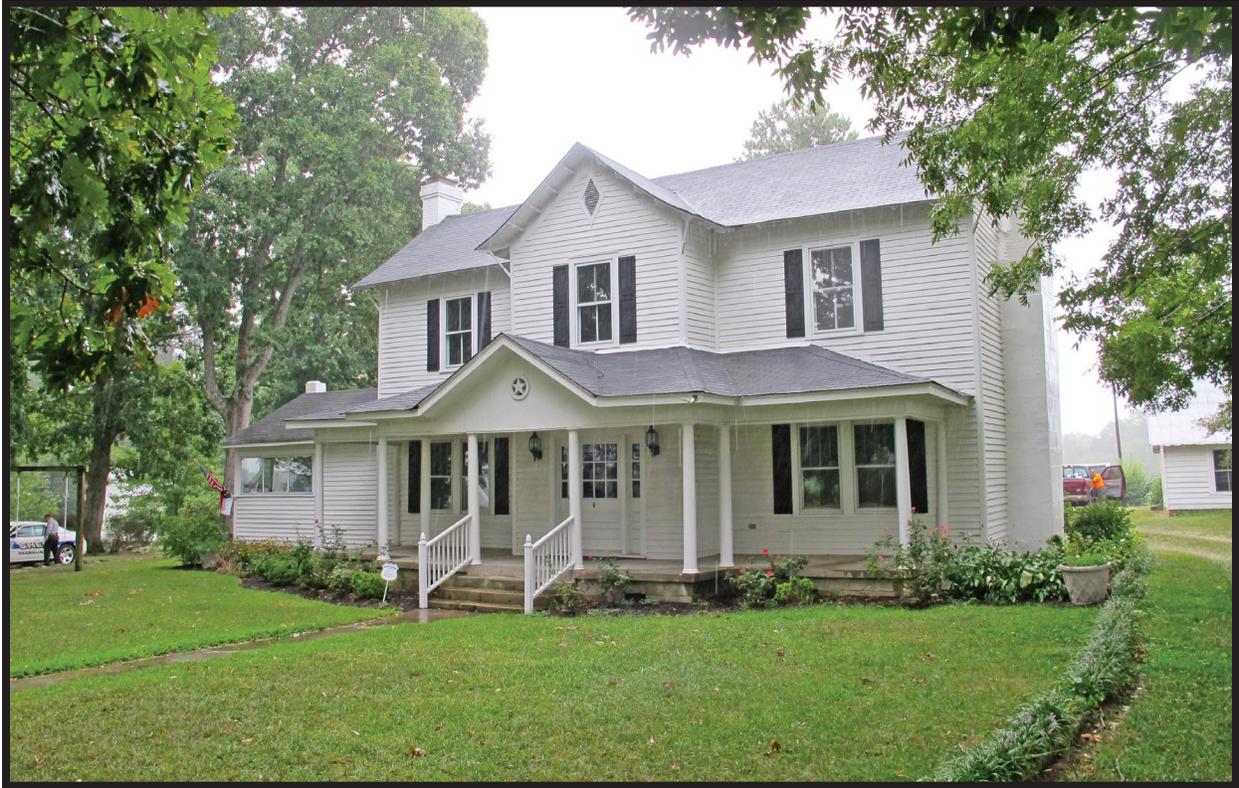
Figure 33. Frazier Farm (FK870). Photograph Courtesy Jeroen ven den Hurk, Commonwealth Heritage Group

A cluster of these projecting front-bay I-houses is found around the communities of Epsom and Ingleside north of Louisburg. The Frazier Farm (FK 870) is an intact version of the form with a hipped-roof columned front porch; scalloped rafter ends and spindled brackets (Figure 33). The house retains its original weatherboard siding, two-over-two windows and stone chimneys with brick stacks. The rear shed room and ell of this property reflects the form of the Phillips-Baker House prior to the construction of the additions. The property also retains a full complement of historic agricultural buildings including sheds, a smoke house, a concrete block livestock barn, a wood livestock barn, tobacco barns, equipment sheds, and a granary.
