# National Register Eligibility Evaluation of the Phillips-Baker House for the Replacement of Bridge 196 over Moccasin Creek on SR 2308 (Fowler Road/Henry Baker Road)

*Wake and Franklin Counties, North Carolina*

TIP No. B-4662  
WBS No. 38457.1.2

November 11, 2016 • **Final Report**  
New South Associates Technical Report 2630

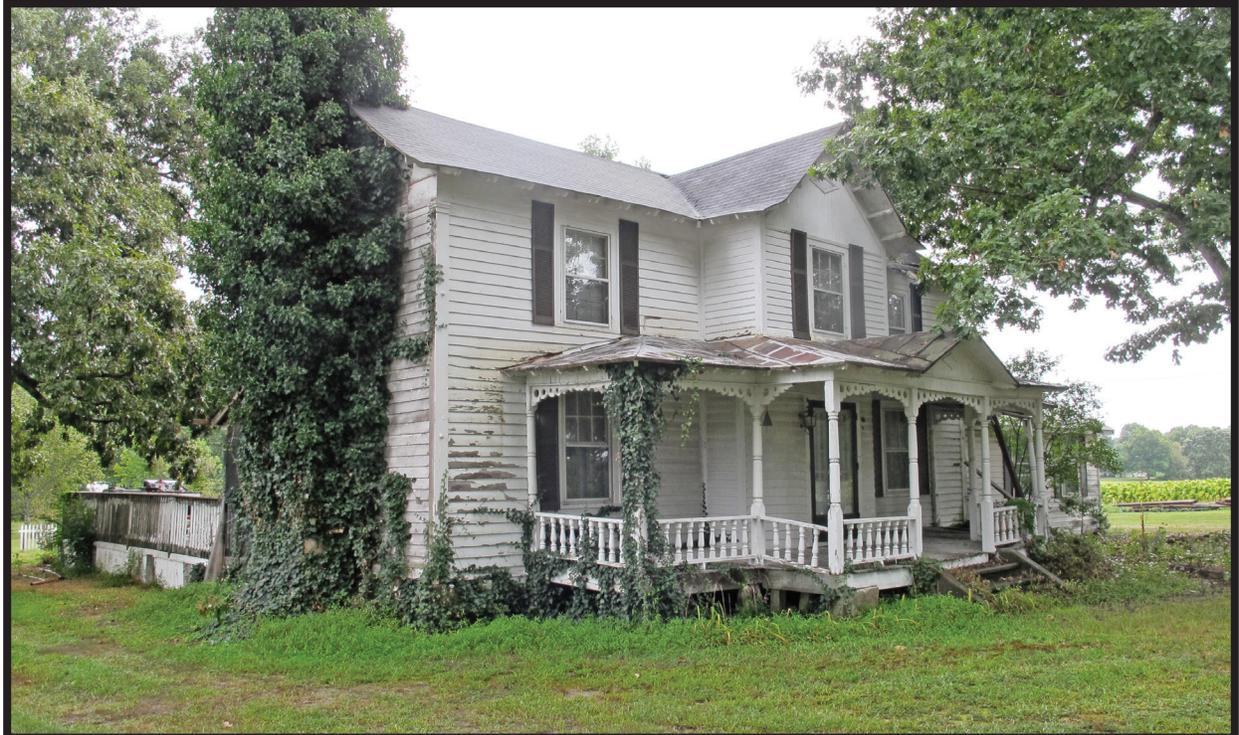
Figure 34. House, (FK 783). Photograph Courtesy Jeroen ven den Hurk, Commonwealth Heritage Group

FK 783 is an intact two-story dwelling with a central projecting bay (Figure 34). The house retains its original weatherboard siding, six-over-six windows and stone chimneys with brick stacks. Across the front is a hipped-roof porch with turned posts, a pierced frieze and a balustrade of squat spindles. The house is notable for the curved corners of the projecting bay under the porch. The house has slightly flared eaves with decorative rafter tails.

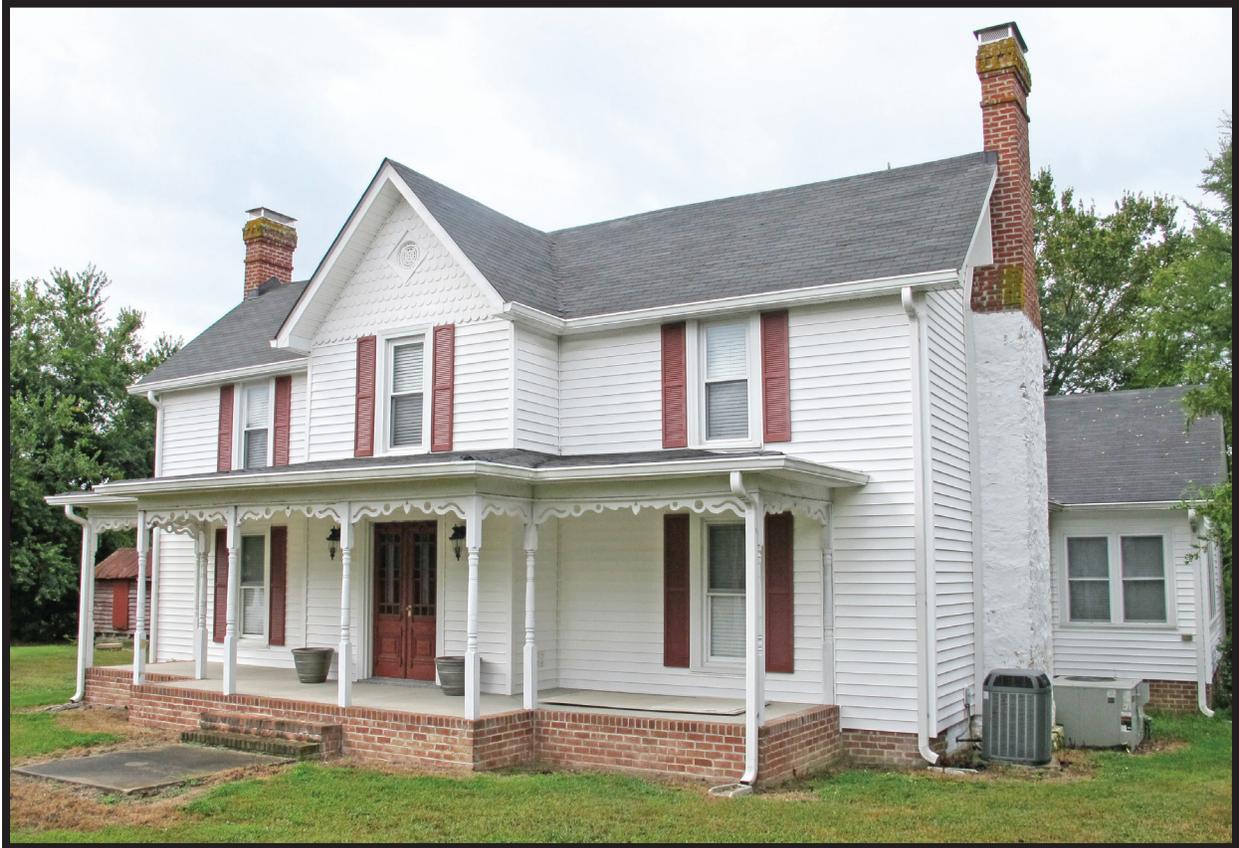
Figure 35. House, (FK 874). Photograph Courtesy Jeroen ven den Hurk, Commonwealth Heritage Group

FK 874 is an altered version of the projecting front bay I-house (Figure 35). Its original siding and windows have been replaced with vinyl facsimiles. The dwelling does retain its hipped-roof front porch with turned posts and a graceful jig sawn frieze. The lower parts of the stone chimneys remain; however, the brick stacks have been rebuilt.
