# **Overview of Oceanfront Shorelines: Cape Lookout to Sunset Beach, NC**

**Prepared By  
William J. Cleary**

**Prepared for  
Moffat & Nichol**

**August 8, 2008**

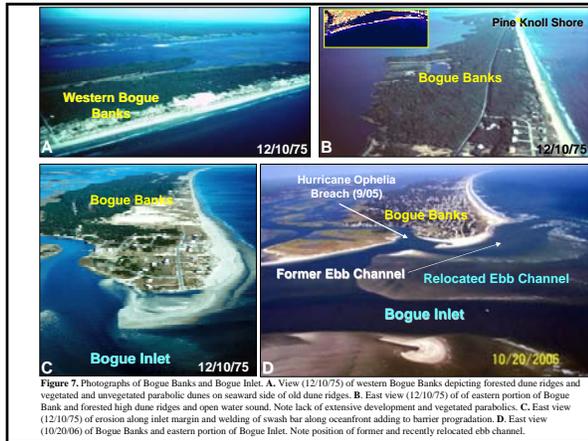
**Figure 7.** Photographs of Bogue Banks and Bogue Inlet. A. View (12/10/75) of western Bogue Banks depicting forested dune ridges and vegetated and unvegetated parabolic dunes on seaward side of old dune ridges. B. East view (12/10/75) of eastern portion of Bogue Bank and forested high dune ridges and open water sound. Note lack of extensive development and vegetated parabolics. C. East view (12/10/75) of erosion along inlet margin and welding of swash bar along oceanfront adding to barrier progradation. D. East view (10/20/06) of Bogue Banks and eastern portion of Bogue Inlet. Note position of former and recently relocated ebb channel.

Bogue Banks is the longest and widest barrier island in SE NC (Figs. 1 and 7). This composite and former progradational barrier is ~ 25.4 miles long and averages 1,970 ft in width. Unlike the areas to the south, the estuary behind Bogue Banks is generally open water (Fig. 7A-D). The lack of significant areas of tidal marsh suggests that inlets have not been active on an island scale in recent historic times. However, historic maps show isolated occurrences of former inlets at several sites. These areas include the low, narrow sites at Emerald Isle and at Atlantic Beach.

Bogue Inlet is one of the larger inlets in southeastern North Carolina (Fig. 7 C-D) and separates Bogue Banks and Bear Island (Hammocks Beach). The inlet drains an expansive portion of the adjacent estuary where two large, relatively deep tidal creeks connect the inlet to the AIWW and the White Oak River Basin (Fig. 4 A). The inlet has been a relatively stable feature over the past several centuries and has been confined to a 2,625 ft wide zone. Seismic studies of the shoreface indicate that the inlet is a “permanent” feature in the area, its location initially controlled by the paleo-channel of the White Oak River which extends across the shoreface (Hine and Snyder, 1985). The inlet has an exceptionally wide throat ~8,500 ft, a relatively narrow ebb channel ~700 ft and a large mid inlet shoal that occupies most of the western portion of the floodway (Cleary, 1996; Cleary and Marden 1999; CS & E, 2001; Cleary et al., 2003). The ebb channel is unstable and has a history of migration related to spit growth on opposing shoulders. The ebb channel began its recent eastward trek in 1981/82 while the outer bar segment of the channel was skewed toward Bear Island (Cleary, et al., 2003). Between 1981 and 2001, the throat section of the channel migrated to the east a net distance of 4,013 ft at an average rate of 201 ft/yr.

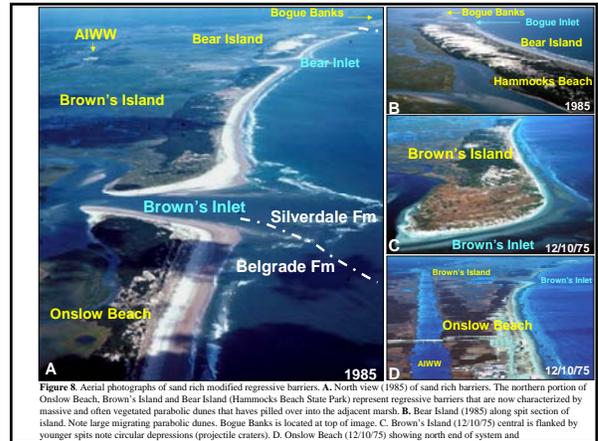
**Figure 8.** Aerial photographs of sand rich modified regressive barriers. A. North view (1985) of sand rich barriers. The southern portion of Onslow Beach, Brown's Island and Bear Island (Hammocks Beach State Park) represent regressive barriers that are now characterized by massive and often vegetated parabolic dunes that have pulled over into the adjacent marsh. B. Bear Island (1985) along spit section of island. Note large migrating parabolic dunes. Bogue Banks is located at top of image. C. Brown's Island (12/10/75) central is flanked by younger spits note circular depressions (projectile craters). D. Onslow Beach (12/10/75) showing north end of system and

Bear and Brown Islands are 3.3 and 3.9 miles long, respectively. They average 1,970 ft in width. They can be classified as altered regressive (prograded dune ridge) barriers (Figs. 4 and 8). Large medano-like and parabolic dunes characterize major portions of both islands. The earliest aerial photographs (1938) show the majority of both island surfaces were covered by large sand sheets with little vegetation cover (Cleary and Hosier, 1979 and Cleary and Pilkey, 1996). The existence of large steep spillover lobes in the adjacent estuary provides evidence for the landward migration of the sand dunes (Fig. 8). Elevations along the eastern portions of the barriers are as much as 52 ft. The nature of the dunes imaged in the 1938 photographs is similar to the migrating parabolic dunes found along all of the Brunswick County barriers in the 1930s and 1940s. The sand that formed the various migrating dune types on Bear and Brown's Islands was thought to have been originally contained in sets of prograded dune ridges similar to what is found on Bogue Banks.

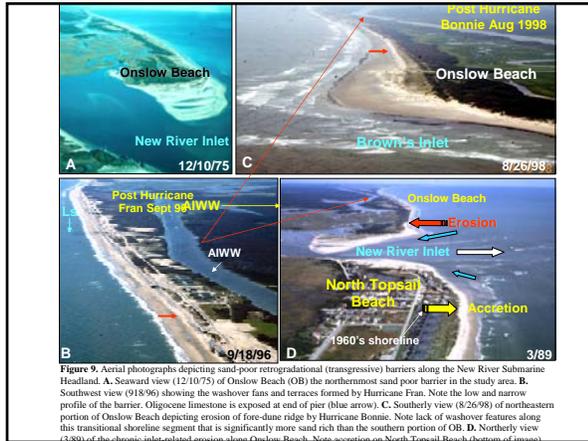
**Figure 9.** Aerial photographs depicting sand-poor retrogradational (transgressive) barriers along the New River Submarine Headland. A. Seaward view (12/10/75) of Onslow Beach (OB) the northernmost sand poor barrier in the study area. B. Southwest view (9/18/96) showing the washover fans and terraces formed by Hurricane Fran. Note the low and narrow profile of the barrier. Oligocene limestone is exposed at end of pier (blue arrow). C. Southerly view (8/26/98) of northeastern portion of Onslow Beach depicting erosion of fore-dune ridge by Hurricane Bonnie. Note lack of washover features along this transitional shoreline segment that is significantly more sand rich than the southern portion of OB. D. Northerly view (3/89) of this chronic ridge-related erosion along Onslow Beach. Note accretion on North Topsail Beach (bottom of image).

The southern segment of Onslow Beach is characterized by a narrow beach strewn with gravel, isolated “haystack” dunes with numerous washover passes and terraces extending into the marsh (Fig. 9 A-C). The structure of the remaining dune field is largely a result of the damage caused by the numerous maneuvers and operations of the U.S. Marine Corps. Staging and landing operations involving US Marines and heavy equipment including tanks and large “air-boats” have been carried out for decades. The highest erosion rates characterize the area immediately updrift of New River Inlet. The southernmost portion of the barrier is currently undergoing very rapid erosion (Fig. 9 D). Changes in the New River Inlet system since the 1940s are primarily responsible for the shoreline retreat (Cleary et al., 2003). The reader is referred to a more detailed report of the inlet contained in a subsequent section of this document.

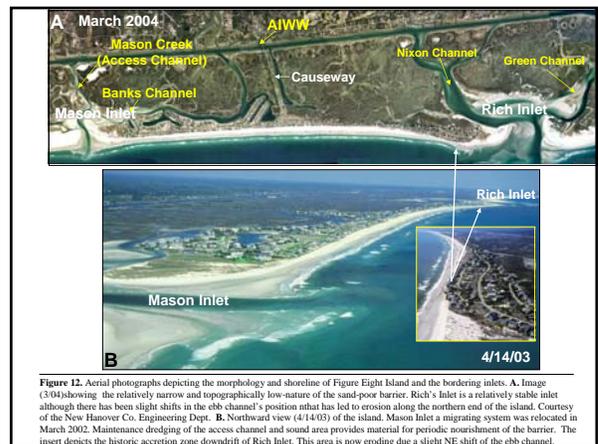
**Figure 12.** Aerial photographs depicting the morphology and shorelines of Figure Eight Island and the bordering inlets. A. Image (3/04) showing the relatively narrow and topographically low-nature of the sand-poor barrier. Rich's Inlet is a relatively stable inlet although there has been slight shifts in the ebb-channel's position that has led to erosion along the northern end of the island. Courtesy of the New Hanover Co. Engineering Dept. B. Northward view (4/14/03) of the island. Mason Inlet a migrating system was relocated in March 2002. Maintenance dredging of the access channel and sound area provides material for periodic nourishment of the barrier. The inset depicts the historic accretion zone downdrift of Rich Inlet. This area is now eroding due a slight NE shift of the ebb channel.

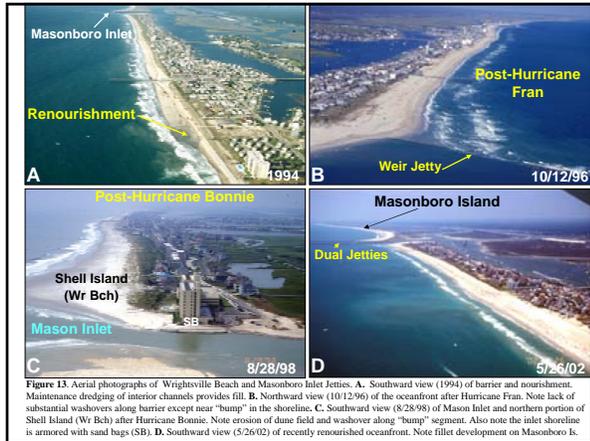
Figure 13. Aerial photographs of Wrightsville Beach and Masonboro Inlet Jetties. A. Southward view (1994) of barrier and nourishment. Maintenance dredging of interior channels provides fill. B. Northward view (10/12/96) of the oceanfront after Hurricane Fran. Note lack of substantial washovers along barrier except near "bump" in the shoreline. C. Southward view (8/28/98) of Mason Inlet and northern portion of Shell Island (Wr Bch) after Hurricane Bonnie. Note erosion of dune field and washover along "bump" segment. Also note the inlet shoreline is armored with sand bags (SB). D. Southward view (5/26/02) of recently renourished oceanfront. Note fill development on Masonboro Is.

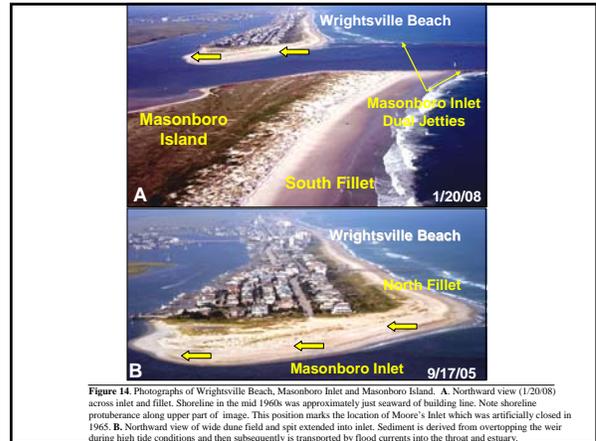
Figure 14. Photographs of Wrightsville Beach, Masonboro Inlet and Masonboro Island. A. Northward view (1/20/08) across inlet and fillet. Shoreline in the mid 1960s was approximately just seaward of building line. Note shoreline protruberance along upper part of image. This position marks the location of Moore's Inlet which was artificially closed in 1965. B. Northward view of wide dune field and spit extended into inlet. Sediment is derived from overtopping the weir during high tide conditions, and then subsequently is transported by flood currents into the throat and estuary.

Masonboro Island is an undeveloped barrier that extends along 8 miles of the coastline between Wrightsville Beach and Carolina Beach Extension (Figs. 14 and 17). Masonboro Inlet separates the island from Wrightsville Beach; Carolina Beach Inlet separates it from Carolina Beach to the south (Fig. 17 C). Masonboro Island was continuous with Carolina Beach until 1952 when Carolina Beach Inlet was artificially opened. Old Cabbage Inlet and other relict inlets (Fig. 17) are recognized by the geomorphic patterns found within the estuary (Cleary and Hosier, 1979). Most of the large dunes (12 ft elevation) are restricted to the northern portion of the island (4 mi) in the fillet of the Masonboro Inlet south jetty. The dunes along the remaining 60% of the barrier are very low and discontinuous (Cleary et al., 1999)

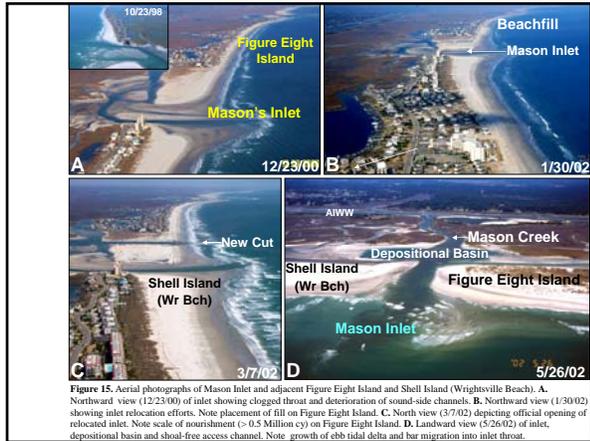
Figure 15. Aerial photographs of Mason Inlet and adjacent Figure Eight Island and Shell Island (Wrightsville Beach). A. Northward view (10/23/98) of inlet showing clogged throat and deterioration of sound-side channels. B. Northward view (1/30/02) showing inlet relocation efforts. Note placement of fill on Figure Eight Island. C. North view (3/7/02) depicting official opening of relocated inlet. Note scale of nourishment (>0.5 Million cy) on Figure Eight Island. D. Landward view (5/26/02) of inlet, depositional basin and shoal-free access channel. Note growth of ebb tidal delta and bar migration into inlet throat.

Mason Inlet located at the north end of Shell Island separates Figure Eight Island a private residential Island from Wrightsville Beach a public accessible barrier (Figs. 15 and 16). This relatively small inlet was the focal point of a number of management and regulatory issues during the period since the mid 1990s. The issues were related to the inlet related erosion hot-spots on both the updrift and downdrift oceanfronts, deterioration of the soundside channels, navigation improvements, armoring of the Shell Island inlet channel bank and the potential closure of the inlet. Historical studies of Mason Inlet documented its opening in the late 1880's and its subsequent southerly migration (Cleary and Hosier, 1979; Brooks, 1988; Cleary and Marden, 1999; and Johnsen, et al., 1999 and Freeman, 2001). The rate of inlet migration has varied by an order of magnitude over decadal scales and there have been minor short-term reversals in the direction of migration. During the period between 1974 and 1997 the inlet migrated southward 3,610 ft at an average rate of ~ 160 ft/yr. Rates over this time interval ranged from 3 - 295 ft/yr with the highest rates coinciding with overall shoaling of the inlet. In 1997 the Shell Island inlet margin was armored with oversized sandbags to protect infrastructure and the former Shell Island Resort complex (Fig. 15).

the channel increasing maximum depths from ~10 to 18 ft (ATM, 2000). Continued degradation of the soundside channels between 1999 and 2001 resulted in shoaling of the ebb channel and partial infilling of the poorly defined marginal flood channel on the updrift Figure Eight shoulder (Fig. 15 A).

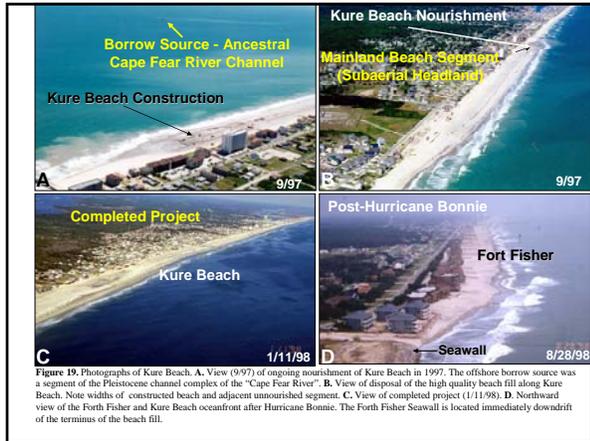
Figure 19. Photographs of Kure Beach. A. View (9/97) of ongoing nourishment of Kure Beach in 1997. The offshore borrow source was a segment of the Pleistocene channel complex of the "Cape Fear River". B. View of disposal of the high quality beach fill along Kure Beach. Note widths of constructed beach and adjacent unnourished segment. C. View of completed project (1/11/98). D. Northward view of the Fort Fisher and Kure Beach oceanfront after Hurricane Bonnie. The Fort Fisher Seawall is located immediately downdrift of the terminus of the beach fill.

The marsh-filled estuary found north, and again south, of Carolina Beach Extension does not exist behind the Carolina-Kure Beach mainland section (Figs. 1 and 19). This portion of the coast is characterized by a perched mainland beach. Elevations landward of the beach are 15 to 20 ft. Pleistocene-aged, erosion-resistant units underlie the mainland beach along the Carolina Beach shoreline segment. This shoreline has had a colorful history of shoreline stabilization attempts similar to those undertaken at Wrightsville Beach. Various generations of groins, berm construction and nourishment took place along this shoreline segment. The projects undertaken since development began (early 1900's) have proved to be short-term fixes; erosion of the mainland beach has persisted. Carolina Beach is one of the most frequently nourished beaches along the east coast. Historically the fill material for nourishment of Carolina Beach is derived from the maintenance dredging of Carolina Beach Inlet (Fig. 18 B). In addition to the aforementioned source of sand, an offshore borrow area was utilized in 1997 to nourish the oceanfront. It is likely that future projects will also rely on the inlet and the shoreface for sources of sand.

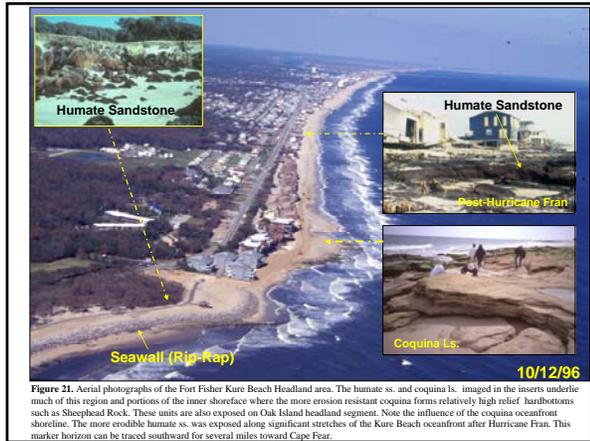
Figure 21. Aerial photographs of the Fort Fisher Kure Beach Headland area. The humate ss. and coquina ls. imaged in the inserts underlie much of this region and portions of the inner shoreface where the more erosion resistant coquina forms relatively high relief handbottoms such as Sheephead Rock. These units are also exposed on Oak Island headland segment. Note the influence of the coquina oceanfront shoreline. The more erodible humate ss. was exposed along significant stretches of the Kure Beach oceanfront after Hurricane Fran. This marker horizon can be traced southward for several miles toward Cape Fear.

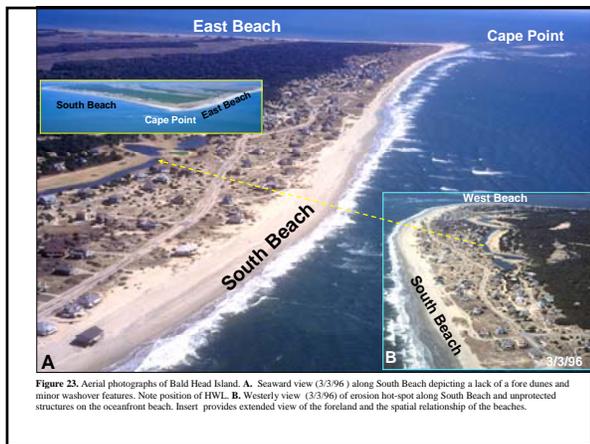
Figure 23. Aerial photographs of Bald Head Island. A. Seaward view (3/3/96) along South Beach depicting a lack of a fore dunes and minor washover features. Note position of HWL. B. Westerly view (3/3/96) of erosion hot-spot along South Beach and unprotected structures on the oceanfront beach. Insert provides extended view of the foreland and the spatial relationship of the beaches.

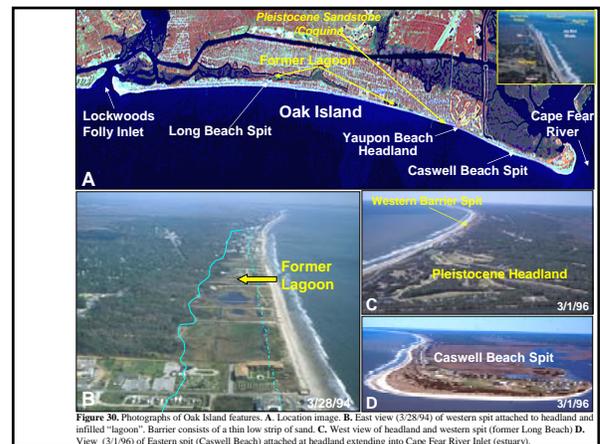
**Figure 31.** Photographs of Oak Island features. Oak Island is actually composed of a headland segment, separated from the mainland by the AIWW, and two spits extending east and west from the headland. A. Location image depicting relationship of major morphologic features. B. East view (1/20/08) of western spit attached to headland at Yaupon Beach. Barrier widens in a westward direction toward Lockwood's Folly Inlet of a thin low strip of sand. C. West view of headland and western spit (former Long Beach) D. View (3/1/96) of Eastern spit (Caswell Beach) attached at headland extending into Cape Fear River Inlet (estuary).

1998. The study continues to date. Under separate legislation and authorization the USACE constructed the Sea Turtle Habitat Ecosystem Restoration project on former Long Beach (now Oak Island), an environmental restoration project authorized under authority of Section 1135 of the Water Resources Department Act of 1986 (Fig. 34). Construction of the 2.3 mi long project was completed in early 2001. The beach fill project involves the placement of 1.83 million cy of material along a portion of the eastern half of Oak Island. The eastern terminus of the project is located ~ 1.0 mi west of the Yaupon Beach Headland (Fig. 34). The borrow source for the ecosystem restoration project was locally termed the Yellow Banks Area, an existing upland dredge material disposal site (Fig. 31) located along the AIWW, ~ 1.0 - 2.2 mi to the northwest (USACE, 1999).

In 2001 an ebb delta breaching event led to the reorientation of the ebb channel at Lockwood's Folly Inlet (Fig. 31 A insert) . The channel's shore-normal alignment ultimately led to a reconfiguration of the ebb delta. The symmetric configuration of the outer bar has initiated a period of accretion along the inlet and oceanfront shorelines (Fig. X). Accretion along the inlet and oceanfront shorelines will continue as long as the ebb channel maintains an alignment that is nearly shore normal or deflects toward Holden Beach.

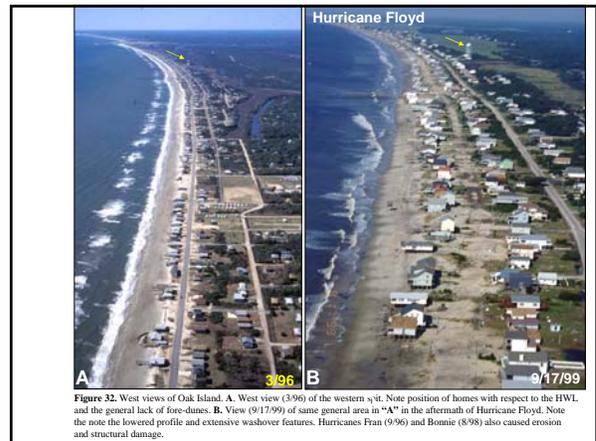
**Figure 32.** West views of Oak Island. A. West view (3/96) of the western spit. Note position of homes with respect to the HWL and the general lack of fore-dunes. B. View (9/17/99) of same general area as "A" in the aftermath of Hurricane Floyd. Note the lowered profile and extensive washover features. Hurricanes Fran (9/96) and Bonnie (8/98) also caused erosion and structural damage.

With the exception of Hurricane Floyd, the hurricanes that impacted the area between July 1996 and October 1999 did minimal structural damage (Figs. 32 and 33). However, erosion of the narrow, artificially enhanced dune line and minor overwash occurred during all storms. Oak Island was spared the damage recorded along the New Hanover, Pender and Onslow Counties beaches after Hurricanes Bertha, Fran, and Bonnie due to its position in the lee of Cape Fear and the track and landfall location of the storms. Although Hurricane Floyd's storm surge only reached 7.9 ft m along Oak Island significant damage occurred (Figs. 32B and 33). Despite the fact that the oceanfront was in poor condition, only the oceanfront homes were seriously damaged. Where elevations were low washover fans extended across much of the coastal road. Damage would have been dramatically more severe had the storm surge reached its maximum potential.

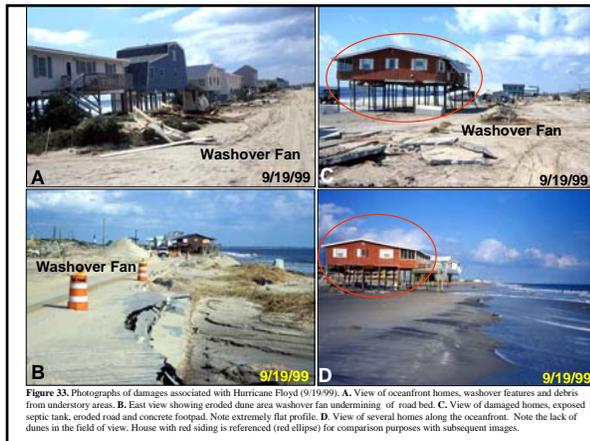
**Figure 33.** Photographs of damages associated with Hurricane Floyd (9/19/99). A. View of oceanfront homes, washover features and debris from understorey areas. B. East view showing eroded dune area washover fan undermining of road bed. C. View of damaged homes, exposed septic tank, eroded road and concrete footings. Note extremely flat profile. D. View of several homes along the oceanfront. Note the lack of dunes in the field of view. House with red siding is referenced (red ellipse) for comparison purposes with subsequent images.

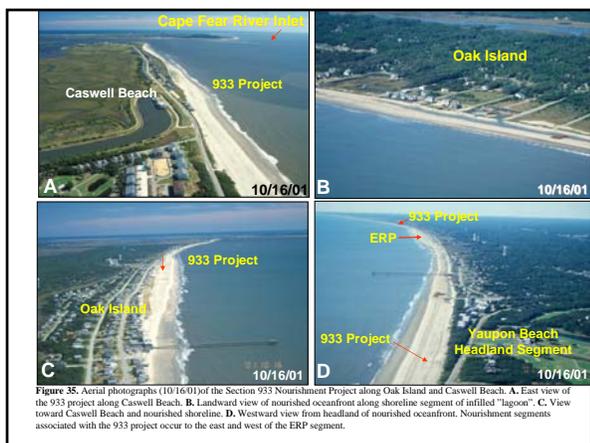
**Figure 35.** Aerial photographs (10/16/01) of the Section 933 Nourishment Project along Oak Island and Caswell Beach. A. East view of the 933 project along Caswell Beach. B. Landward view of nourished oceanfront along shoreline segment of "infilled" lagoon". C. View toward Caswell Beach and nourished shoreline. D. Westward view from headland of nourished oceanfront. Nourishment segments associated with the 933 project occur to the east and west of the ERP segment.

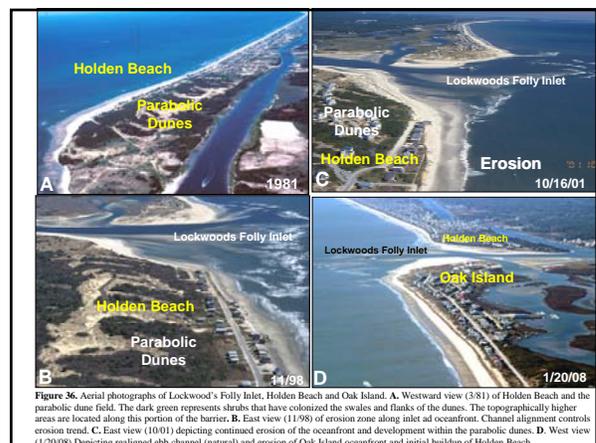
**Figure 36.** Aerial photographs of Lockwood's Folly Inlet, Holden Beach and Oak Island. A. Westward view (3/81) of Holden Beach and the parabolic dune field. The dark green represents shrubs that have colonized the swales and flanks of the dunes. The topographically higher areas are located along this portion of the barrier. B. East view (11/88) of erosion zone along inlet ad oceanfront. Channel alignment controls erosion trend. C. East view (10/01) depicting continued erosion of the oceanfront and development within the parabolic dunes. D. West view (1/20/08) depicting realigned oxb channel (natural) and erosion of Oak Island oceanfront and initial buildup of Holden Beach.

Holden Beach is a 8.1 mile long transgressive barrier bordered by Lockwood's Folly Inlet to the east and Shallotte Inlet to the west (Figs. 36 and 37). The island is comprised of several zones where large parabolic dunes are present that reach elevations of ~32 ft (Fig. 36). The intervening shoreline reaches connecting the topographically wider and higher segments are former inlet zones that are considered to be high hazard zones (Fig. 38). Although the two inlets that border the barrier have been reasonably stable during the past 70 years, significant changes have occurred along the Holden Beach oceanfront due to the changing position and alignment of the ebb channels of Lockwood's Folly Inlet (Cleary, 1999b) to the east and Shallotte Inlet to the west (Figs. 36, 39 and 40).

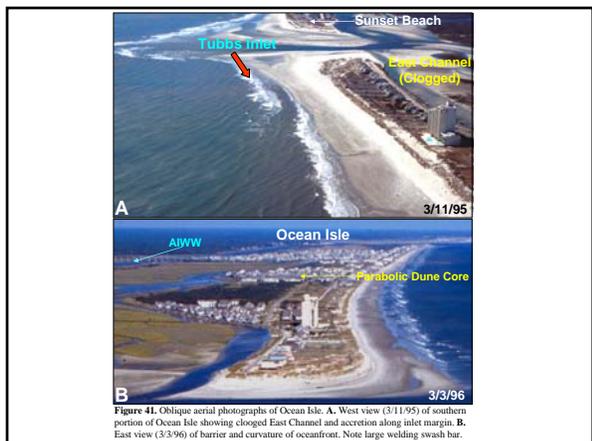
Figure 41. Oblique aerial photographs of Ocean Isle. A. West view (3/11/95) of southern portion of Ocean Isle showing clogged East Channel and accretion along inlet margin. B. East view (3/3/96) of barrier and curvature of oceanfront. Note large welding swash bar.

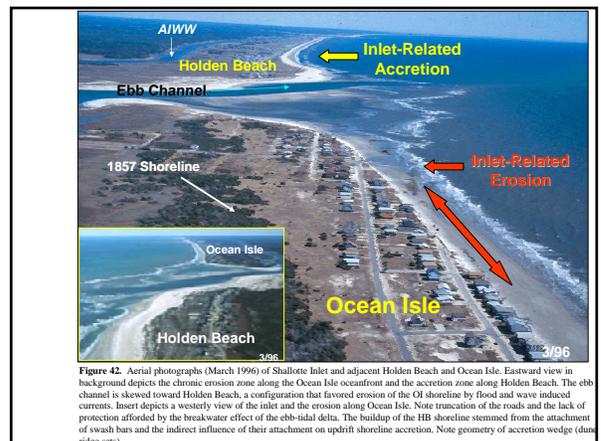
Figure 42. Aerial photographs (March 1996) of Shallotte Inlet and adjacent Holden Beach and Ocean Isle. Eastward view in background depicts the chronic erosion zone along the Ocean Isle oceanfront and the accretion zone along Holden Beach. The ebb channel is skewed toward Holden Beach, a configuration that favored erosion of the OI shoreline by flood and wave induced currents. Insert depicts a westerly view of the inlet and the erosion along Ocean Isle. Note truncation of the roads and the lack of protection afforded by the breakwater effect of the ebb-tidal delta. The buildup of the HB shoreline stemmed from the attachment of swash bars and the indirect influence of their attachment on updrift shoreline accretion. Note geometry of accretion wedge (dune ridge area)

Since the mid 19<sup>th</sup> century Shallotte Inlet has been a relatively stable inlet with respect to its location (Fig. 42). However in terms of a morphologic aspect, it has been highly unstable inlet which has led to significant changes along the Ocean Isle shoulder. These changes are directly related to the changing position and deflection/reorientation of the ebb channel, that facilitates changes in the symmetry of the ebb delta. Since the early 1970's a variety of erosion mitigation efforts have failed to stabilize the shoreline near the inlet (Fig. 43). When the ebb channel was skewed toward Holden Beach (SE alignment), the Ocean Isle margin eroded. This configuration existed from the mid 1960s until 2001 when the channel was relocated by the USACE. During the early 1960's when the channel alignment was ~ shore normal, accretion was common on both shoulders of the inlet. Deviation from this alignment promoted erosion on one or both shoulders as the ebb delta assumed an asymmetrical and altered its breakwater effect (Marden and Cleary, 1999 and Marden, 1999)

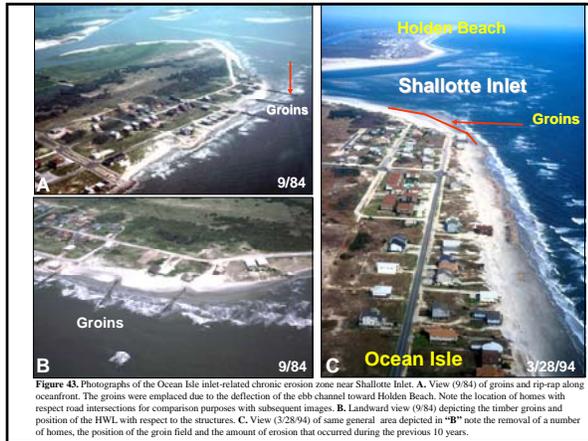
**Figure 43.** Photographs of the Ocean Isle inlet-related chronic erosion zone near Shallotte Inlet. A. View (9/84) of groins and rip-rap along oceanfront. The groins were emplaced due to the deflection of the ebb channel toward Holden Beach. Note the location of homes with respect to road intersections for comparison purposes with subsequent images. B. Landward view (9/84) depicting the timber groins and position of the HWL with respect to the structures. C. View (3/28/94) of same general area depicted in "B" note the removal of a number of homes, the position of the groin field and the amount of erosion that occurred during the previous 10 years.

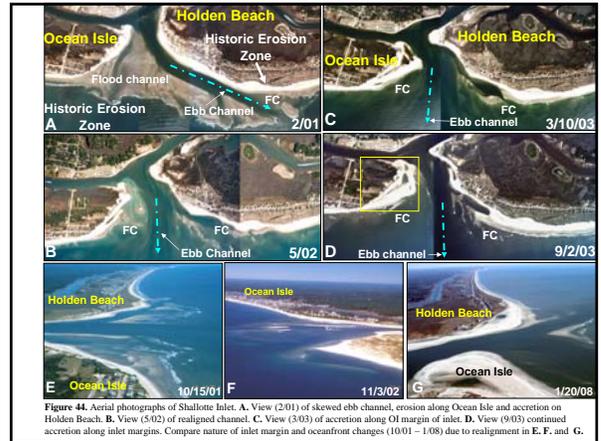
**Figure 44.** Aerial photographs of Shallotte Inlet. A. View (2/01) of skewed ebb channel, erosion along Ocean Isle and accretion on Holden Beach. B. View (5/02) of realigned channel. C. View (3/03) of accretion along OI margin of inlet. D. View (9/03) continued accretion along inlet margins. Compare nature of inlet margin and oceanfront changes (10/01 - 1/08) due to realignment in E, F, and G.

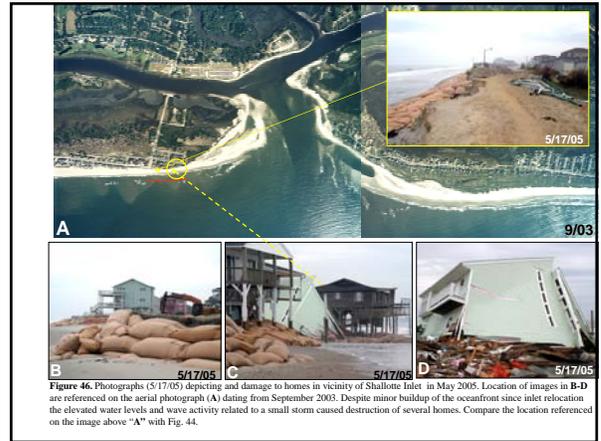
**Figure 46.** Photographs (5/17/05) depicting and damage to homes in vicinity of Shallotte Inlet in May 2005. Location of images in B-D are referenced on the aerial photograph (A) dating from September 2003. Despite minor buildup of the oceanfront since inlet relocation the elevated water levels and wave activity related to a small storm caused destruction of several homes. Compare the location referenced on the image above "A" with Fig. 44.

In May 2005 a small storm moved through the area and the associated elevated water level and increased wave activity eroded the oceanfront immediately adjacent to the inlet. In addition to the loss of the newly accreted material the storm destroyed several homes (Fig. 45) along this high hazard zone. Figure 47 depicts the condition of the oceanfront shoreline within this zone following Hurricane Ophelia that moved up the upcoast on September 20, 2005. The image clearly illustrates that this oceanfront segment will continue to erode during high energy events due the fact that its planform (curvature or protuberance) is a vestige of a former accretionary period and shoreline armoring. The dashed yellow delineates the likely equilibrium

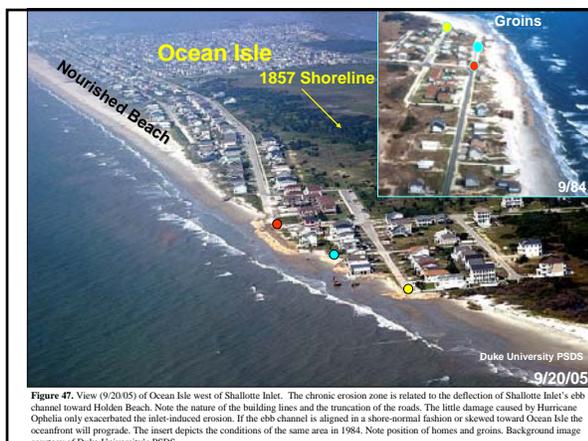
**Figure 47.** View (9/20/05) of Ocean Isle west of Shallotte Inlet. The chronic erosion zone is related to the deflection of Shallotte Inlet's ebb channel toward Holden Beach. Note the nature of the building lines and the truncation of the roads. The little damage caused by Hurricane Ophelia only exacerbated the inlet-induced erosion. If the ebb channel is aligned in a shore-normal fashion or skewed toward Ocean Isle the oceanfront will prograde. The insert depicts the conditions of the same area in 1984. Note position of homes and groins. Background image courtesy of Duke University's PSDS.

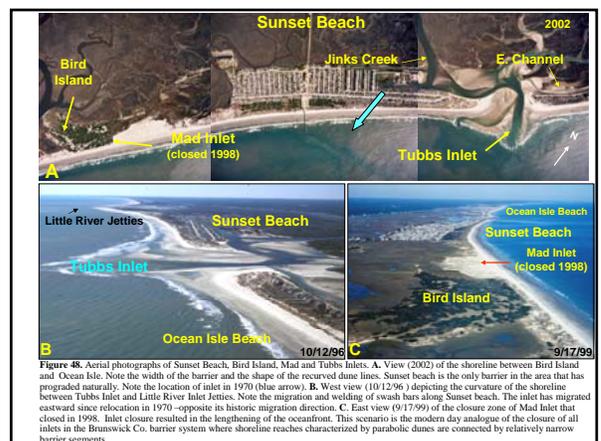
**Figure 48.** Aerial photographs of Sunset Beach, Bird Island, Mad and Tubbs Inlets. A. View (2002) of the shoreline between Bird Island and Ocean Isle. Note the width of the barrier and the shape of the recurved dune lines. Sunset beach is the only barrier in the area that has prograded naturally. Note the location of inlet in 1970 (blue arrow). B. West view (10/12/96) depicting the curvature of the shoreline between Tubbs Inlet and Little River Inlet Jetties. Note the migration and welding of swash bars along Sunset beach. The inlet has migrated eastward since relocation in 1970—opposite its historic migration direction. C. East view (9/17/99) of the closure zone of Mad Inlet that closed in 1998. Inlet closure resulted in the lengthening of the oceanfront. This scenario is the modern day analogue of the closure of all inlets in the Brunswick Co. barrier system where shoreline reaches characterized by parabolic dunes are connected by relatively narrow barrier segments.

The combined influence of the spacing and migration habits of Mad and Tubbs Inlets has dictated the observed shoreline change patterns on Sunset Beach. Data clearly show that between 1949 and 2002 the mid-barrier portion exhibited a net progradation of as much as 395 ft, a trend unique to southeastern North Carolina barrier islands. Shoreline accretion increased toward the western portion of the barrier, east of the Mad Inlet closure zone, where as much as 426 ft of accretion occurred along the western spit extension of Sunset Beach. The shoreline change patterns west of the core of Sunset Beach may have been influenced by the dual jetty system at Little River Inlet ~2 km to the west. In contrast, along the Sunset Beach shoreline farther to the east (towards Tubbs Inlet), net accretion decreased dramatically due to the truncation of the oceanfront shoreline as the inlet-influenced erosion hot-spot shifted in an eastward direction. Net erosion has become the norm along the realigned shoreline of the elongating spit immediately west of Tubbs Inlet. Erosion along this shoreline reach is predicted to increase as the inlet continues to track in an easterly direction and the island lengthens. These results show that during periods of inlet convergence the island experienced net accretion, while showing net erosion during episodes of inlet divergence (Budde and Cleary, 2006).
